# Your survey & valuation report

Property Address

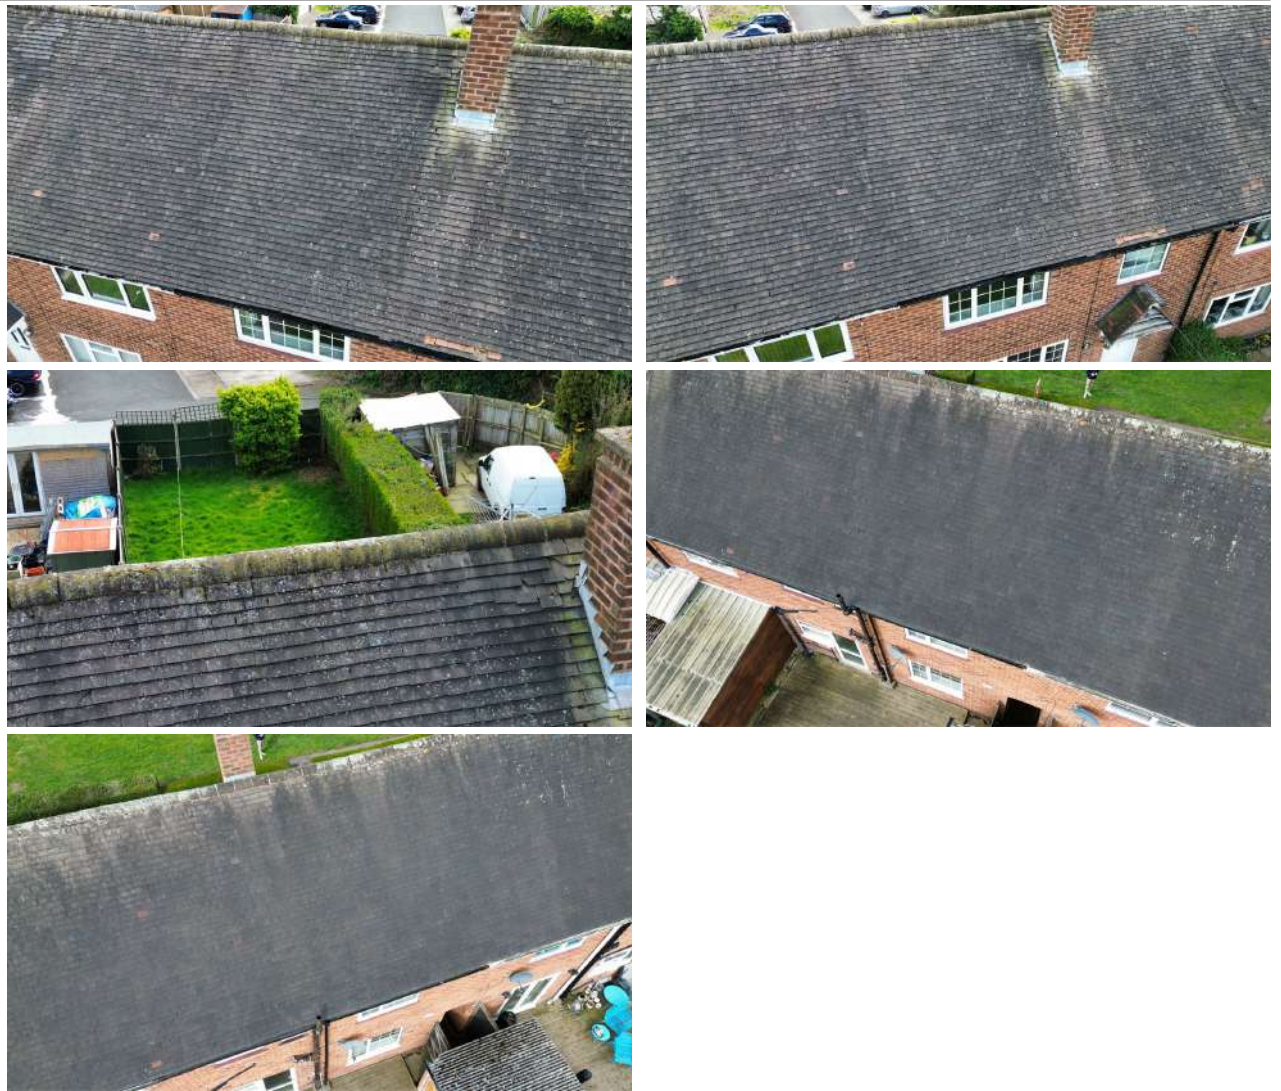
The roof covering appeared to be generally serviceable at the time of inspection, although cracked and slipped tiles were noted together with limited ventilation provision. Localised repairs and routine maintenance should be undertaken to keep the roof weathertight and reduce the risk of water ingress.

Moss growth was noted and should be managed on a routine basis, as excessive build-up can impede the proper run-off of rainwater, contribute to deterioration of the roof covering and increase the risk of blockages to the rainwater goods. Once removed, some localised repairs to the roof covering may also prove necessary.

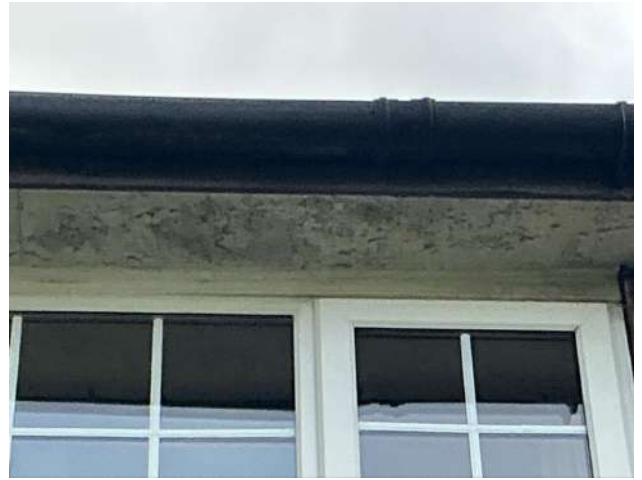
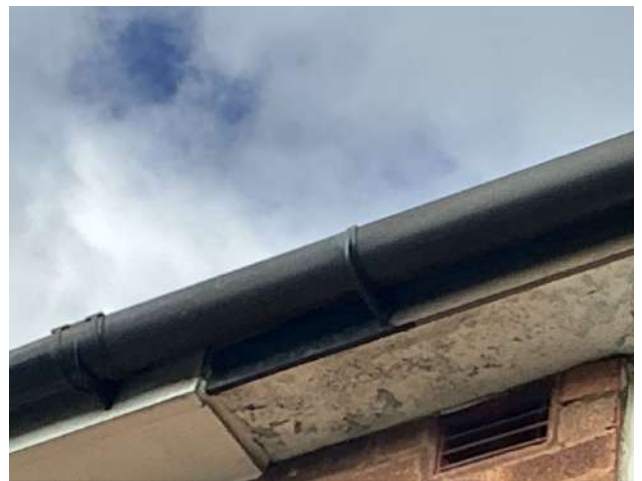
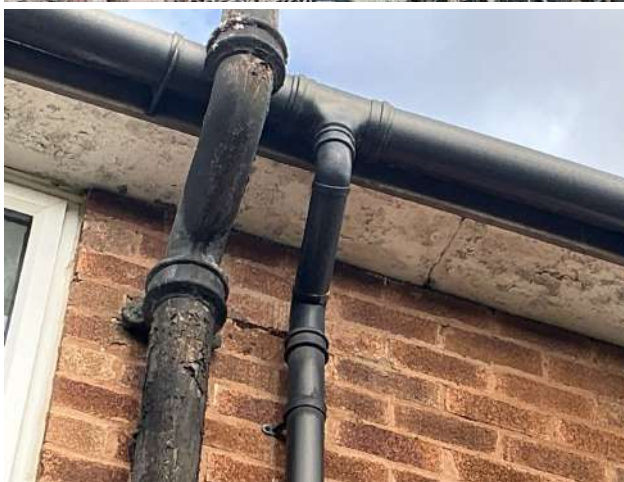
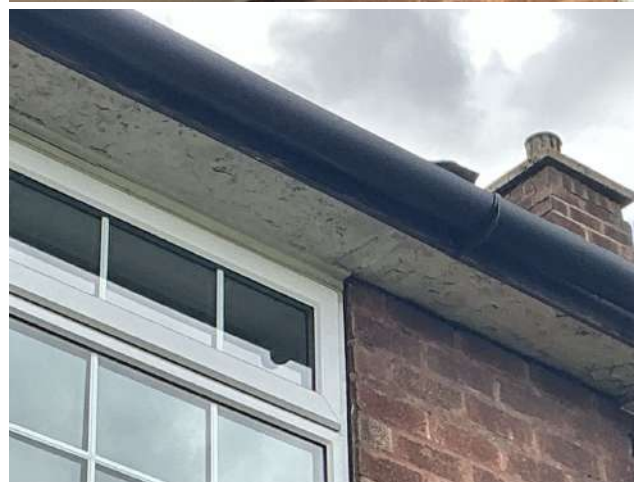
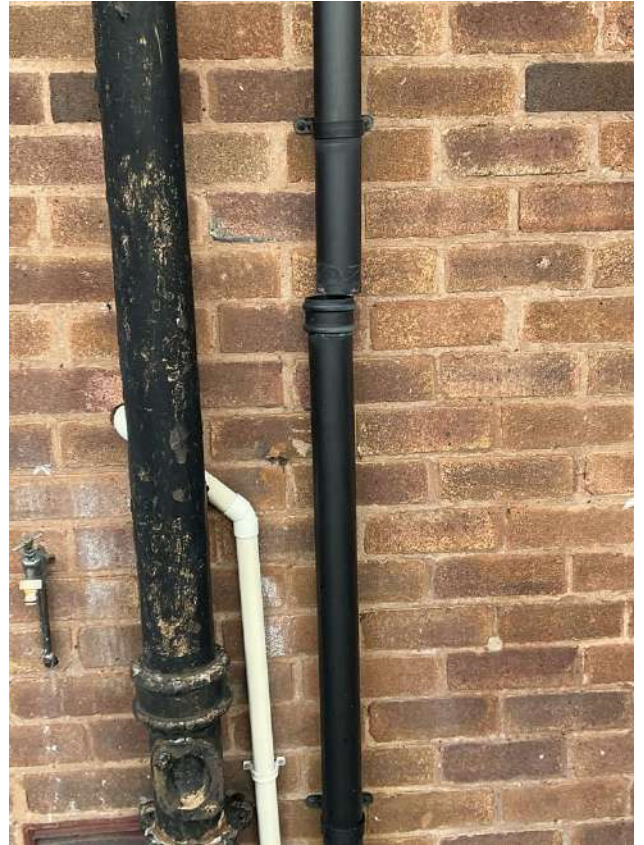
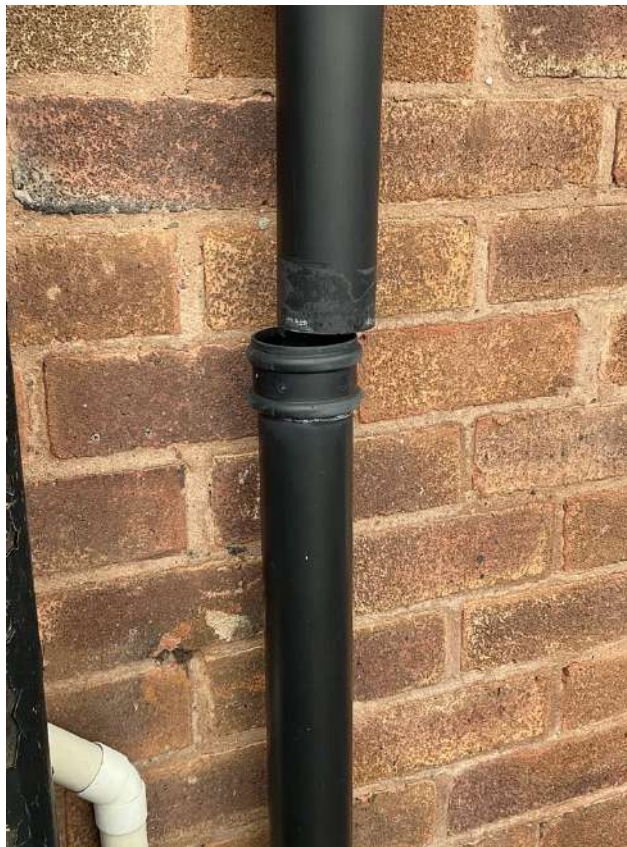
### D3 Rainwater pipes and gutters

The rainwater goods were found to be generally functional but we noted some defects such as soiled, stained sections, defective fixings and debris in gutters. Repair and maintenance works are now required.

Leaking rainwater disposal systems can lead to penetrating dampness and deterioration of the building. Rainwater goods should be kept clean and free of any standing debris and moss at, all times, to ensure the free flow of surface water runoff from roofs. Regular inspections should, therefore, be undertaken moving forward. Shortly after taking up occupation, you should arrange for the gutters to be cleaned, removing any moss, leaves and general debris.

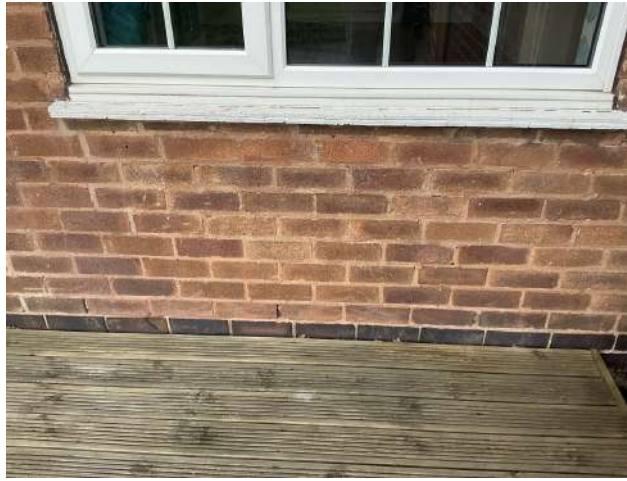
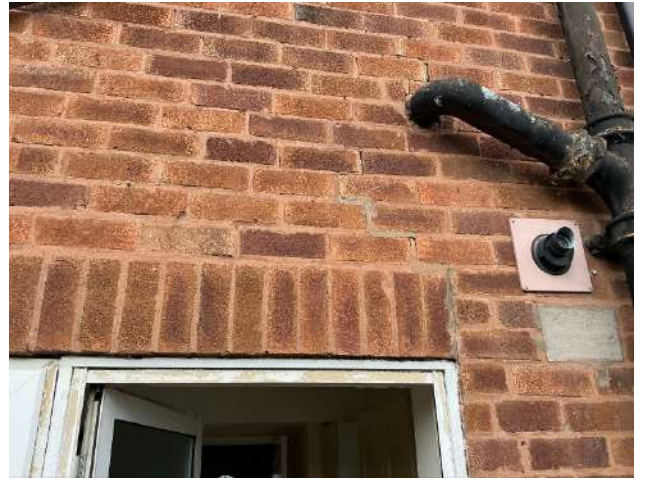
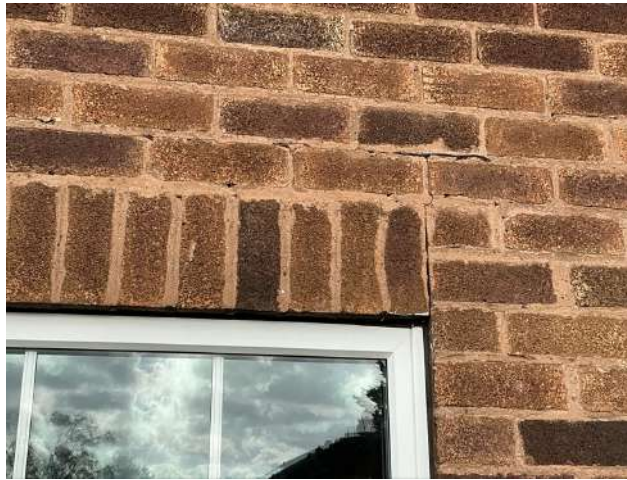
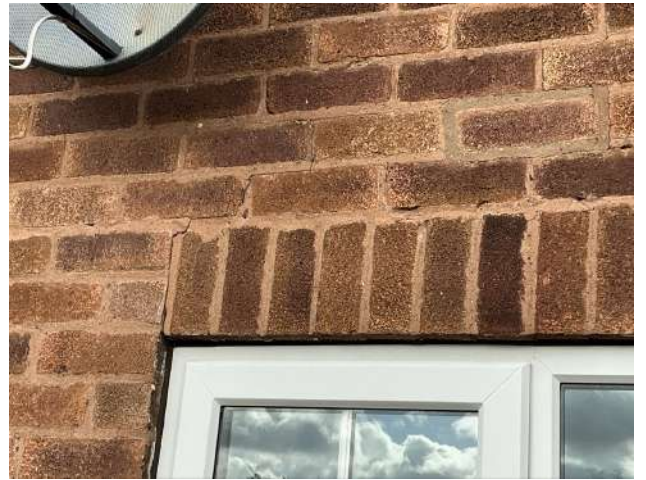
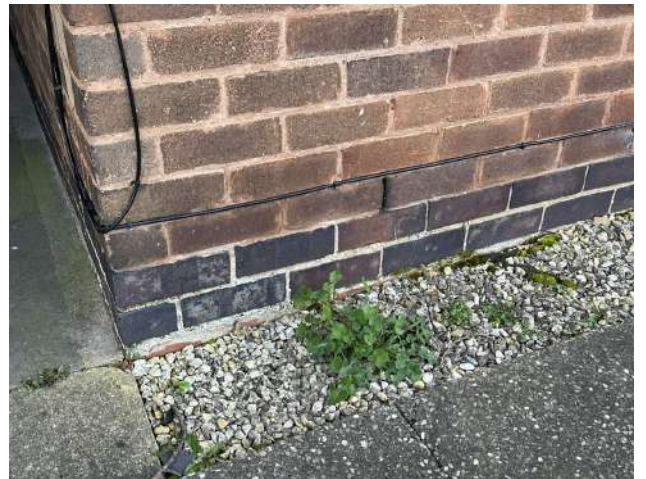
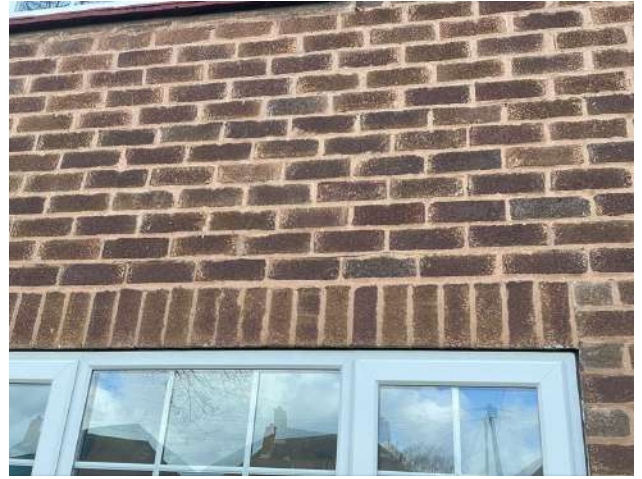
#### D4 Main walls

The overall condition of the walls were found to be adequate but some defects were noted, such as weathered pointing, minor cracking and weathered finishes. Repair and maintenance works will be required in due course.

There are a number of minor cracks in the external walls, probably due to nominal thermal moisture changes, installation work and settlement. Whilst not structurally serious, cracks should be filled to prevent water penetration.

Properties of this age are unlikely to have full lintel support above the openings. As slight settlement was noted above some of the openings, you should consider upgrading the support in order to prevent problems with frames and openings. You should therefore budget accordingly.

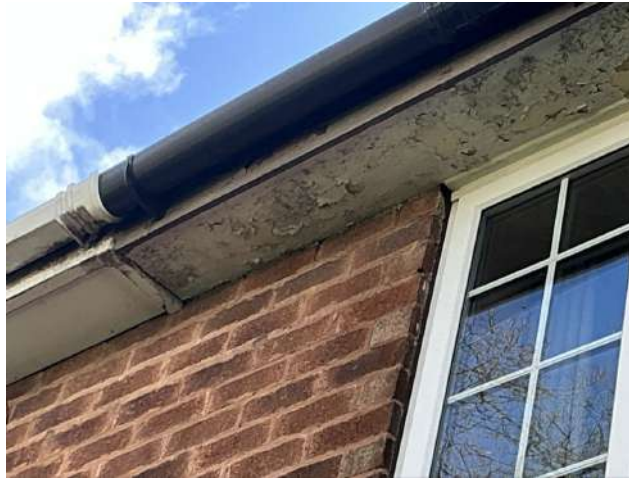
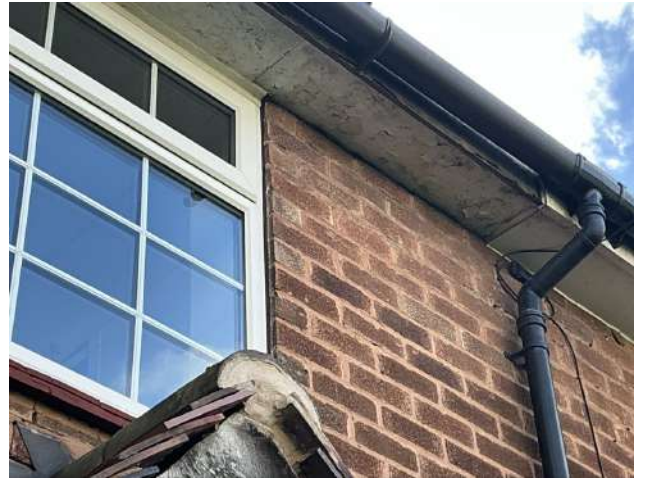
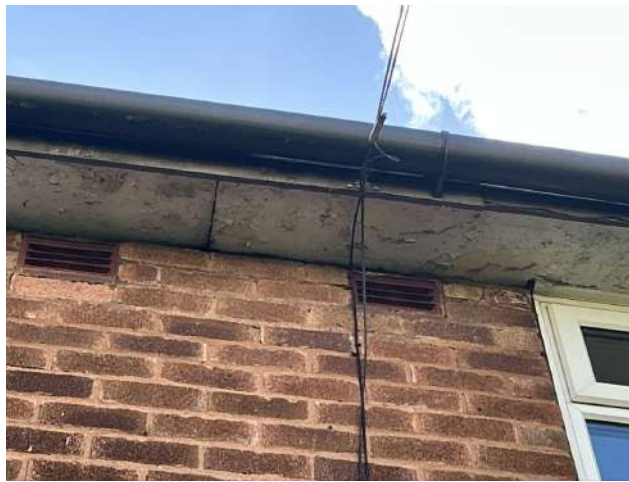
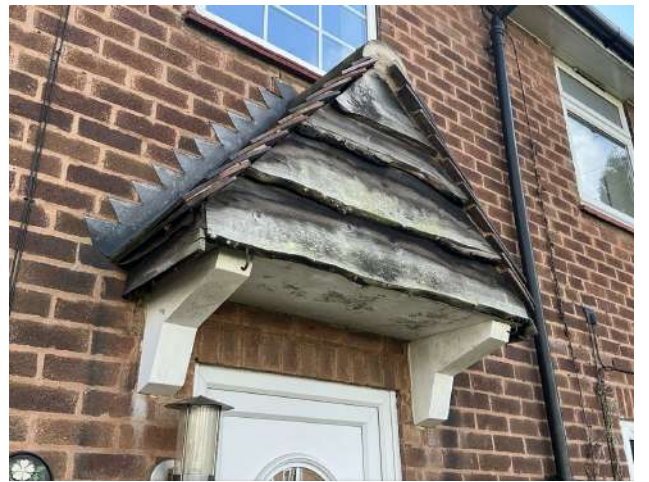
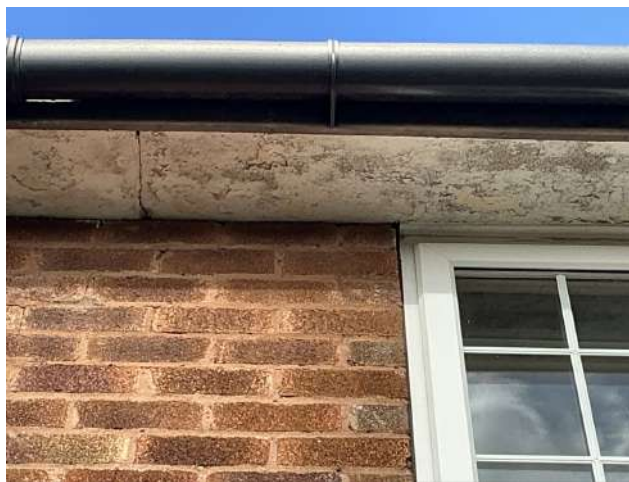
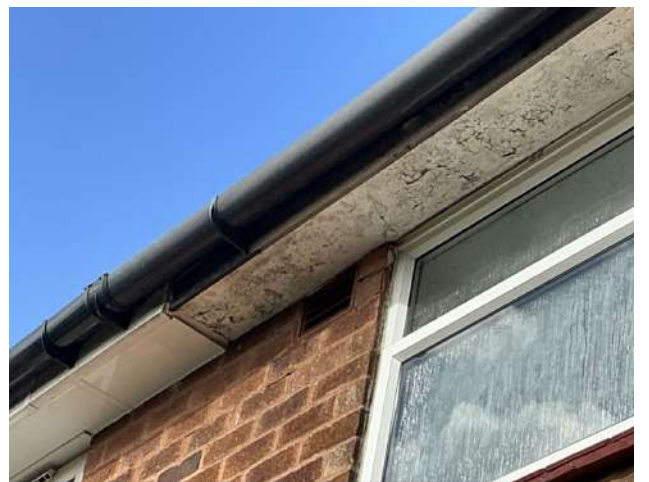
External decorations are deteriorating in some areas. The affected sections should be thoroughly prepared and redecorated in the near future.

The external woodwork will need regular redecoration, typically on a 3 - 5 yearly cycle depending on the quality of paint or stain coatings, exposure factors, and condition of the surfaces beneath.

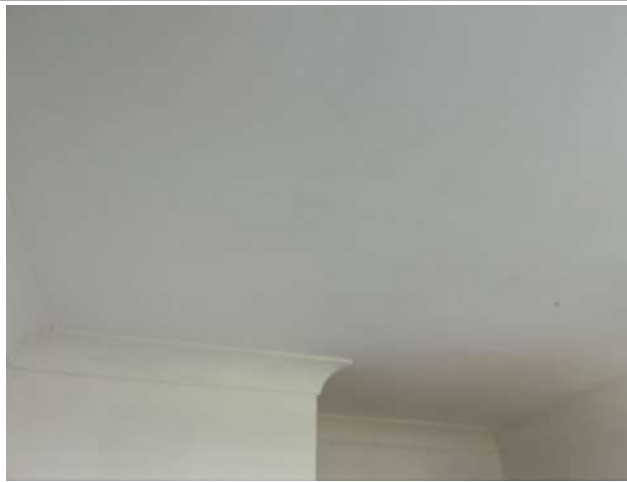
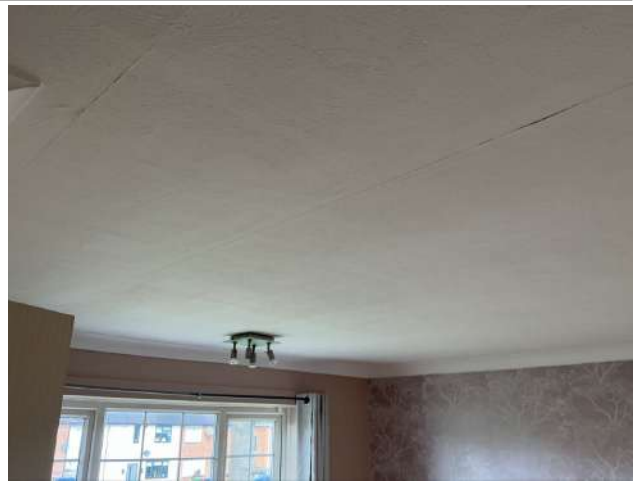
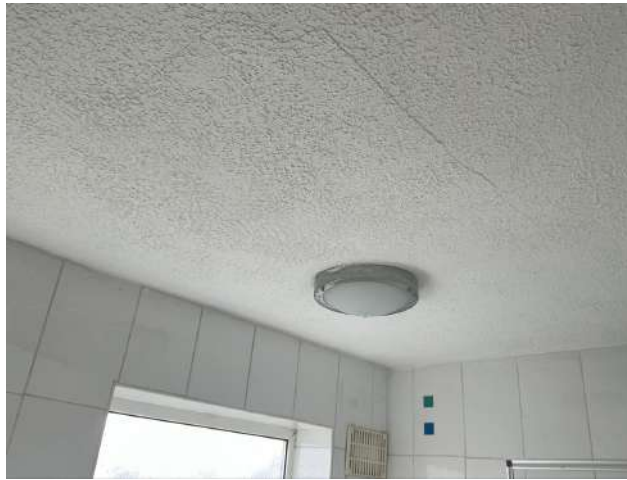
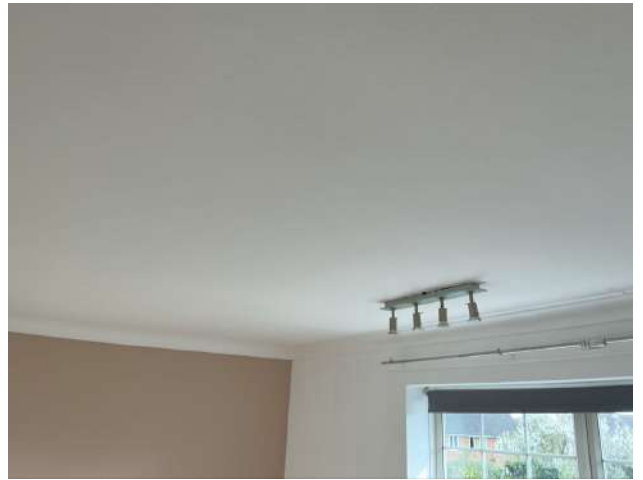
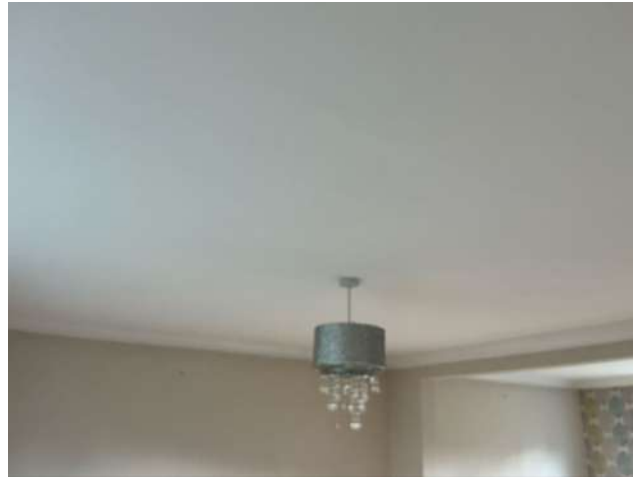
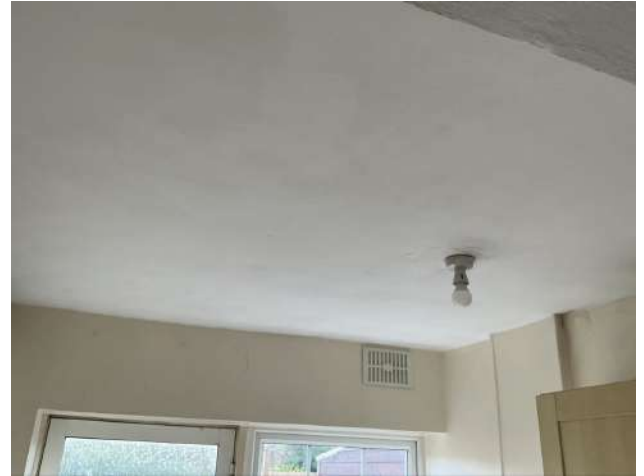
The ceilings are in a serviceable condition, however, localised areas of hairline shrinkage cracking were noted, which is a result of thermal changes in the building materials and is considered cosmetic in nature. These can be attended to during normal routine re-decoration periodically. These types of cracks are very common in a property of this age and type of construction and do not give cause for concern.

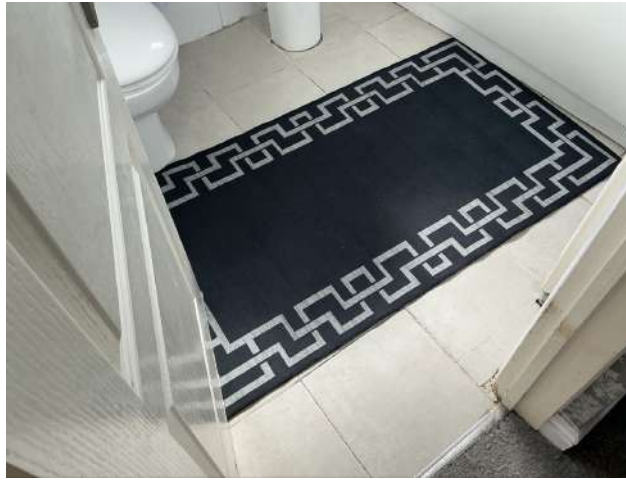
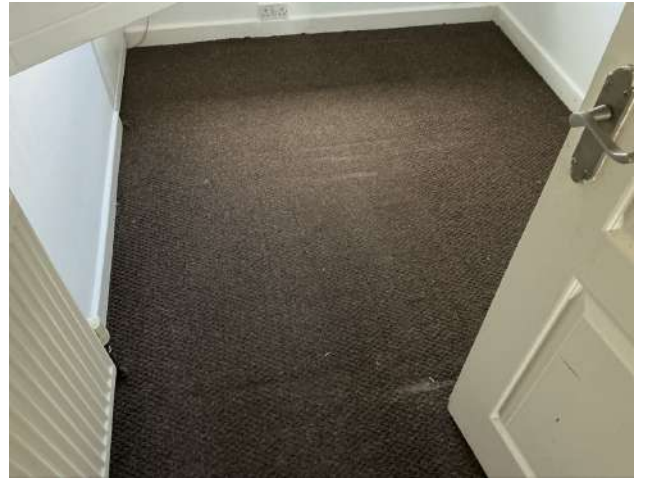
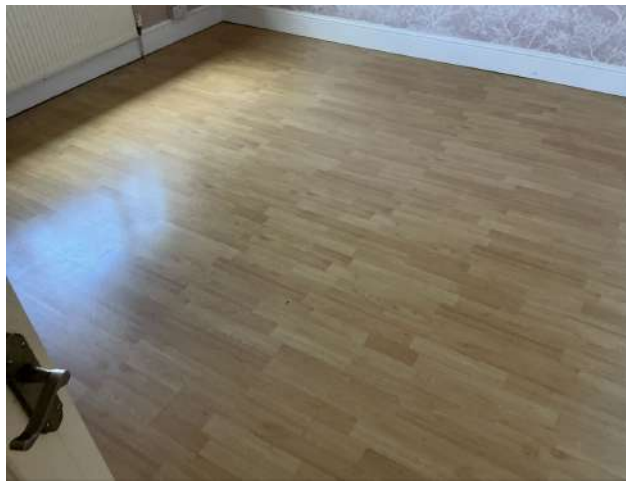
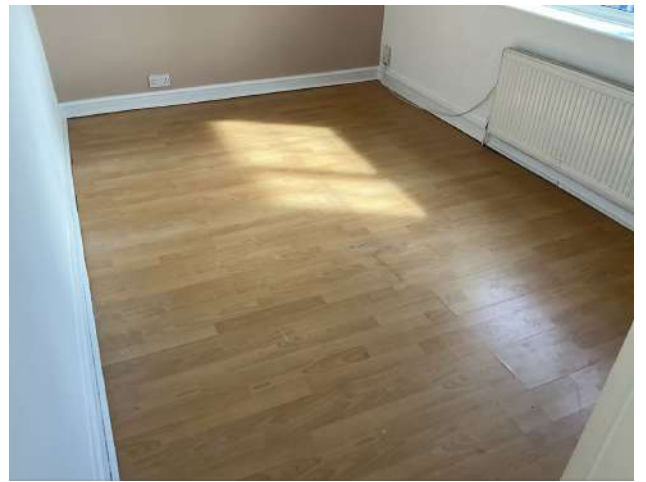
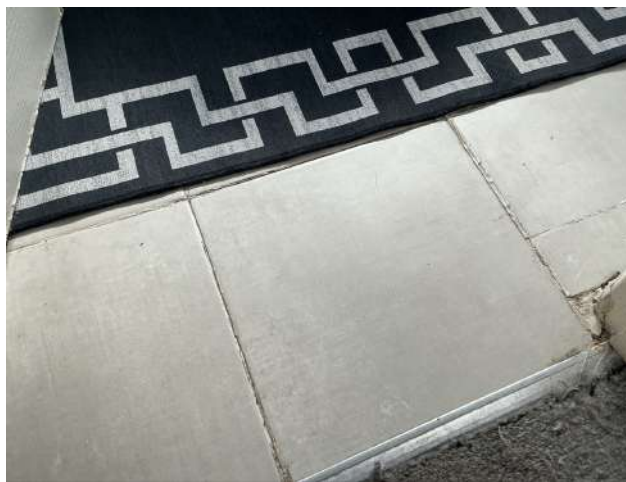
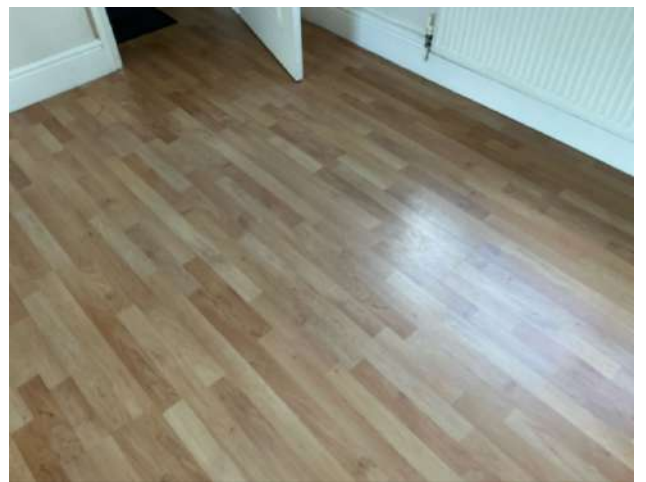
## E4 Floors

Floor finishes are generally worn and may require replacement or upgrading to suit your needs. We also noted that a later floor covering appears to have been laid over the original tiled finish with an additional underlay, which has slightly raised the floor level. As a result, the covering is catching on the back door and preventing it from opening freely. Improvements are required. These may include lifting and removing the later lino covering, or making more isolated adjustments to achieve adequate clearance and allow the door to operate properly.

Ceramic floor tiles are present in parts of the property. Some of the grouting and finishes were poor and require improvement as necessary. It should be borne in mind that ceramic tiles are inherently brittle and, where laid on suspended timber floors, can be prone to cracking because of the natural movement and slight springiness of the structure beneath.

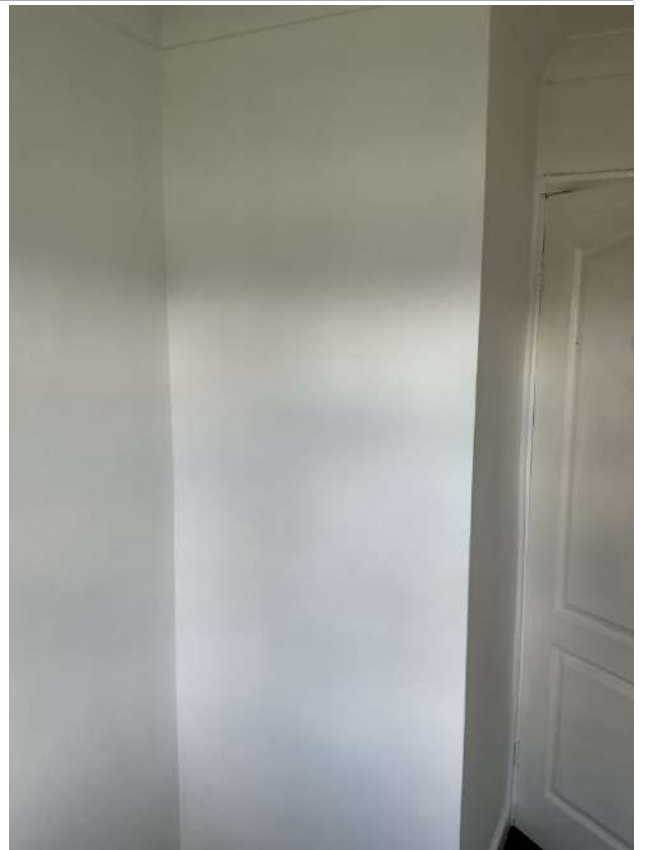
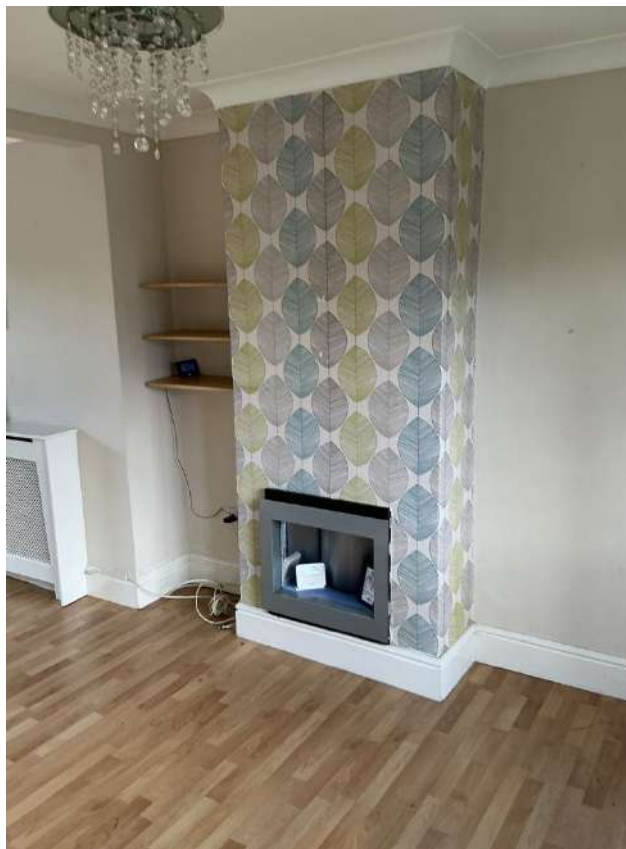
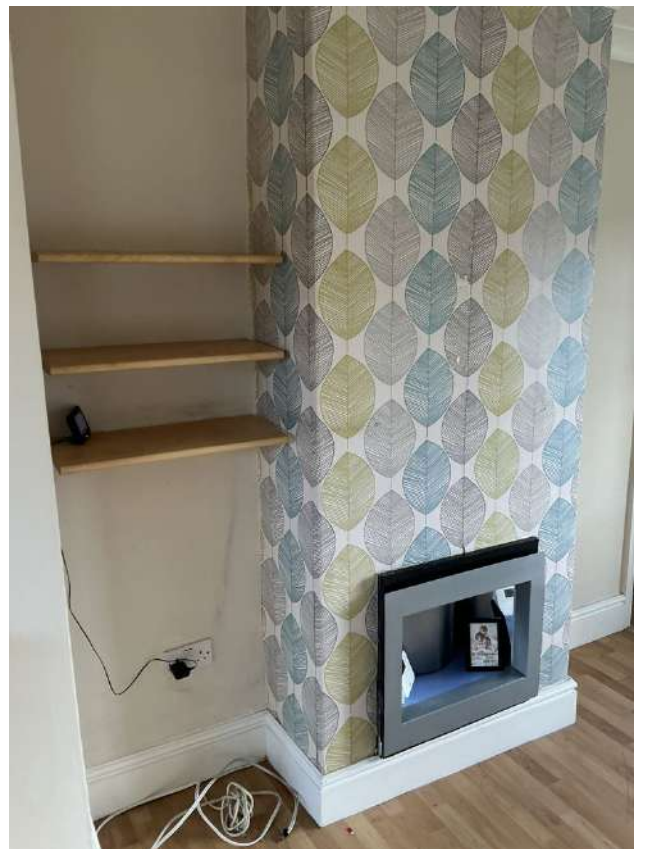
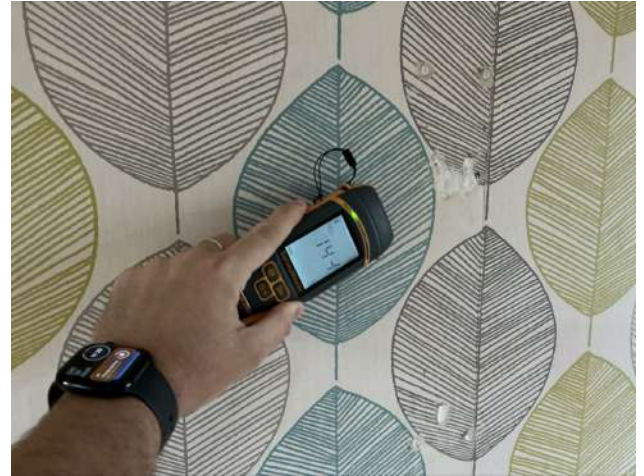
## E5 Fireplaces, chimney breasts and flues

The chimney sites appear to be largely redundant and disused. If you propose to use the fireplaces in the future, we recommend that the flues are checked and swept before use. It is also possible that flue linings will need to be fitted/flue linings have deteriorated and may need to be renewed. Background ventilation levels should also be checked and these may need to be upgraded. You should obtain further advice from a HETAS-registered contractor.

There is a possibility of migration of salts and sulphates from the flues into the plasterwork. These salts are hygroscopic and attract atmospheric moisture which can give the appearance of dampness. Should this occur in the future then these areas will need to be replastered after the brickwork behind has been sealed to prevent further salt migration.

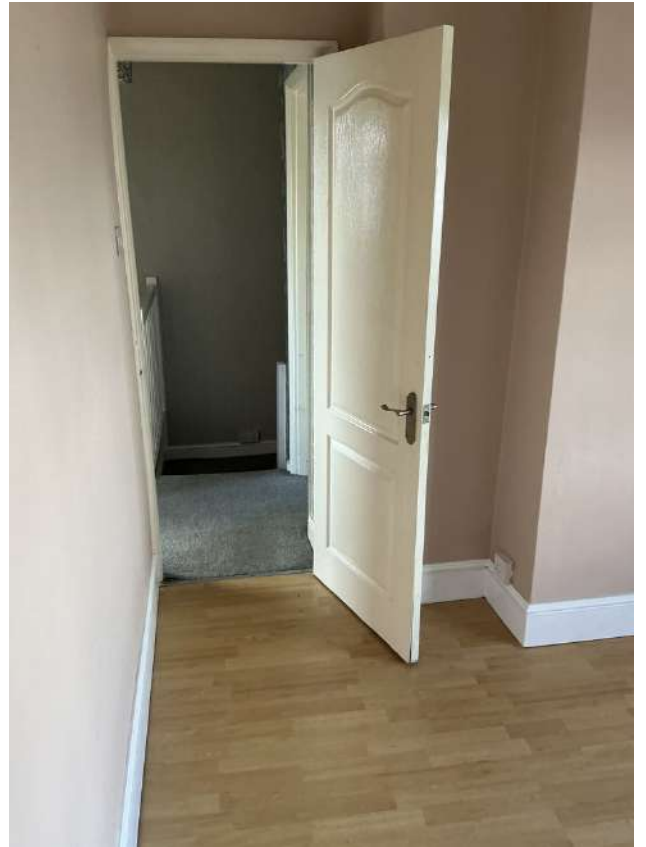
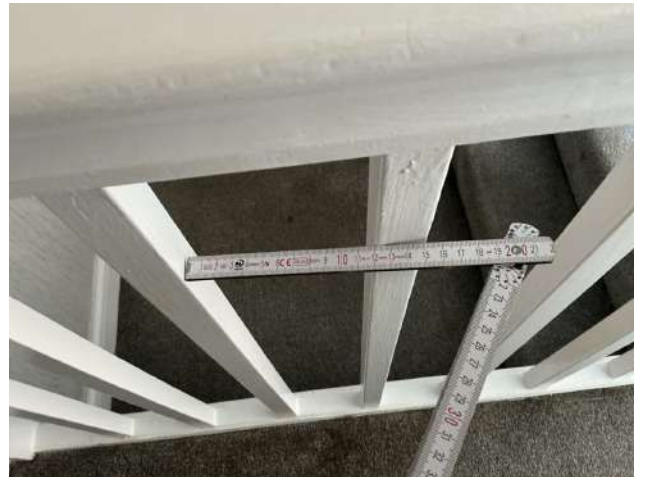
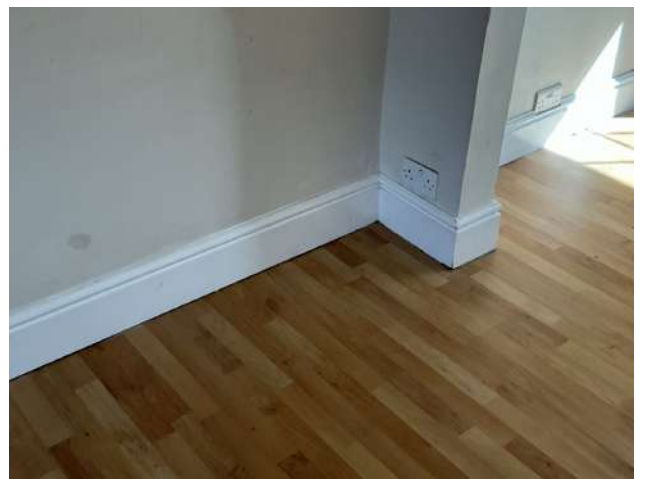
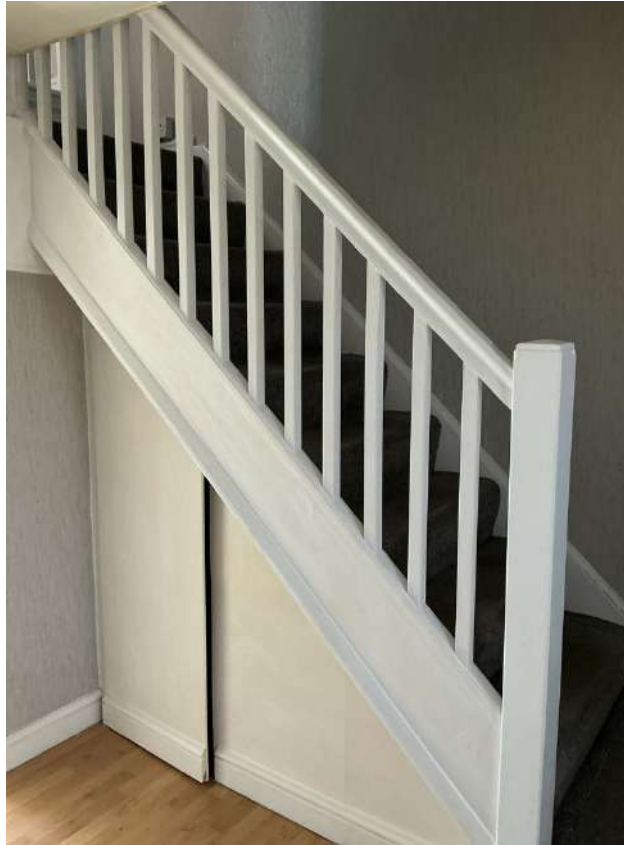
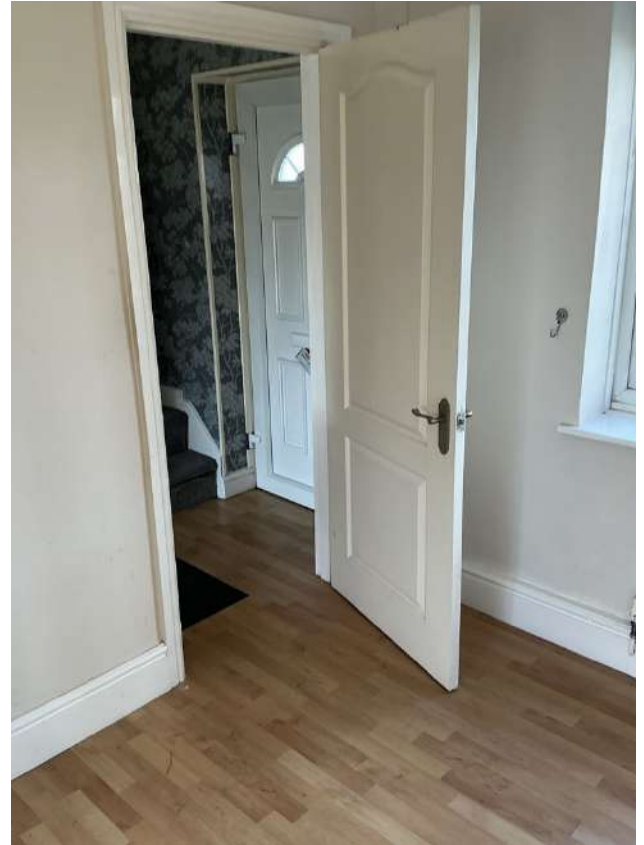
## E7 Woodwork (for example, staircase joinery)

The staircase is of dated timber construction and rather too steep to comply with current regulations but in keeping with the house. Additional care should be taken when using it because of the associated increased risks of tripping or falling.

Over time, the wood to staircases can shrink and split loosening the various joints, causing the stairs to creak when used. Repair and maintenance will be required from time to time.

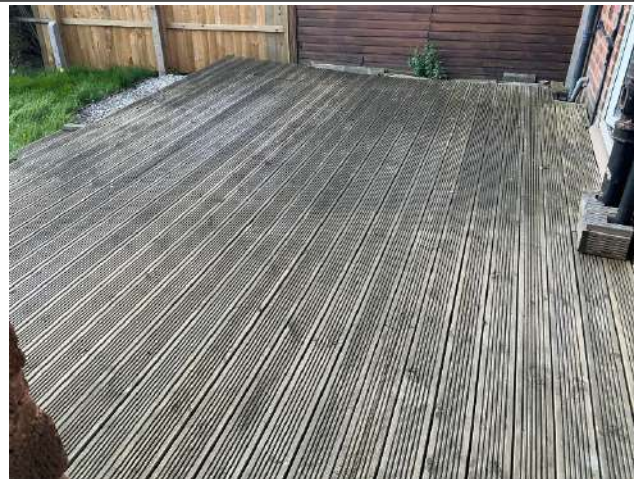
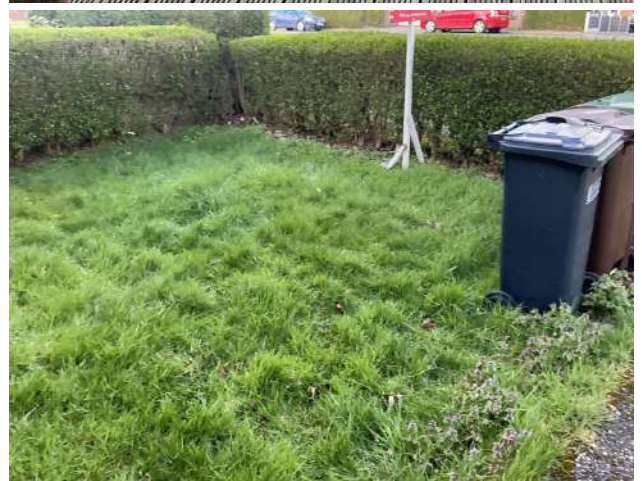
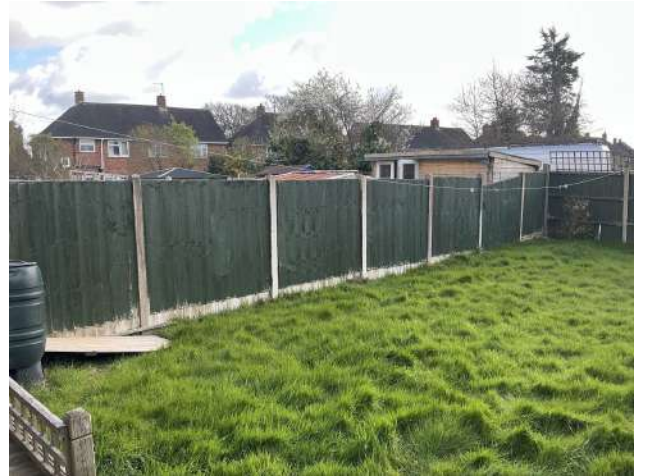
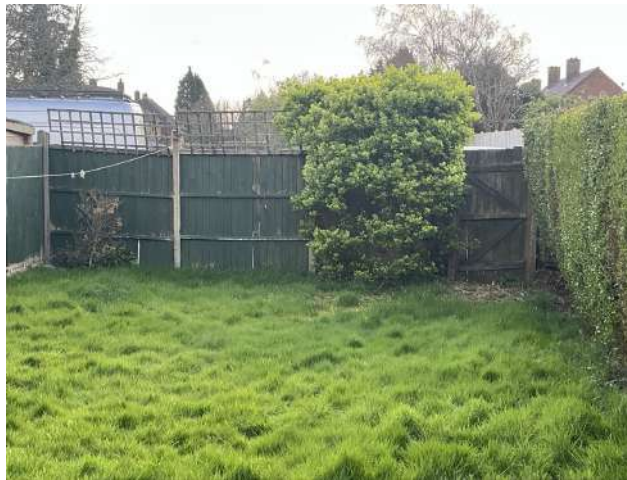
The external areas appeared generally maintainable but we noted some defects/issues that will require repair or renewal including deterioration of the timber fencing and deterioration of the gate. Repairs and improvements are now required in order to prevent issues from arising in the future.

Periodic maintenance of the decking will be required to prevent deterioration and the build-up of algae/grime which can cause the surface to become slippery when wet.
