LEVEL 3

Your survey report

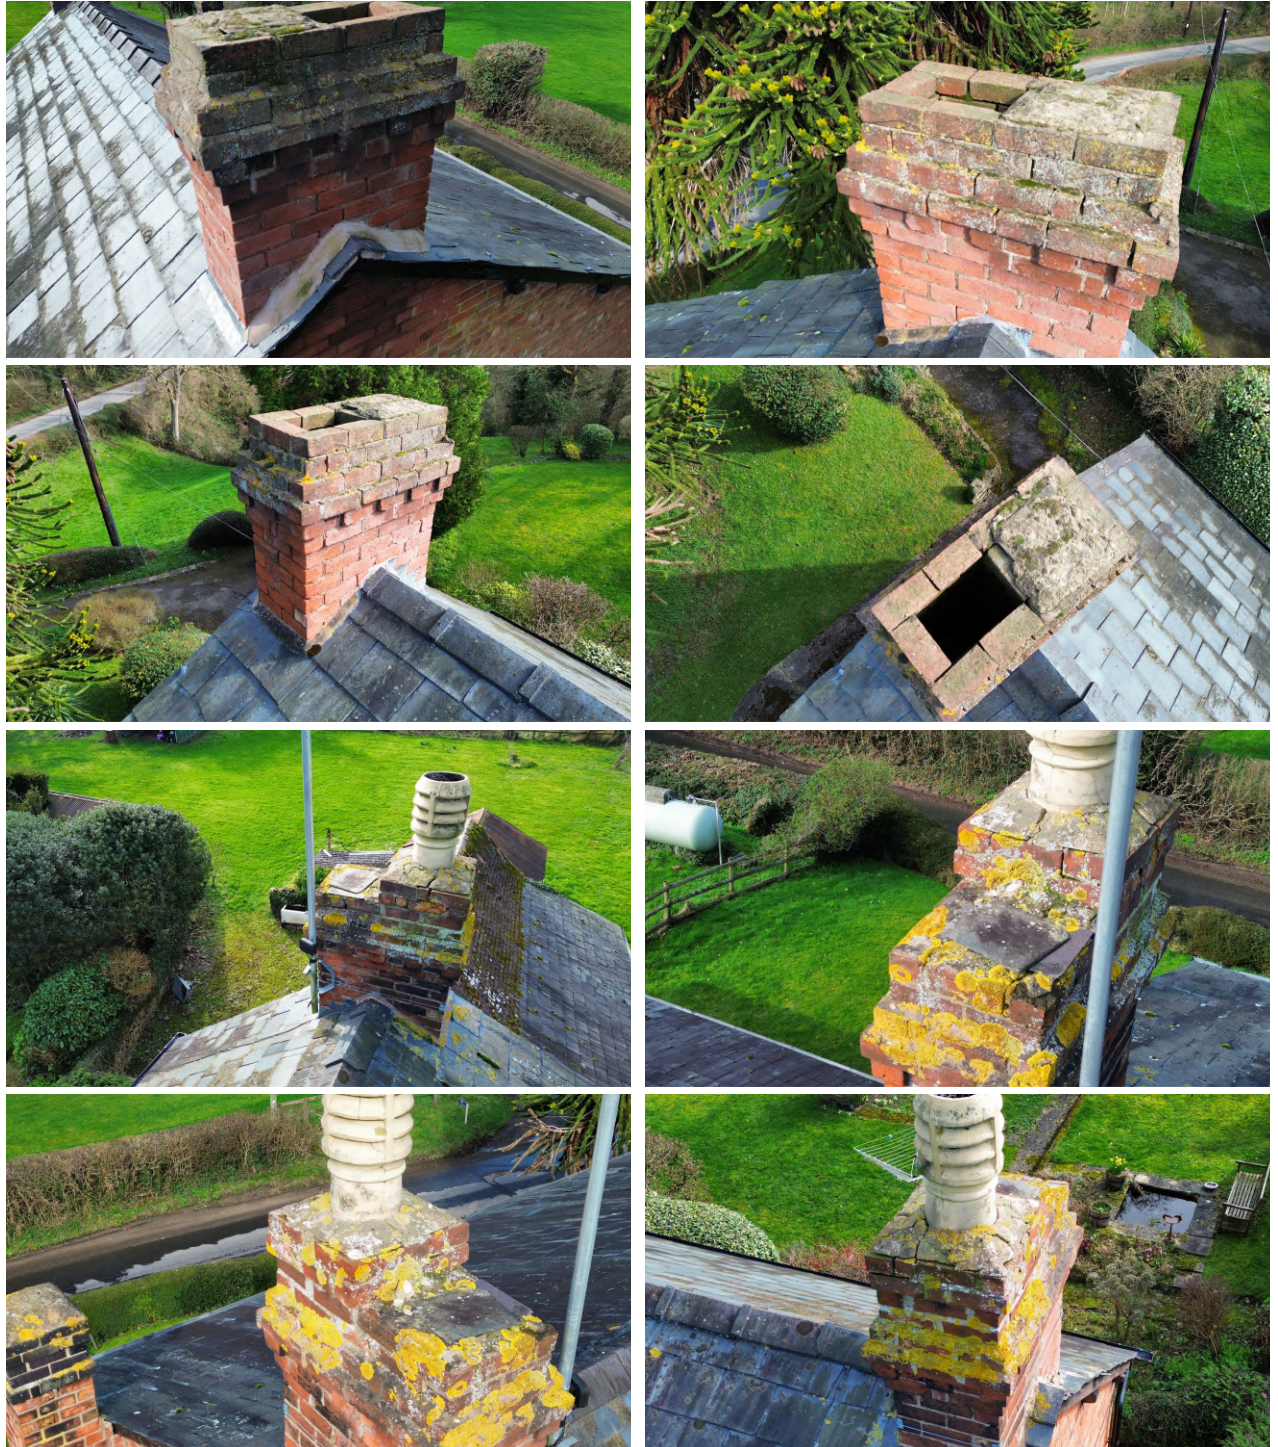
The chimney stack located to the side elevation of the property is fitted with two flues. One flue has been covered, although the covering arrangement appears basic. The second flue is entirely open and exposed, with no protective terminal or capping and no visible flashing detail to properly bed and seal the pot or opening. In its current condition, this open flue allows direct rainwater penetration into the chimney structure, which can lead to dampness within the stack and internally within the building. The top of the stack should therefore be repaired with appropriate flashing and the flue suitably capped or fitted with a ventilated terminal to prevent rain entry while allowing airflow if the flue is redundant.

The second chimney stack, located on the opposite side of the property, also serves two flues. One flue has been fitted with a ventilated chimney pot which will assist with airflow and help reduce moisture accumulation within the flue. The second flue, however, has been covered with what appears to be a loose roofing slate which has simply been placed over the opening. No proper flashing detail was visible to secure this covering in position. This arrangement is unlikely to provide an effective or durable weather seal and may become dislodged by wind or movement over time. The slate covering should therefore be removed and replaced with a suitable ventilated cap or properly bedded terminal with appropriate flashing to ensure a stable and weather-resistant finish.

The third chimney stack is located above the utility area of the property. The top of this stack has been entirely covered with a layer of concrete flashing. While this approach may provide some protection from direct rainwater penetration, such solid coverings can sometimes restrict ventilation within redundant flues. If the flues below are no longer in use, it is generally preferable to provide controlled ventilation to reduce the risk of condensation and dampness developing within the stack. The condition of the concrete flashing should therefore be monitored, and consideration should be given to introducing suitable ventilated terminals if the flues are redundant.

Internally, damp staining was noted to the ceiling adjacent to the side chimney breast at first floor level. This staining indicates that moisture has entered the structure at some stage. While chimney stacks of this age do not normally contain a damp proof course and can therefore absorb moisture during periods of prolonged or wind-driven rain, the position of the staining adjacent to the stack suggests that defective flashing or detailing at the roof junction may also be contributing to water ingress. The lead flashings and adjacent masonry should therefore be inspected at close quarters and repaired or renewed where necessary to ensure the junction between the stack and roof covering is properly sealed.

The mortar flashing around chimney pots and flue openings is particularly exposed to driving rain, frost action and general weathering. Where defective, cracked, or absent, water can enter the chimney structure and migrate internally through the masonry. The various flue terminations across the stacks are inconsistent and in some cases poorly detailed. A programme of repairs is therefore recommended

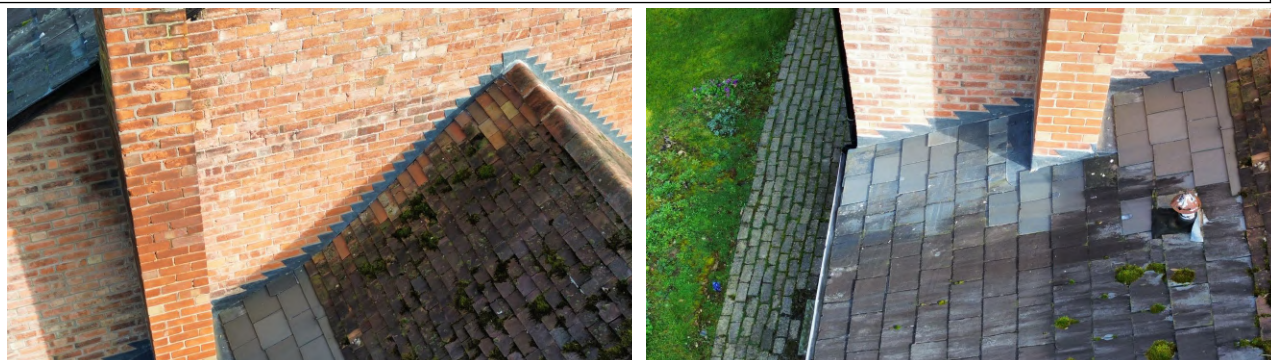
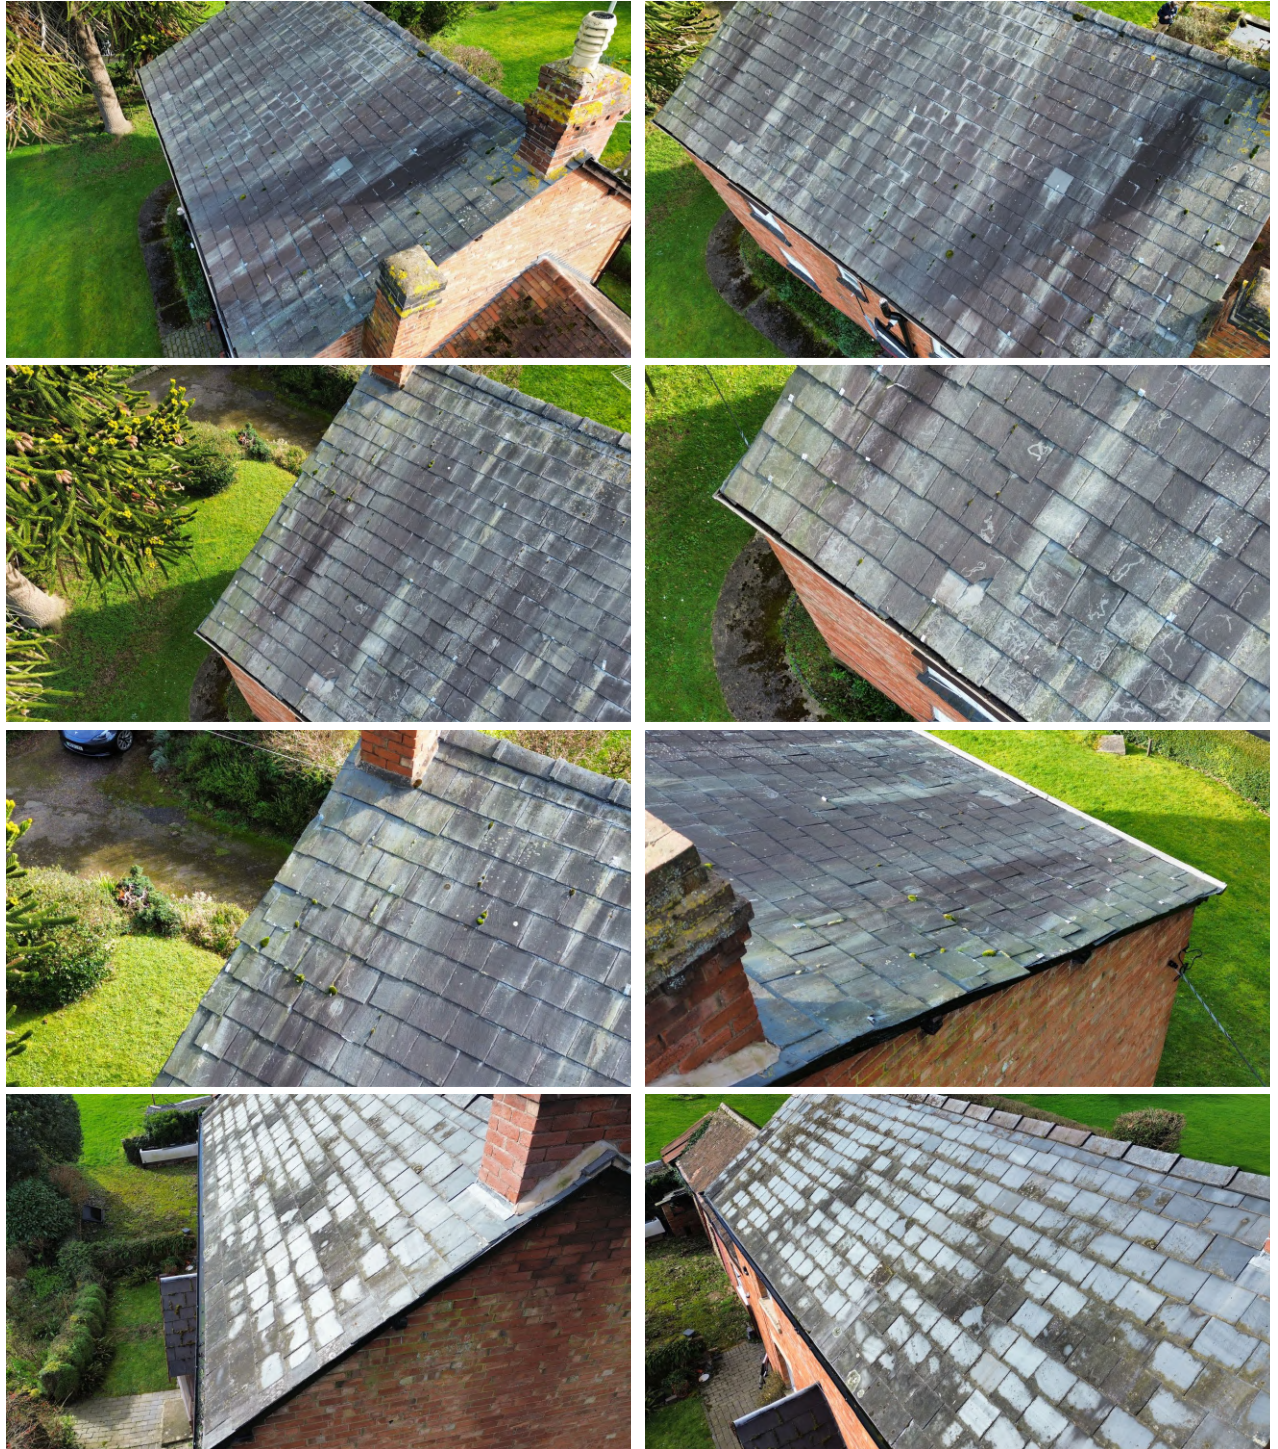
D2 Roof coverings

From the areas visible during the inspection, the slate covering appears generally functional and broadly consistent with the age and character of the building. However, a number of slipped and cracked slates were noted. These defects are typical of older slate roofs where fixings may deteriorate over time and

The junctions between roof slopes and adjoining masonry walls are weathered with metal flashings, typically lead, designed to prevent water ingress at these vulnerable abutments. From the available vantage points these flashings appeared to be in generally satisfactory condition. Nevertheless, such details should be periodically checked as part of routine roof maintenance, as failure of flashings is a common source of water penetration in older buildings.

A separate section of roof covering is present to the side part of the property, which comprises a combination of the current utility area and converted outbuilding structures. This section is covered with clay roof tiles rather than slate. The tiles appear generally appropriate for their age and were performing their intended function at the time of inspection. However, there is a noticeable build-up of moss across sections of this roof covering. Excessive moss can retain moisture against the surface of the tiles and may impede proper drainage of rainwater, particularly where it accumulates around laps and in gutters. The moss growth should therefore be carefully removed and the roof covering cleaned as part of a programme of routine maintenance. Ongoing cyclical maintenance should include periodic removal of moss and organic debris to help prolong the service life of the roof coverings.

individual slates become displaced or damaged. Defective slates should be replaced and slipped slates re-fixed by a competent roofing contractor to ensure the roof covering remains weather-tight and to prevent water penetration into the roof structure.

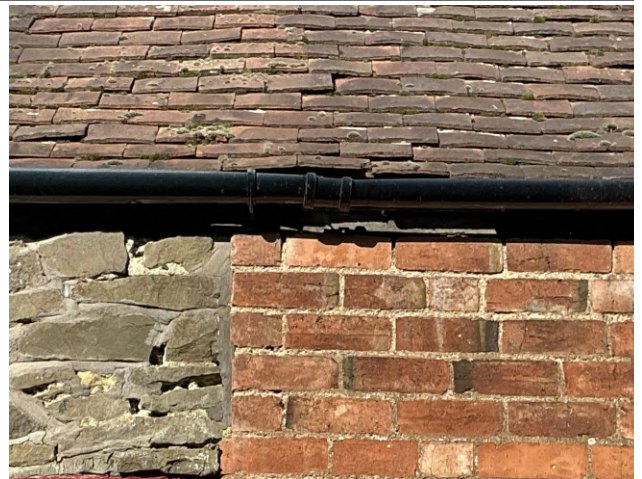
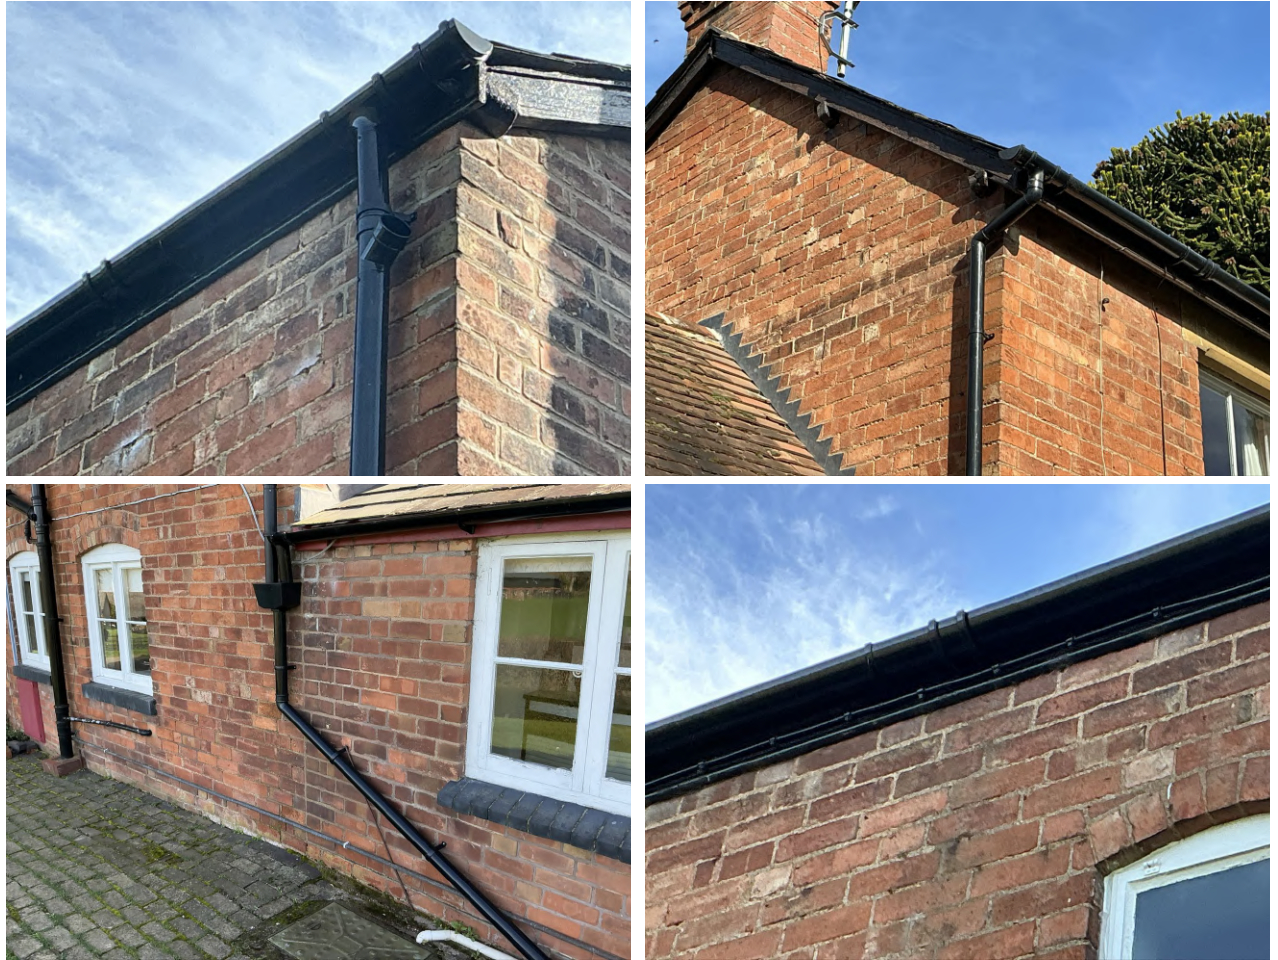
D3 Rainwater pipes and gutters

From the areas visible at the time of inspection, the rainwater goods appear to be in generally serviceable condition with no evidence of significant distortion, major leakage, or widespread failure. However, as with all external drainage systems, regular maintenance will be required to ensure that the

At the time of inspection, there were signs of organic growth and debris accumulation associated with the roof coverings, particularly moss from the adjacent roof slopes. This material can wash into the gutters and contribute to blockages over time. It is therefore advisable that the gutters are cleaned shortly after occupation, removing any moss, leaves and general debris that may have accumulated. Thereafter, the rainwater goods should be inspected and cleared periodically as part of routine property maintenance, typically at least once or twice annually depending on surrounding vegetation and environmental conditions.

The inspection took place during dry weather conditions and therefore it was not possible to observe the rainwater system in operation. As a result, the watertightness of joints, unions and connections could not be confirmed. It is recommended that the gutters and downpipes are observed during periods of rainfall, or water tested shortly after occupation, to confirm that they are operating correctly and that there are no leaks, blockages or areas of overflow. Localised repair or replacement of joints and sections may be required once the system is tested in use.

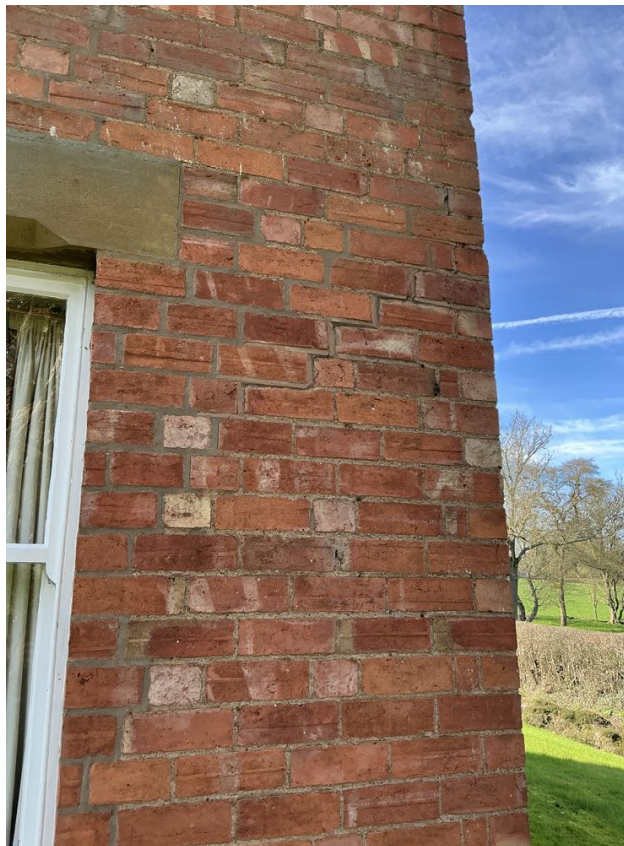
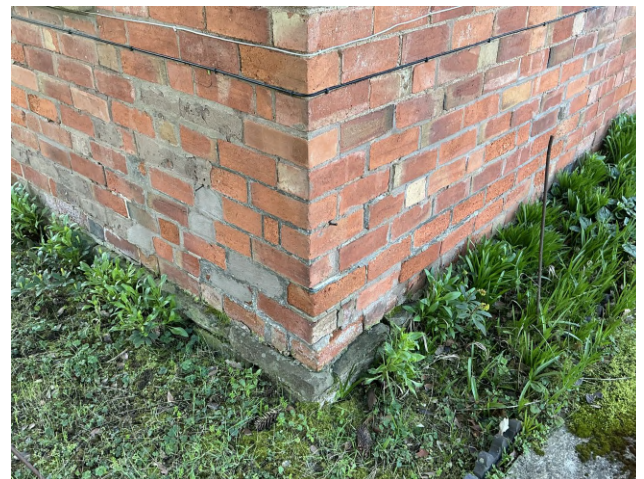
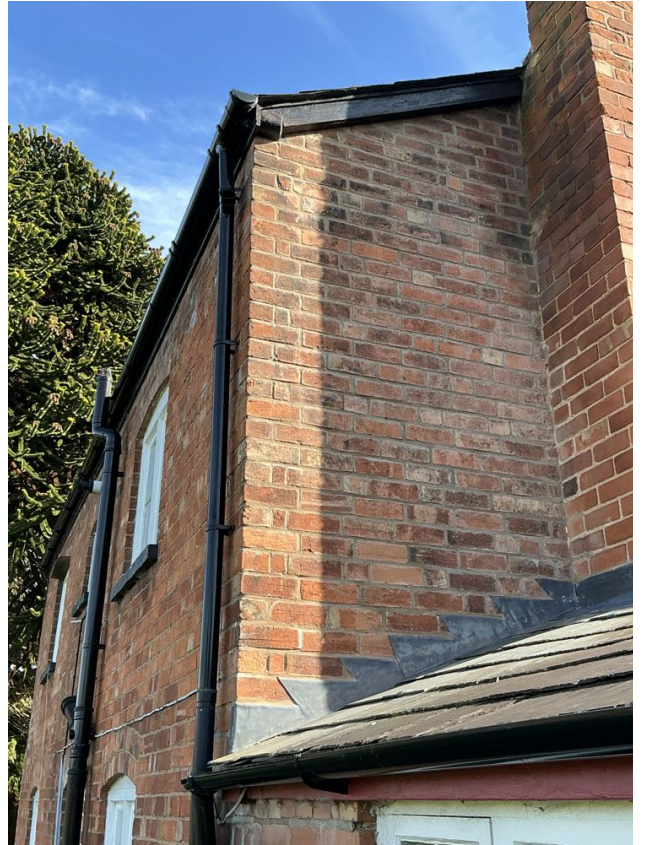
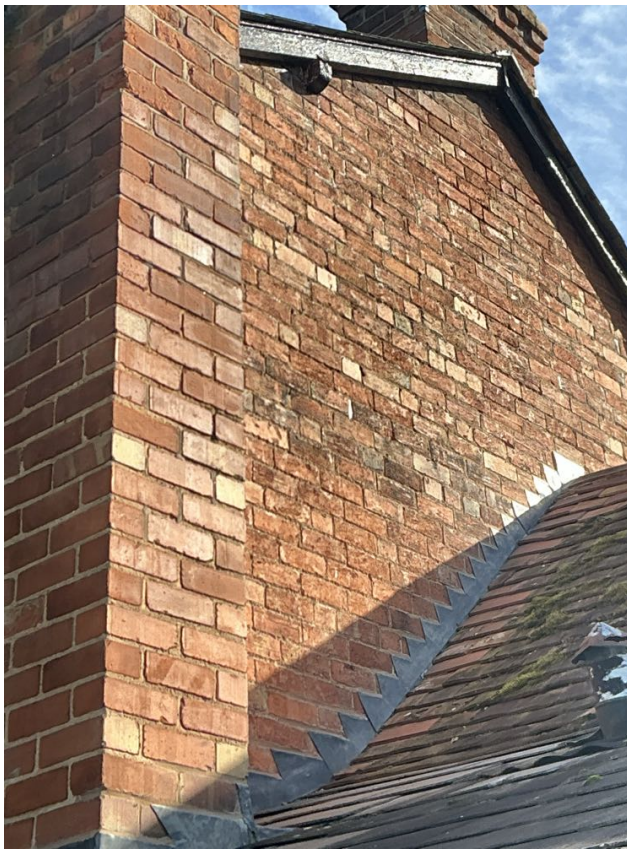
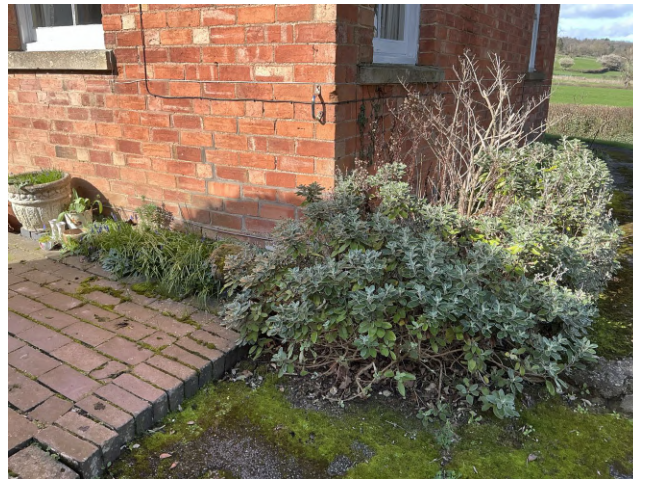
D4 Main walls

Finally, vegetation was noted growing close to parts of the external walls. While this is unlikely to cause immediate structural harm, plants and shrubs located close to masonry surfaces can trap moisture against the wall and restrict airflow, increasing the risk of damp penetration and gradual deterioration of the wall fabric. Vegetation should therefore be cut back and maintained to ensure that foliage does not obstruct windows, ventilation openings, rainwater goods or external wall surfaces.

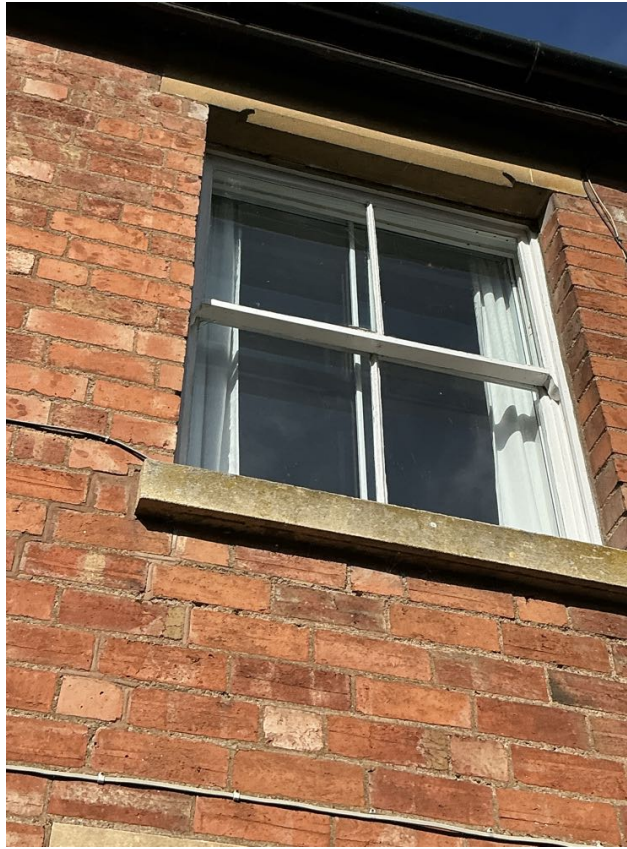
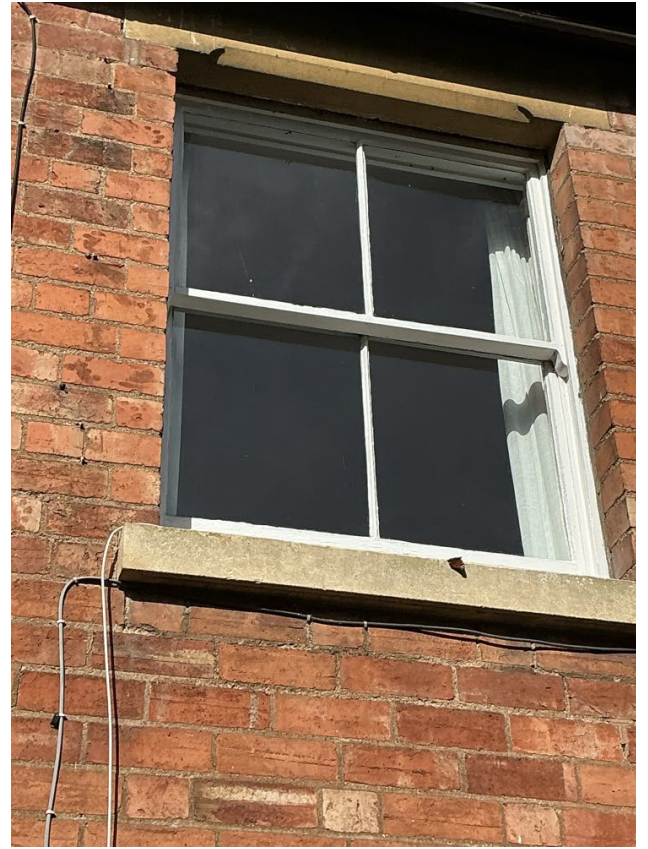
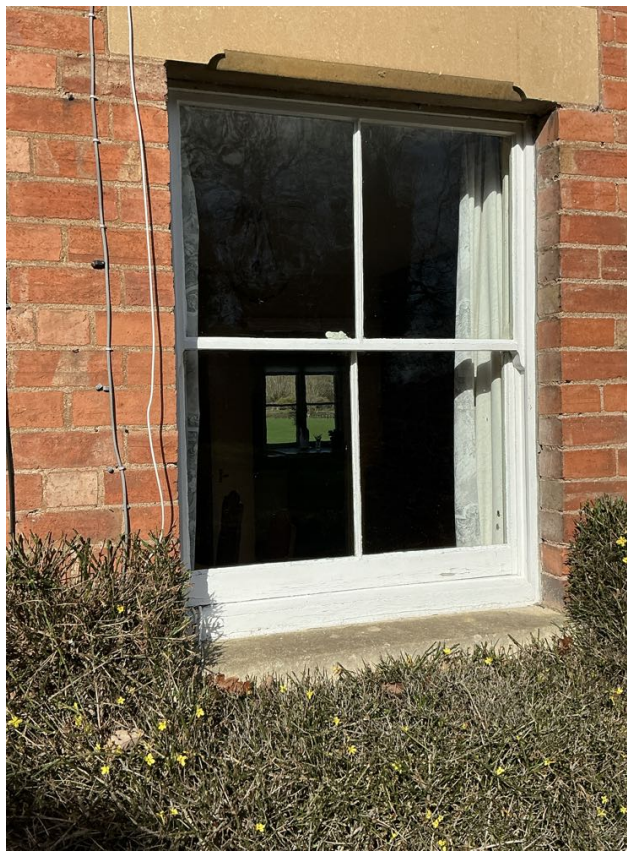
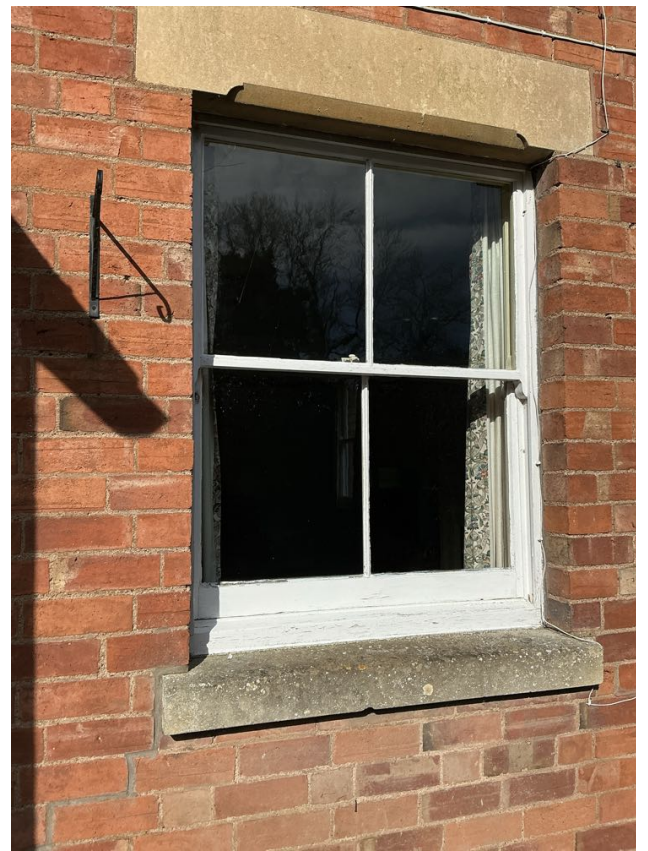
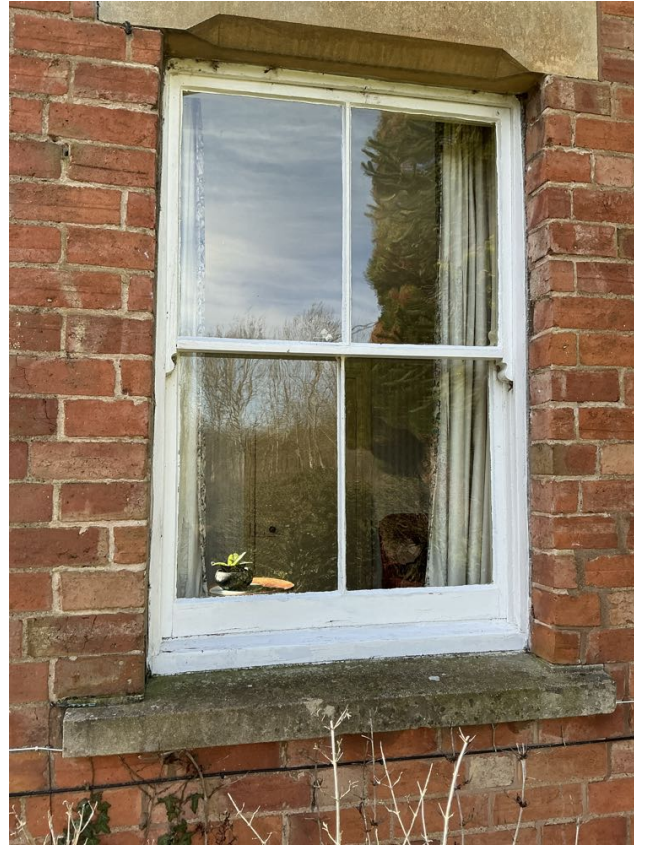
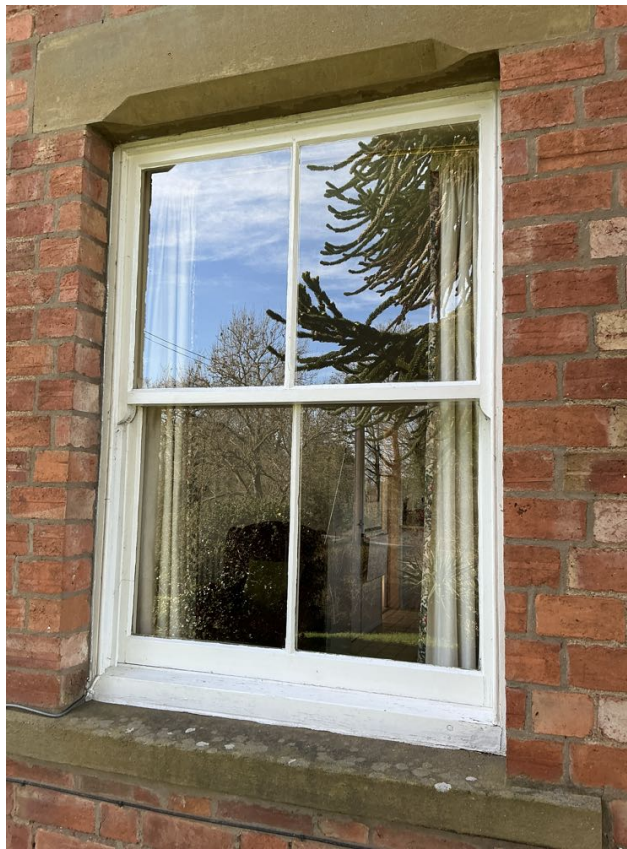
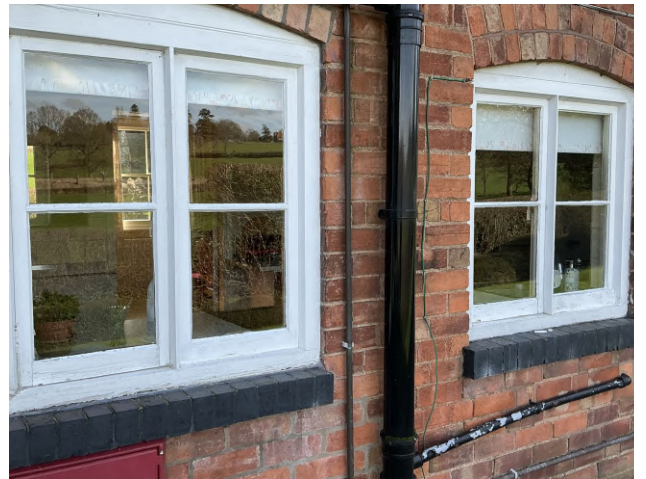
D5 Windows

In summary, the existing timber sash windows are broadly in keeping with the character of the property but require ongoing maintenance and periodic repair to ensure their continued performance. Routine maintenance should include regular inspection and attention to moving parts, ironmongery, sash cords, glazing putty, seals, frames and sills, together with periodic repainting of the timber joinery to protect it from weathering and decay. Homeowners should anticipate and budget for such maintenance as part of the normal upkeep of traditional timber windows.

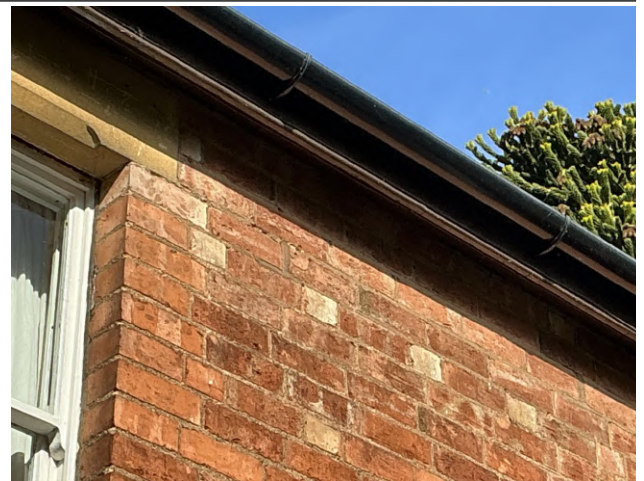
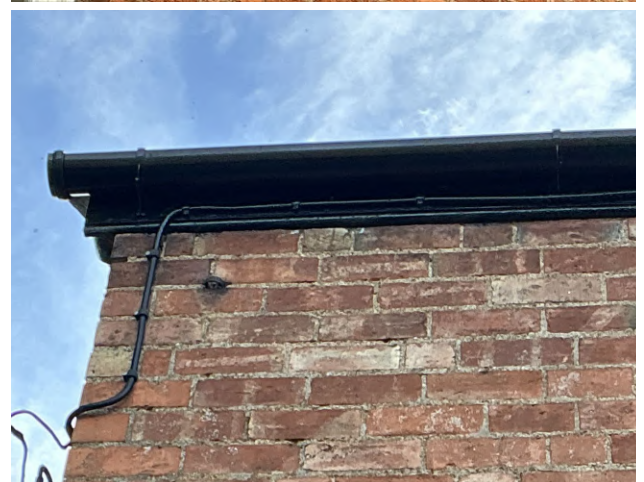
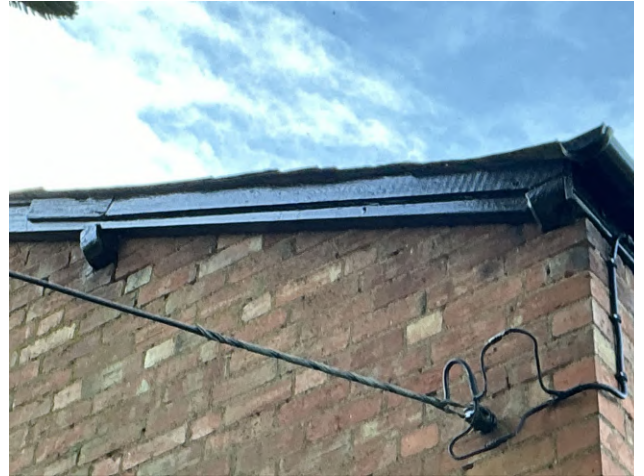
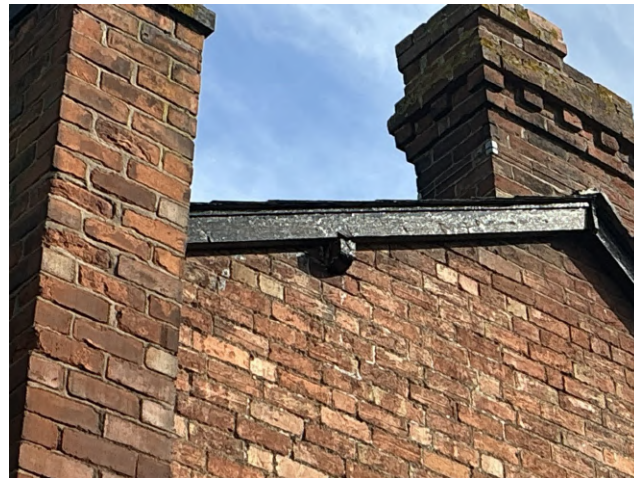
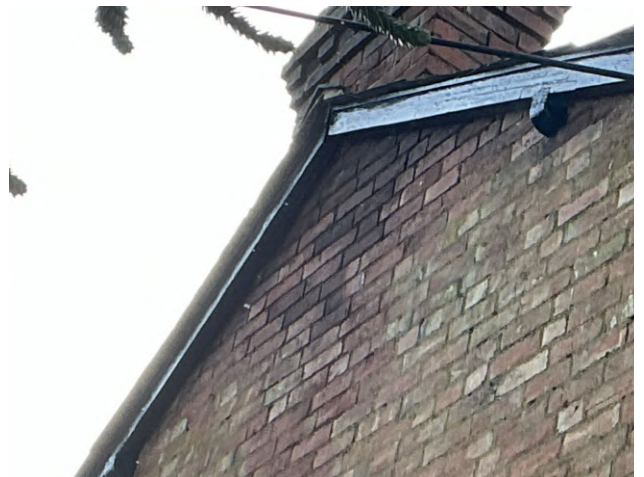
D8 Other joinery and finishes

However, the external decorative finishes to some areas of timber joinery were observed to be weathered and beginning to deteriorate. Where paint coatings break down, the underlying timber can become vulnerable to moisture penetration which may eventually lead to rot or deterioration of the

Timber joinery exposed to external weather conditions requires ongoing cyclical maintenance. As a general guide, external timber elements should be inspected regularly and redecorated on approximately a three to five year cycle, depending on the quality of previous coatings, levels of exposure to weather and the condition of the underlying timber surfaces. Regular maintenance will help protect the timber, prolong the life of the joinery and reduce the likelihood of more extensive repairs being required in the future.

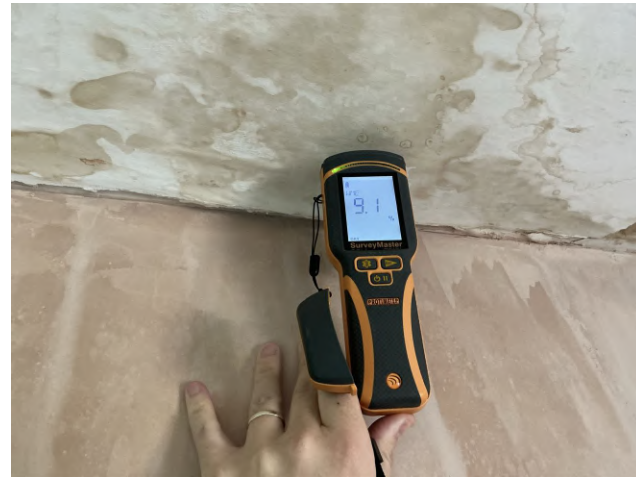
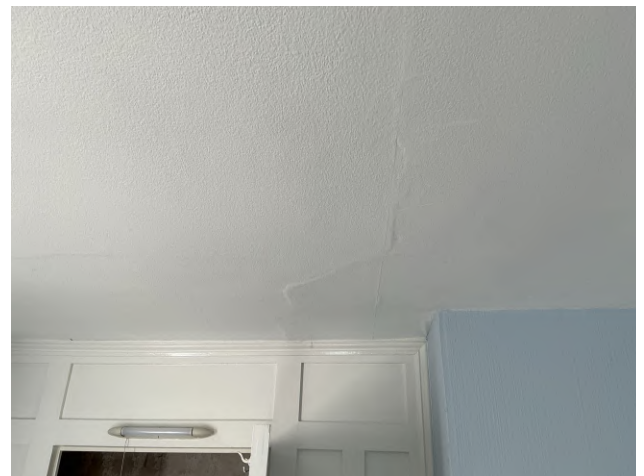
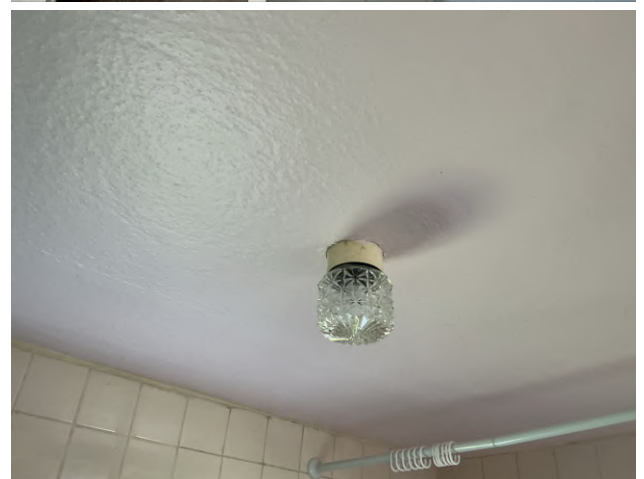
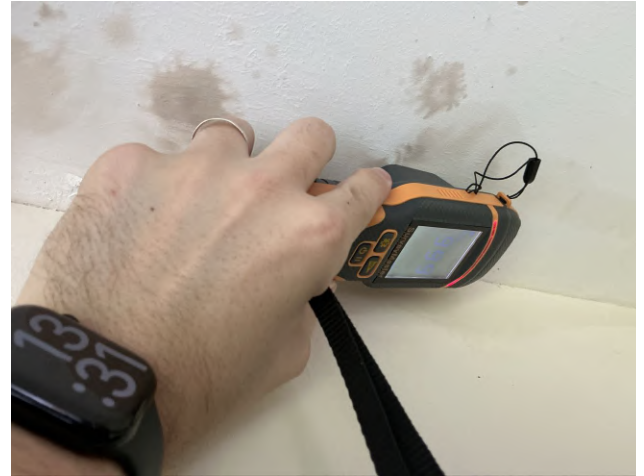
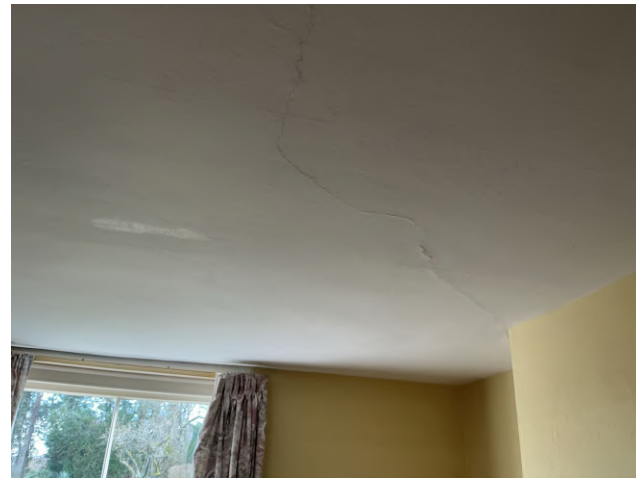
E2 Ceilings

was evident at the time of inspection, it is realistic to anticipate ongoing repairs to defective areas and, in the longer term, more extensive renewal may be required in some locations. The risk of detachment can also increase where old wallpaper linings are removed during redecoration, as these can sometimes be providing additional support to weakened plaster.

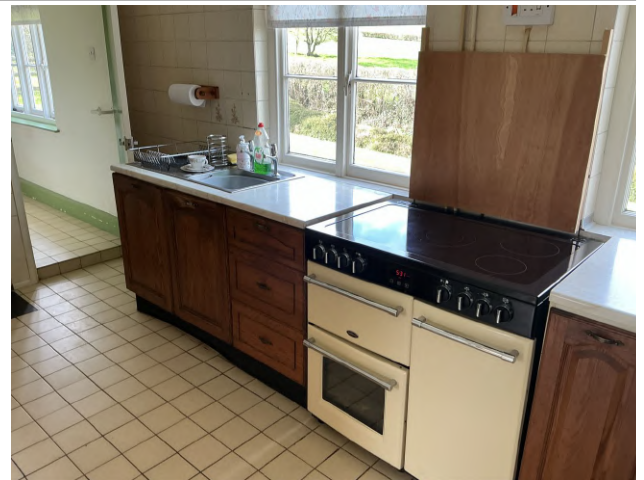
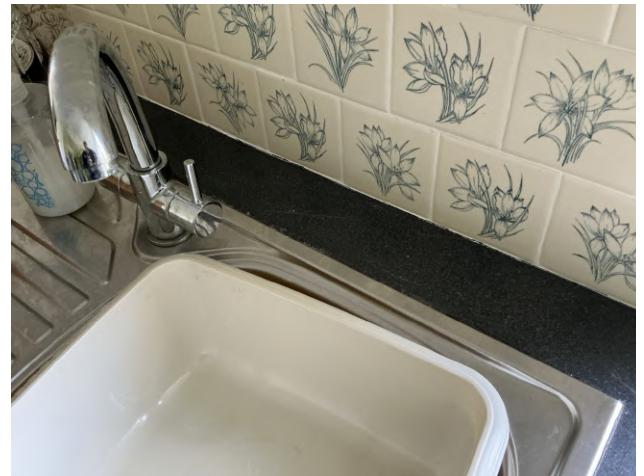
E6 Built-in fittings (built-in kitchen and other fittings, not including appliances)

Overall, the kitchen fittings appear dated and show signs of general wear and tear consistent with age and use. Replacement or upgrading of these fittings is likely to form part of future improvement works to the property. You have likely already considered the adequacy and suitability of these fittings, and other built-in elements, when assessing the property for your own purposes.

In addition to mechanical extraction, background ventilation should be maintained within the kitchen area. This is typically achieved through a combination of trickle vents within window frames and maintaining an appropriate gap beneath internal doors (typically around 10mm) to allow air circulation between rooms.

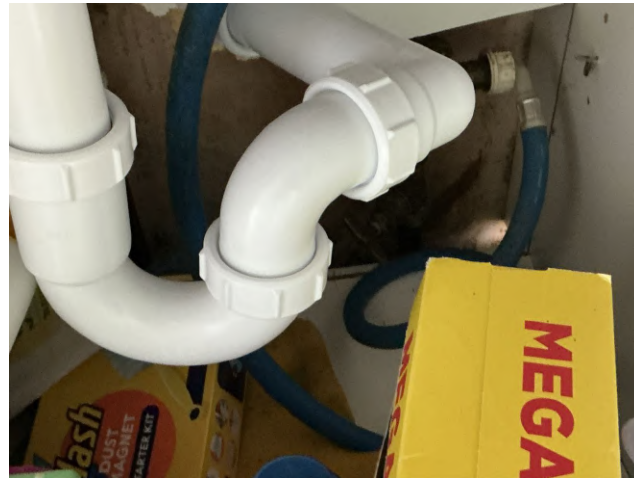
In view of the age of the property the incoming water main may be of old lead pipe. Lead is now considered to be inappropriate material to carry drinking water supplies due to the toxins that can be deposited. We recommend that you establish the nature of the pipes and consider upgrading to modern polypropylene if necessary.

The internal water system includes a number of different types of metal pipes in the same plumbing system and this may result in leaks. Although there are no leaks at present, you should plan to replace some of the pipes with suitable alternatives soon. In some cases, you may find it more economical to replace the whole system.
