## The Report

For the Jones

11111 Sample Address, Shawnee, KS 66211

# PROPERTY INSPECTION

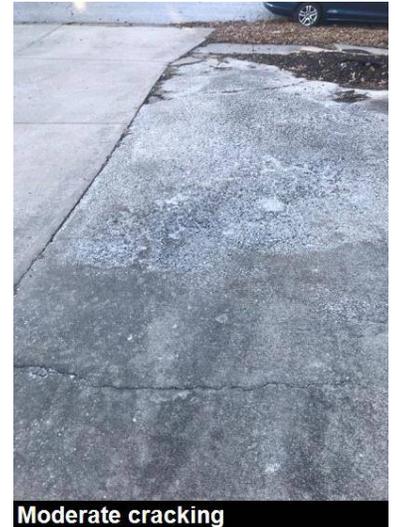
**Monitor:** Moderate cracks were observed in the pavement. They were not significant in terms of the performance of the driveway. However, we recommend that the driveway cracks be monitored and repaired as necessary.

Moderate cracking

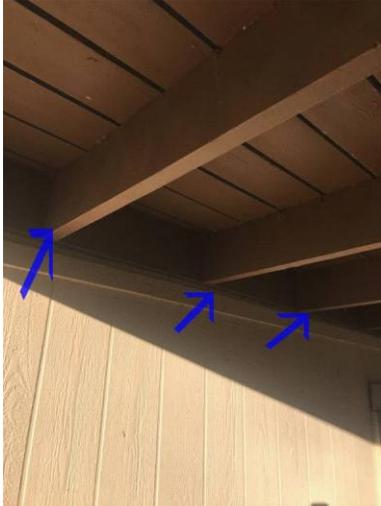
**Repair:** The deck was missing joist hangers. We recommend the installation of the joist hangers as required. **Safety Concern:** The ledger board of the deck was not attached to the building properly. Currently it is attached with only nails or deck screws. Recommend adding more lag screws as recommended by best practices.. Common building practice is for the ledger board to be attached with lag screws for safety. We recommend further review for a better understanding of replacement costs/repairs and present condition.

No joist hangers

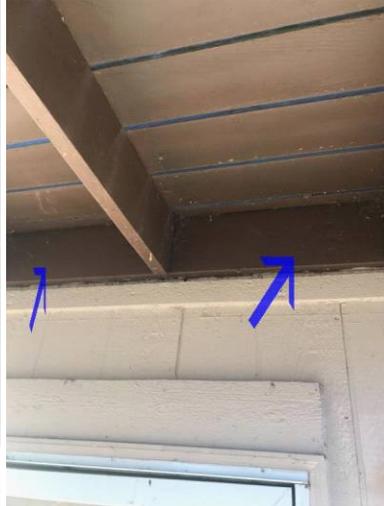
**Safety Concern:** The ledger board of the deck was not attached to the building properly. Currently it is attached with only nails or deck screws. Recommend adding more lag screws as recommended by best practices.. Common building practice is for the ledger board to be attached with lag screws for safety. We recommend further review for a better understanding of replacement costs/repairs and present condition.

No lag screws

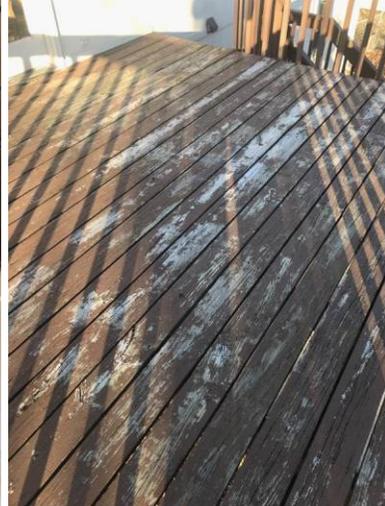
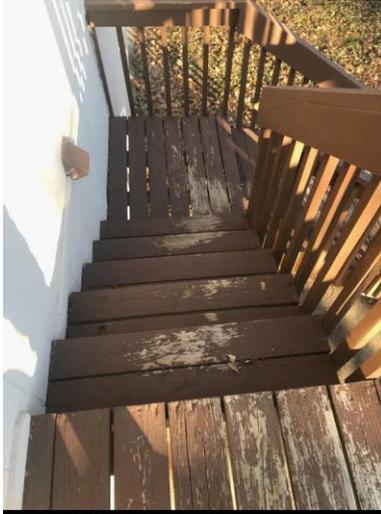
**Maintenance:** The deck(s) were weathered and in need of general maintenance such as powerwashing and re-sealing.

Needs maintenance

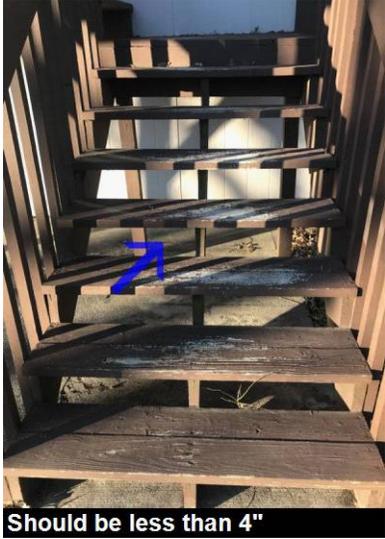
**Repair:** Best practices recommend a gap of no more than 4" on the risers of the stairs as a safety concern. Recommend installing additional boards to reduce this gap.

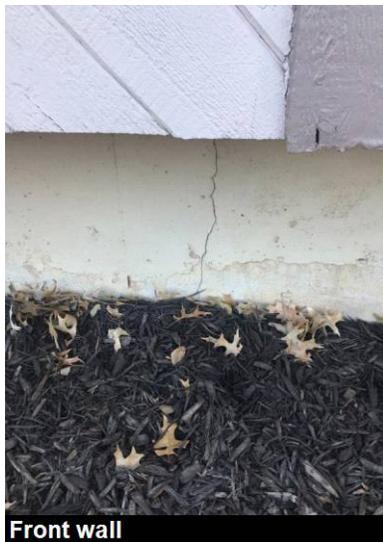
Front wall

**Monitor:** Cracks less than 1/4 inch were noted in the foundation walls: south wall and front wall on exterior and rear and front walls in basement. This condition does not yet warrant further investigation provided the movement is not recent or does not show differential movement. If future movement is noted or the cracks grow, then further investigation by a professional structural engineer and/or a licensed qualified foundation contractor will be needed to determine the cause and course of action. Recommend sealing cracks with concrete caulk and monitor for movement.

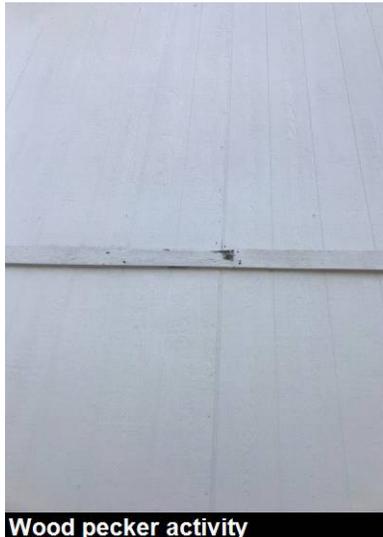
**Repair:** Damage siding was noted at the left side area exterior wall surfaces: wood pecker and deterioration. Attention to the hole and/or damage is required to keep out water intrusion and pests. We recommend repair to current industry trade standards as required.

Wood pecker activity

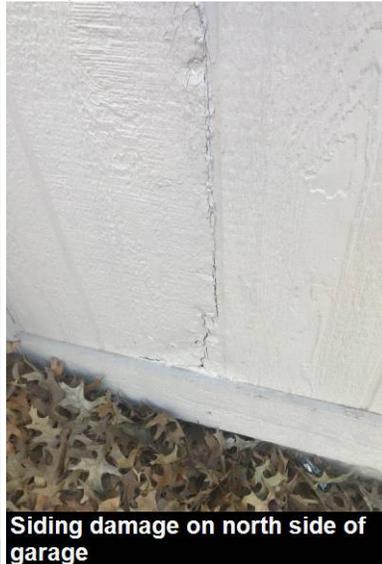
Siding damage on north side of garage

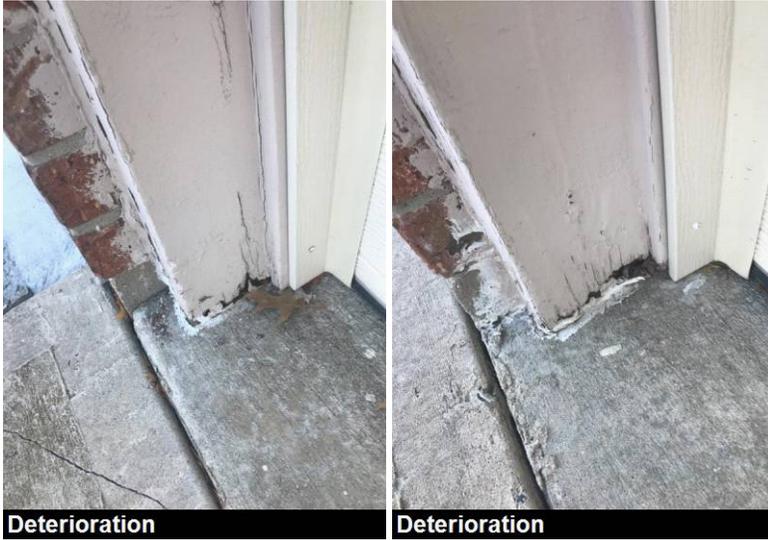
**Repair:** Deterioration of the trim was observed at the front side exterior garage door frames. We recommend that any deteriorated exterior door trim be repaired or replaced as required.

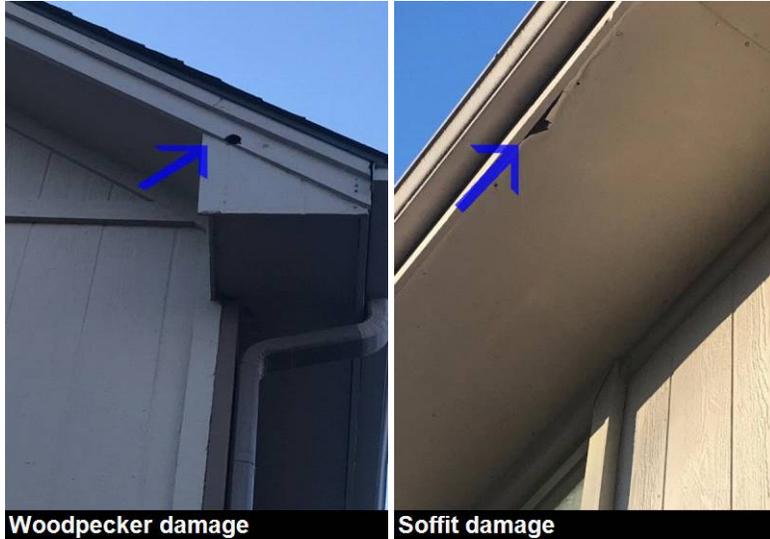
**Repair:** Damaged fascia board caused by a woodpecker was noted at the left side area. We recommend that any damaged fascia board be repaired or replaced as required.

**Repair:** Damaged soffit board was noted at the back side area(s). We recommend that any area of soffit deterioration or damage be repaired or replaced.

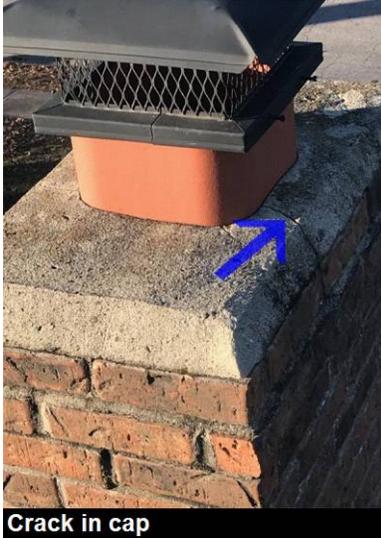
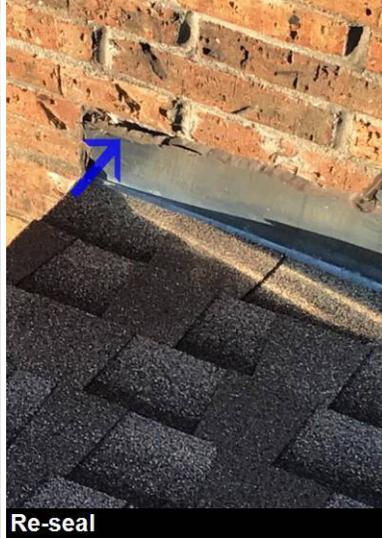
**Repair:** The mortar cap on top of the chimney has cracked and is in need of repair. Attention to the repair of the mortar cap is recommended to keep out moisture.

**Repair:** the flashing around the base of the chimney on the roof is failing in that the flashing is torn or bent, the caulking is cracked or missing, or the flashing is separated from the roof or chimney. Recommend repair.

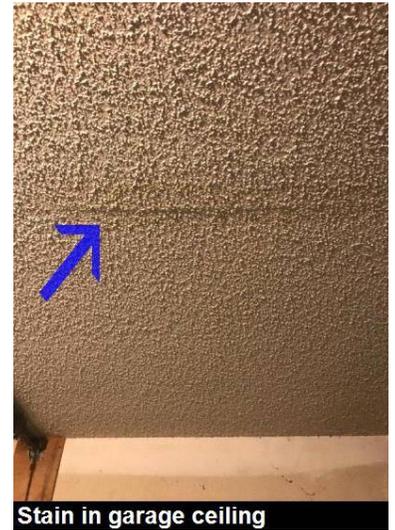
**Consult Seller:** Stains at the ceiling were observed at the garage indicating a past or present leak. Consult with the seller as to the nature of the staining and any possible repairs made.

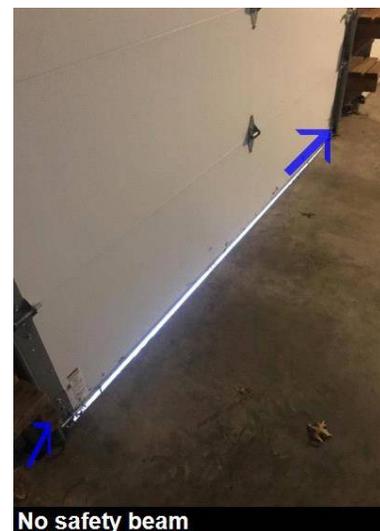
**Safety Concern:** The south garage door opener did not have safety beam system to reverse the movement in the event of contact with an object. We recommend the installation of such a safety device as an upgrade to the garage door opener system.

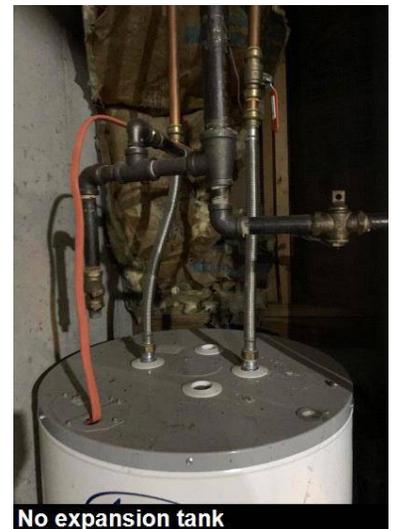
**Further Review:** a hot water pressure relief tank was not installed. A hot water heater expansion tank can both resolve and prevent high water pressure. Unresolved, excessive pressure can seriously compromise the durability, performance and the efficiency of the system. Recommend installing an expansion tank.

No expansion tank

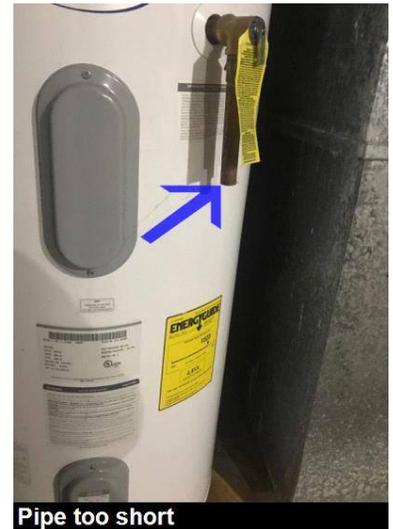
**Safety Concern:** The water heater temperature pressure relief valve discharge piping terminates too high off the ground. For safety, the temperature and relief valve discharge pipe should terminate within 6" of the ground or floor. We recommend repair as required.

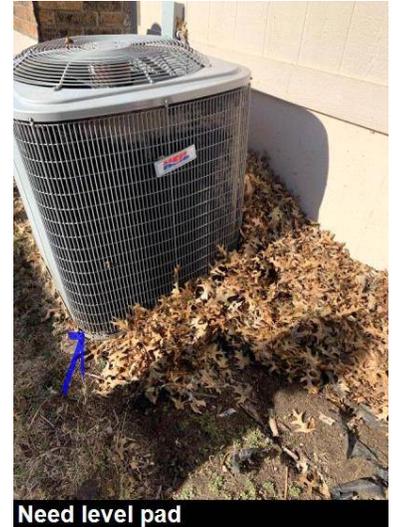
**Repair:** The AC pad at the central zone must be level within 5 degrees. An non level surface by more than this amount will void manufacturers warranties and may have adverse effects on the longevity of the unit. We recommend that a pad be installed and properly leveled to achieve a flat non-sloped surface as required.

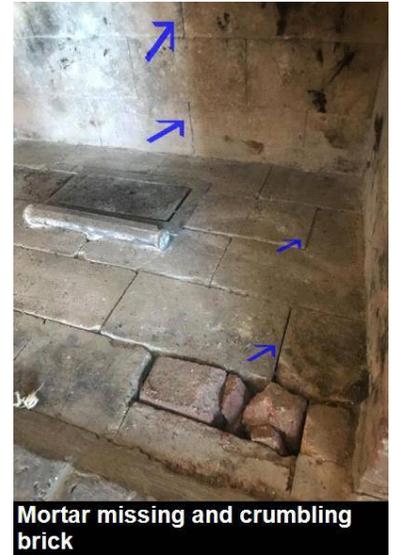
**Safety Concern:** some or all of the mortar was missing between the bricks in the fireplace box as well as a crumbling brick. This is a safety concern as sparks can exit between these seams and through the crumbling brick. Recommend sealing these gaps by a chimney expert.

Mortar missing and crumbling brick

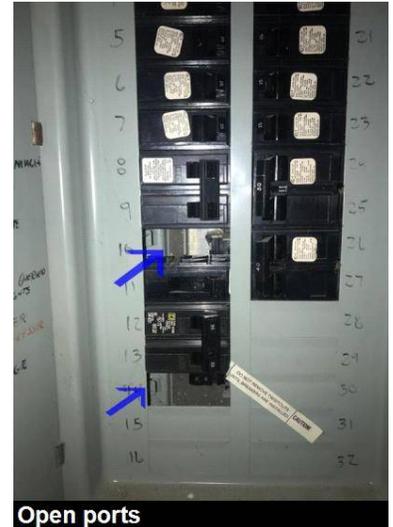
**Safety Concern:** Two open ports were observed in the main service panel where a "knockout" had been removed. This presents a safety hazard to probing fingers and a pathway into the panel for insects and rodents. We recommend that these holes be covered as necessary to block entry into the "hot" portions of the panel.

Open ports

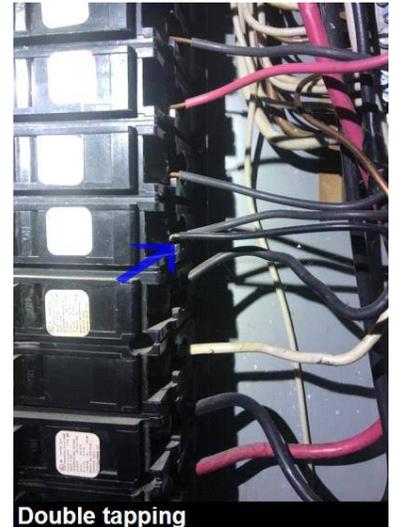
**Repair:** More than one wire was installed in at least one breaker(s) which was designed for the installation of only one wire: lower right side. This "double tapping" cannot ensure that both wires, installed under a screw designed to carry only one wire, receive the same amount of pressure from the screw. Because positive connection for all the wires under the screw may not be the same there is a possibility of arcing. This arcing can result in dangerous resistance and heat buildup within the circuit, and is considered an improper electrical trade practice. We recommend the elimination of all double tapping by an appropriate person.

Double tapping

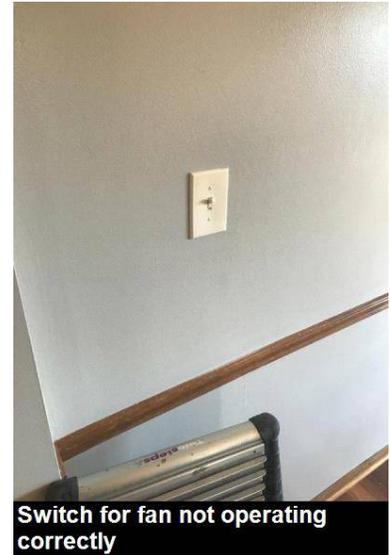
**Repair:** A 3 way switch was observed in the dining room as not functioning correctly. It is possible that a 2 way switch has been installed at this location making the 3 way circuit inoperable when in the off position. We recommend replacement of all non functioning or incorrect type switches.

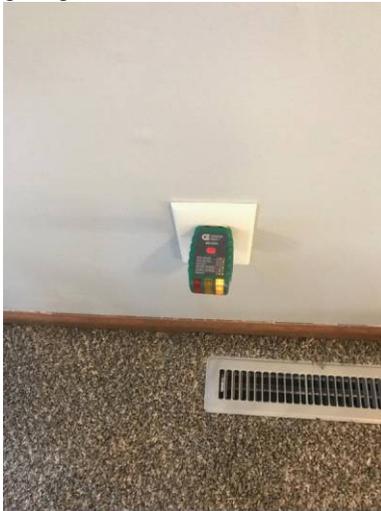
By front door

**Safety Concern:** The neutral or white wire was not connected properly and it is quite possible that the ground is carrying the current at the outlet to the left of the front entrance. This is a safety concern and should be promptly addressed. We recommend that the receptacle and circuit be evaluated and repaired as required.

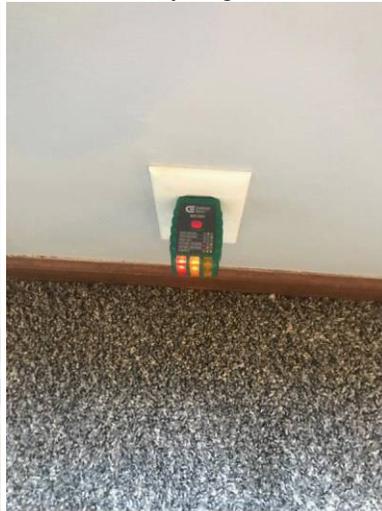
Under front living room window

**Repair:** The outlets at the following locations were observed to be wired backwards, or reverse polarity: under front window in living room, in basement, in garage on south and north walls, and downstairs family room. All improperly wired receptacles should be repaired to ensure that they are safe and dependable.

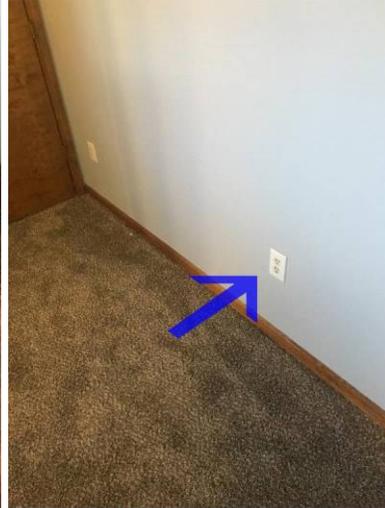
**Repair:** Ungrounded three-prong receptacles were observed at in the lower level bedroom on front wall and on garage on back wall. We recommend that any ungrounded three-prong receptacle be grounded.

Ungrounded

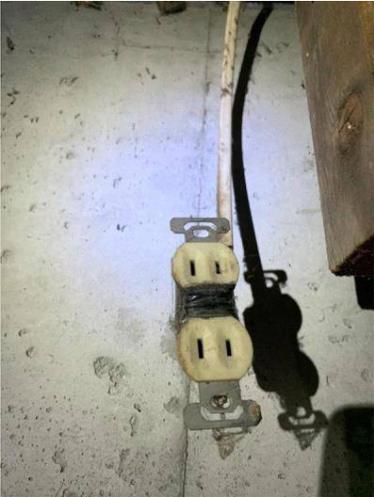
**Repair:** Missing conduit was noted in the basement along walls and above the water heater and in the garage on south and north walls. Additionally, there were unsecured outlets in the cabinet above the microwave and in the basement on the front wall.. We recommend that conduit be installed and the outlets secured.

Secure outlet

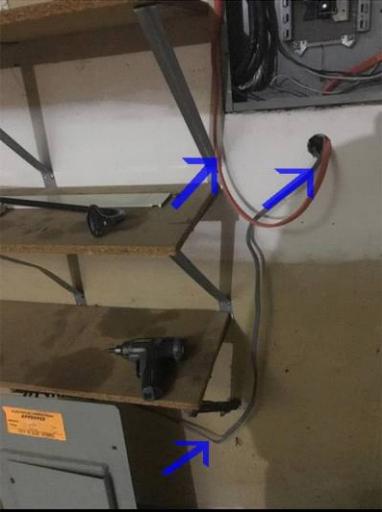
Missing conduit

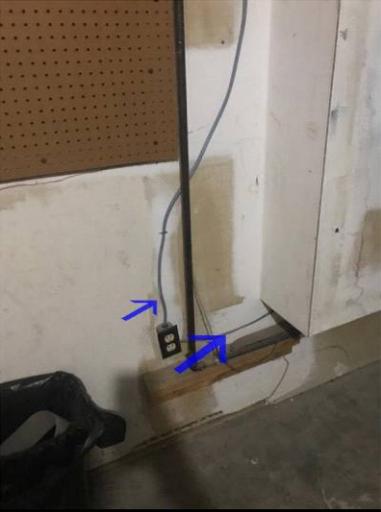
Missing conduit

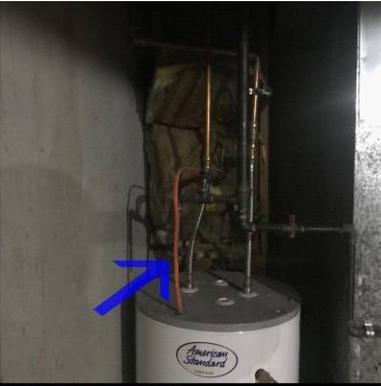
Missing conduit

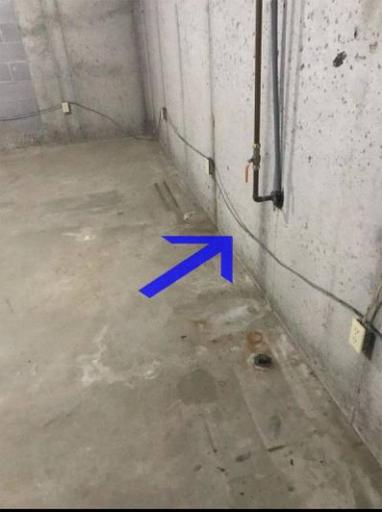
Missing conduit

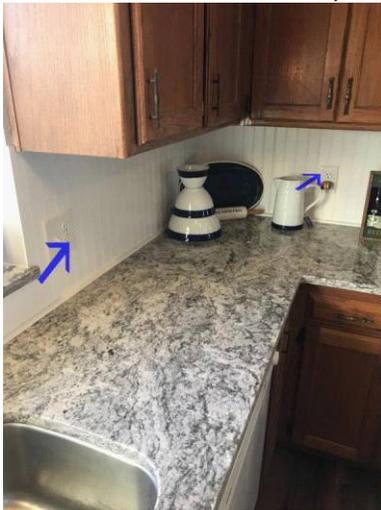
**Safety Concern:** A ground fault circuit interrupter breaker (GFCI) was not installed for all currently required locations. This could pose a serious safety condition and this shock protection device should be installed at locations within 6 feet of a water source (sink), a garage or workshop area and at all exterior receptacle locations. We recommend that GFCI receptacle protection be installed according to current applicable standards as a safety upgrade wherever needed. Missing in Kitchen- 1 north, 2 right side of sink, exterior, basement bathroom, basement and garage. **Safety Concern:** The master bath ground fault circuit interrupter breaker (GFCI) receptacle did not function as intended. This could pose a serious safety condition and we recommend that this GFCI breaker be replaced as soon as possible.

No GFCI

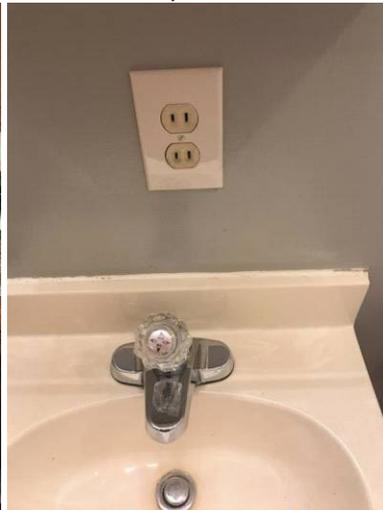
Ungrounded and no GFCI

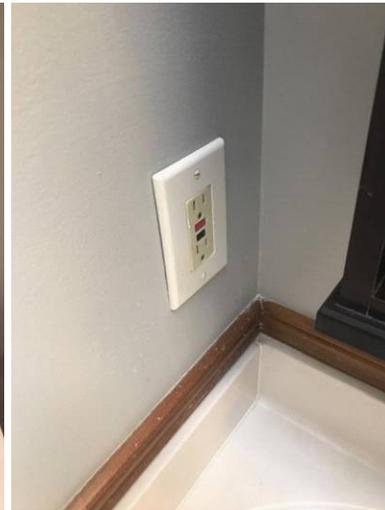
Not functioning correctly

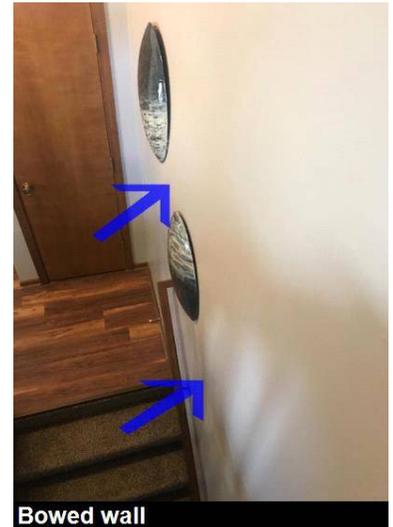
**Repair:** An area of the wall appeared to be bowed on the wall between the stairwell and the garage. Cause could not be determined. Recommend further investigation and repair.

Bowed wall

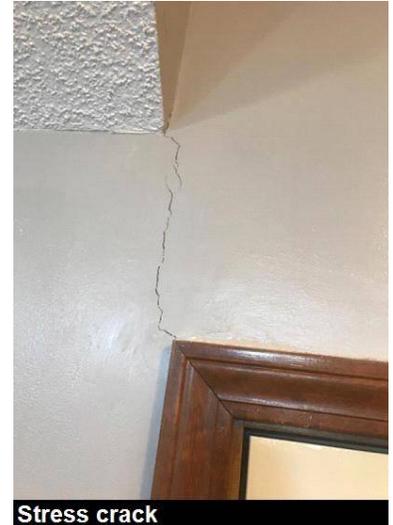
**Monitor:** One stress crack was observed at the living room walls above the front entrance door. These types of cracks are common and are generally a cosmetic condition only. No visible structural issues were observed. Many factors contribute to this type of crack. Shrinkage and settlement are the primary causes. We recommend that the stress cracking be monitored with correction as necessary.

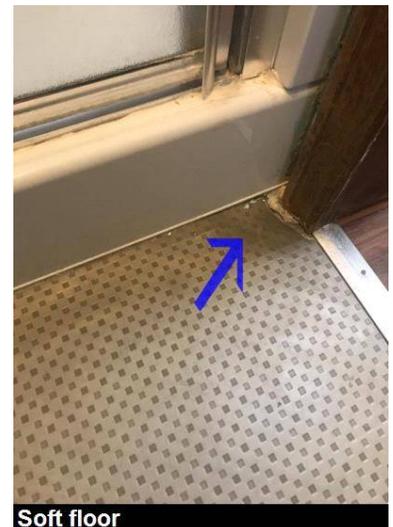
**Further Review:** The floor was observed to be soft/spongy in front of the shower in the master bath. Soft flooring may indicate non visible structural issues. We recommend further review for a better understanding of replacement costs/repairs and present condition.

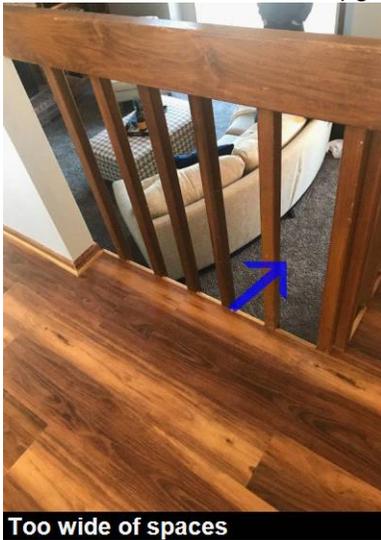
**Safety Concern:** The baluster spacing on the upper floor on both sides of the stairway were non-conforming, the balusters were spaced too far apart (greater than 4"). Although this installation may have been acceptable at the time of construction, upgrading for safety should be considered.

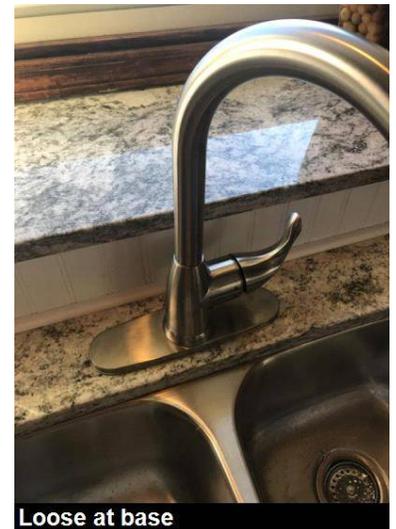
**Repair:** The faucet on the kitchen sink was found to be loose at the base. This may allow water to leak into the cabinet below and/or cause leakage from movement. We recommend re-securing and sealing the faucet.

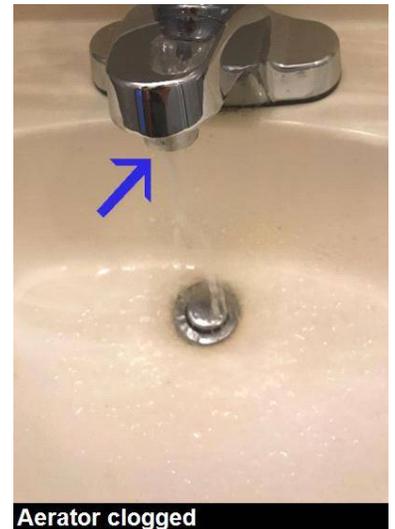
**Repair:** The aerator is partially clogged in the lower level bath(s). We recommend the replacement or cleaning of the faucet aerator(s) for proper fixture function.

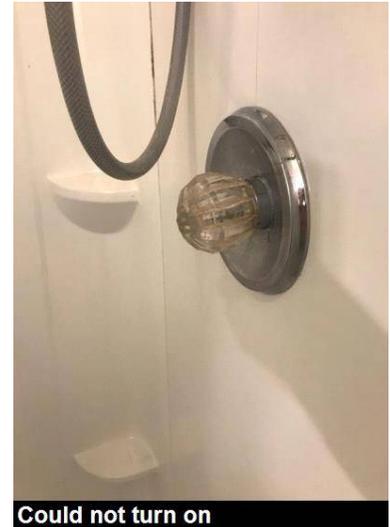
**Repair:** The lower level bath tub/shower faucet(s) was found to be difficult to operate and was not able to be turned on. We recommend repair or replacement of the faucet(s).
