Metro Tunnel Inspection Demo Report 1

@Korea, by Jackie Cheung 2025/06/26

Indeogwon Station, Line 4

Tunnel Type: NATM
(New Austrian Tunnelling Method)

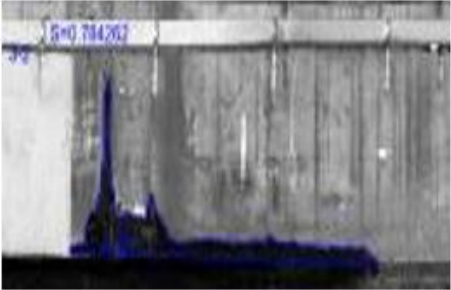
No.	Area (m ²)	Length (m)	Width (mm)	Defect	Reference
3-2	0.7843	0.0000	0.0000	Moist

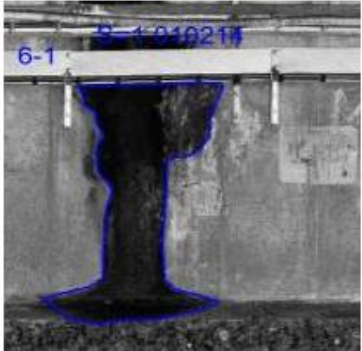
6-1	1.0102	0.0000	0.0000	Moist

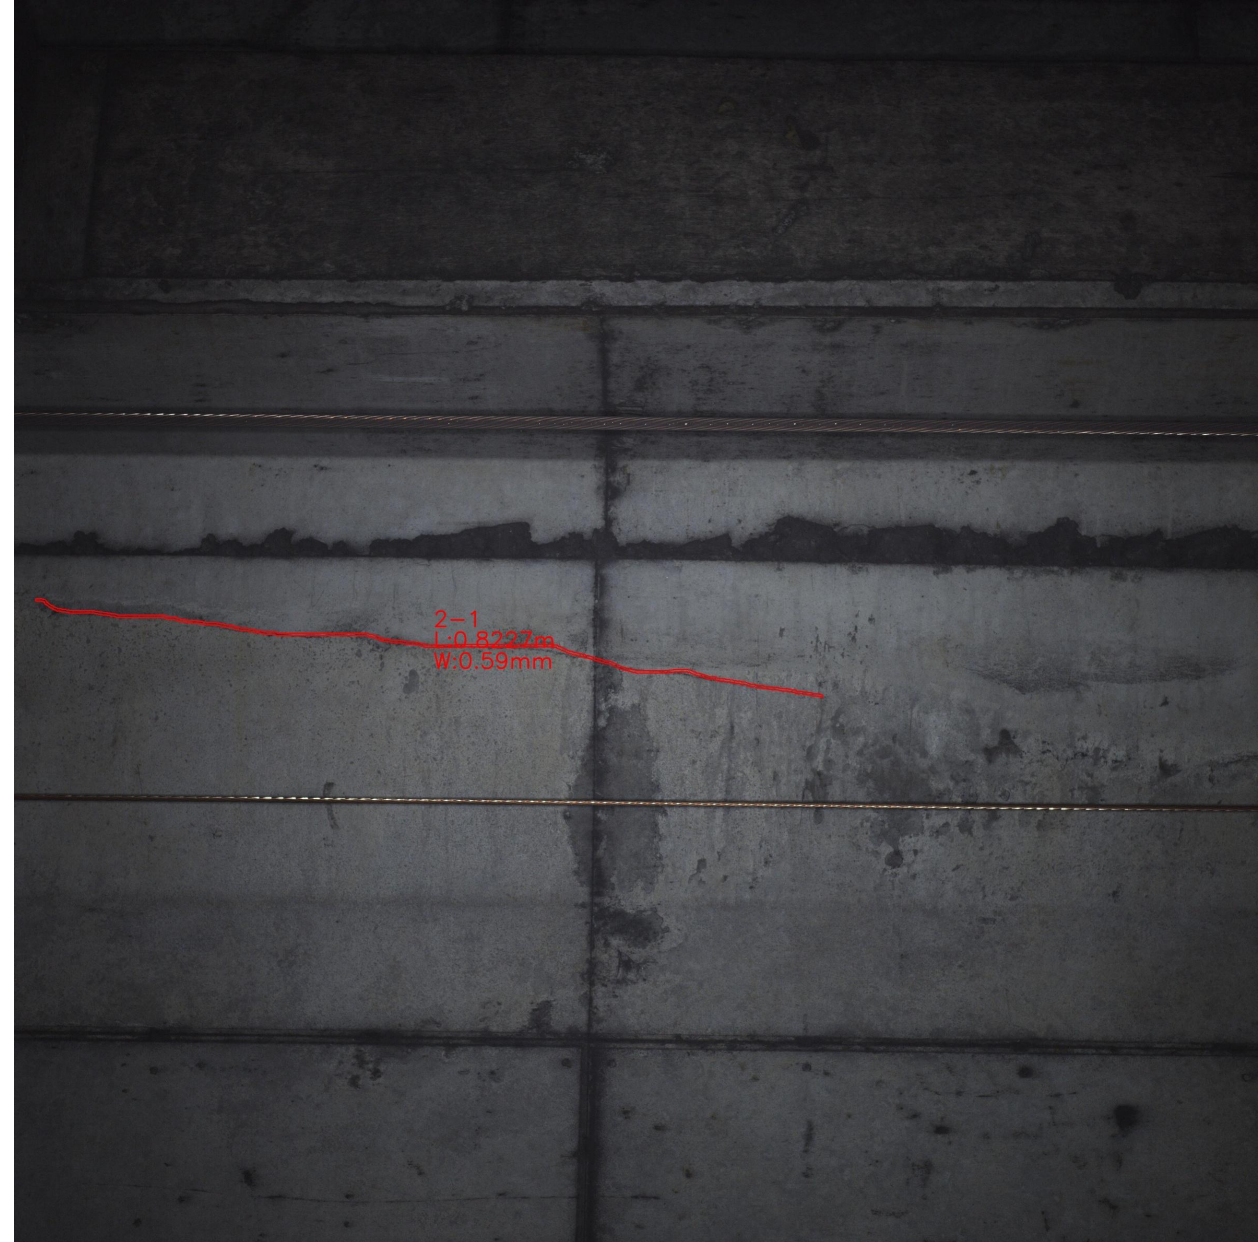
4. Outputs Display ⑦ - Detected Crack in HD Image

l:crack

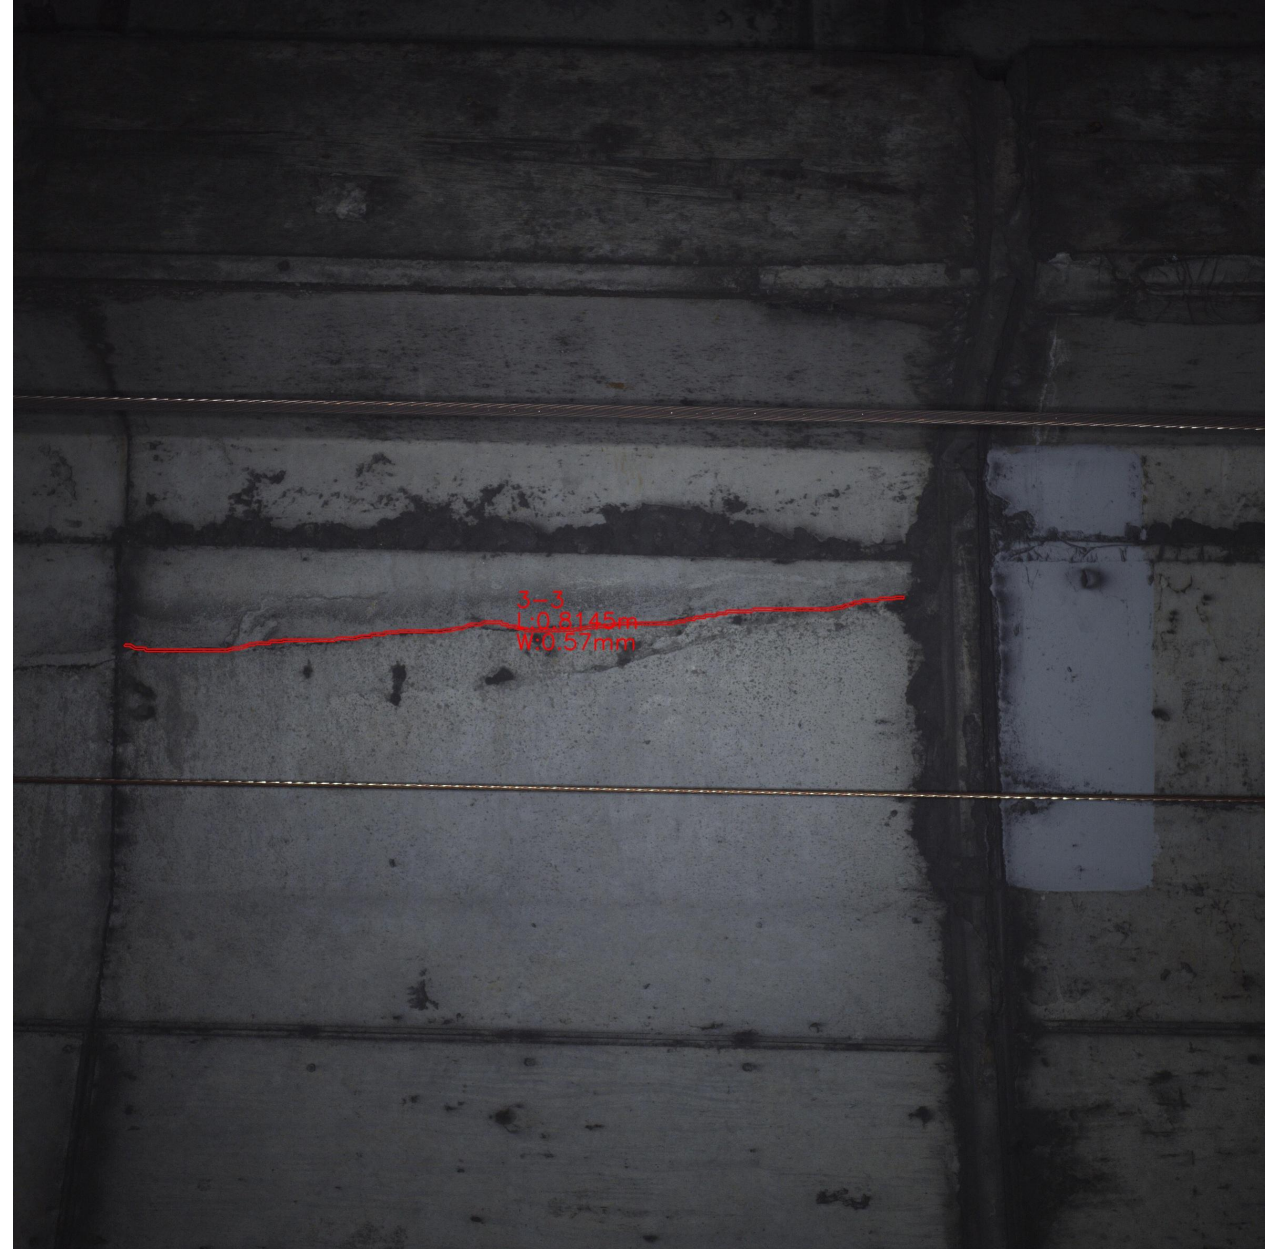
4. Outputs Display ⑦ - Detected Crack in HD Image

l:crack

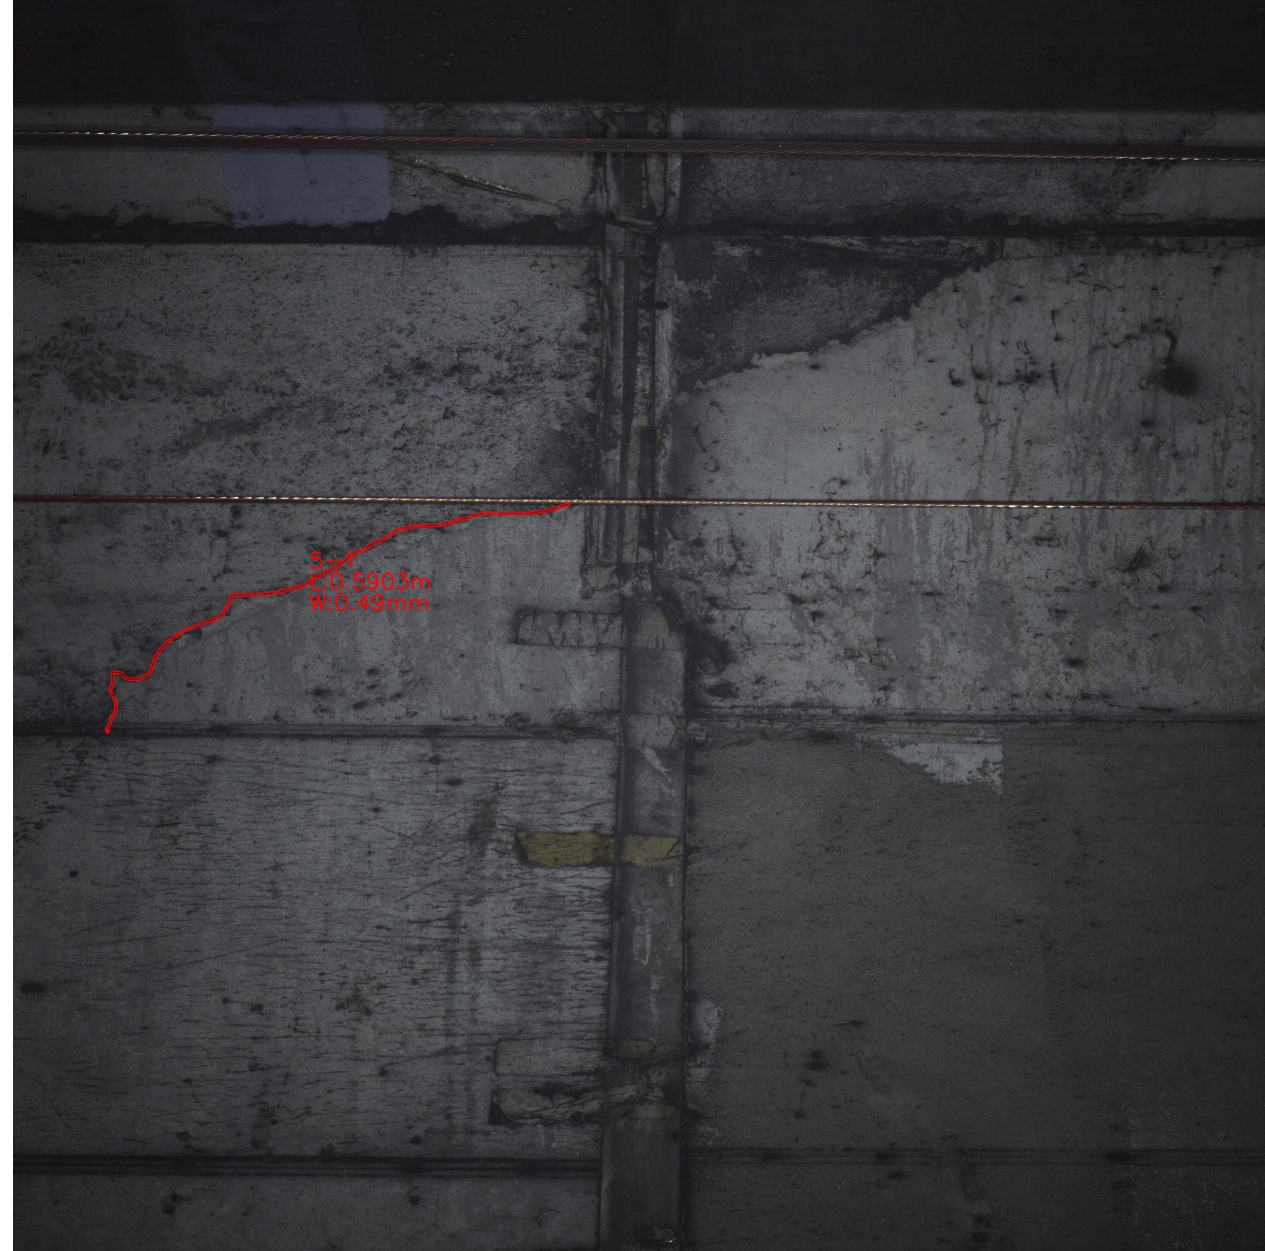
4. Outputs Display ⑦ - Detected Crack in HD Image

S:
L: 5903m
W: 49mm

l:crack
