Inspection Report

Sunday, September 4, 2016

PROPERTY INSPECTION REPORT

Present at Inspection: Buyer Selling Agent Listing Agent Occupant
Building Status: Vacant Owner Occupied Tenant Occupied Other
Weather Conditions: Fair Cloudy Rain 92 F Outside Temp.
Utilities On: Yes No Water No Electricity No Gas
Special Notes: New Home Final Construction

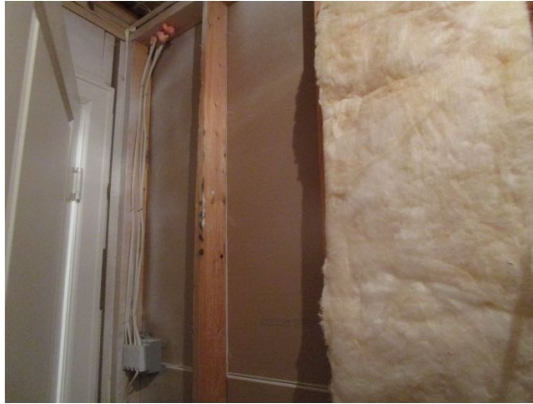
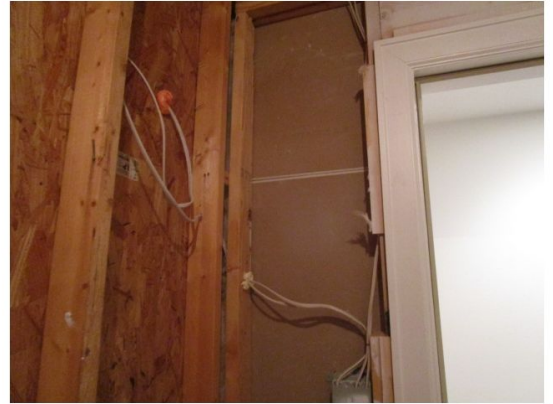
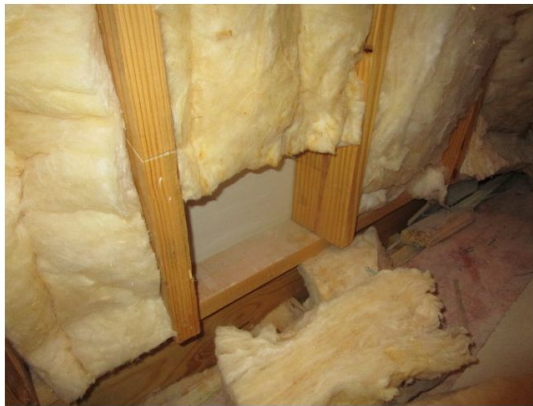
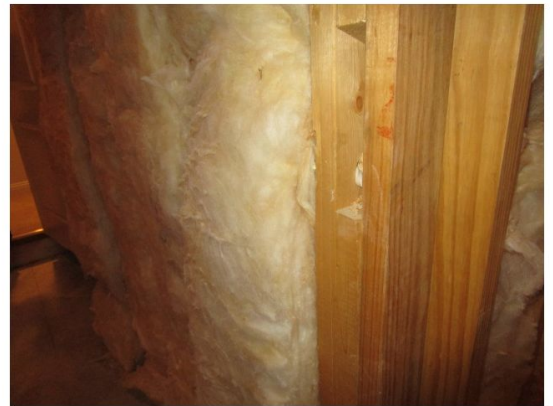
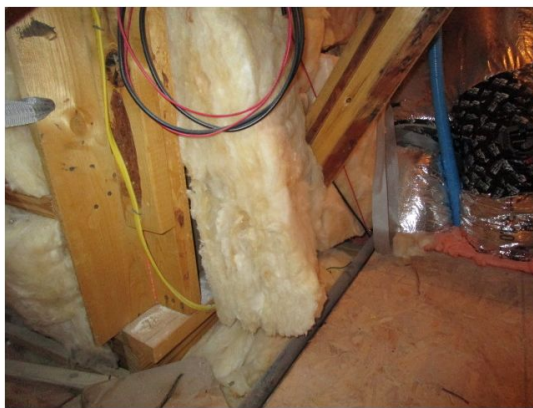
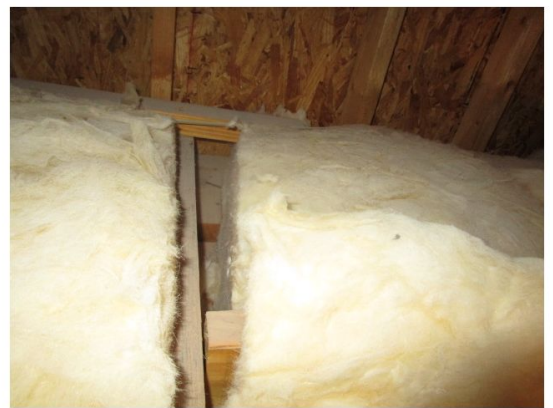
Comments: The insulation on the attic was not complete where there are gaps between the batts. The insulation is not complete on some of the interior attic walls. The insulation has not been properly secured to be kept from falling down on the interior attic walls. It is recommended that additional insulation be added for energy efficiency.

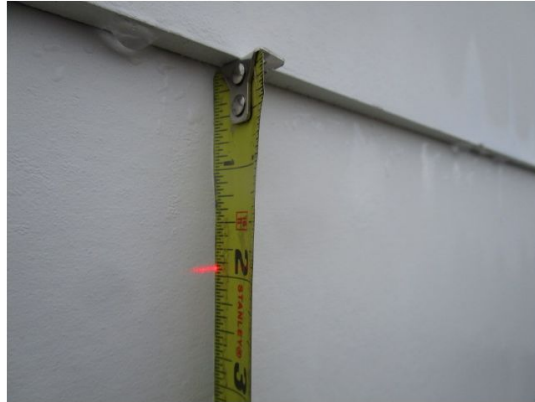
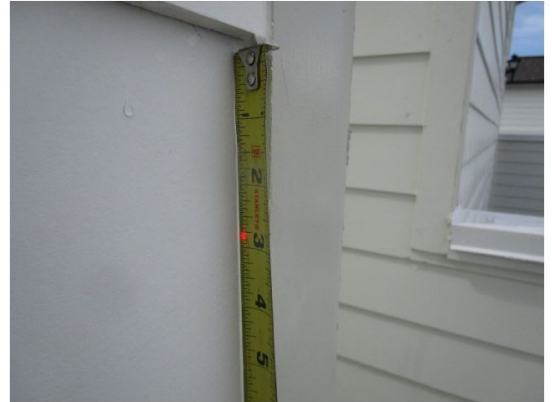
The exterior siding has been installed notably not level on the front of the home at the fourth floor deck area.

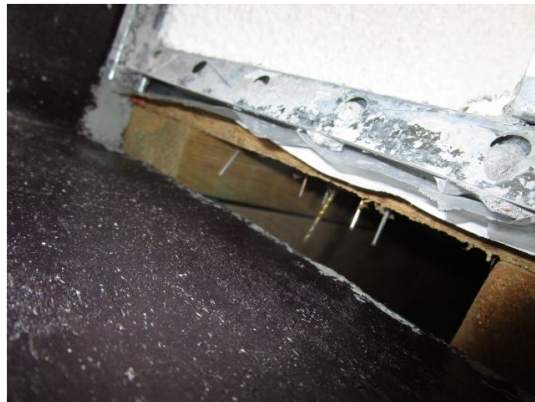
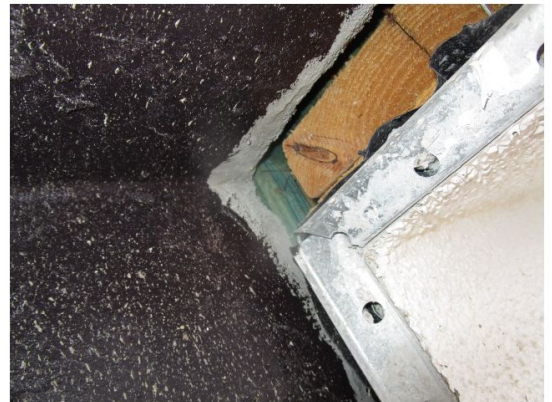
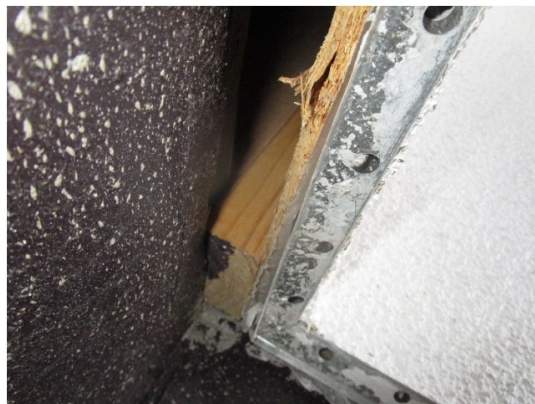
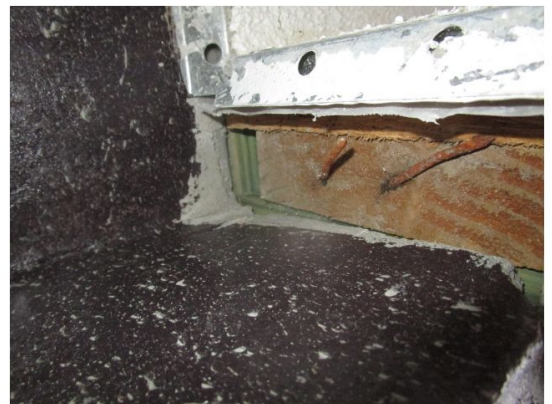
There are large gaps under the stucco walls at the front of the garage where the bottom wall plates are not complete and the walls are cantilevered off the foundation leaving the structure exposed.

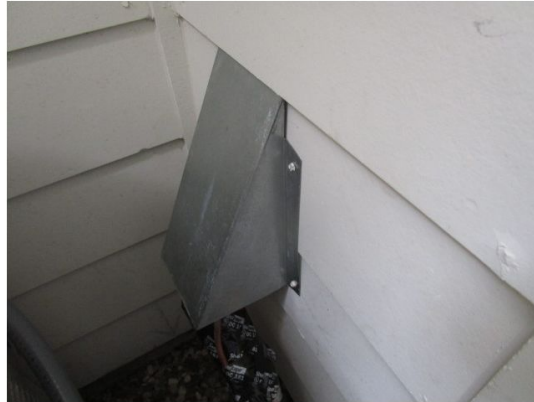
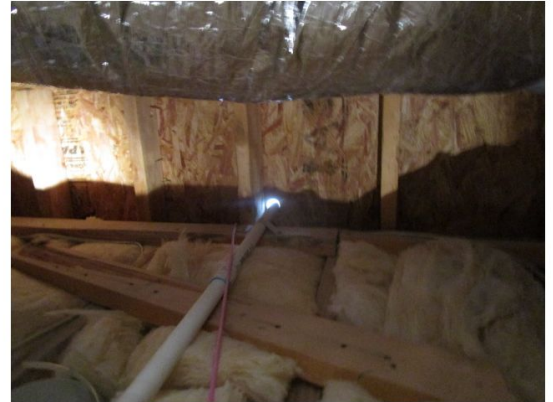
It is necessary to seal around the exterior vent wall caps, the electric meter box, the air conditioning compressor quick disconnect box, where the plumbing lines and air condition refrigerant lines enter the home and where the air conditioning safety pan drain line exits the siding in the attic to prevent water/moisture penetration to the structure.

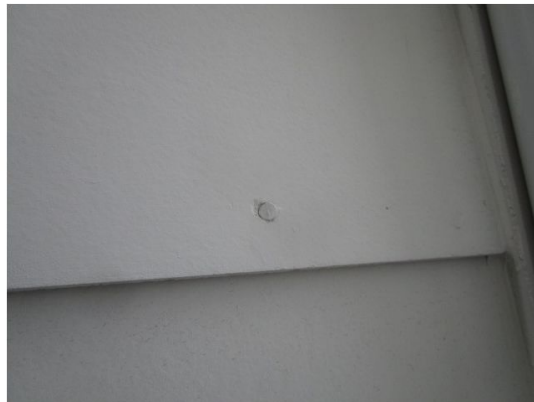
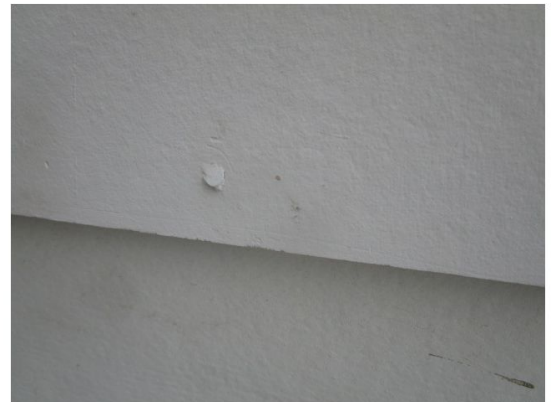
Several of the nails in the exterior siding have not been recessed and sealed properly and many have been bent over. Exposed nail heads can allow water to penetrate past the exterior siding given enough time. As the exposed portion of the nail rusts, more space will become available between the nail and the siding material for water to penetrate.

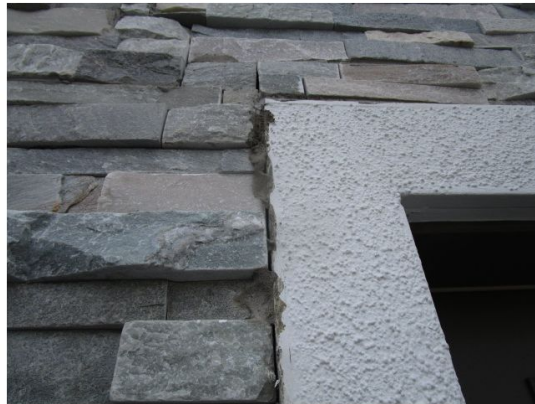
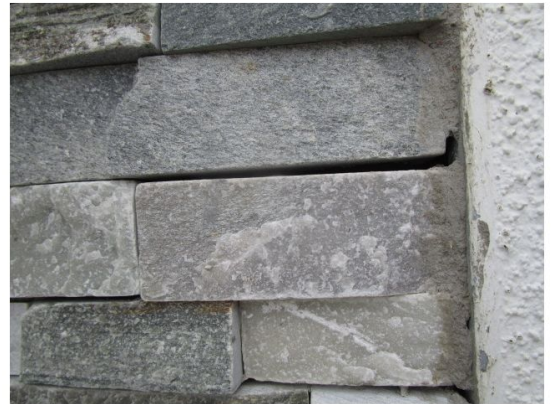
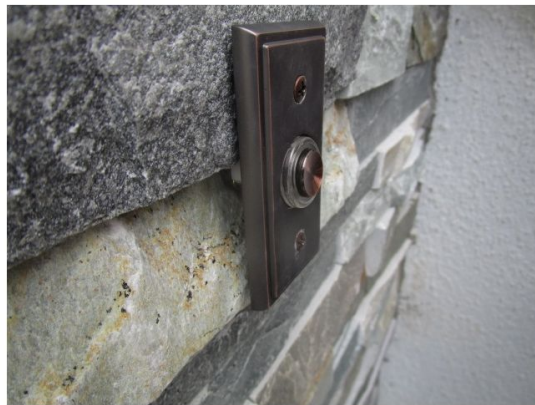
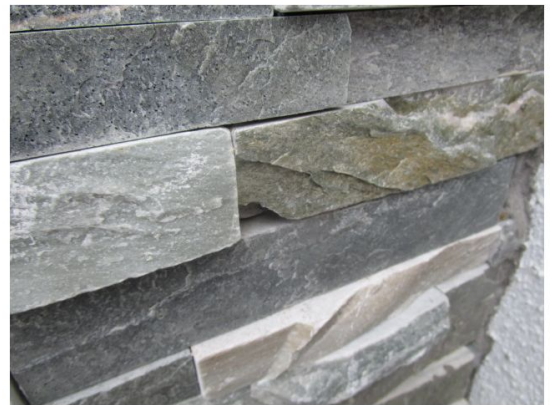
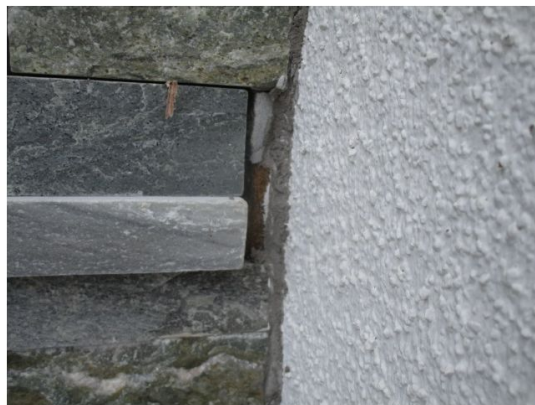
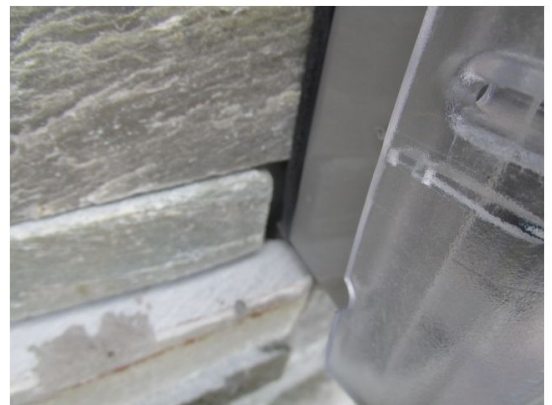
There are voids in the exterior stone mortar where it meets the front door, at the front exterior outlet and the door bell button and there are gaps in the stone work that should be filled to prevent water/moisture penetration to the structure.

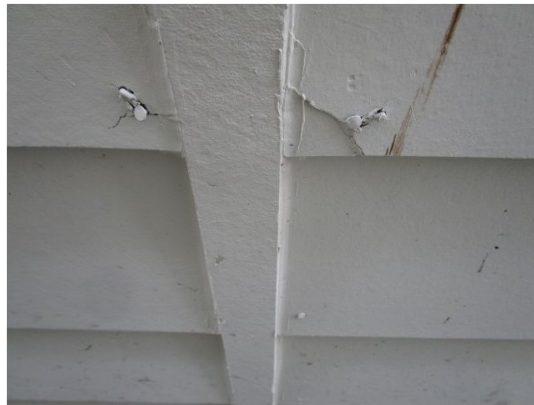
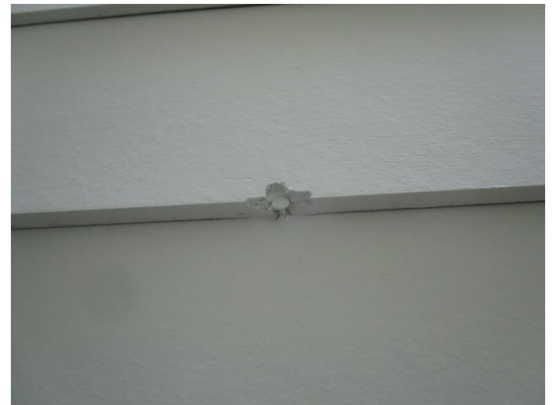
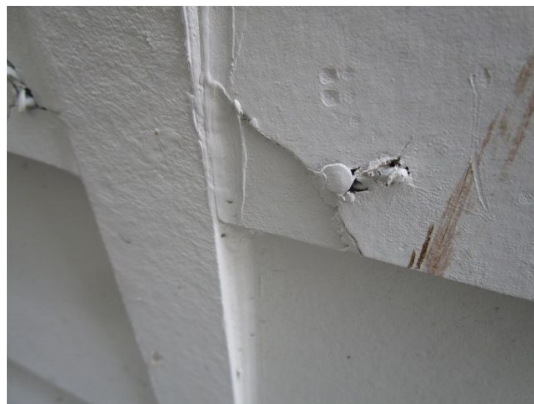
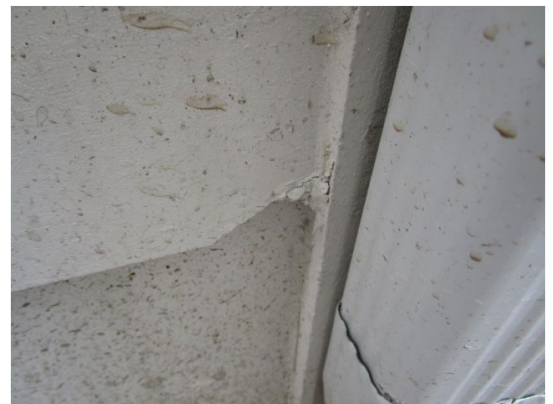
Some of the corners of the exterior siding are damaged in several areas and there is a damaged piece of exterior trim at the rear southwest corner of the home.

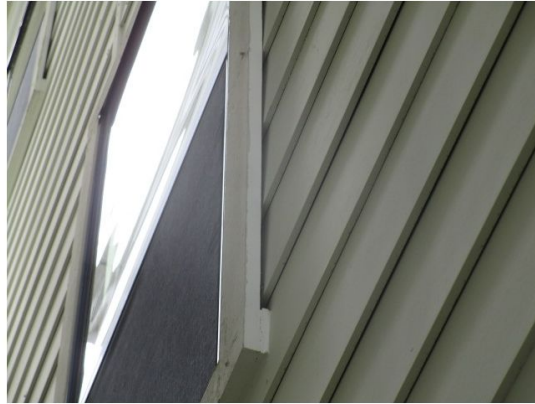
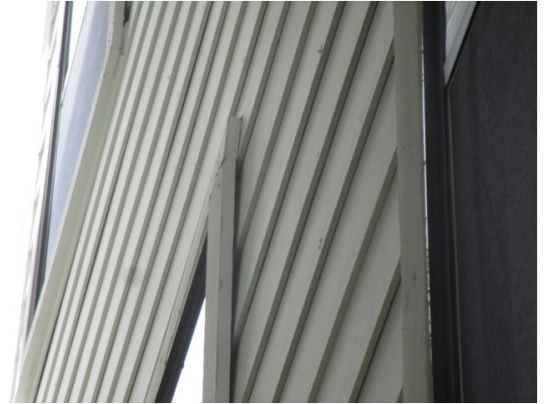
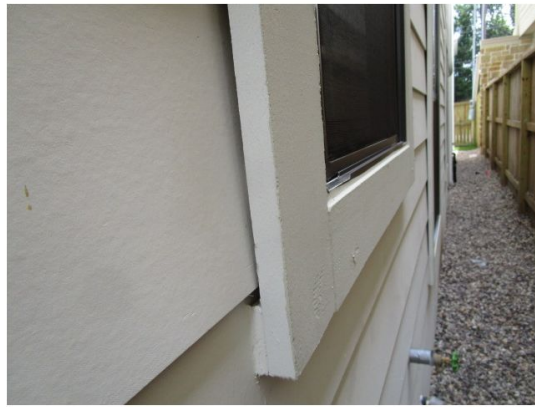
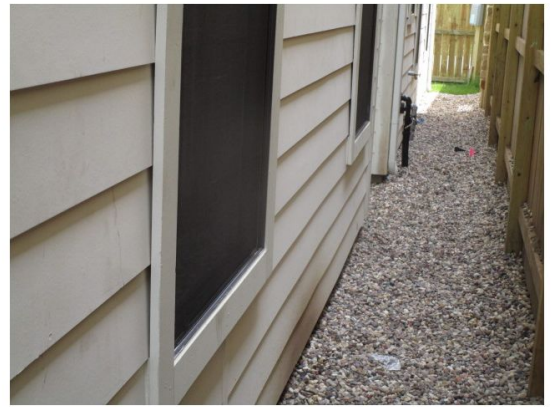
It is recommended that all exterior trim be sealed where it meets the siding and stonework in order to prevent possible water penetration.

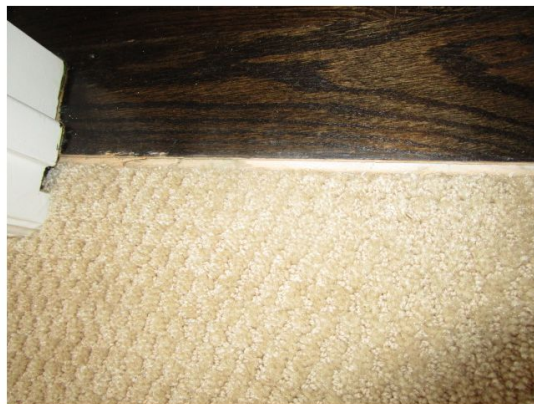
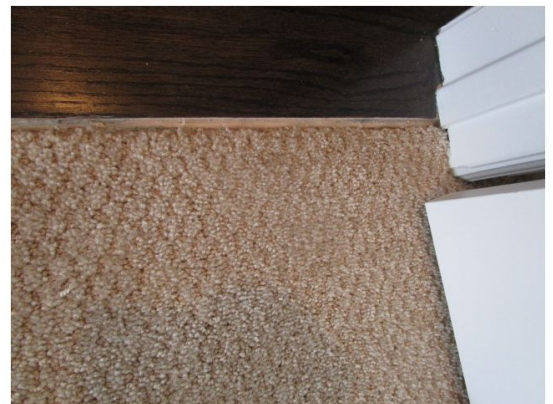
There is a gap between the hardwood flooring and the carpet at the entrance to the master bathroom and third floor guest bedroom.

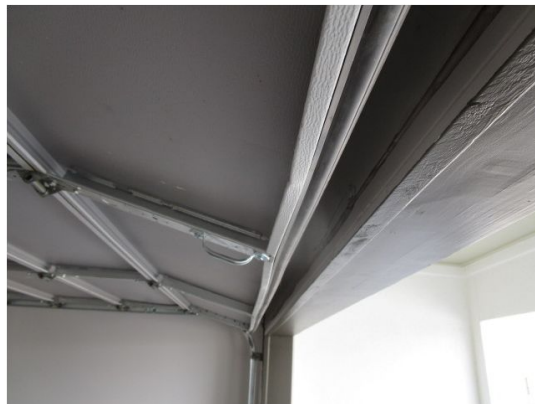
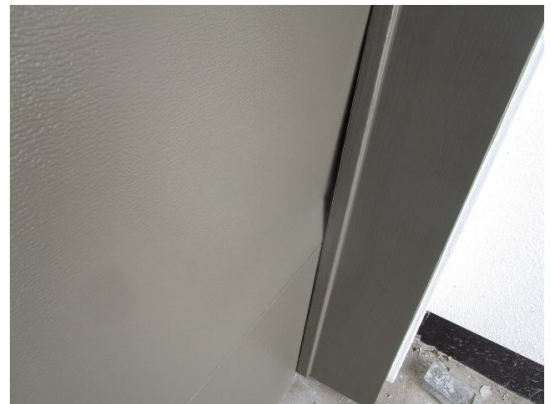
The bottom panels on the overhead garage door are damaged/bent.

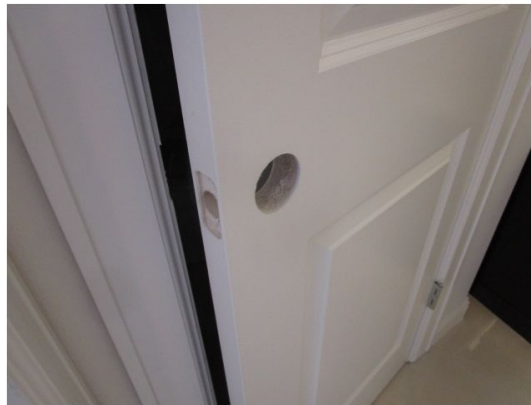
The door knob is incomplete at the third floor hall closet door.

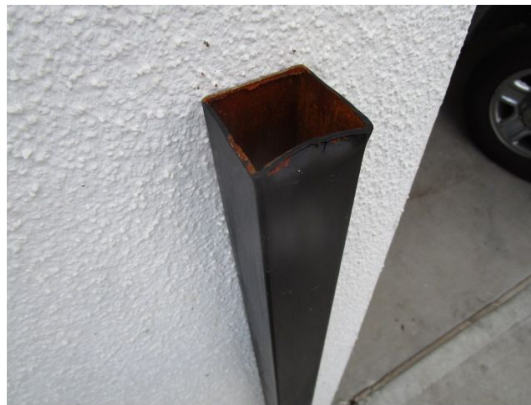
The cap is not installed on the metal fence post next to the home which will allow water to fill the pipe and promote further corrosion.

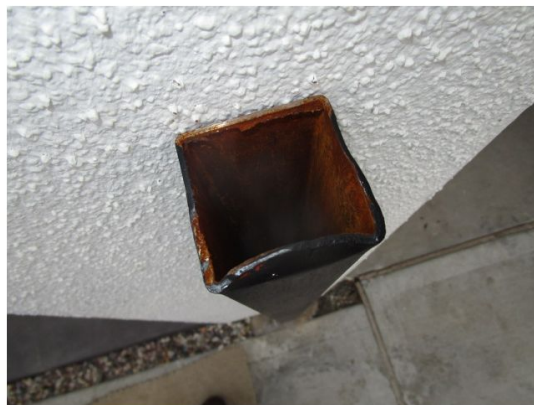
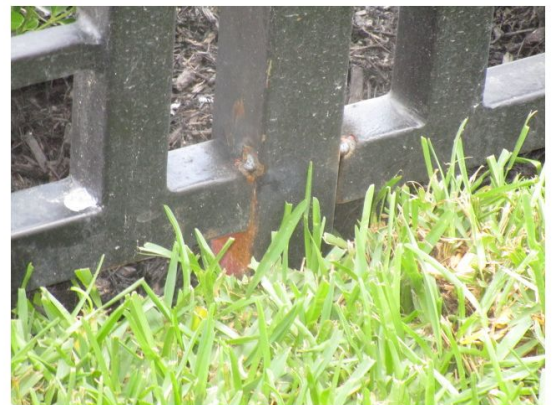
There is minor corrosion on some areas of the metal fencing and some areas are not completely painted.

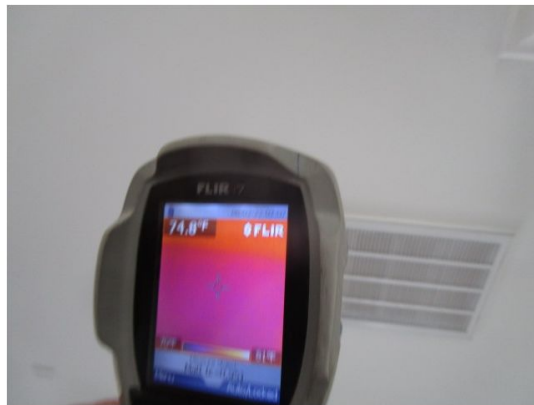
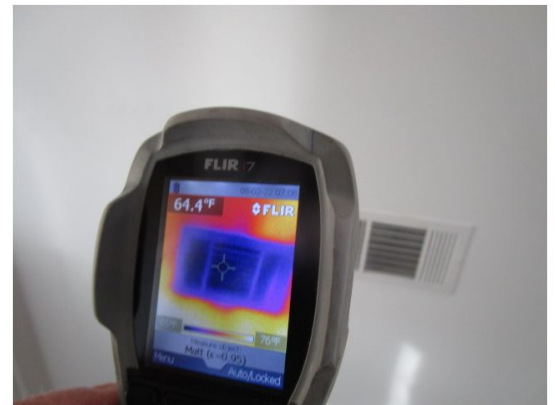
**Differential Air Temperature Drop During Operation:
Air Going Into System: 74 f Returned Air: 64 f**

The system did not operate within the allowable tolerances. The air coming out of the vents should be 14 to 21 degrees cooler than where it goes into the cold air return. It is recommended that a qualified contractor be consulted regarding this matter.

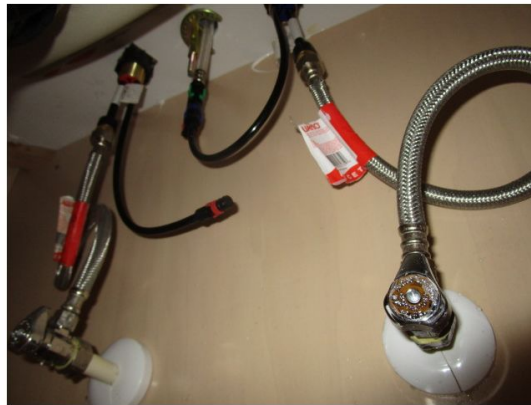
There is a leak where the plumbing lines are not completely installed at the sink in the first floor bathroom. Leaks can promote water penetration to the structure. Concealed damage is a possibility. This condition has caused water damage/stains in the cabinet below.

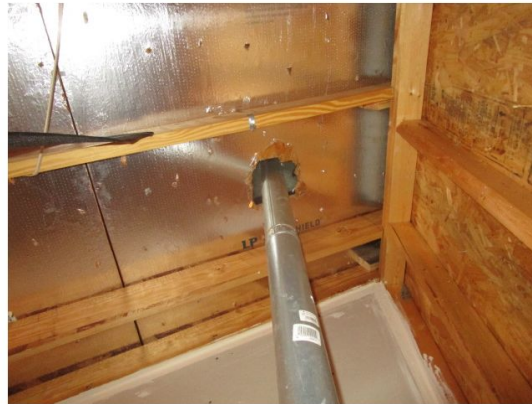
There is debris in the safety pan. In the event of a system malfunction, the safety pan is designed to catch the water overflow and carry it to the outside of the home. It does not take much debris to stop up the safety pan drain line. These pans should be kept clean and checked regularly as a part of a proper maintenance.
