## Inspection Report

Tuesday, July 12, 2016

## PROPERTY INSPECTION REPORT

By: Brad Leland, Lic #5229 07/12/2016  
(Name and License Number of Inspector) (Date)

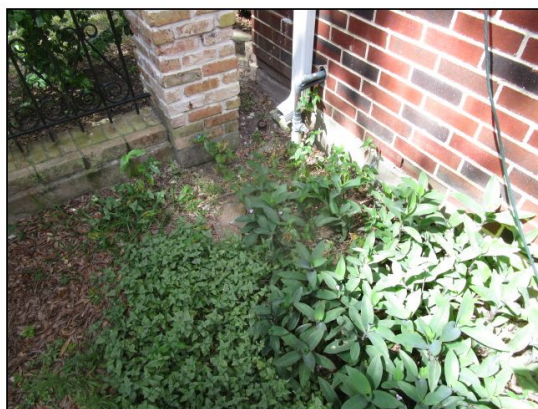
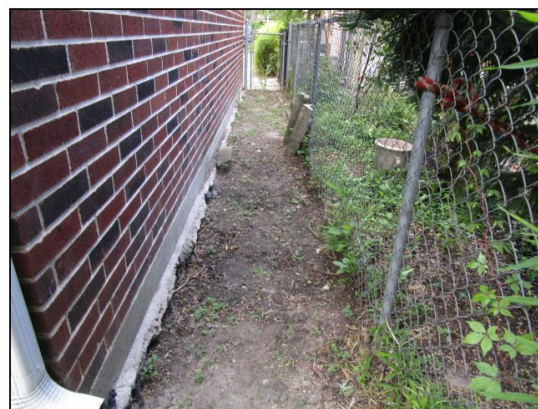
There are low areas that appear to be collecting rain water on the east side of the home and the west side of the garage. The drainage strategy of the yard as it relates to the foundation is important. Expansive soils can be destructive to the foundation if the moisture content of the perimeter varies. Improvement should be made to the grading of the yard in this/these areas.

There is water collecting on the east side of the yard near the air conditioning compressor which appears to be draining from the neighbors home.

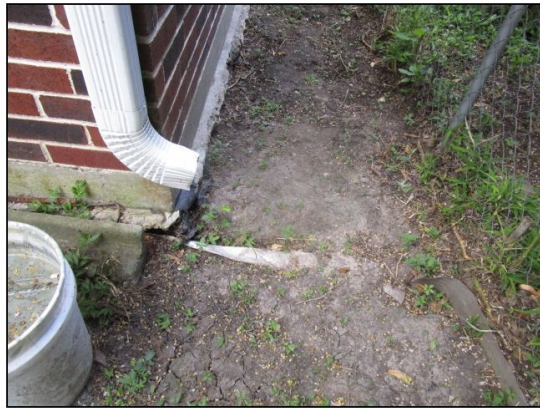
It is recommended that splash plates be installed at the gutter downspout terminations to prevent erosion of the soil and to direct rain water away from the perimeter of the foundation.

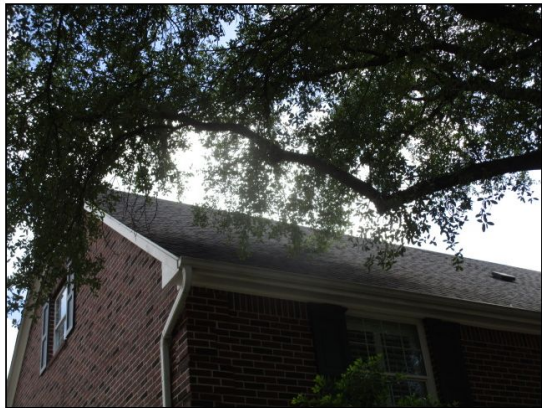
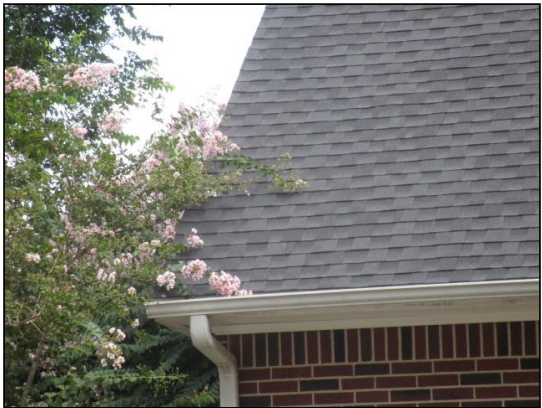
***Comments:*** There were tree branches impinging the main roof at the front southwest corner and also at the front southwest corner of the garage. Tree branches can damage a roof even in a gentle breeze. Whenever a tree is in contact with the roof structure the branches should be cut back aggressively.

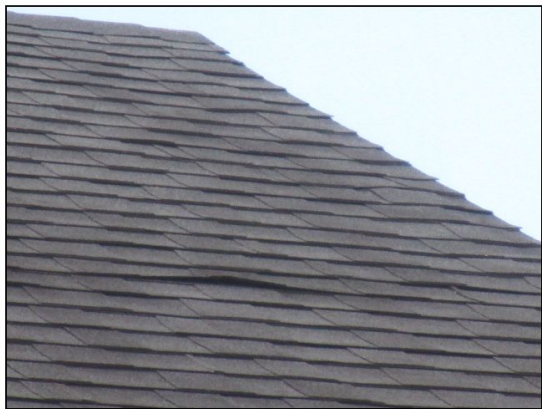
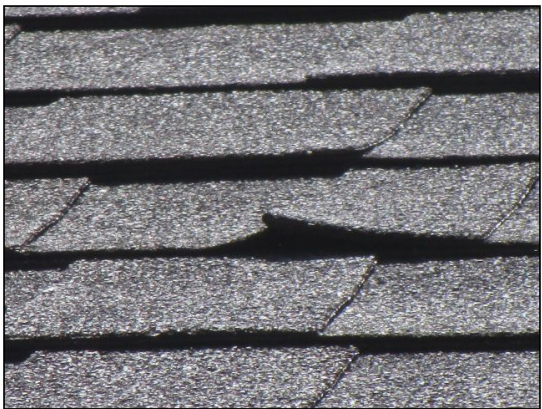
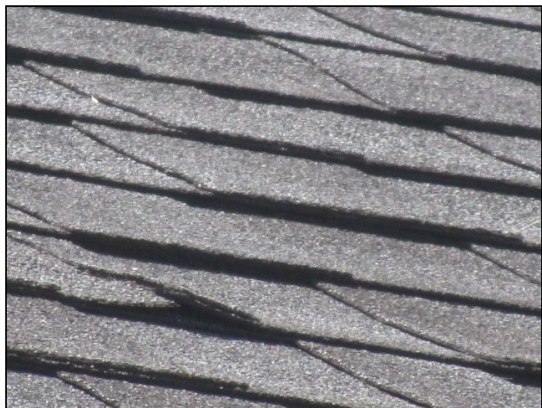
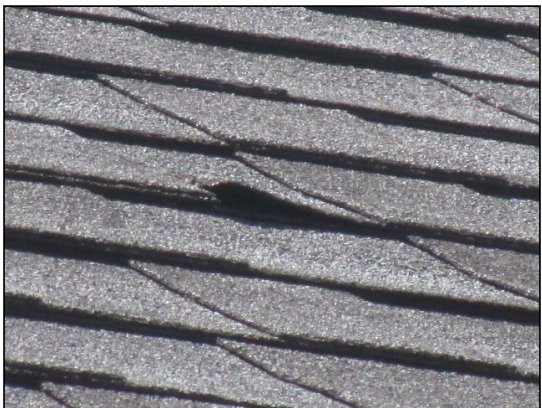
There are several lifted shingles that may be caused by nails backing out at the back of the main roof. A qualified roofing contractor should be consulted regarding this condition.

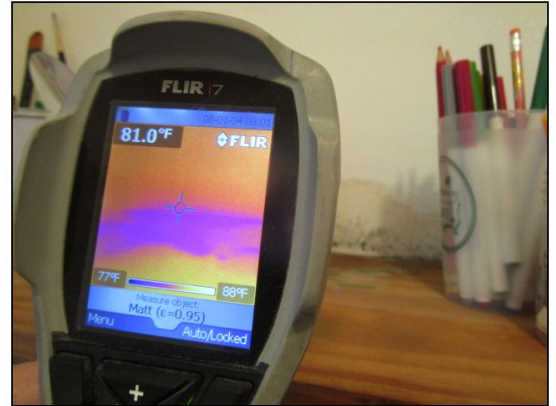
**Comments:** High moisture readings, water stains and dark discoloration that may be mold were observed on the wall above the shelf in the garage apartment closet. There is an active leak from the AC refrigerant line above this area that is not properly insulated. Hidden damage is a possibility. All damage material should be repaired/replaced. A separate mold inspection would be necessary to determine if this condition has caused mold growth that is a health concern.

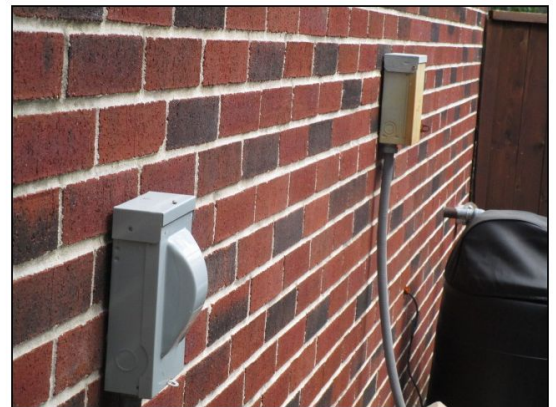
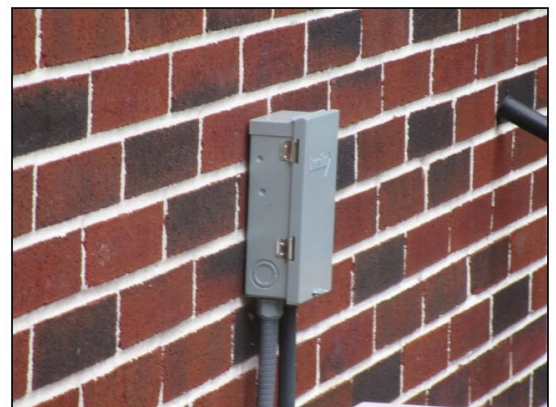
It is necessary to seal around the electric meter box, the air conditioning compressor quick disconnect boxes and where the plumbing lines enter the home to prevent possible water penetration to the structure.

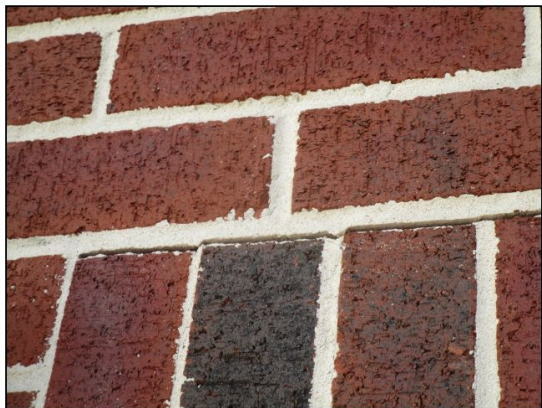
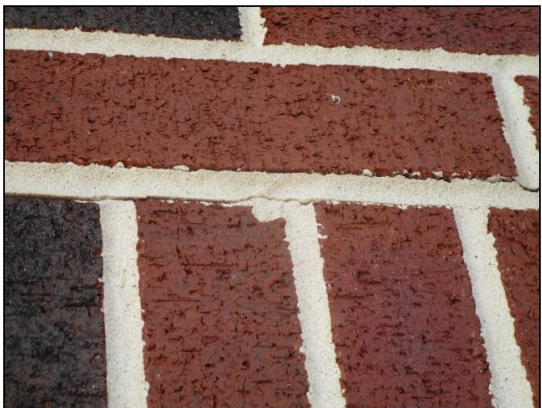
There were small cracks in the exterior brick in the front of the garage. Cracks near the windows and doors are usually indications that there is some degree of movement occurring in the structure. The severity of the cracks can be an indication of the amount of movement in a structure. These cracks should be filled and monitored for further activity.

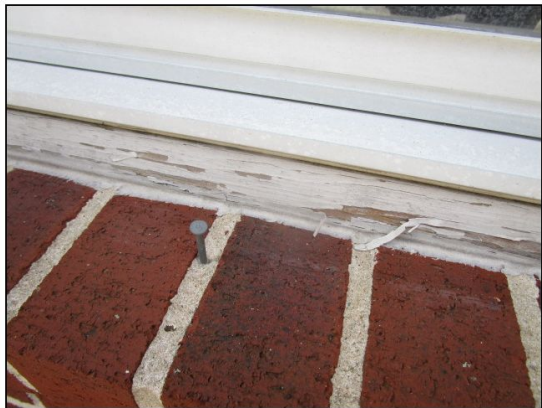
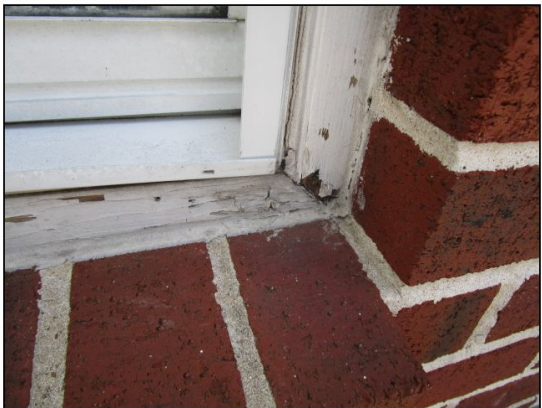
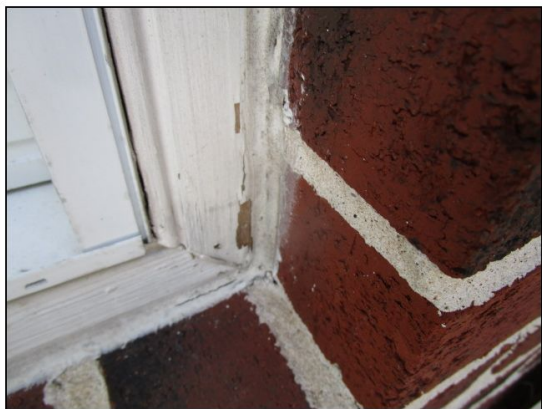
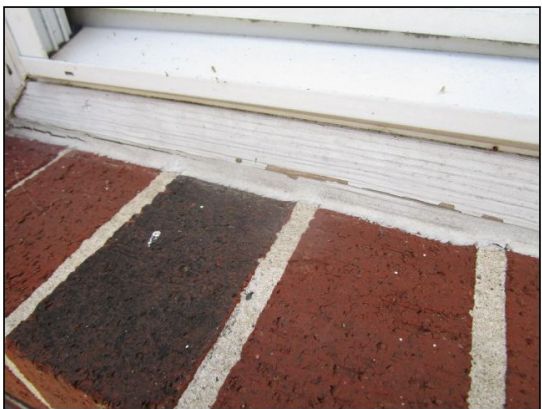
The exterior paint was peeling on the exterior trim at the back door off the master bedroom and around the master bedroom windows. Exposed or weathered wood is considered a conducive condition for wood decay and water penetration. It is recommend consulting a painting contractor so a course of corrective action can be evaluated.

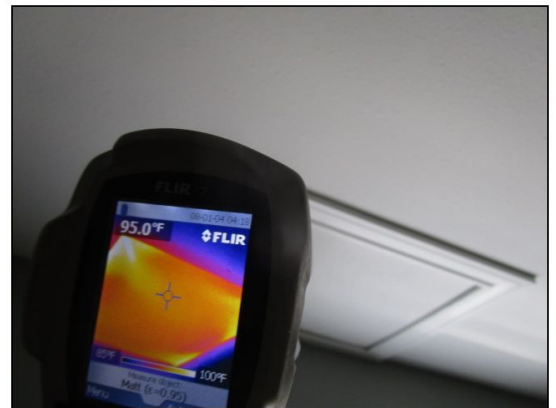
The attic access scuttle panels in the third floor game room and the garage apartment are not insulated. The attic panels should be insulated to prevent radiant heat from transferring from the attic to the living quarters.

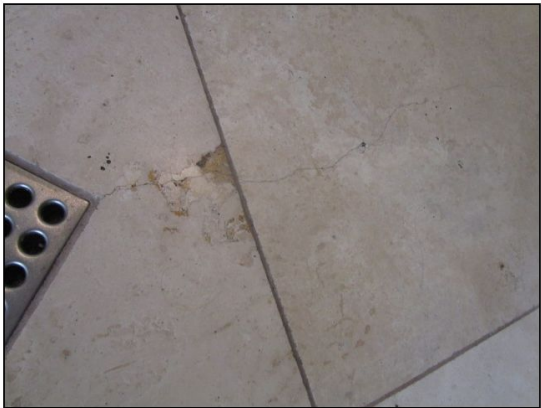
There are two cracked floor tiles near the floor drain in the utility room. These cracked tiles may be a result of past movement in the structure. It is recommended that these tiles be replaced and then these areas should be monitored in the future.

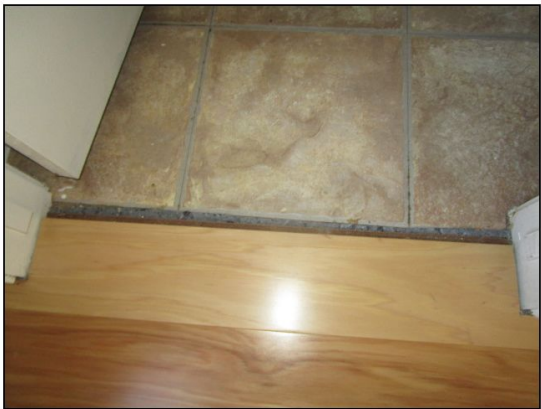
There is no transition strip installed between the garage apartment sleeping area and bathroom flooring.

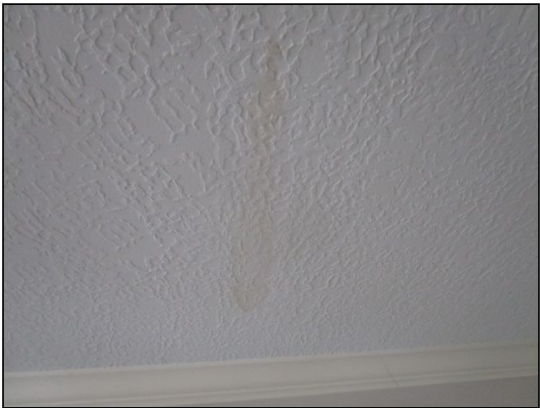
There was evidence of water penetration (water stain) on the ceiling of the upstairs rear northeast bedroom. This area was dry when tested. Leaks can cause hidden or concealed damage. All damaged elements should be repaired or replaced. The reason for the water penetration is unknown. This area should be monitored, especially during heavy rain, to determine if the leak is active.

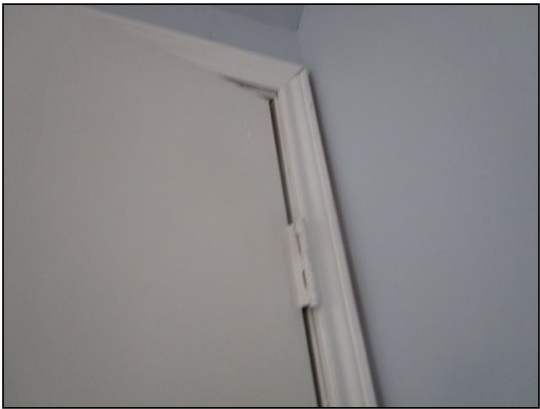
**Comments:** The top hinge is loose at the garage apartment lower attic door.

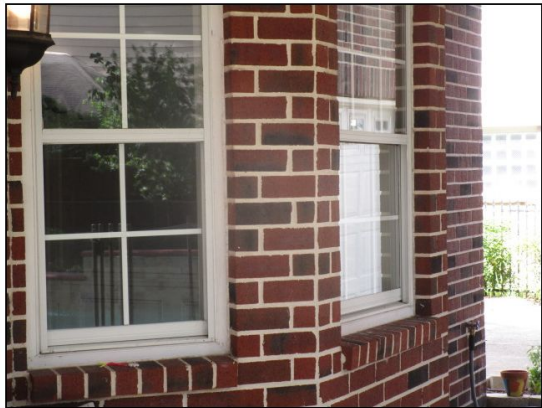
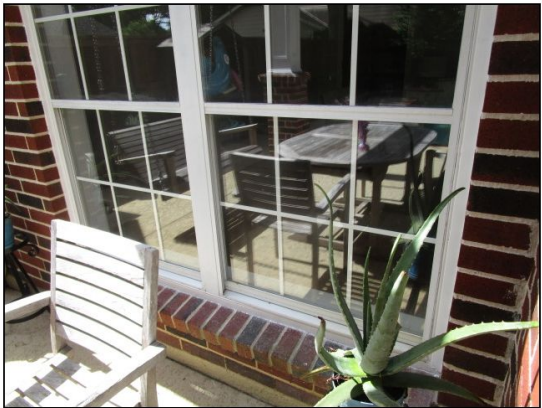
**Comments:** Window screens were missing. Screens are mentioned in this part of the report as they are a specific item in the T.R.E.C. Guidelines. All windows that have channels for screens should have them installed.

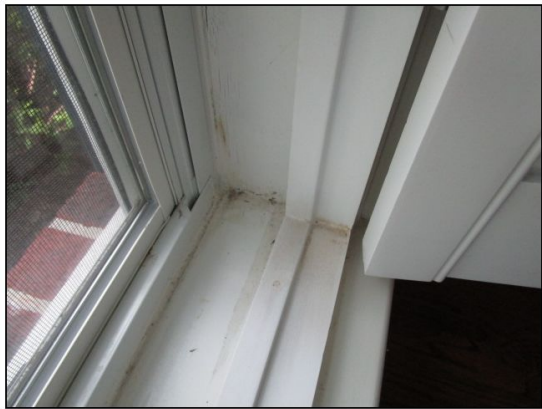
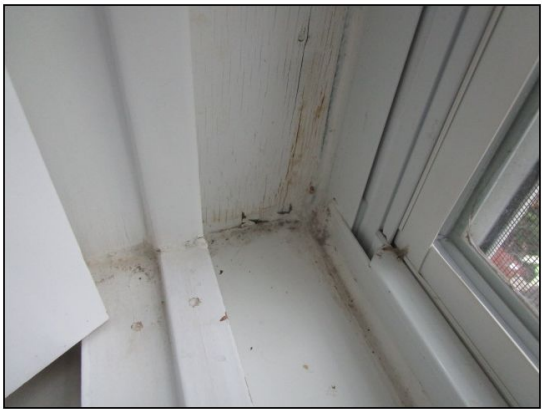
There was evidence of water penetration at the bottom of the front formal living room window opening. Windows are a common source of water penetration. Caulking or sealing the exterior window frames can sometimes remedy this condition.

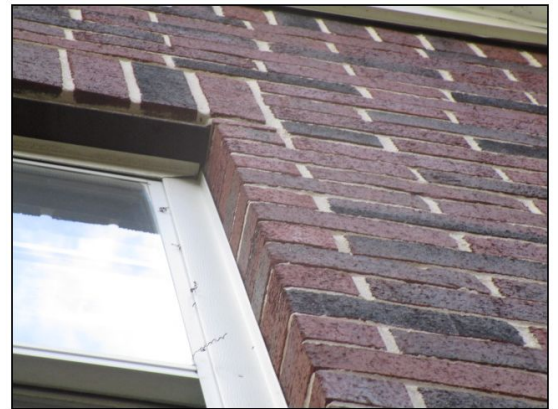
It is recommended that the exterior of the garage apartment windows be sealed in order to prevent water penetration to the structure of the home.

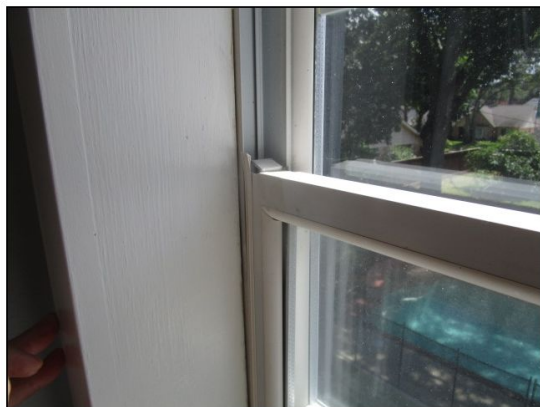
The east side window in the garage apartment does not seal/latch properly when closed and it is loose in the frame.

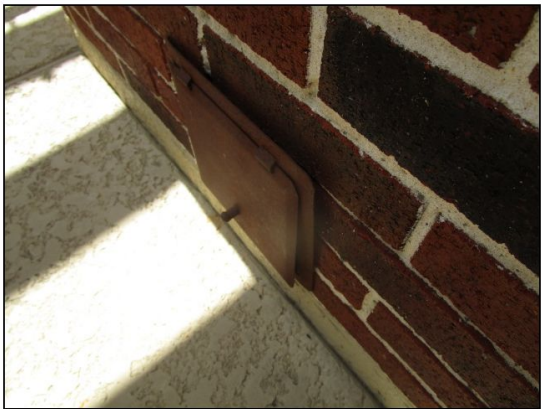
The ash dump door on the exterior is loose.

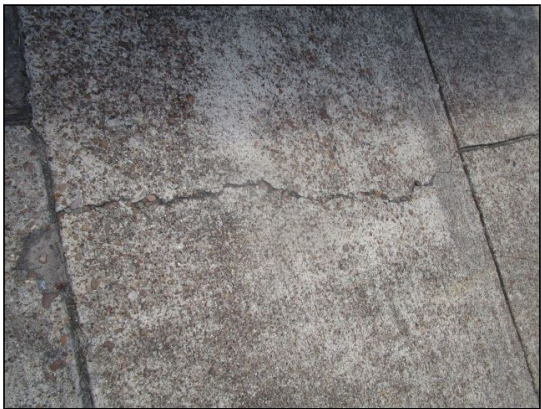
**L. Other**  
**Comments:** One of the driveway sections is cracked.

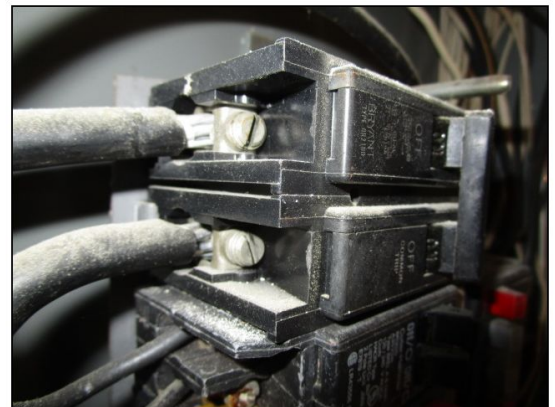
**Comments:** An inhibitor paste has not been applied to the main aluminum wires. The surface of aluminum can oxidize when it is exposed to air resulting in a poor connection.

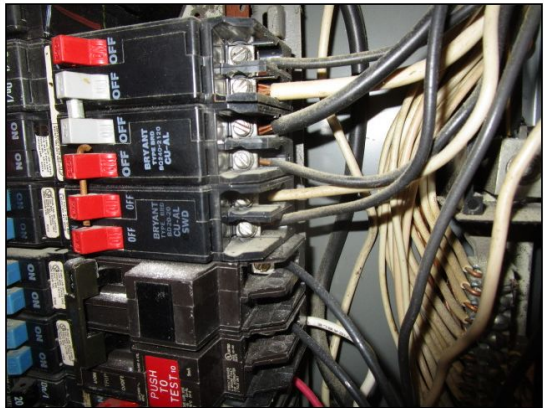
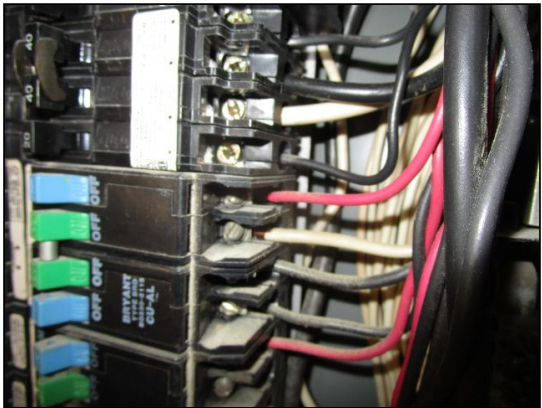
White wires were used as a "hot" wire and are connected to a circuit breaker. In most instances the white wires are the grounded conductors, and if they are used as a "hot" wire, they must be wrapped with black or red tape to identify them as a "hot" wire.

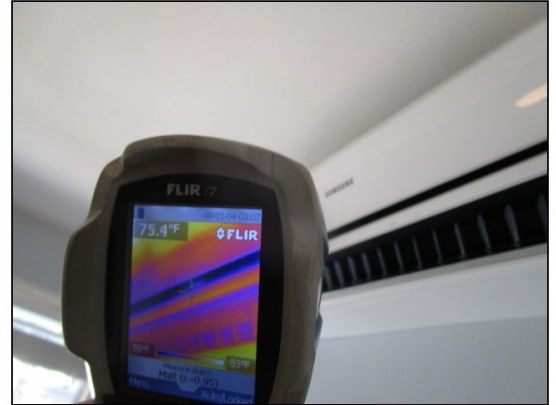
**Garage Apartment Zone Air Going Into System: 82 f Returned Air: 75 f**

The system did not operate within the allowable tolerances. The air coming out of the vents should be 14 to 21 degrees cooler than where it goes into the air return. It is recommended that a qualified contractor be consulted regarding this matter.

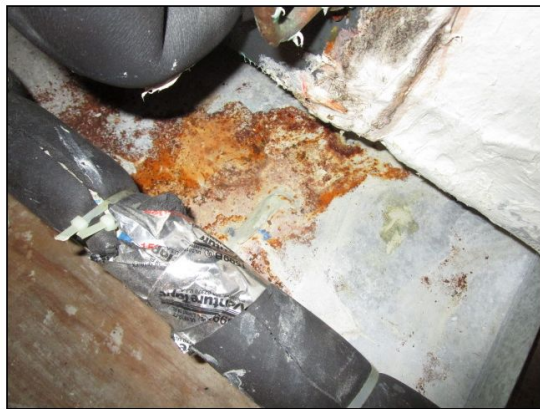
There was corrosion in the safety pan under the coil box for the 2nd/3rd floor zone. This condition is an indication that the unit has leaked in the past or leaks during heavy use.

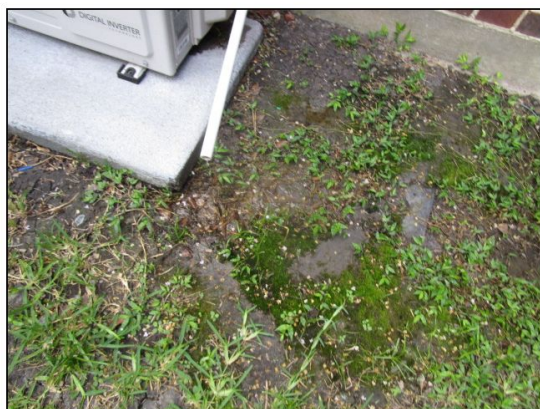
The main drain line coming from the coil box for the garage apartment zone should terminate into an internal drain rather than to the outside of the home. When this line drains to the outside of the home it interferes with maintaining an even moisture content around the perimeter of the foundation.

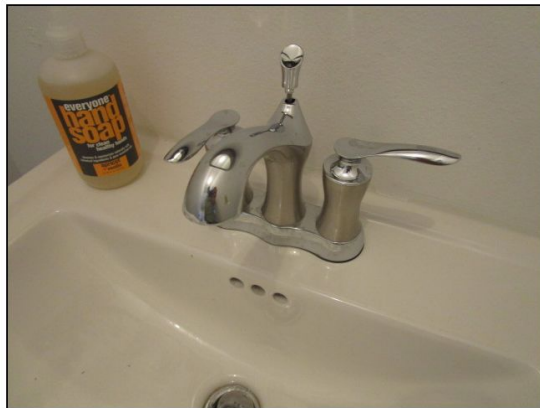
**Comments:** There was no hot water supplied to the garage bathroom sink.

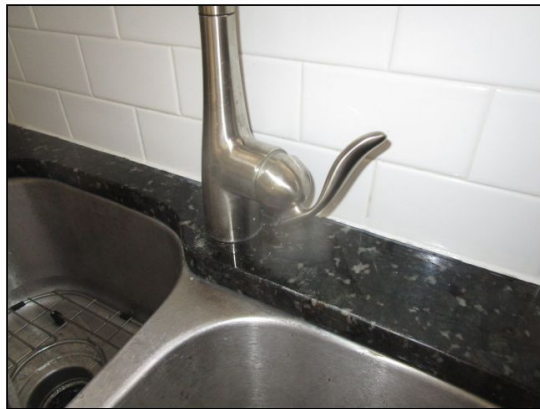
The kitchen sink faucet is not secured to the countertop.

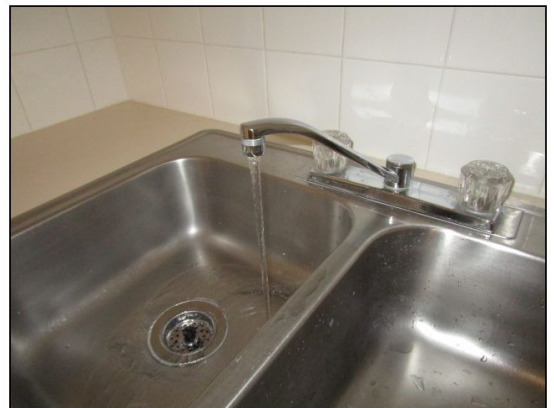
The water pressure was low at the garage bathroom sink and the garage apartment kitchen sink. Water pressure is determined by running two faucets at the same time. There is no guideline for flow rates. If the water pressure appears to be very low, it is mentioned in this report. As there are several causes for low water pressure, a licensed plumber should service the utility.

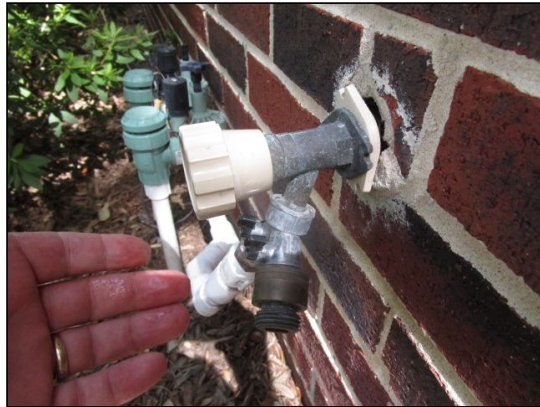
The exterior faucet at the front of the home continues to drip when it is turned off.

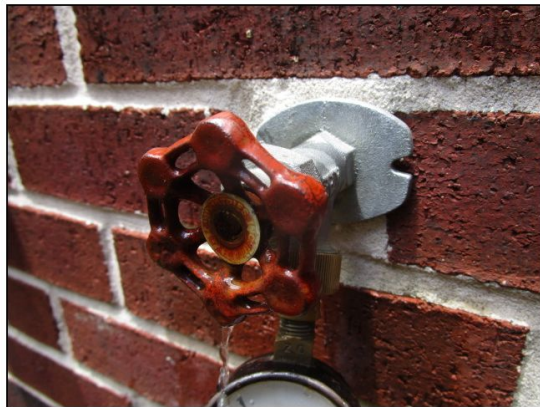
The exterior faucet on the east side of the home leaks from the handle when it is operated.

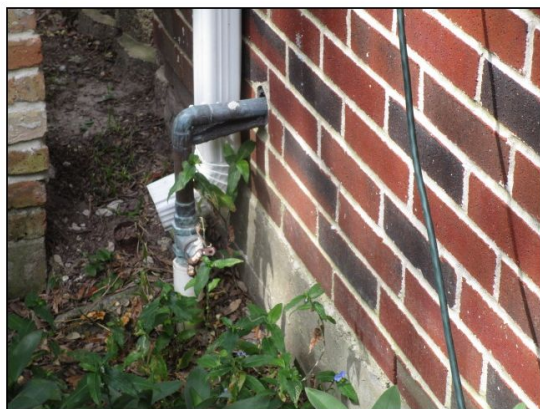
It is recommended that all of the exterior water lines be insulated from the weather in order to prevent freezing.

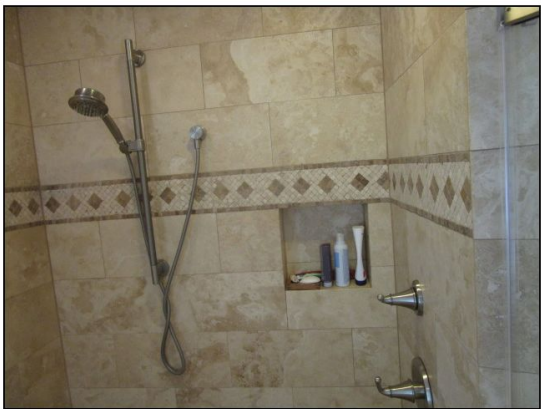
It is recommended that there be inspection ports provided on the back side of the plumbing walls of the tile showers so that it is possible to check for leaks.

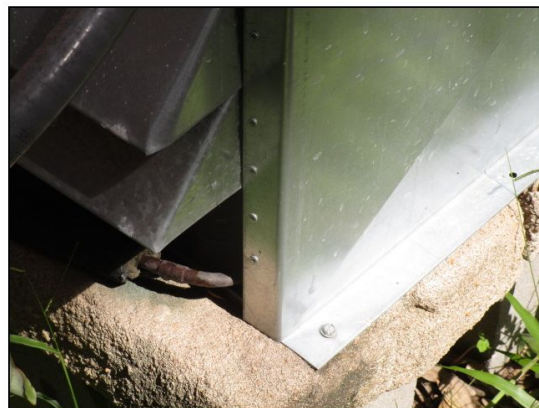
**Comments:** The refrigerant line was not fully insulated to the exterior compressor for the wine closet. This condition causes the line to sweat and slightly degrades the performance of the system. Applying foam tubes and taping them will remedy this condition.
