## Pre- Sheetrock Frame Phase Inspection Report

Monday, July 18, 2016

# PROPERTY INSPECTION REPORT

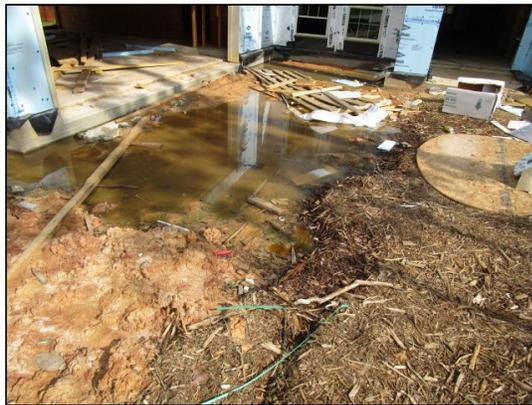
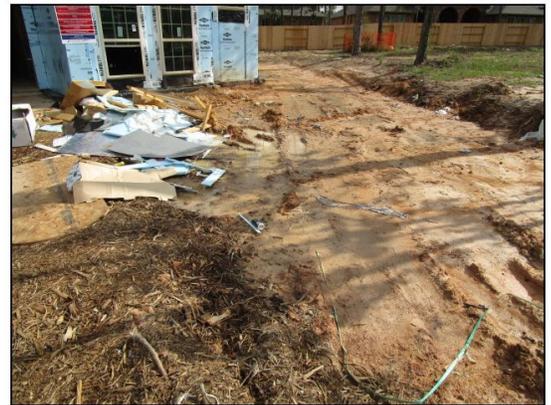
**Comments:** Not Complete and there is some standing water around home.

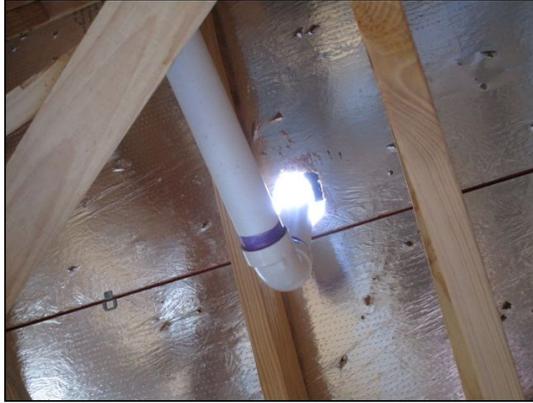
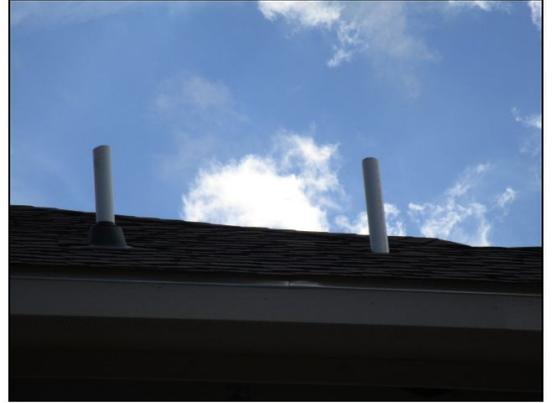
**Comments:** The roof jack is missing over the plumbing drain vent pipes above the front upstairs west side bedroom closet which will allow rain water to enter the structure.

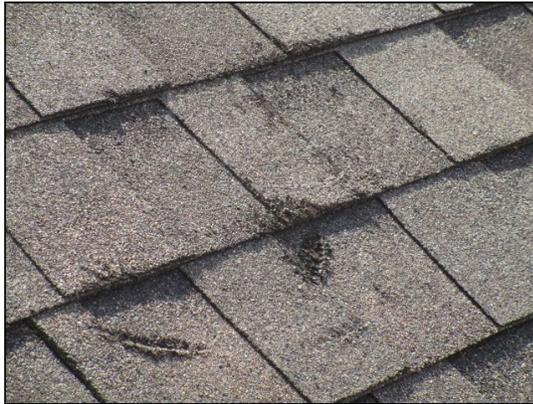
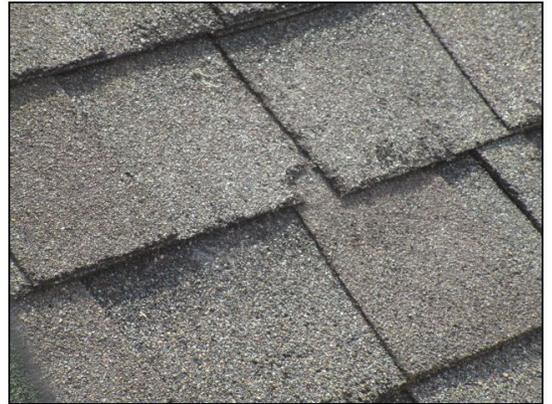
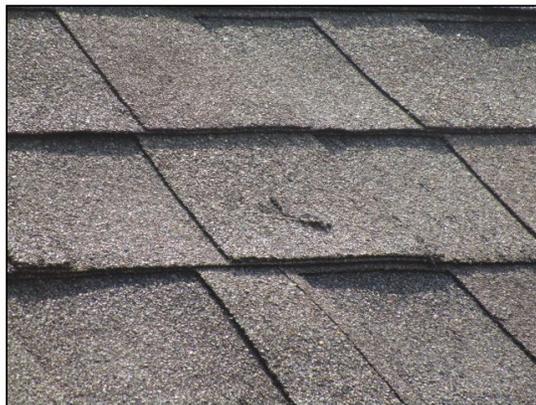
There are damaged shingles at the back of the garage roof. These shingles should be replaced.

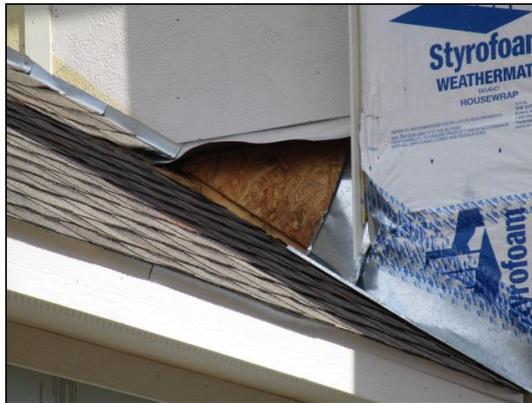
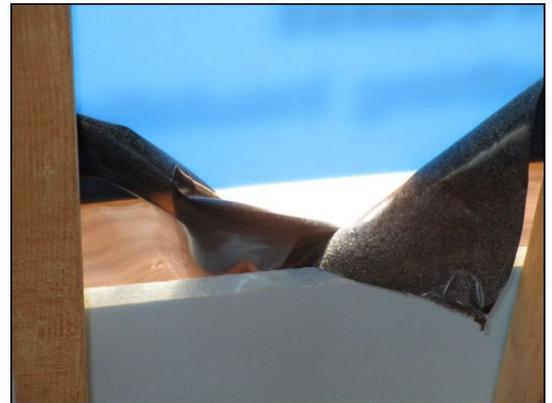
**Comments:** The moisture barrier on the exterior framework is not complete where the garage roof meets the second story and also at the east wall outside the upstairs rear bedroom. This moisture barrier is important in order to prevent possible water/moisture penetration into the structure.

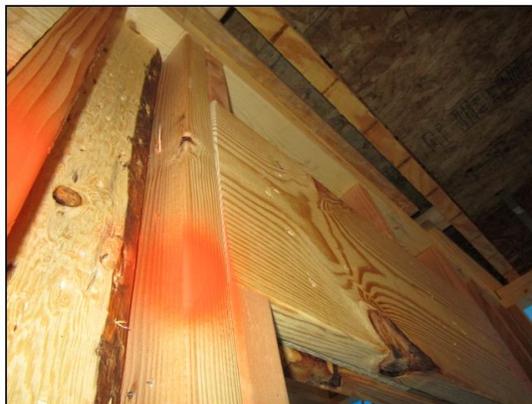
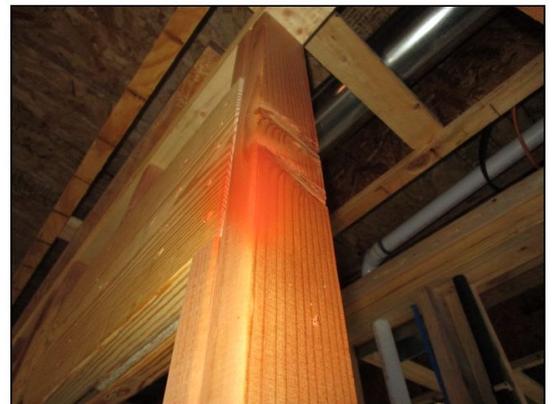
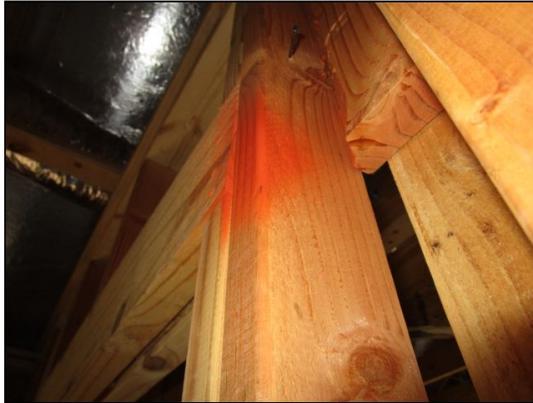
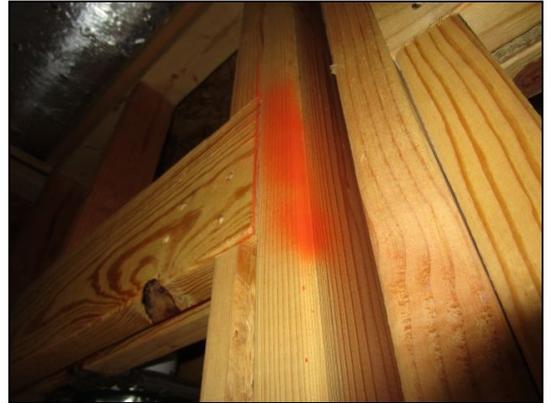
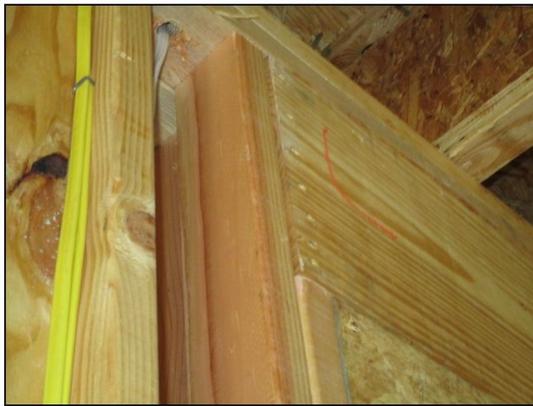
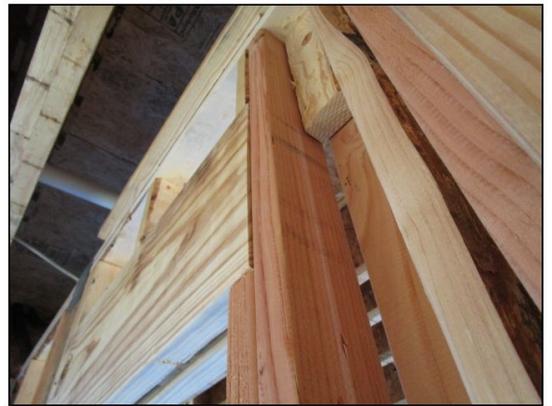
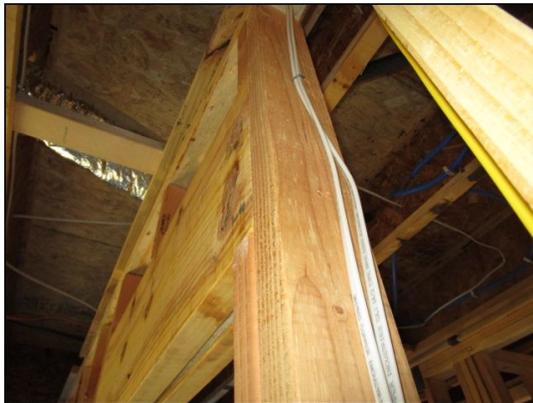
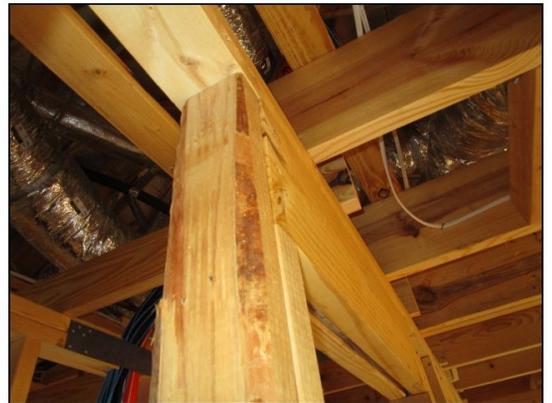
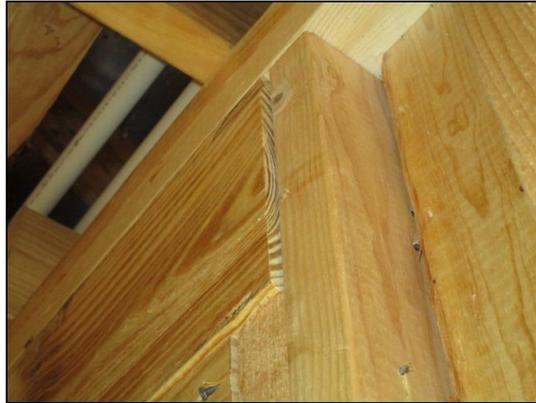
It is necessary to provide additional nailing through the wall studs into the supporting headers at several of the door and window openings.

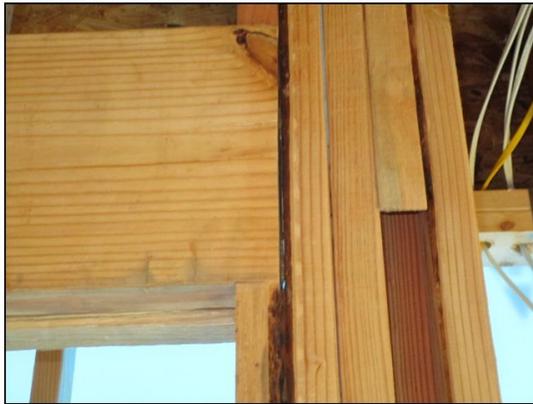
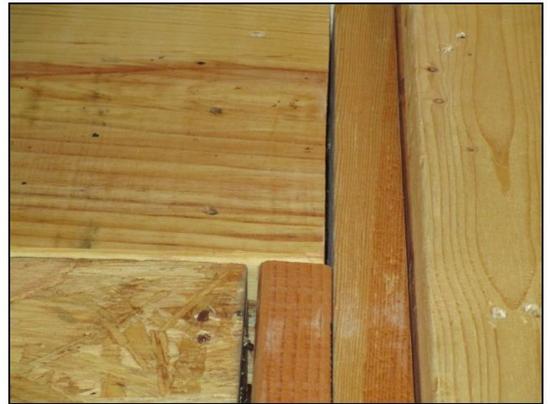
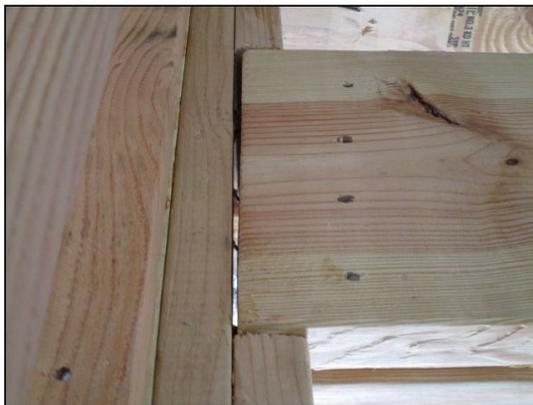
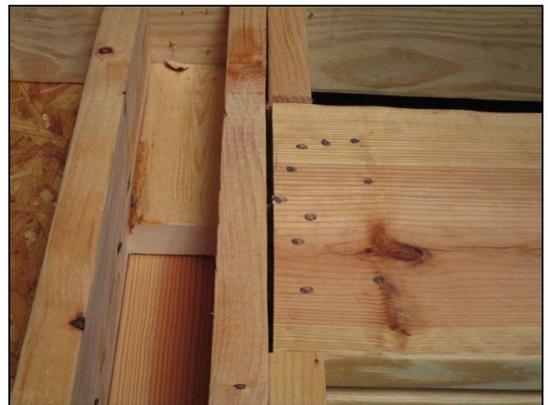
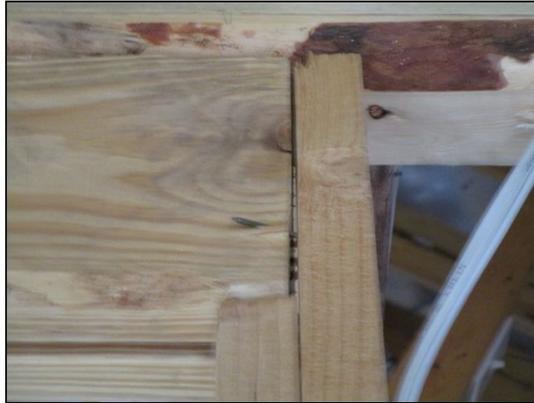
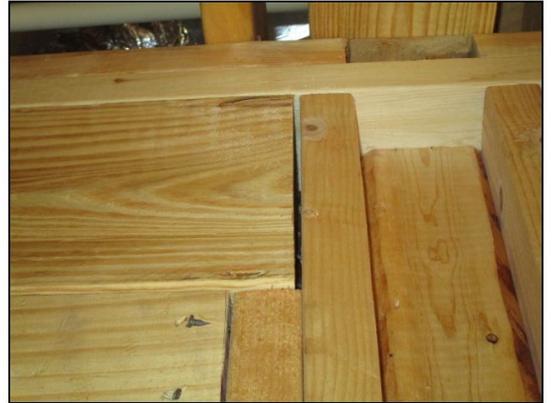
It is necessary to shim/fill the gaps between the wall framing at the supporting headers.

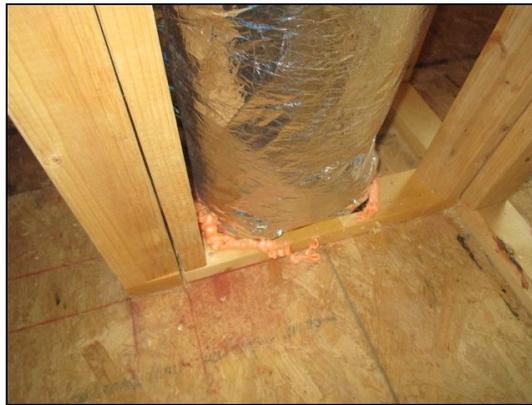
A protection plate (nail guard) needs to be installed at the bottom plate in the back of the media room to prevent nails/screws from puncturing the HVAC duct.

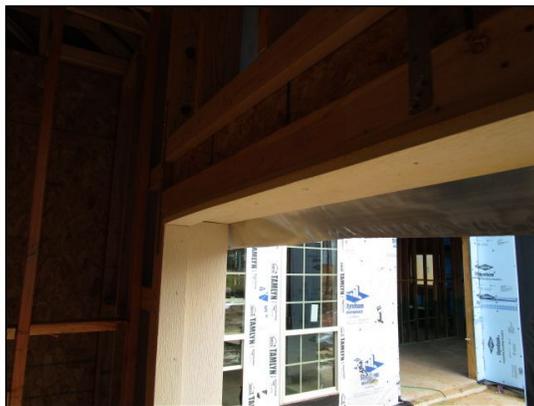
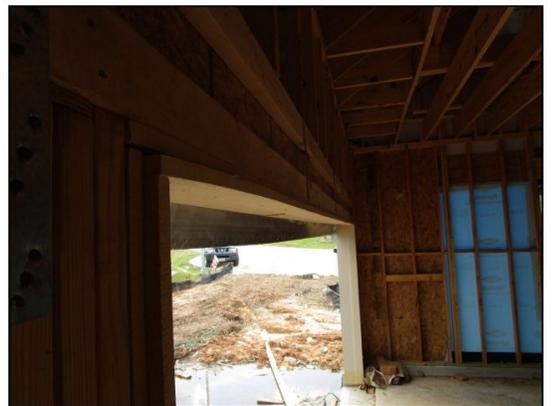
The trim at the top of the overhead garage door opening is notably not level/not square.

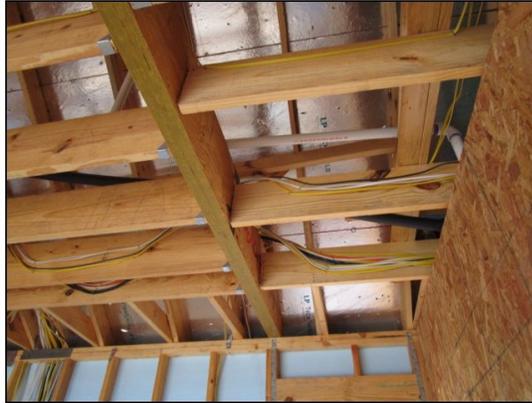
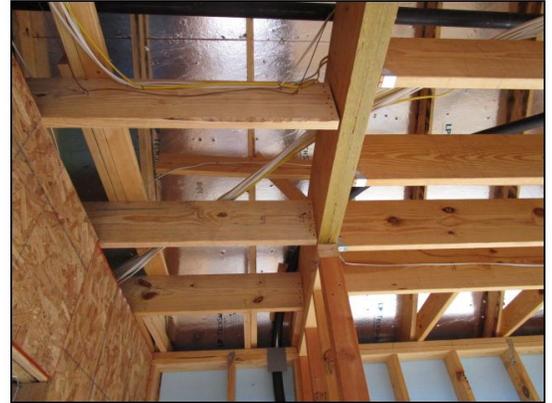
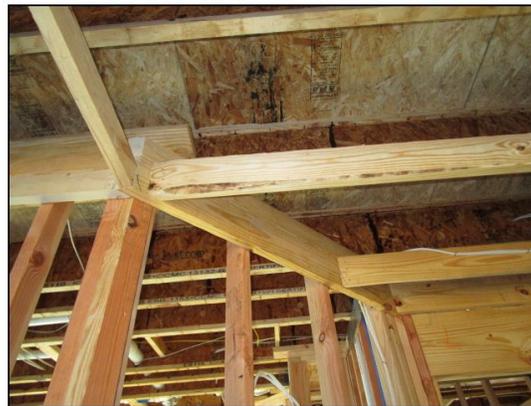
**Comments:** Joist hangers need to be installed on some of the ceiling joists in the garage and in the master bedroom.

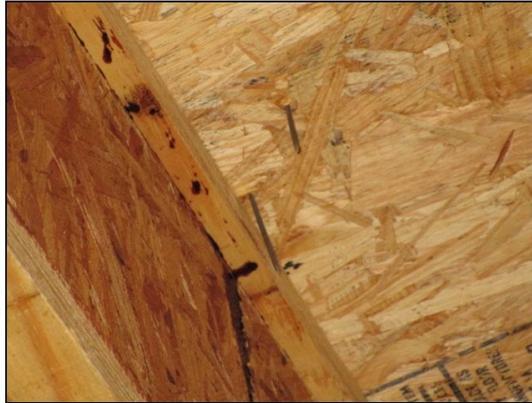
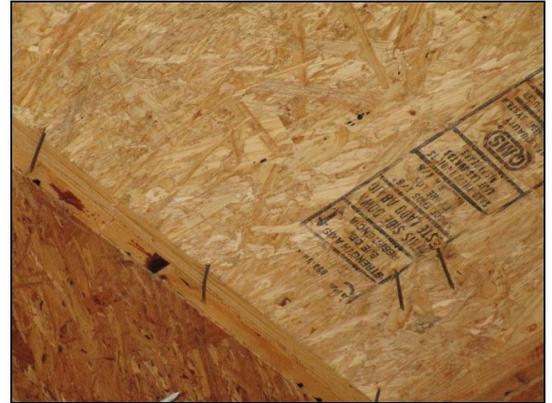
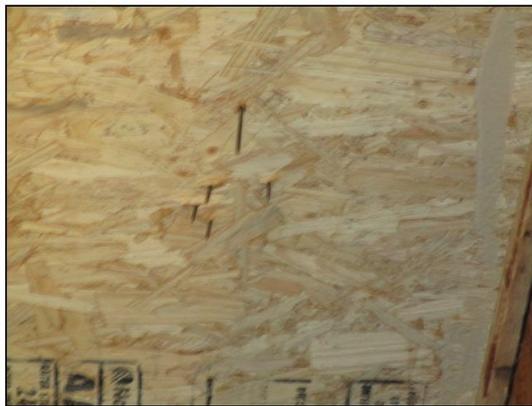
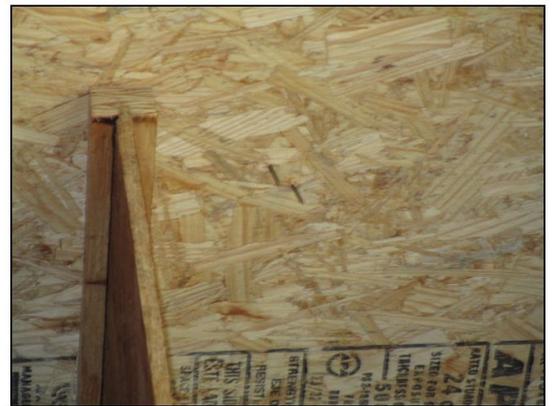
Several nails from the second floor sub flooring in the study and in the rear west side bedroom have missed the ceiling joists. It is recommended that these nails be removed as they may cause squeaks in the upstairs floor to develop in the future.

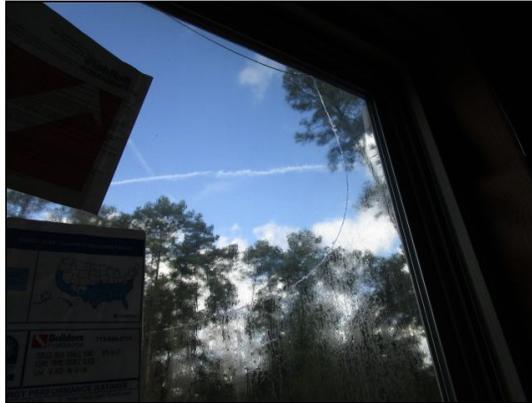
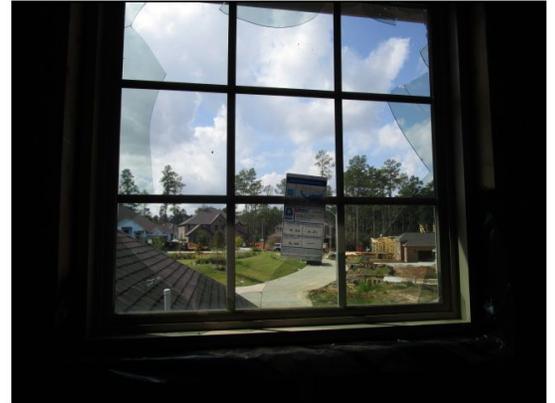
**Comments:** There was broken glass in one of the windows in the front downstairs west side bedroom and also in the upstairs front west side bedroom closet.

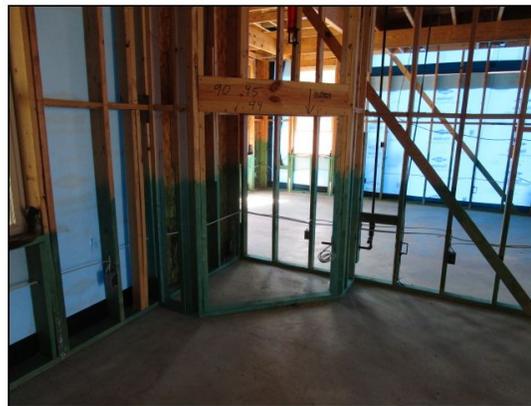
**Comments:** The fireplace was not installed at the time of the inspection.

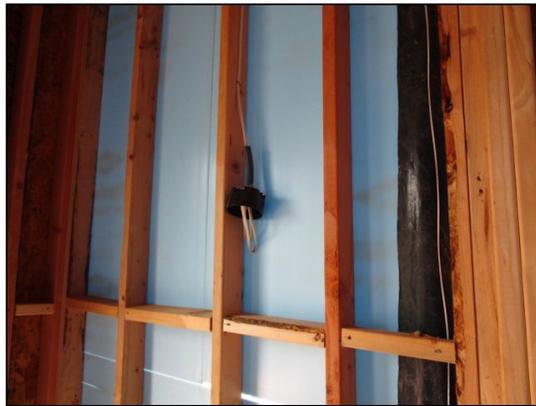
**Comments:** The light box for the front entry light has not been installed on the exterior of the home.

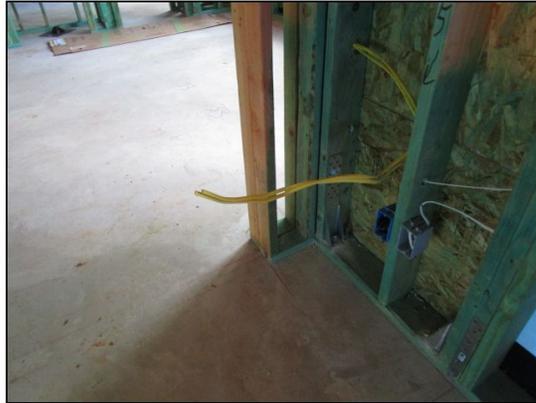
There are electrical wires that are not inside of an outlet or junction box on the rear wall of the living room.

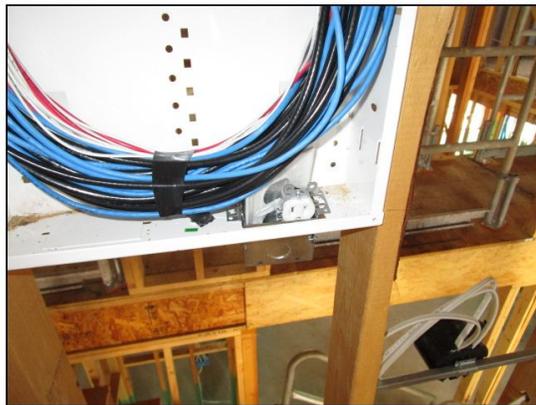
The rough in wiring for the outlet in the communication box has not been installed in the upstairs front middle bedroom closet.

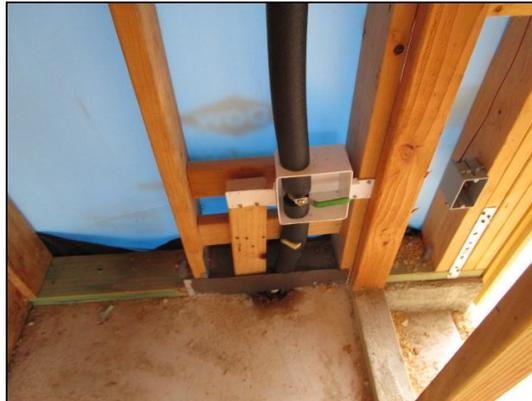
**Comments:** There was no water supply to the home as is necessary in order to check for possible leaks before the installation of the sheetrock and insulation.

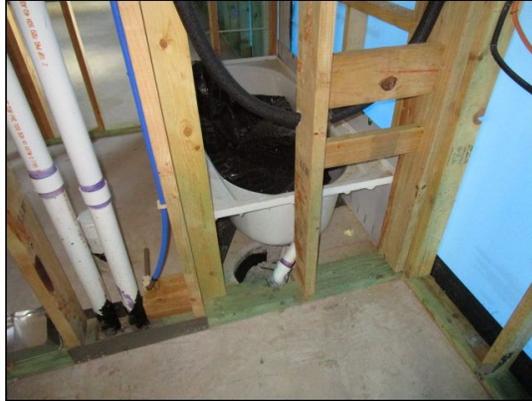
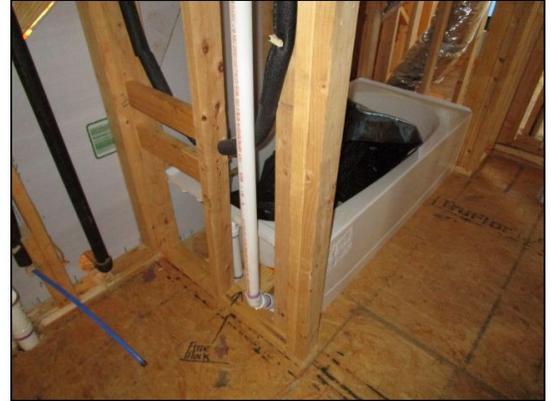
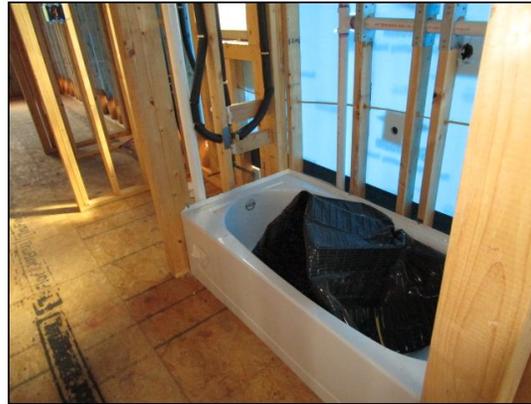
**Comments:** A top out test (fill the drain system with water) must be done in order to check for leaks before the installation of the insulation and sheetrock.

It is recommended that there be inspection ports provided for the bathtub/shower units in all of the bathrooms so that it is possible to check for leaks, as well as for service to be performed on

the plumbing if needed when the home is complete.

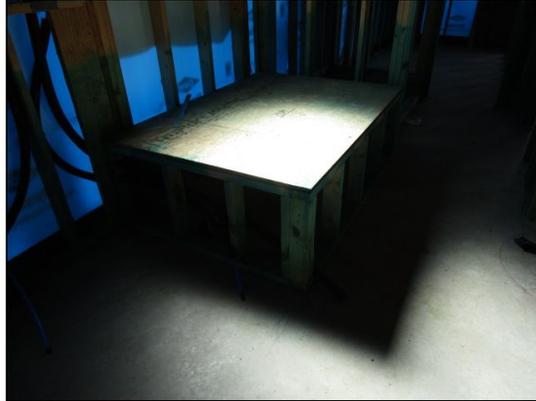
It is necessary that there be an inspection port provided for the whirlpool bathtub so that it is possible to check for leaks and have access to the pump motor when the home is complete. There was no access to this area at the time of the inspection. This does not comply with National Electric Code (Ref. NEC 680-72) Accessibility. "Hydro massage bathtub electrical equipment shall be accessible without damaging the building structure or building finish.

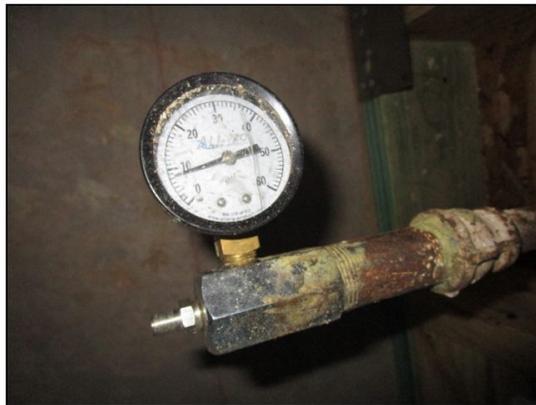
**Comments:** The gas lines are not pressured up with 30 to 40 psi as is necessary to check for leaks in the system.

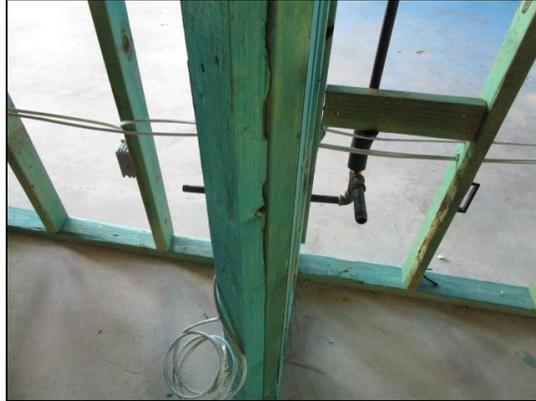
The rough in gas piping for the fireplace is not complete.
