## Inspection Report

Saturday, July 16, 2016

## PROPERTY INSPECTION REPORT

By: Brad Leland, Lic #5229 07/16/2016  
(Name and License Number of Inspector) (Date)

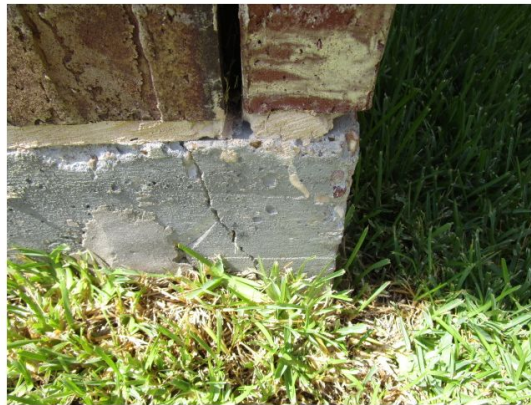
**Performance Opinion:** There was a crack in the rear southeast corner of the foundation. These cracks are common in "post-tensioned" foundations and are not a structural defect. Expansion properties in the brick in the brick veneer can cause these cosmetic blemishes. As these cracks can continue past the finish grade, it is considered to be a likely point of entry for insects as well as moisture. I recommend that these cracks be sealed in order to prevent possible future damage.

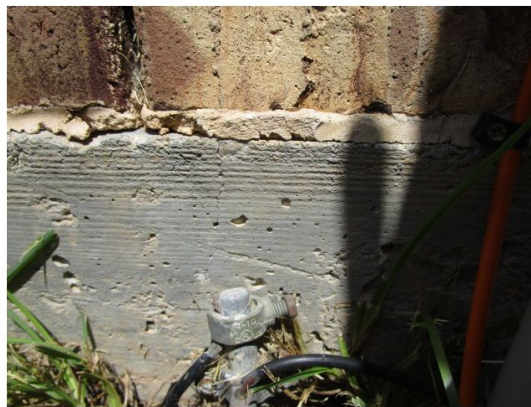
There is a small crack of the foundation face near to the ground connection under the breaker box location on the west side of the garage and there is a small crack in the finished concrete surface of the garage. These areas should be monitored for further activity.

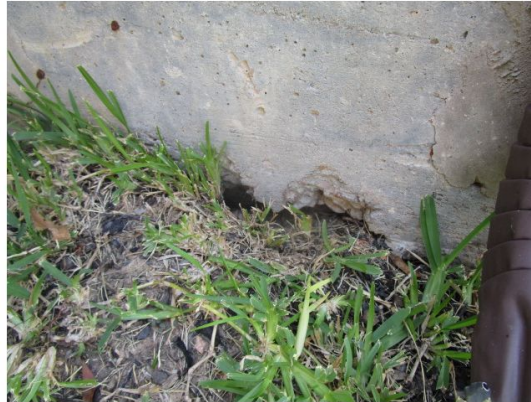
There is a small void in the foundation at the front of the east side of the home that should be filled.

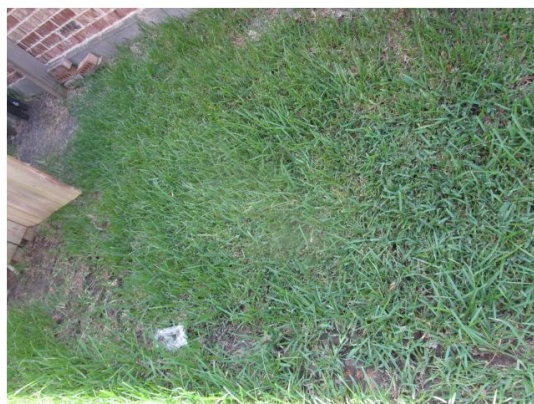
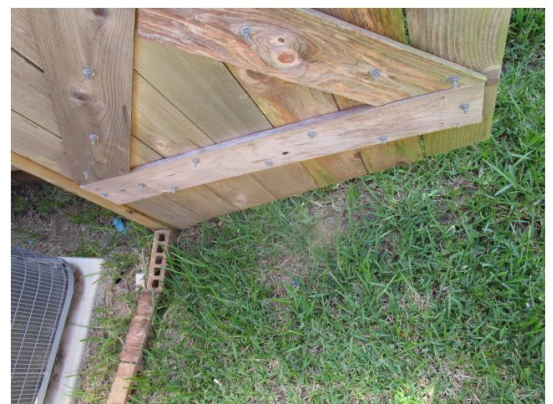
**Comments:** There are low areas that are collecting rain water on both sides of the home. The drainage strategy of the yard as it relates to the foundation is important. Expansive soils can be destructive to the foundation if the moisture content of the perimeter varies. Improvement should be made to the grading of the yard in this/these areas.

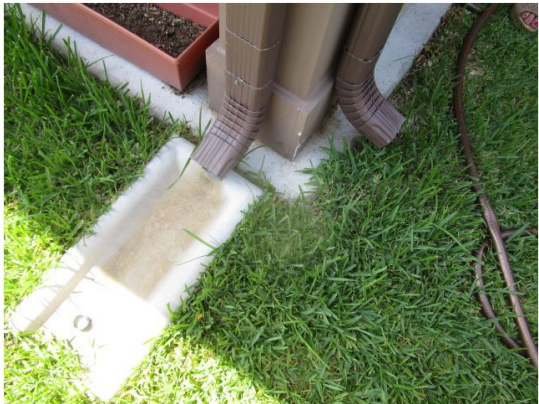
It is recommended that splash plates be installed at the gutter downspout terminations to prevent erosion of the soil and to direct rain water away from the perimeter of the foundation.

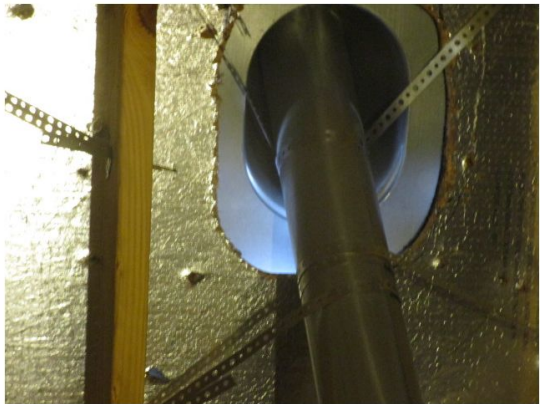
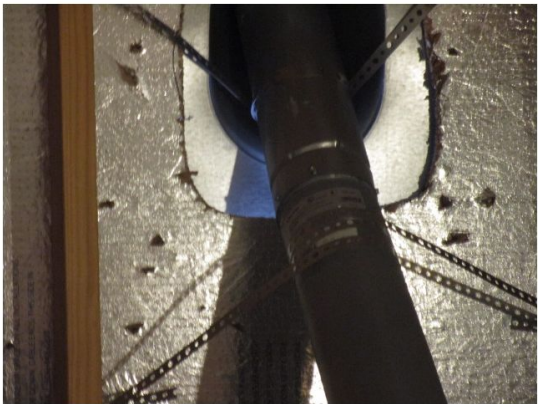
**Comments:** The flashing has lifted above the plane of the roof line at the furnace flue pipes and at the plumbing drain roof jack above the master bathroom . This condition is considered a conducive condition for water penetration and can be uplifted in high winds. Sealing and securing the flashing is recommended.

A qualified roofing contractor should be consulted regarding the repair of the above items as well as check the entire roof covering for any other possible defects.

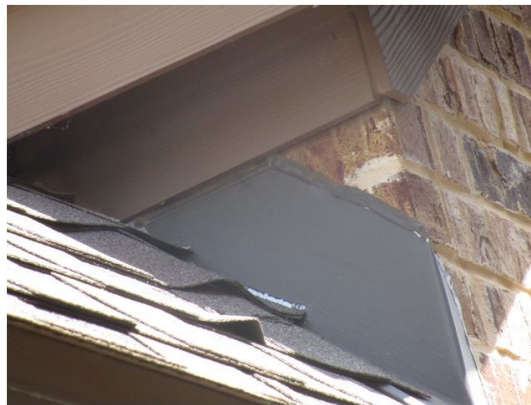
There are lifted shingles that may be caused by nails backing out near the edge of the roof on the west side of the home. A qualified roofing contractor should be consulted regarding this condition.

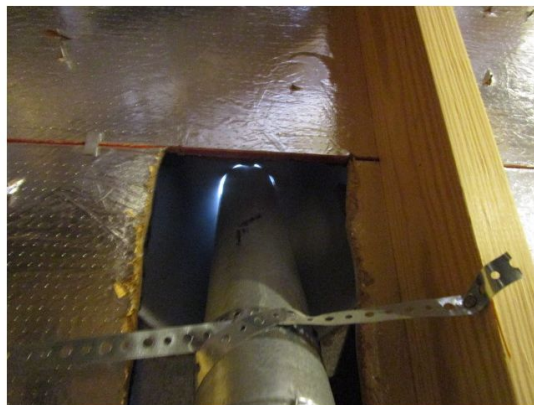
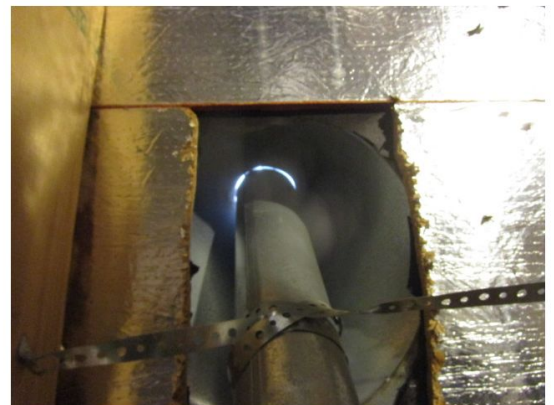
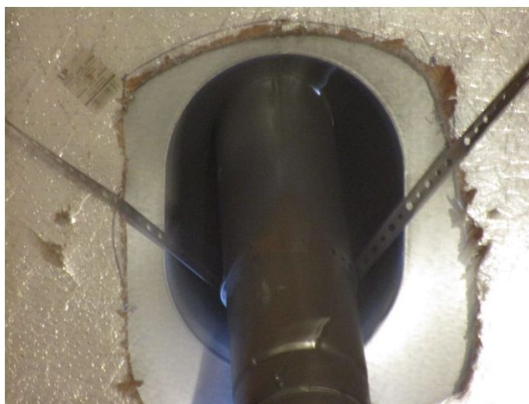
Both of the water heaters and one of the furnace flue pipes are not completely sealed at the rain collars on the roof as daylight can be seen around these pipes in the attic area.

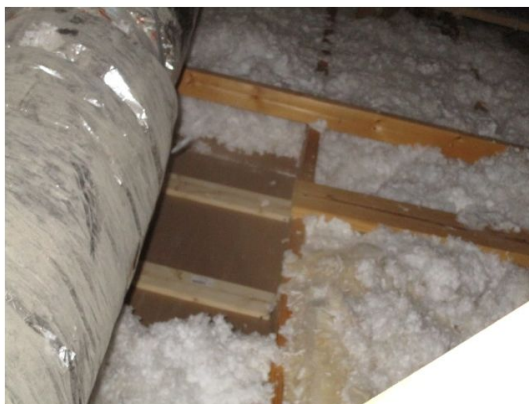
**Comments:** The insulation on the attic floor was not complete above the formal dining room. It is recommended that additional insulation be added for energy efficiency.

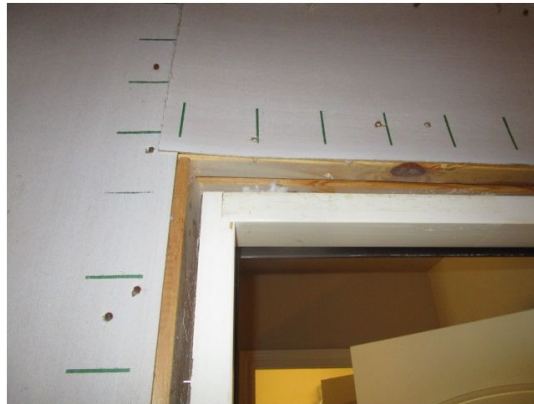
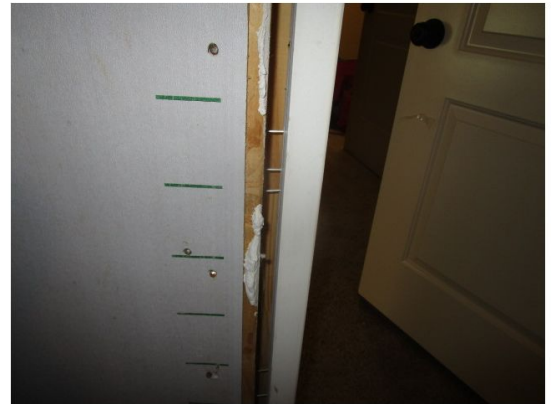
It is necessary to insulate around the upper attic access door frame.

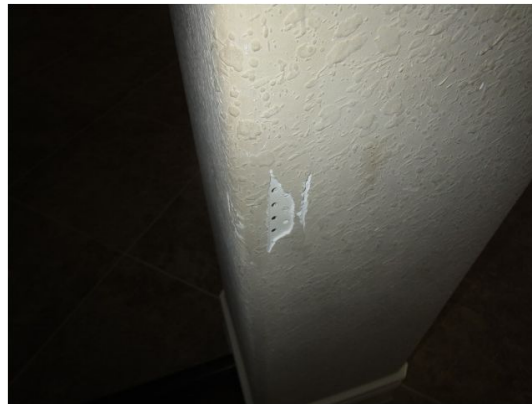
**Comments:** There is damaged sheetrock where the corner bead is loose at the column near the kitchen entrance.

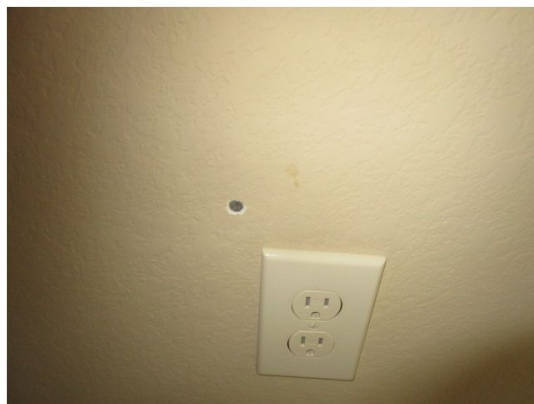
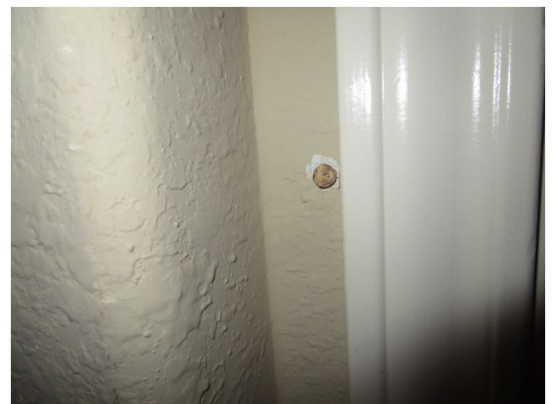
There are nail pops next to the outlet on the rear wall of the master bedroom and in the hallway next to the door to the garage.

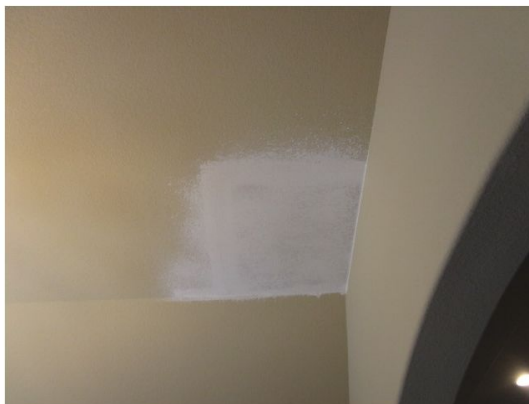
**Comments:** There is an incomplete repair to the ceiling in the formal dining room.

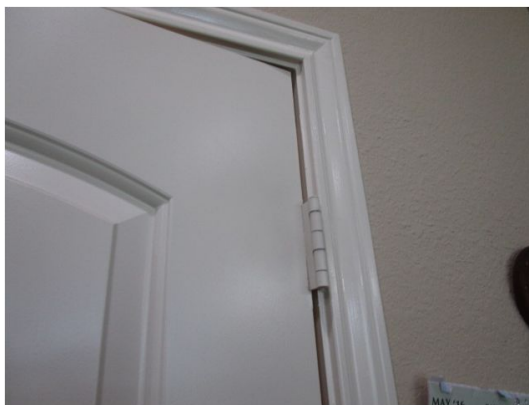
**Comments:** The top hinge is loose at the pantry door.

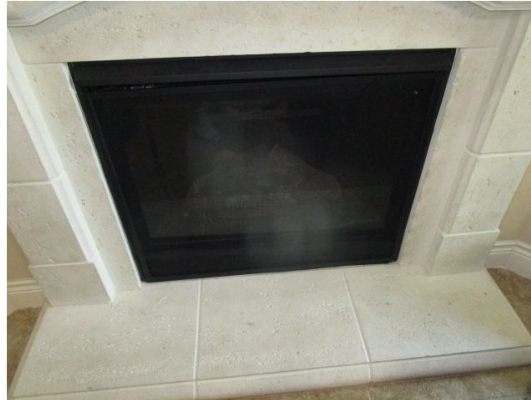
**Comments:** The fireplace does not respond to the remote when tested.

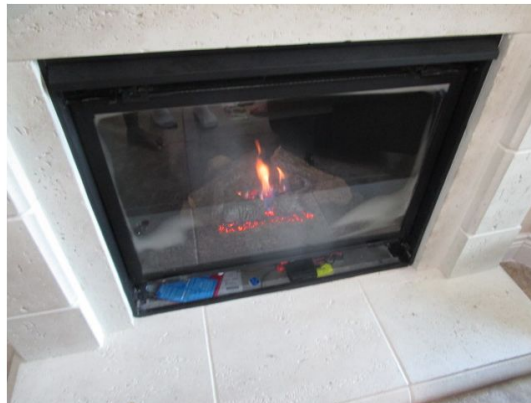
The right side of the protective cover on the front of the fireplace is not secured to the bottom of the firebox.

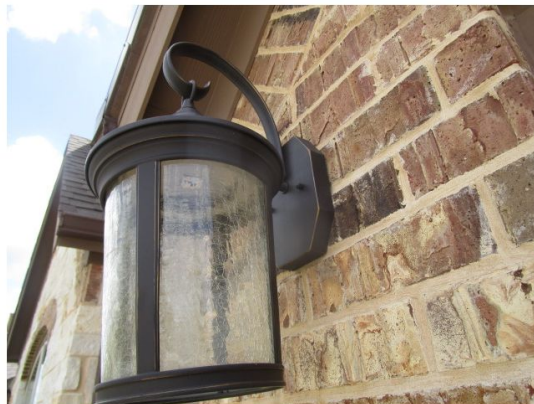
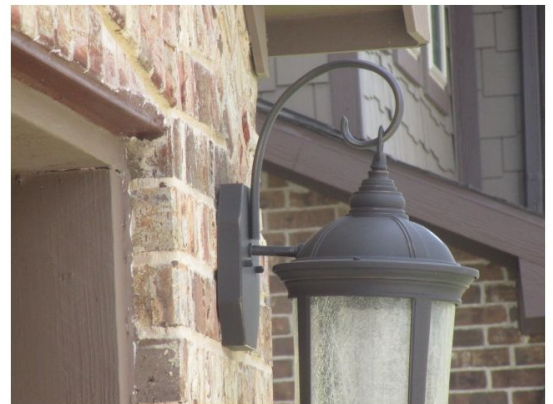
**Comments:** The base of the exterior light fixtures are not sealed and secured properly where they meet the home as they should be in order to prevent water penetration into the fixture where the electric connections are located.

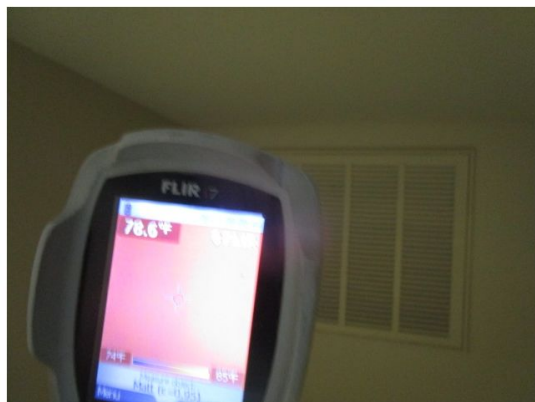
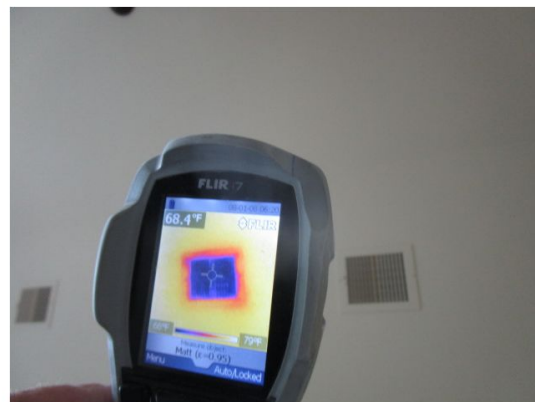
**Downstairs Zone Air Going Into System: 78 f Returned Air: 68 f**

The systems for both zone did not operate within the allowable tolerances. The air coming out of the vents should be 14 to 21 degrees cooler than where it goes into the cold air return. It is recommended that a qualified contractor be consulted regarding this matter.

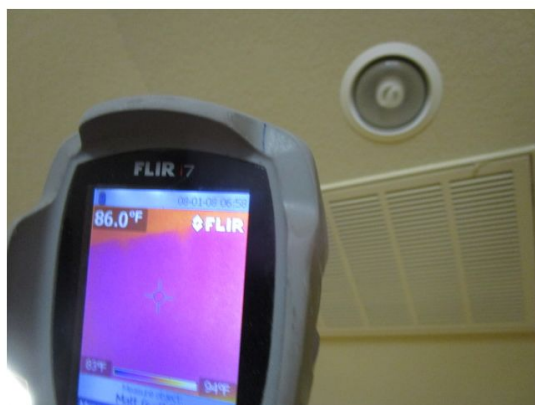
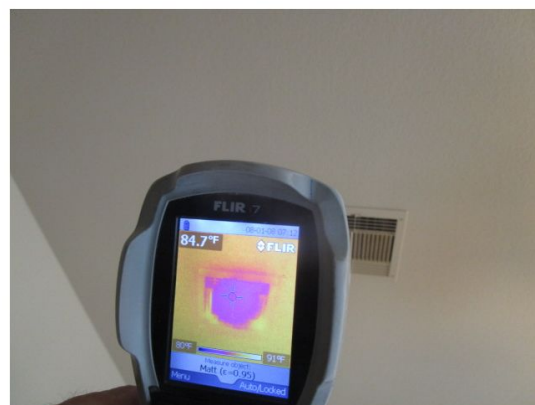
**Upstairs Zone Air Going Into System: 86 f Returned Air: 84 f**

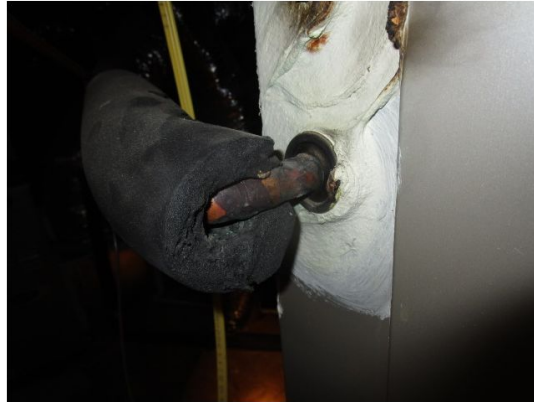
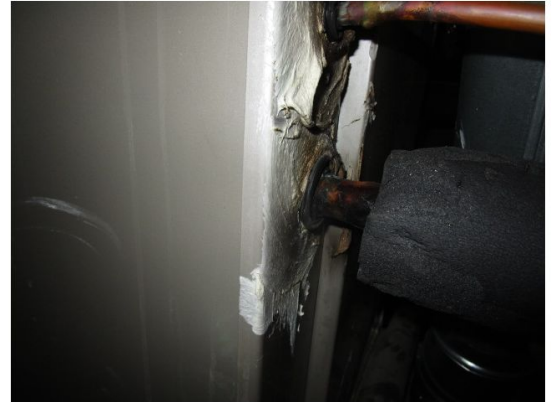
The refrigerant lines were not fully insulated and sealed to the coil boxes for both zones. This condition causes the line to sweat and slightly degrades the performance of the system and may also cause water damage.

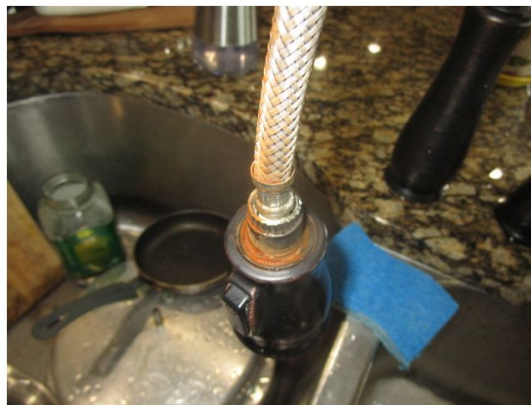
**Comments:** There is corrosion on the sprayer head and hose for the kitchen sink faucet.

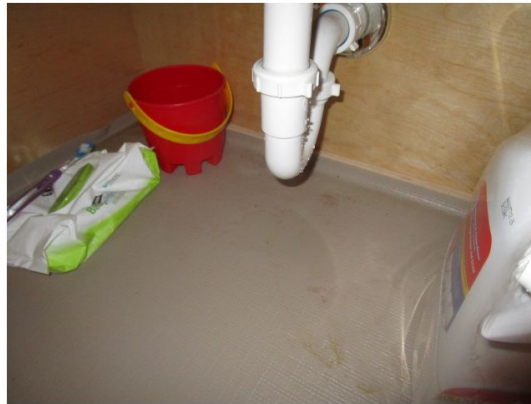
**Comments:** There is a leak at the drain for the front bathroom sink.
