Brad Leland  
Inspections you can Trust

## Inspection Report

Thursday, July 9, 2015

# PROPERTY INSPECTION REPORT

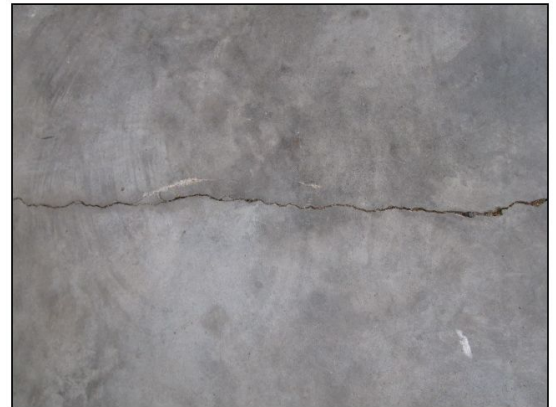
**Performance Opinion:** There are signs of past movement in the structure such as cracks in the exterior stucco, cracks in the garage floor and when measured the north side of the home was approximately 2 1/2" low in some areas. As discussed, these conditions indicate that the foundation may require a permanent remedy to stabilize the structure in some areas. The best course to follow for foundation settlement is to consult a professional (structural) engineer so that a course of corrective procedures can be evaluated. This can consist of a certification that the foundation is functioning as intended at this time, or alternately, a plan may be designed for underpinning.

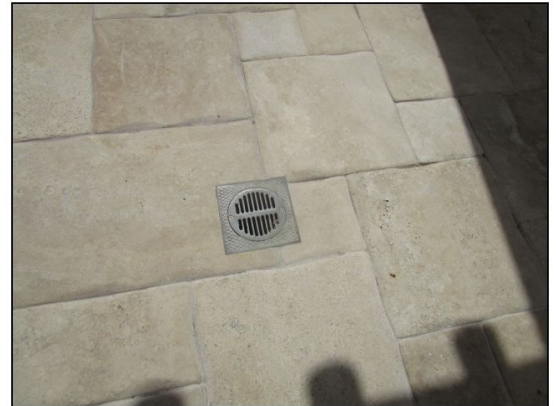
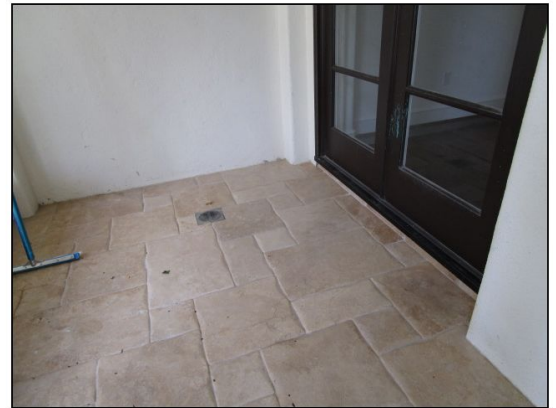
The soil levels are high in relationship with the interior of the home in some areas of the garden beds. When soil levels are high against the face of the foundation it promotes water penetration of the structure and insect infestation. This item should be corrected so there is some exposure of the foundation face without creating reverse drainage. It is generally accepted that in an ideal situation, a house should have about 4-6 inches of clearance.

There is a sub surface drain system with a sump pump installed. This drain system should assist in diverting rain water to the street or storm sewer. The overall effectiveness of this system was not determined. Underground drains can become clogged or obstructed.

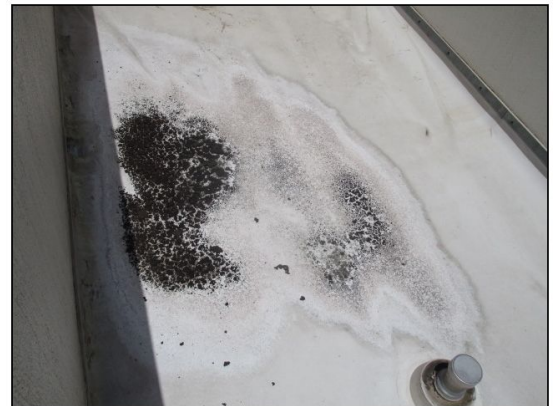
There are several low areas where it appears that water is collecting. Due to the hot dry weather recently, no water was noted collecting but stains were observed. There was dark debris on the roof surface that may be caused by long standing or ponding water.

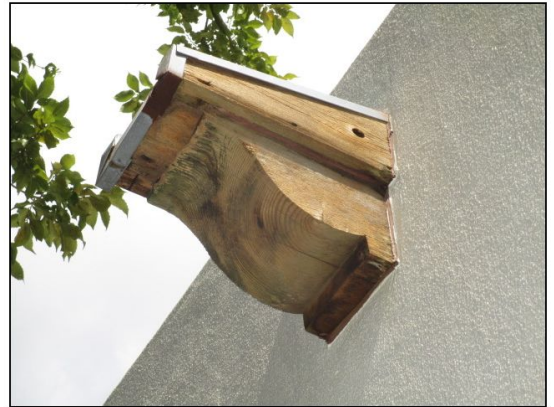
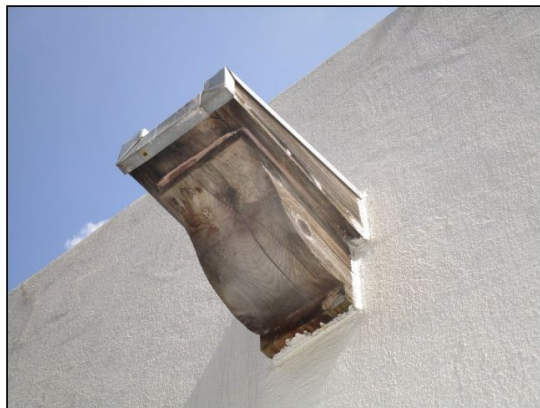
The outriggers on the exterior of the home are weathered and several are water damaged.

A qualified roofing contractor should be consulted regarding the above conditions.

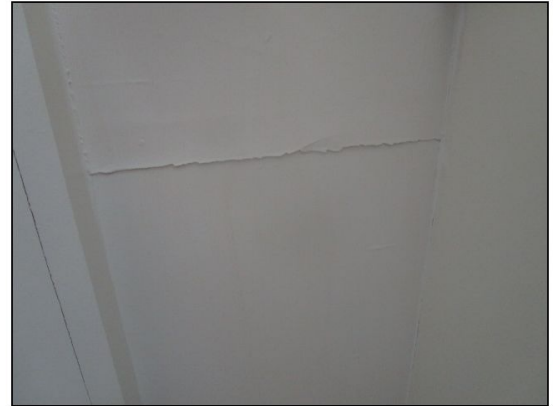
There were cracks in the exterior stucco in several areas around the home. Cracks in the stucco can be indications that there is some degree of movement occurring in the structure. The severity of the cracks can be an indication of the amount of movement in a structure. It is recommended that a stucco expert be consulted regarding this condition.

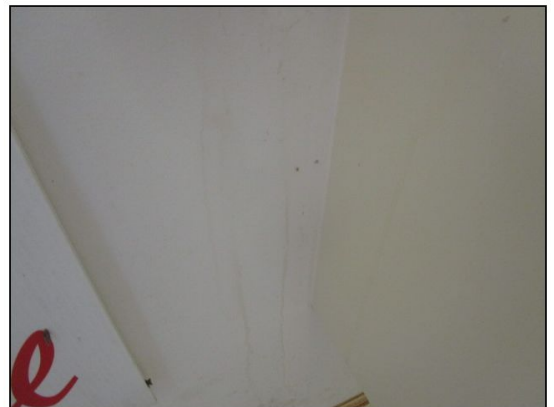
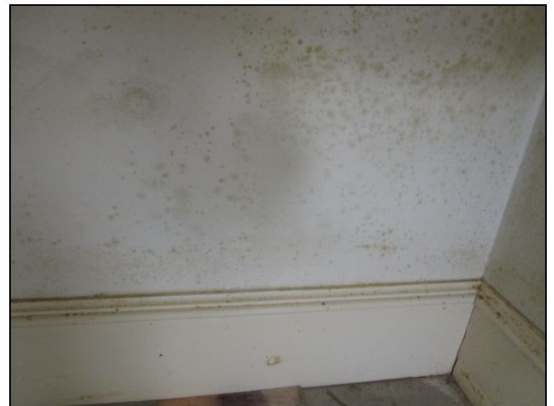
There is discoloration/water stains on the bottom of the walls in the garage storage room near the utility room. The walls were dry at the time of the inspection and the reason for this condition was not determined

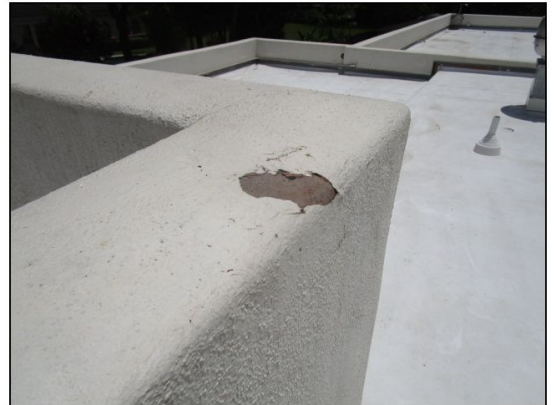
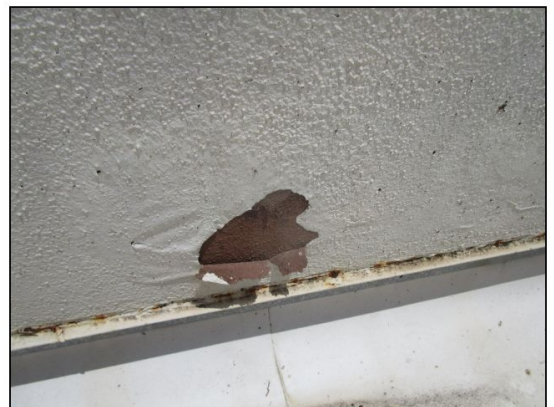
The finish on the roof parapet walls is deteriorating in some areas. This condition should be examined by a stucco expert for proper repair.

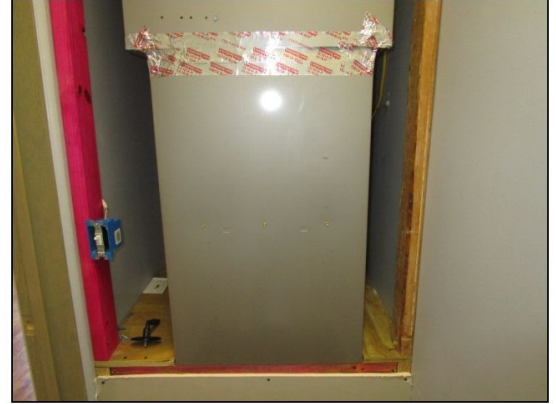
The sheetrock was not complete in the upstairs front north bedroom closet.

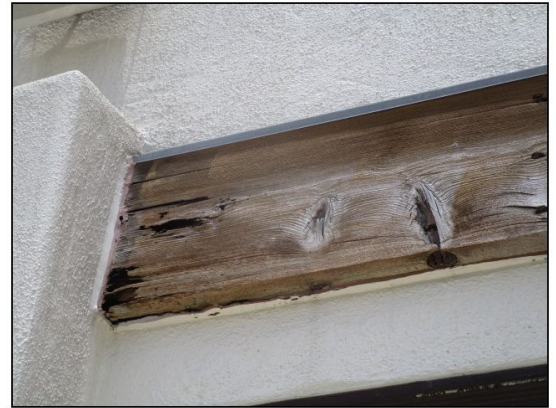
There is water damage to the 2 x 12 above the screen door off the outdoor kitchen.

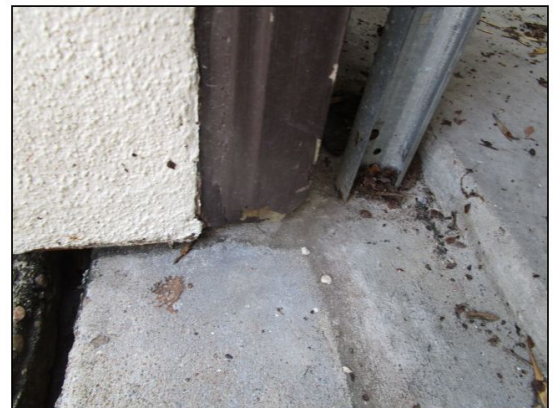
There is water damage to the exterior trim at the bottom of the overhead garage door openings. All damaged material should be repaired/replaced.

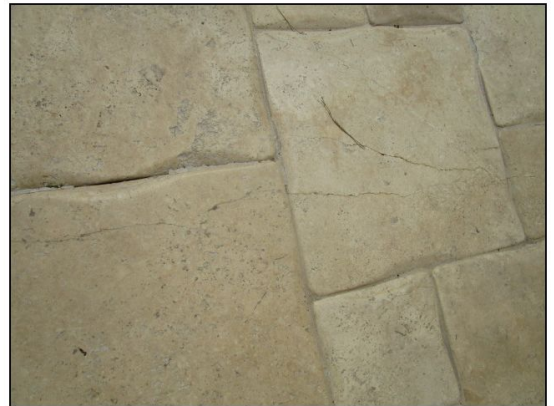
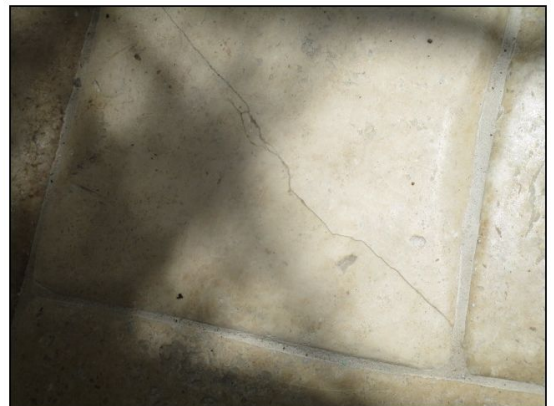
There are several cracked tiles in the back patio and pool decking area. These cracked tiles may be a result of past movement.

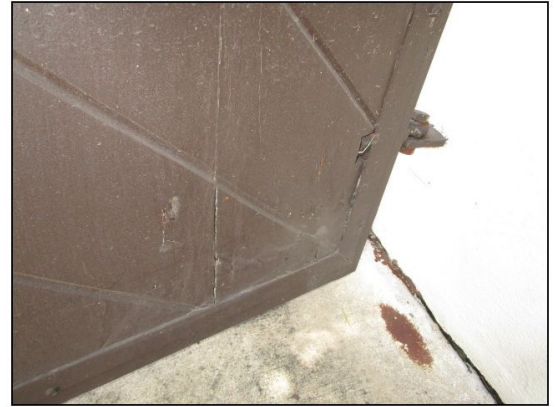
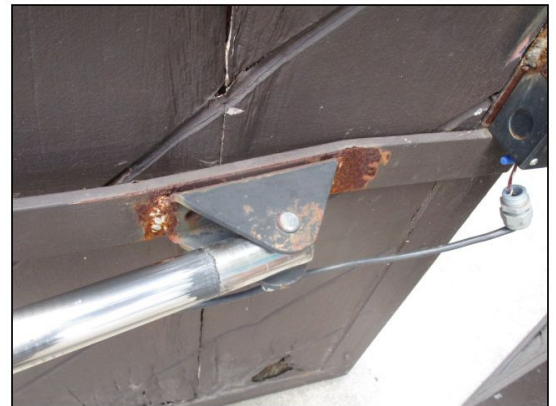
**Comments:** There is water damage to the driveway gate and corrosion on the metal frame. All damaged material should be replaced.

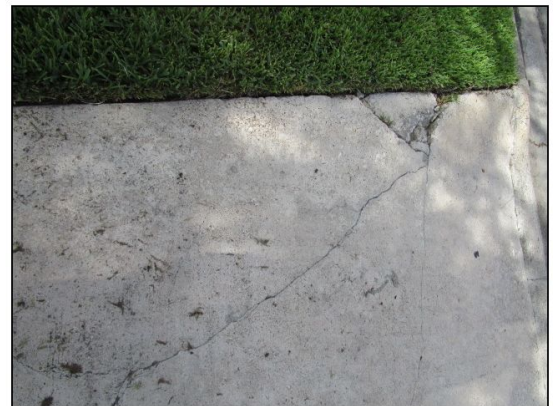
Driveway sections and the area under the carport were cracked and have settled unevenly.

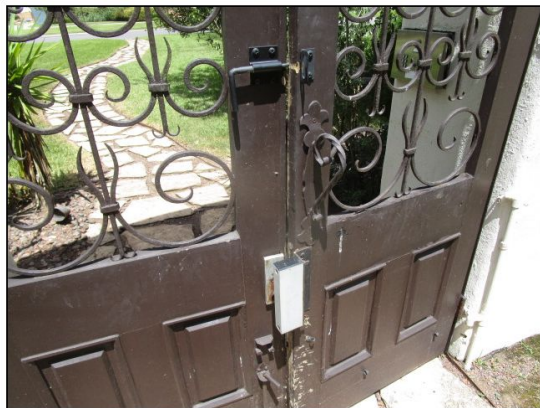
The front walkway gate doors hit each other when operated and will not close properly.

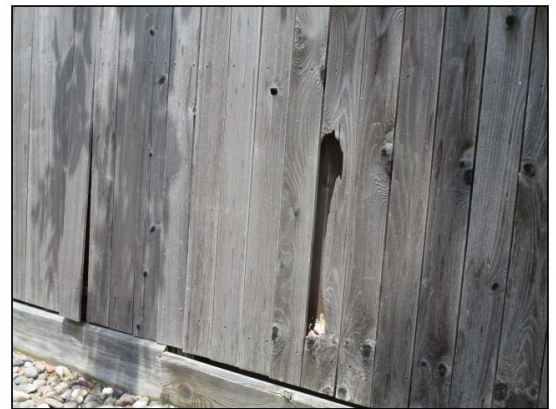
The fence is leaning notably and there are damaged fence boards on the north side of the driveway.

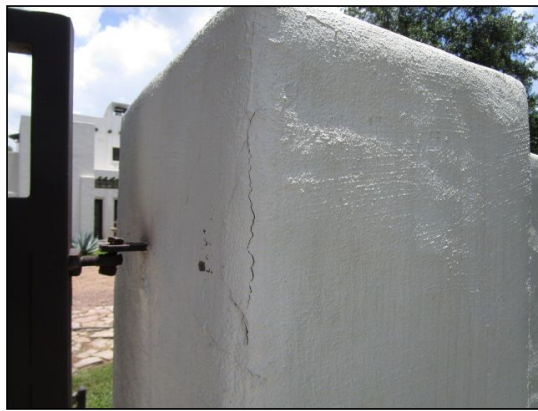
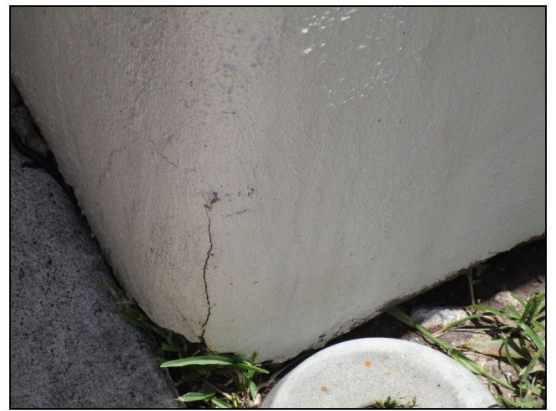
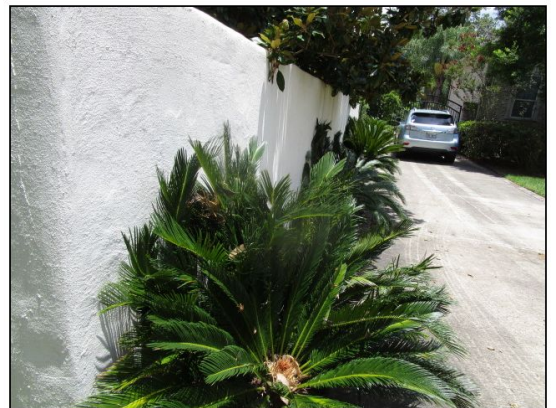
The stucco fence wall is damaged and has cracks in the finish. The exterior south side is not completely visible due to heavy foliage.

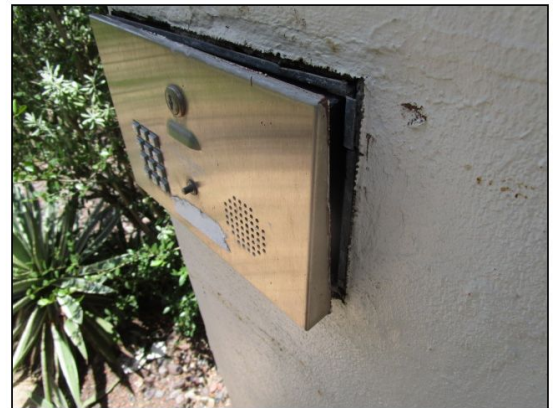
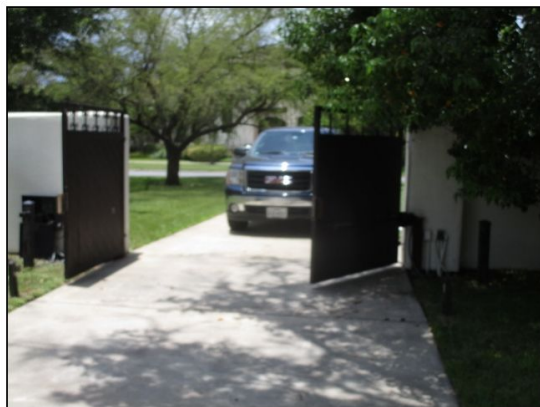
The security system, the communication box system and the gate operator are beyond the scope of the inspection. It was noted that the communication box at the front gate is not secured and was not in operation condition. The driveway gate opener did not have a remote present and did not appear to open/close properly.

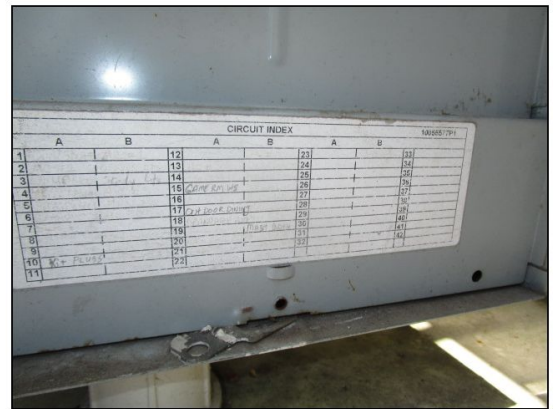
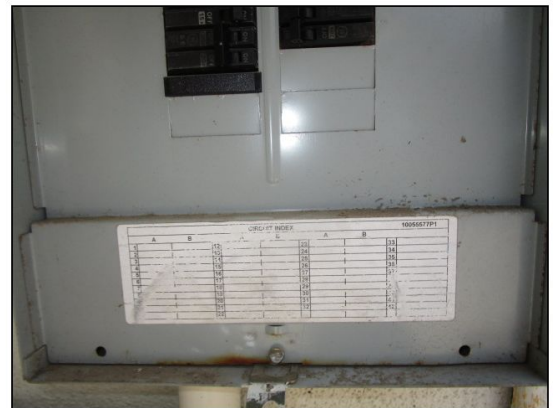
**Comments:** Breakers were not labeled at the service boxes as required.

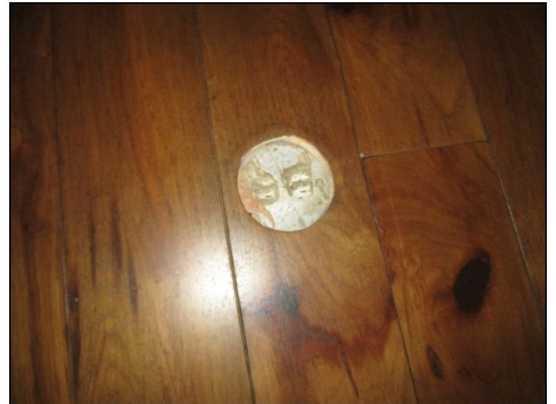
**Comments:** Electrical fixture face plates are missing in the screen room, the master bedroom, the floor outlet in the study and the upstairs front north bedroom closet. The cover is not complete for one of the living room floor outlets and the cover is not the correct type near the outdoor fireplace. Face plates that are missing for either light switches or electrical outlets are considered a safety concern.

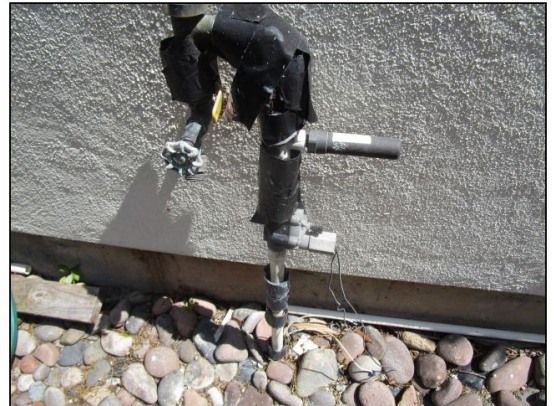
It is recommended that all of the exterior water lines be insulated from the weather in order to prevent freezing.

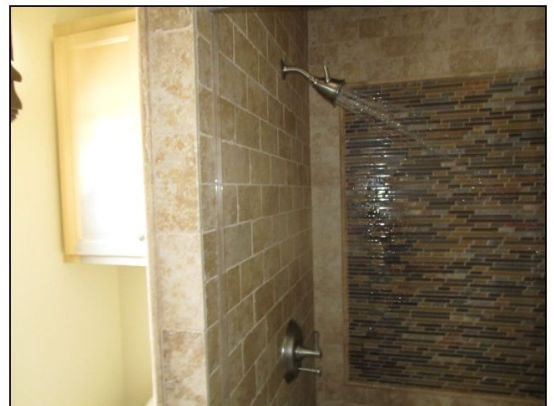
It is recommended that there be inspection ports provided on the back side of the plumbing walls of the tile showers so that it is possible to check for leaks.

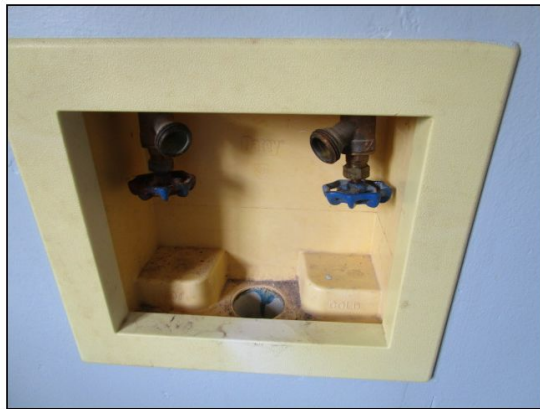
The hot and cold water supply valve handles have not been distinguished at the washing machine hook up location (either identified or color coded - red /hot, blue/cold.

A qualified plumber should be consulted regarding the repair of the above items as well as check the entire plumbing system for any other possible defects.

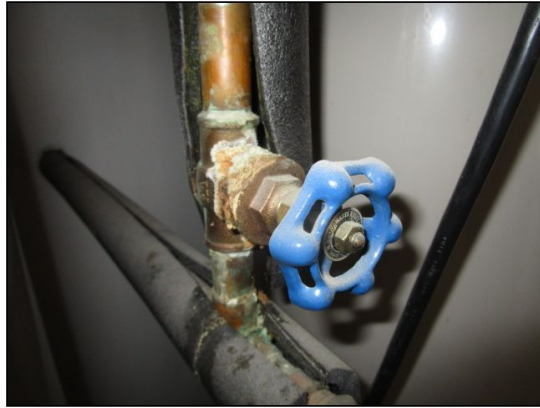
There was corrosion at the water supply lines/valve between the water heater units. It is recommended that these fittings be replaced whenever possible to prevent future leaks.

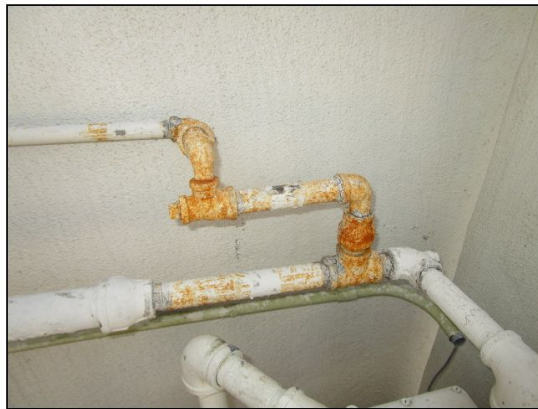
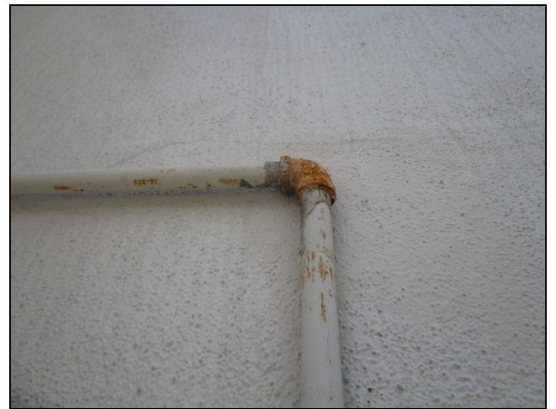
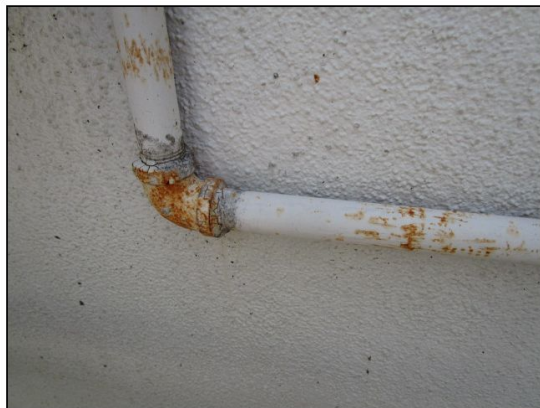
**Comments:** There is corrosion on gas lines coming off the meter.

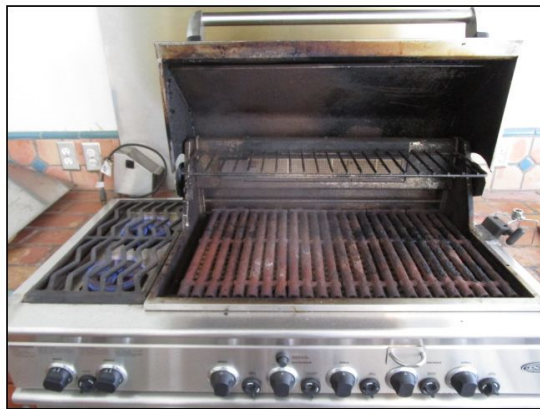
The igniter switches did not operate on the outdoor kitchen grill. The burner elements on the left side did operate. It is recommended that the unit be cleaned and serviced.

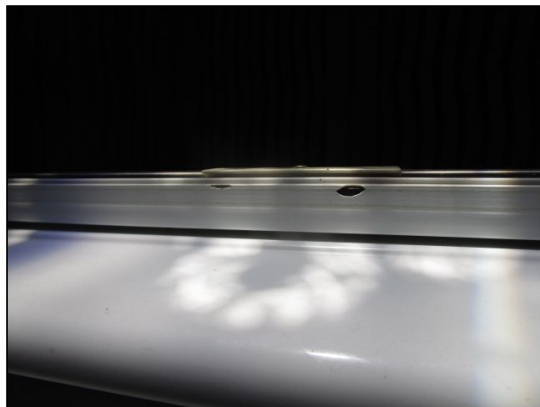
The built in refrigerator seal is damaged on the top of the refrigerator door side.
