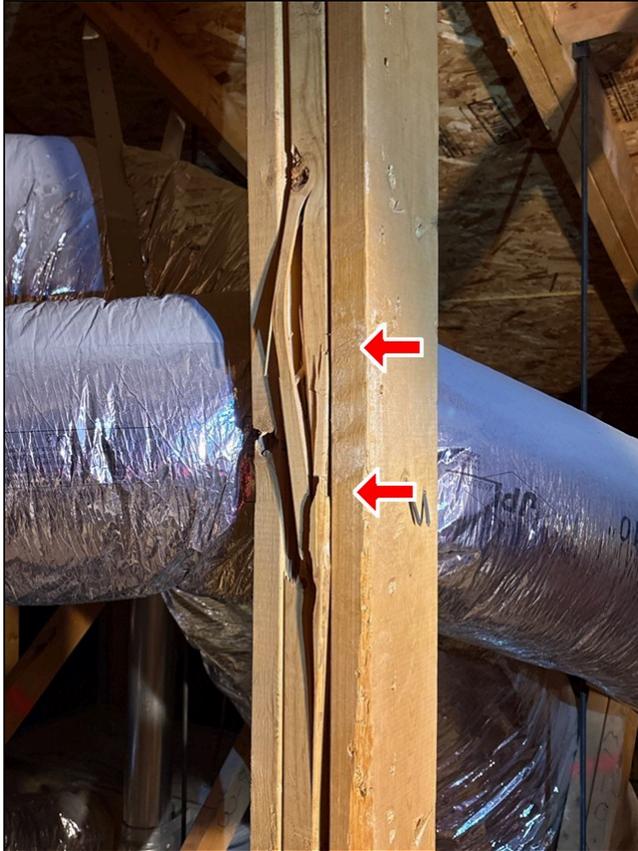
(2) There is evidence of previous repairs or modifications to one or more trusses. Improper truss repairs can allow the roof to sag. Ask the owner or occupant about the reason for the repairs.

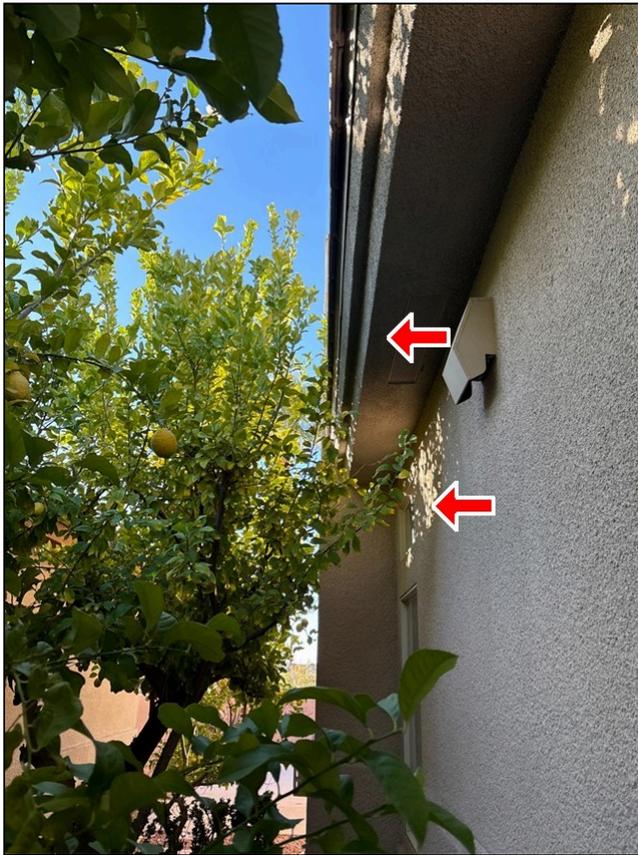
3.2 Item 1 (Picture)

Tree branches are in contact with the roof cover(s). This condition can cause damage to roof covers and all tree limbs in contact with or over hanging roof covers should be removed.

Part of a tree(s) at the left side (facing front) is touching the building. This can lead to costly damage to the building or roof, especially during high winds. Have a qualified technician prune the tree(s).

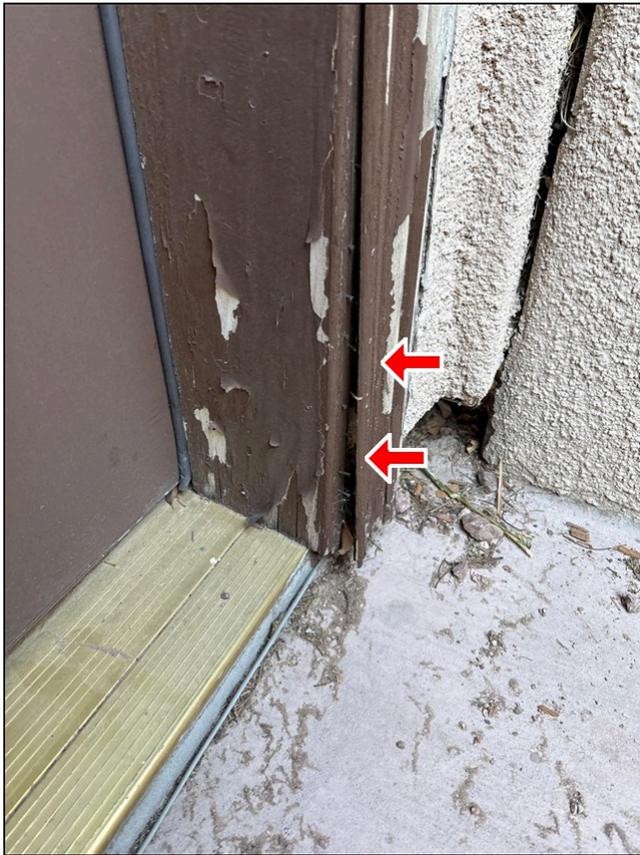
3.7 Item 1 (Picture)

(2) Some of the exterior trim is damaged and/or deteriorated in several areas. We have NOT listed every instance of trim damage. Have a qualified contractor examine all exterior trim for deterioration, damage or missing parts, and repair or replace as necessary. Regular routine maintenance is recommended.

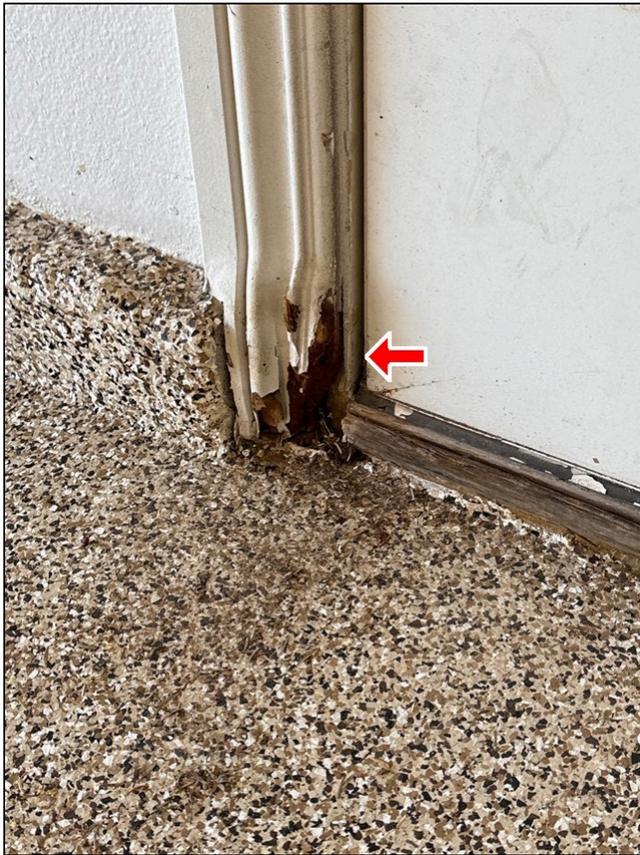
3.9 Item 1 (Picture)

There is evidence of water penetration below the sill plate or in areas of the interior finished surfaces at several exterior passage doors. This is evident in water stains or damage to the sill plate or surrounding drywall surfaces. We did not try to list every location however we Recommend repair or sealing of any areas leaking moisture by a qualified contractor.

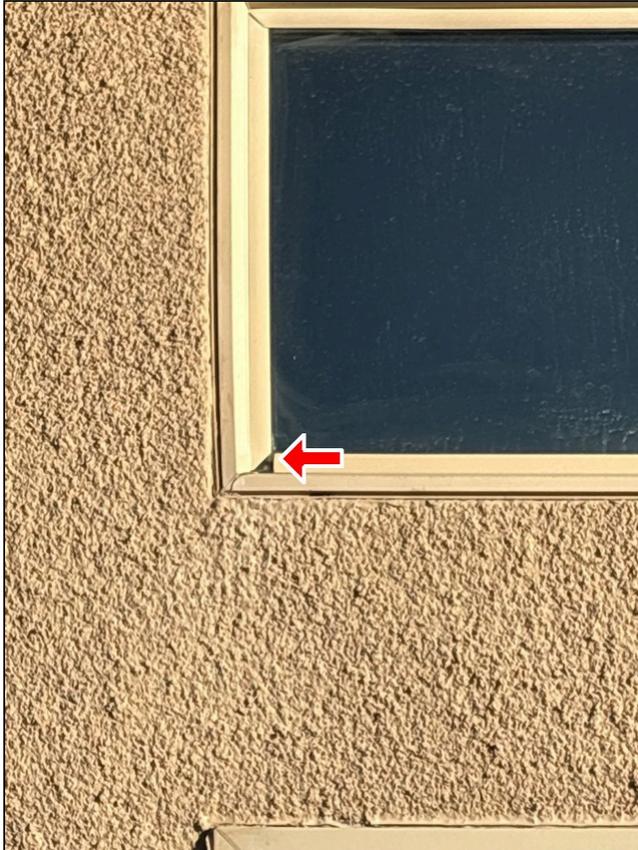
3.10 Item 1 (Picture)

A window(s) have missing or damaged plastic trim around their perimeter. This trim aids in keeping the windows sealed. Recommend a qualified contractor repair or replace any damaged trim.

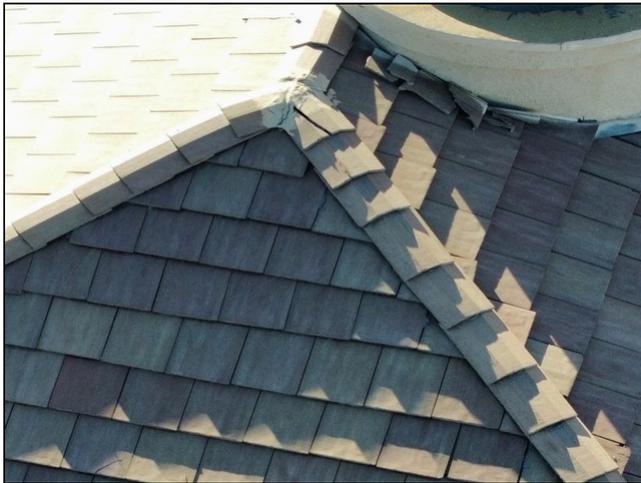
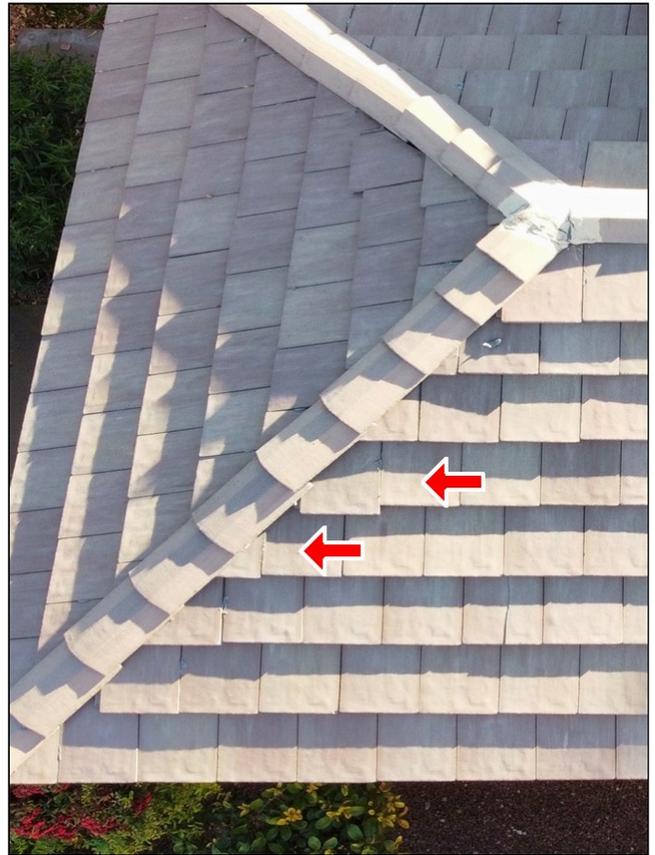
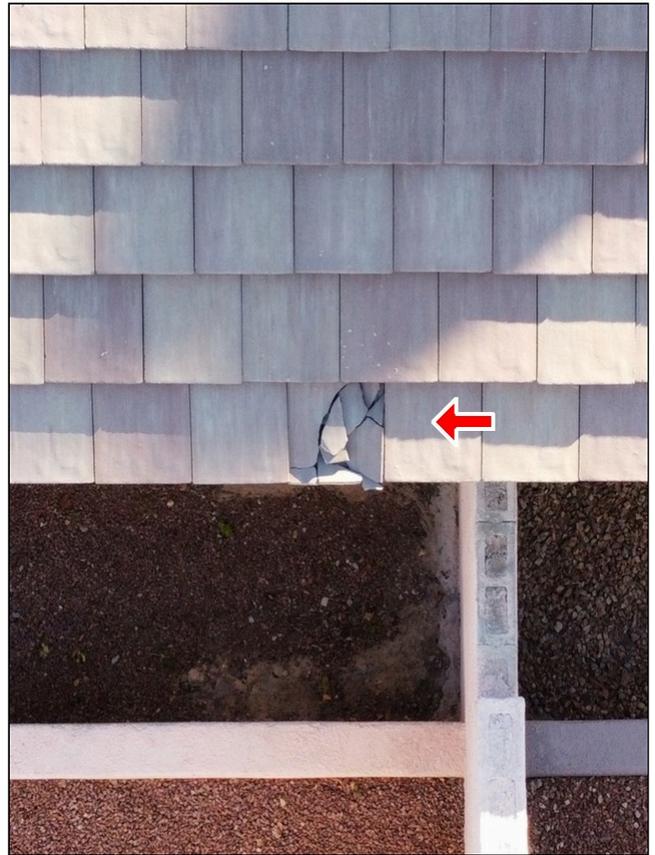
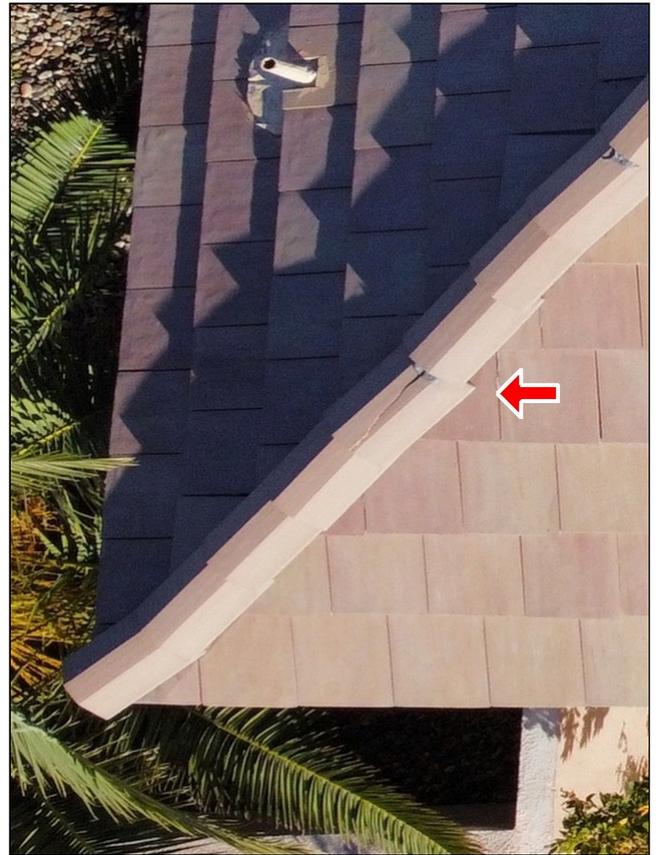
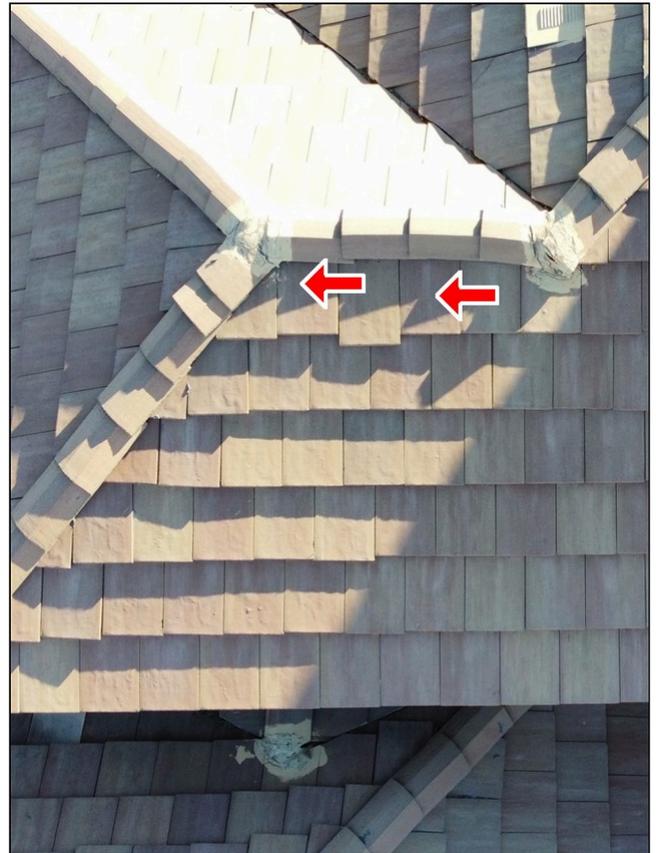
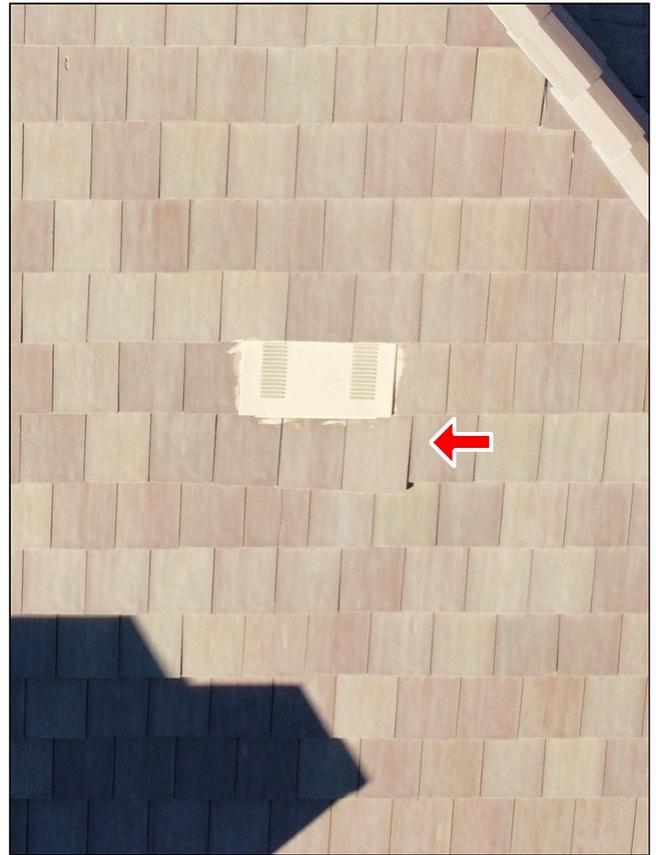
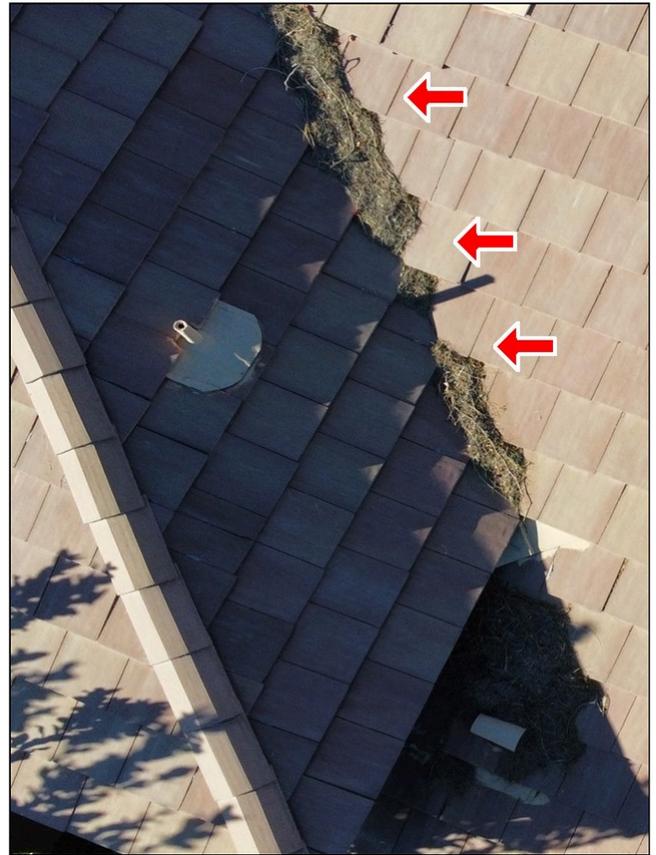
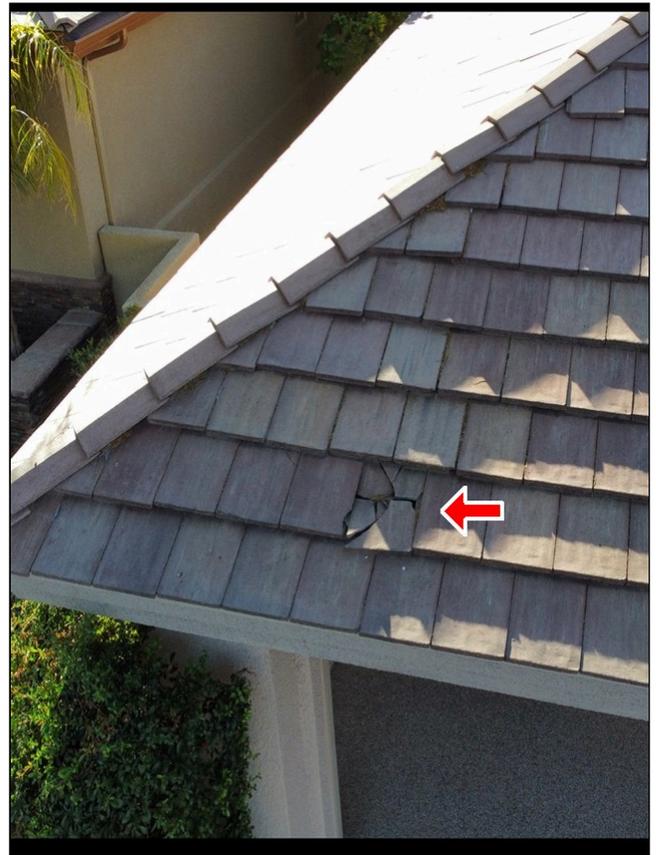
(2) Typical cracking of tiles was observed in a few areas of the roof. Periodic maintenance is needed to correct cracked tiles. Recommend Repair - Seal / replace as necessary.

There are dislodged tiles at various locations leaving the felt underlayment, flashing exposed. A qualified roofing contractor should review the roof covers and repair, replace tiles / underlayment as necessary.

Field tile that have slipped from their original positions were observed. A qualified roofing contractor should view these areas and make any needed repairs to hold tiles securely in the field.

The mastic securing the ridge and or hip tiles has dried out and needs to be replaced. Replacement may be necessary at some or all of the ridge / hip tile. A qualified roofer should review these areas and repair loose tiles as necessary. This is a typical maintenance item.

Suggest removing the dirt, leaves and debris from the roof systems to prevent water retention which will lead to increased deterioration of the roofing materials.

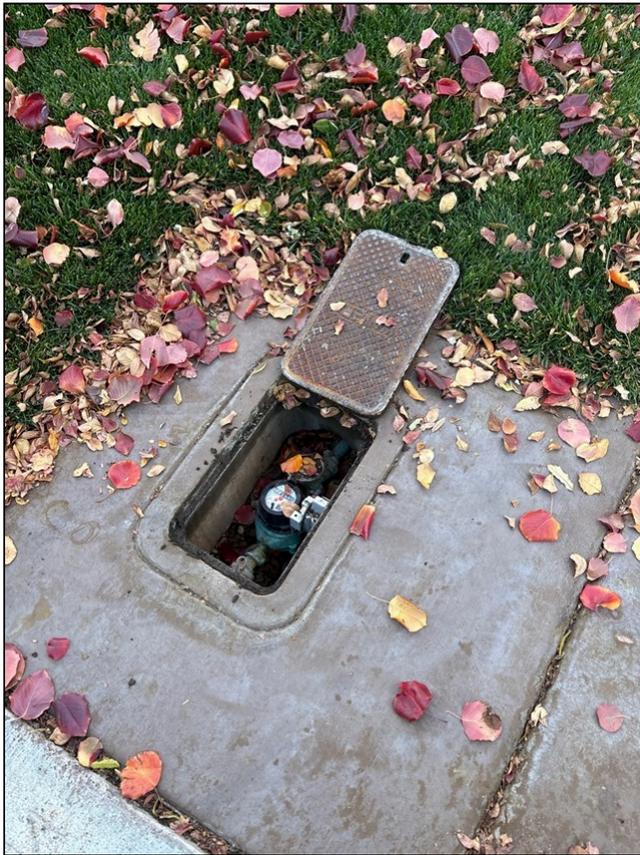
5.3 Item 1 (Picture)

(1) The photos show your shut off devices at the front of the house, and water meter. The meter was moving indicating that a leak in the supply lines is present. We recommend that you have a qualified plumber and or leak detection company review and repair as necessary.

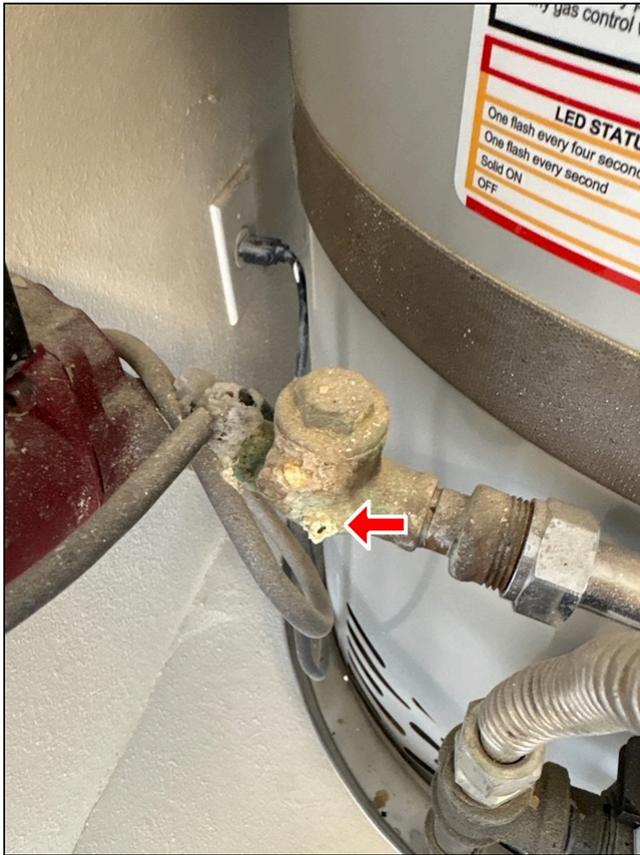
5.7 Item 3 (Picture)

(2) Corrosion is present at the water heater plumbing in the garage. No leaking was observed at the time of inspection, however corrosion can be indicative of slow leaking and can lead to sudden failure in the future. Recommend proactive repair of corroded plumbing and valves by a plumbing professional or careful monitoring.

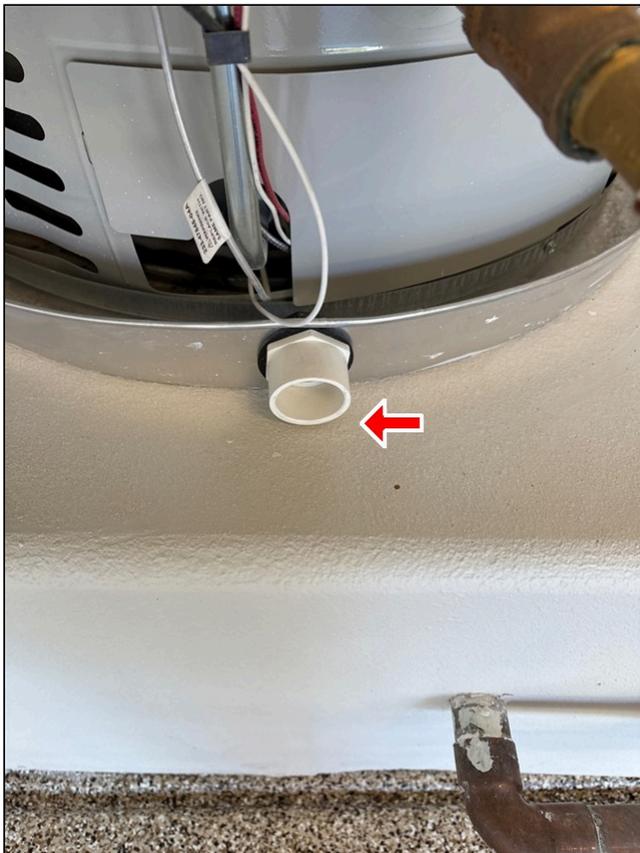
5.7 Item 4 (Picture)

(3) Recommend extending the water heater drain pan discharge to the garage floor to avoid the drywall and structure platform in the event the water heater should leak.

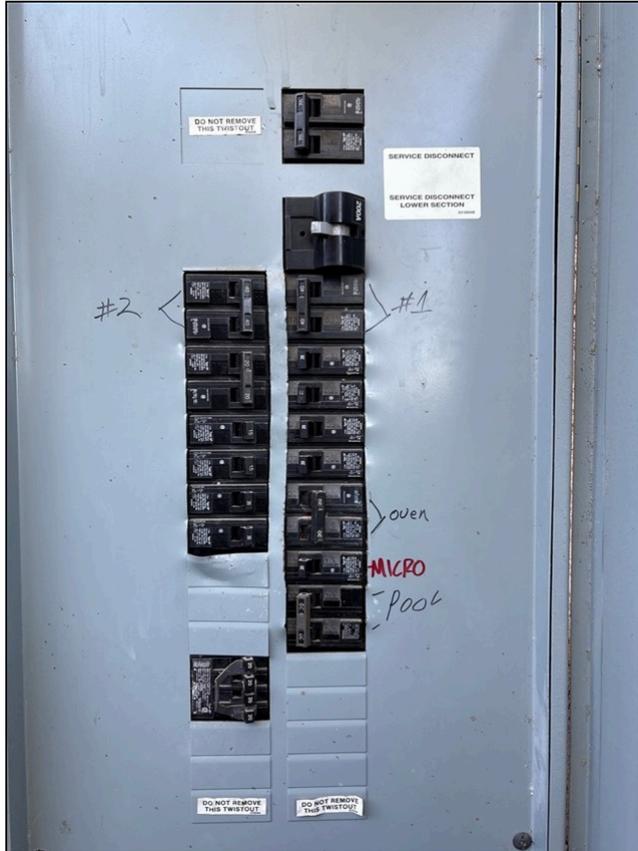
6.3 Item 1 (Picture)

Circuits in the panel are not labeled. While the labeling of the various electrical circuits in the panel is not related to fire hazards or potential electrical shock safety, they do identify which breakers control which circuits, and are important for determining which breakers to turn off when working on the system. If desired, the client can have a licensed electrician identify and label the circuits.

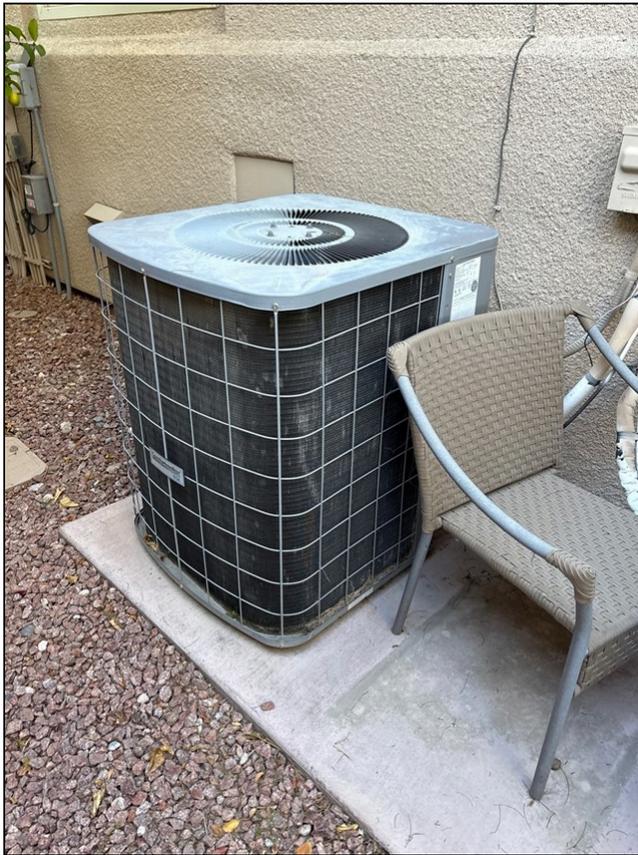
7.4 Item 1 (Picture)

The cooling equipment is old (10+ years), but responded to user operating controls. As part of routine maintenance, the evaporator, coil, condensate drain line and pan should all be flushed and cleaned annually. Have licensed contractor further evaluate and make all necessary repairs.

As part of routine maintenance, the evaporator coil, condensate drain line and pan should be flushed and cleaned annually. A qualified technician should do the work.

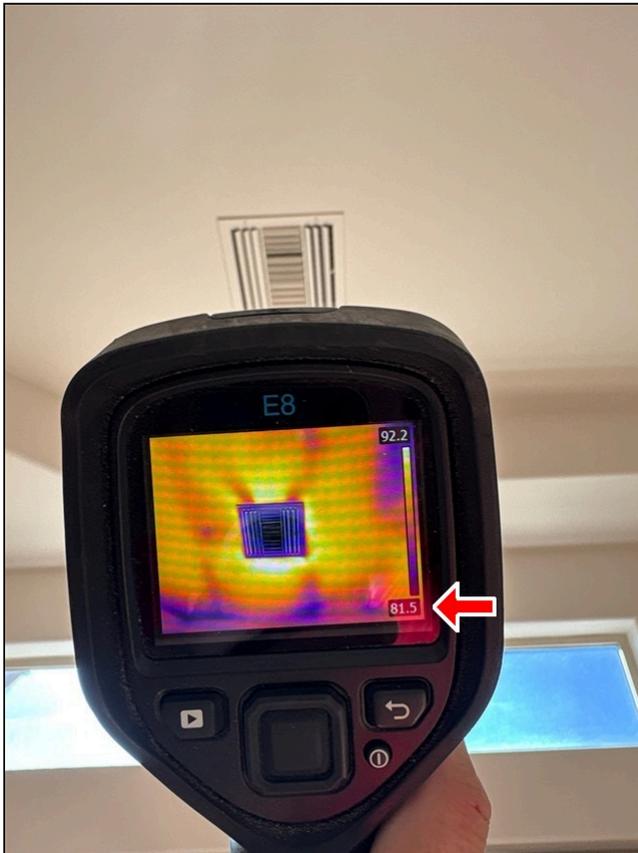
7.7 Item 2 (Picture)

(2) The AC at the right side of the home that includes the master bedroom and that side of the house is not working and did not respond to normal operation and or controls. Have licensed contractor further evaluate and make all necessary repairs.

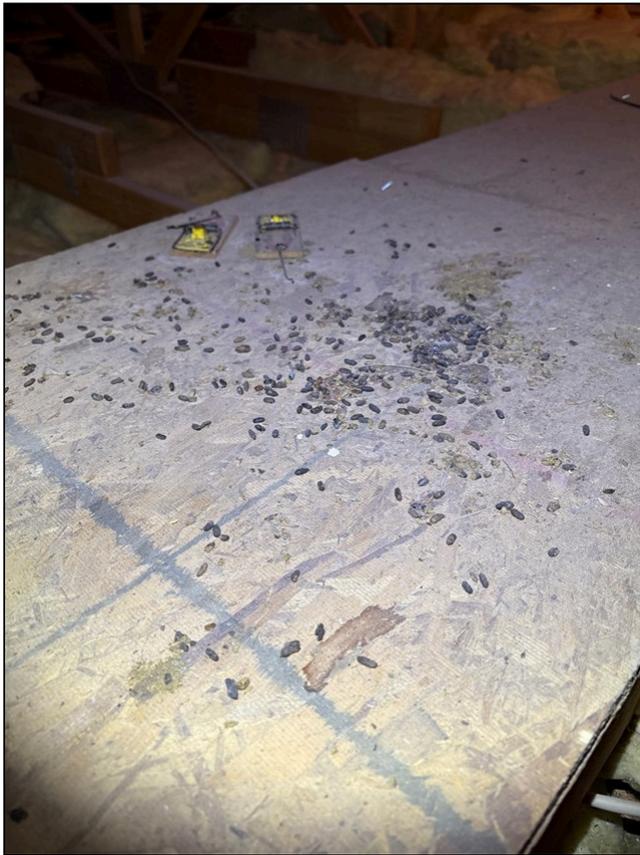
8.0 Item 1 (Picture)

There is an excessive amount of pest droppings located in the attic. It is also noted that there are rodent traps. Have licensed contractor further evaluate and make all necessary repairs.

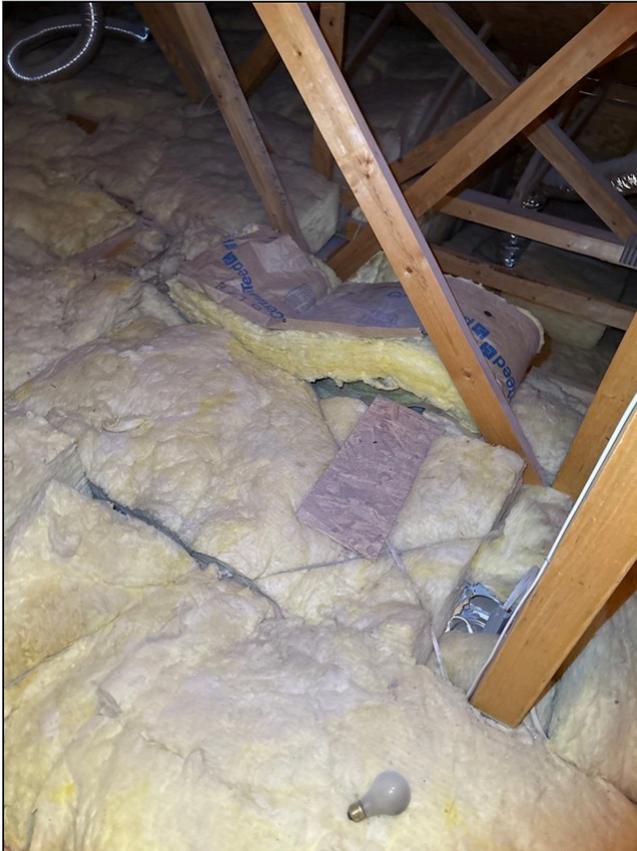
8.3 Item 2 (Picture)

(2) Some of the insulation in this area is missing, or is out of place. Where insulation is missing, new insulation should be installed. Where insulation is out of place, it should be put back into place. A qualified technician should do the work.

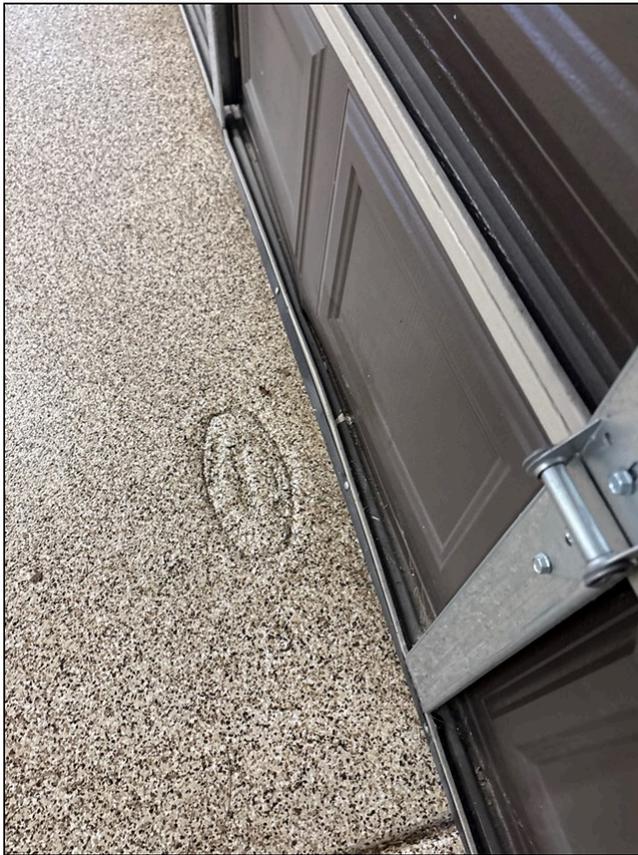
9.2 Item 9 (Picture)

(2) The garage vehicle door is dented and slightly damaged. The door was operated multiple times and no impediment to the doors operation was observed. This is a cosmetic condition that can be corrected by a qualified garage door technician.

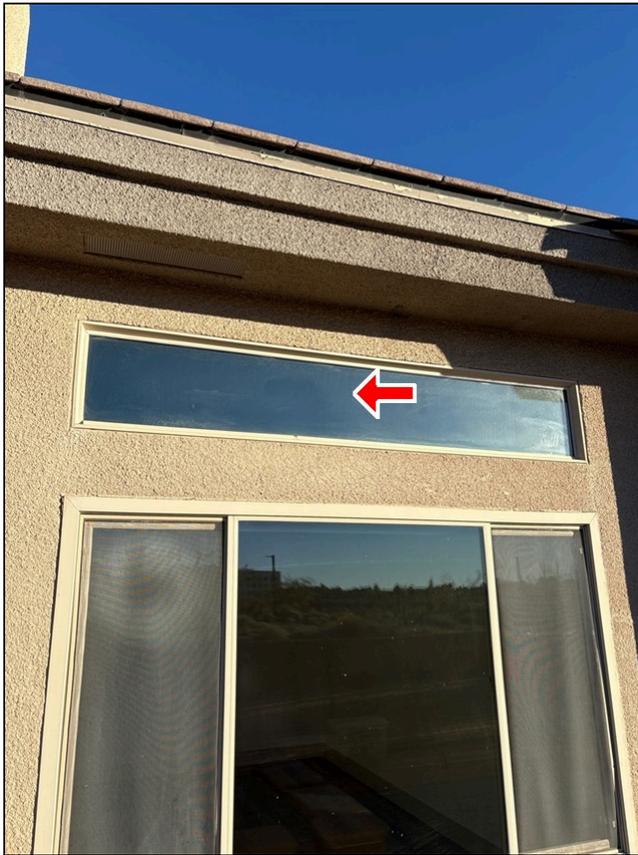
10.5 Item 1 (Picture)

Condensation staining, or droplets, is present between the panes of one or more insulated glass windows in the living room. This suggests a failure of the factory seal between the twin pieces of glass. There are some companies that can repair windows with moisture between panes without replacing the window. "Fogged" windows can still perform their function for ventilation and light admittance, but can become so opaque that visibility is impaired and have reduced energy efficiency. Any insulated glass units which display symptoms of breached seals should be evaluated and repaired or replaced by a window professional.

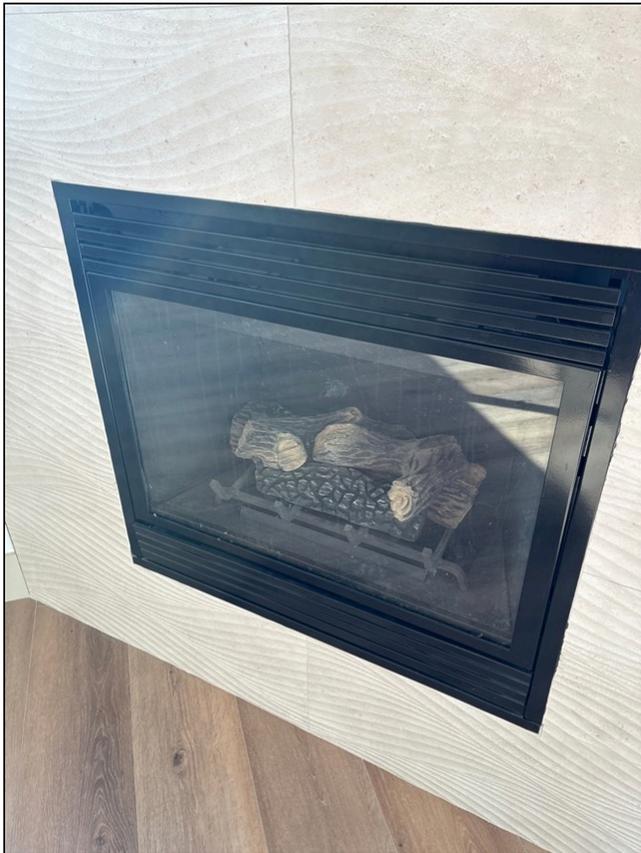
10.9 Item 4 (Picture)

(2) The gas fireplace operates from a wall switch and did not respond when tested. The gas valve under the fire box was verified as being open. This may indicate an issue with the ignition and or switch. Consult a qualified person for repairs.

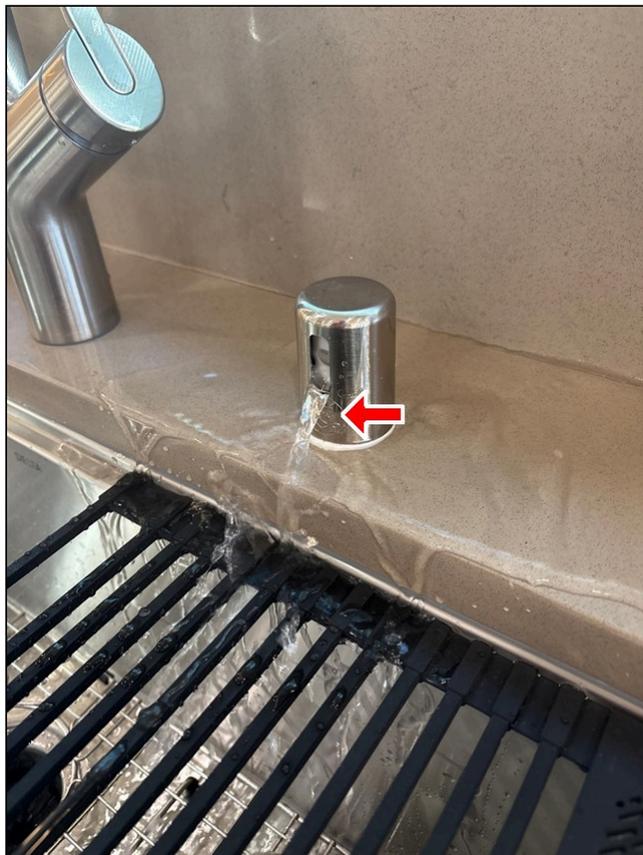
11.8 Item 2 (Picture)

(2) The air gap or its connection to the disposal is restricted or kinked. This causes water to flow out of the air-gap during the drain cycle of the dishwasher and leak into the cabinet under the sink. The dishwasher drain system should be cleaned or repaired to restore proper operation. A qualified plumbing professional should do the work. The dishwasher was not operated through a complete cycle due to the drain defect.

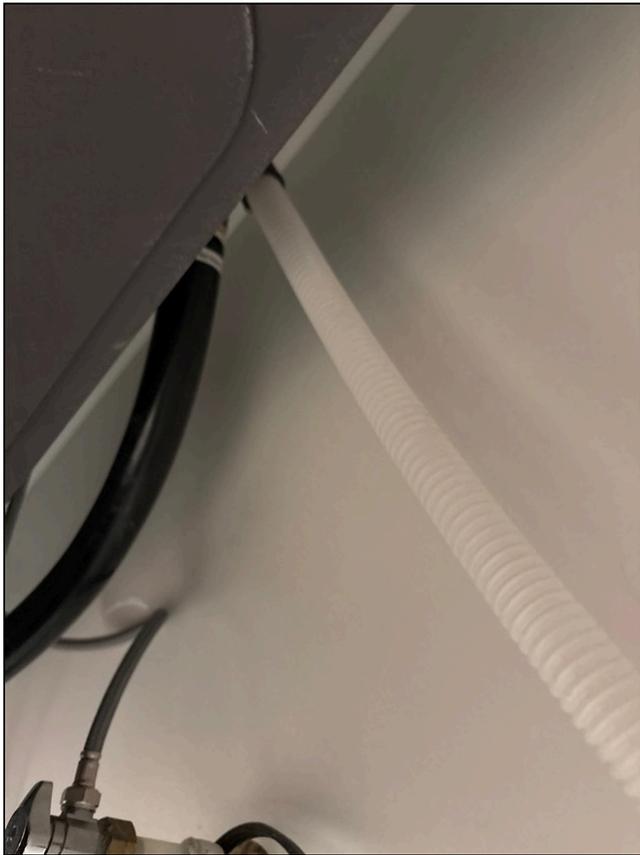
11.8 Item 4 (Picture)

(3) The air gap hose connections leak. All leaks should be repaired.

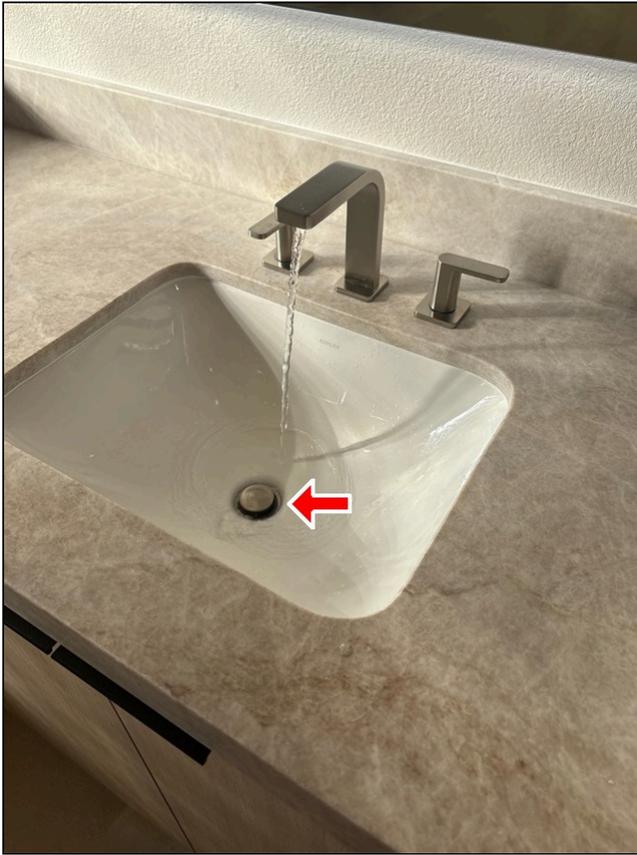
12.1 Item 1 (Picture)

(1) Drain stops are missing or inoperative at Master Bathroom. Recommend repair by a plumbing professional.

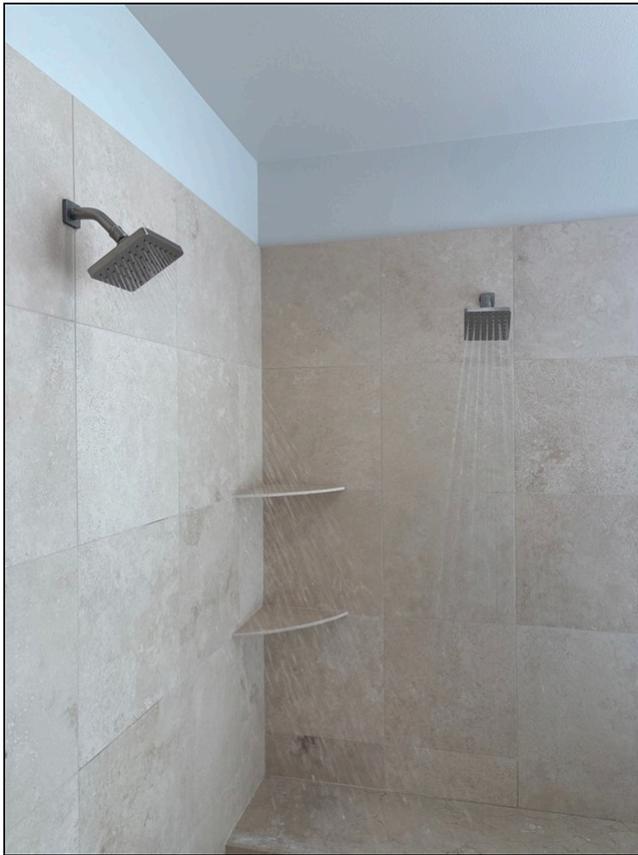
12.1 Item 2 (Picture)

(2) The shower faucet at the Master Bathroom shower is hot/cold reversed which can present a burn hazard. Recommend evaluation and repair by a plumbing professional.

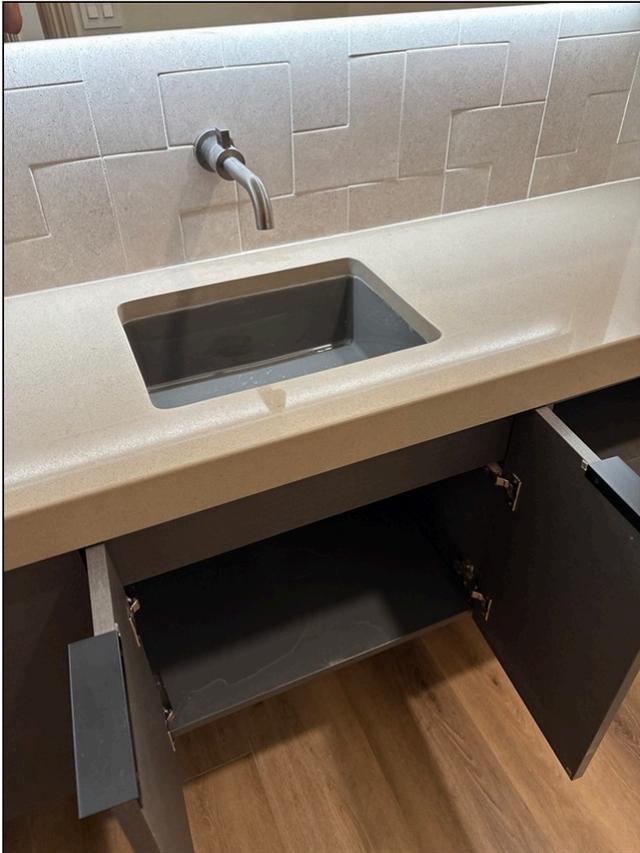
12.1 Item 5 (Picture)

(3) Thermal Imaging photos have been taken to further clarify noted leak. Purple in color shows a high level of moisture.

An apparent drain leak is present at the guest bathroom bathroom sink. Recommend repair to all contributing leaks by a licensed plumbing professional.

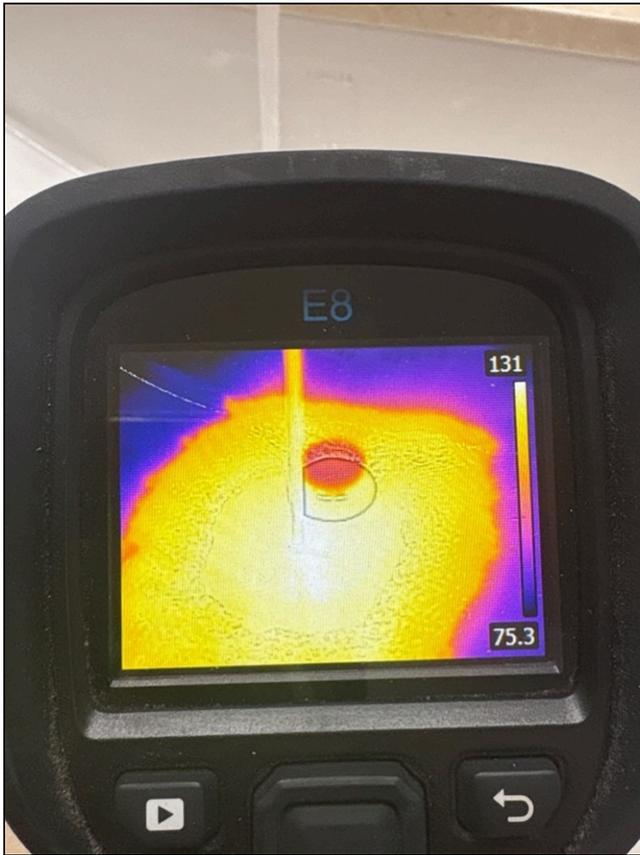
12.1 Item 9 (Picture)

(4) The hot water at the guest bathroom was not getting to the proper temperature. The hot water did not exceed 100° at the shower. It did exceed over 100 at the sink. This could have to do with the handle and lower the valving of the shower. Have licensed contractor further evaluate and make all necessary repairs.

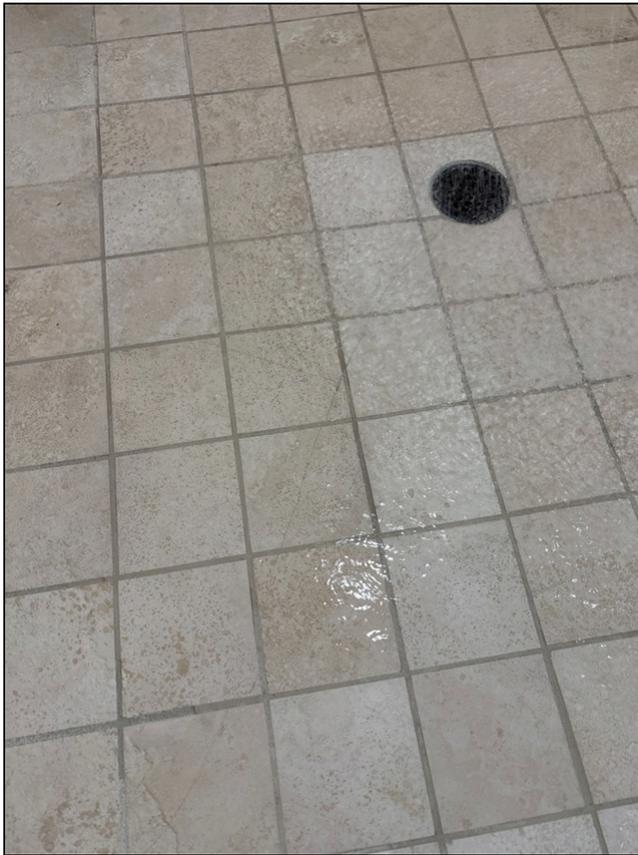
12.4 Item 1 (Picture)

(2) It is noted that there were a few cracked tiles at the master bathroom shower. Have licensed contractor further evaluate and make all necessary repairs.

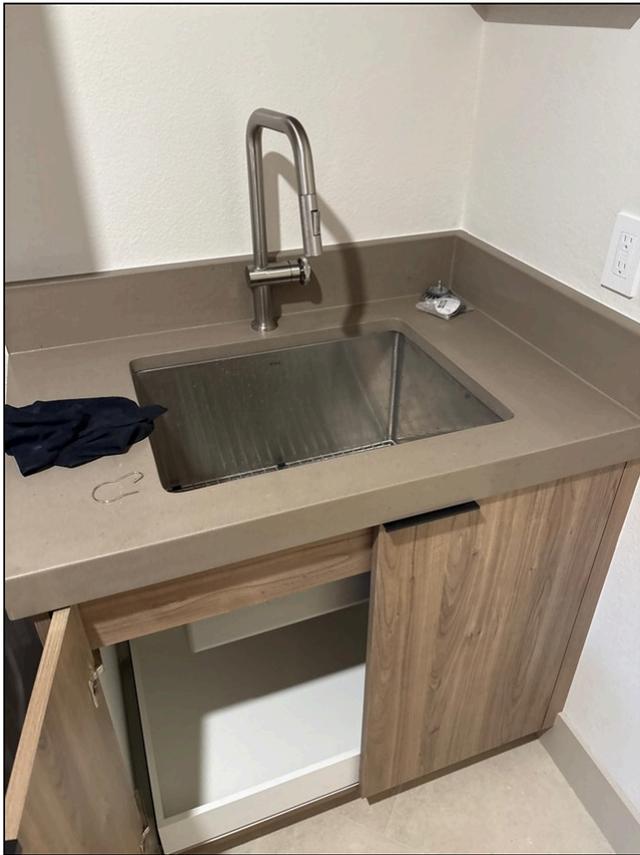
13.7 Item 1 (Picture)

The sink in the laundry room was leaking from the drain at the time of inspection. The thermal imaging photo shows a dark purple and confirms the moisture underneath the sink. Have licensed contractor further evaluate and make all necessary repairs.

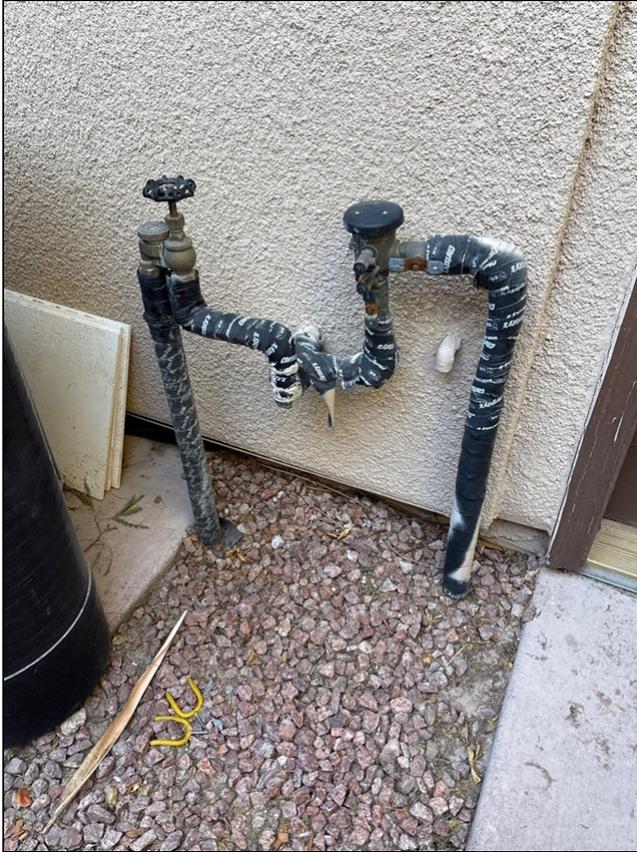
14.1 Item 2 (Picture)

(2) Anti-syphon valve is leaking and or damaged and is need of repair. Have licensed contractor further evaluate and make all necessary repairs.

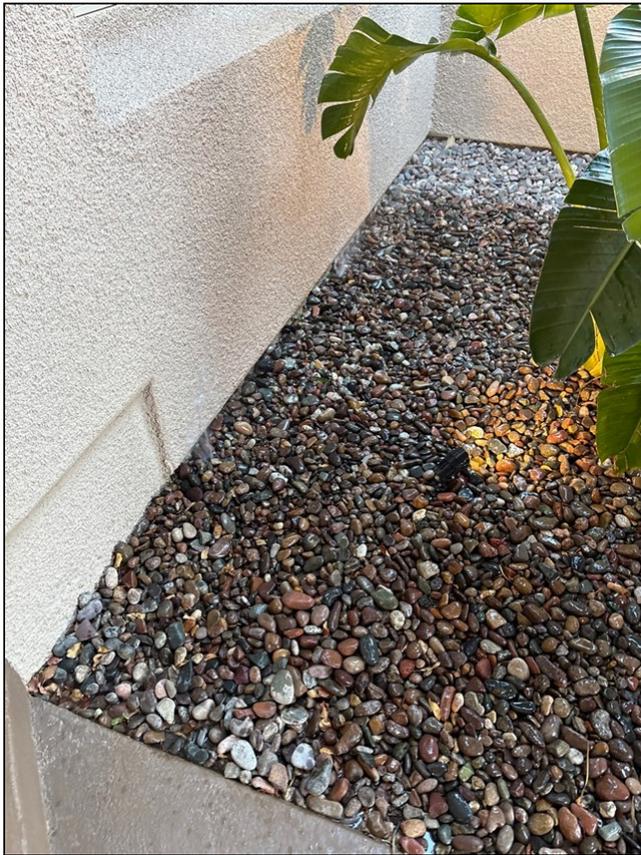
14.1 Item 4 (Picture)

(3) The irrigation supply loop at the (LOCATION) of the house is leaking. Recommend repair by a plumbing or landscape professional.

The ground at the front of the building was saturated at the time of this inspection. This condition may be caused by improper grading, over-watering or defective irrigation components. If present, the irrigation system should be adjusted and/or repaired by a qualified technician and these conditions re-evaluated after the repairs have been completed. If the condition persists, further investigation as to the source of the moisture should be made.

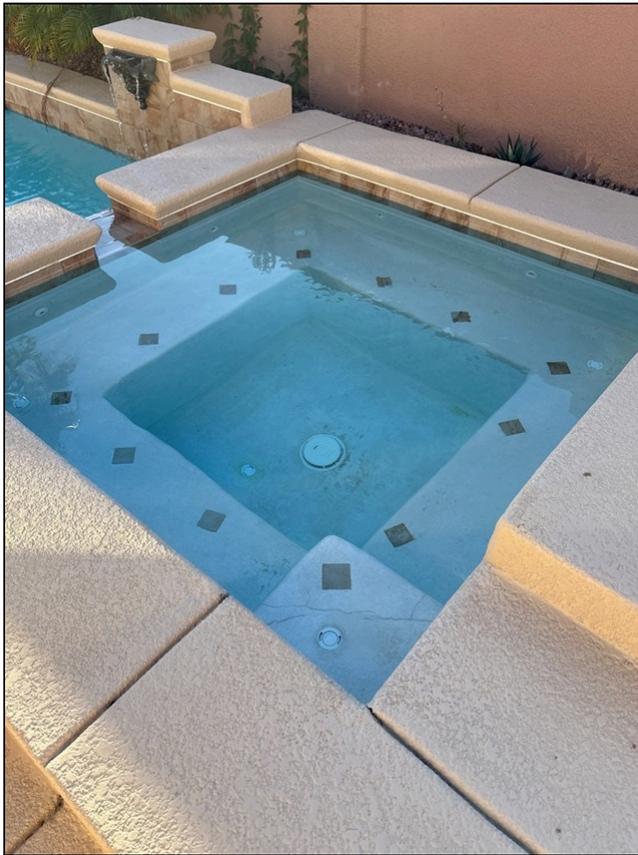
15.1 Item 1 (Picture)

Spa is not functioning properly.

When jets start failing, the most like case is that your hot tub pump is not working correctly. There could be an airlock in valves and or valves not labeled. Clogged filters or water intakes can also cause jet issues. Have licensed contractor further evaluate and make all necessary repairs.

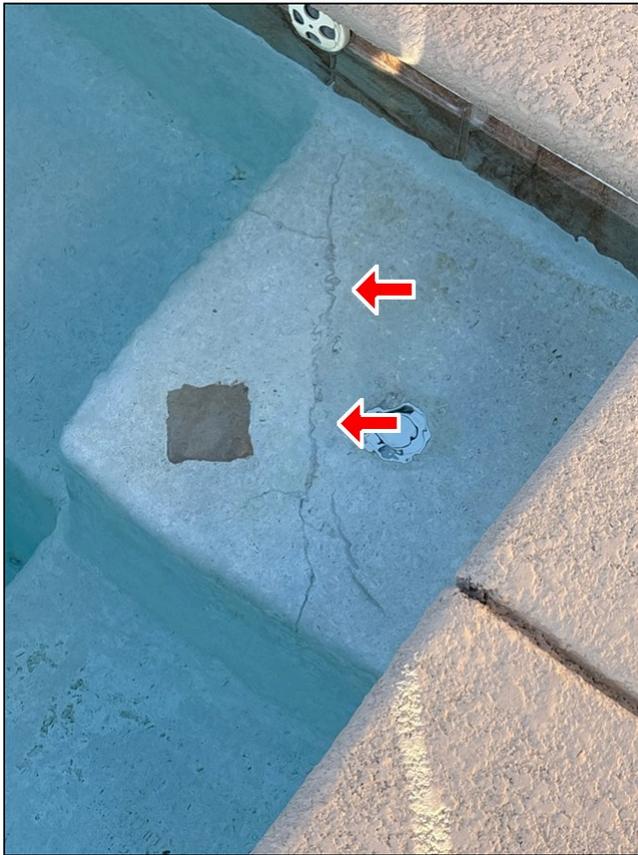
15.3 Item 1 (Picture)

Cracks and possible areas of loose plaster are present on the surface of the pool. All concrete and plaster pools require repair and resurfacing during their lifetime. Recommend further evaluation by a licensed pool professional to determine the timetable for required repair and the estimated cost.

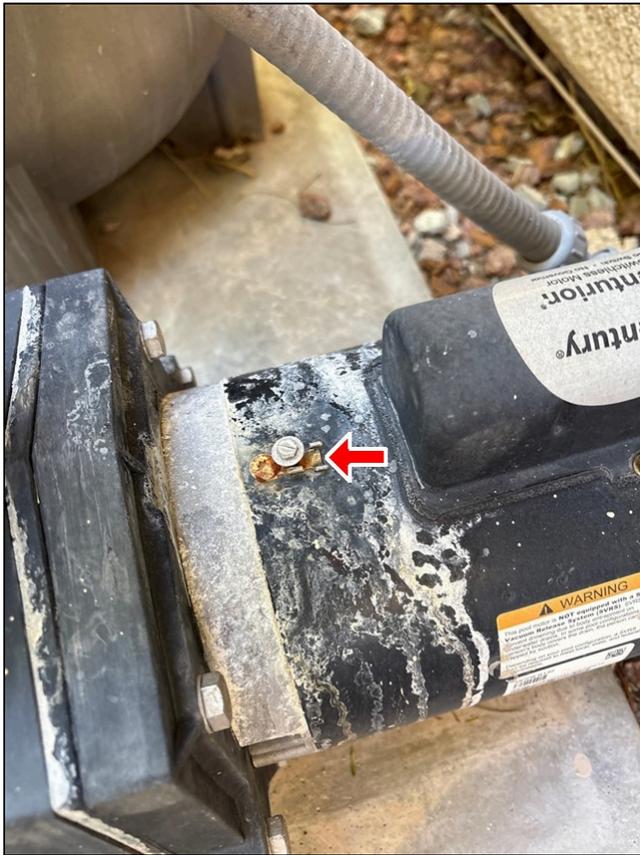
15.5 Item 5 (Picture)

(2) A pool pump needs to be both grounded (connected to the earth via the main electrical system) and bonded (connected to all other metal parts in and around the pool) to prevent serious electrical shock hazards, a requirement enforced by electrical codes like the NEC for safety, ensuring stray currents go to the earth or are equalized across all conductive parts.
