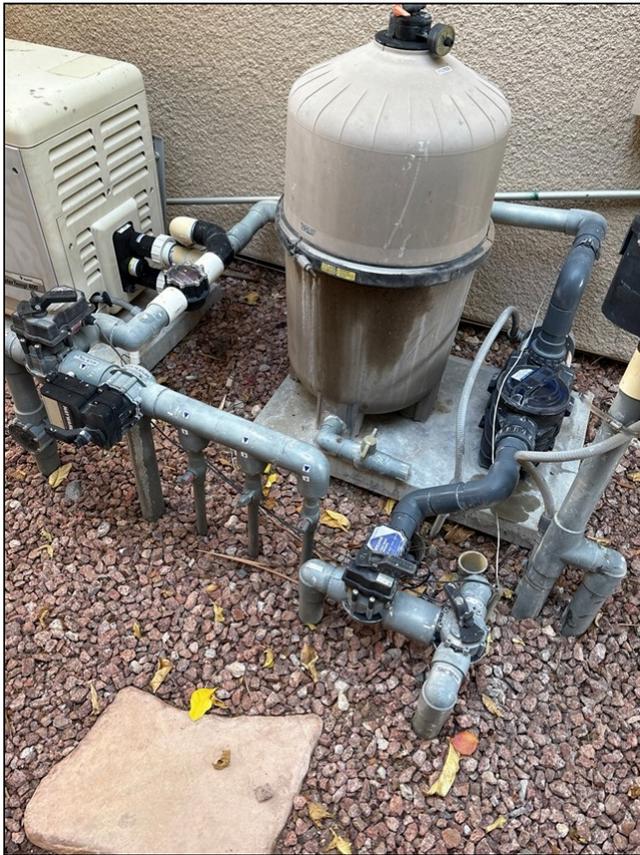
15.7 Item 1 (Picture)

Leaks at the pool plumbing are present where indicated. Recommend repair by a licensed pool professional.

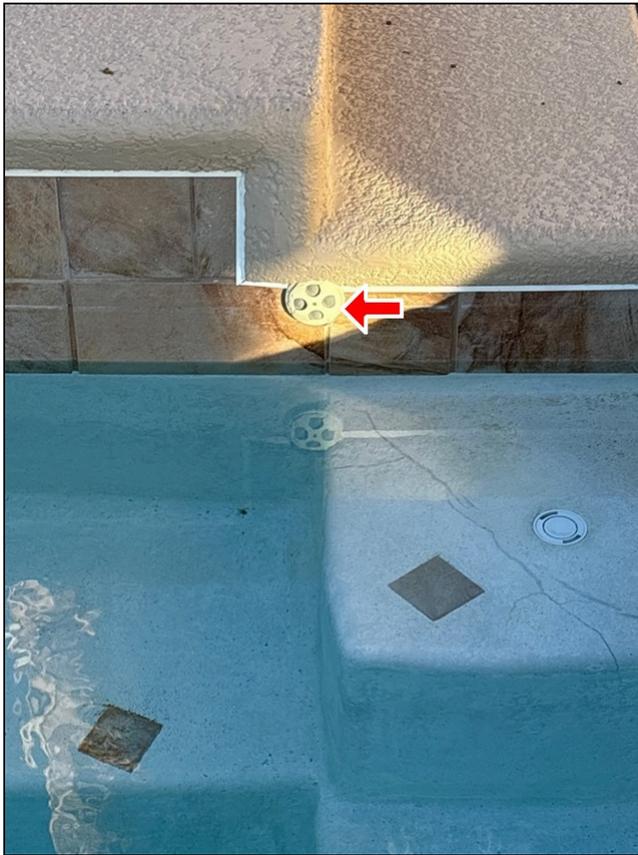
15.9 Item 1 (Picture)

(1) The pool and spa lights were not functional at the time of inspection. Have licensed pool contractor further evaluate and make all necessary repairs.

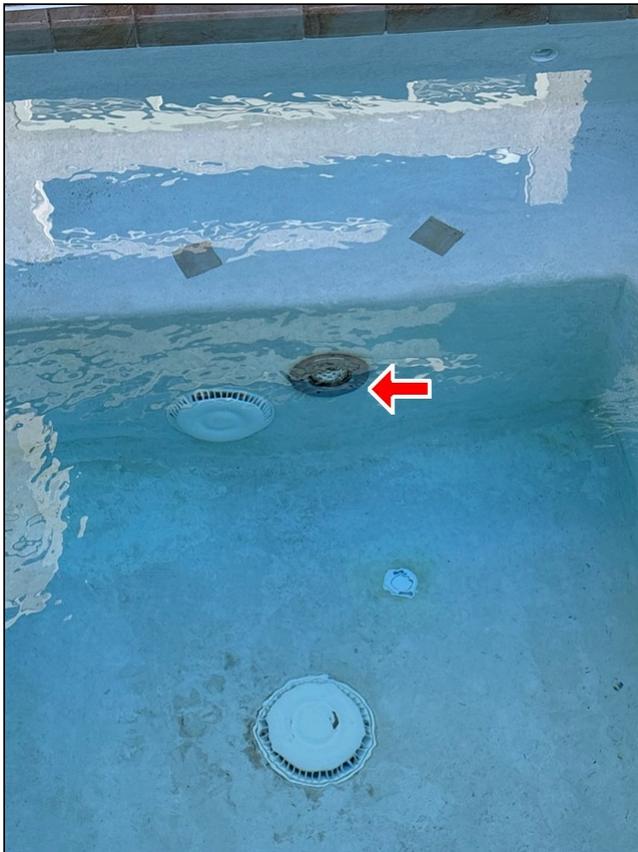
15.9 Item 2 (Picture)

(2) Pool and spa light are not working with normal controls. I suggest a pool professional evaluate and repair.

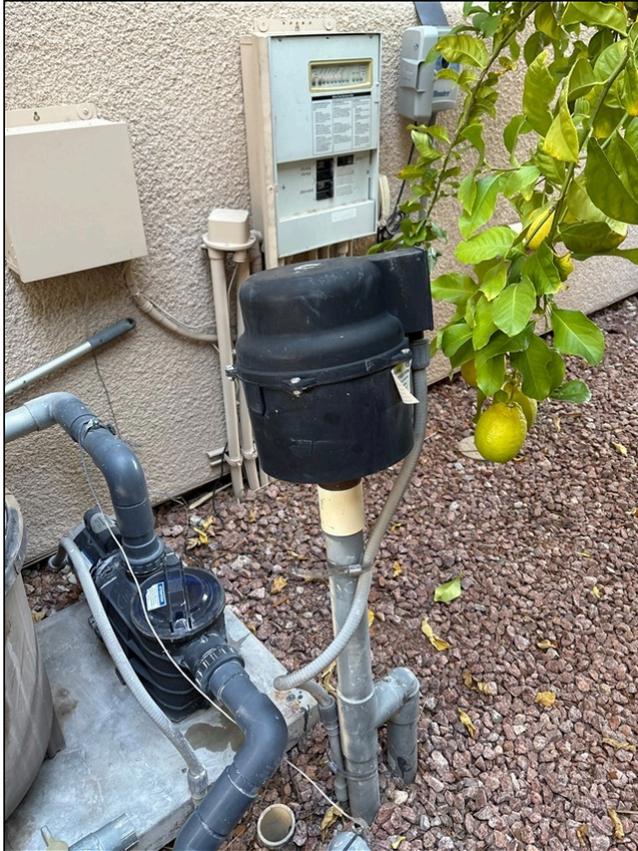
15.11 Item 1 (Picture)

The blower failed to respond to normal operating controls at the time of this inspection. A qualified technician should repair or replace the blower motor.
