Power Loss

The 1999 Ford Power Plant Explosion:
A Study of Problems Encountered
During Large-Loss Fire Investigations

By **Kim Mniszewski, Hal Lyson, and Crispin Hales**

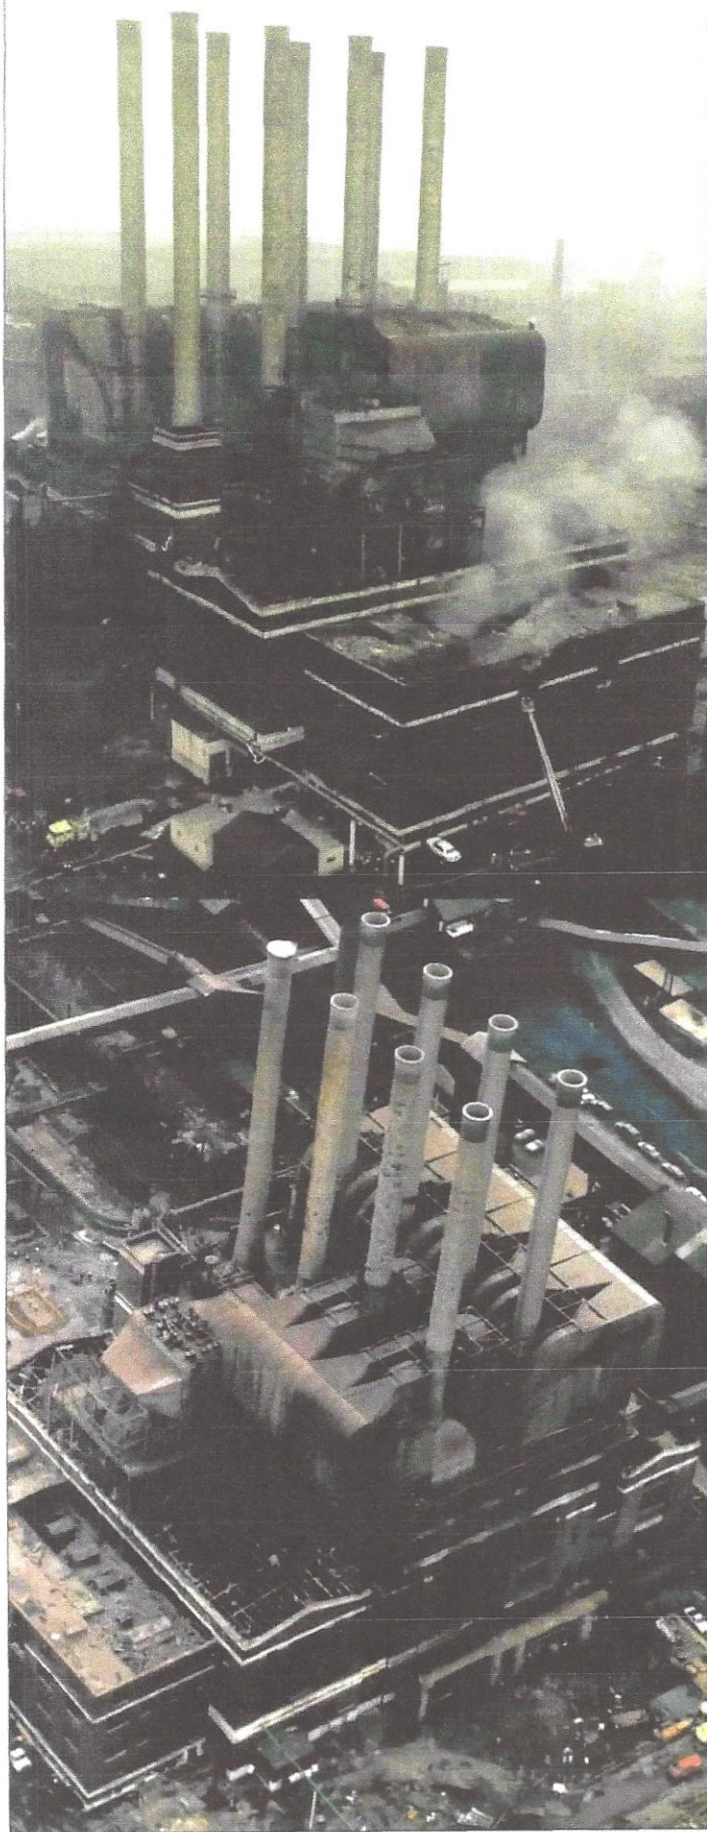
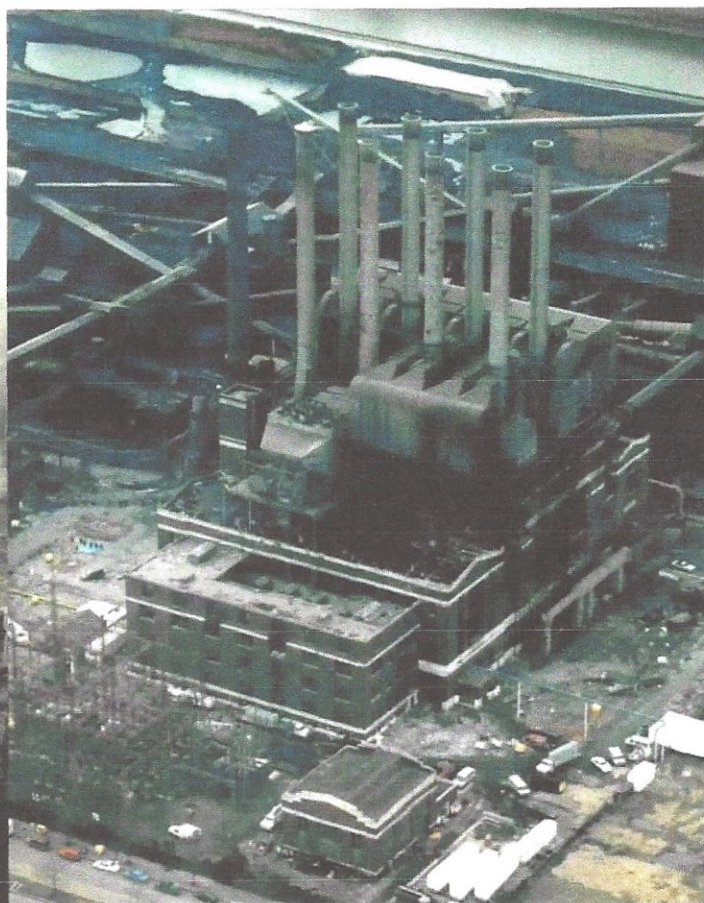
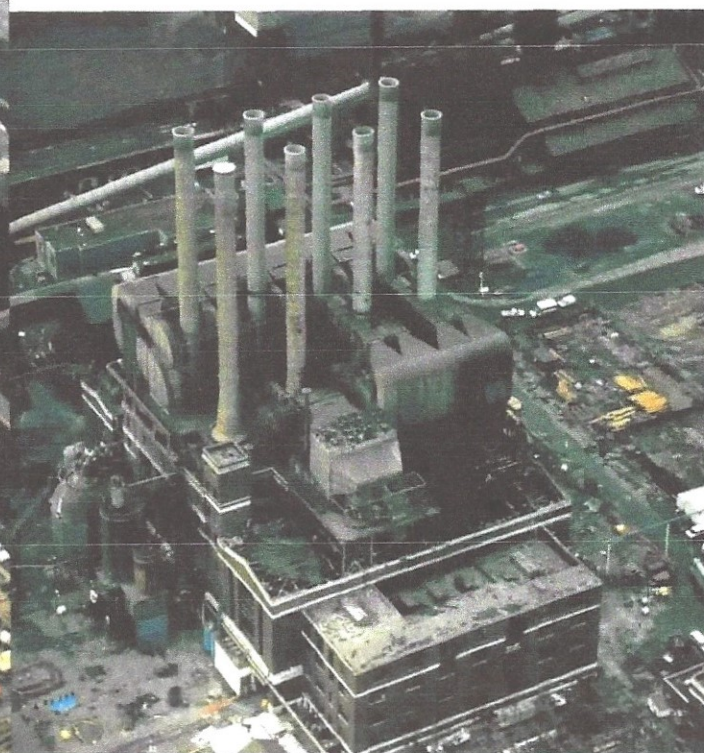
Several views of the Rouge complex of the Ford Motor Company in Dearborn, Michigan, including a view from the explosion site (top left) as two firefighters on a ladder truck pour water into the huge power plant on Monday, February 1, 1999.

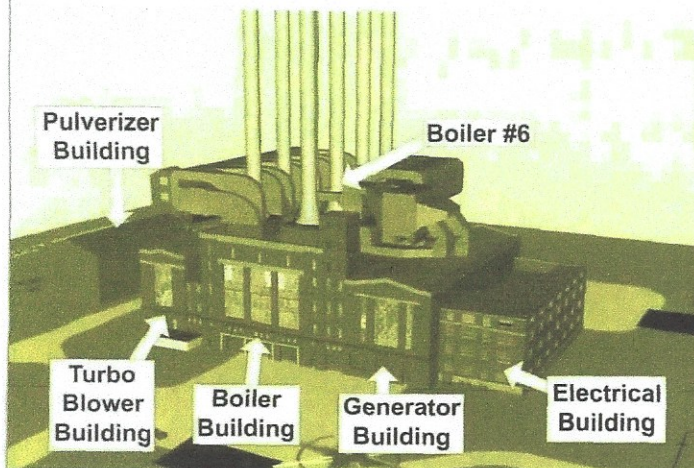
Figure 1: Ford Power Plant Facility

The unprotected, noncombustible structure covered a ground-floor area of 80,874 square feet (4,452 square meters), and included several distinct operational areas, separated by walls, creating smaller "buildings" within the overall structure (see Figure 1). Among these smaller buildings was the boiler house building, located in the center of the larger structure, and the turbo blower building to the west. The generator building was east of the boiler building, and the electrical building was to the east of the generator building.

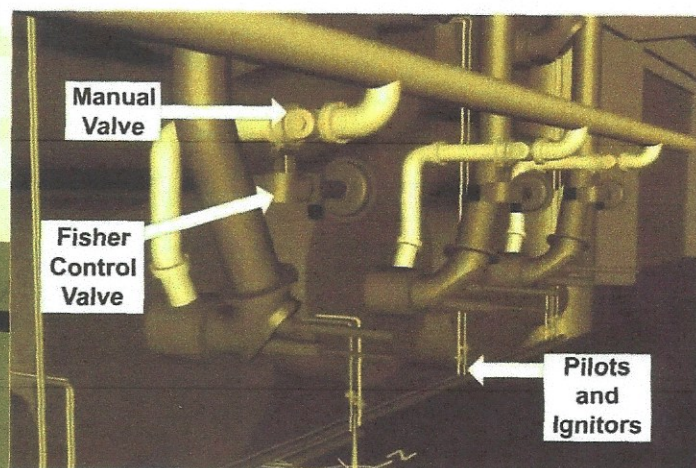
Figure 2: Three natural gas burners on each side of Boiler 6

the boiler (see Figure 2). These six feed lines each had a manual plug valve and a pneumatically controlled butterfly valve, the actuators for which were regulated by two controllers. The controllers, designated as the east and the west, regulated the three burners on one side of the boiler and were situated in the Boiler 6 control room on the third floor. They used a 30-psig (14-millibar) air supply to control the three 6-inch (15-centimeter) feed lines on the east and west sides of the burner as groups. Each burner was also fed from a blast furnace gas line 30 inches (76 centimeters) in diameter and a coal primary air line 12 inches (30 centimeters) in diameter.

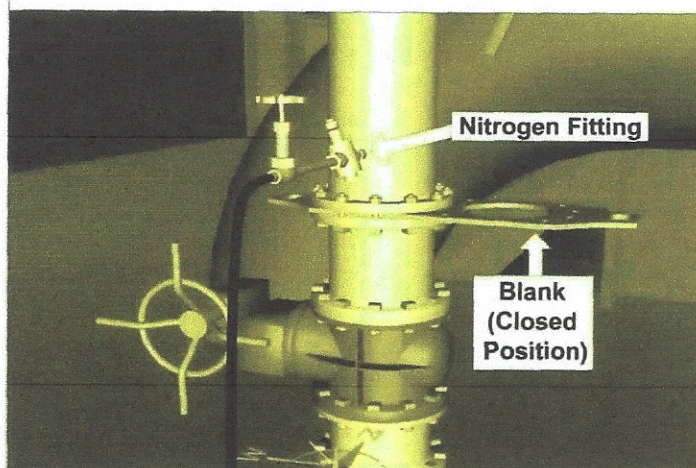
Figure 3: Valving and blanking hardware on natural gas piping

The risers had 10-inch (25-centimeter) manual valves on the second floor, above which “blanks” were located for a positive gas shut-off during maintenance. On the third floor, there was an 8-inch (20-centimeter) manual valve, next to which was a flame-sensing valve that had been manually wired in the open position. Crossovers from the east and west risers were connected to the igniter system below the third floor.

Employees in the final stages of inserting the blank opened the gas valves to the west burners and to the east natural gas burners. However, the manual natural gas valve on one of the main gas lines on the second and third floors had not been closed, and gas flowed into the boiler through the three east natural gas burners mixing with air from an operating forced-draft fan for 90 to 120 seconds before the flammable mixture was ignited, probably by hot fly ash residue or the discharge of the electrostatic precipitator. Moments before the explosion, an employee in the control room noticed the mistake and tried to alert the crew, but it was too late.

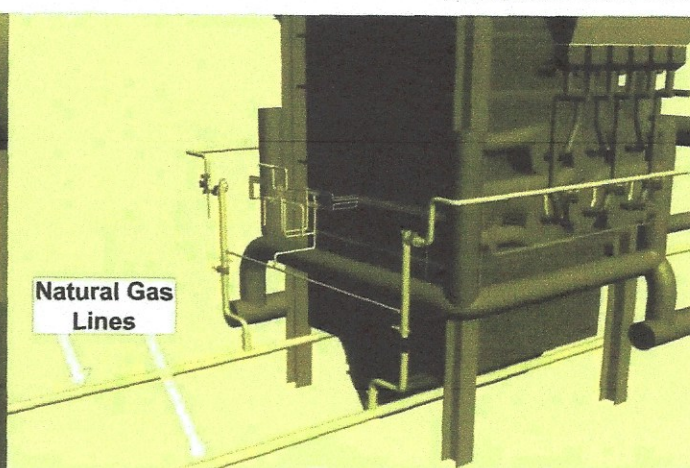
Figure 4: Two natural gas feed lines supplying Boiler 6

Around 1987, the fuel and fuel control systems of Boiler 6 were modified so that 6 of its 12 burners could be fired with natural gas, which the gas company supplied at about 25 psig from a meter house southeast of the facility through two ground-floor risers, one at the southwest corner of the boiler and one at the southeast corner (see Figure 4). The two risers had mirrored valve arrangements.

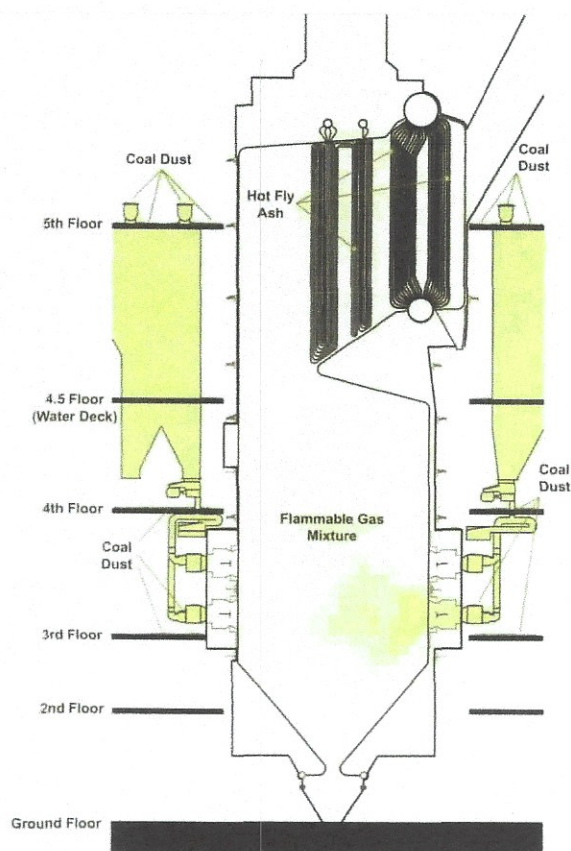
Figure 5: Cross-section of Boiler 6

To control the heating effect of the combustion gases and use them as efficiently as possible, the water walls on the rear side of Boiler 6 curved inward to form a “bull nose” that divided the unit into an upper and a lower chamber into which heated air for combustion was forced. After hot flue gases wove their way up through the boiler and its regenerative components, they passed through the electrostatic precipitator, which imparted an electrostatic charge to the dust particles in the flue gases allowing the dust and fly ash to precipitate out to provide clean emissions to the chimney (see Figure 5).

The examination of Boiler 6 showed evidence of an internal explosion, all four corners of the boiler having been ruptured at various levels. There was overpressure damage from the first floor through the flue gas ducts to the precipitator on the roof, and the damage patterns showed that the fire had vented at different areas of the boiler, projecting flames into the generator building's engine room, the electrical building, the turbo blower building, the conveyor area, and the pulverizer building.
