FORENSIC ENGINEERING **INVESTIGATIONS**

Crispin Hales, PhD, FIMechE, CEng.

HALES & GOOCH LTD.

Case Example: Process Boiler Explosion

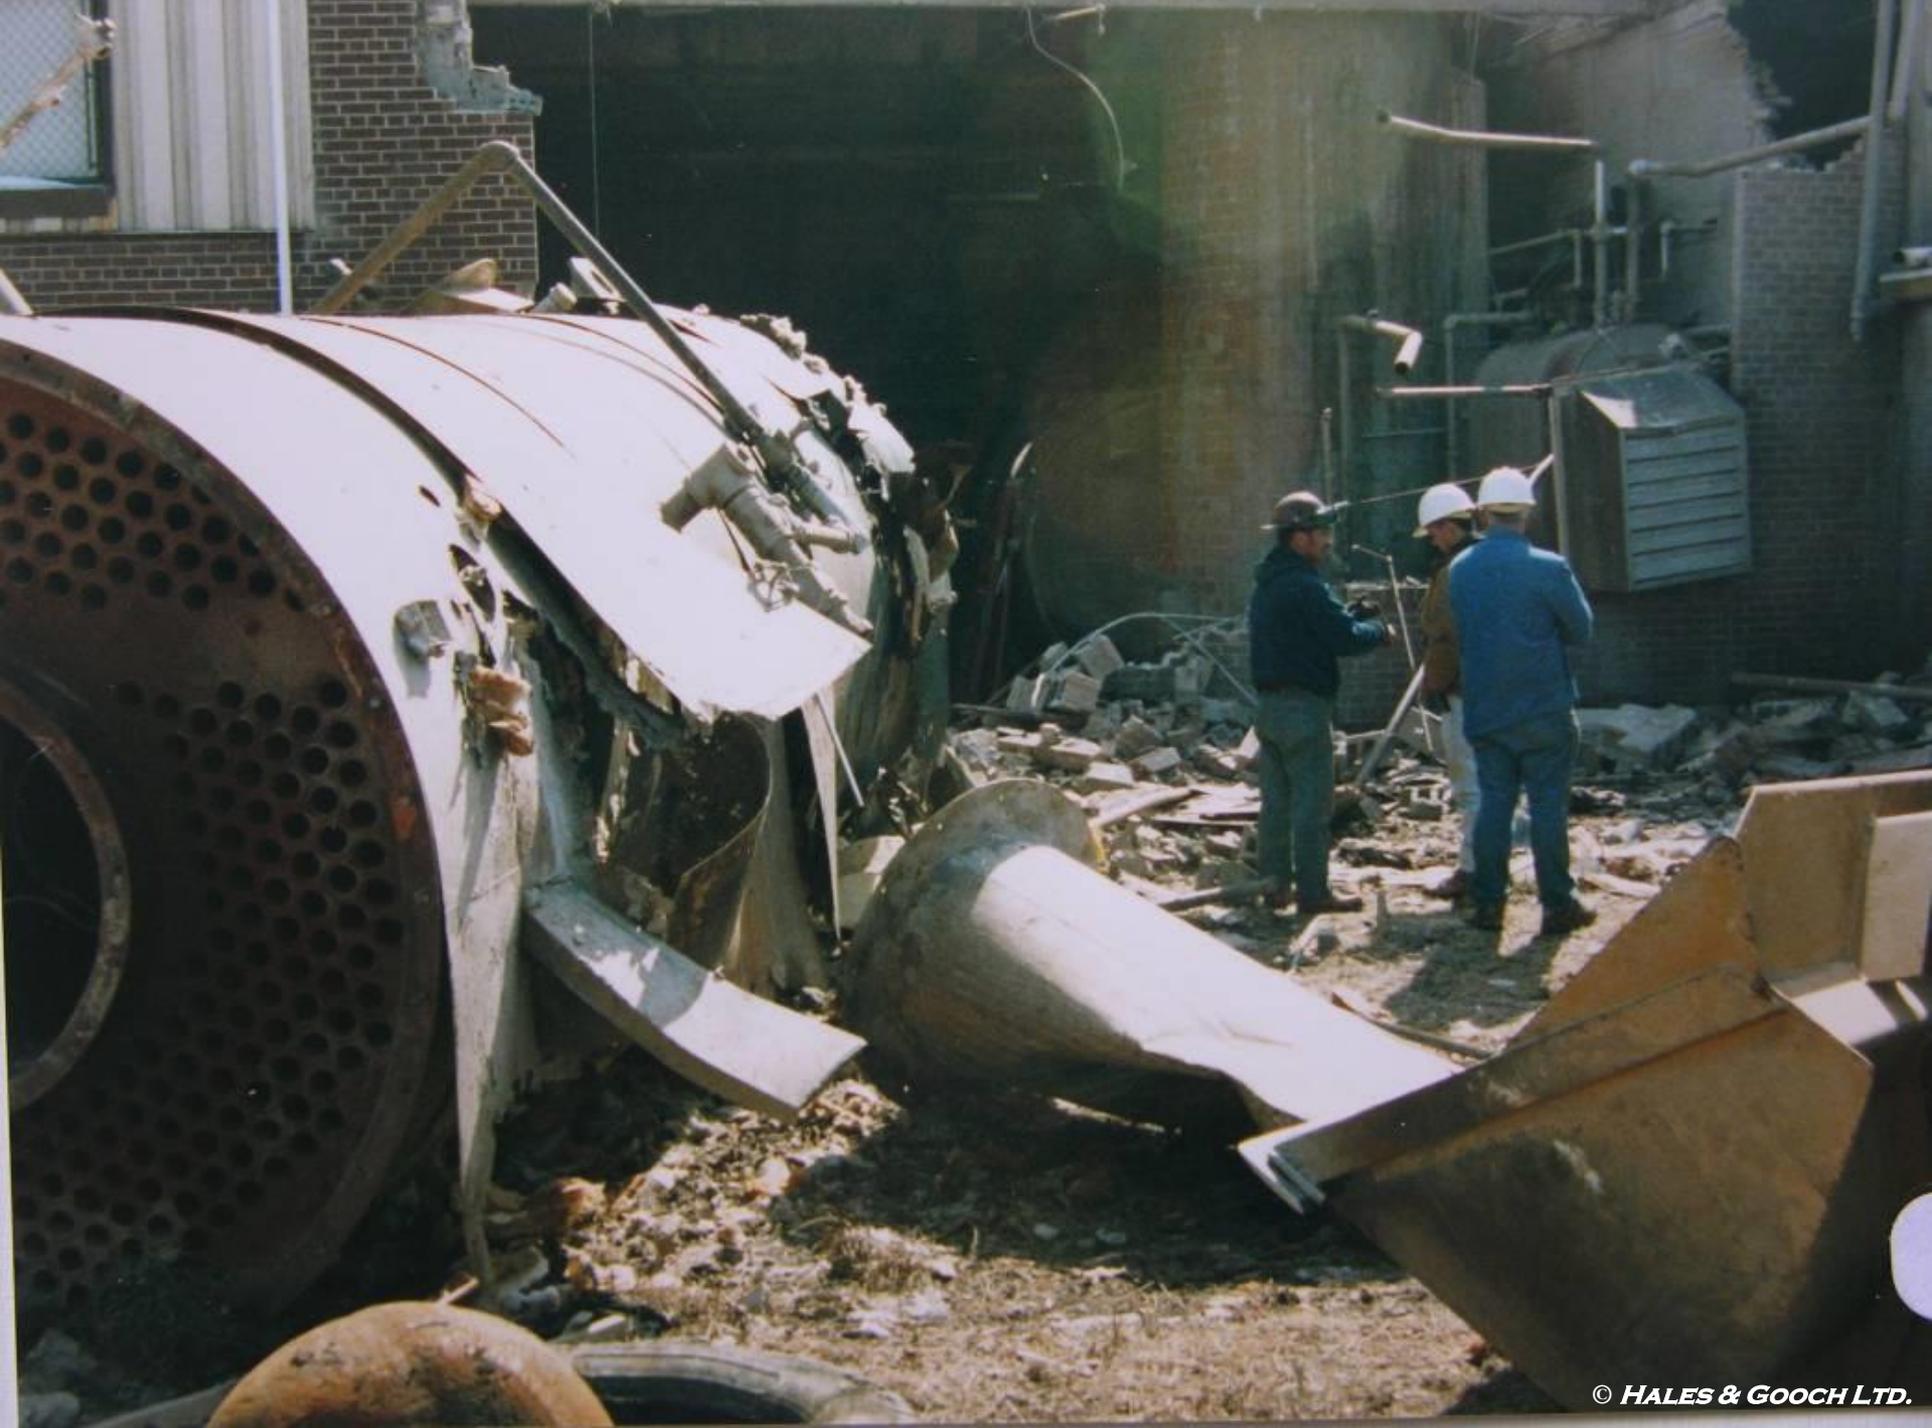
Boiler went end-over-end through wall of building

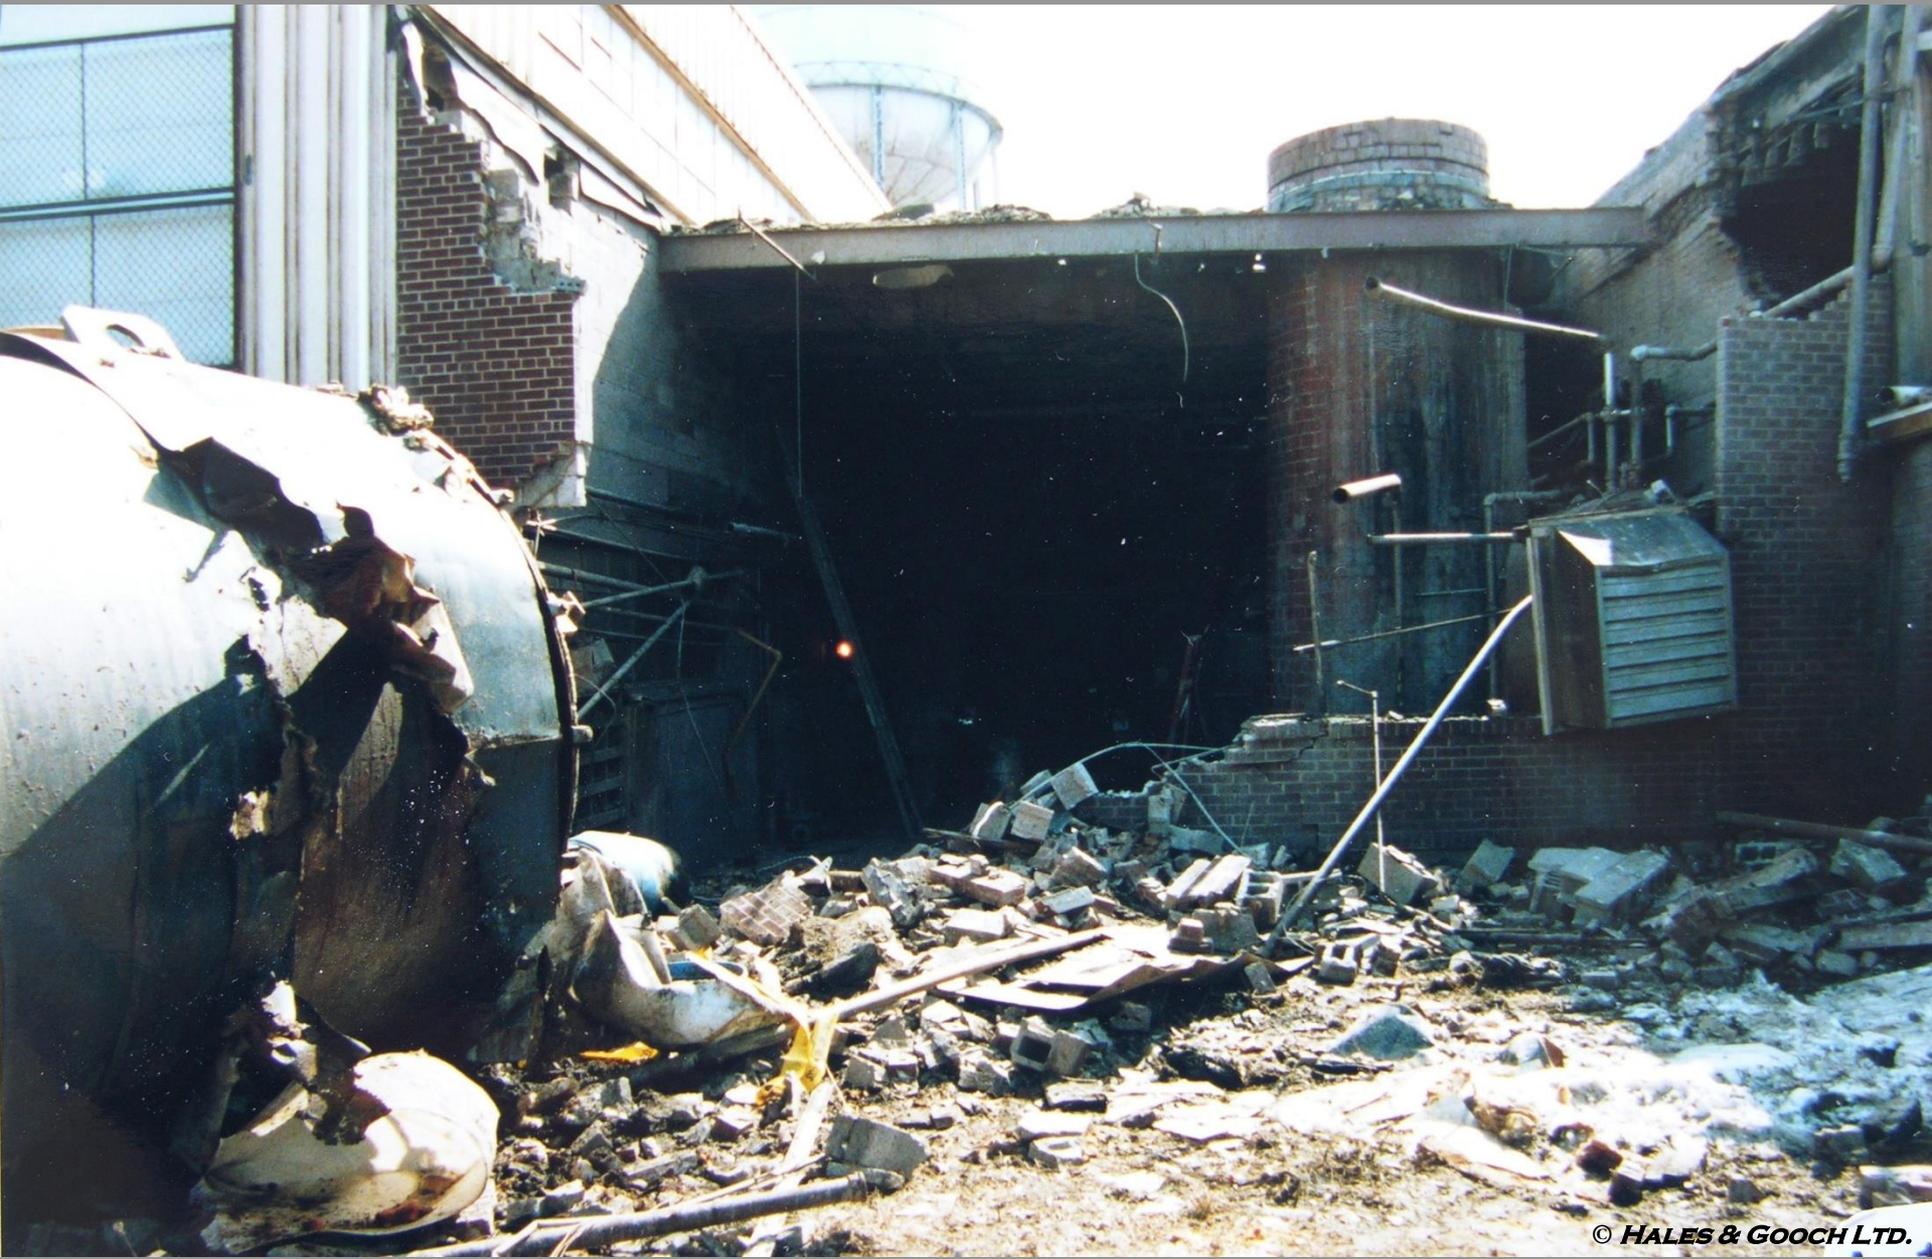
Took everything with it – skid, pumps, pipes and all

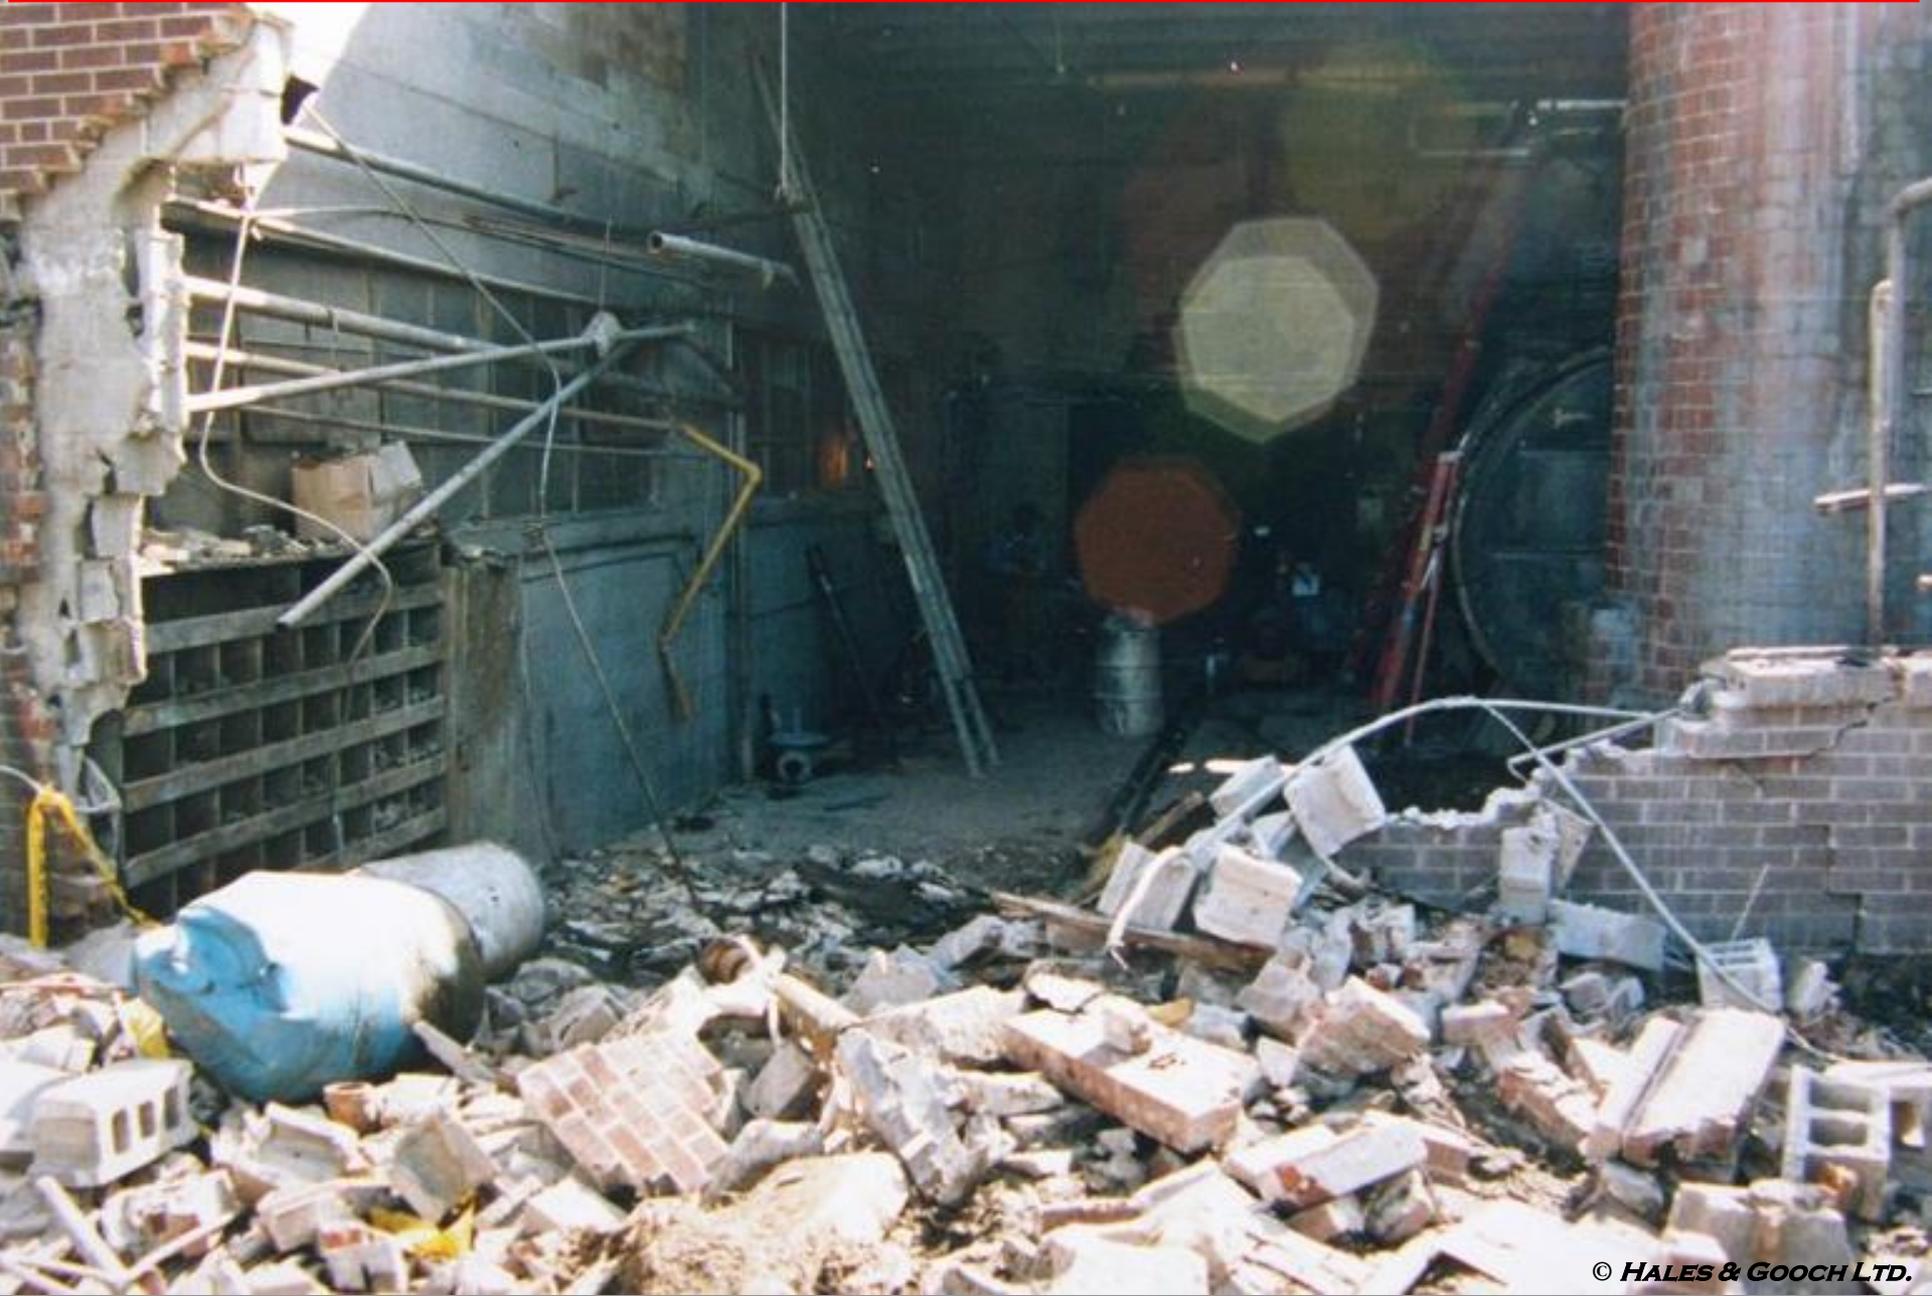
Burner went other way – straight through machines

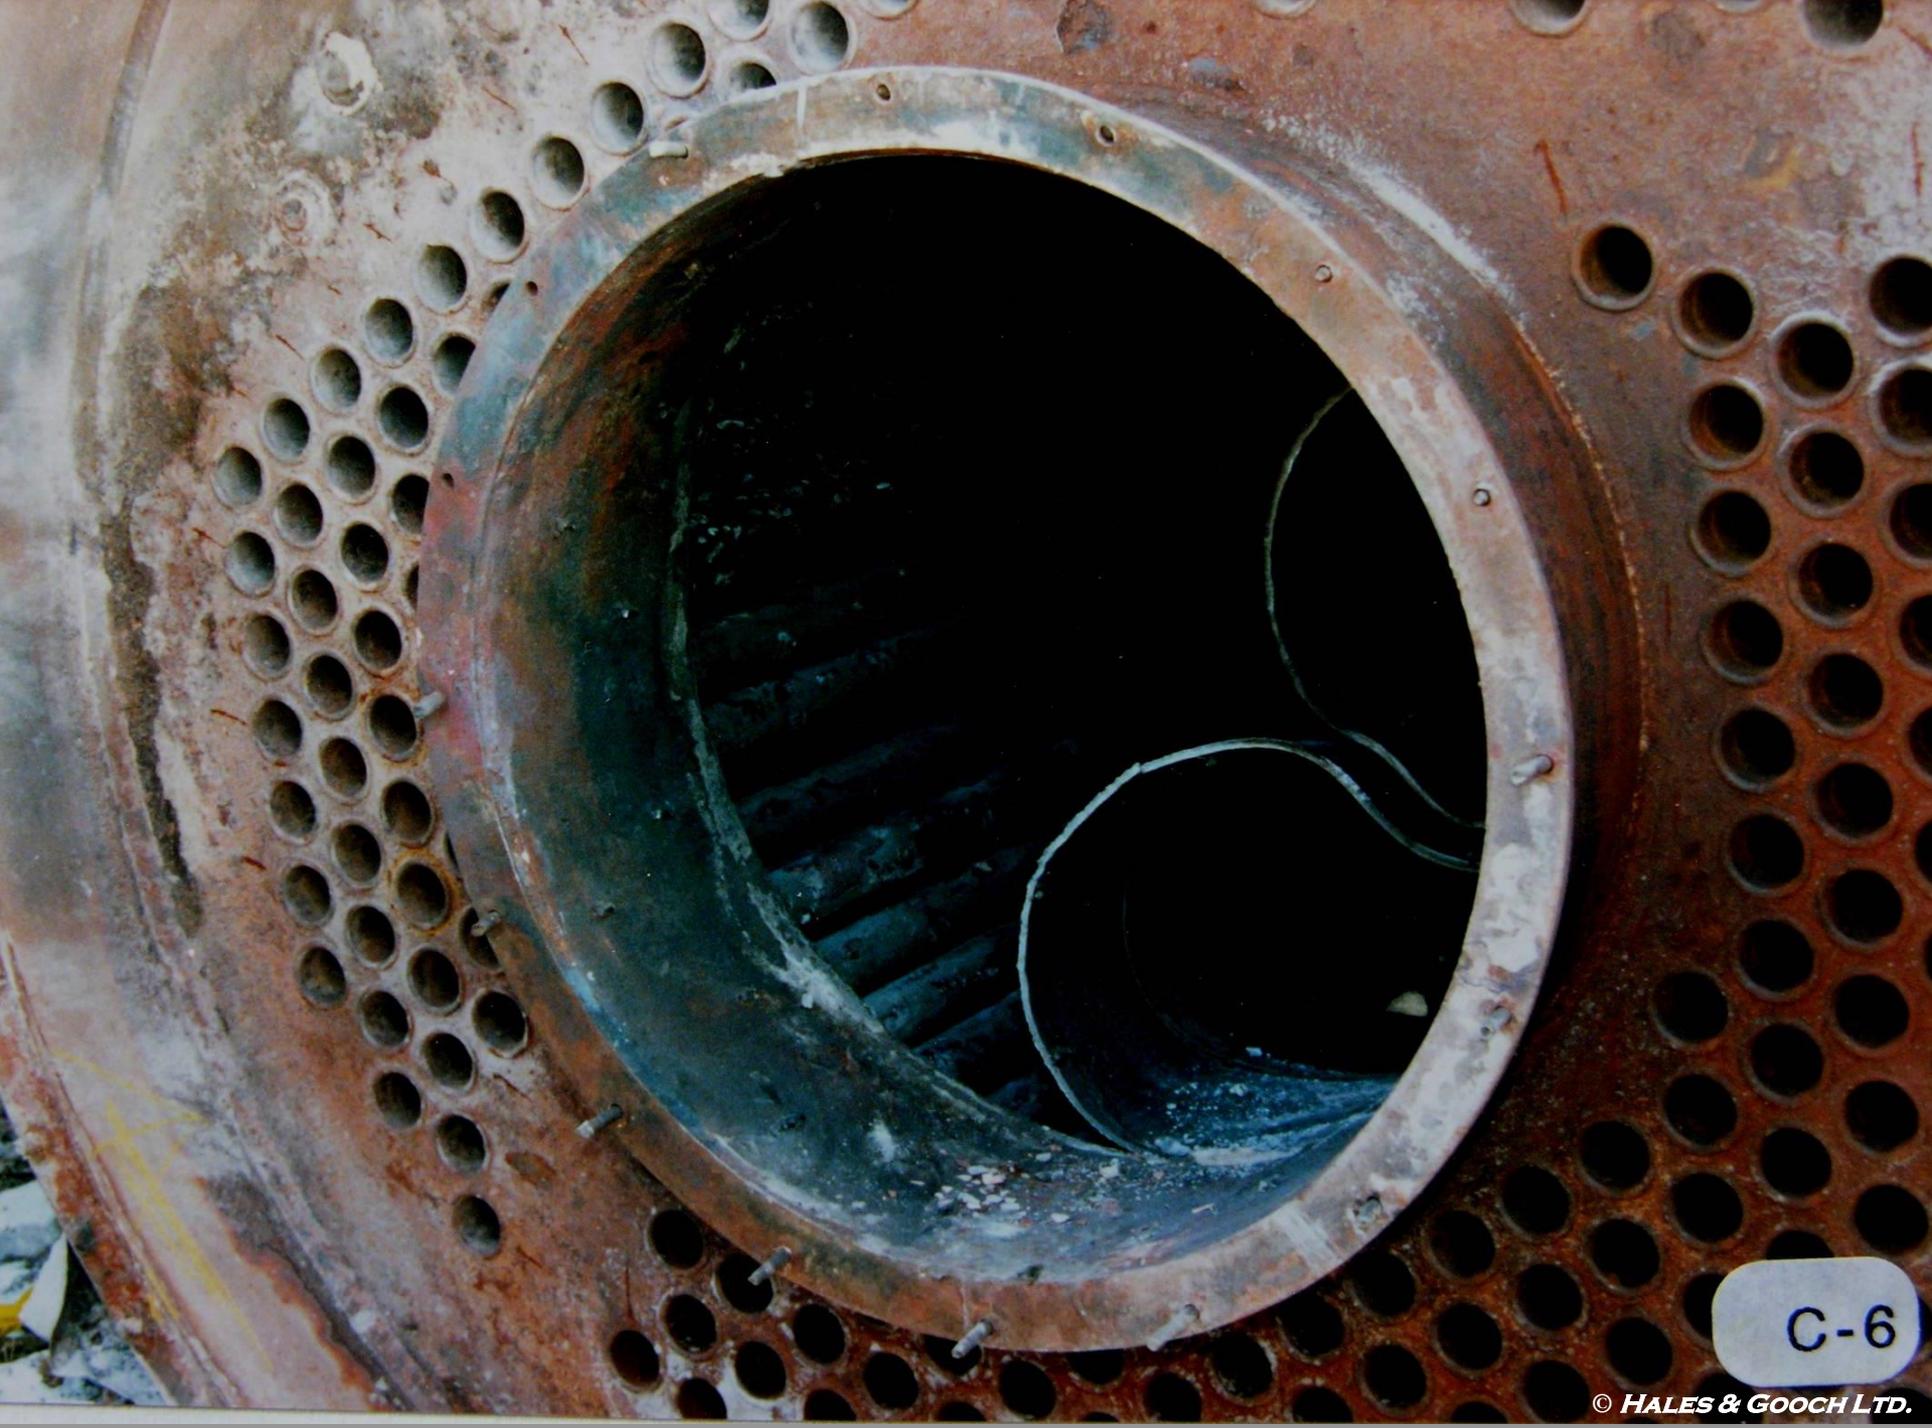
C-6

Morrison tube collapse – Low water?

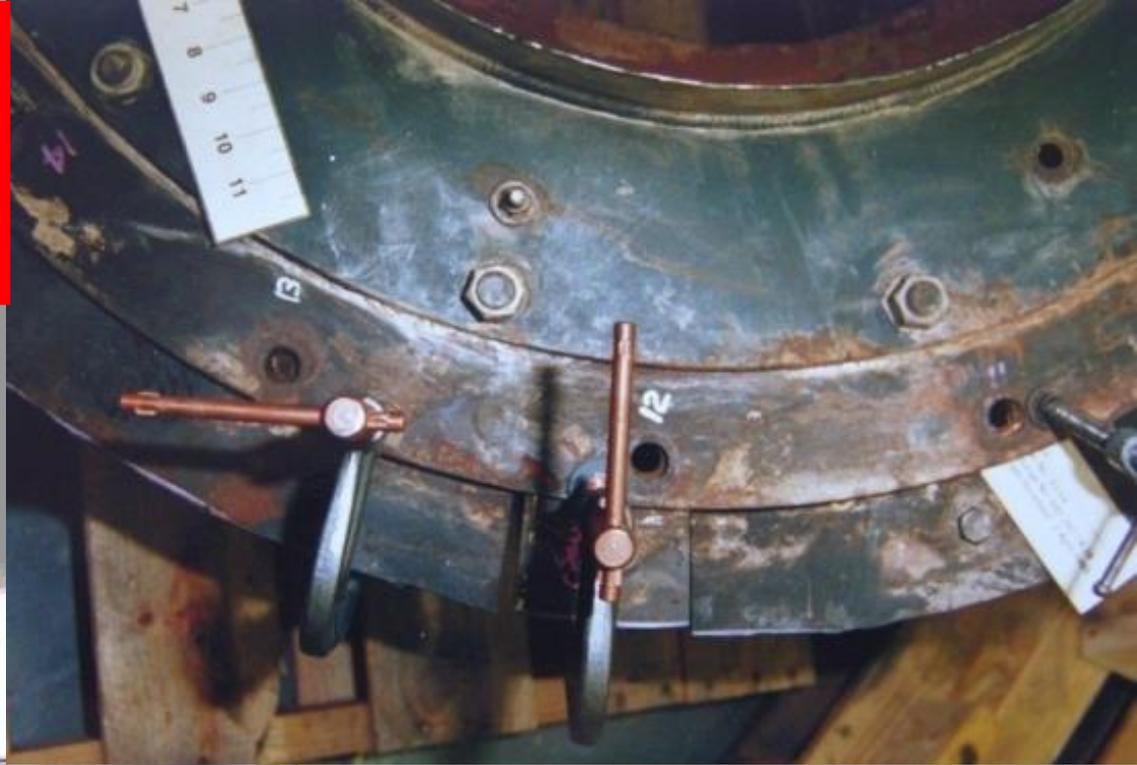
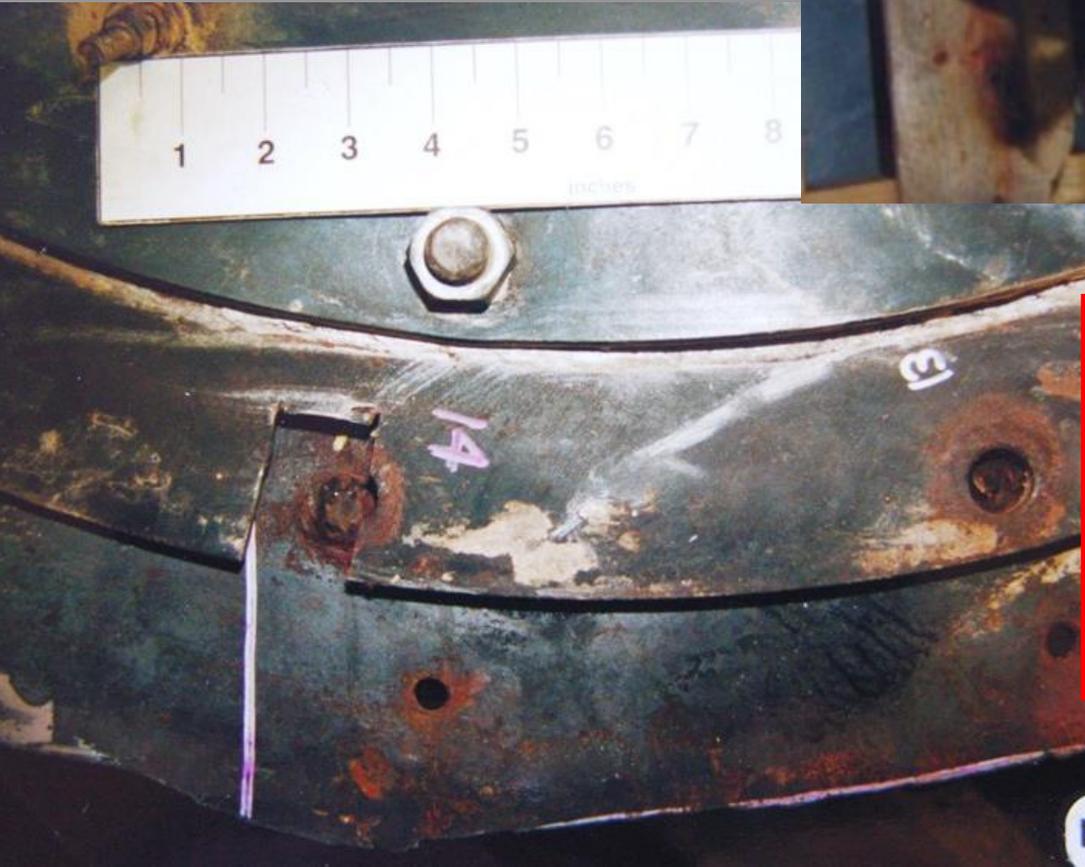
Reconstruction of adapter plate bolting at a lab in Texas

Each bolt told its own story – during the five years each one failed, but in a different way!

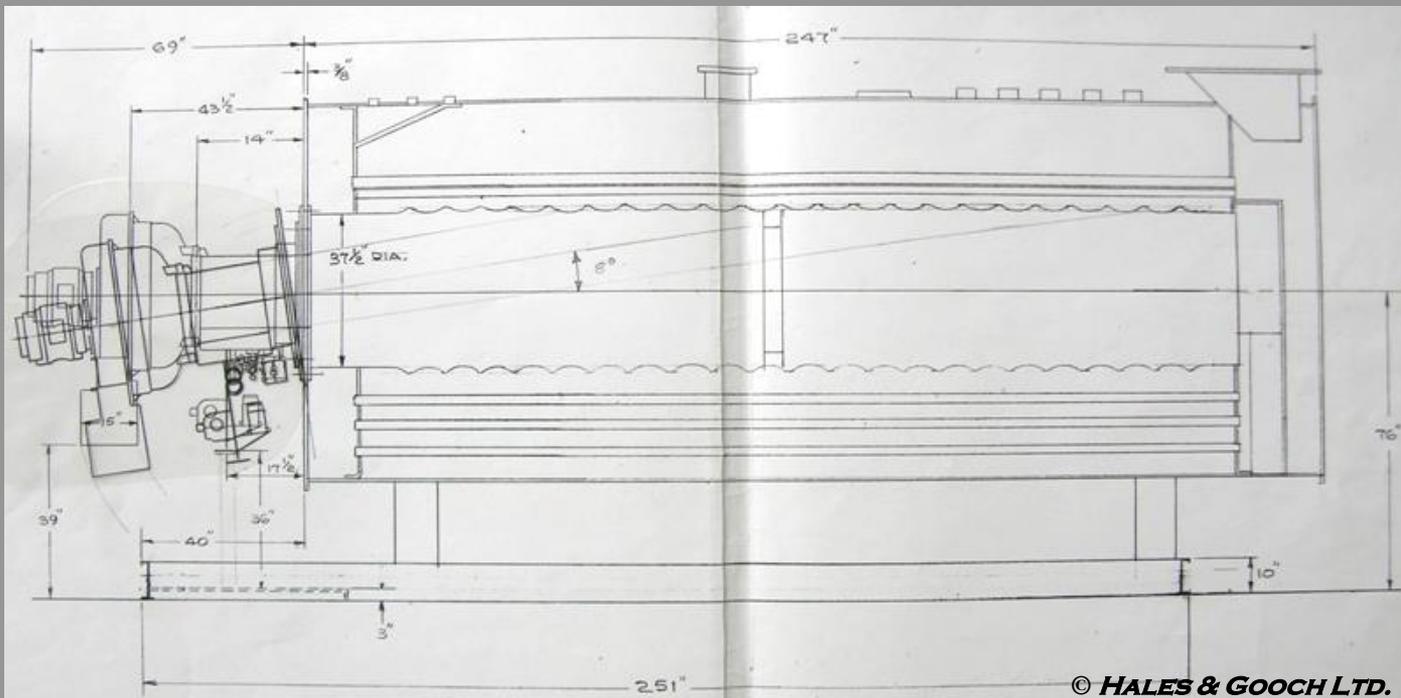
BURNER
5 YEARS
LATER

- 5.1 The primary cause of the explosion was flame impingement on the inner surface of the furnace (Morrison) tube, leading to a catastrophic collapse of the tube with rapid depressurization and ejection of steam and water.
- 5.2 The flame impingement resulted from angular displacement of the retrofitted burner assembly, during otherwise normal operation of the boiler.
- 5.3 The angular displacement of the burner was the trigger event in a progressive sequence of failures caused by faulty design and manufacture of the support system used to connect the replacement burner to the boiler.

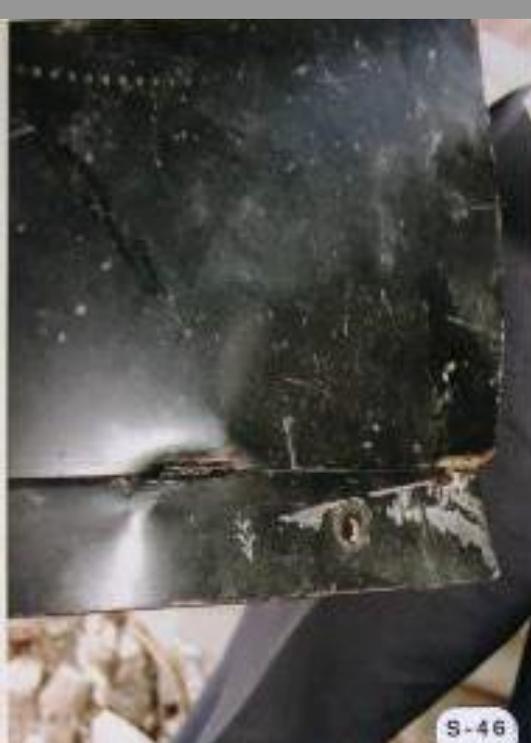
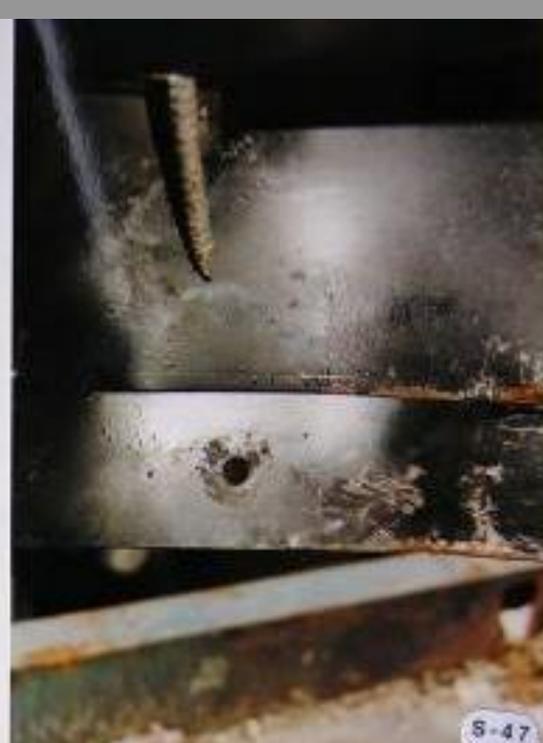
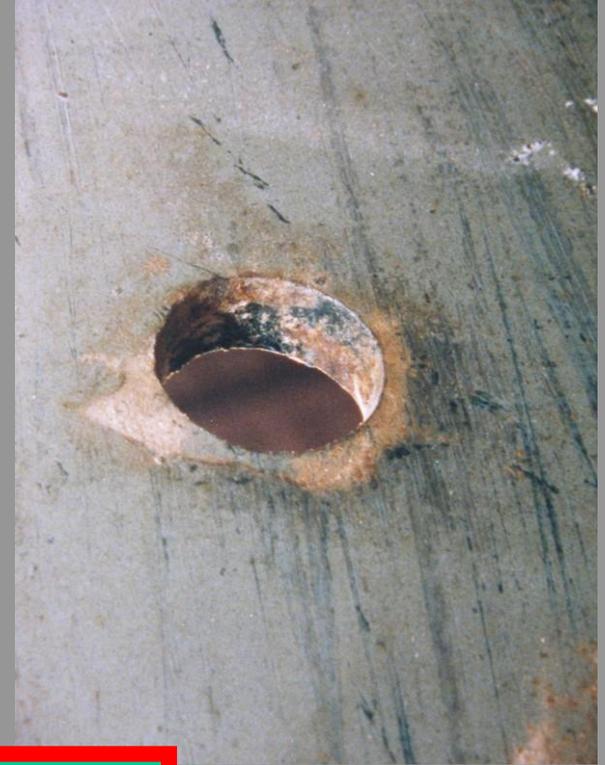
- Flange already cut out
- Positioning difficult
- Luckily skid all there
- Boiler refitted on skid
- Leg was bent but intact
- Measured accurately
- **No support had ever been fitted under leg!**

NO BOLTING – NO SUPPORT!
(i.e. Burner was hanging from flange bolts)

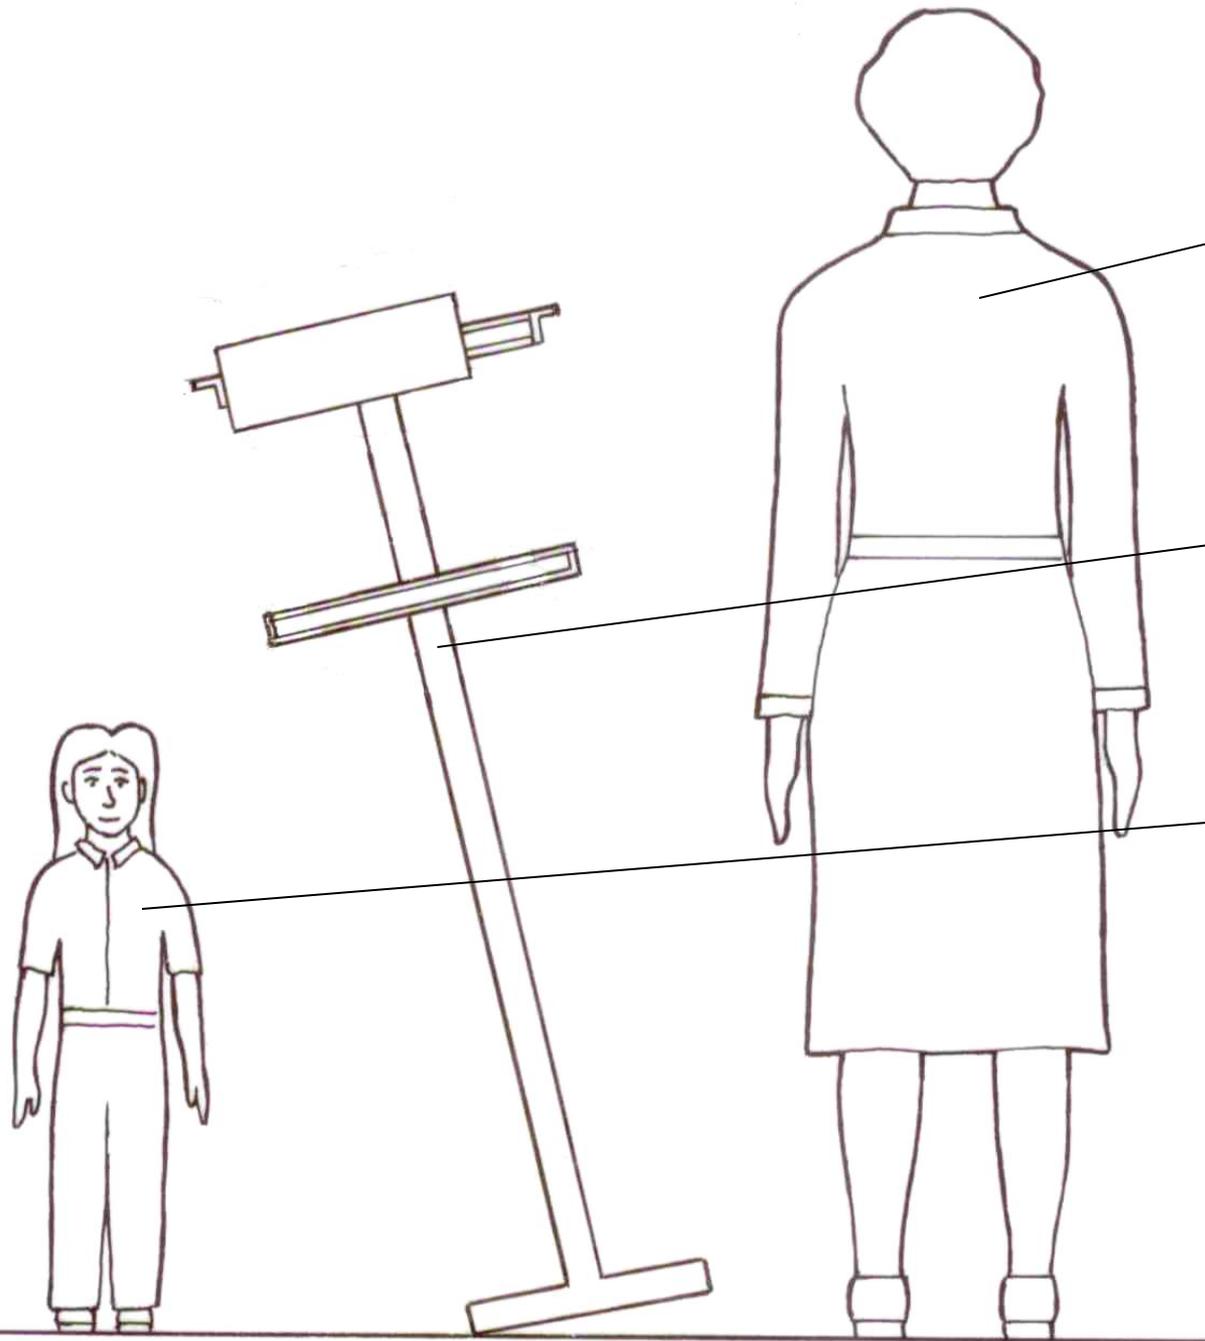
RELATIVE SIZES

**2.2° off vertical creates
unique characteristic!**

- Welder said he made stands vertical
- Store manager said they looked OK to him
- Weber's Law: "Just noticeable difference"
- Grandma just pulled until a bag came off
- Child did nothing, but is now brain-injured
- **So, who should pay the \$2 million claim?**
- Lawsuit took 5 years – store + fabricator paid
- **Key issue - lack of stability in design**

Now they have a heavy circular stable base!

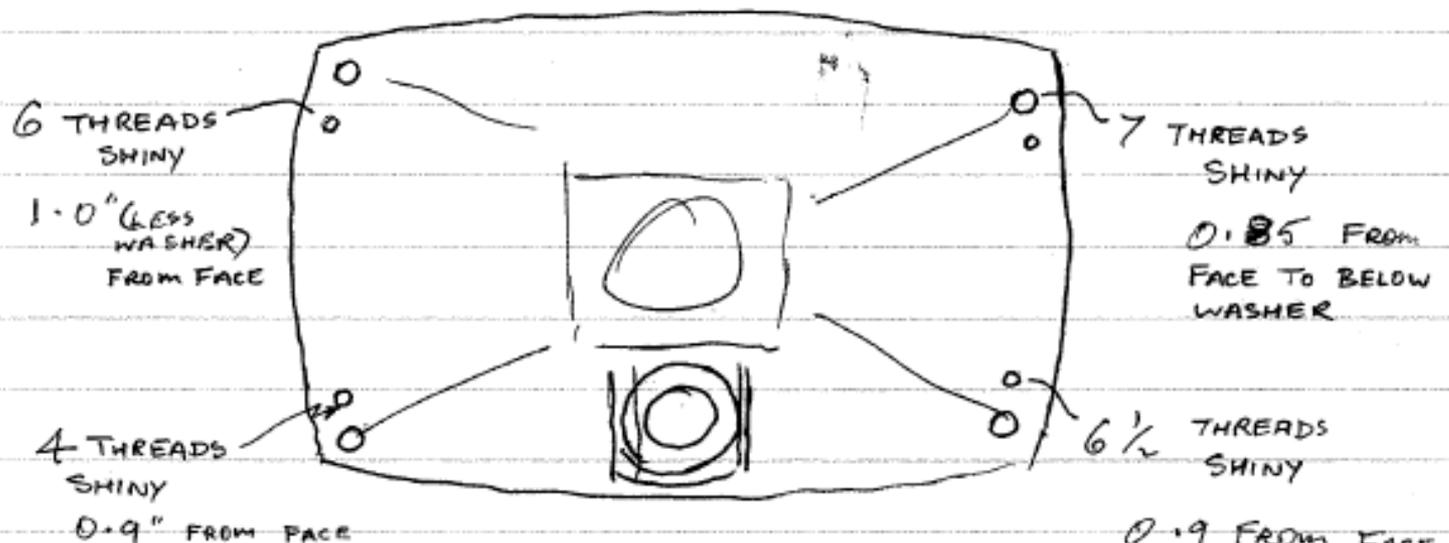
- 16 THREADS/INCH
- ϕ 5/16" BOLTS X 1 3/4" LG.
- WASHERS: 0.075" THICK
- LOOSE FIT THREADS
- IMPACT MARKS AROUND PERIMETER OF SHROUD.
- METALLIC RATTLING IF BOLTS LOOSE

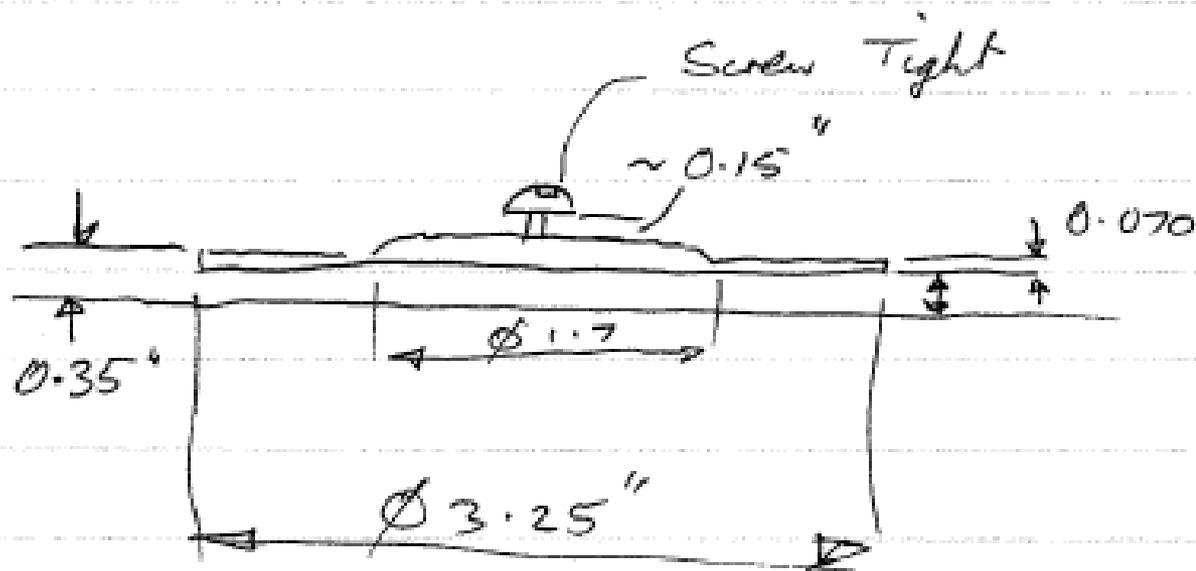
CLOSED END - NO. 3 - SEAL ON SHROUD.

- Cork washer $0.055''$
- Spring force about same as drive end.
- On non-drive end screw loose.
- Washer stuck on but peels off.

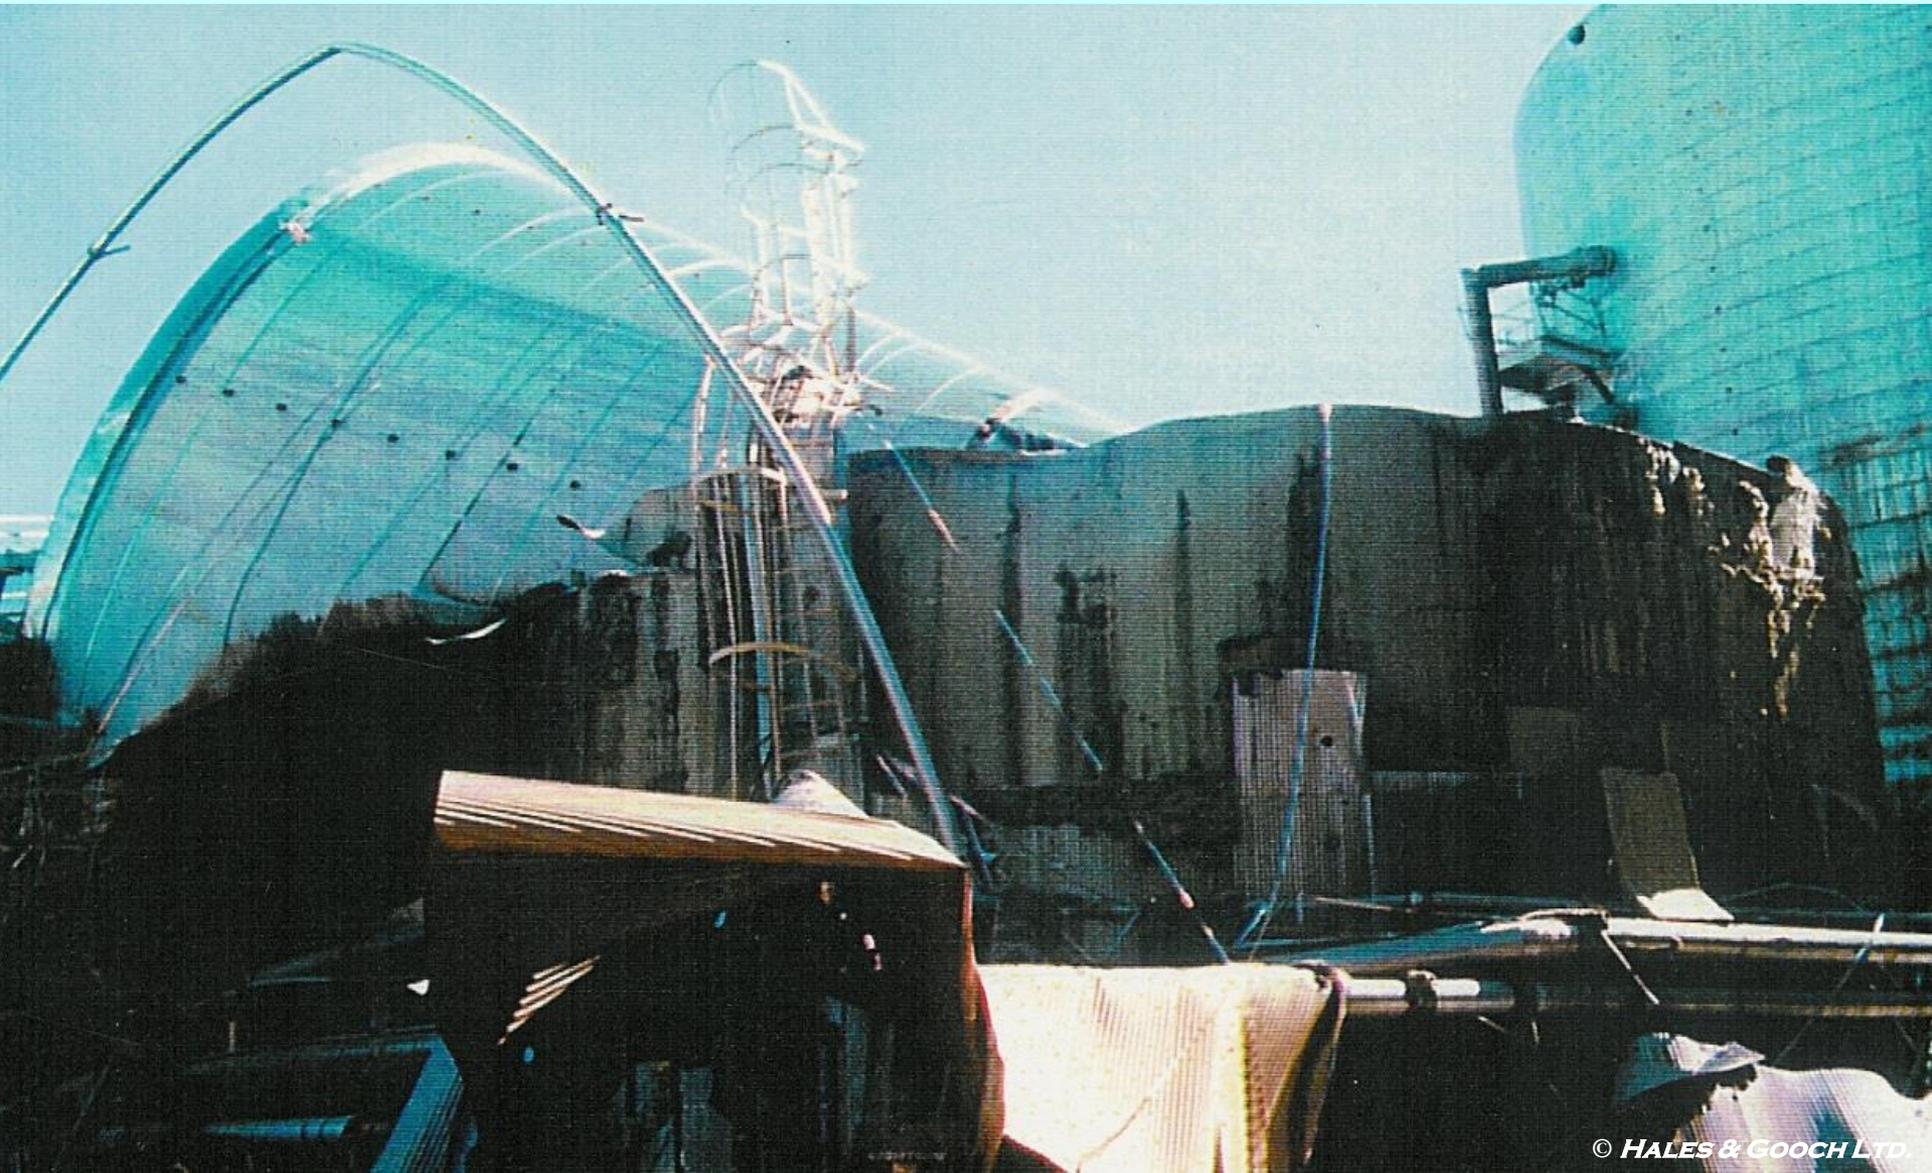
Top half fell into bottom half

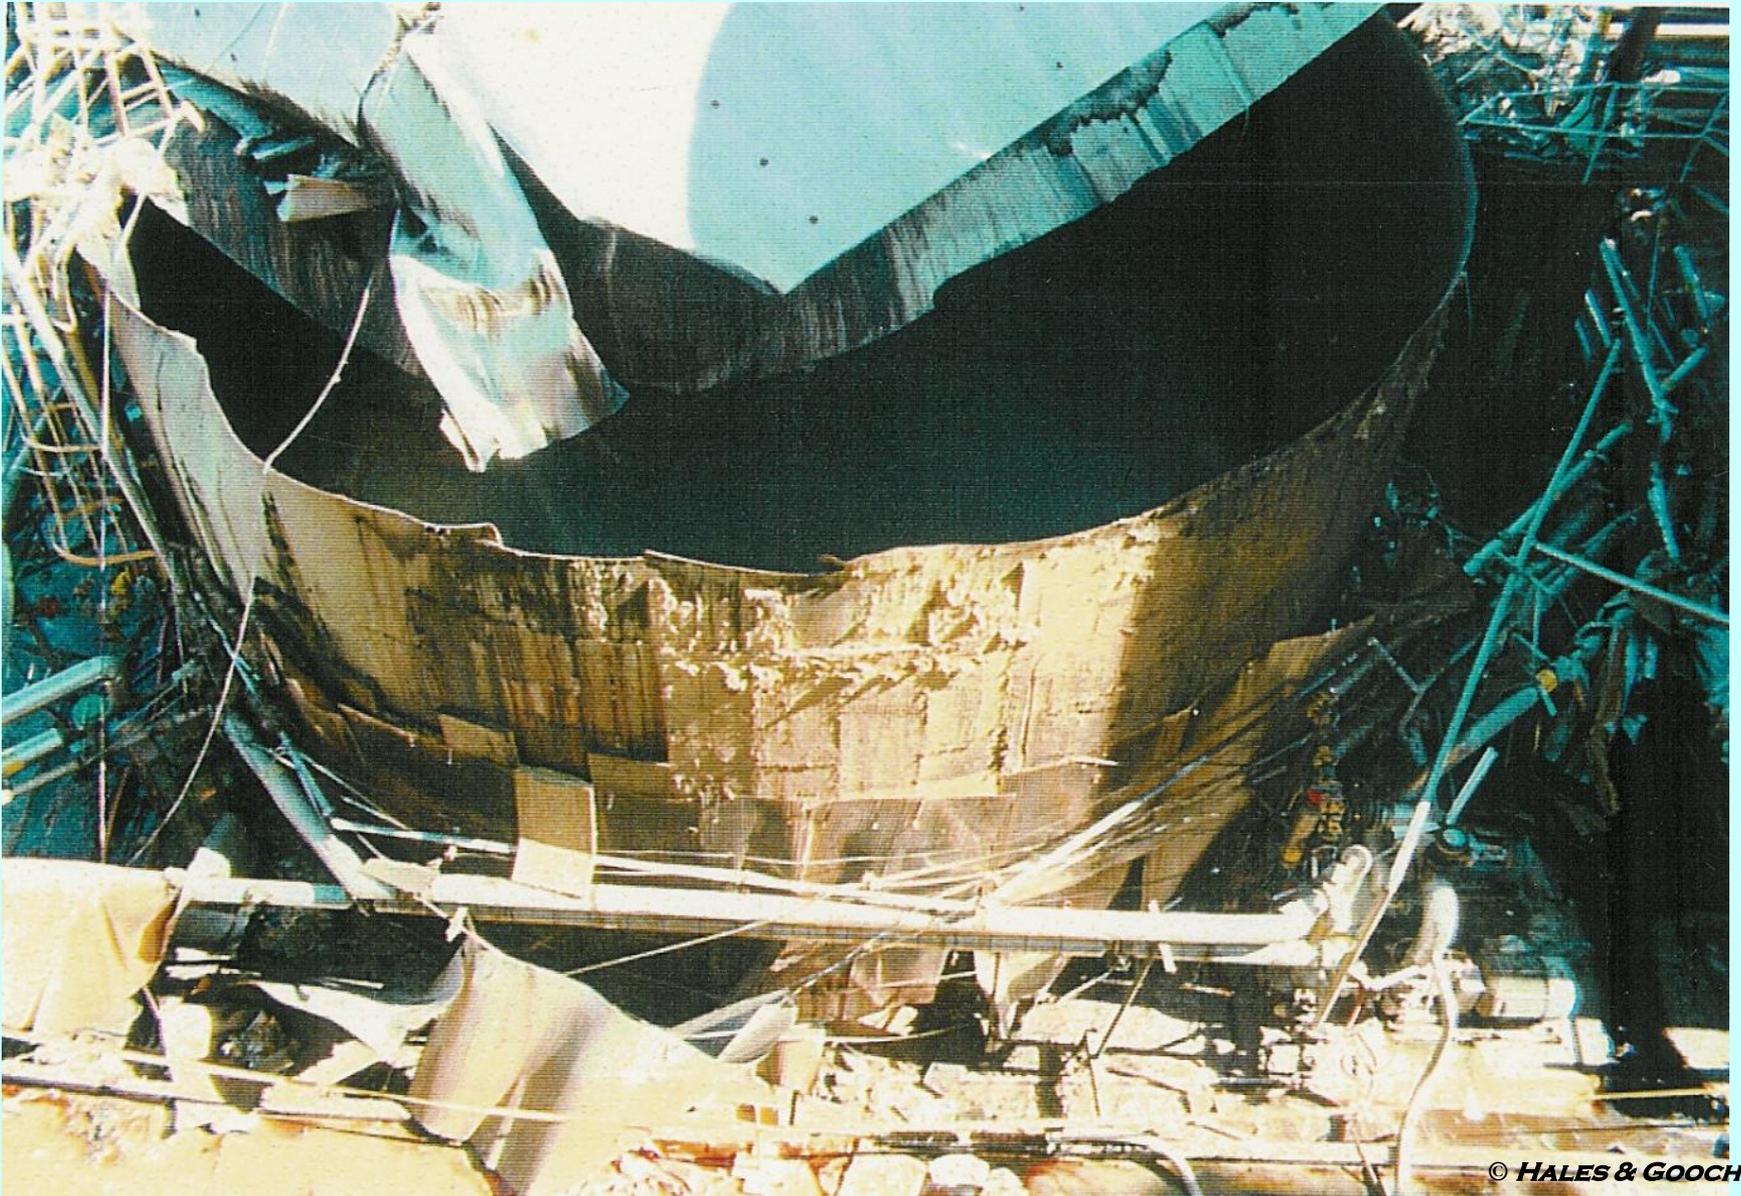
Torn off all the way around
