FORENSIC ENGINEERING **INVESTIGATIONS**

Crispin Hales, PhD, FIMechE, CEng.

HALES & GOOCH LTD.

Case Example: Process Boiler Explosion

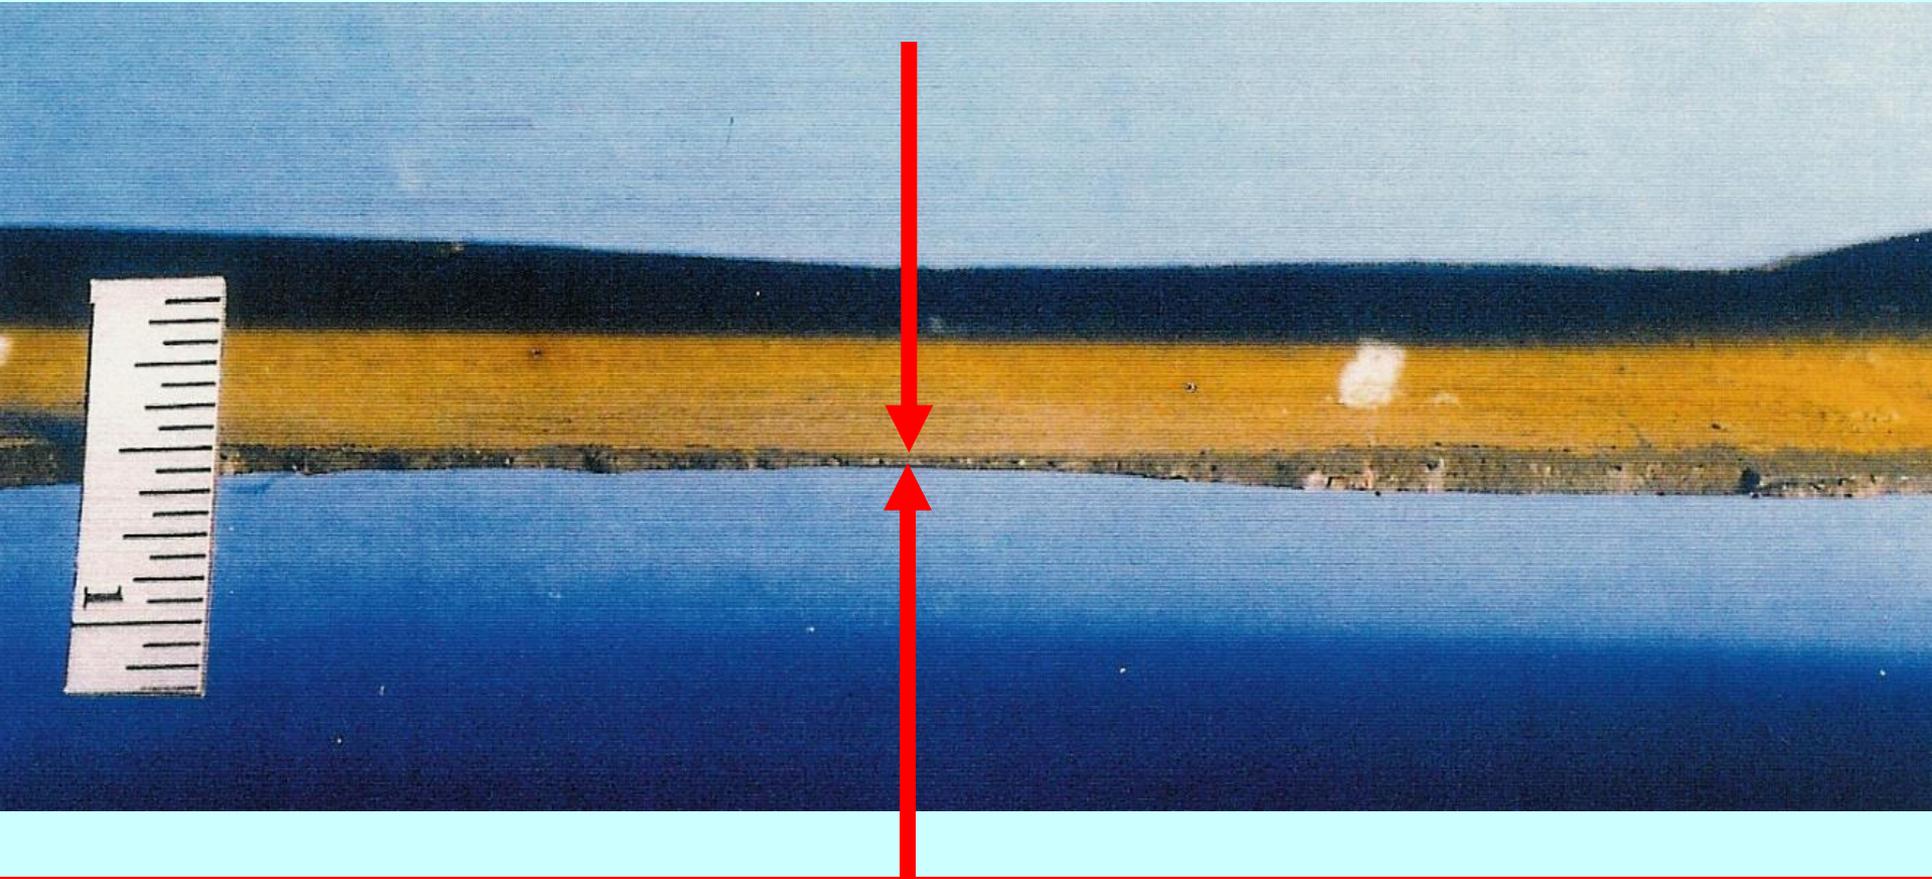
Wall thickness corroded from 0.500" to 0.020" here!!

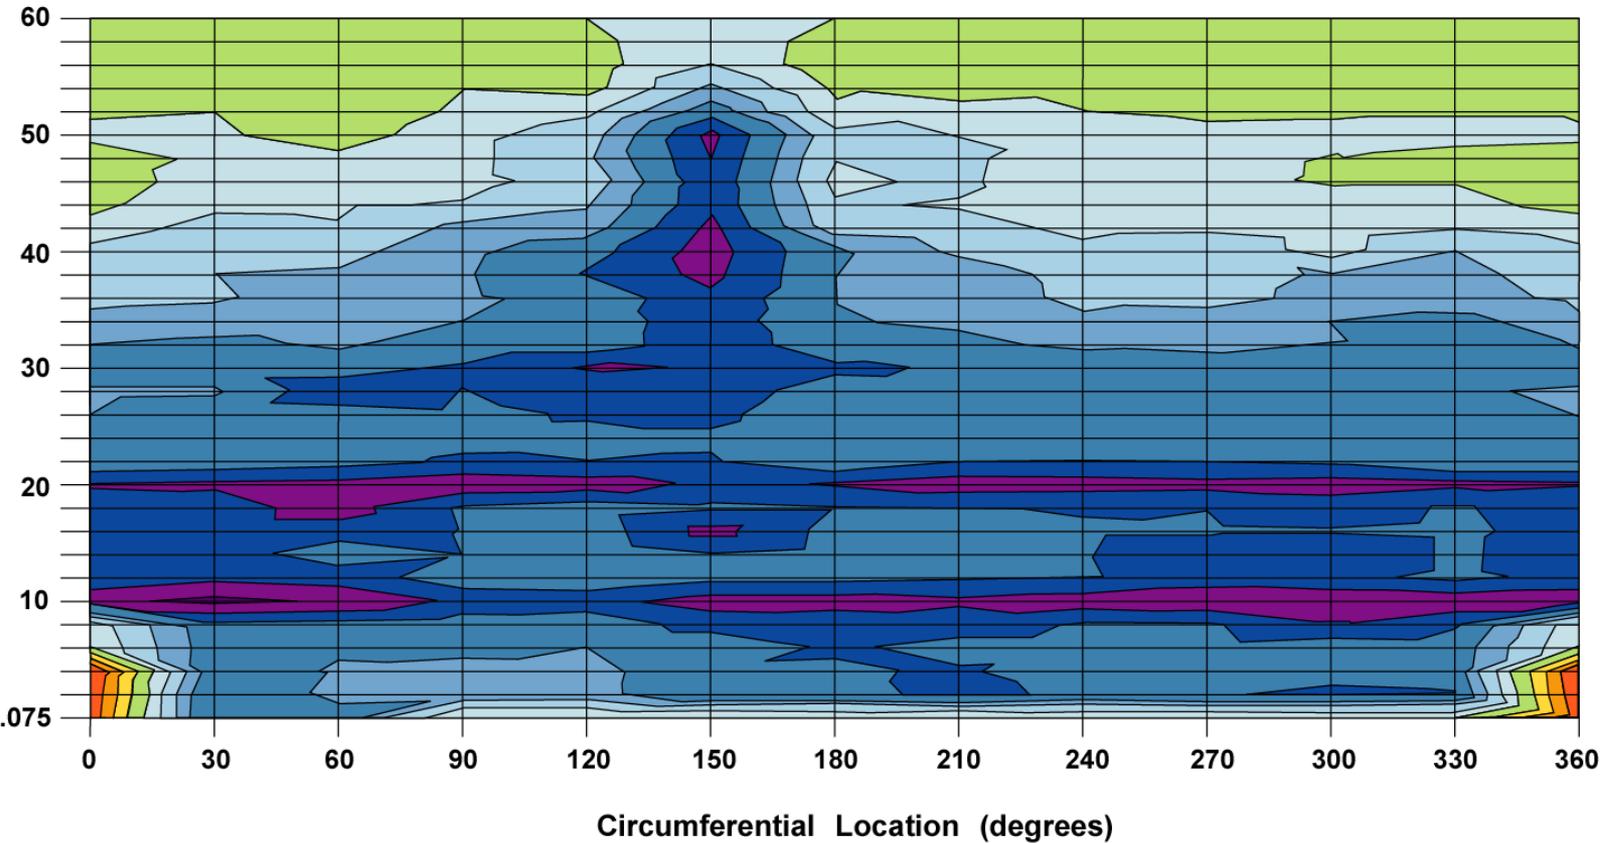
NORTH BLACK LIQUOR TANK

- Plant did not analyze data in detail
- “Averaging” calculations not to API Standard
- Data showed consistent pattern
- Pattern showed accelerating corrosion

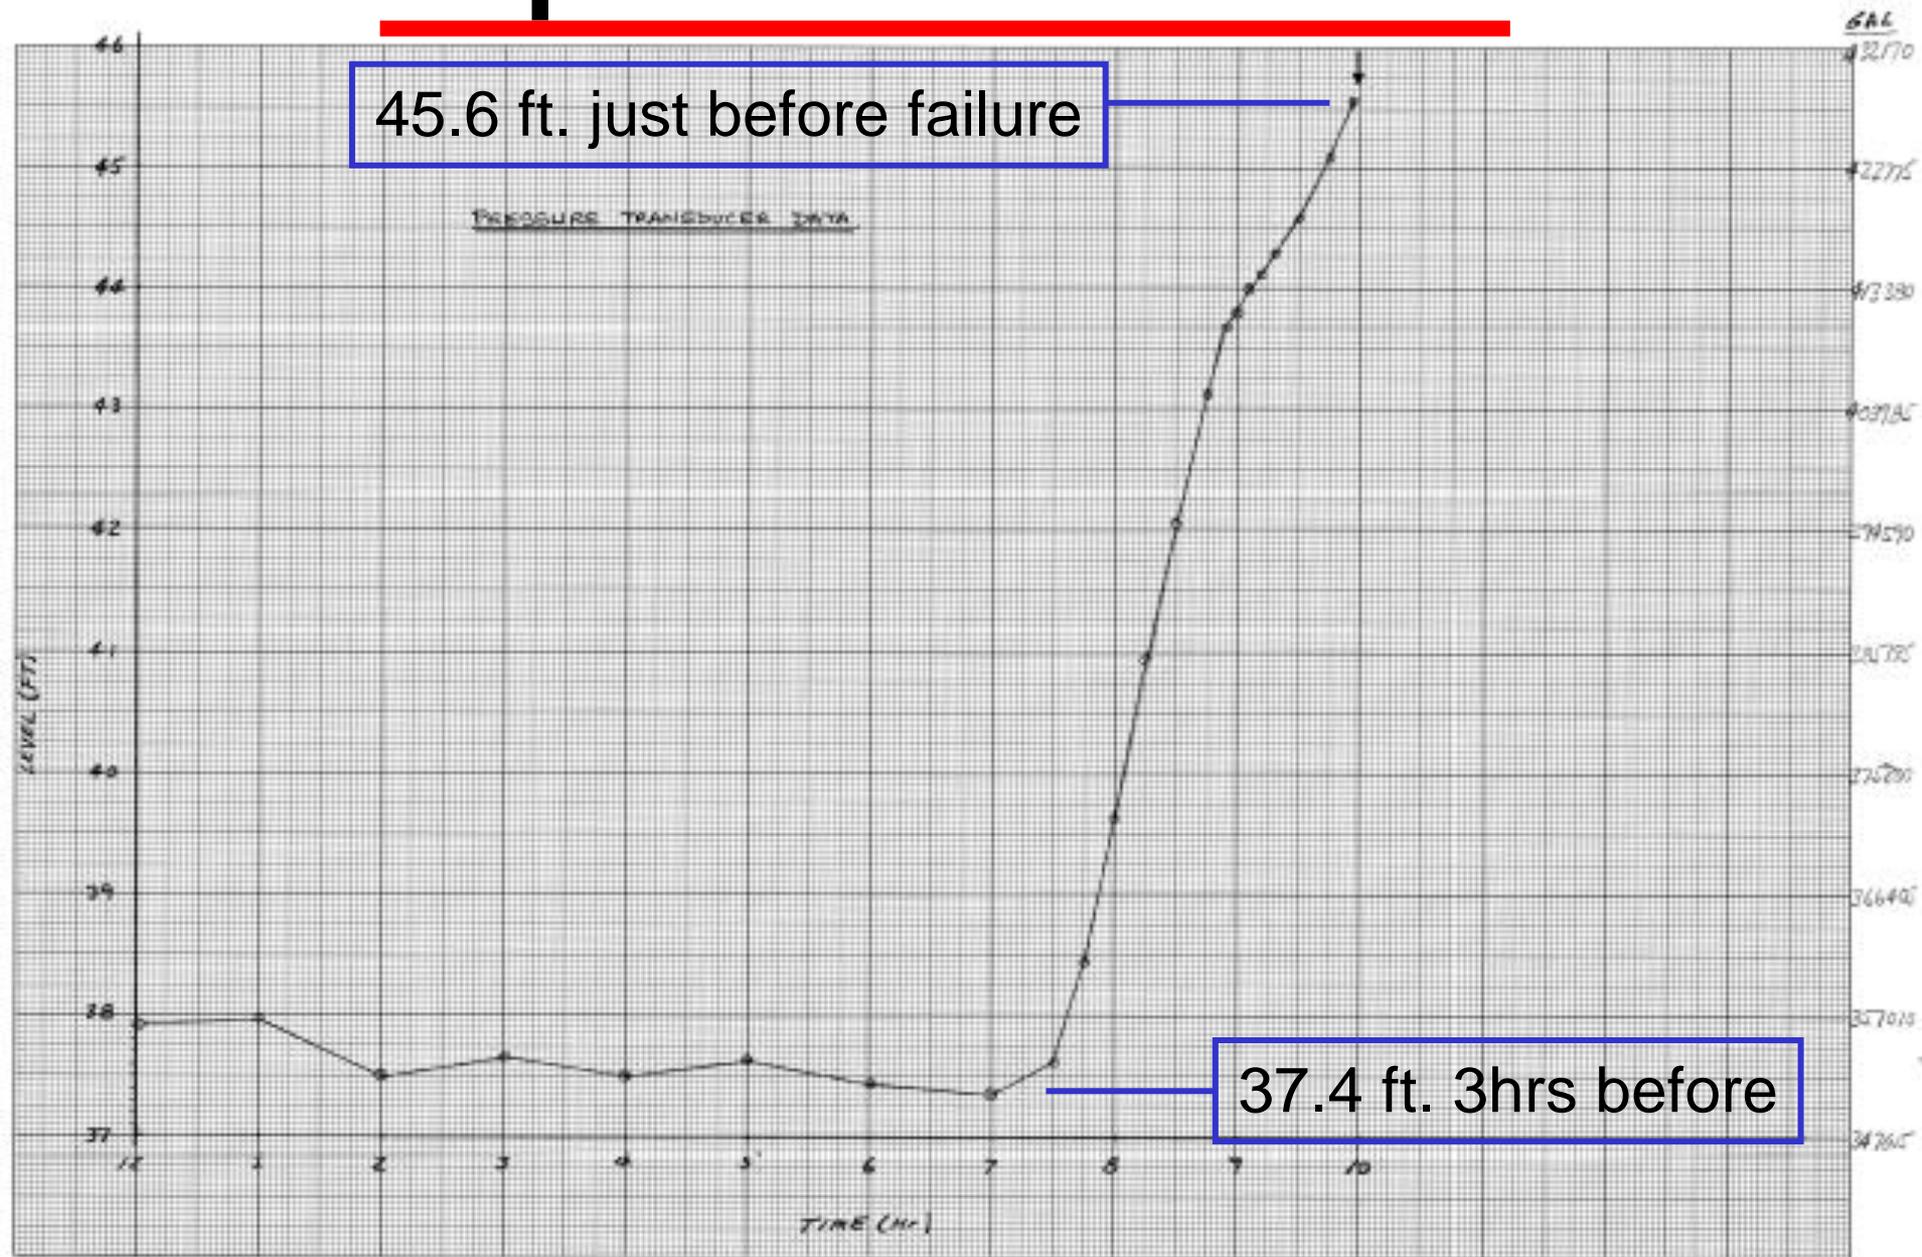
PRESSURE TRANSDUCER DATA

45.6 ft. just before failure

37.4 ft. 3hrs before

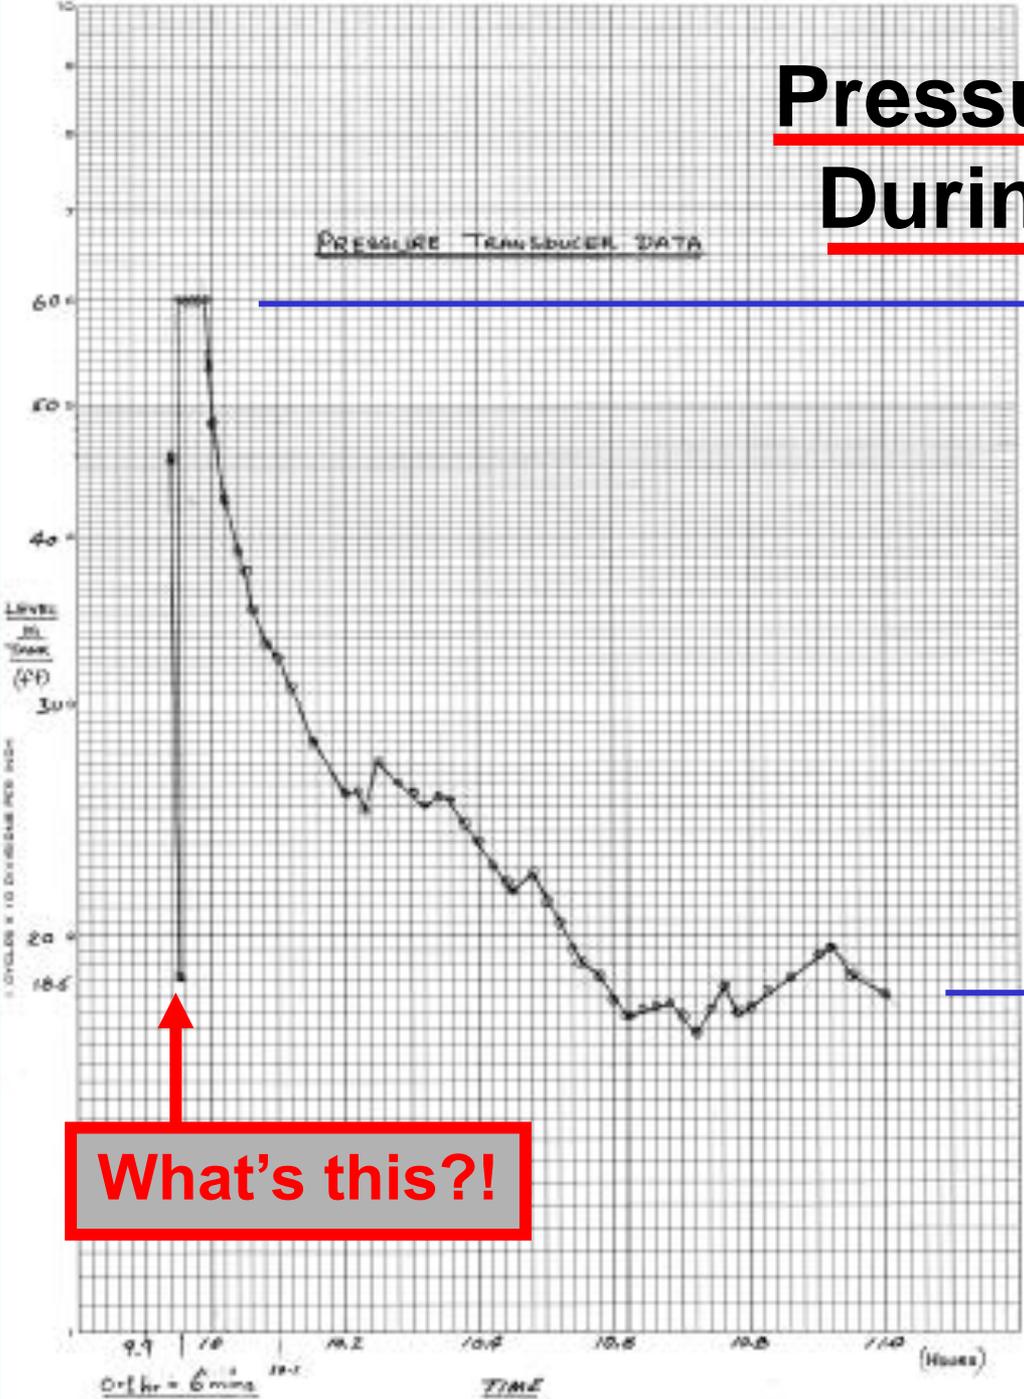
Pressure Transducer Data During and After Failure

“Pegged” at 60 ft.

18.5 ft. after failure

Pressure transducer operating correctly - confirmed by data on liquid level in tank after failure.
