# Arrowhead Point Entrance Monuments

## 2022 Repairs and design modifications

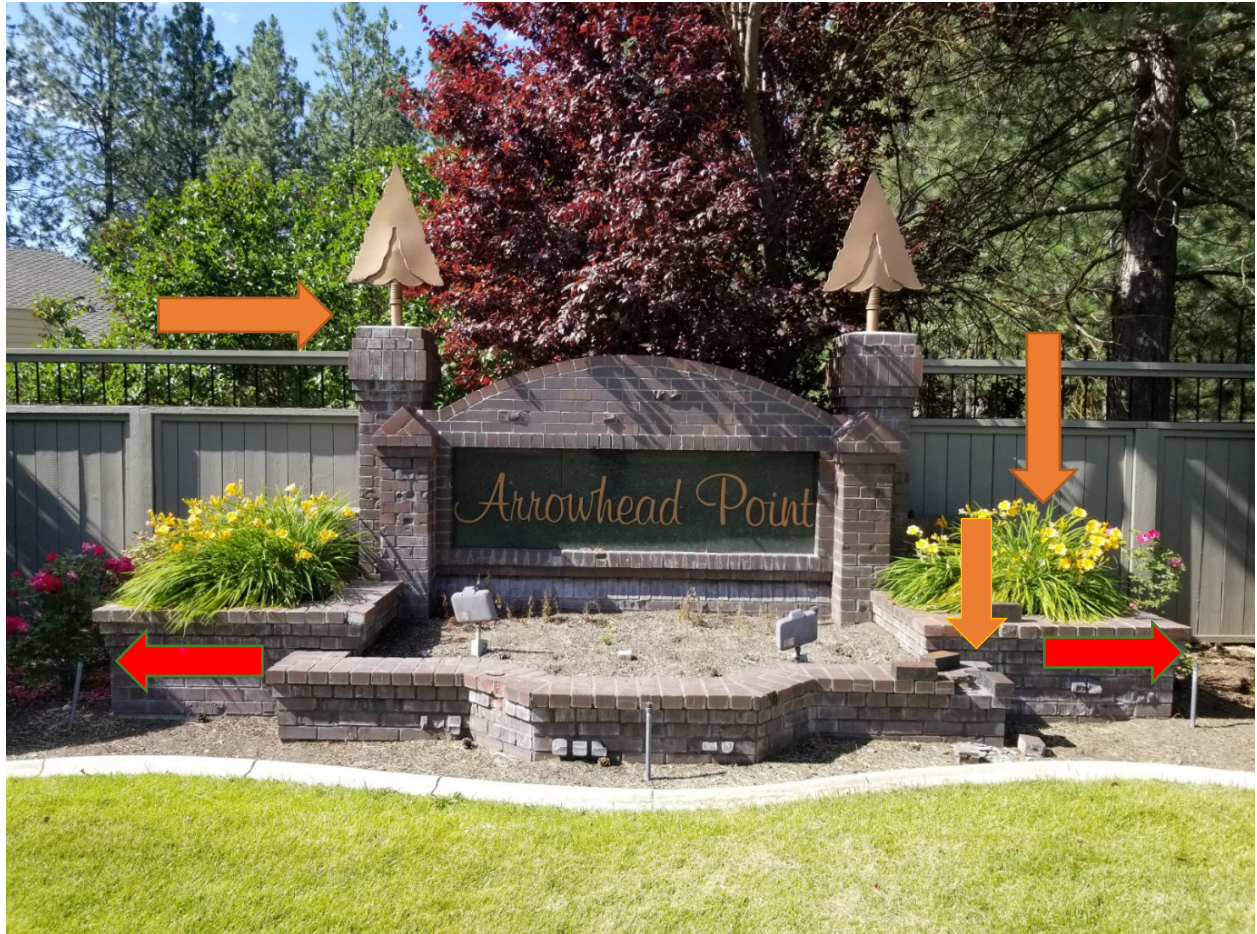
Orange arrows show areas of mostly poor brickwork design. Red arrows show areas of mostly poor sprinkler design. But please remember, everything works together as a whole and water in its frozen form is the main problem.

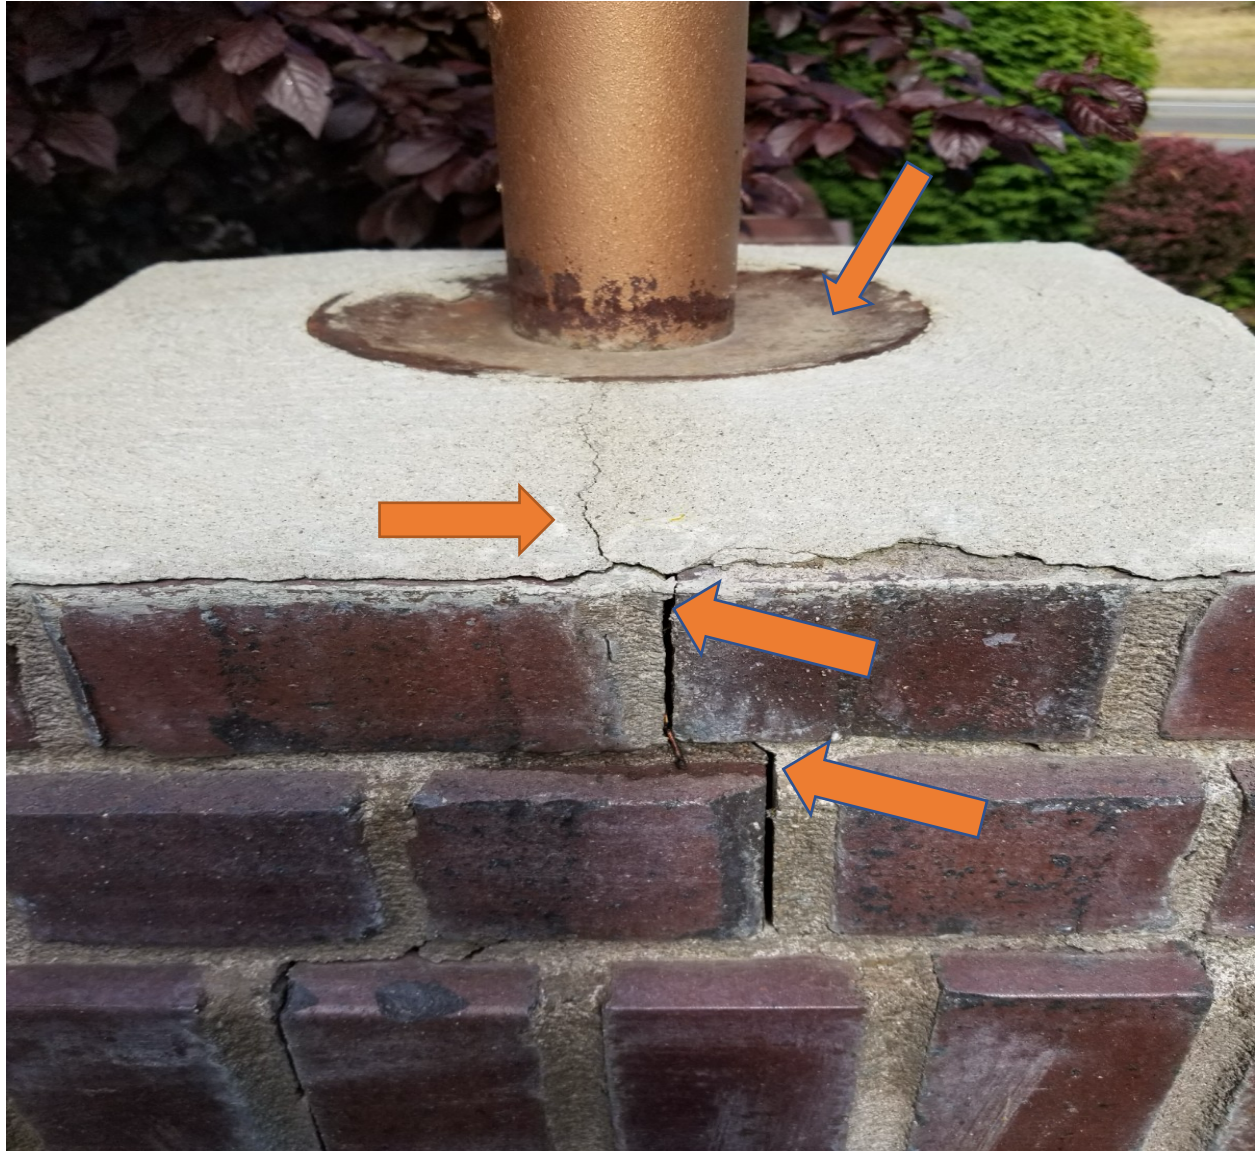
This is an example of very poor design. Rain water and melting snow collect on top of the column (in the “cup” and through the crack in the mortar cap) and drain into the brick column. Gradually the column splits open when the ice trapped inside freezes and expands making cracks in the mortar joints. After that even more water can then enter. The brick “ledges” or “steps” contribute to the collection of snow/rainwater and further increase the amount of water that can seep into the column. You can see water draining from the top mortar joint and collecting on the middle “ledge”.

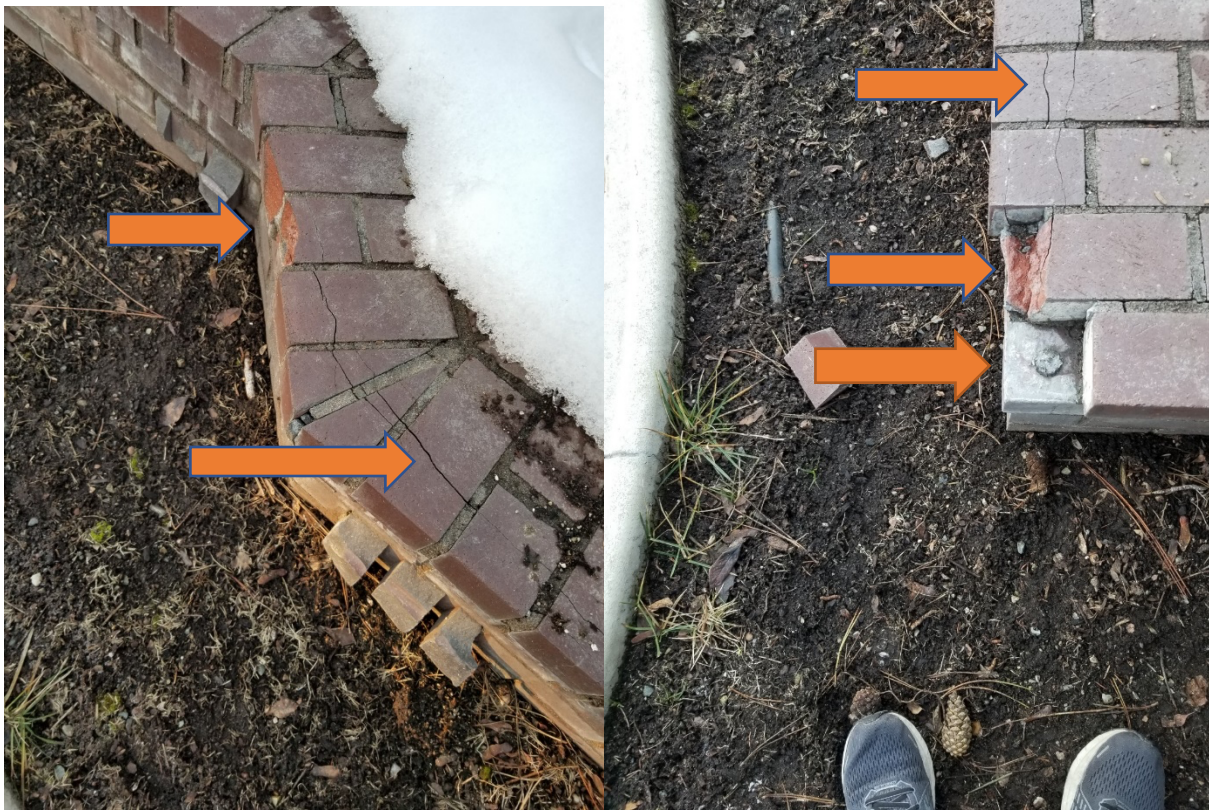
The top row of brickwork has fractured and spalled due to multiple cycles of freezing and thawing. Eventually pieces of brick simply fall off (called spalling).

So far, only the top row of brick has been damaged. Left alone, the next row down will fail in the same way

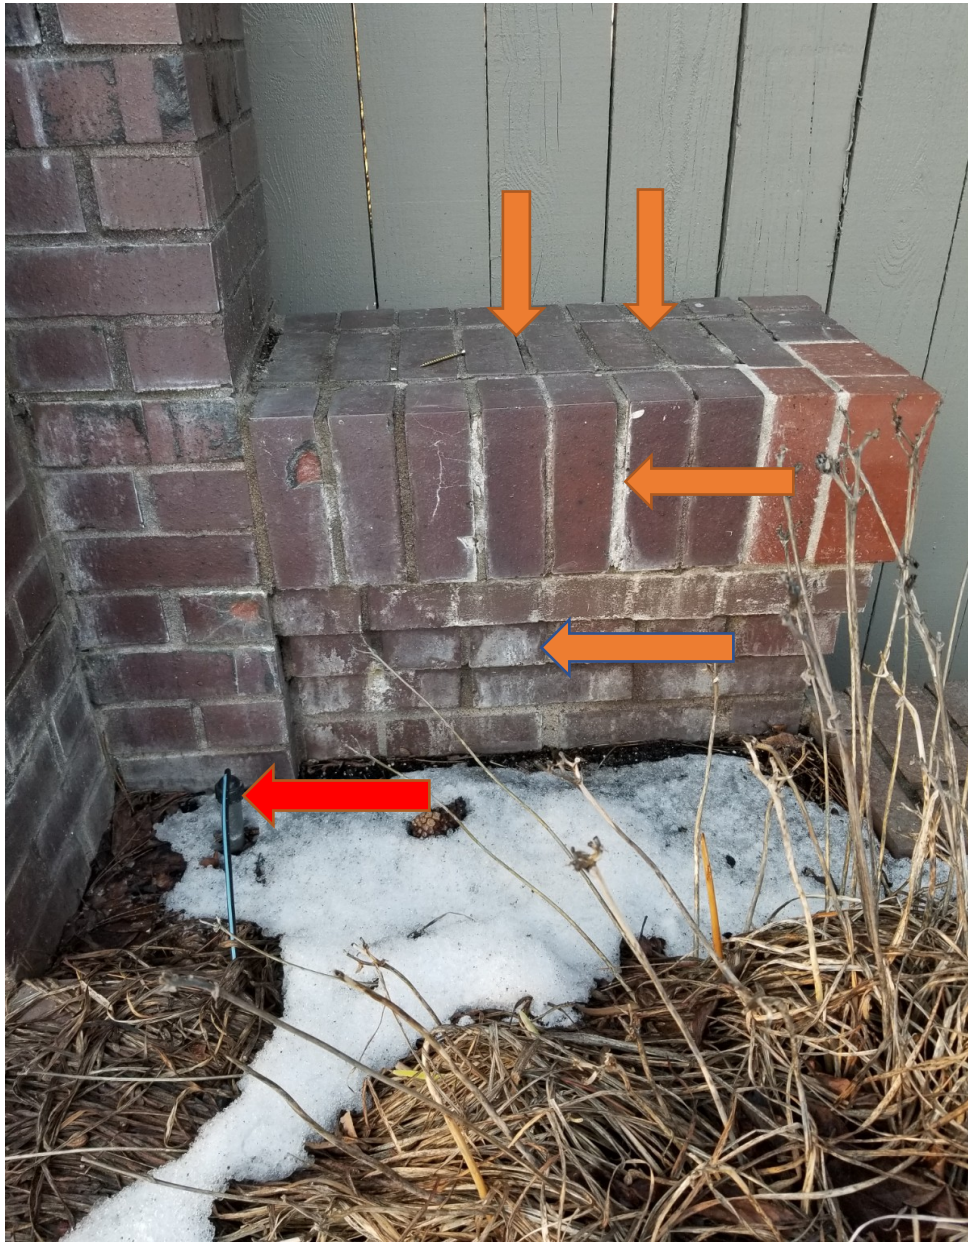
This image illustrates many of the problems associated with the Arrowhead Point brick monuments.

1. Much of the brickwork is flat. It has no slope to drain water away from the surface.

2. Sprinklers spray water for the plants (day lilies in this case) right up till winter.

3. Originally, the water sprayed

everywhere, and hard water salts built up on the brick surfaces (the whitish scum) making it harder for water to migrate to the surface and evaporate.

4. Note also that the sprinkler head (red arrow) has now been changed from a “spray everywhere” style to a plastic tube that waters the plant much more directly and efficiently. There are still several sprinkler heads that need to be modified to match this technique in the coming spring.

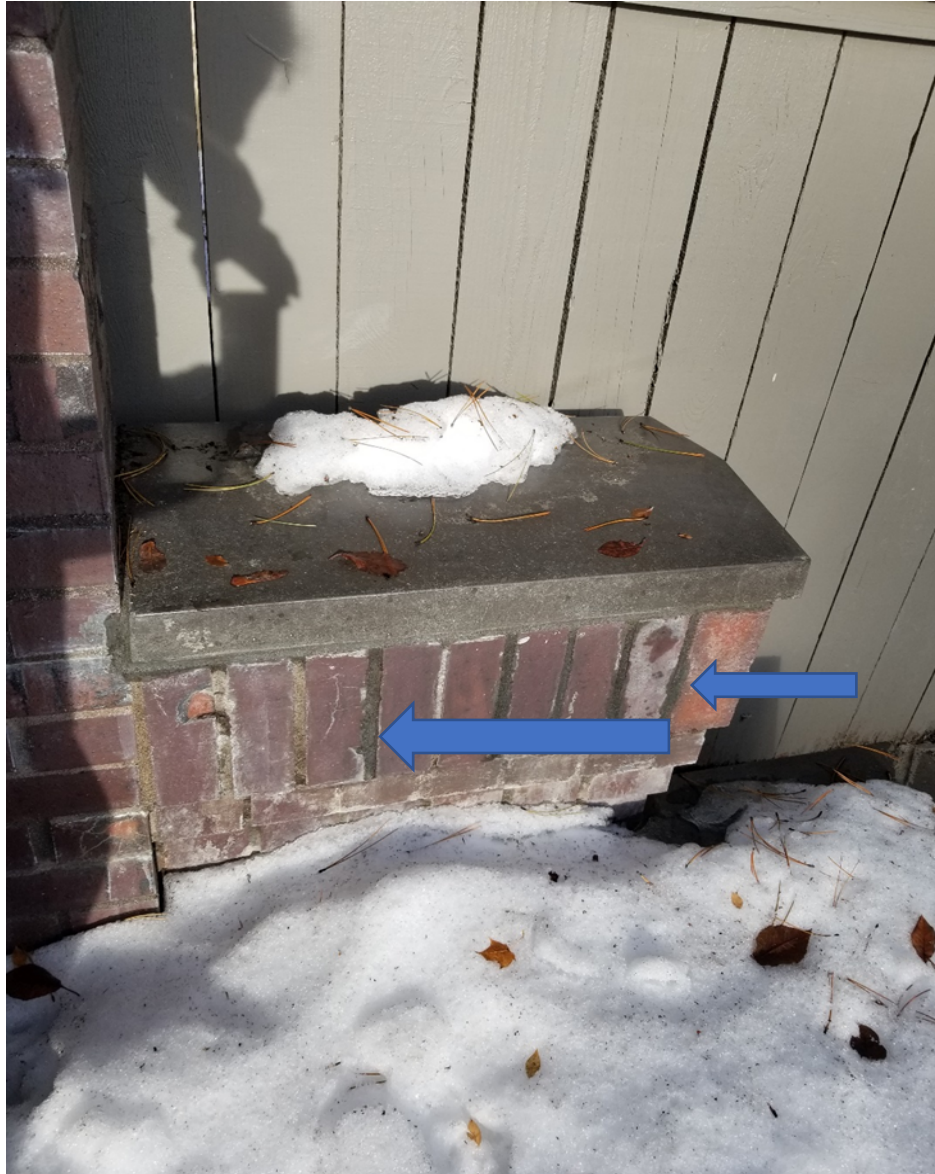
This will be an area to watch closely. If this holds up over the next several winters, then we will know that stopping water entry from the top and rearranging the sprinkler heads are the best practice to follow.

Removing the white residue is a future goal, but very difficult at this point because the build up is so thick. We will be doing some experiments this spring and summer.

Unfortunately, this was not one of our ideal repairs. We wanted to replace the entire top row of vertical bricks but there just weren't enough good bricks left over. So, we simply capped the flat surface and re-pointed the mortar joints as best we could.
