# Arrowhead Point Entrance Monuments

## 2022 Repairs and design modifications

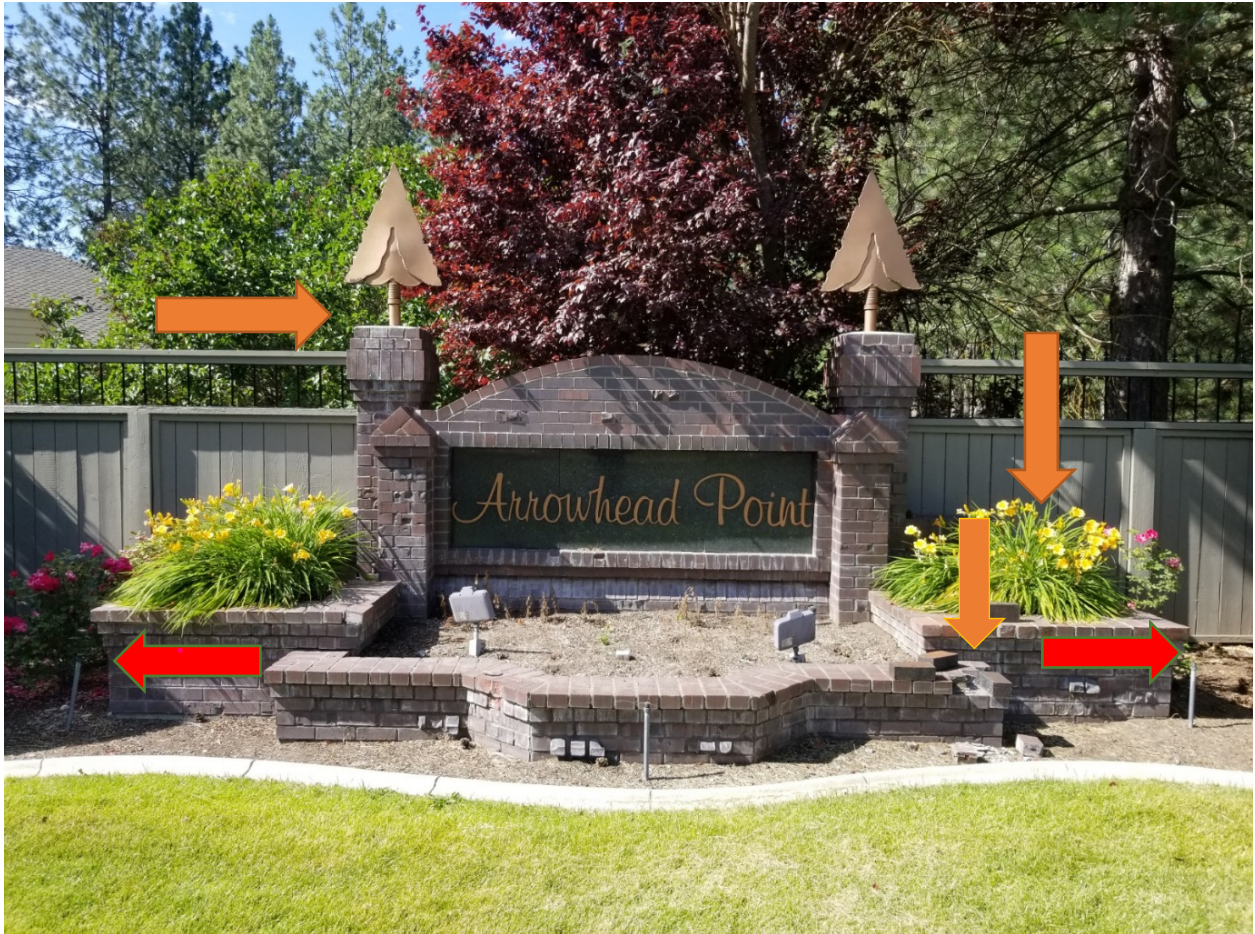
Orange arrows show areas of mostly poor brickwork design. Red arrows show areas of mostly poor sprinkler design. But please remember, everything works together as a whole and water in its frozen form is the main problem.

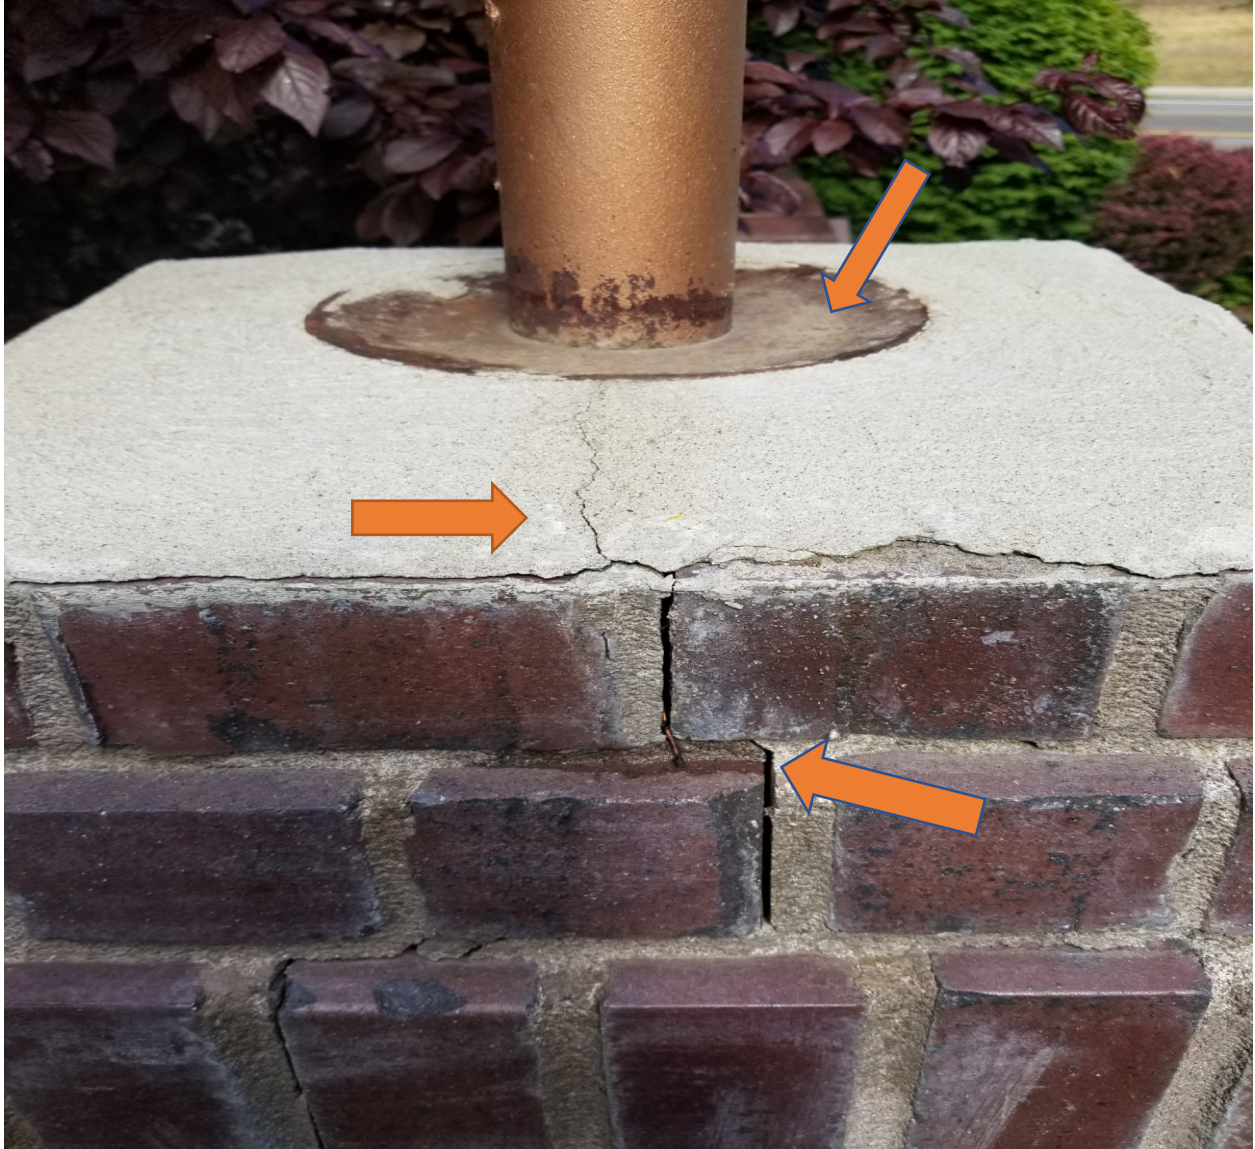
This is an example of very poor design. Rain water and melting snow collect on top of the column (in the “cup” and through the crack in the mortar cap) and drain into the brick column. Gradually the column splits open when the ice trapped inside freezes and expands making cracks in the mortar joints. After that even more water can then enter. The brick “ledges” or “steps” contribute to the collection of snow/rainwater and further increase the amount of water that can seep into the column. You can see water draining from the top mortar joint and collecting on the middle “ledge”.

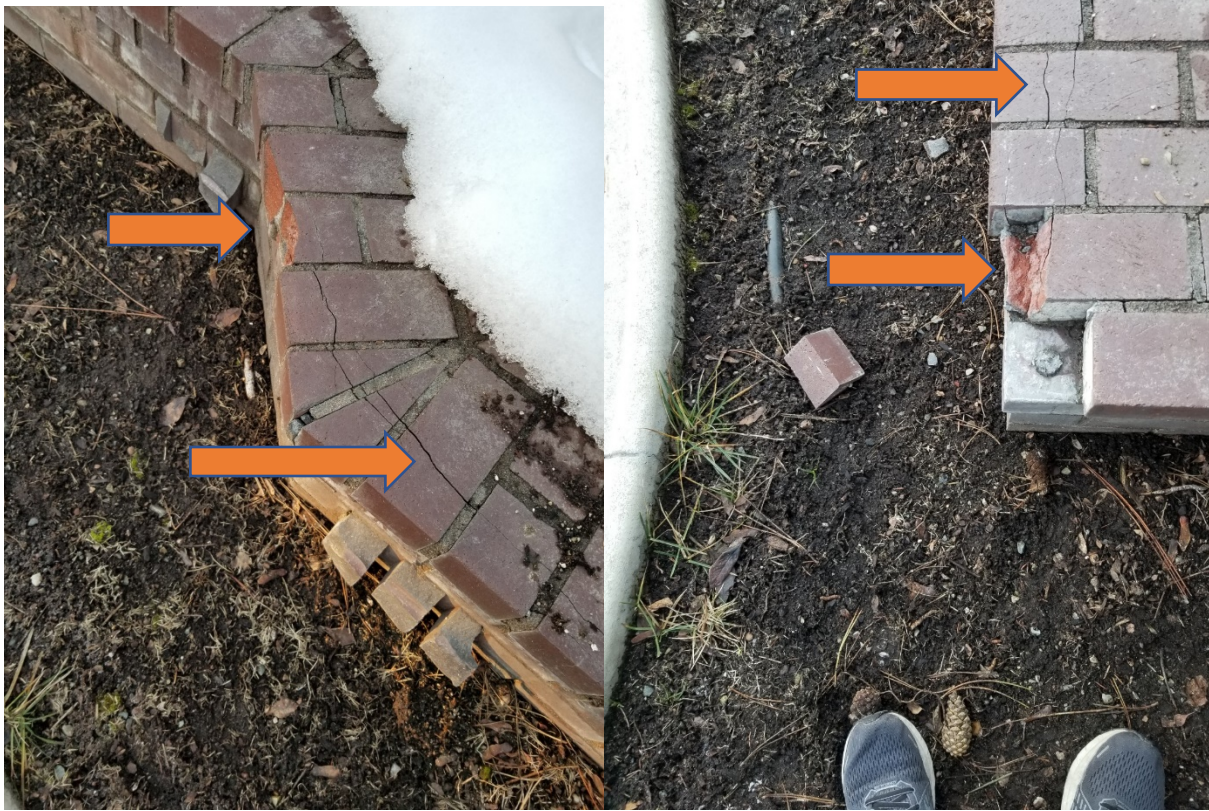
The top row of brickwork has fractured and spalled due to multiple cycles of freezing and thawing. Eventually pieces of brick simply fall off (called spalling). So far, only the top row of brick has been damaged. Left alone, the next row down will fail in the same way

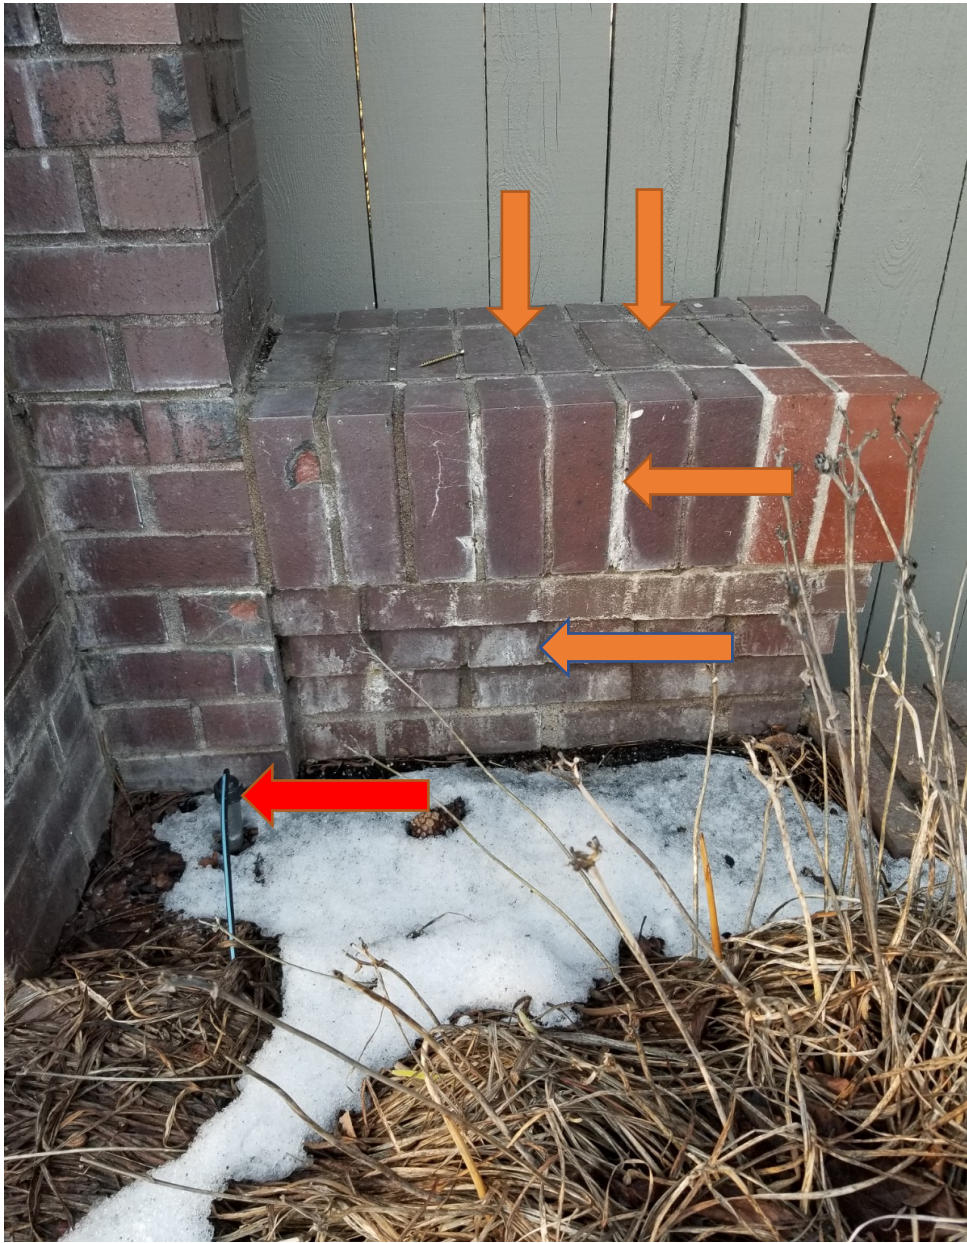
This image illustrates many of the problems associated with the Arrowhead Point brick monuments.

1. Much of the brickwork is flat. It has no slope to drain water away from the surface.

2. Sprinklers spray water for the plants (day lilies in this case) right up till winter.

3. Originally, the water sprayed

everywhere, and hard water salts built up on the brick surfaces (the whitish scum) making it harder for water to migrate to the surface and evaporate.

4. Note also that the sprinkler head (red arrow) has now been changed from a “spray everywhere” style to a plastic tube that waters the plant much more directly and efficiently. There are still several sprinkler heads that need to be modified to match this technique in the coming spring.

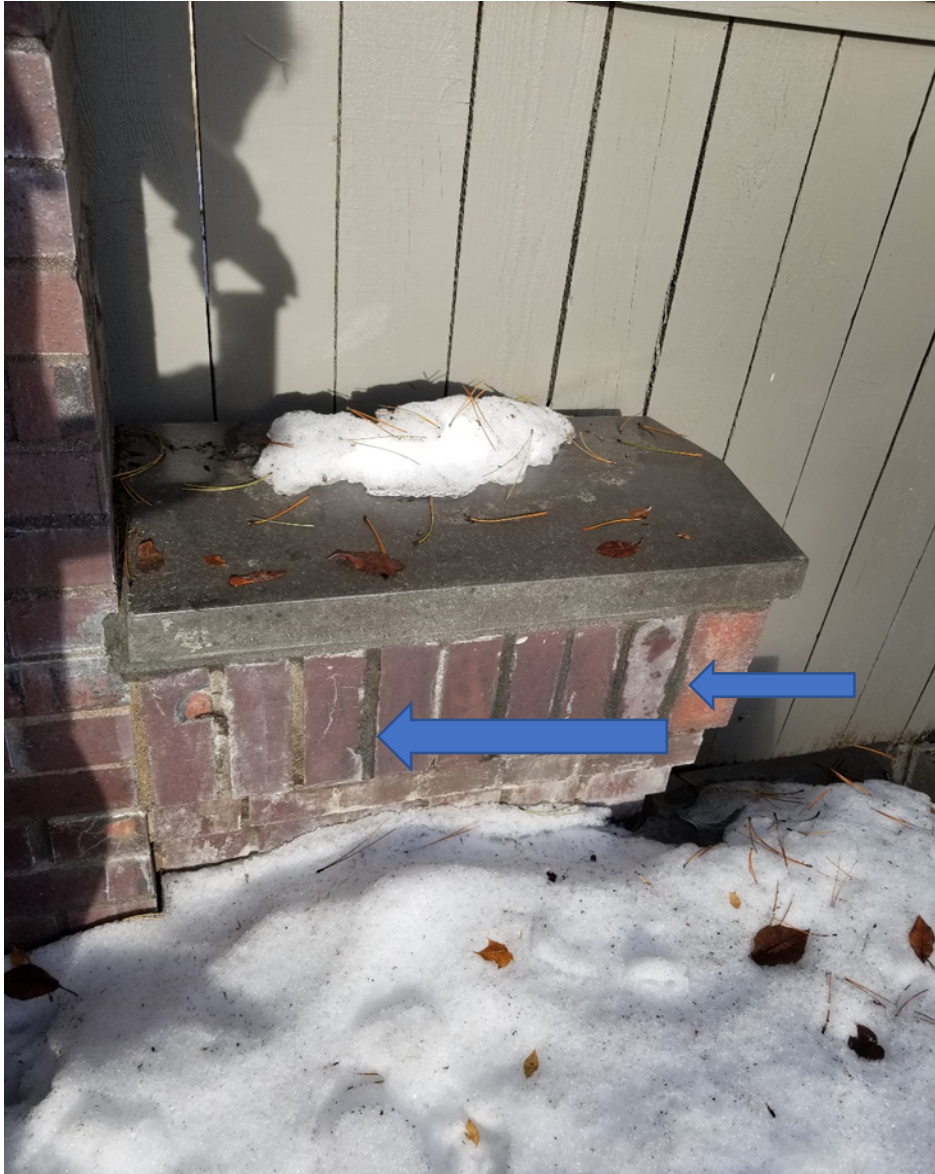
This will be an area to watch closely. If this holds up over the next several winters, then we will know that stopping water entry from the top and rearranging the sprinkler heads are the best practice to follow.

Removing the white residue is a future goal, but very difficult at this point because the build up is so thick. We will be doing some experiments this spring and summer.

Unfortunately, this was not one of our ideal repairs. We wanted to replace the entire top row of vertical bricks but there just weren't enough good bricks left over. So, we simply capped the flat surface and re-pointed the mortar joints as best we could.
