**KUHN FAMILY**  
**HOME INSPECTIONS**

INSPECTION REPORT  
123 Main St  
NoWhereVille NJ 00000

INSPECTED BY  
Ryan Kuhn  
Kuhn Family  
Home  
Inspections LLC  
#24GI00152800

INSPECTION DATE  
📅 1/1/2023  
🕒 03:30:00 PM

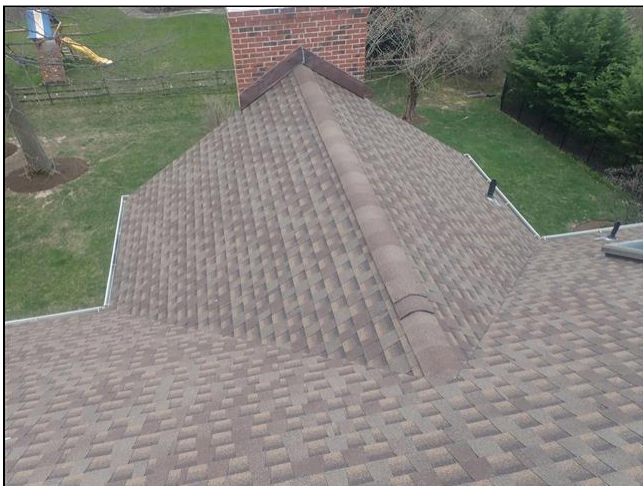
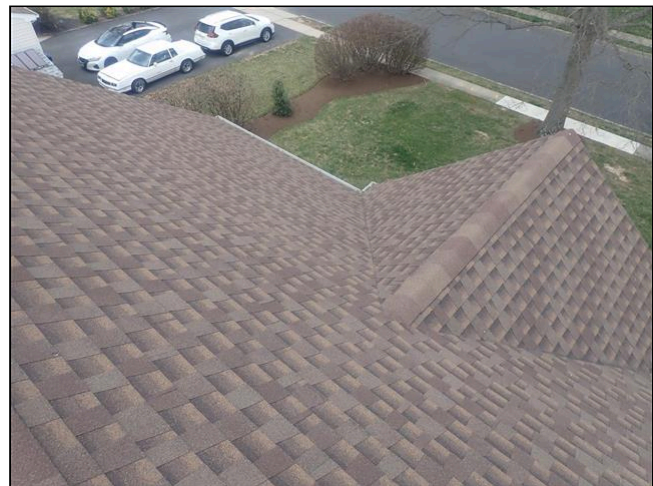
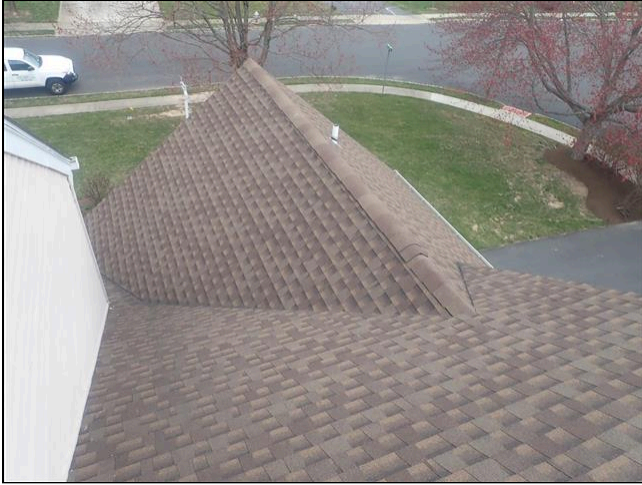
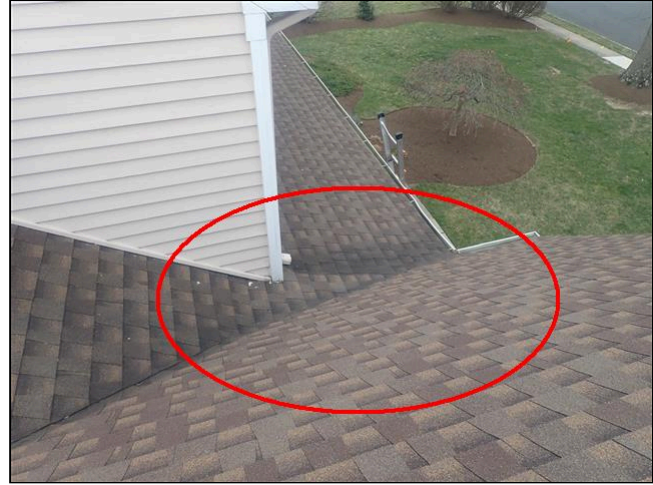
**1.0** Roof covering is estimated to be 5-10 with a typical 20-25 year design life. Shingle condition appears consistent with age of the material, normal wear and tear observed throughout. Area around valley on front-left section near garage/house area will wear quickly over time and should be monitored.

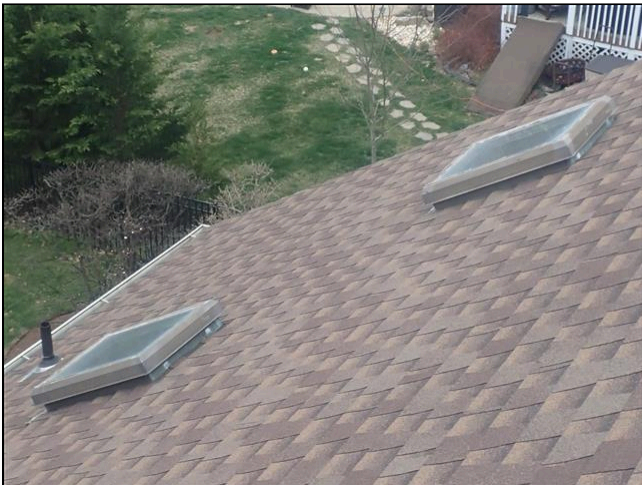
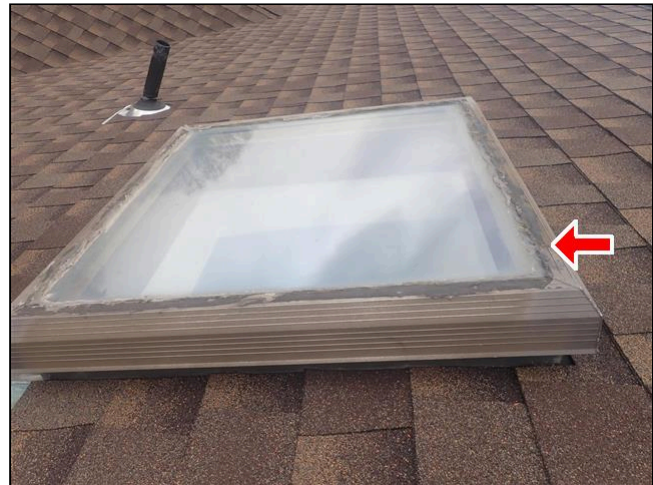
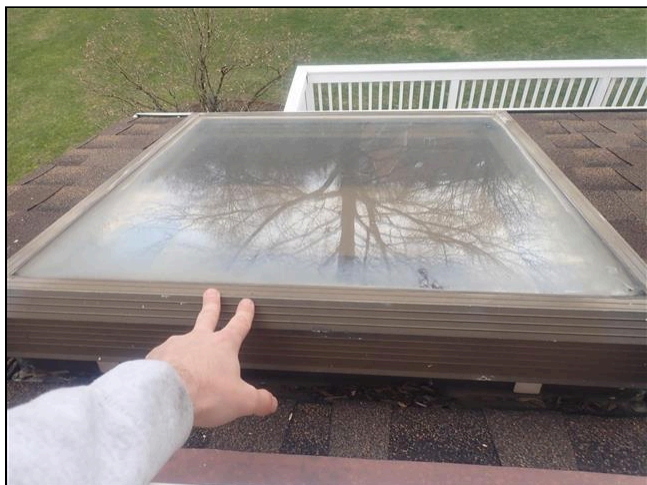
**1.2** Skylight appear older and have been heavily caulked around glass pane. While no immediate defects were noted replacements should be anticipated based on age & deteriorated condition.

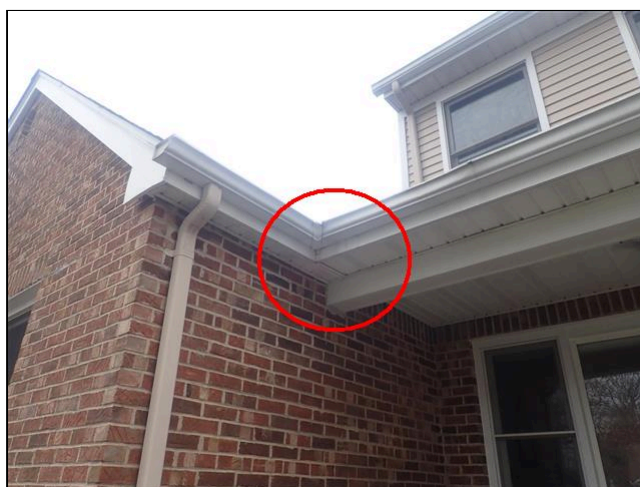
1.4 Item 1 (Picture)

**1.4 (1)** Slight rot and deterioration noted around front-left corner of gutter at lower roof. Repair as preventative maintenance to avoid larger damages over time.

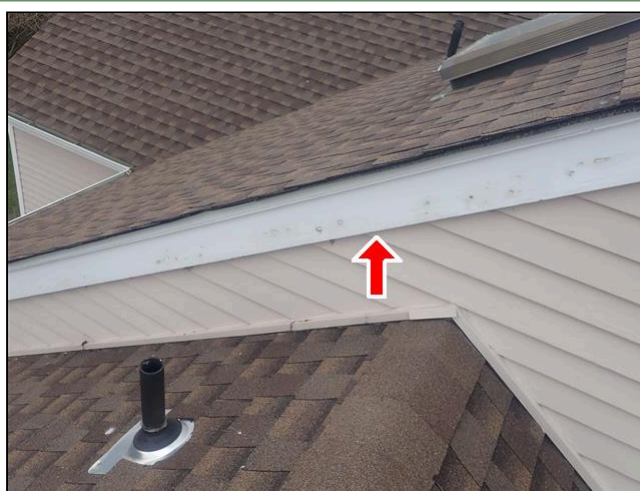
1.4 Item 2 (Picture)

**1.4 (2)** Evidence of past carpenter bee damage/activity observed at upper roof on left side of building appears treated and repaired. This is for your information.

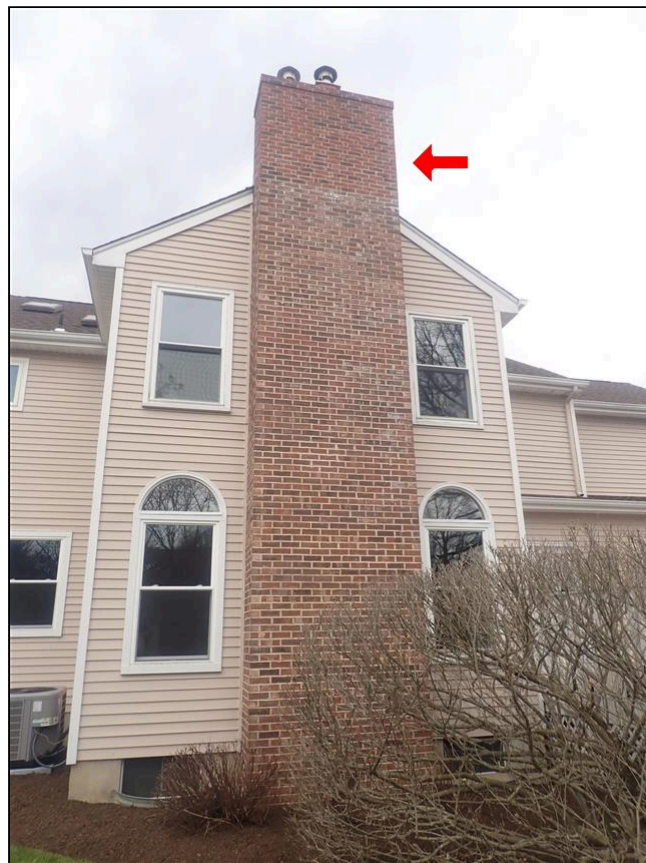
2.0 Item 1 (Picture)

**2.0** Chimney shows evidence of past repairs, appears to have been rebuilt above roof line. Efflorescence noted throughout base of chimney is indicative of water penetration into masonry block. While common, ongoing water infiltration can lead to larger damages if not properly maintained over time. Obtain documentation from seller regarding past repairs and maintain exterior masonry over time.

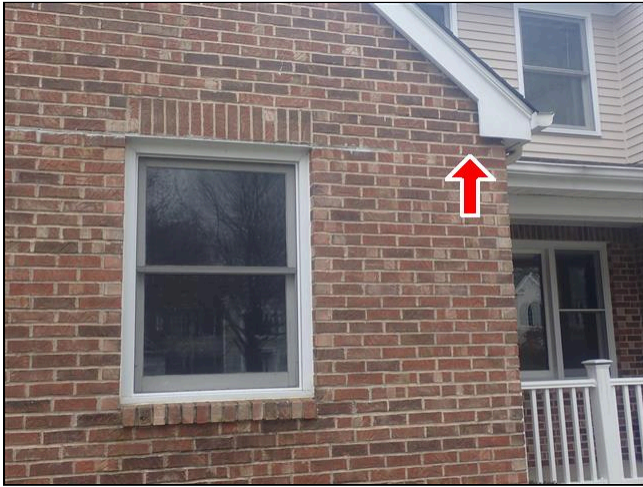
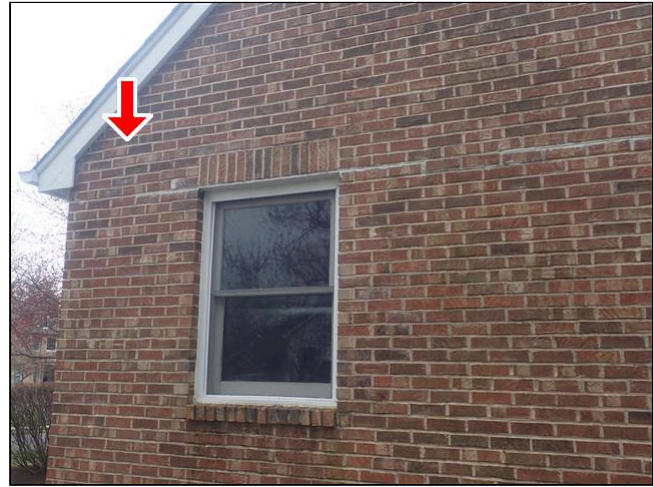
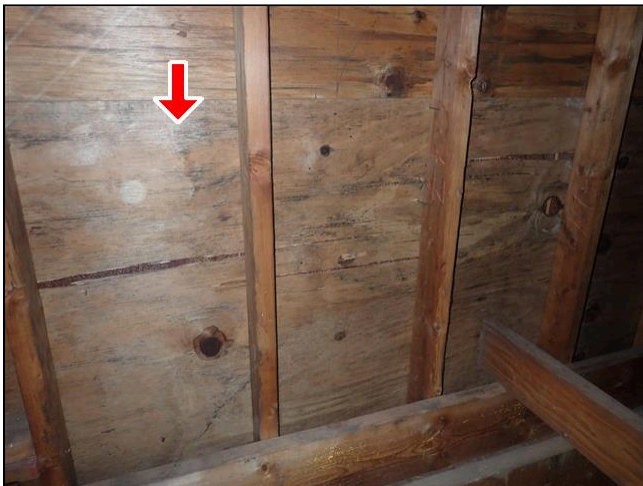
1. Brick veneer siding at garage area is poorly installed and damaged. Lack of proper weep holes

or drainage system prevents proper drainage behind siding material and lead to moisture concerns.

- Large cracks observed around window lintels indication of settlement and damages.
- Suspect mold was observed on plywood sheathing behind wall in garage attic location.
- Efflorescence noted throughout masonry (white/chalky depositing on bricks) is indication of water penetration.

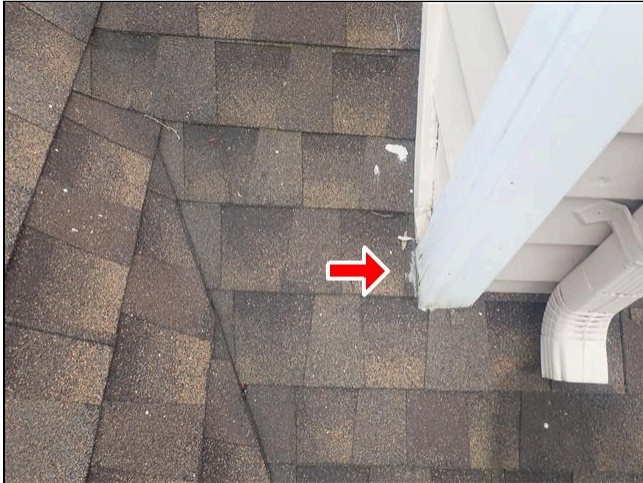
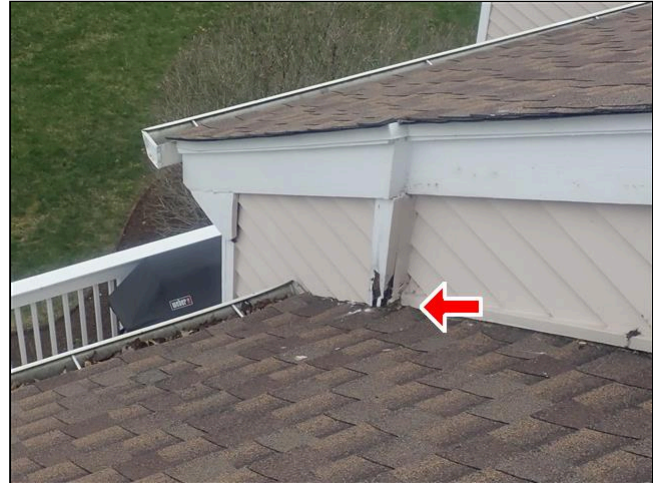
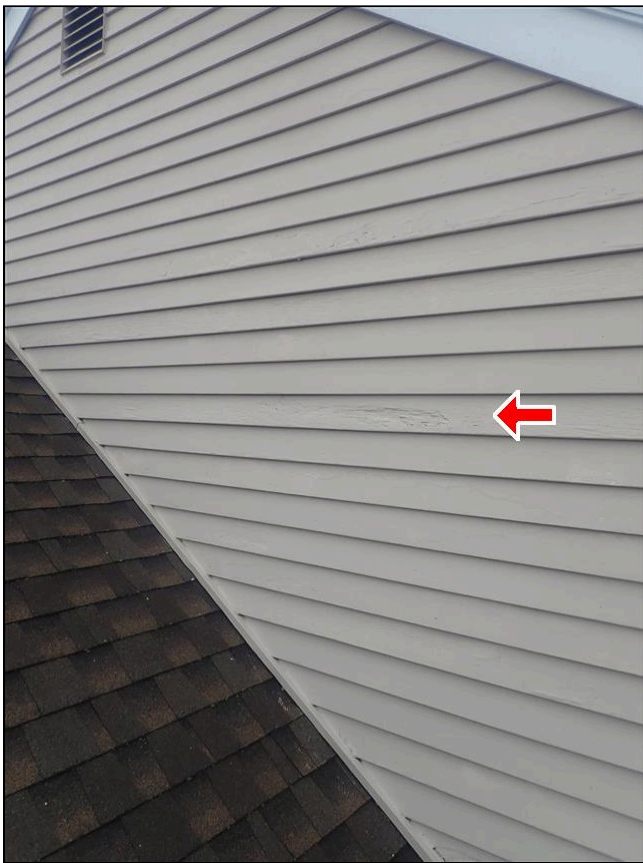
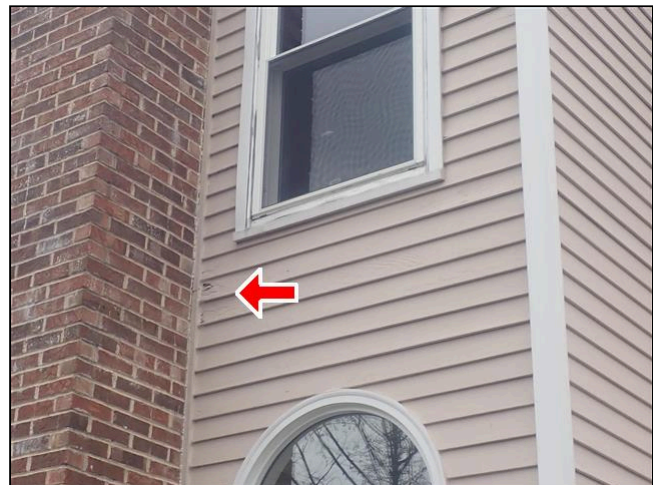
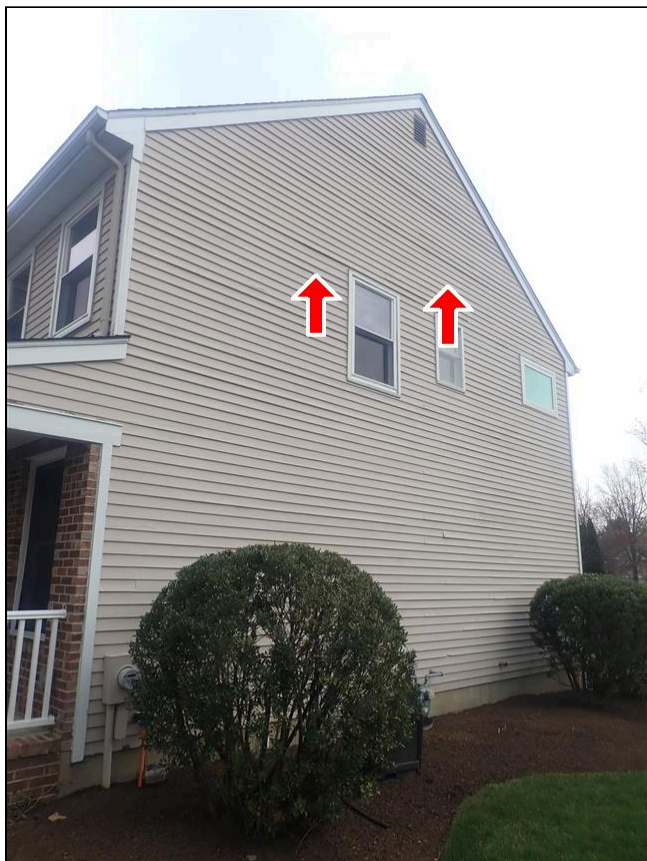
**2.1 (2) Rotting wood siding was at various locations:**

1. Loose and curling wood boards observed throughout right side of building
2. Rotting boards around chimney area on backside of home
3. Rotting trim at upper sections of roof at backside of home
4. Soft areas of siding noted at upper section of building at left side

Based on conditions observed, recommend having qualified contractor assess to determine repairs necessary and costs associated.

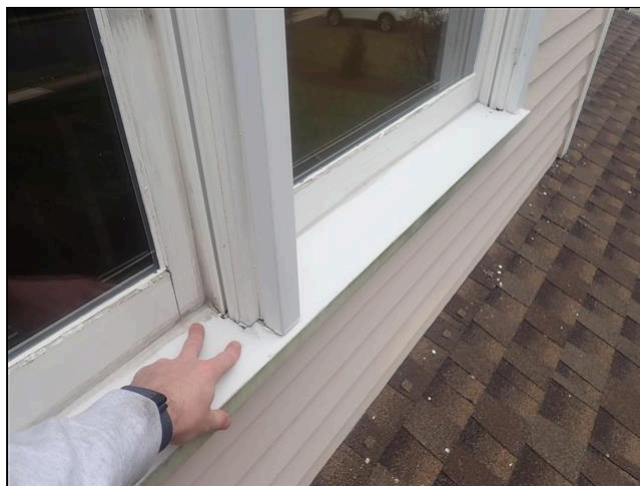
2.3 Item 1 (Picture)

1. The evaluation of windows is based on a limited inspection of representative, readily accessible units. Varying conditions may be found at other units. Review the Interior Section for additional information on window conditions.
2. Vinyl window trim at front-middle of home (second floor) has large gaps around sides and is leading to water damage around framing. Recommend repairing to prevent ongoing damaged and future concerns.

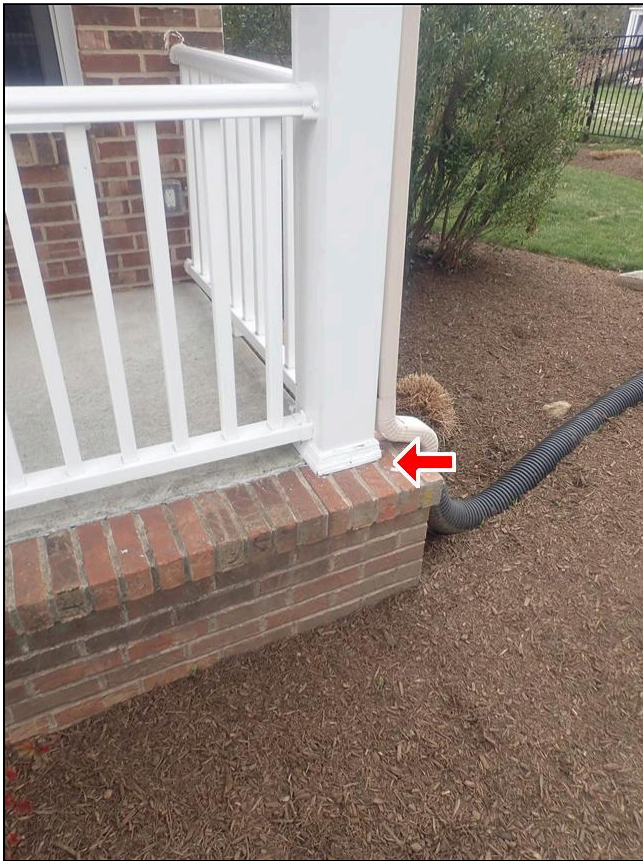
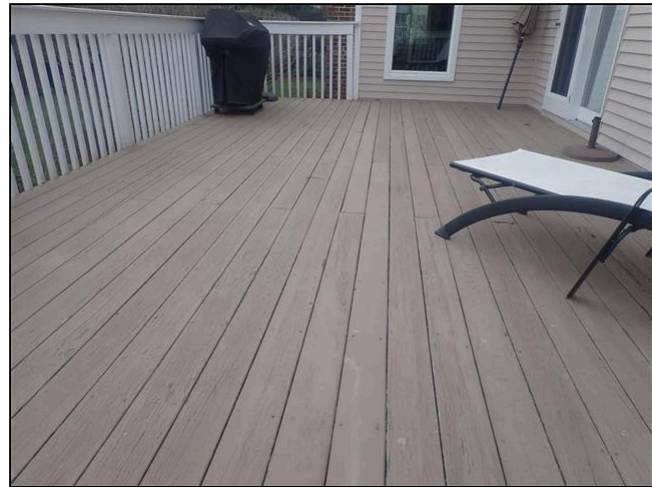
1. Repair rotting base at far-right column of front porch.
2. Older decking materials noted throughout with normal wear and tear observed. While no significant/immediate concerns were observed, eventual replacement of decking materials should be anticipated as normal upgrades.

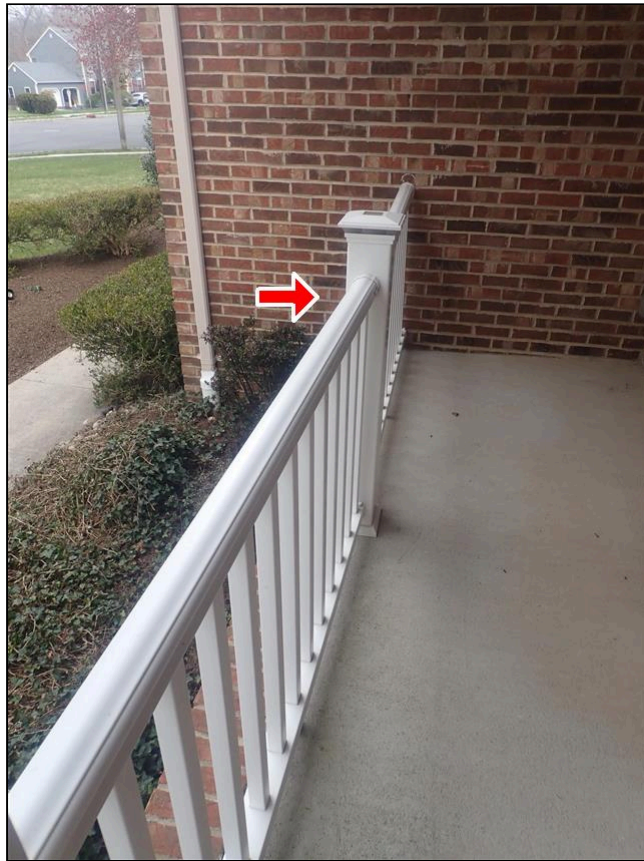
2.6 Item 1 (Picture)

**2.6** Left side of railings at front porch are crooked.

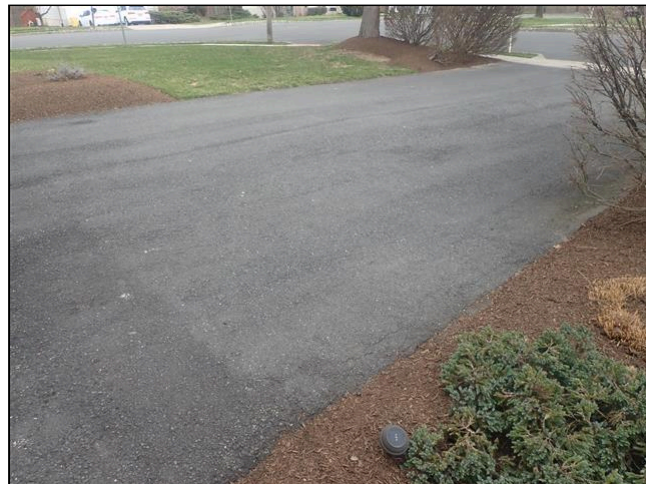
3.2 Item 1 (Picture)

**3.2** Asphalt driveway observed with normal shrinkage cracking and deterioration. No significant concerns, anticipate maintenance overtime. Cracks should be sealed regularly to prevent ongoing concerns and trip hazards.

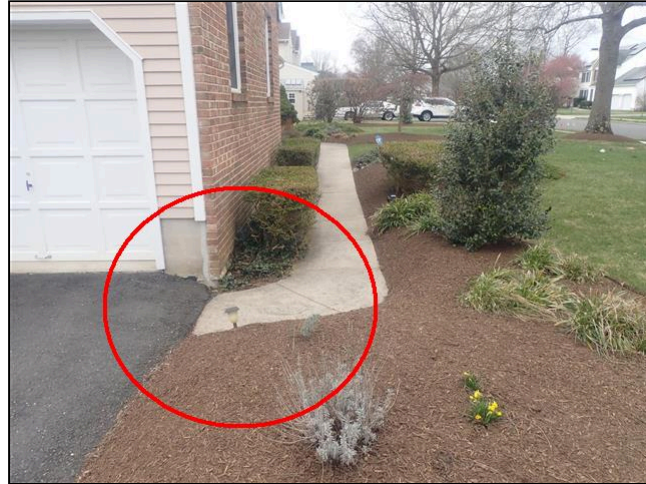
3.6 Item 1 (Picture)

**3.6** Walkways slope towards garage foundation area and may not drain well. Monitor drainage provisions and improve to prevent ponding around foundation and water penetration/settlement concerns.

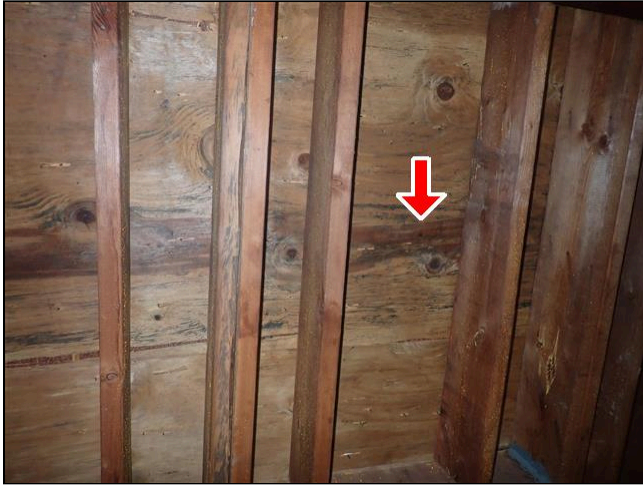
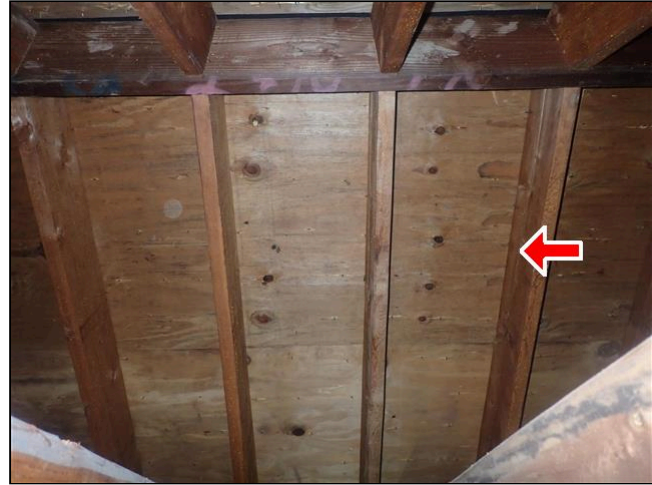
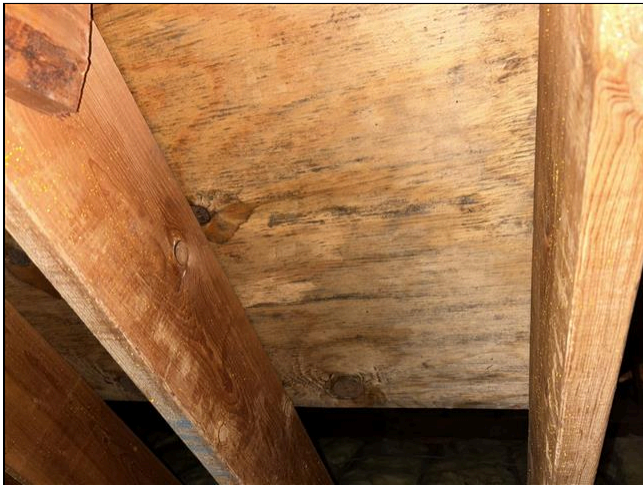
**5.3** (1) Venting an attic space is not a one-way-fits-all type of situation. Many factors and variables can affect performance such as insulation levels, air-sealing, attic fans, humidity levels throughout home and lower levels, roof leaks, etc. While no apparent defects were observed, recommend monitoring regularly for changes throughout attic. This is for your information.

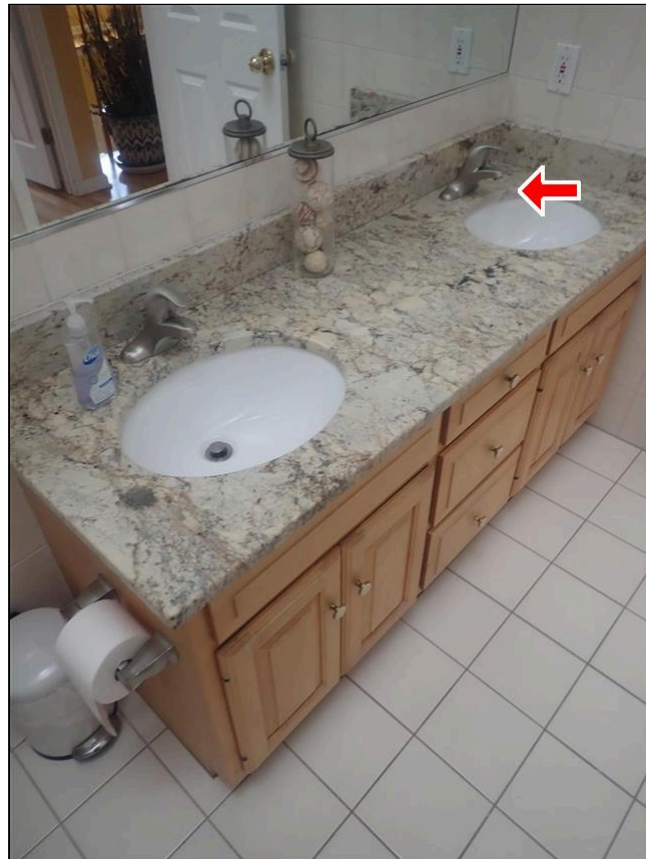
6.0.A Item 1 (Picture)

1. See main plumbing section for comments regarding corrosion.
2. Right side sink did not have hot water during inspection, mixing valve is defective. Recommend repairing.

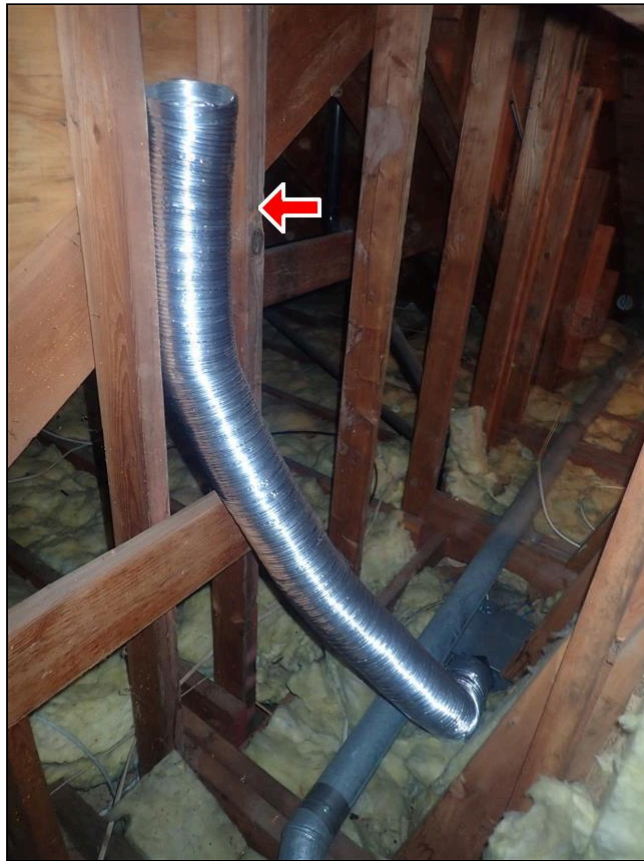
6.9.A Item 1 (Picture)

**6.9.A** Ceiling vent discharges into attic, vent should properly discharge to exterior to prevent moisture concerns in attic and poor venting. Recommend extending to exterior.

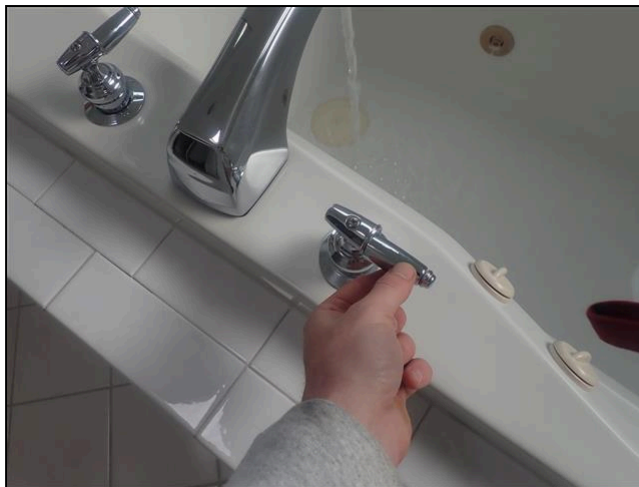
6.2.B Item 1 (Picture)

**6.2.B** Bathtub was functional however active leaks were observed at ceiling of finished space below. See interior section for comments. Secure loose handles at tub as normal maintenance.

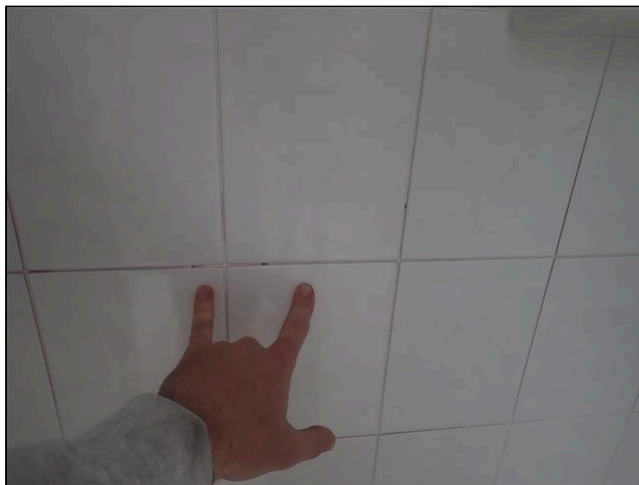
6.4.B Item 1 (Picture)

**6.4.B** Repair gaps in wall tile at shower area to prevent leaks and possible damages behind wall tile.

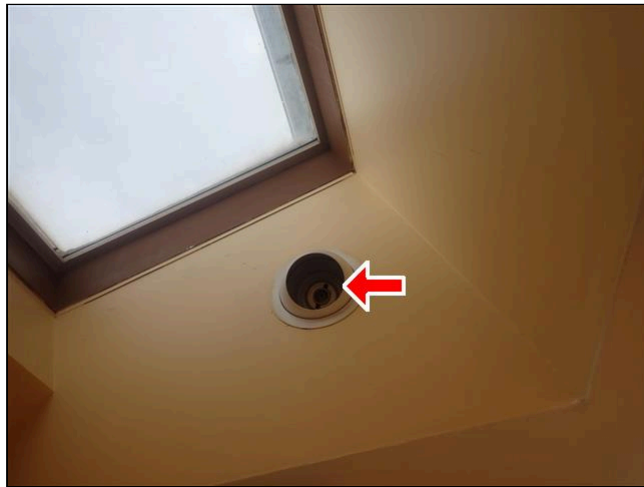
7.0 Item 1 (Picture)

1. Recommend adding GFCI outlets to ALL kitchen locations to meet current electrical and safety standards. GFCI's were noted at some, not all, locations.
2. Replace ceiling light over kitchen sink location.

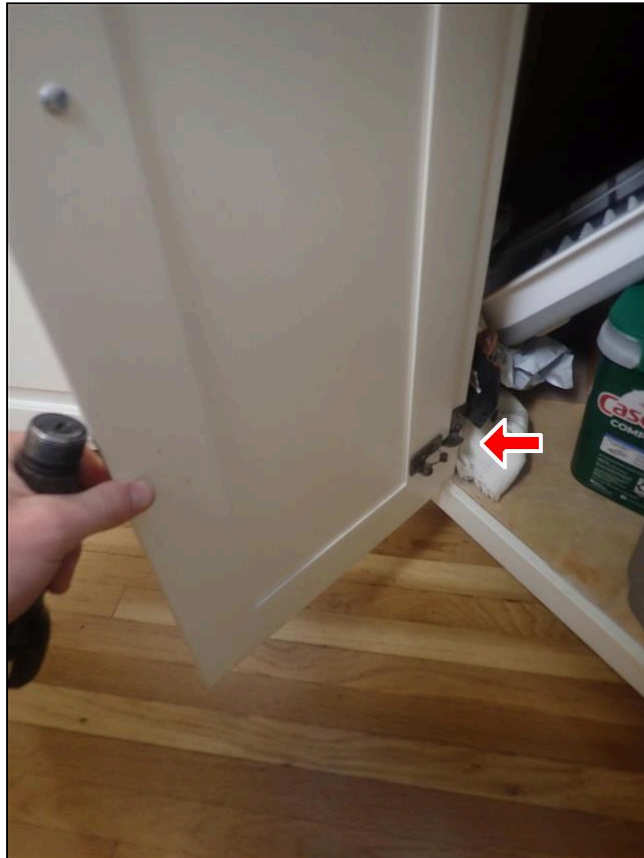
7.2 Item 1 (Picture)

- 7.2 Secure loose hinge at bottom left of sink area.

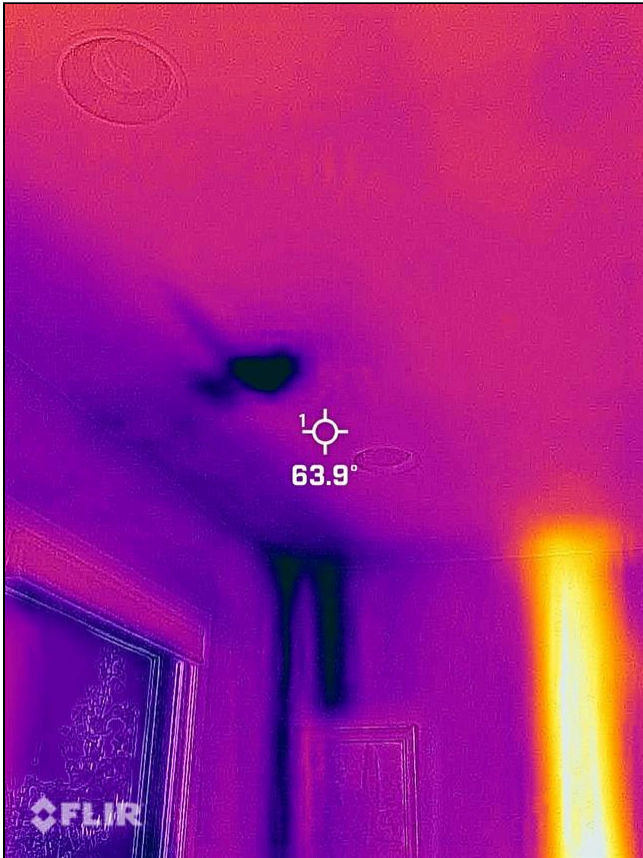
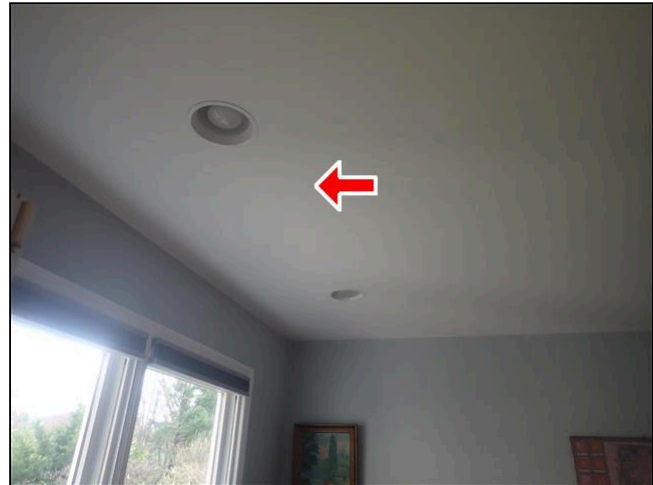
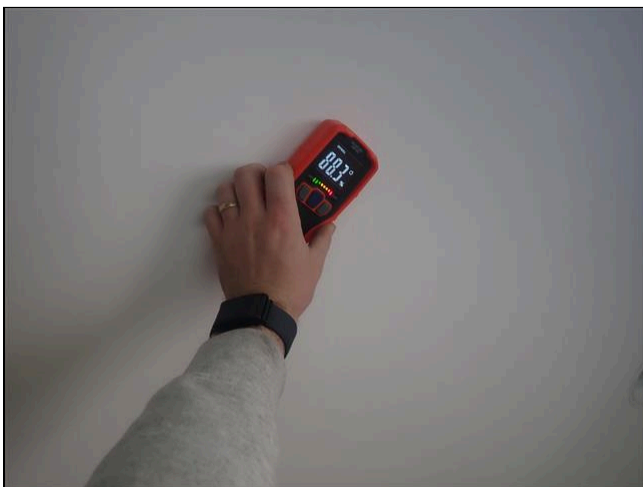
**8.0** (2) Active water leak was observed under the master bathroom tub down into the ceiling below. Moisture meter and thermal camera were used with active concerns observed. Recommend further evaluation by a qualified professional to assess conditions and repair.

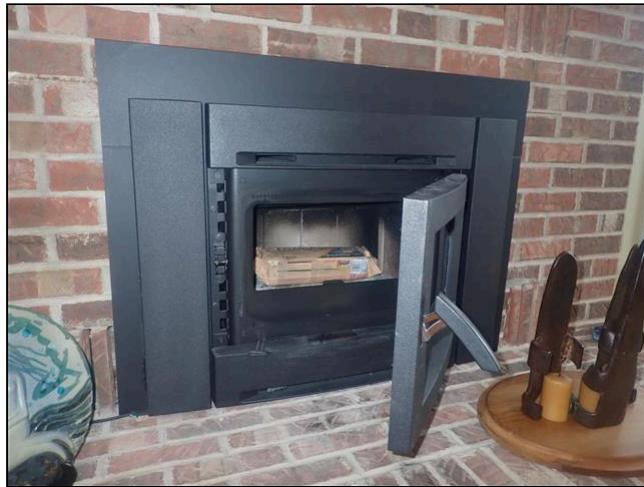
8.7 Item 1 (Picture)

**8.7** Recommend annual cleaning and inspection of wood-burning stove by a qualified professional as normal maintenance.

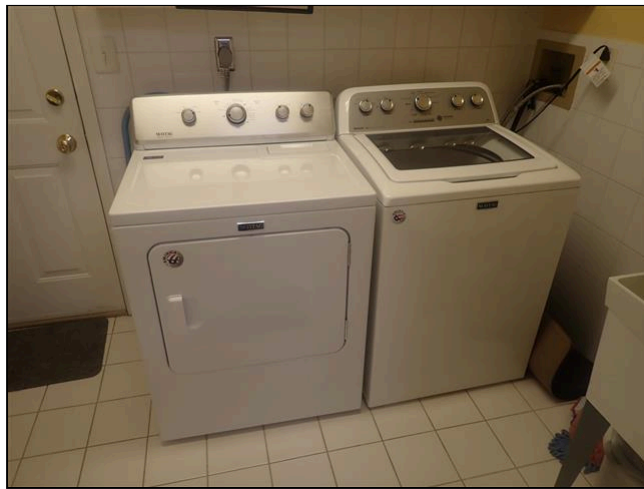
8.8 Item 1 (Picture)

**8.8** Laundry and auxiliary equipment (all plug-in appliances) was not operated and is not covered under stand home inspection guidelines, have operated prior to closing to ensure function. Dryer vents should be cleaned regularly to prevent possible fire hazards.

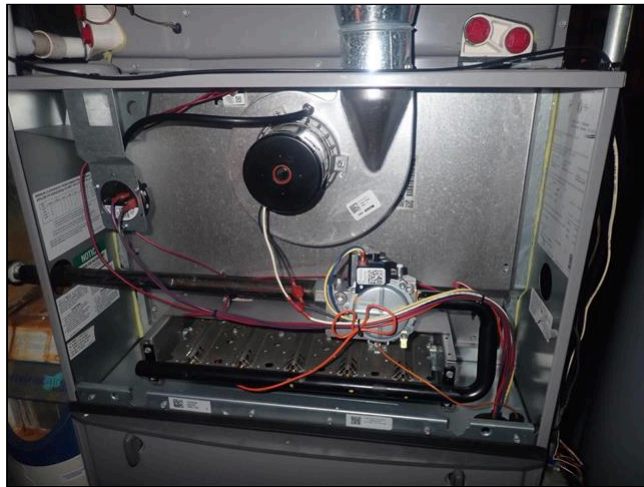
10.0 Item 1 (Picture)

**10.0** Heating system is estimated to be 2-4 years old with a typical 15-20 year design life. System was operational during the inspection with no immediate concerns or defects noted. Recommend annual servicing by a qualified professional as normal maintenance.

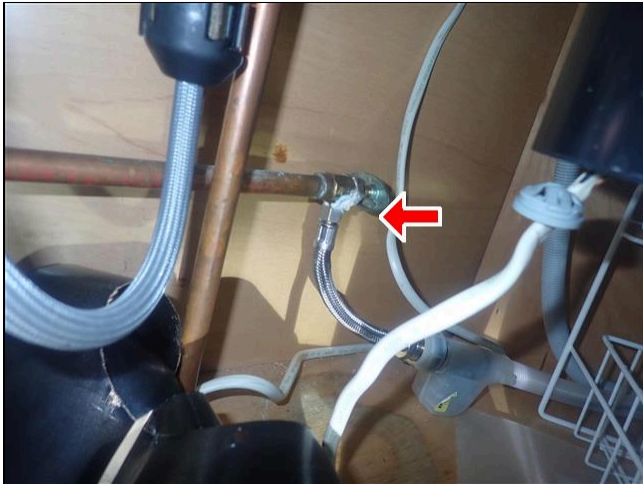
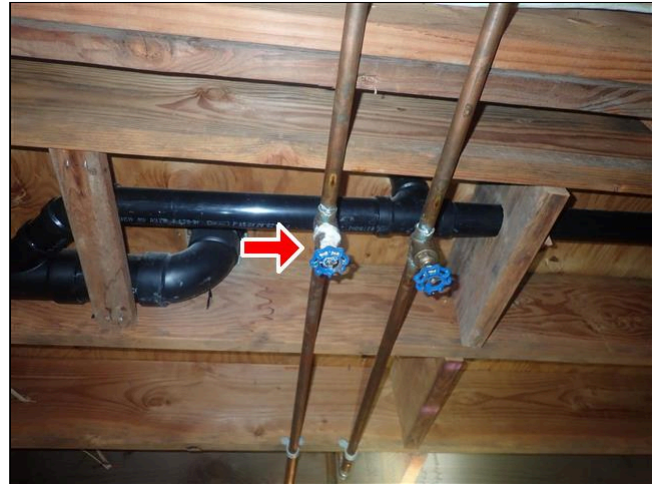
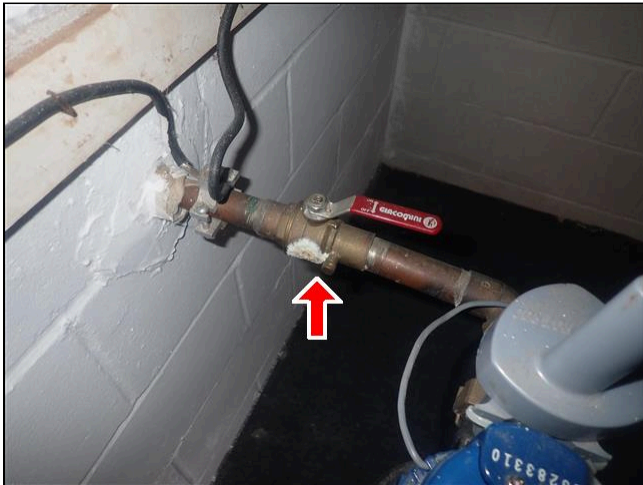
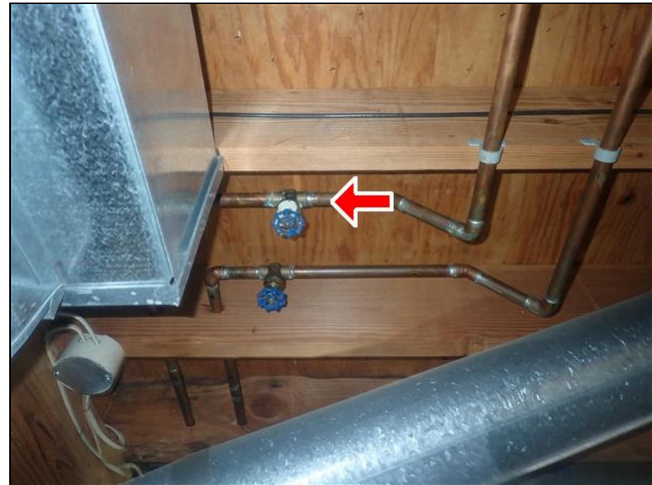
**13.0** Excessively corroded valves and fixtures were observed throughout the home, specific locations include:

Recommend a full evaluation by a qualified plumber to assess and repair damaged areas to prevent possible failure and damages.

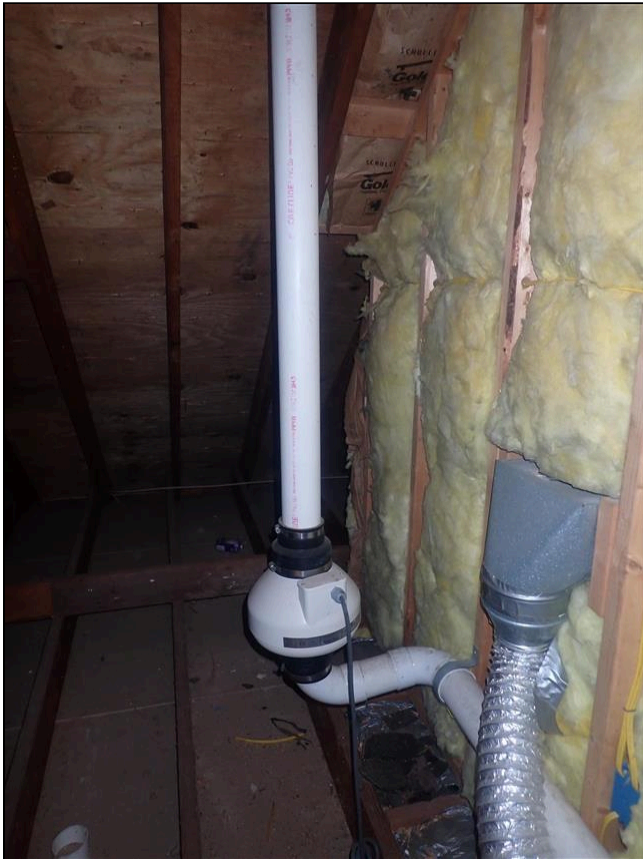
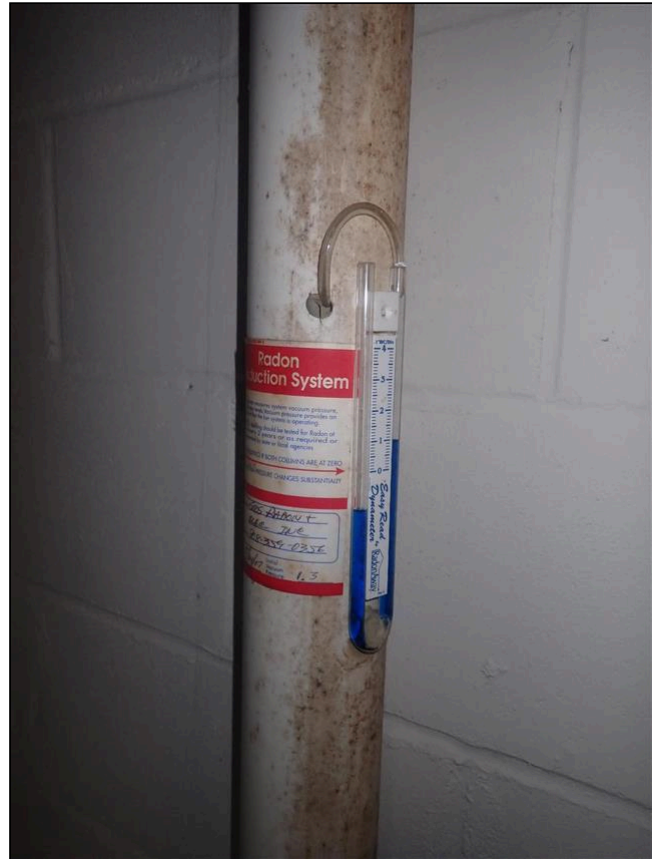
**15.12** There is an active radon mitigations system installed, fan located in garage attic space, site-gauge located in basement. System was operational, test is ongoing to determine results.

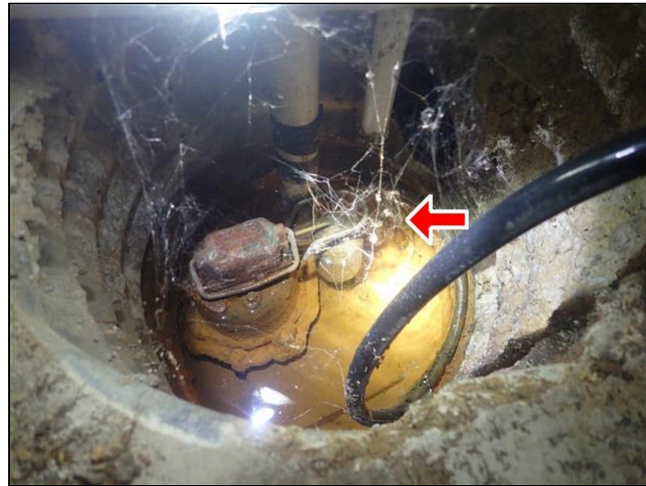
16.2 Item 1 (Picture)

**16.2** Sump pump is excessively rusted and in poor condition. Float valve turned on but did not adequately turn off during the inspection, had to be manually turned off. Recommend replacing based on deteriorated condition.
