Inspection 1 Home Inspection Services
59 Grove Street
Oakland, NJ 07436

Inspection 1 Home Inspection Services

General Information

Property Address deleted for website
City Oakland State NJ Zip 07436

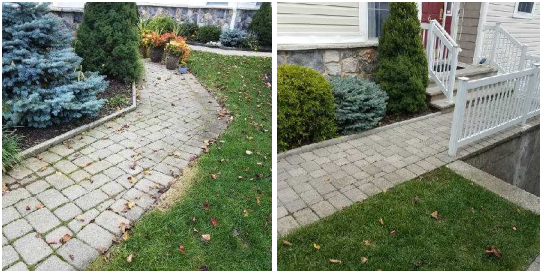
2. ☒ ☐ ☐ ☐ ☐ Walks: Paver

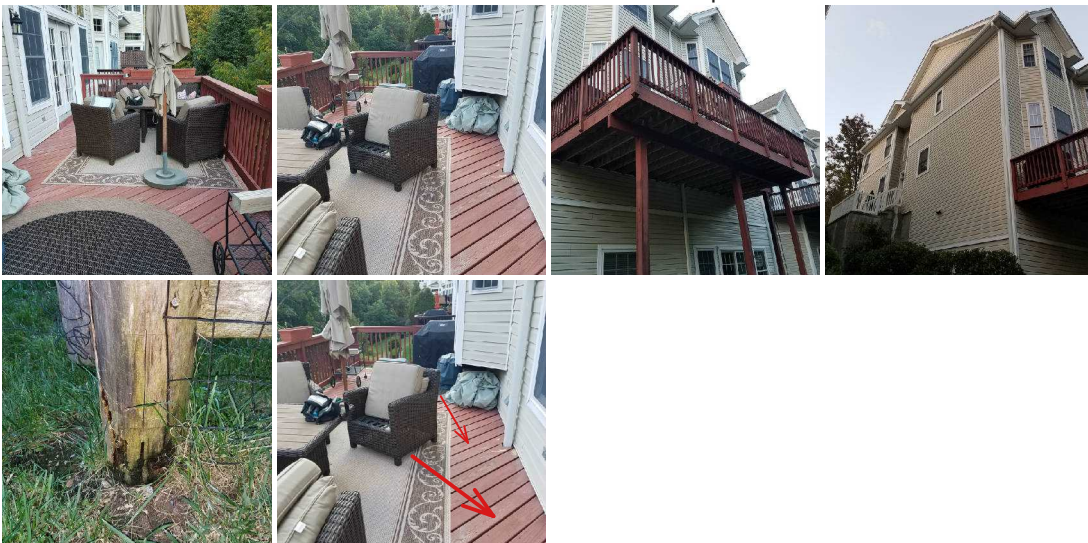
4. ☐ ☐ ☐ ☐ ☒ Deck: Treated wood - Deck boards are cupping and the finish is in poor condition. A qualified contractor is recommended to evaluate and estimate repairs.

1. Deck: Treated wood - Deck boards are cupping and the finish is in poor condition. A qualified contractor is recommended to evaluate and estimate repairs.

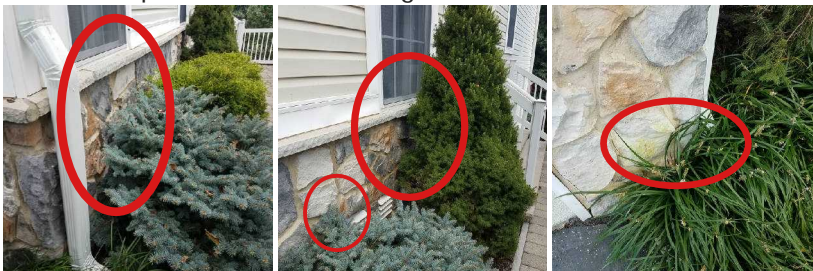
5. ☒ ☐ ☐ ☐ ☐ Vegetation: Shrubs, Trees - Suggest trimming back landscaping to avoid contact with the homes exterior to prevent future damage.

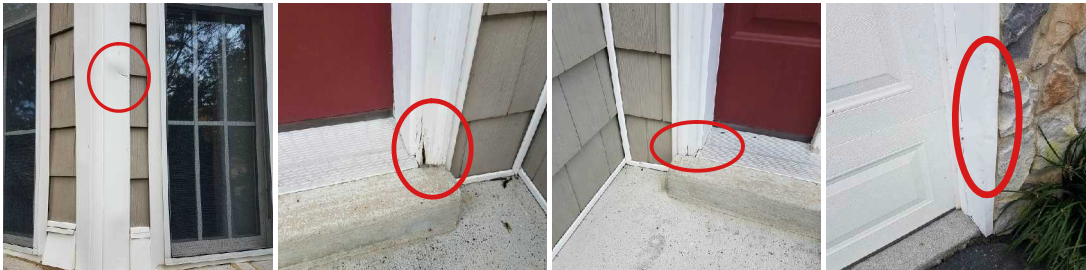
1. ☒ ☐ ☐ ☐ ☐ Type: Vinyl siding, stone
2. ☐ ☐ ☐ ☐ ☒ Trim: Vinyl, Wood, Metal - Exterior trim around the window on the front of the house (dent / crack), main entrance door (wood rot), and garage entrance (dented) are in need of replacement. Some of these items may or may not be covered by the home owners association. A qualified contractor is recommended to evaluate and estimate repairs.

3. Trim: Vinyl, Wood, Metal - Exterior trim around the window on the front of the house (dent / crack), main entrance door (wood rot), and garage entrance (dented) are in need of replacement. Some of these items may or may not be covered by the home owners association. A qualified contractor is recommended to evaluate and estimate repairs.

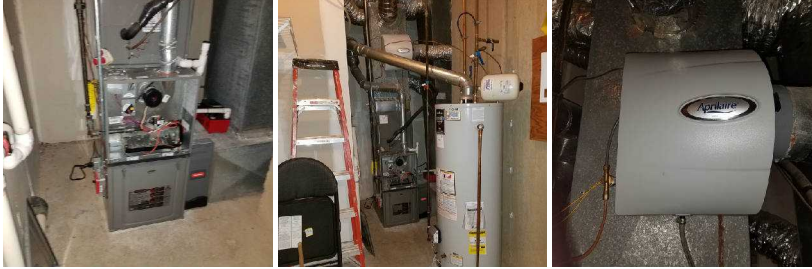
9. ☒ ☐ ☐ ☐ ☐ Heating System Operation: Adequate - Heating system is in serviceable condition at this time

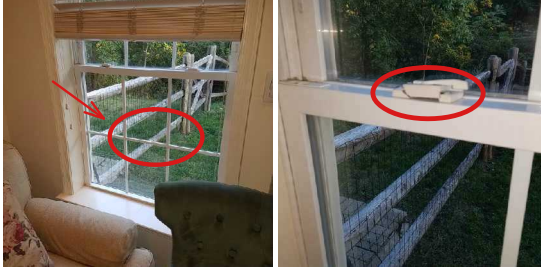
18. ☒☐☐☐☒ Windows: Vinyl double hung - Window has a broken lock, screen is missing and is stiff to operate.

12. basement family room Living Space Windows: Vinyl double hung - Window has a broken lock, screen is missing and is stiff to operate.
