February 26, 2024

**RE: Chateaux, A Condominium, Inc. – Milestone Phase 1 Inspection Report Summary
19440 Gulf Boulevard,
Indian Shores, Florida 37785
KEG File# 21RT-0715**

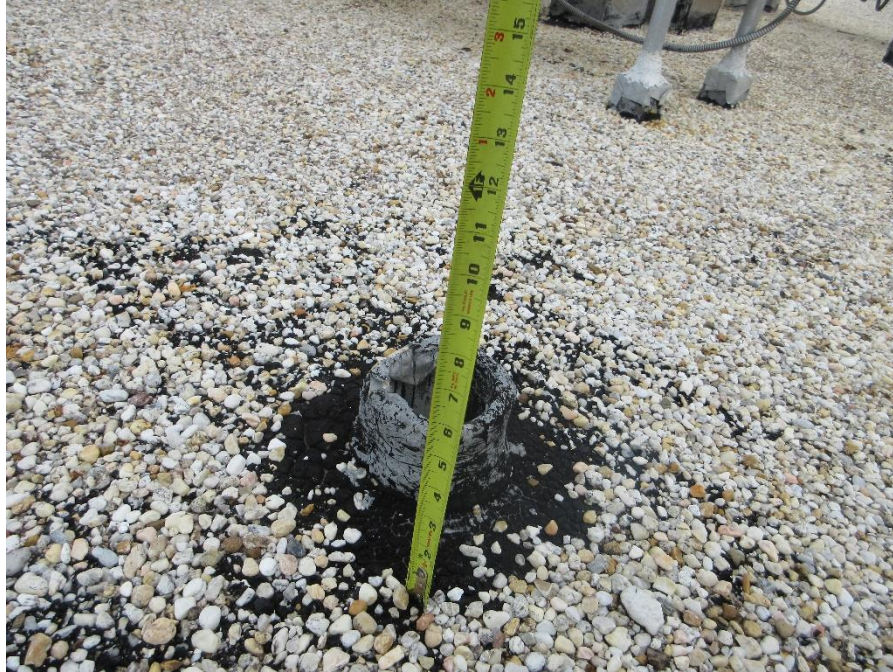
Photo #7 – Roof Vent Pipe Is Shorter than Allowed per FBC.

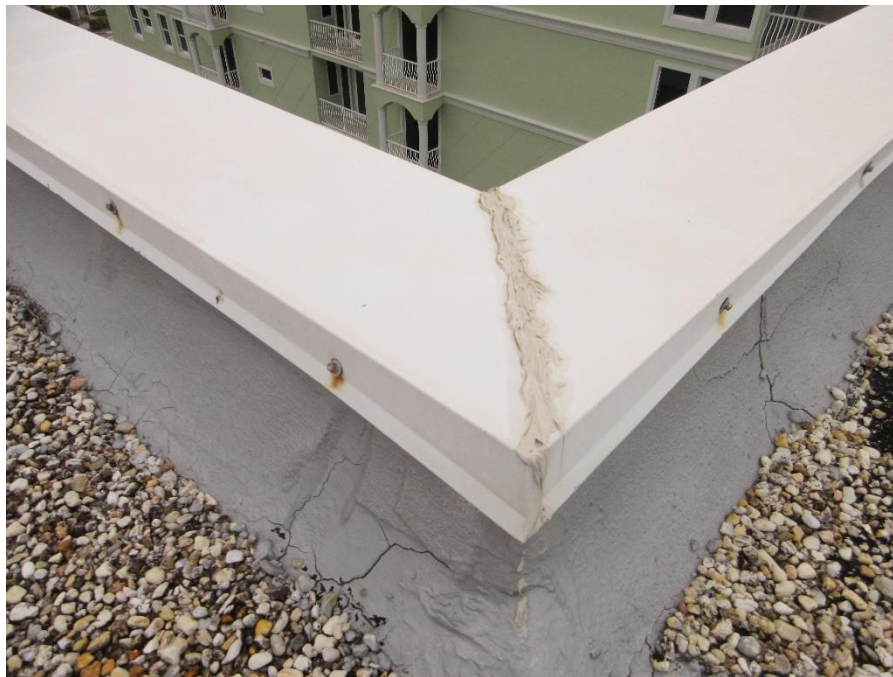
Photo #8 – Rusted Fasteners and failing sealant at Coping Caps (TYP.)

2. The visible exterior sealant was in fair condition. KE recommends that all exterior sealants be completely removed and replaced at each paint cycle. It is not known if this was completed during the most recent painting project. New sealants should be applied to all window frames and door sills to prevent water intrusion into the unit, and instead direct the water towards the weep holes and to the exterior as necessary. Sealant replacement should also be conducted at all light fixtures, electrical outlets and railing brackets and cable tv penetrations at balconies. The sealant work should take place during the next scheduled restoration/painting project.

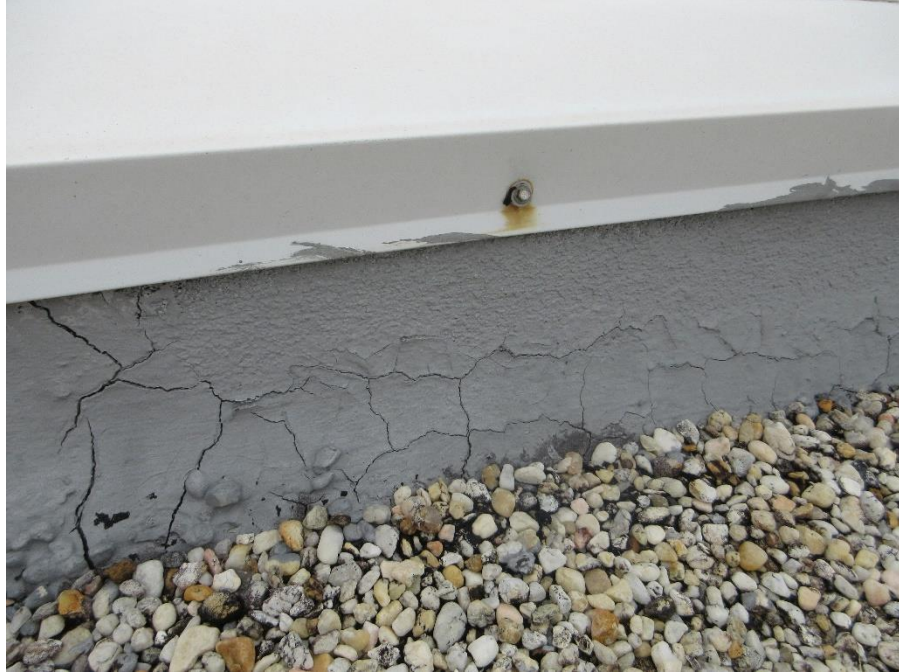
Photo #9 – Loose Fasteners and Scarred Flashing Membrane at Roof Perimeter (TYP.).

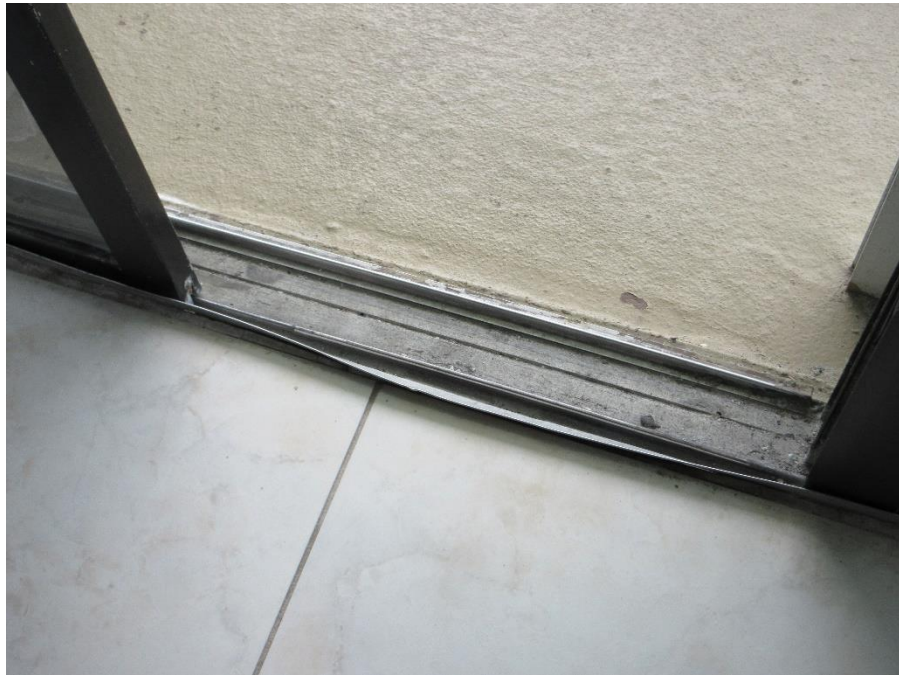
Photo #10 – Damaged and Low Door Threshold (TYP.).

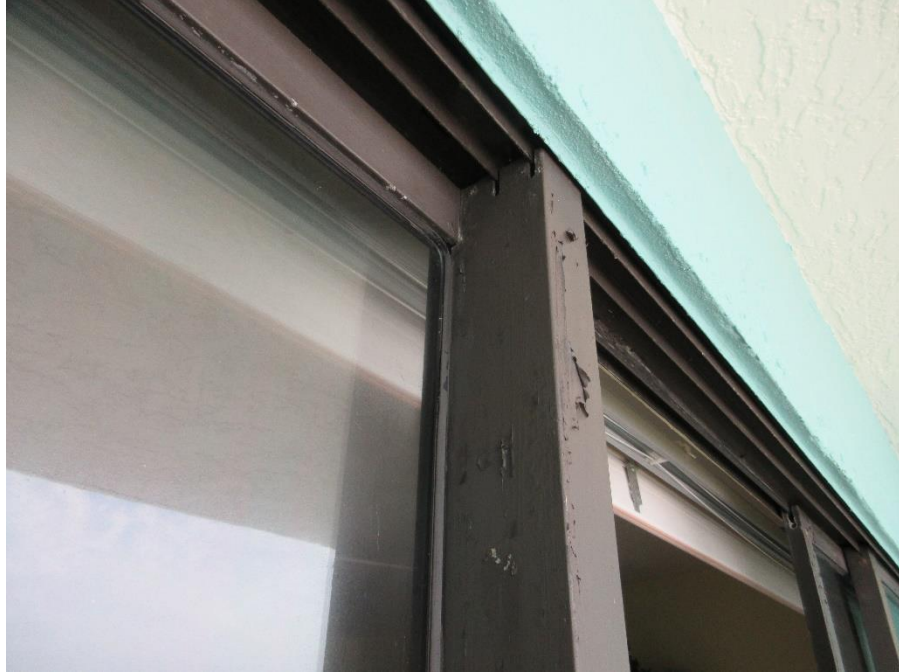
Photo #11 – Peeling Paint at Older Sliding Glass Door (TYP.)

1. Select sliding glass doors at balconies and the exterior windows at individual units have recently been updated to adhere to the code during recent repairs. However, most of the windows and doors installed at Chateaux are typically outdated and currently show heavy signs of rust, scratches, and peeling paint. Due to the building age of approximately 42 years old, it is recommended that all original windows and doors in the building be considered for replacement.

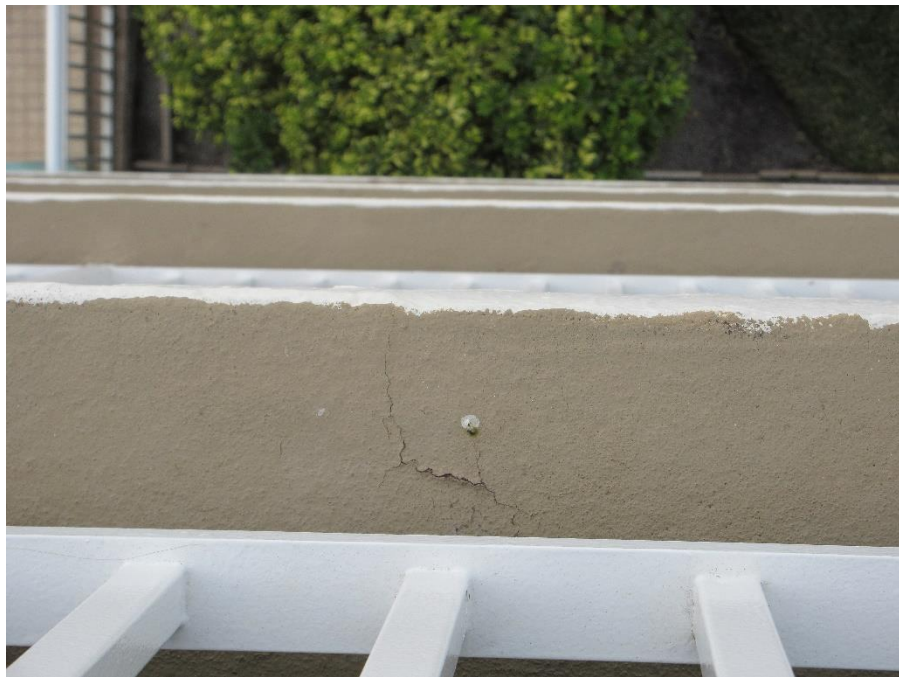
Photo #12 – Hairline Crack Perpendicular to Slab Edges (TYP.)

1. Minor concrete spalling and cracking was noted at the private unit balconies, windowsills, and common walkways. KE recommends that these areas be addressed during the next restoration project. The Board may want to consider repairing these areas at the same time as the Contractor is performing repairs in the parking garage area.

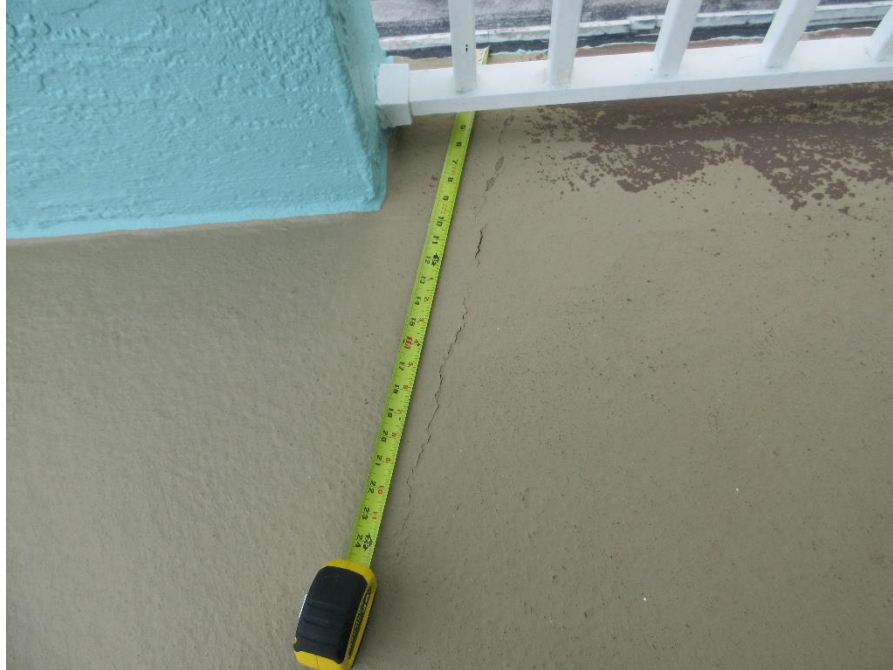
Photo #13 – 45-Degree Crack at NW Edges of Balcony Slabs (TYP.)

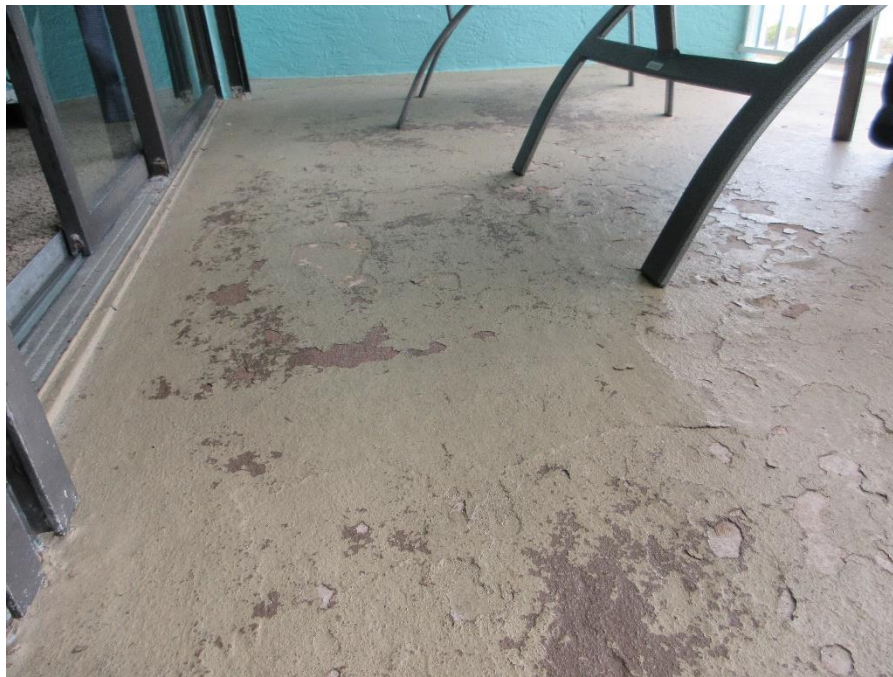
3. Existing waterproofing membranes/coatings at the balconies and common walkways appear to be approaching the end of useful life. It appears that a secondary coating/paint was installed on top of the previously installed membrane during the last painting project. All the coatings are currently failing and providing limited protection to the concrete

Photo #14 – Deteriorated Deck Membrane at Unit's Balconies (TYP.)

slabs below. It is recommended that all reinforced concrete in proximity to the Gulf of Mexico be protected with liquid applied urethane membrane due to the corrosive environment typical in coastal areas. It is recommended that all balconies be waterproofed, including all balconies with original or existing tile that pre-dated the installation of the newer style aluminum guard rails. It is KEGs understanding that at locations with original tile and/or tile installed prior to the installation of the balcony guardrails do not have a waterproofing membrane and/or the time elapsed since the tile install exceeds any reasonable warranty period or useful life of typical materials used for these applications. KE recommends that the floor coatings be relaced with the next 1 to 2 years.

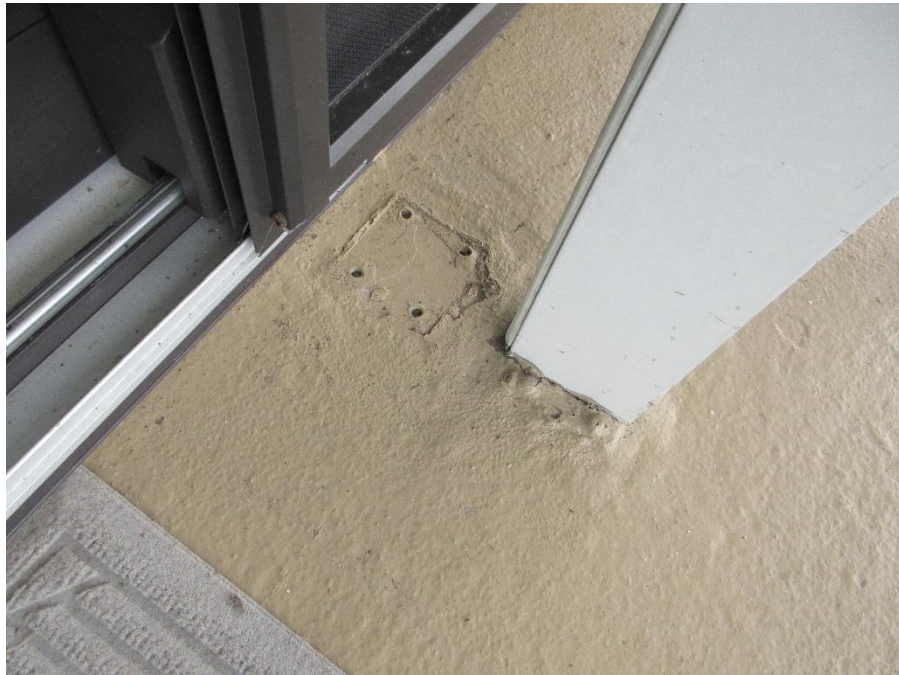
Photo #16 –Unfilled Holes Left in Balcony Deck.

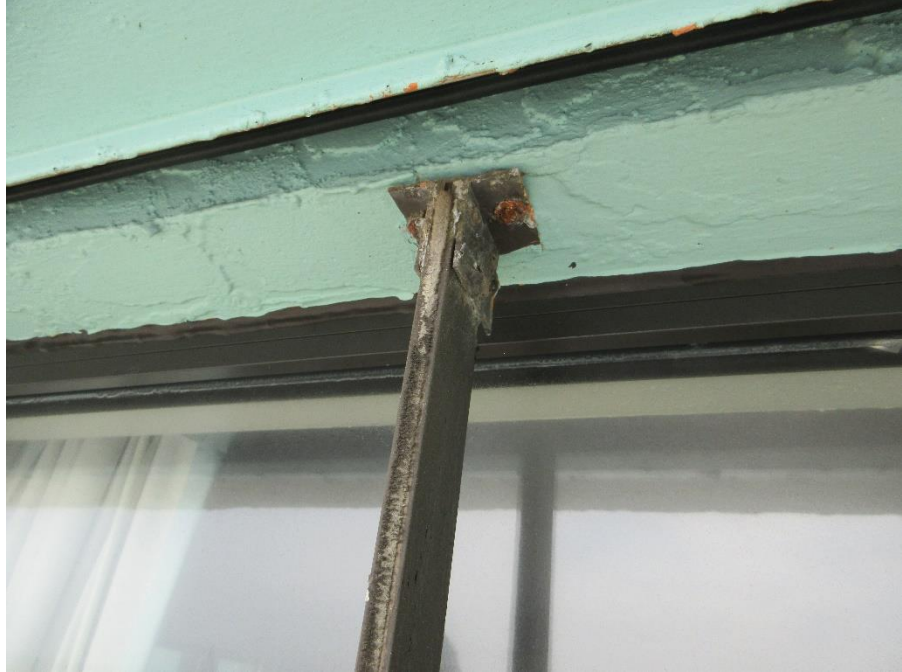
Photo #17 –Corroded Shutters Framing (TYP.)

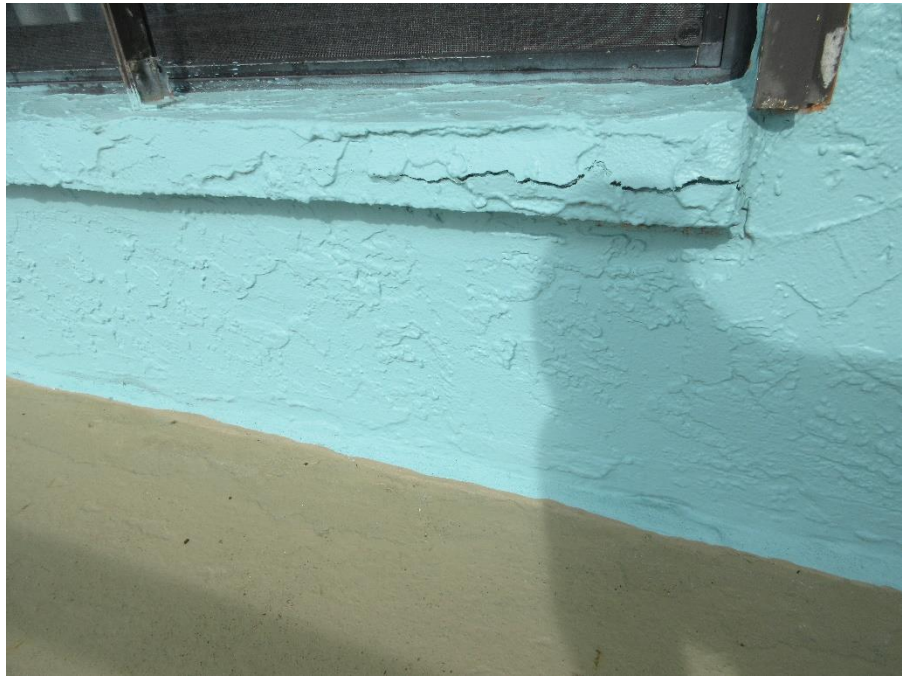
Photo #18 – Broken Windowsill at Unit #501.

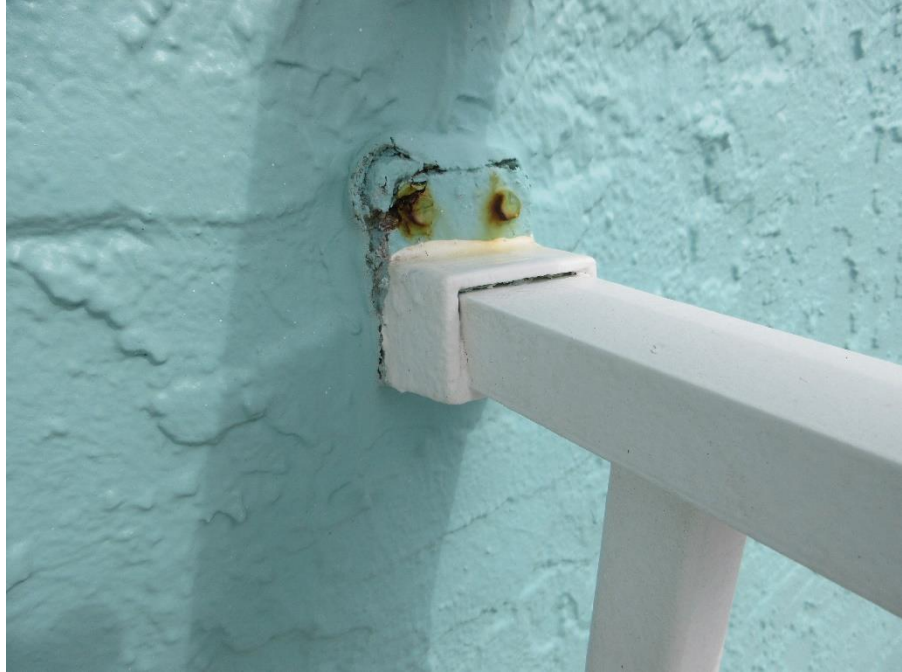
Photo #19 – Broken Railing End Bracket at Walkways due to Rust. (TYP.)

2. KEG noted a number of locations where railing fasteners were either missing or corroded. Given that railings are an important life safety aspect of the building, KEG recommends any missing and/or corrode fasteners be replaced with new same sized 316 stainless steel fasteners as soon as possible. This work should be completed by a licensed General Contractor that specializes in concrete restoration.

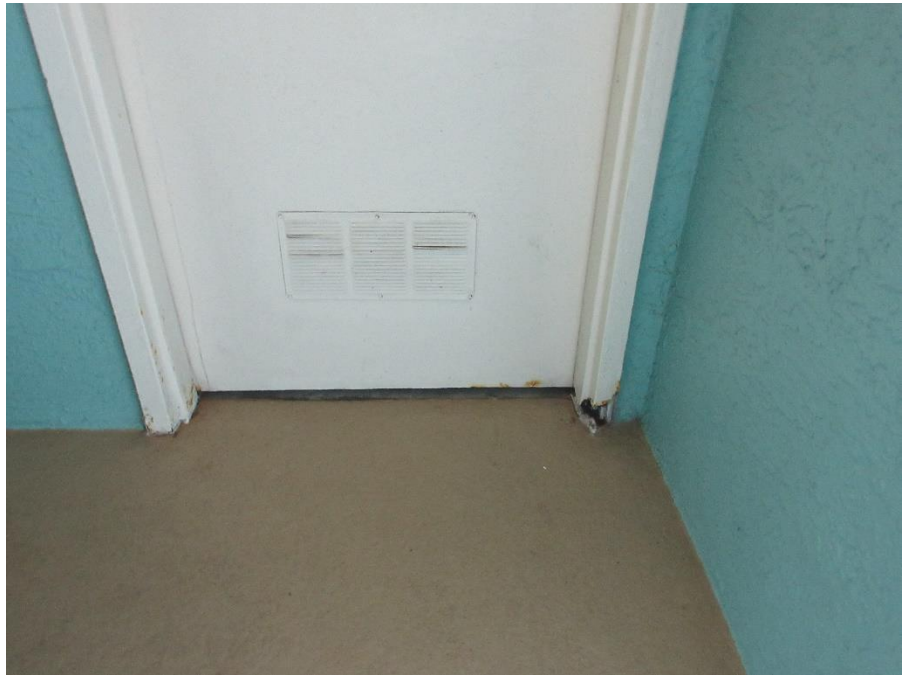
Photo #20 – Corroded Door Jambs at Storage Room (TYP.)

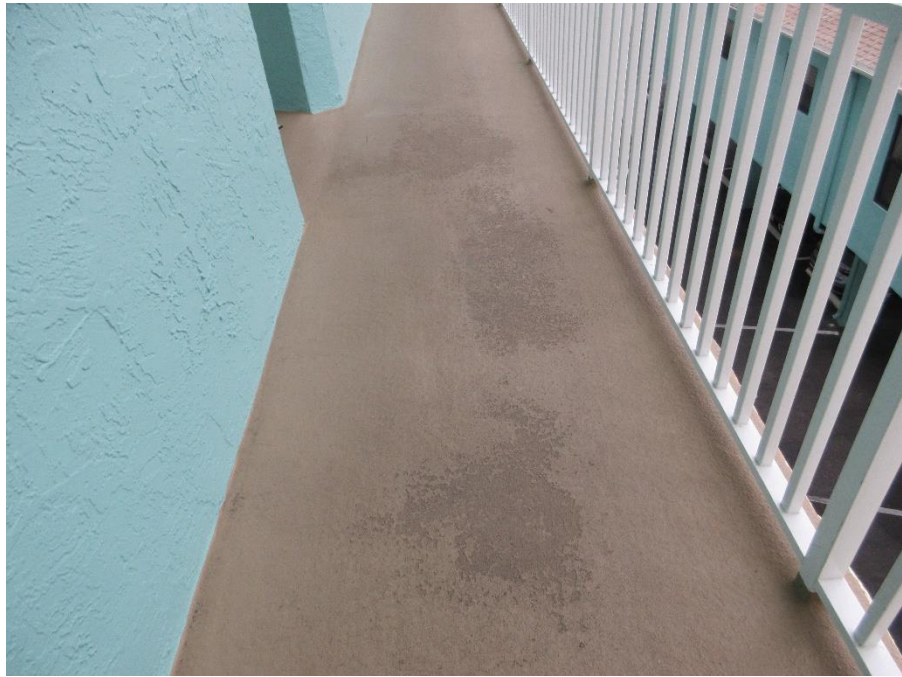
Photo #22 – Typical Concrete Slab Surface Damages or Spalls Covered with Floor Paint (TYP.)

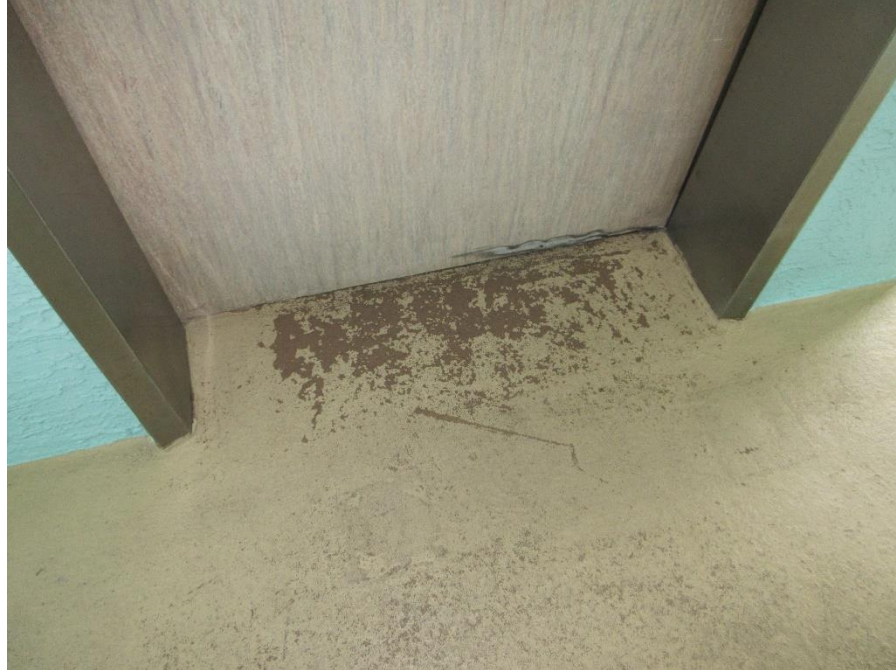
Photo #23 – Deck Coating Peeling at Elevator Room Door (TYP.)

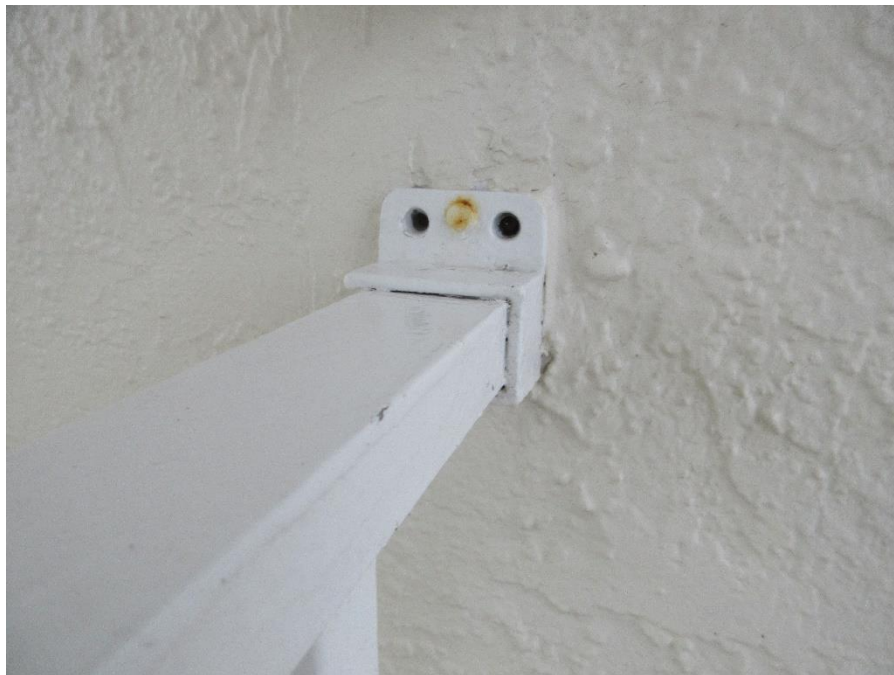
Photo #24 – Missing Fasteners at Railing Ends Brackets (TYP.)

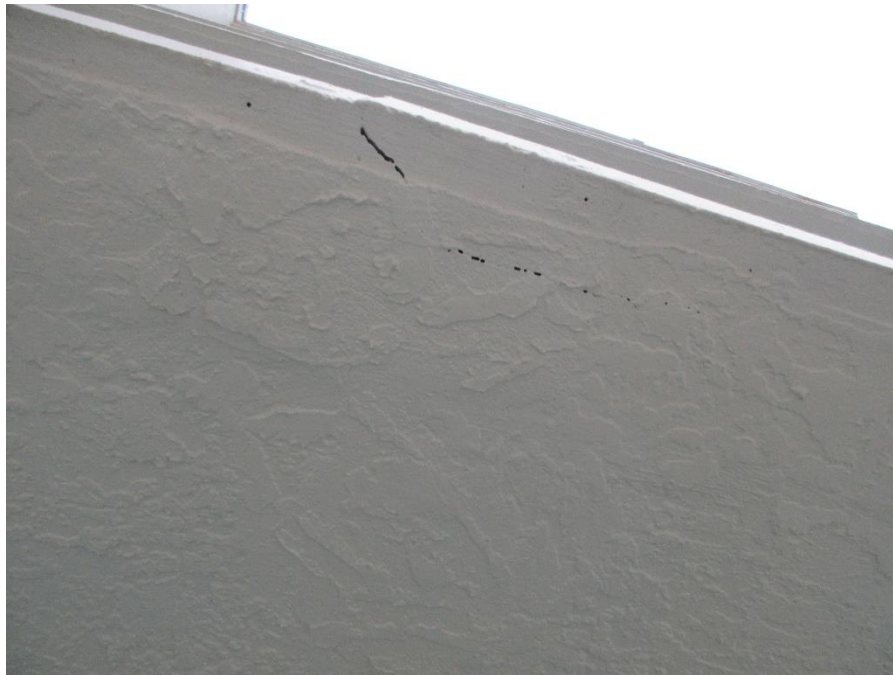
Photo #26 – Concrete Edge Crack at 2nd Floor Slab on East Side of Building.

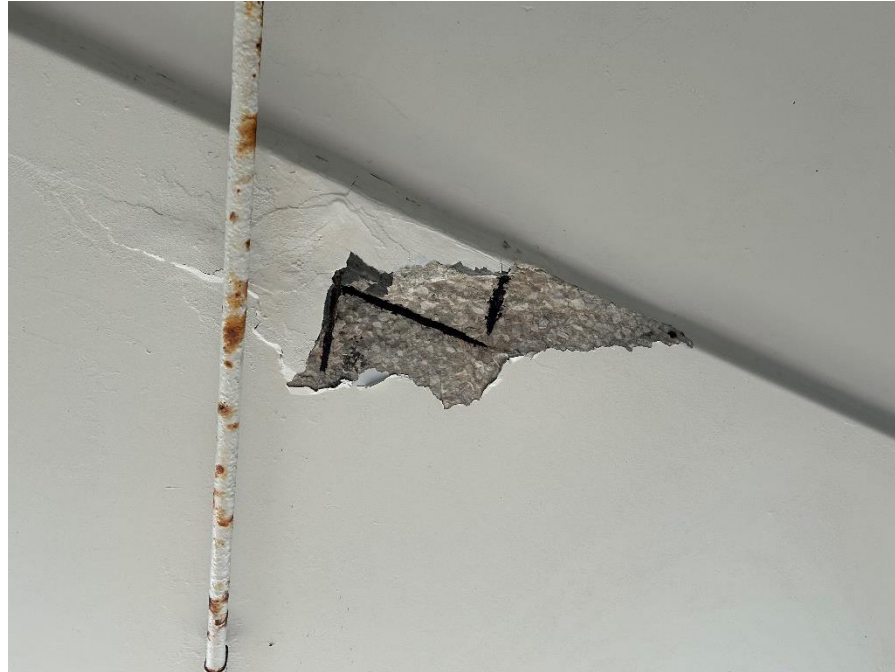
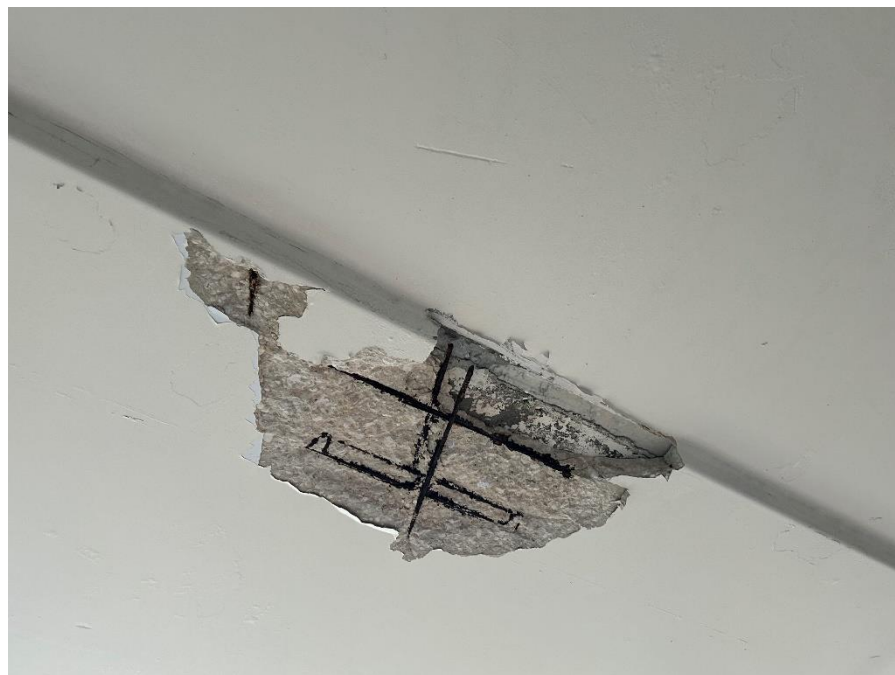
1. Corroded exposed metals/hangers, cracks and large spalling concrete were noted in the underbuilding parking's ceiling. Some areas were roped off for the residents' safety. Recommendations would include removal of all unused metal fasteners, exposed metals, and the repair of the precast concrete panels in accordance with ACI and ICRI Guidelines. As the failing concrete poses a life safety risk if it falls on residents and guests, this work should be completed as soon as possible by a licensed General Contractor that specializes in concrete restoration.

Photo #27 – Concrete Spalls on Underbuilding Parking's Ceiling (TYP.)

Photo #28 – Concrete Spalls on Underbuilding Parking's Ceiling (TYP.)

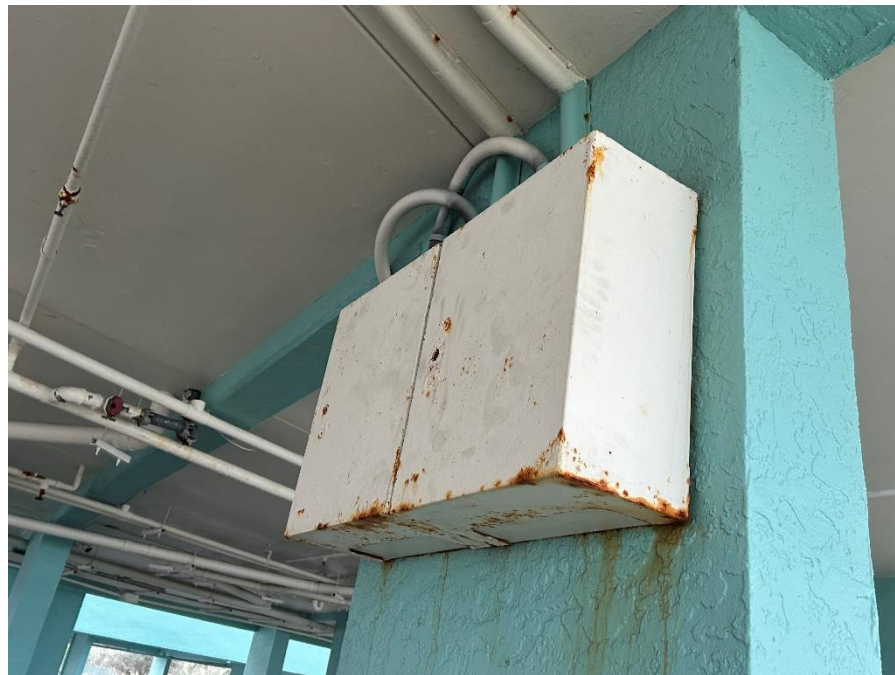
Photo #30 – Rust and Efflorescence at Electrical Meter Box in Garage.
