Water Transmission Main Condition Assessment

March 6, 2024

City of Elyria Water System

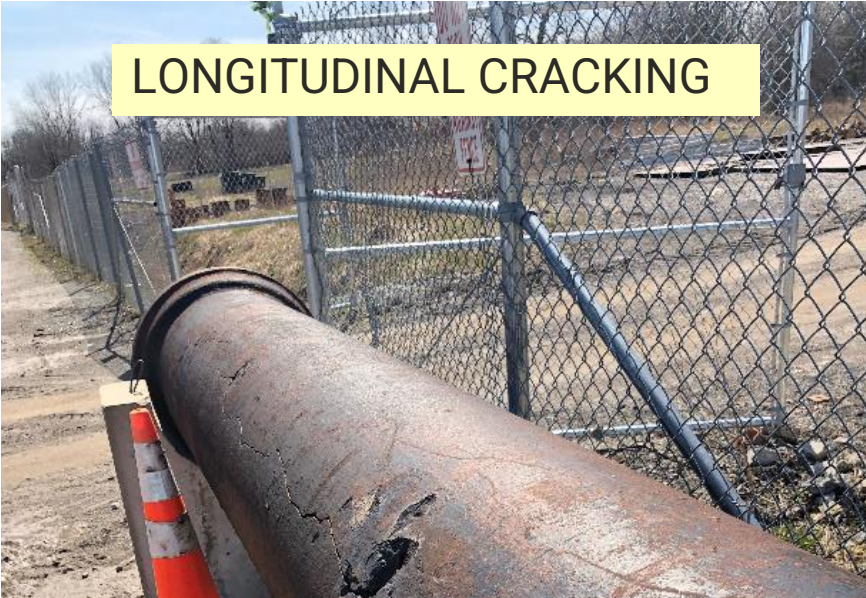
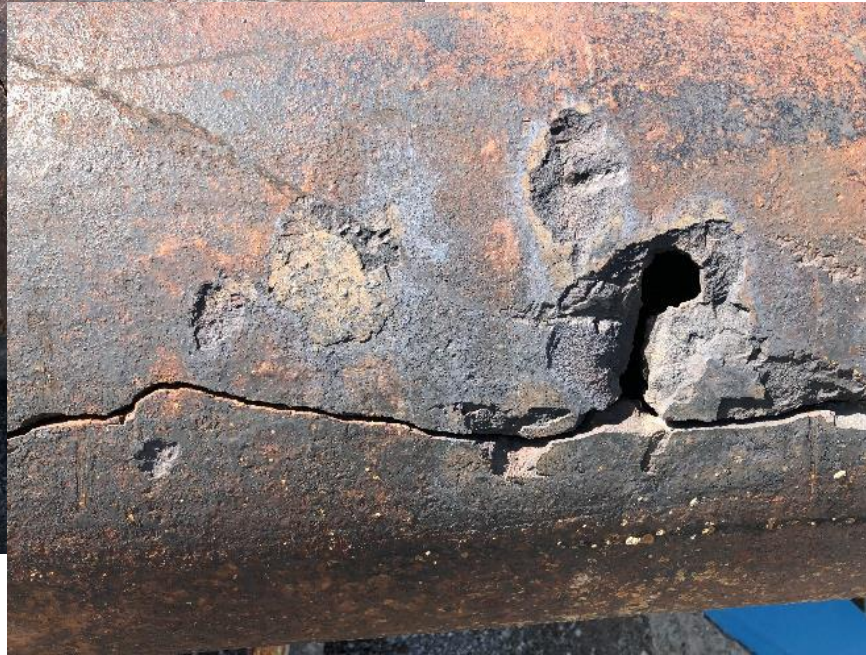
LONGITUDINAL CRACKING

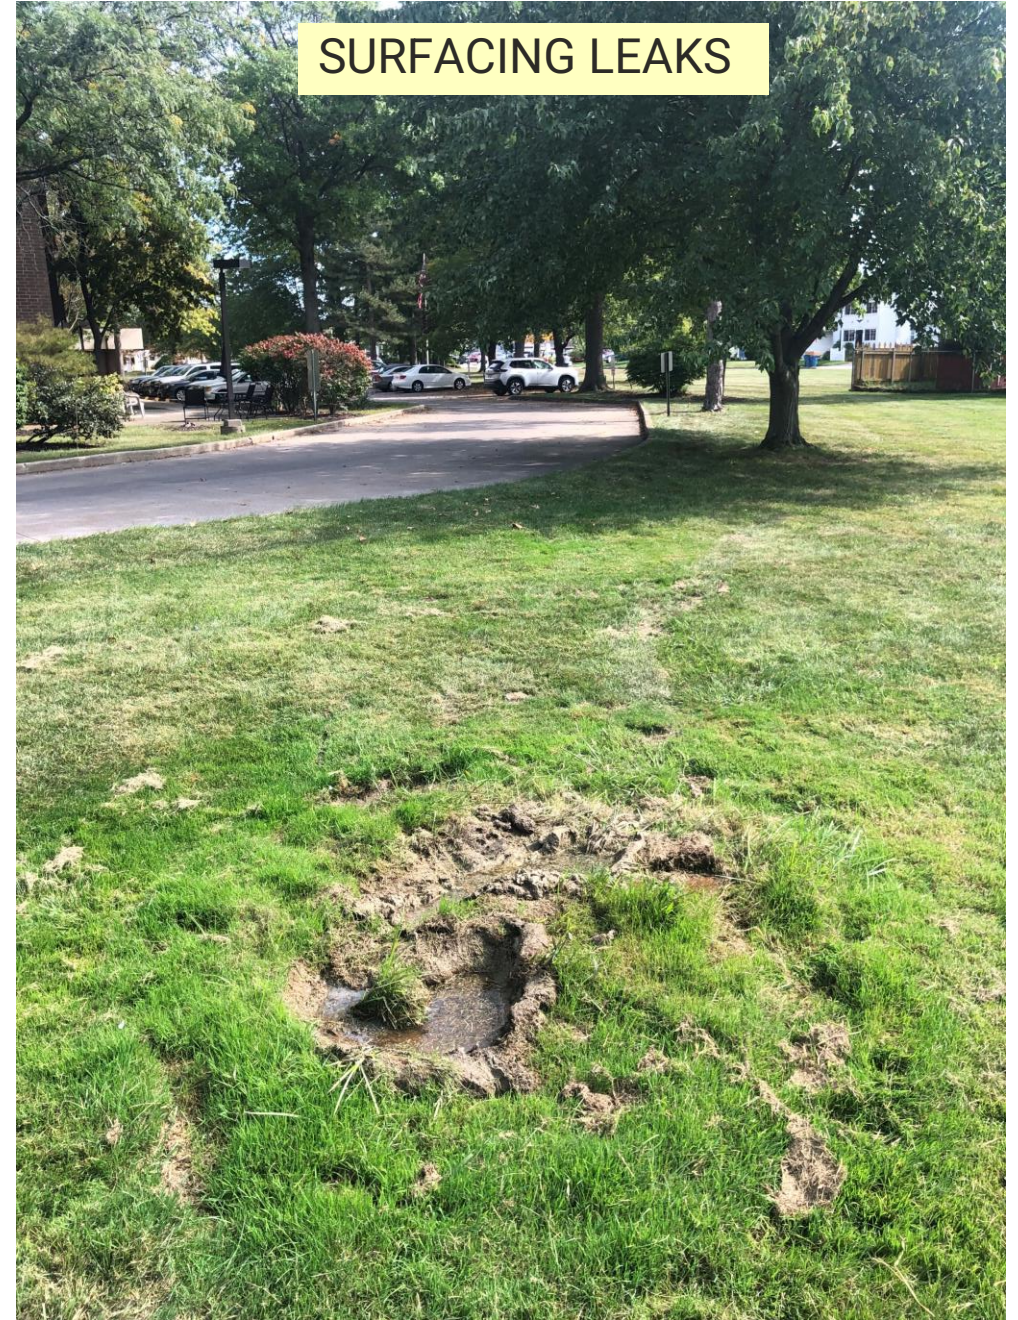
SURFACING LEAKS

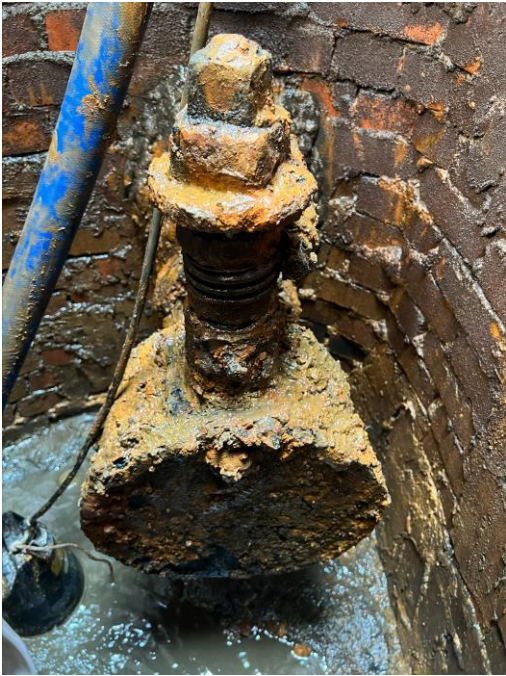
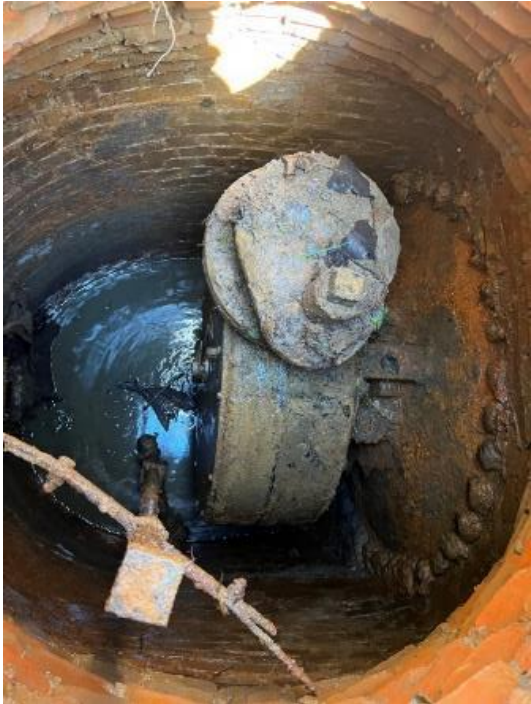
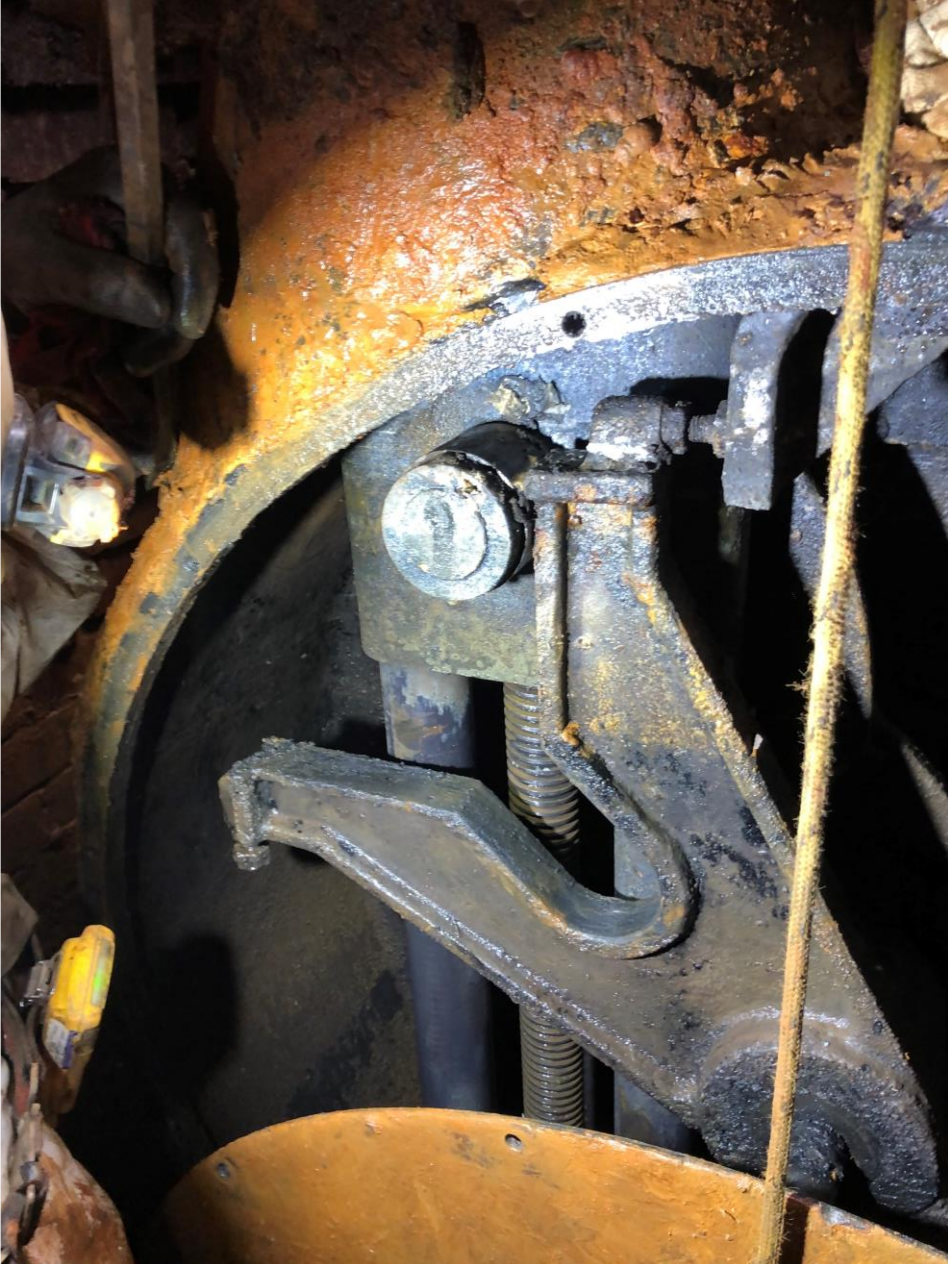
All cone valves operated very well and were in great condition.

48 – 30-inch Cross-connection gate valves also operated well

- **No action needed prior to inspection**

- Continue to monitor performance of valves and exercise valves on a scheduled program.

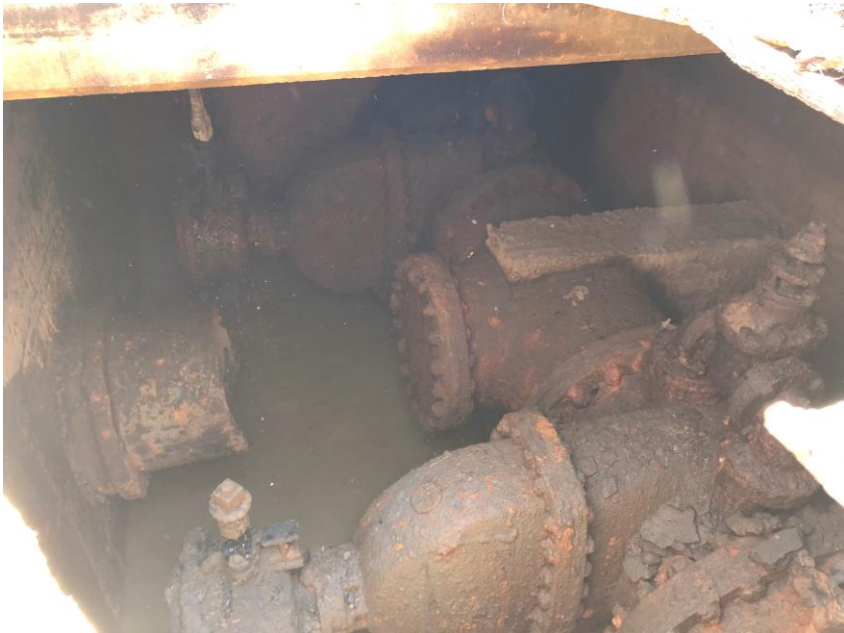
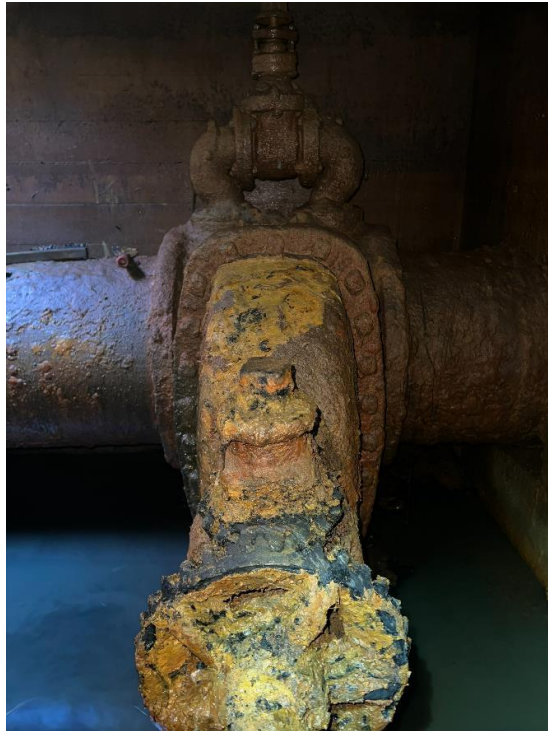
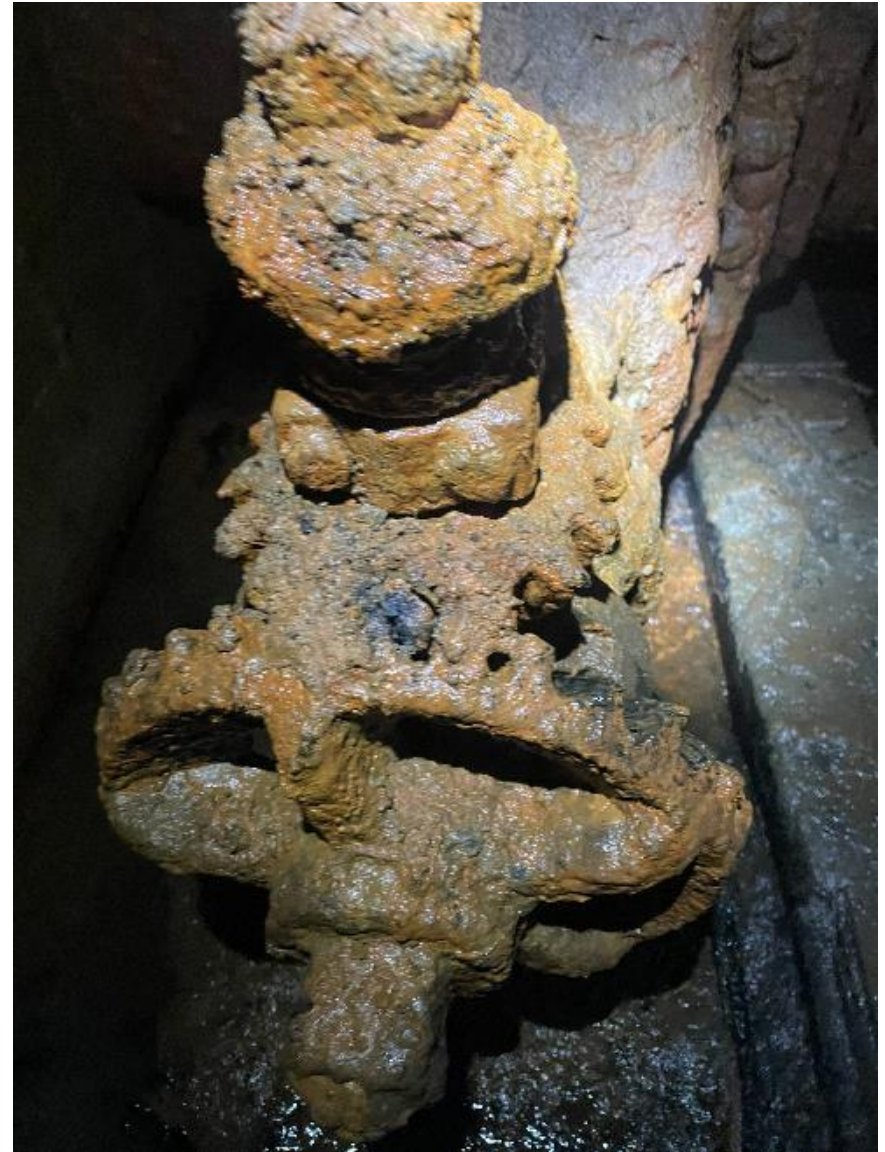
Valves were very corroded

Valves struggled to exercise 25% often

Some exposed gear boxes on the 20-inch CIP valves in very poor condition – did not exercise

- No action needed prior to inspection.

- Continue to exercise valves in operable condition
- Avoid exercising high risk valves identified in TM
- Replace all valves including air valves and drain valves during pipeline rehabilitation project or within 10 years.

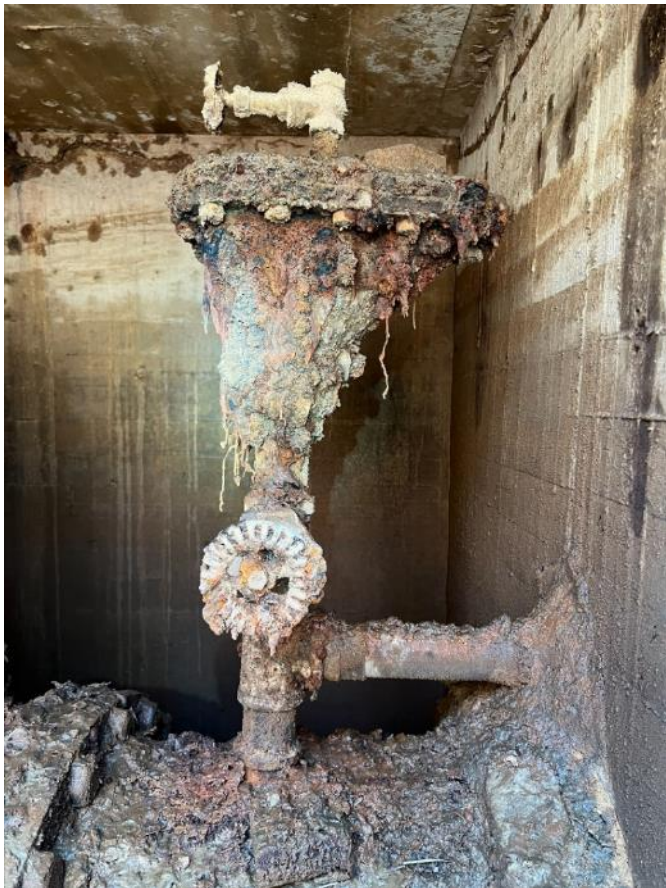
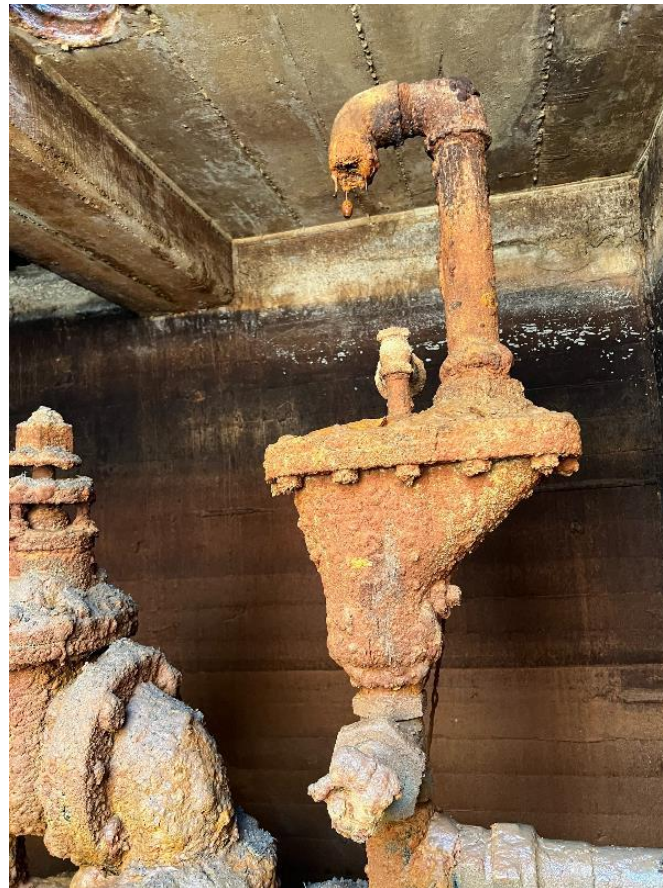
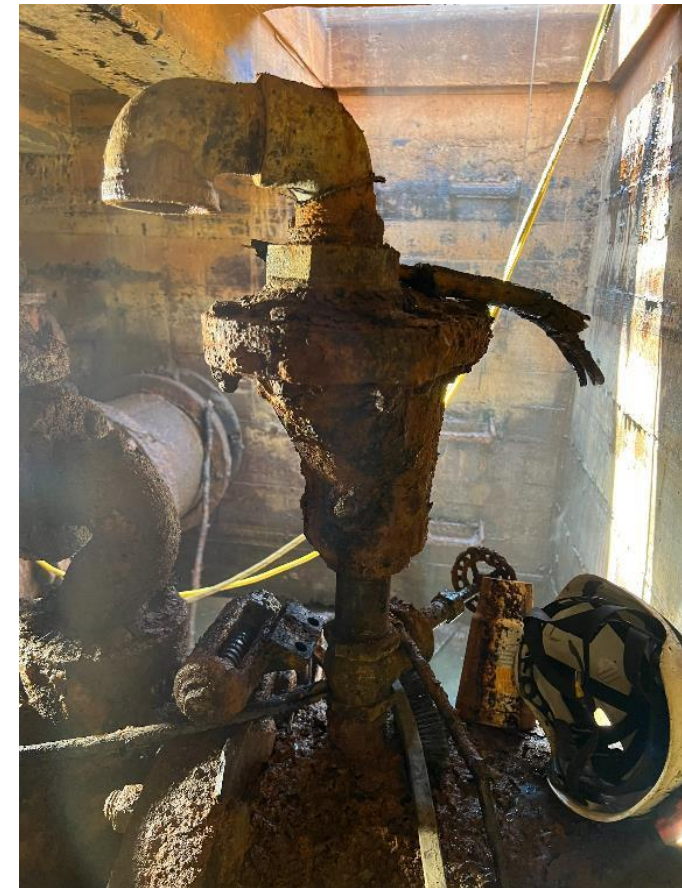
Air Valves were very corroded and in poor condition

Did not operate or exercise air valves
