VII. ANALYSIS

7.1.3 Events after the collision of the Train No.12841 with Goods Train N/DDIP

8.2 Cause of the Accident.

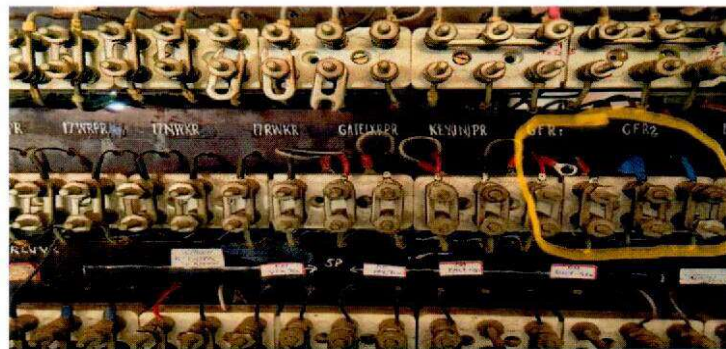
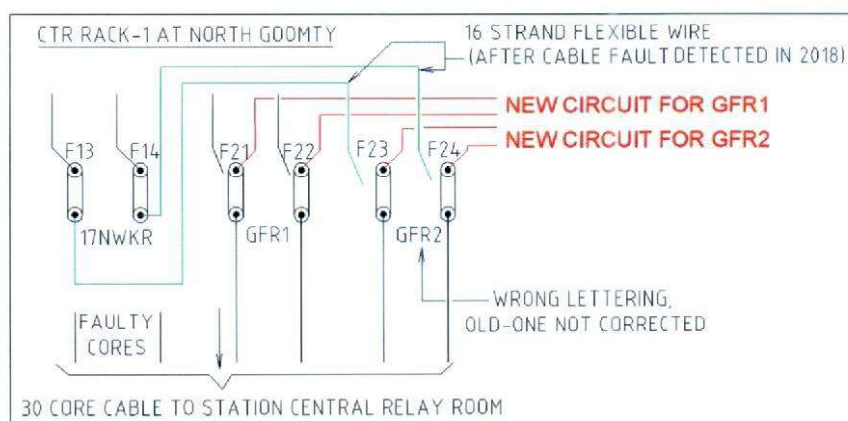
- iv. Thus, 17NWKR circuit was running on the terminals F23&F24 which were marked as GFR2 on the cable terminal rack at the North Goomty.
- v. While carrying out the wiring work of the new ELB, the S&T staff had disconnected the existing wires at terminals F23&F24, and F21&F22, assuming GFR2, and GFR1 respectively, and rewired for new ELB accordingly.

This is depicted in the following picture: -

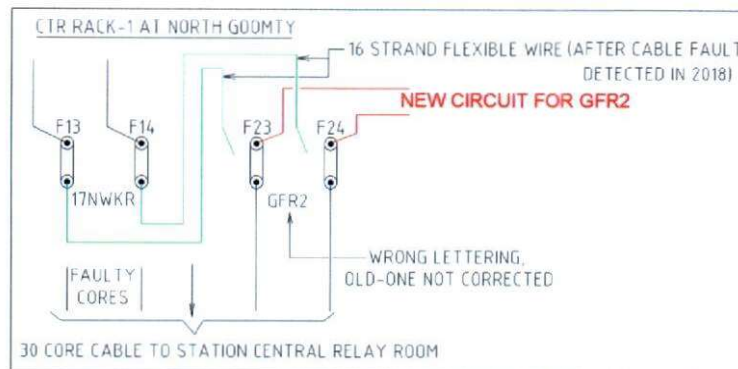
7.2.4.5 The S&T staff realized that they had disconnected the feed coming from the Crossover 17A/B to 17NWKR circuit, and instead connected 3GF RR circuit feed, which is normally available continuously, to 17NWKR circuit; thereby indication feed of Crossover 17A/B was disassociated from the status of the points at site. The following circuit diagram may please be referred in this regard:-

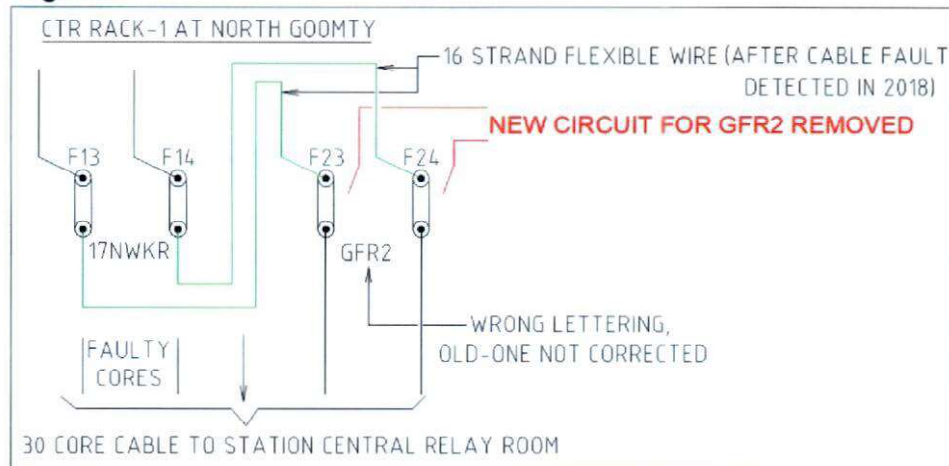
7.2.4.6 After the accident, at 23:28:51:046 hrs, 17NWK1R dropped automatically, picked up and finally dropped at 23:28:58:750 hrs. As per their deposition during the inquiry on 19.6.23, after noticing the mistake in the wiring mentioned above, second GFR (3GF RR) circuit, terminated on F23 & F24, was removed, and the originally released wires for 17NWKR were connected back. The following circuit diagram may please be referred in this regard:-

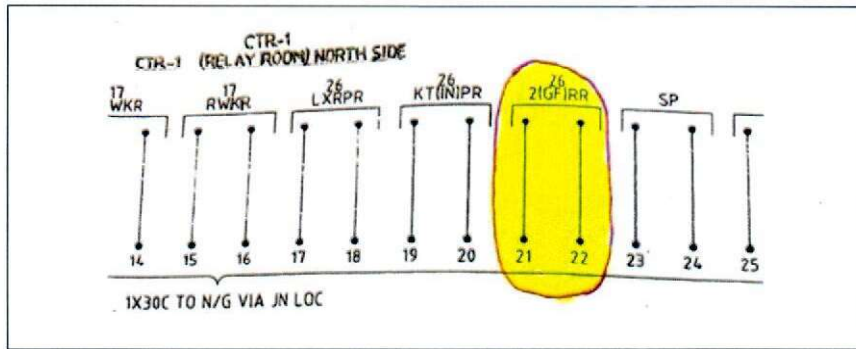
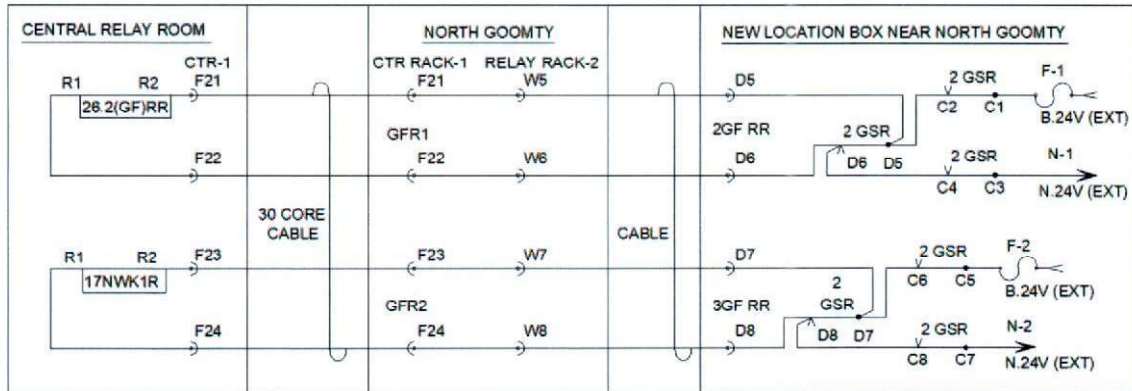
7.2.4.7 The S&T staff expressed that they were misled by following anomalies: -

- Wrong lettering on the terminal F23 & F24 as GFR2 where 17NWKR circuit was running.
- They had no knowledge of shifting of 17NWKR circuit from terminals F13 & F14 to terminals F23 & F24; the shifting of this circuit, wherein wires were drawn from back-side of the rack, was not visible from the front side.
- The circuit of LC 79/BLS requires two GFR circuits, viz. 2GF RR, and 3GF RR, whereas for LC 94 only one GFR, viz. 26.2(GF)RR (as designated in the Central Relay Room) was needed which was available at F-21 & F22 terminals. This following extract from the terminal chart of BNBR station [complete terminal chart is enclosed at Annexure (xiv)], and an extract of as made wiring diagram of for ELB-replacement work of LC-94 [diagram at Annexure (xv)] may please be referred in this regard: -

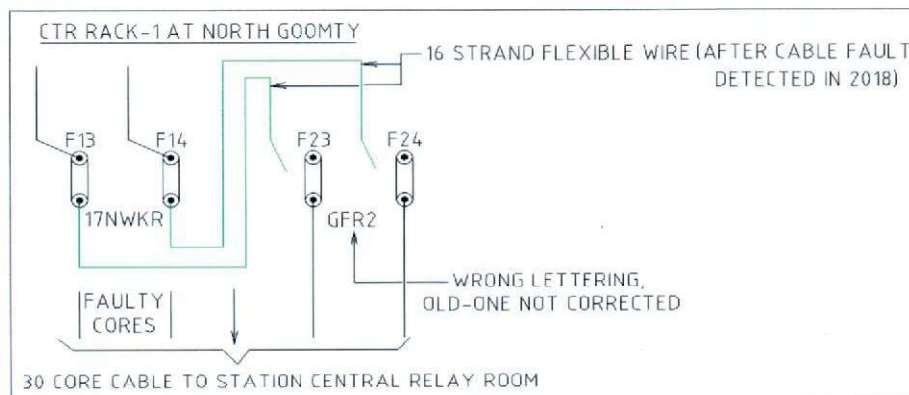
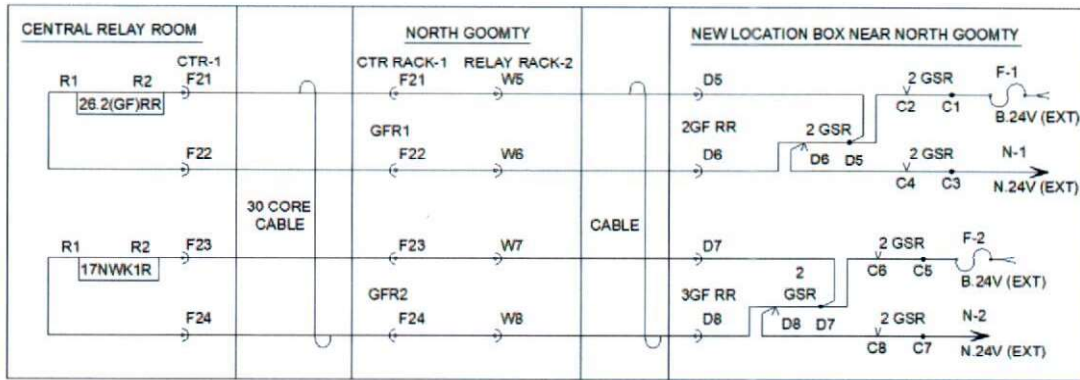
8.1.1 The first instance of point failure of the Crossover 17A/B, on 02.06.23, was recorded at 16:20:53:437 hrs, wherein it unexpectedly failed at Normal position.

Explanation: After obtaining disconnection permission at 16:20 hrs, the point failed as the 17NWKR circuit was removed from terminals F23 & F24 on CTR Rack-1 for replacement of GFR2 circuit as per the lettering on these terminals by connecting second GFR (3GF RR) circuit of LC 94 as per the wiring diagram of LC-79/BLS. The following circuit diagrams may please be referred in this regard: -

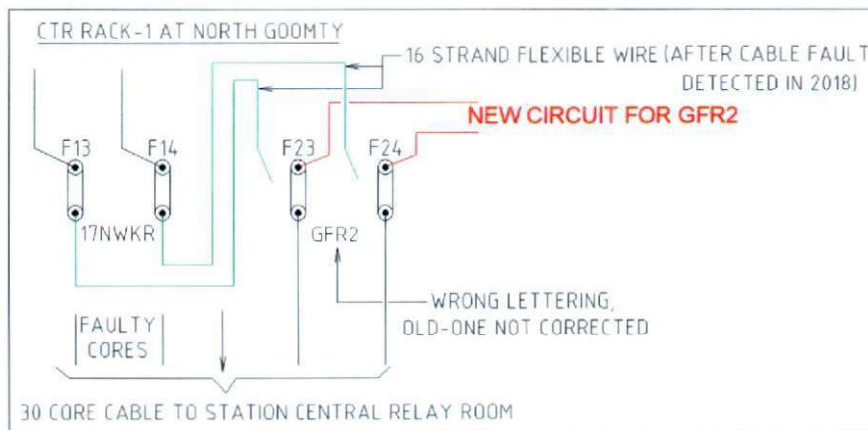
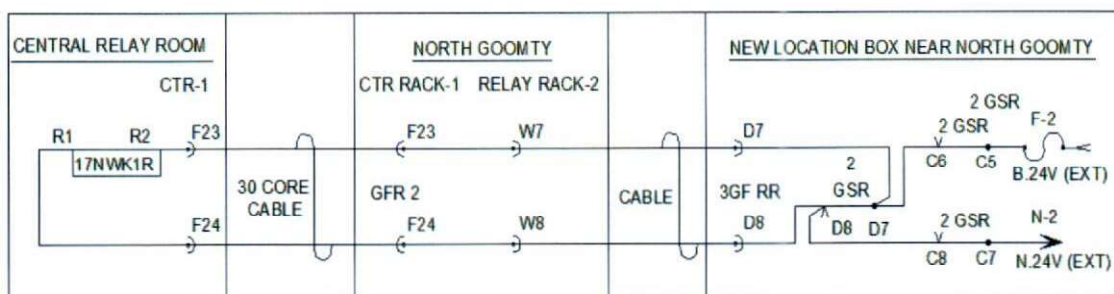
8.1.2 Then SM/BNBR operated the crossover A/B through individual-operation from Normal to Reverse, it took usual time of around 14 seconds, but when he operated the point through individual-operation from Reverse to Normal, it took around 37 seconds and the crossover A/B was set to Normal at 16:22:19:671 hrs – this was unusual.

Explanation: The second GFR (3GF RR, as per the circuit of LC-79/BLS) circuit of LC 94 was connected at 16:22:19:671 hrs at terminals F23 & F24 of CTR Rack-1 of North Goomty, and its feed was extended to the Central Relay Room for 17 NWK1R. Since this feed is normally available, feed to the 17NWK1R was available permanently irrespective of the status (Normal or Reverse) of the Crossover 17A/B. Though the Crossover 17A/B was set to Normal at site, but its indication relay (17NWK1R at Central Relay Room) picked up only after connection of the second GFR circuit at 16:22:19:671 hrs – this explains the reason for time of 37 seconds instead of usual time of 13 to 14 seconds. The following circuit diagrams may please be referred in this regard:-

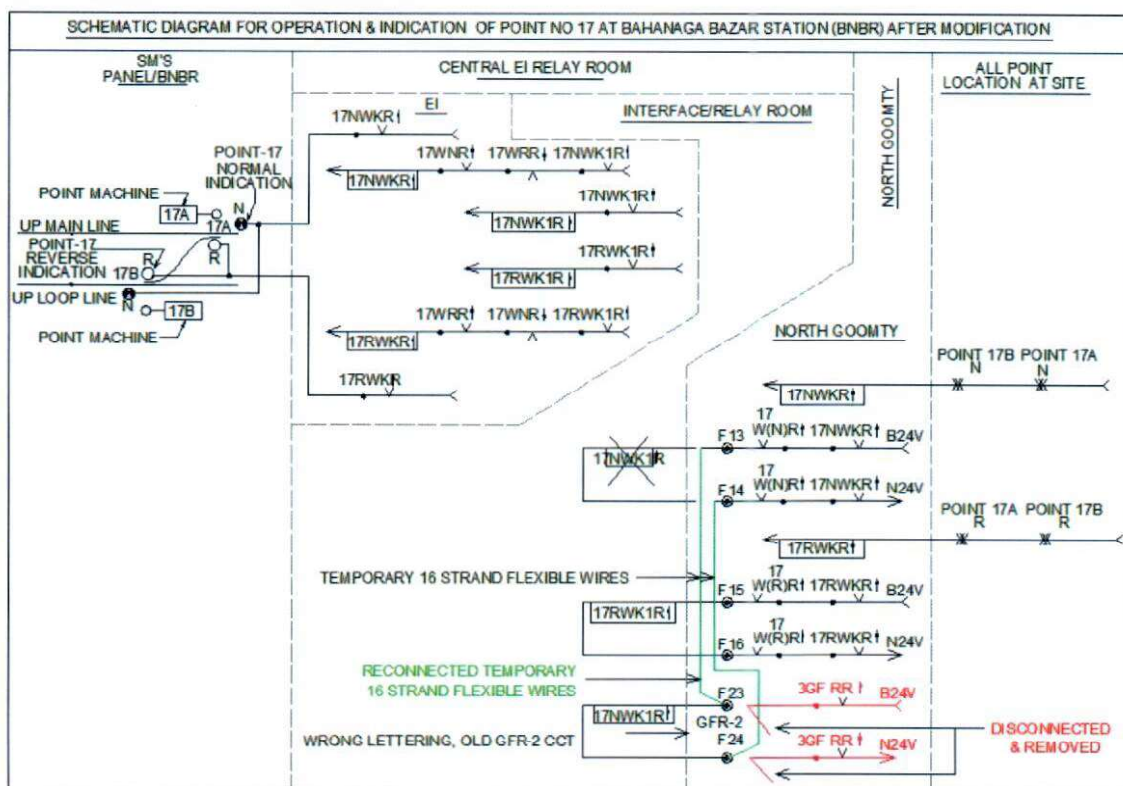
8.1.3 Further, the Crossover 17A/B was set to Reverse from Normal at 18:14:22:953 hrs through initiation of the Signal Route 1B, i.e., for reception of an UP Goods train on the UP-Loop line. Subsequently, with the same point setting, another Goods train No. N/DDIP was received on the UP-Loop line, and the Route 1B was released at 18:34:52:968 hrs.

Explanation: The design of Point circuit was such that though NWK1R was in picked up state, it was possible to operate the point to Reverse from Normal. As the Point reverse indication circuit was not disturbed, keeping correspondence with actual site condition, 17RWK1R was picked up at the Central Relay Room. As the command relay WRR was in picked up state (which forced dropped relay WNR), 17NWKR logic got dropped though 17NWK1R was picked up – this allowed 17RWKR to pick up. Thus, the Signal could be taken off for the UP loop line. The following circuit diagrams may please be referred in this regard:-

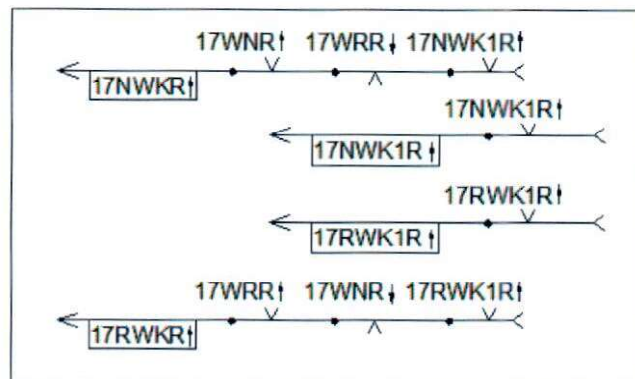
- i. From 16:22:19:671 hrs, 17NWK1R (in central relay room) was in picked up state with the feed of the second GFR/LC 94, and when the Crossover 17 A/B was set to reverse at 18:14:22:953 hrs, 17RWK1R (in central relay room) picked up in correspondence with the point status at site. It may be observed that both 17 NWK1R, and 17RWK1R were in picked up state from this time. The moment individual command was initiated, the logic bit 17NWKR in EI picked up immediately as pick up state of 17NWK1R was readily available by false feed [of

second GFR circuit (3GF RR)]. The following extract of the schematic diagram of operation and indication of crossover 17A/B [the complete drawing at Annexure (xvi)] may please be referred in this regard:-

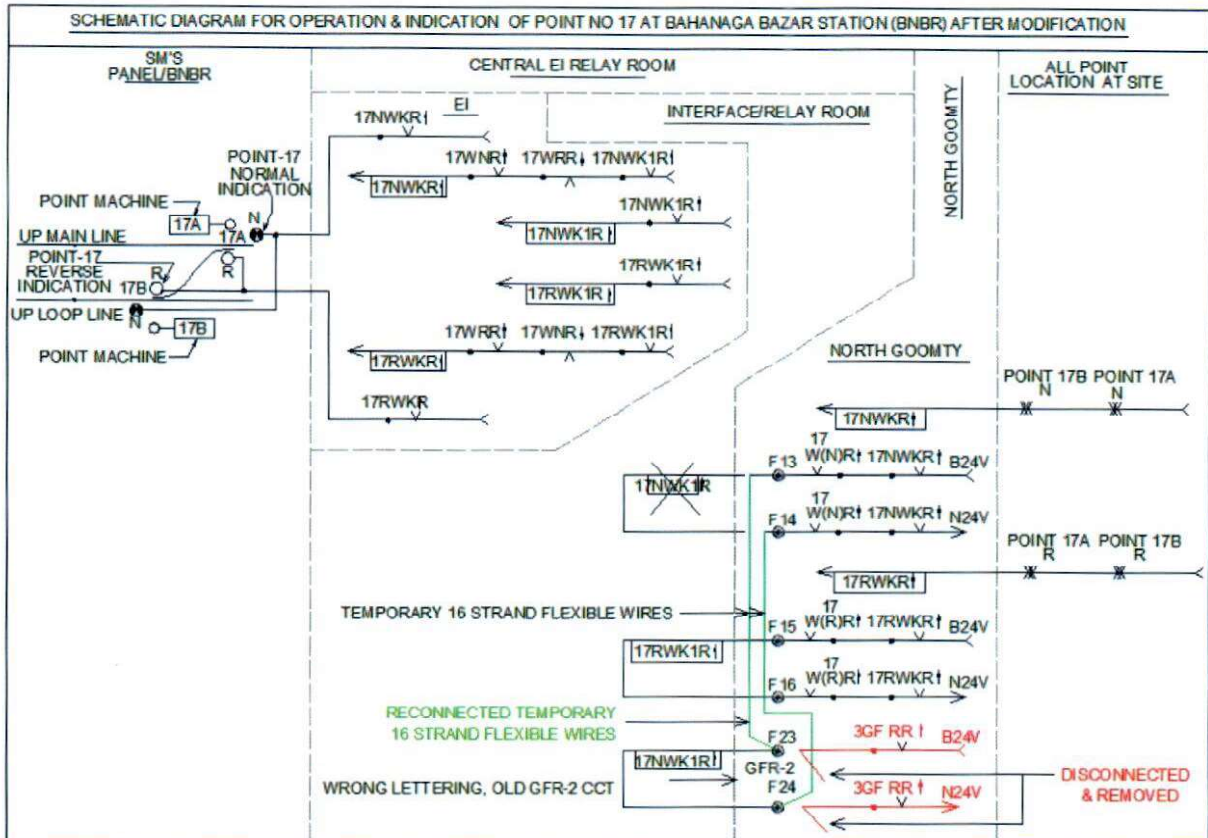
8.1.5 Even after 18:34:59:265 hrs though in the Panel the Crossover 17 A/B was showing Normal, but at site it was in Reverse state, and accordingly, 17RWK1R was in picked up state in the Central Relay room.

- i. As 17NWK1R was already in picked up state, even after initiation of individual command for operating the point from Reverse to Normal, the command was not extended to the North Goomty and 17W(R)R latch relay remained in picked up state at the North Goomty. Through this latch relay pick up, feed at the North Goomty was extended to 17RWK1R.
- ii. Though both 17NWK1R and 17RWK1R were in picked up state, as the last command logic bit (17WNR) for Normal operation of Crossover 17 A/B was in picked up state, it force-dropped 17WRR and thereby 17RWKR logic bit became low, and allowed 17NWK1R to high in EI logic. Due to this, Normal indication of the Crossover 17A/B was available on the Panel even when it was Reverse at site.

The following circuit diagram [also at Annexure (xvi)] may please be referred in this regard:-

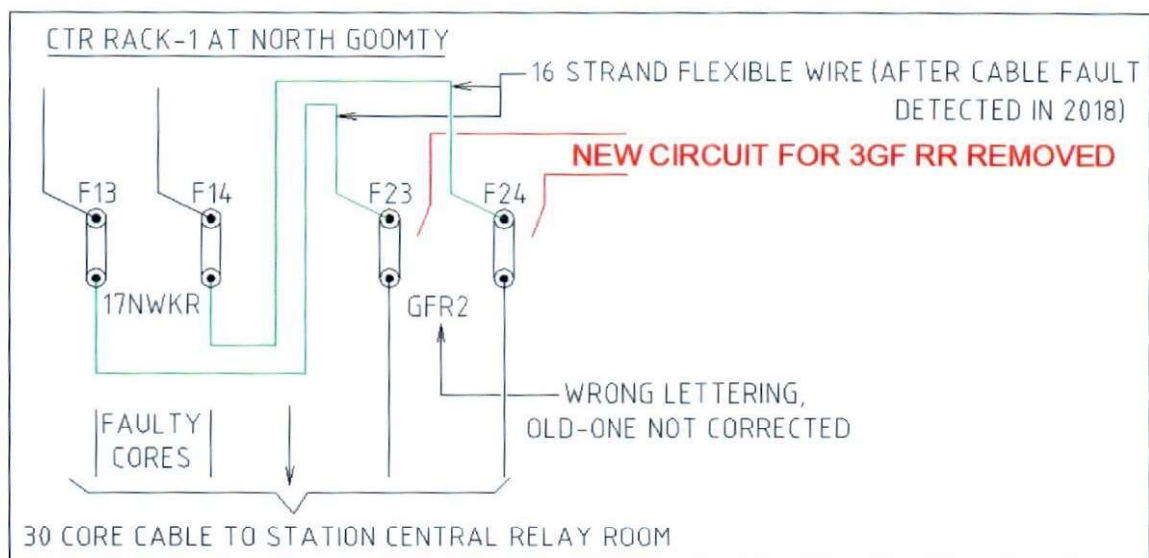
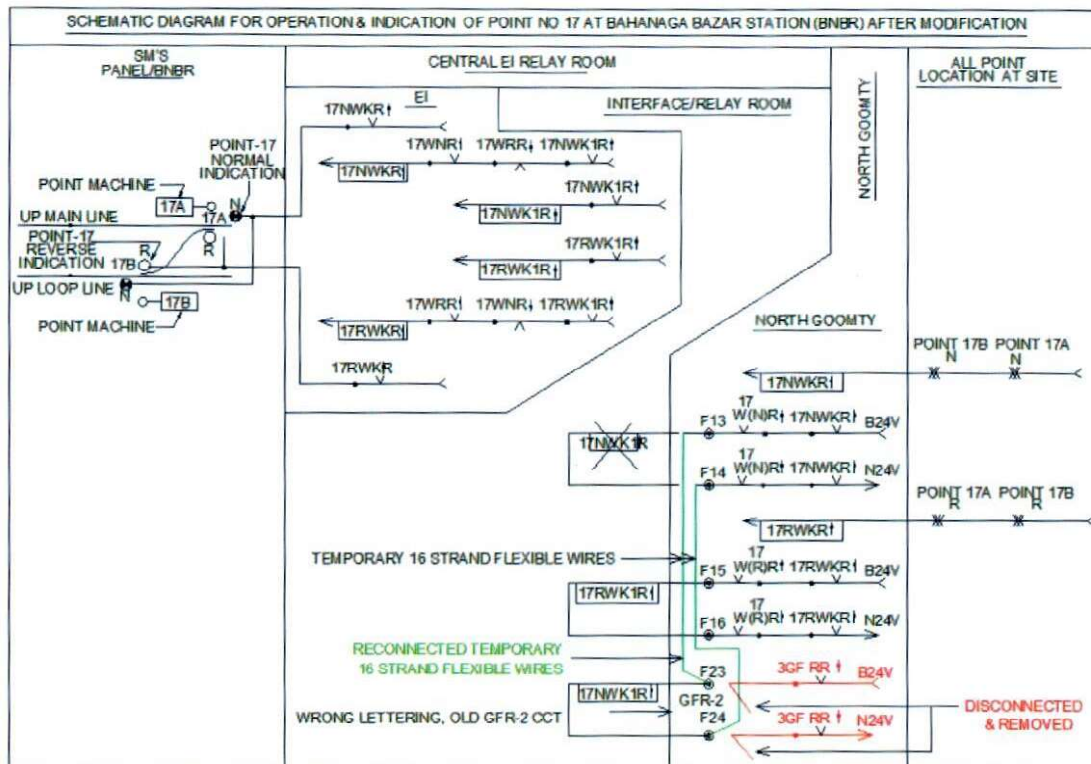
8.1.9 After the accident, at 23:28:51:046 hrs, 17NWK1R dropped automatically, picked up and finally dropped at 23:28:58:750 hrs.

Explanation: As per the deposition of Shri Amir Khan SSE/Sig/SFO, Shri A.R. Mohanty Tech III/BNBR, Shri Pappu Kumar Tech III/BLS, Shri A.K..Mohanta, SSE/Sig/Incharge, during the inquiry on 19.06.23, after noticing the mistake in the wiring mentioned above, second GFR circuit (3GF RR), terminated on F23 & F24, was removed and the original released wires for 17NWK1R were connected back at North Goomty. Now 17NWK1R restored back in association with the status of Crossover 17 A/B. As point machines of points 17A & 17 B were damaged, the detection-feed from the points was disconnected and that's why 17NWK1R dropped at the North Goomty, and feed to 17NWK1R at the Central Relay Room was also discontinued. This is clear from the circuit diagrams given hereunder [and at Annexure (xvii)]:-

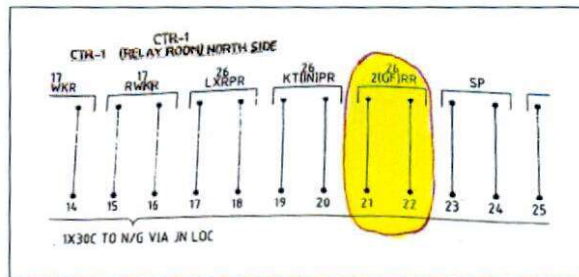
- iii. From the cable termination diagram of F-Row of the CTR-Rack-1 of the Central Relay Room (connected to the CTR-Rack-1 at the North Goomty), approved on 05.01.2015 (extract shown hereunder), it can be seen that only one GFR circuit was allotted at terminals F21 & F22 of CTR-1 for the purpose of LC-94. Whereas, in the wiring diagram of LC 79, two numbers of GFR circuits were required. Had only one GFR circuit been wired at the corresponding terminals at F21 & F22 at the North Goomty on CTR Rack-1, there would have been no need to alter the circuits at F23 & F24 (where the 17 NWKR circuit was extended from terminals F13, & F14) for the wiring of second GFR circuit (3GF RR as per wiring diagram of LC 79), and thereby this accident could have been prevented.
