# Wolverine Home Inspection LLC

## Home Inspection Report

**Birch Run , MI**

Inspected on Fri, Aug 23 2019 at 10:37 AM

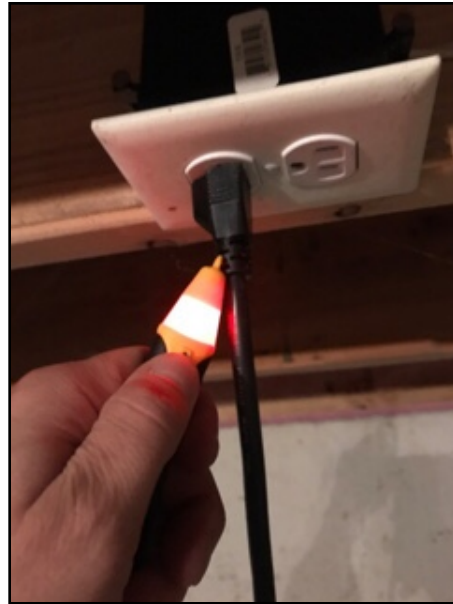
Figure 14-2

Both sump pumps bad. Power confirmed going to pump

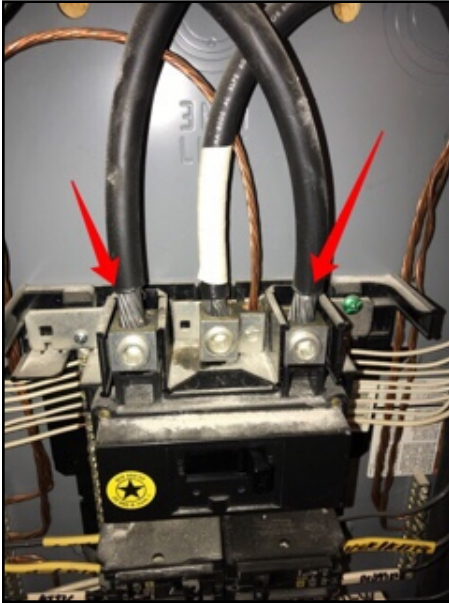
Figure 18-1

Comment 18:  
No anti corrosive paste on service wires .

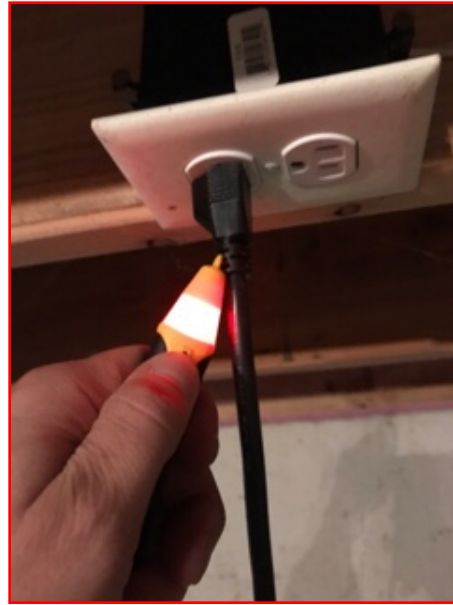
Figure 14-2

- 2) Both sump pumps bad. Power confirmed going to pump

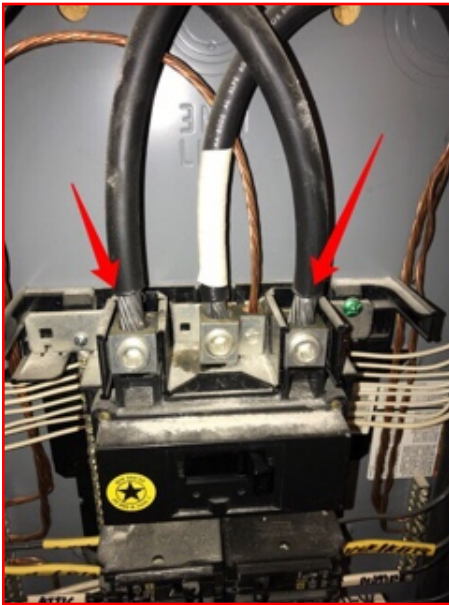
Figure 18-1

3) No anti corrosive paste on service wires .
