Home Inspection Report

Property address: **12431 Bree Ct**

Yucaipa, CA 92399

Inspection date: **Friday, September 9, 2022**

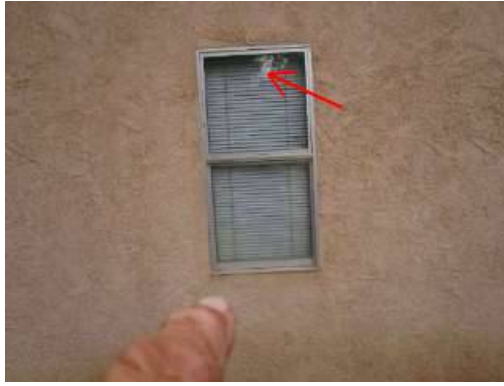
Photo 1-10 Missing window screen

- 1) Photo 1-3 Hose bib pipe valve needs replacing.
- 2) Photo 1-10 Missing window screen.
- 3) Photo 1-11 Screen is on the ground and needs to be replaced.
- 4) Photo 1-14 Broken lattice members around patio structure.
- 5) Photo 1-15 Patio cross members are deteriorating.
- 6) Photo 1-16 Back patio door latch does not work correctly.
- 7) Photo 1-28 Landscaping, many of the valves are broken and do not work correctly. The entire landscaping water system needs to be repaired.
- 8) Photo 2-6 Roofing tiles have slipped or are broken in a few different areas. A licensed roofer should evaluate and repair all issues, you may want to get a roof certificate.
- 9) Photo 3-6 Garage door auto light sensor does not work correctly, does not allow the door to stay down, intermittent.

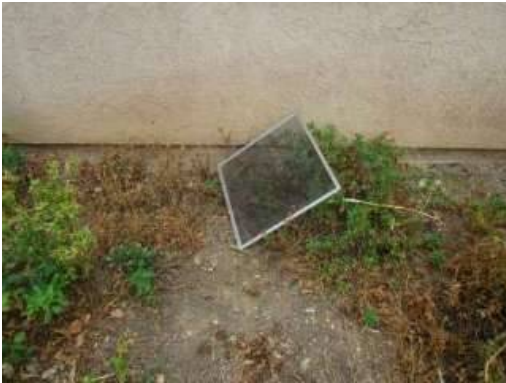
Photo 1-11 Screen is on the ground needs to be replaced

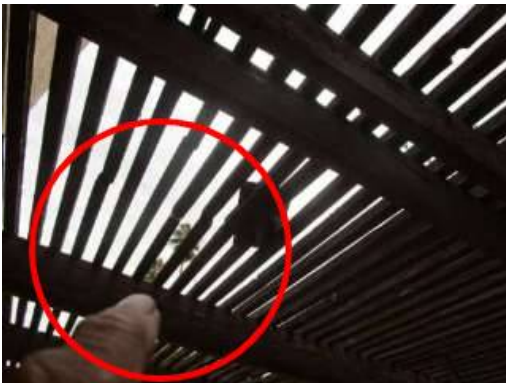
Photo 1-13 Patio lattice work has deteriorated and should be replaced

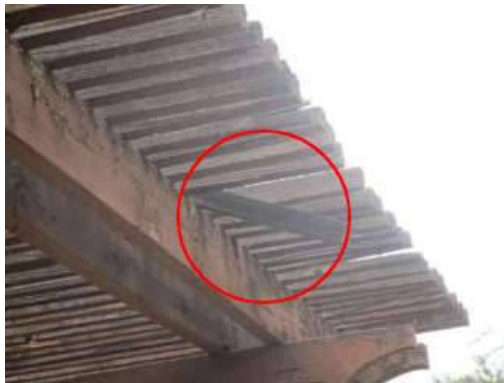
Photo 1-14 Broken lattice members around patio structure

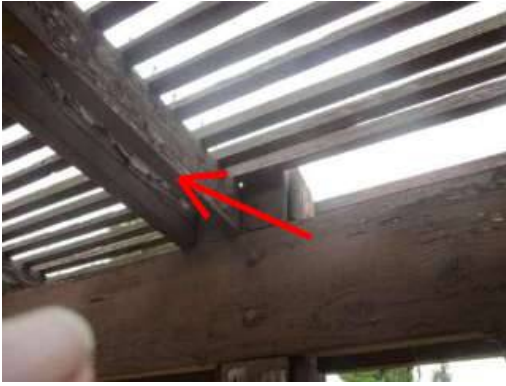
Photo 1-15 Patio cross members are deteriorating

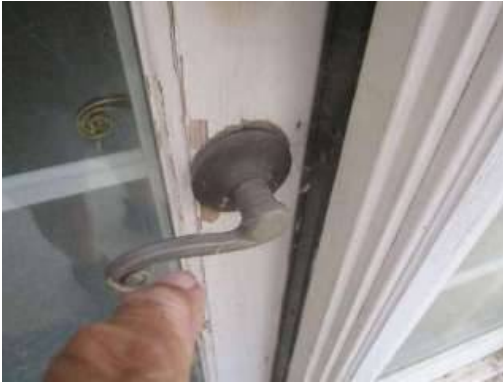
Photo 1-16 Back patio door latch does not work properly

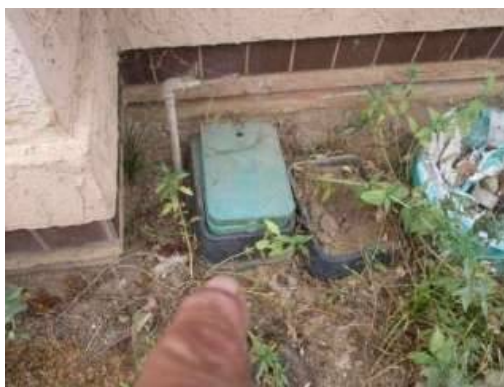
Photo 1-28 Landscaping, many of the valves are broken and do not work correctly. Entire landscaping water system needs to be repaired

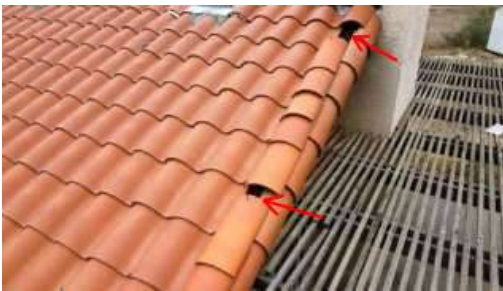
Photo 2-6 Roofing tiles have slipped or are broken in a few different areas. A licensed roofer should evaluate and repair all issues, you may want to get a roof certificate.

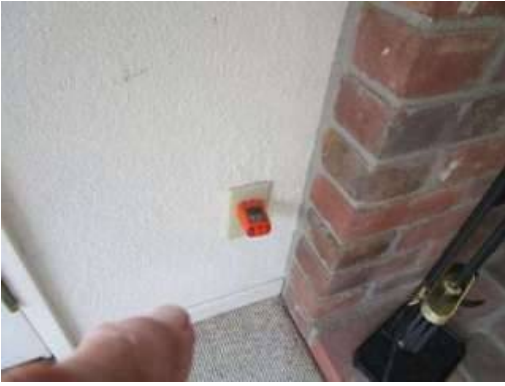
Photo 5-3 The fireplace exterior plug does not work correctly, it is also the wrong outdoor plug per code. A licensed electrician should repair it.

- 10) Photo 4-4 Many abandoned tv cables have been left in the attic, you may want to remove them. (this is not an issue)
- 11) Photo 5-3 The fireplace exterior plug does not work correctly, it is also the wrong outdoor plug per code. A licensed electrician should repair it.

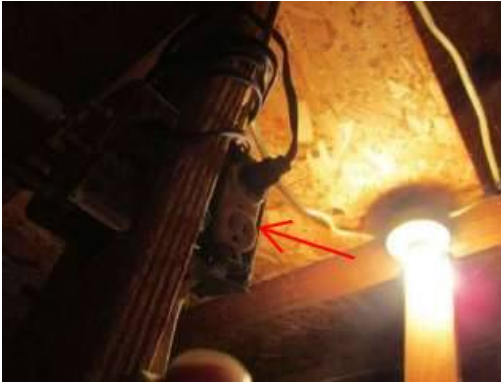
Photo 5-4 The attic electrical outlet needs a cover plate.

- 12) Photo 5-4 The attic electrical outlet needs a cover plate.
- 13) Photo 5-6 The garage GFCI plate has been cut, this is not to code, repair.
- 14) Photo 8-1 Laundry room in the garage wall needs to be repaired.

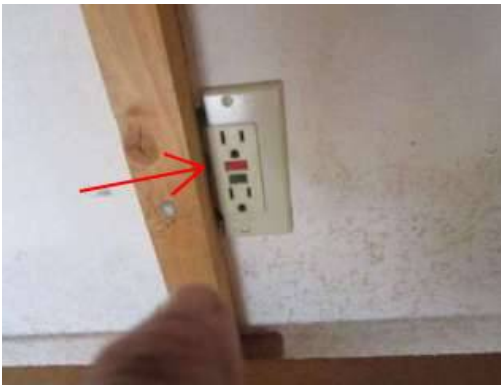
Photo 5-6 The garage GFCI plate has been cut, this is not to code, repair.

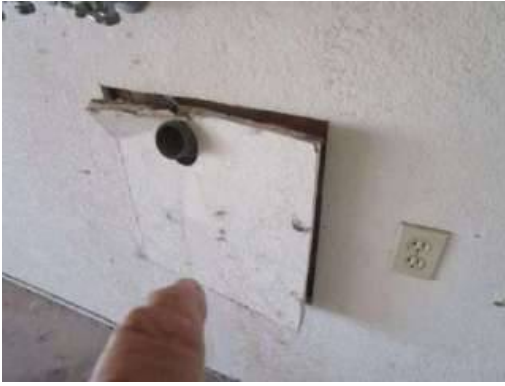
Photo 8-1 Laundry room in the garage wall needs to be repaired.

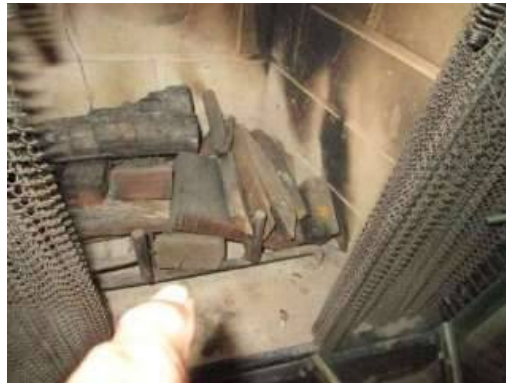
Photo 9-2 Wood burning gas fireplace. This is not an issue, just an observation.

- 15) Photo 9-2 Wood burning gas fireplace. This is not an issue, just an observation.
- 16) Photo 10-4 The microwave door open button is broken.
- 17) Photo 10-7 Some of the kitchen cabinet doors and drawers have defects, they should be evaluated and repaired.

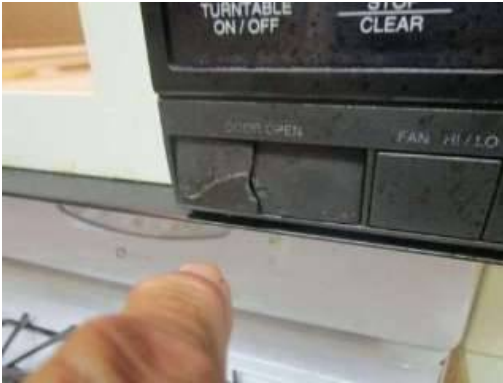
Photo 10-4 The microwave door open button is broken.

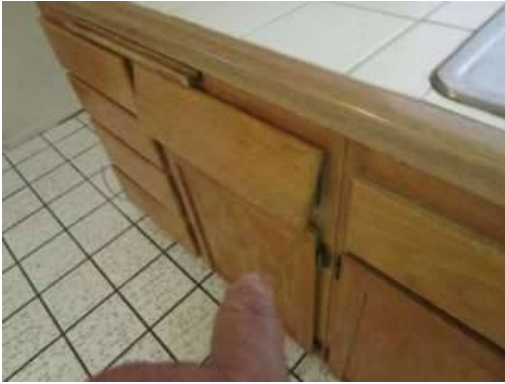
Photo 10-7 Some of the kitchen cabinet doors and drawers have defects, they should be evaluated and repaired.

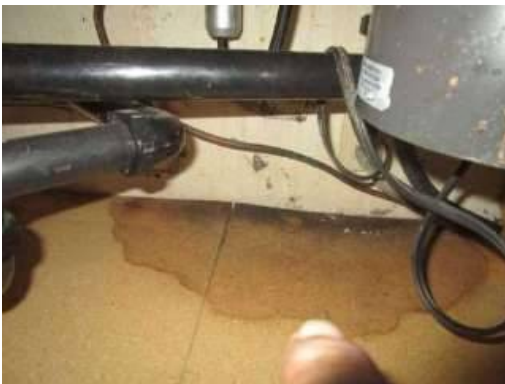
Photo 10-11 Under the kitchen cabinet sink shows signs of previous water damage this should be evaluated by a licensed plumber.

- 18) Photo 10-11 Under the kitchen cabinet sink shows signs of previous water damage this should be evaluated by a licensed plumber.
- 19) Photo 10-12 The grout needs to be repaired at the edge of the countertop.

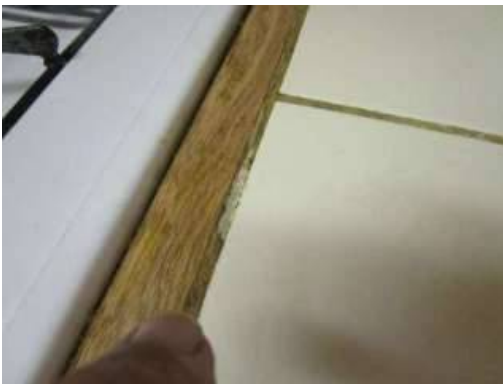
Photo 10-12 The grout needs to be repaired at the edge of the countertop.

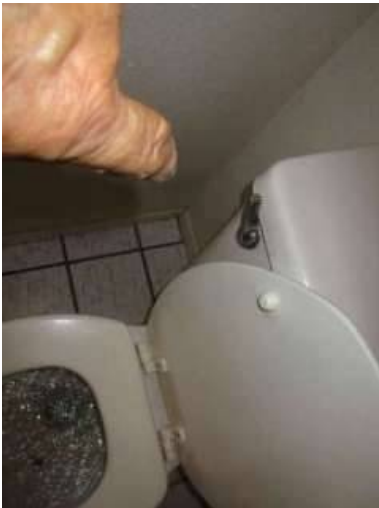
Photo 11-5 The hall bathroom toilet latch needs repair.

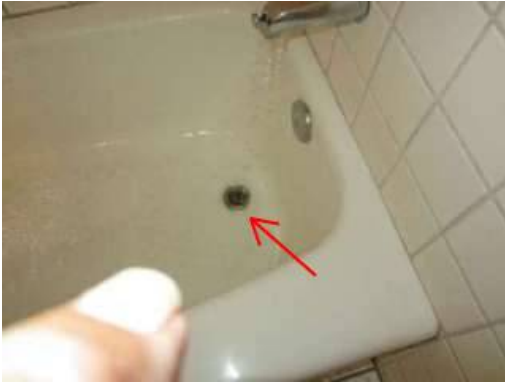
Photo 11-7 The bathtub drain is missing a stop.

- 20) Photo 11-7 The bathtub drain is missing a stop.
- 21) Photo 11-8 The shower valve does not turn properly, the valve is frozen.
- 22) Photo 12-1 The bathtub water diffuser is broken, does not allow water to flow freely, nor does it reroute water to the shower head correctly.

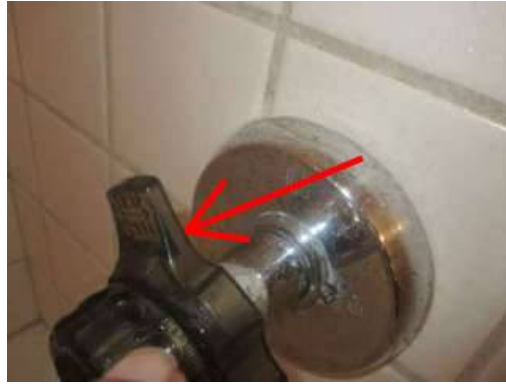
Photo 11-8 The shower valve does not turn properly, the valve is frozen.

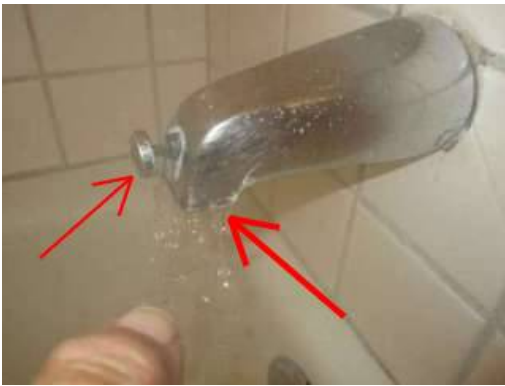
Photo 12-1 The bathtub water diffuser is broken, does not allow water to flow freely, nor does it reroute water to the shower head correctly.

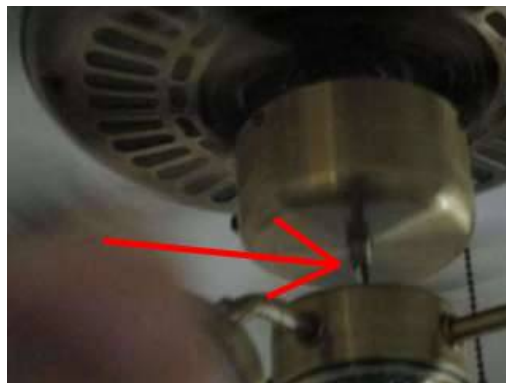
Photo 13-2 The fan in the living space bedroom needs repair. Electrical wires are holding fan from falling this is a safety hazard and issue.

- 23) Photo 13-2 The fan in the living space bedroom needs repair. Electrical wires are holding fan from falling this is a safety hazard and issue.
- 24) Photo 13-5 The blinds are broken in some areas of the house.

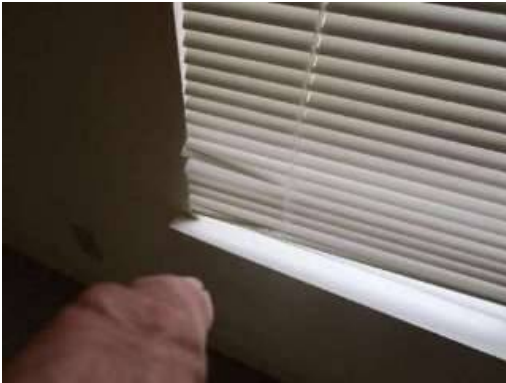
Photo 13-5 The blinds are broken in some areas of the house.

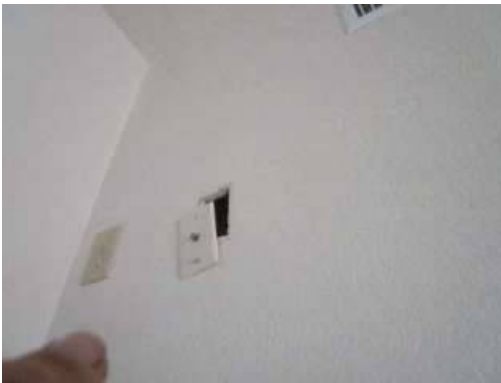
Photo 13-8 The bedroom cable cover is coming off this should be repaired.

- 25) Photo 13-8 The bedroom cable cover is coming off this should be repaired.
- 26) Photo 13-10 The door is missing from the closet.
- 27) Photo 13-11 Some of the blinds need repair.

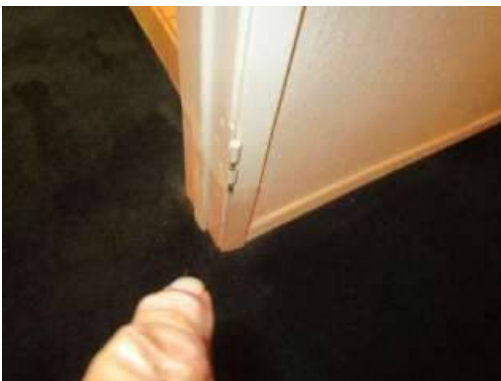
Photo 13-10 The door is missing from the closet.

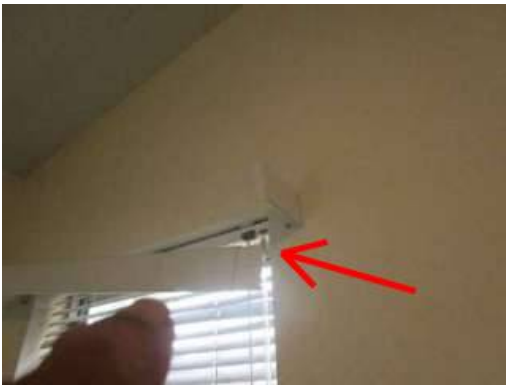
Photo 13-11 Some of the blinds need repair.

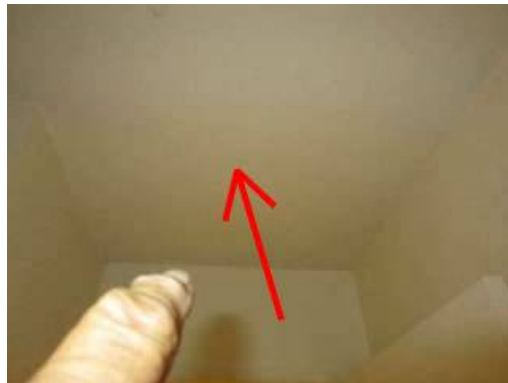
Photo 13-14 Smoke detectors need to be installed in each room. A carbon monoxide detector is missing and needs to be installed.

- 28) Photo 13-14 Smoke detectors need to be installed in each room. A carbon monoxide detector is missing and needs to be installed.
- 29) Photo 13-15 Smoke detectors need to be installed in each room. A carbon monoxide detector is missing and needs to be installed.

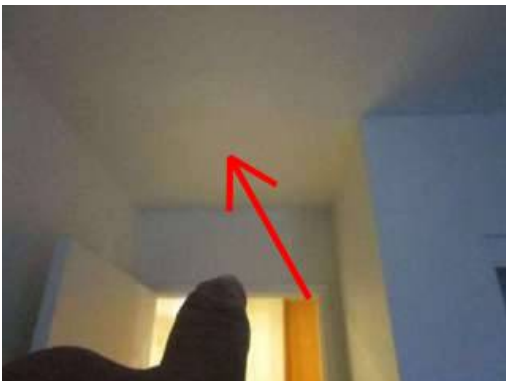
Photo 13-15 Smoke detectors need to be installed in each room. A carbon monoxide detector is missing and needs to be installed

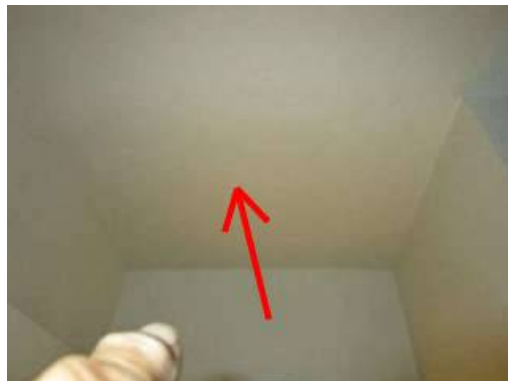
Photo 13-16 Smoke detectors need to be installed in each room. A carbon monoxide detector is missing and needs to be installed

- 30) Photo 13-16 Smoke detectors need to be installed in each room. A carbon monoxide detector is missing and needs to be installed.
- 31) Photo 13-17 The pocket door does not move freely and this should be repaired.

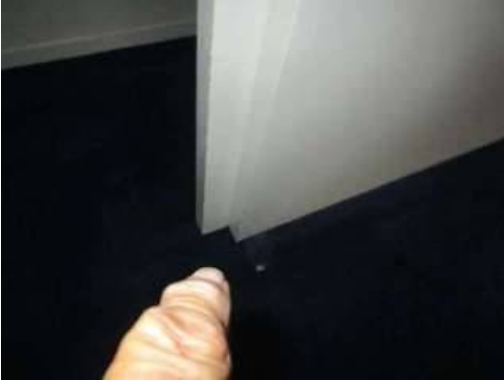
Photo 13-17 The pocket door does not move freely and this should be repaired.

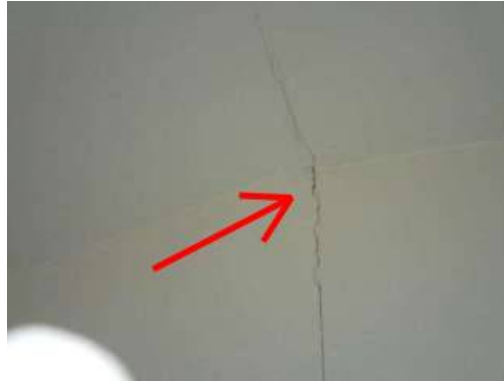
Photo 13-20 The living room wall has a crack in it and this should be evaluated by a licensed general contractor.

- 32) Photo 13-20 The living room wall has a crack in it and this should be evaluated by a licensed general contractor.
- 33) Photo 14-1 The lighting soffit fluorescent bulbs are not working and should be replaced.

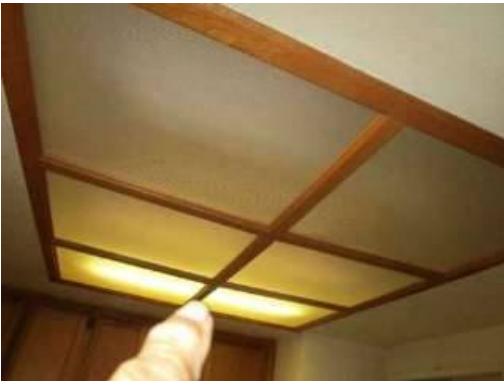
Photo 14-1 The lighting soffit fluorescent bulbs are not working and should be replaced.

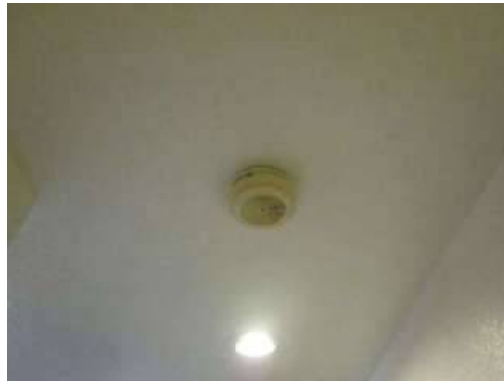
Photo 14-2 The smoke detector in the hallway appears to work.

- 34) Photo 14-2 The smoke detector in the hallway appears to work.
