# *External Refurbishment Works*

- Lower Ground Steps / Structural Underpinning
- Raised Ground Floor
- First Floor Balustrade

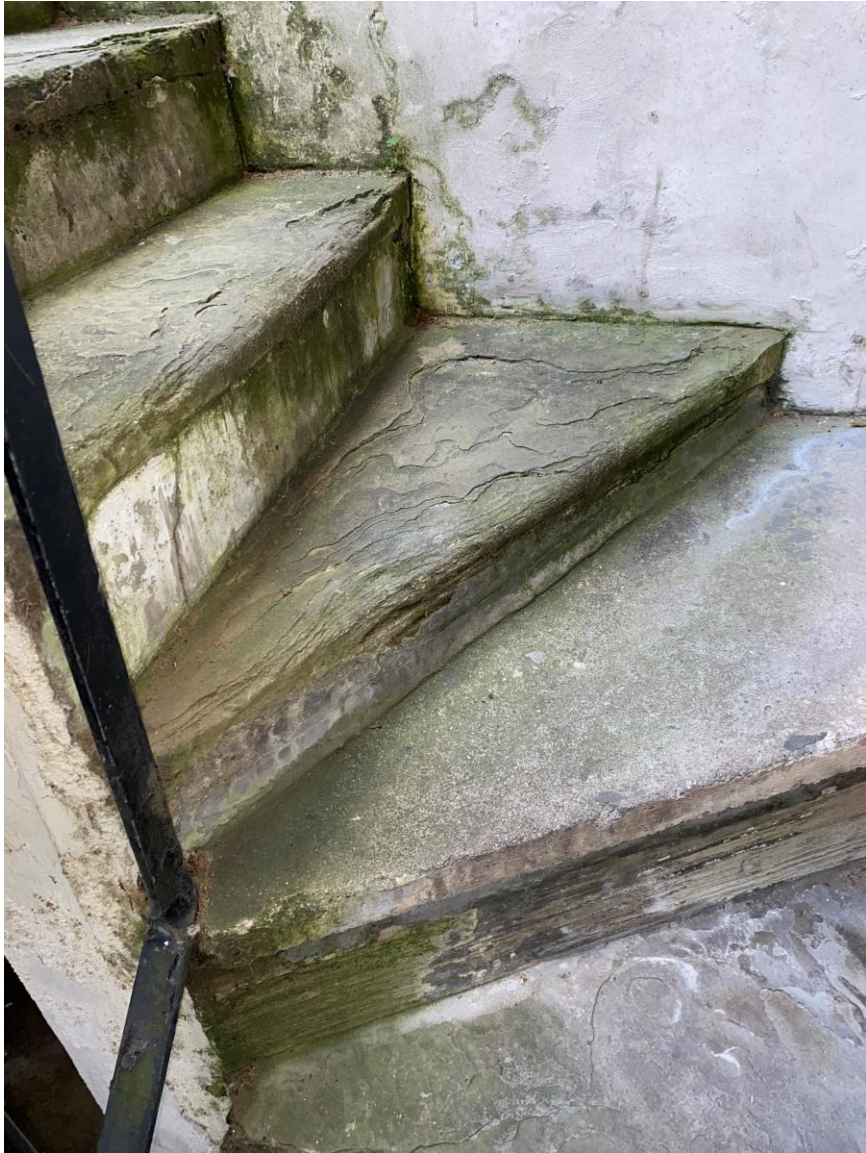
Collapsing Steps [before]

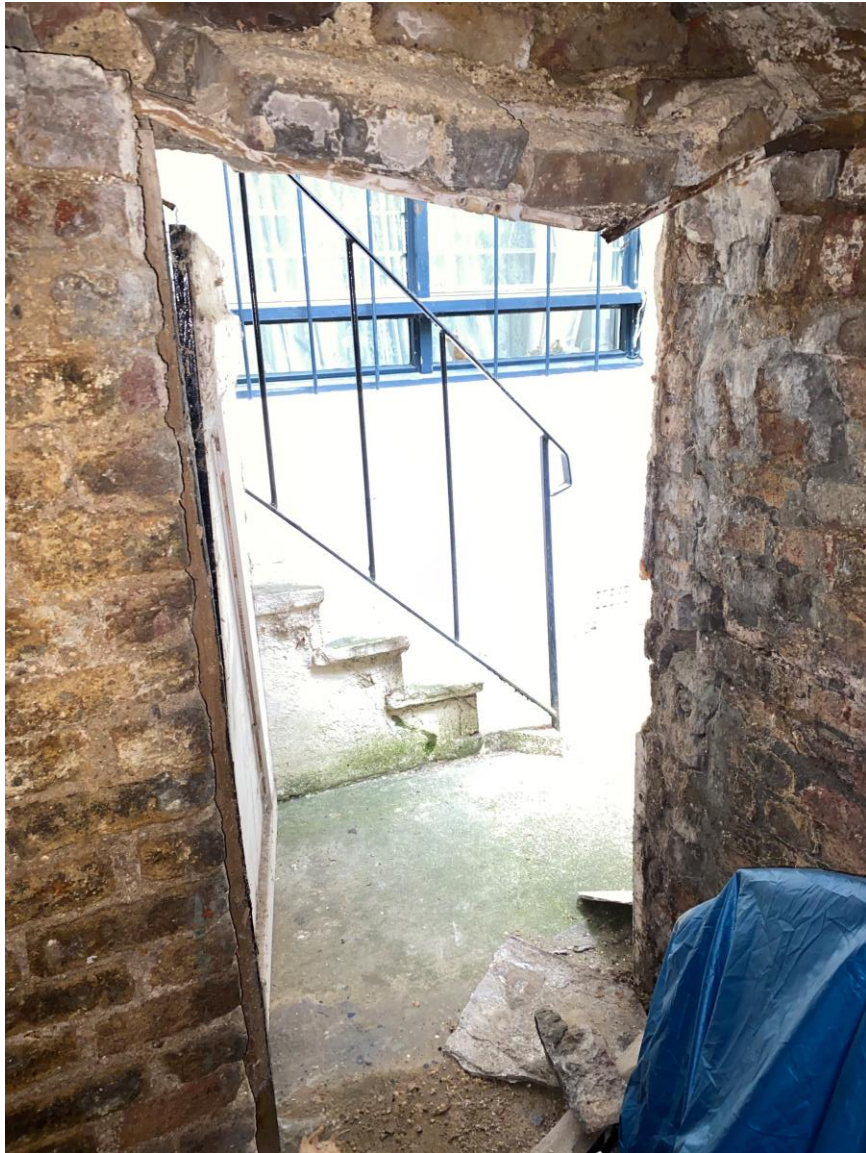
Collapsing Vault Lintels Internal [before]

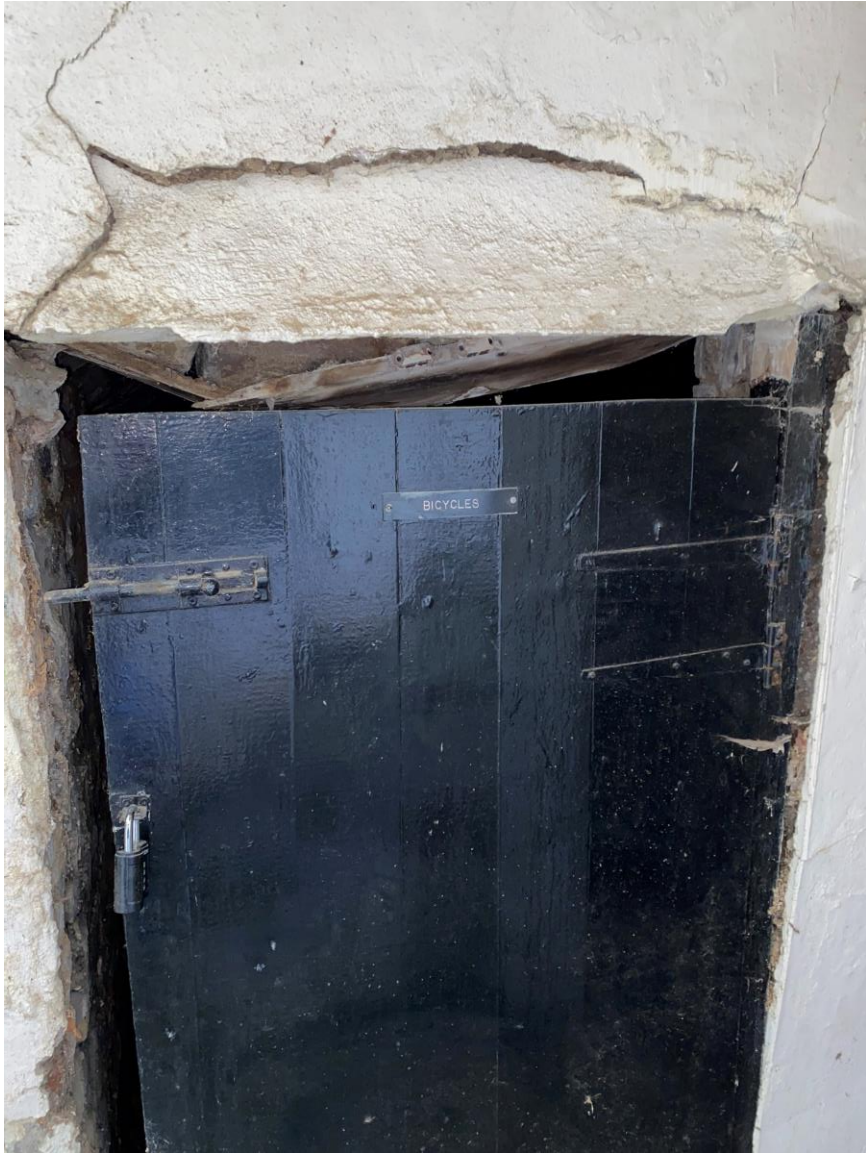
Collapsing Vault Lintels External [before]

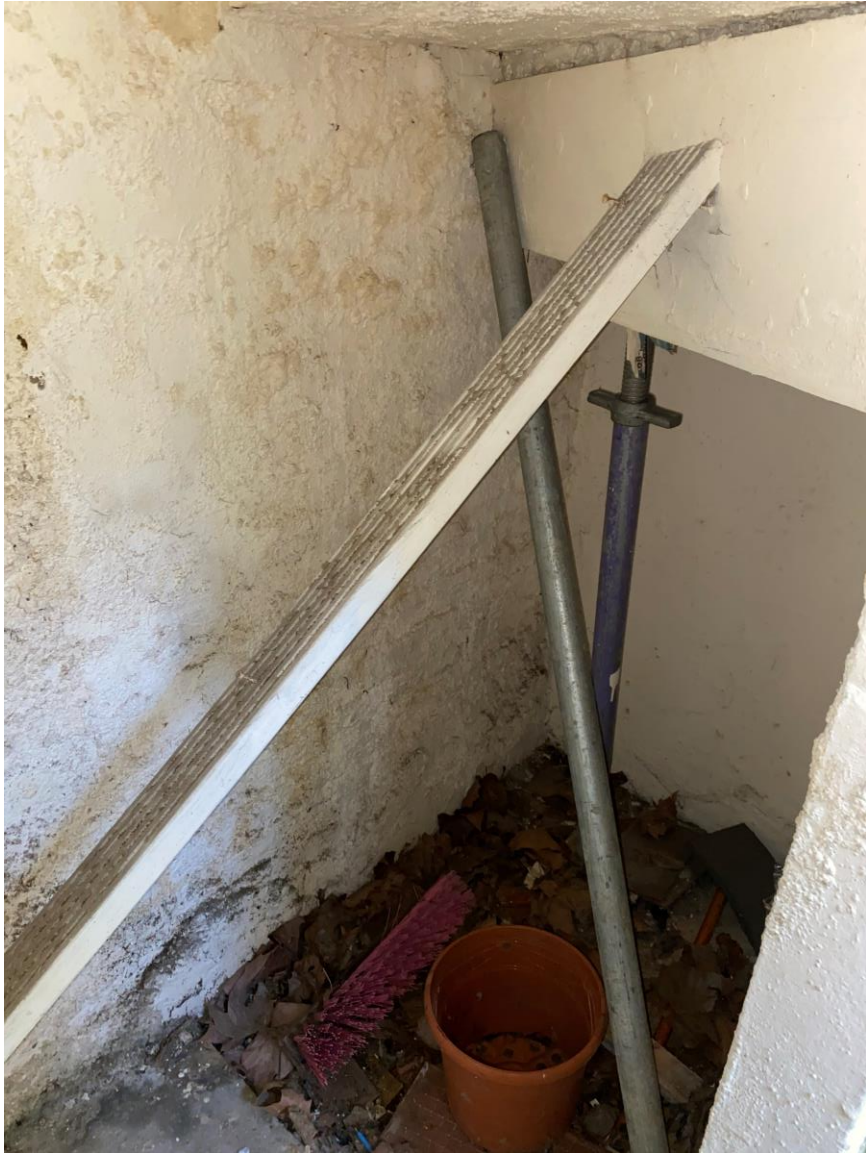
Collapsing LG Steps [before]

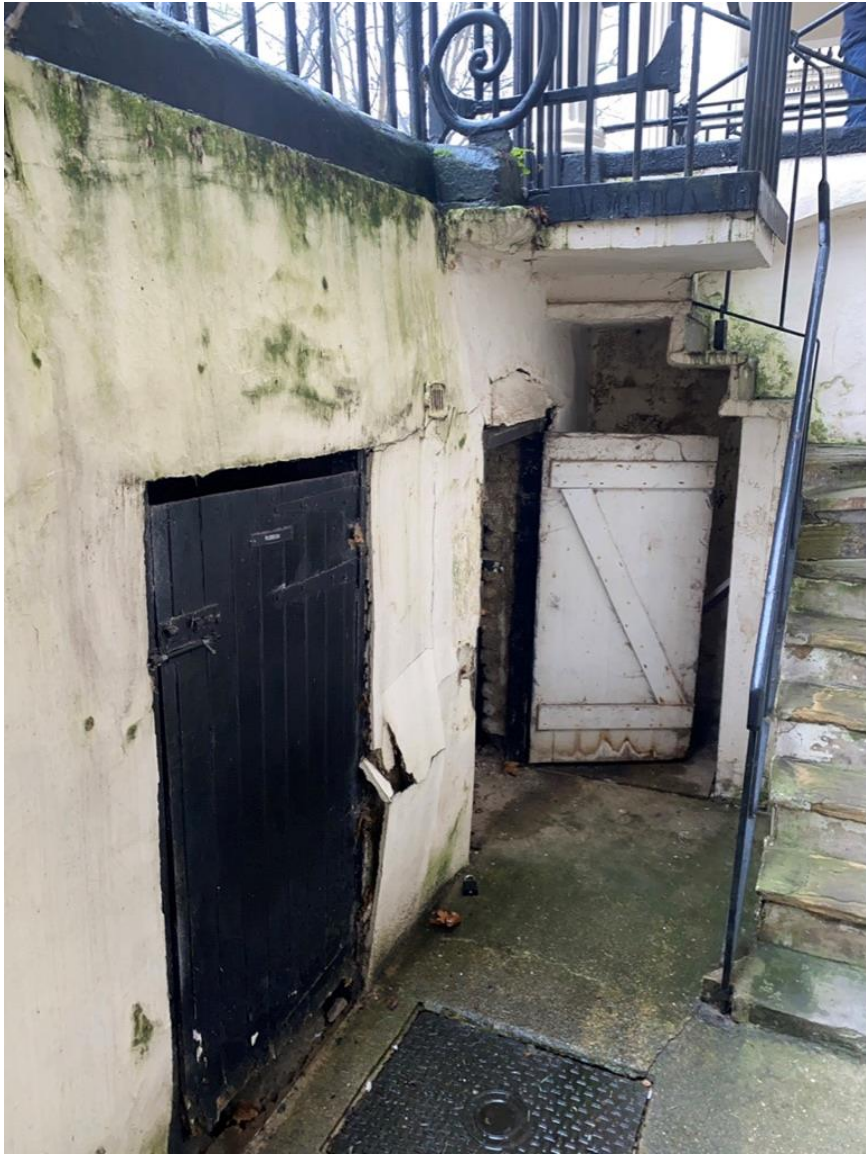
Dilapidated External Vaults Collapsing Supporting Walls & Steps [before]

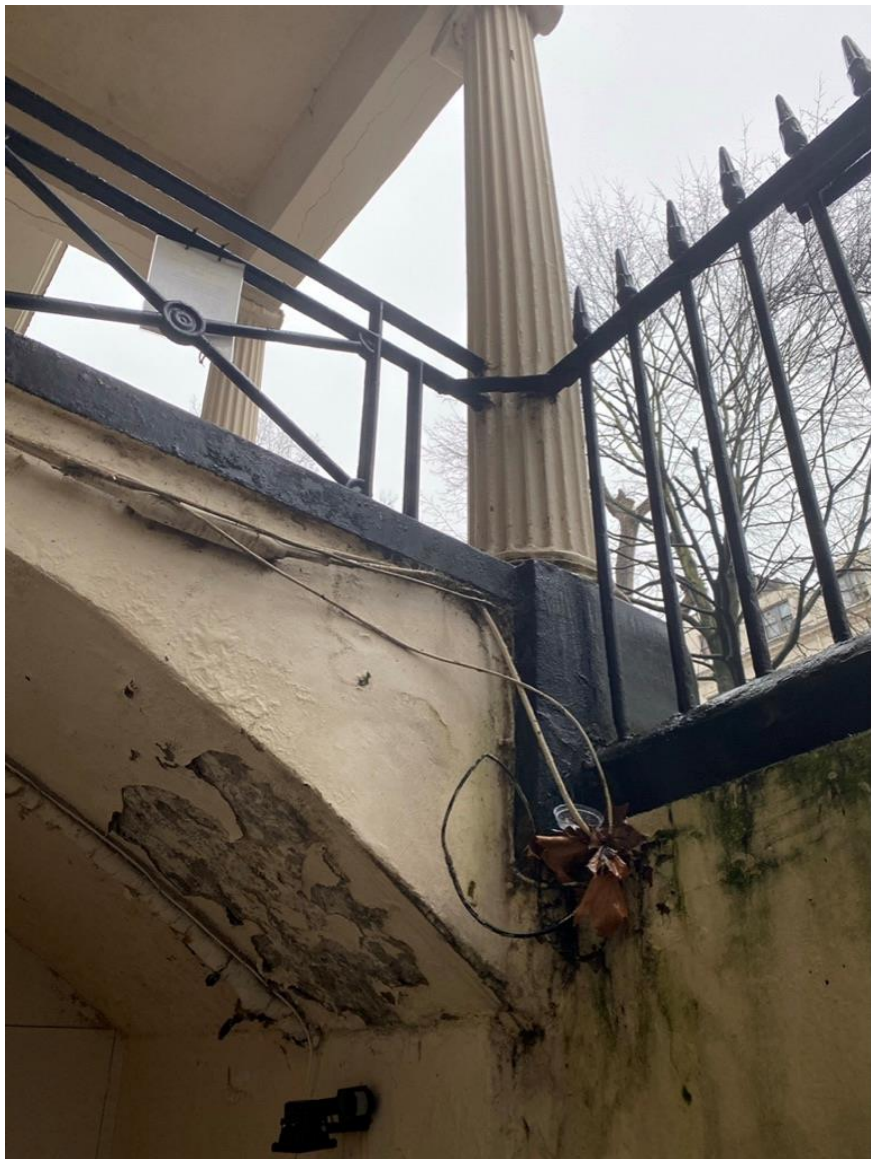
Dilapidated Unsupported Underside Portico [before]

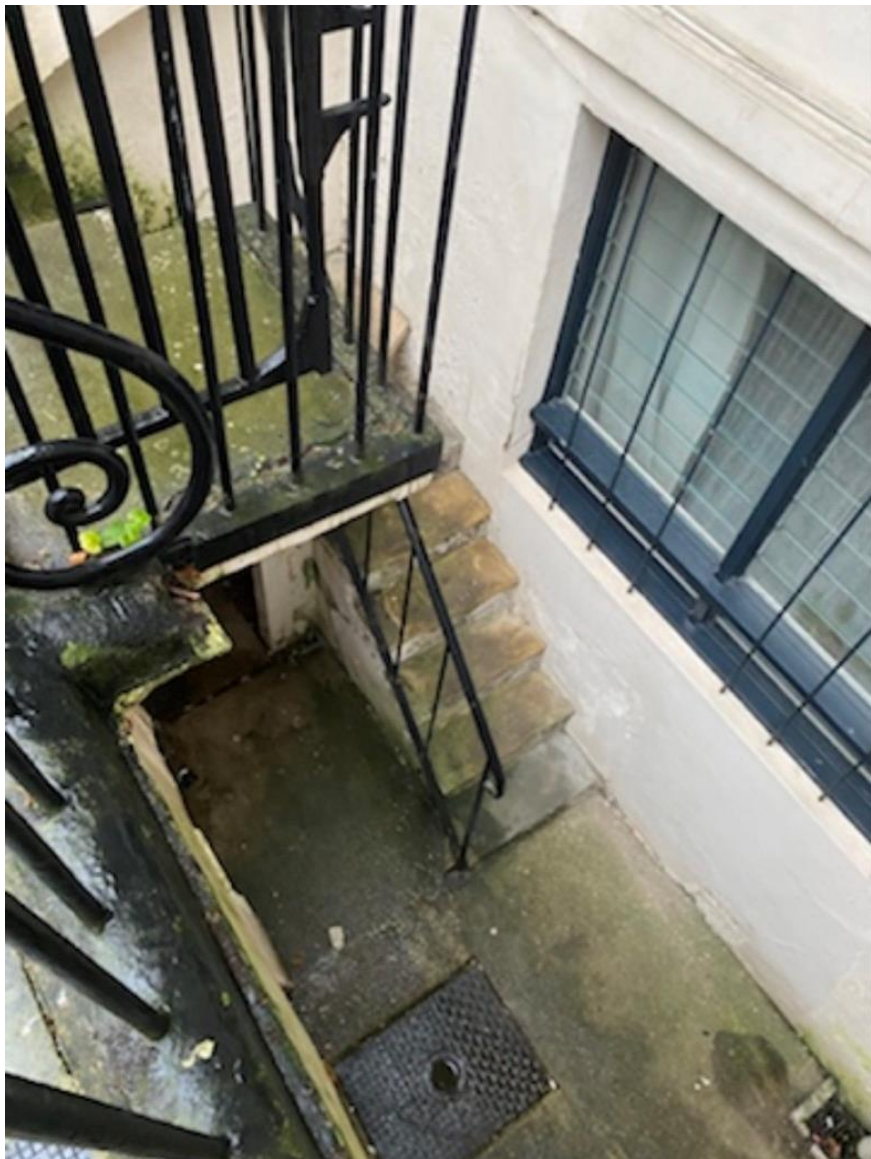
Dilapidated Unsupported LG Steps [before]

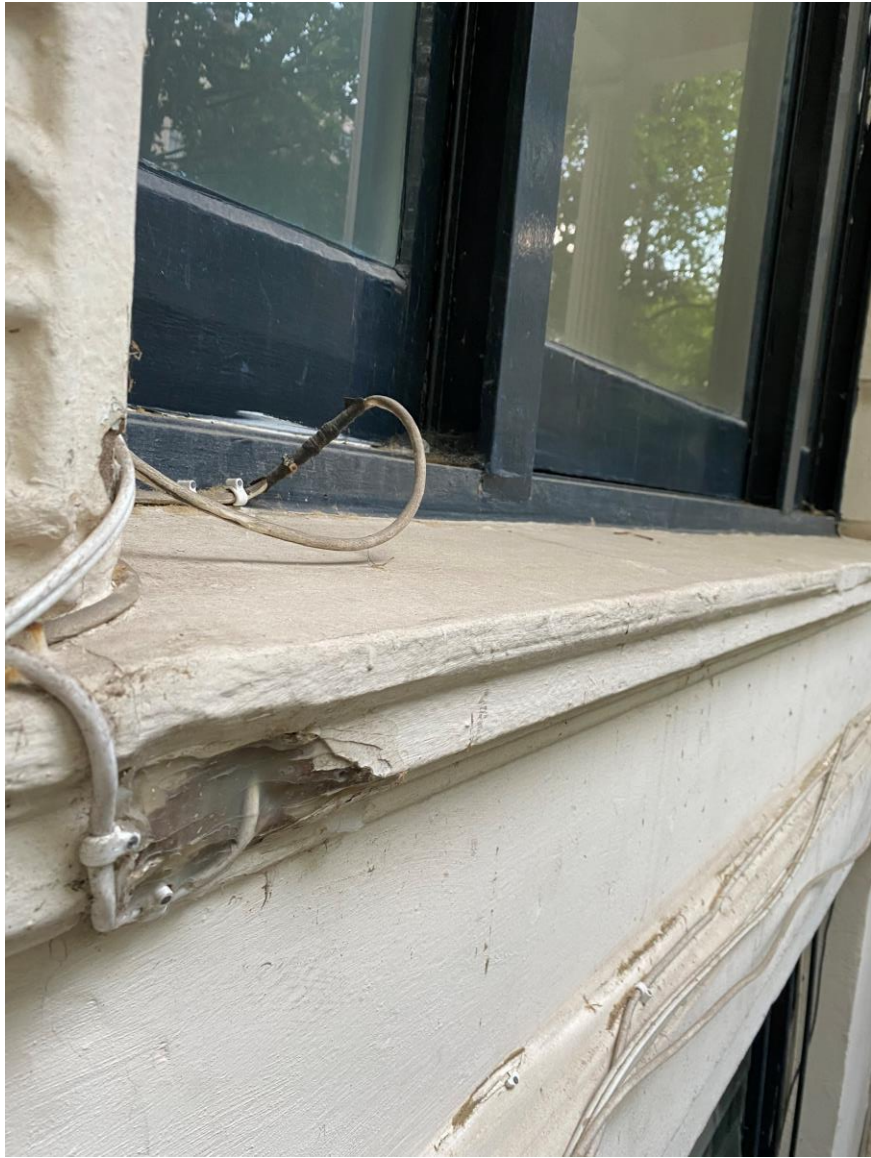
Destroyed Listed Sill Detail [before]

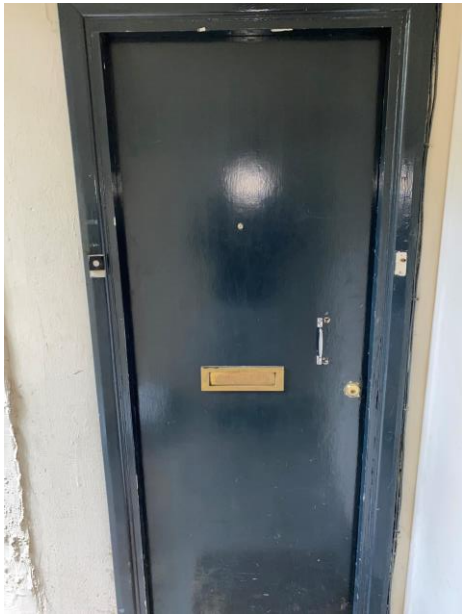
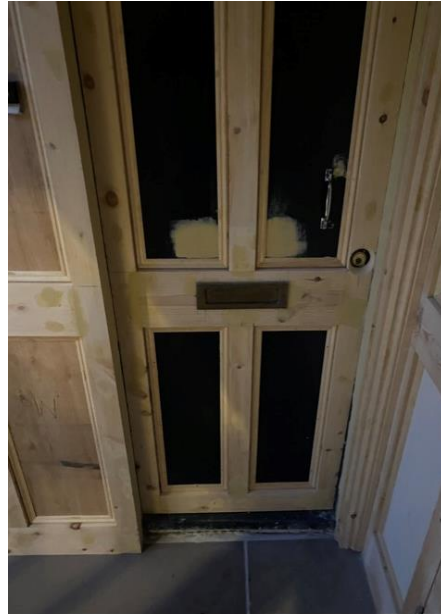
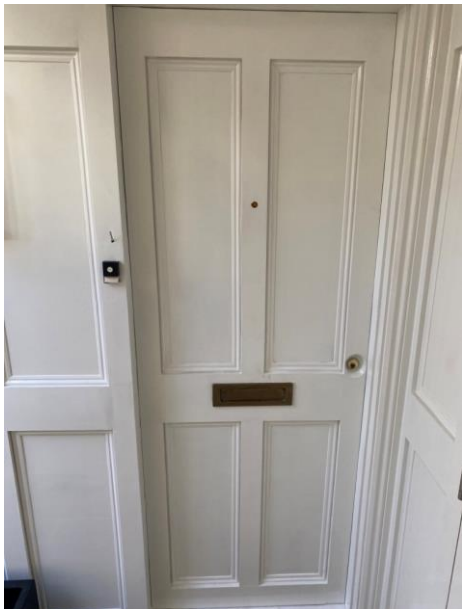
Existing LGF Entrance [before]

Existing LGF Entrance Reclad With Added Molding [during]

Existing LGF Entrance Finished [after]

LGF Entrance  
[before & after] plywood  
paneling & beading  
added to match main  
entrance street level door.

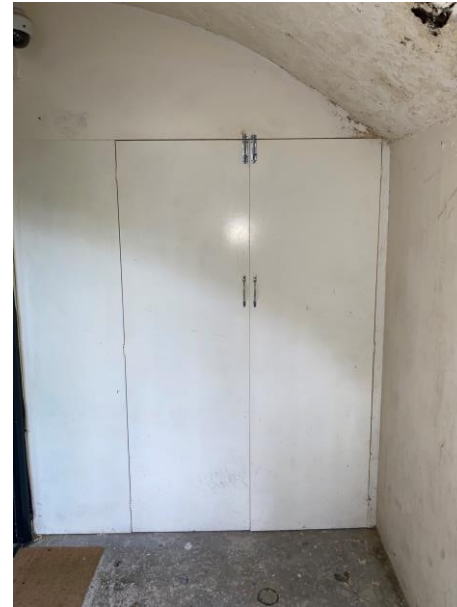
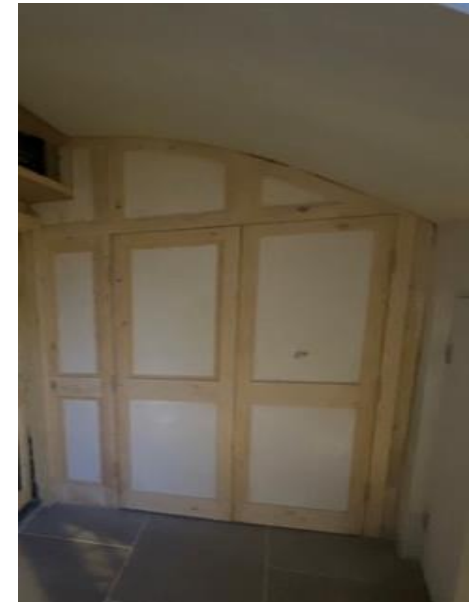
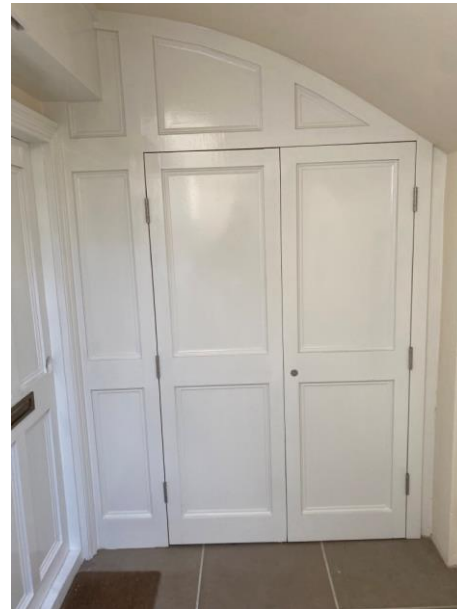
Existing LGF Gas Meter Cupboard [before]

Existing LGF Gas Meter Cupboard Reclad With Added Molding [during]

Existing LGF Gas Meter Cupboard [finished]

LGF gas meter cupboards  
[before & after] removed  
and saved during flooring  
works reclad and reinstalled.
