# PROPERTY INSPECTION REPORT

**1234 Buena Vista St**  
**Inspection Prepared For: Happy Client**  
**Agent: Christian Castner - Harcourts Luxury Estates**

**Date of Inspection: 2/6/2019**  
**Year Built: 1944 Size: 2158**

## **Sunset Property Inspection**

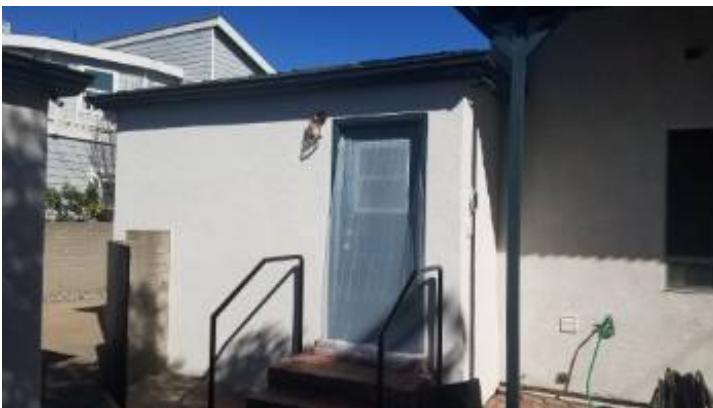
- Damage at exterior doot seen. Rear exit door does not appear to be an exterior rated door. Moisture damage seen. Recommend replacing with an exterior rated door to prevent further deterioration.
- Downstairs sliding glass door is difficult to slide. Recommend improving operation. A qualified contractor is needed
- Kitchen exterior door bottom weather stripping is dragging on the floor. Recommend adjustments be made by a qualified handyman.
- Cloudiness/condensation observed in thermopane double glazed door at upstairs bedroom. This is an indication of a failed seal. A qualified contractor should review for replacement as needed.

Rear Exit Door Covered With Rain Protection

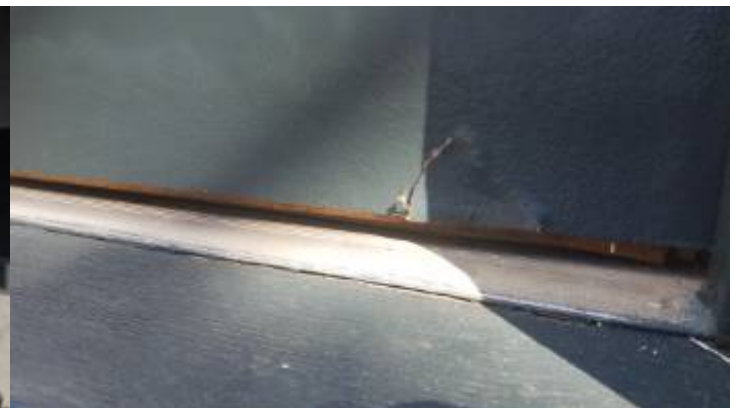
moisture damage at bottom of door

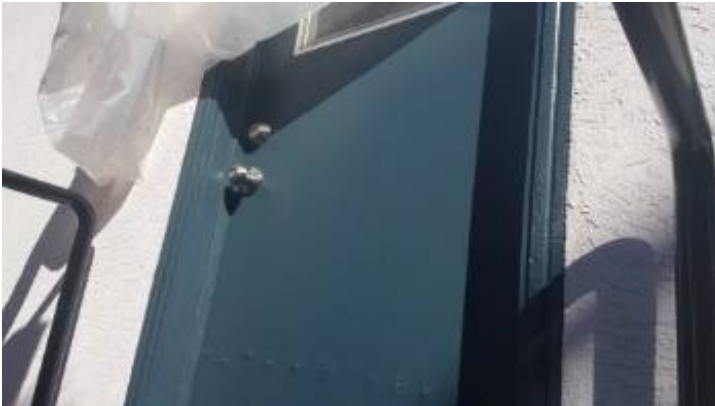
Moisture damage at staples

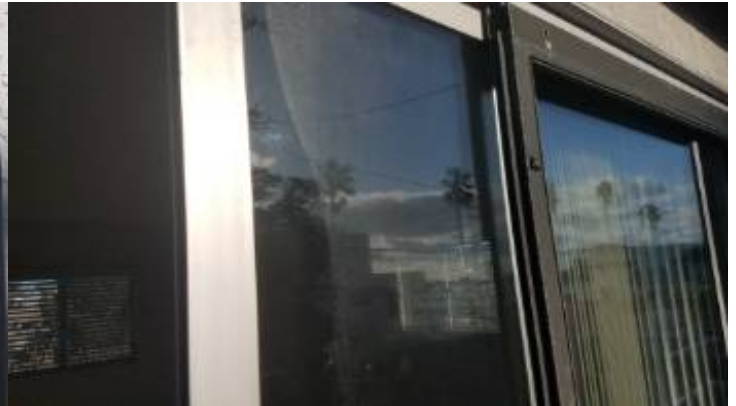
bad seal in upstairs sliding glass dual pane door

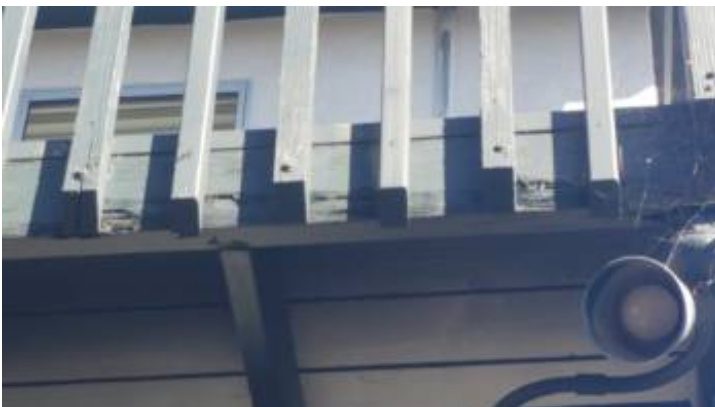
- Lag screws and other proper means of attachment are not visible at the house to balcony connection. Have the balcony reviewed for proper installation and attachment. Check for history of permits.
- Flashing is missing or can not be seen. Ledger connection must be properly flashed. Water entry at the ledger connection causes wood rot and is a significant contributing factor in many deck collapses. Recommend further review by a qualified deck contractor.

weathered wood surface at balcony framing

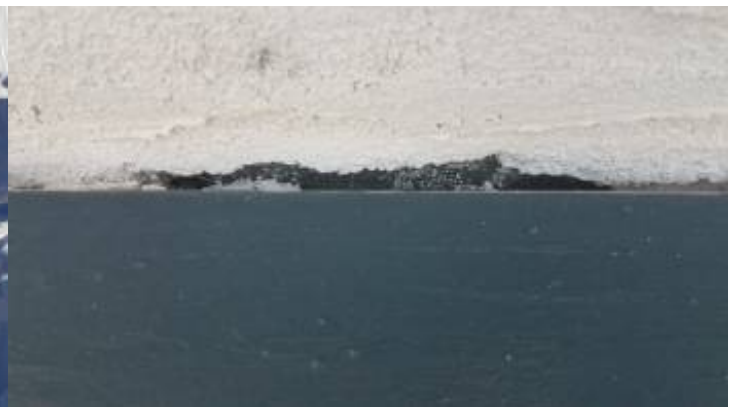
Exposed framing behind stucco. No flashing seen between balcony and stucco

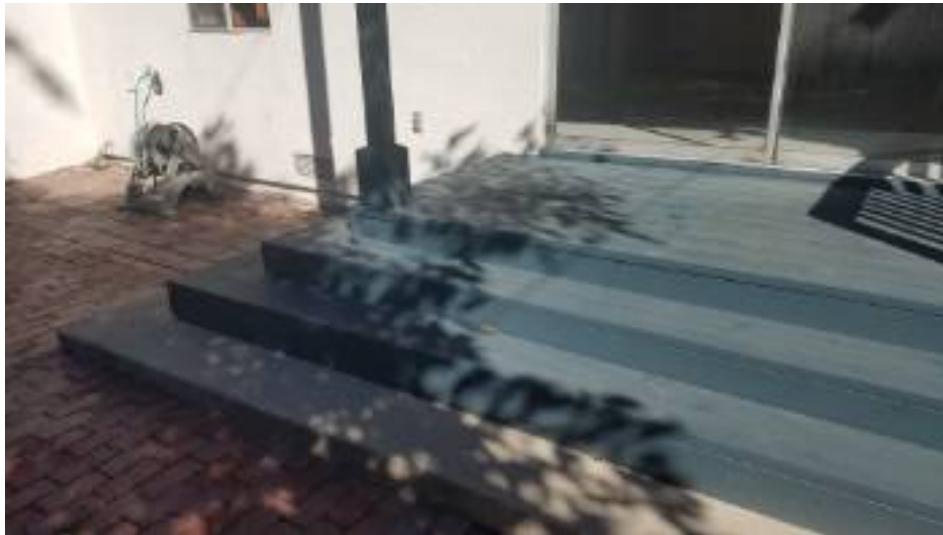
- Handrails not installed at rear patio steps. This is a safety hazard. Handrails are required in order to prevent trip and fall accidents. Recommend a qualified contractor install appropriate handrail.

no handrail present

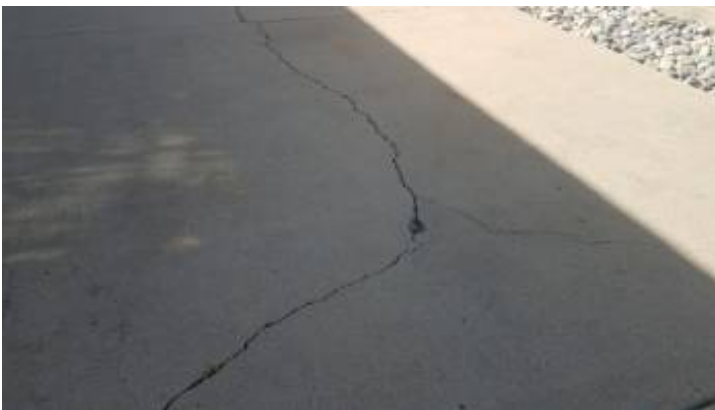
- IMPROVE: Typical cracking was observed at the concrete surfaces. Further deterioration will occur as water expands and contracts from freeze and thaw cycles. Recommend sealing the cracks to prolong the life of the concrete.

cracks in driveway

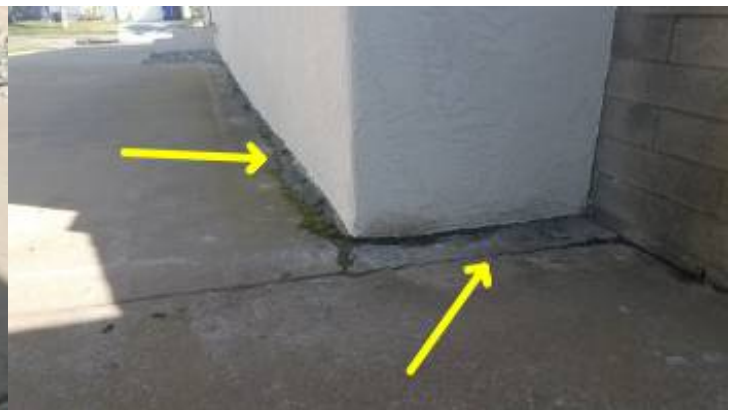
improper slope

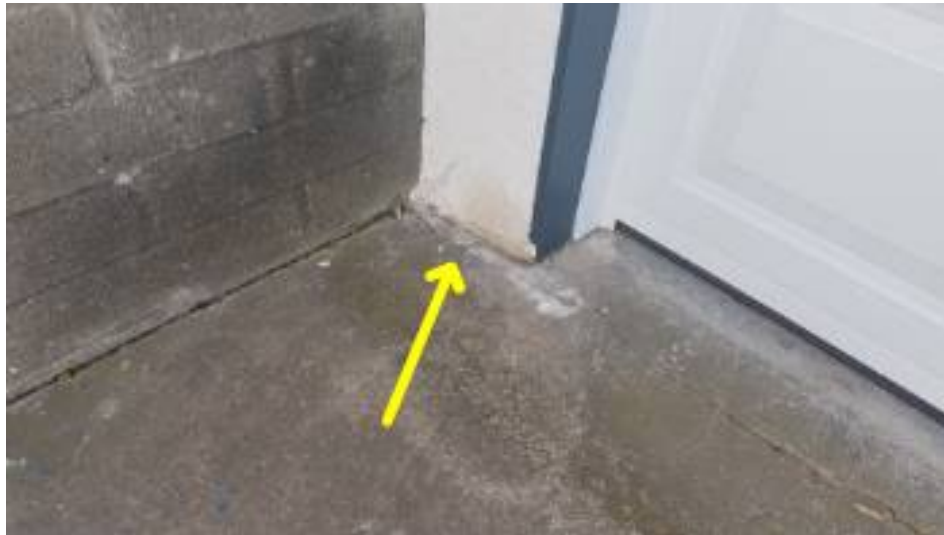
Improper slope

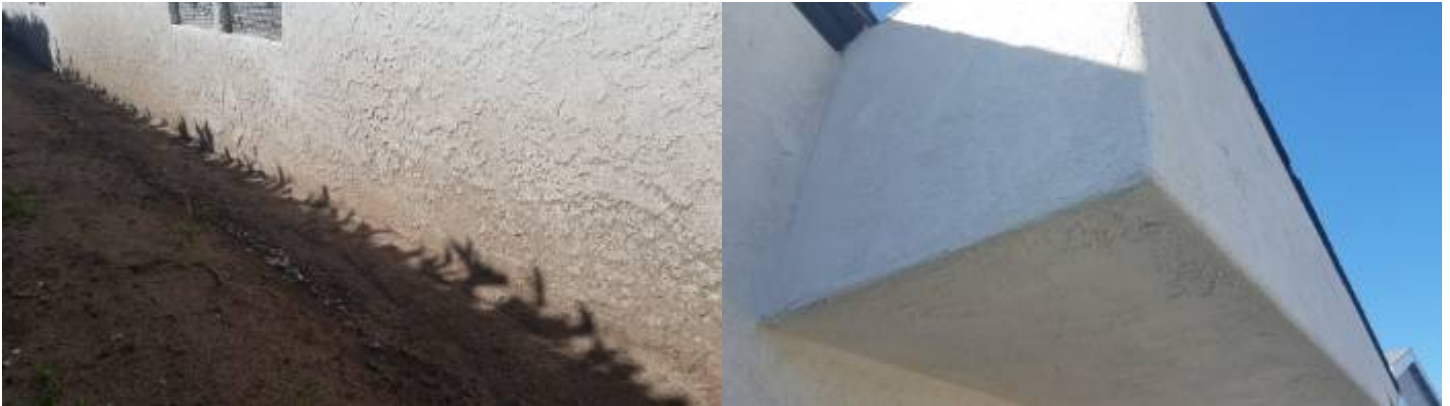
- No weep screed visible or improper clearance to soil/concrete. The present standard distance is 4" to soil and 2" to concrete. Weep screeds are necessary for proper moisture drainage from behind stucco and prevent premature deterioration to the stucco, framing or moisture entry into the interior. We recommend correcting the condition(s) noted.

No weep screed

no weepscreed at front entrance overhang

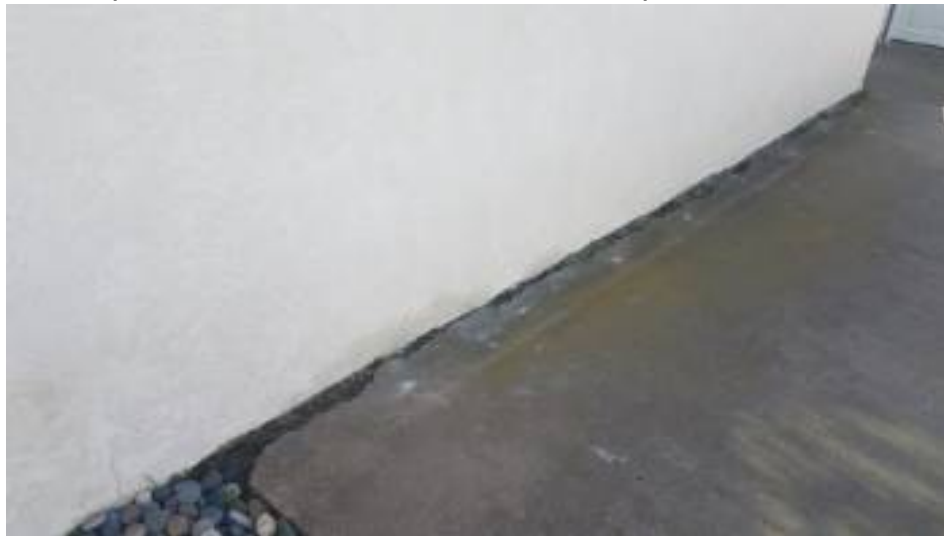
No weep screed

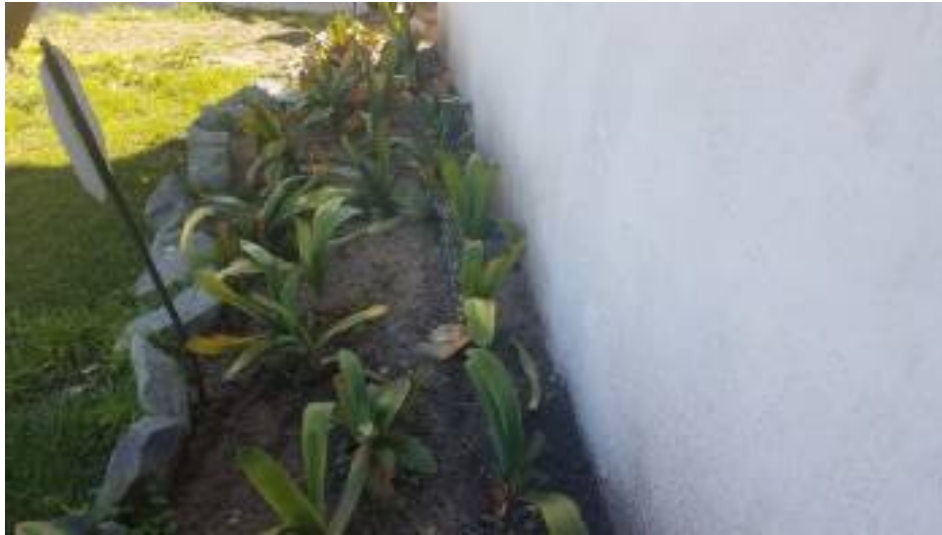
- Lot grading and drainage have a significant impact on the building, simply because of the direct and indirect damage that moisture can have on the foundation. It is very important, therefore, that surface runoff water be adequately diverted away from the home. Lot grading should slope away and fall a minimum of one (1) inch every foot for a distance of six (6) feet around the perimeter of the building. A soil gradient sloping away from the foundation was not established. The soil gradient was essentially flat at planter beds and/or lawn areas next to the foundation. Correcting the soil pitch is needed to improve drainage so that surface drainage is directed away from the foundation.

Poor grading at foundation

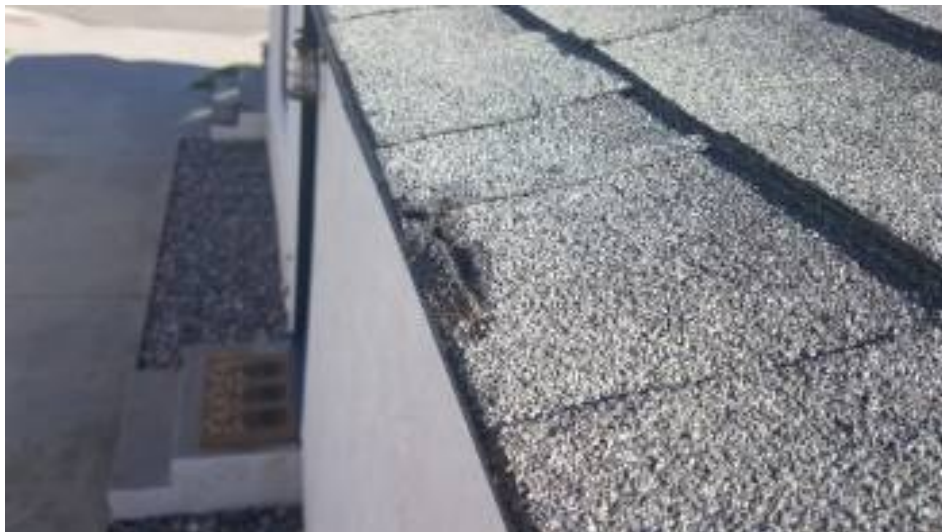
- These shingles appear to be in the second third of their life cycle.
- There are a few damaged perimeter roofing shingles. Water can penetrate into the interior surfaces. Recommend replacing the damaged shingles.

damaged shingle

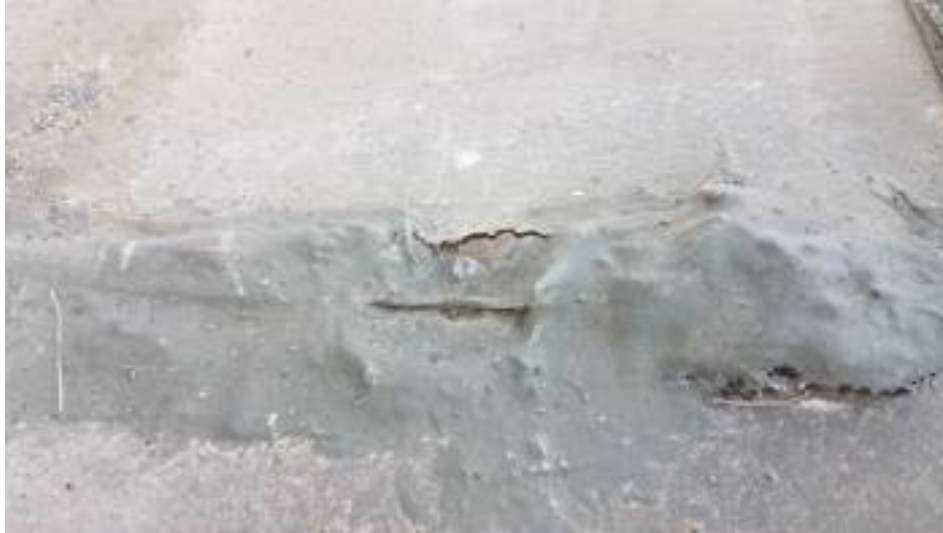
- Sealant at valley flashing seam is cracked. This has a high likelihood of leaking. Recommend a qualified roofing contractor inspect all roof flashing for any potential repairs

damaged seam at valley flashing

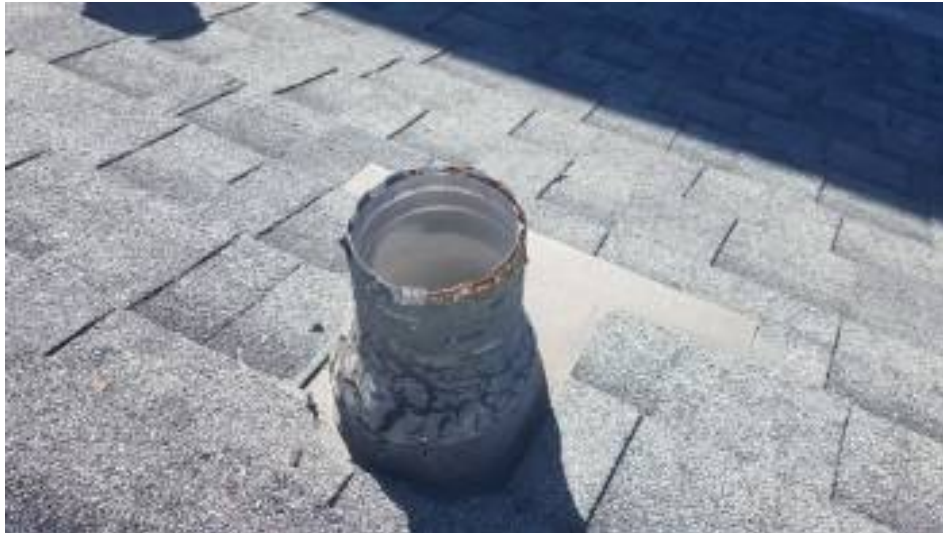
- Furnace exhaust vent is missing a rain cap. Rain is entering in the vent pipe and making its way into the furnace. Further damage will occur. Replacement of a vent cap is needed

rain cap missing on furnace exhaust vent

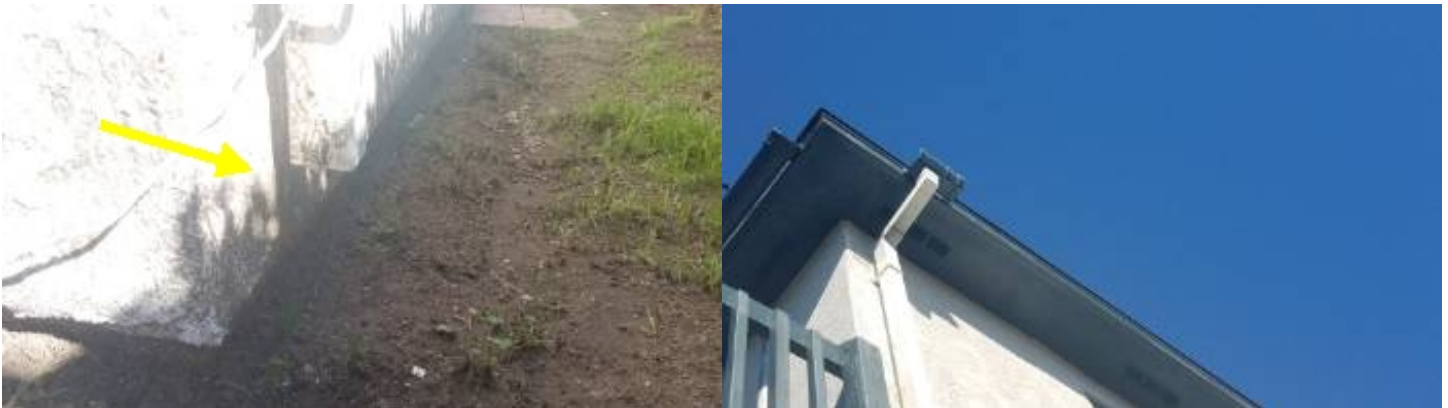
- Downspouts which discharge onto the ground - above grade - should discharge a good distance away from the house -- four (4) to six (6) feet or more, if possible. The slope of the ground in this area should be away from the house to direct water away from the foundation.
- There is no gutter/downspout installed at the roof drainage system. Location: Several sections. Potential water intrusion can occur and damage components. Recommend installing a gutter/downspout and properly extending away from the foundation to allow for proper drainage.

Downspout Next To Foundation

gutter missing

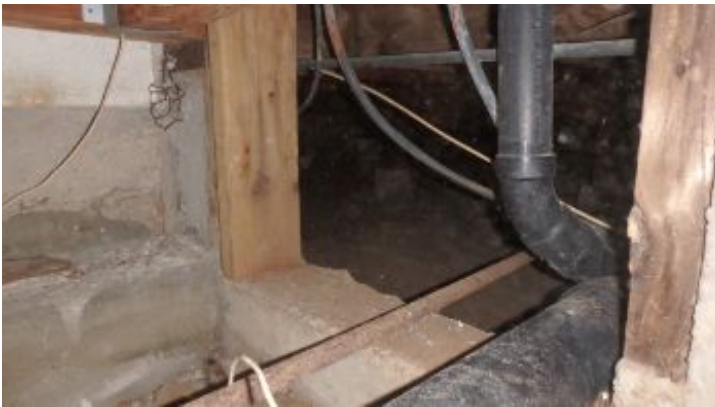
- Floor insulation is damaged, missing and displaced in several areas. Recommend a professional insulation installer remove or replace all damaged insulation
- The access at the center stem wall was restricted by plumbing. No access into the original portion of the East side of the home was performed.

Restricted access into front crawlspace

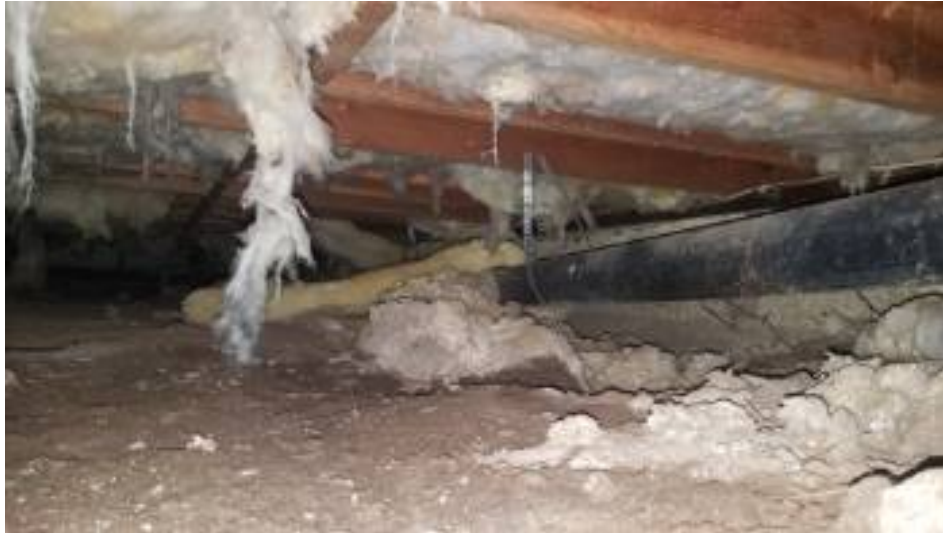
Insulation detached from floor in crawlspace

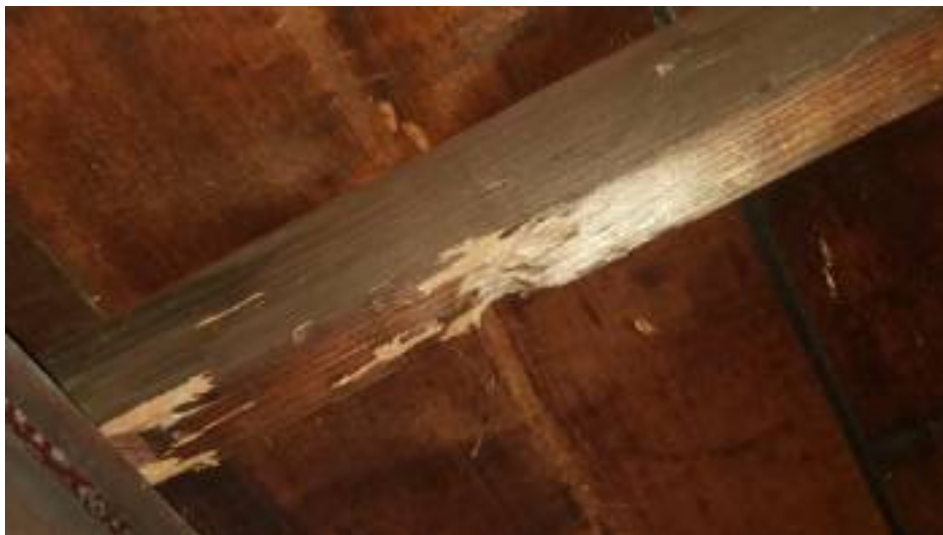
- Limited view due to finishing materials.
- Damaged wood and potential would destroying organisms at wall framing in garage. Recommend further review by a qualified termite inspector

damaged joist in garage

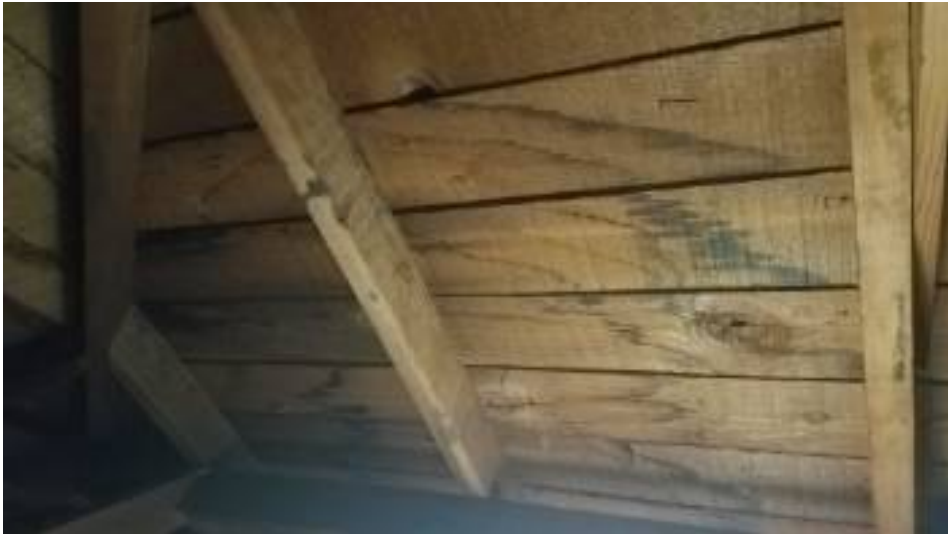
- Staining was observed at the roof sheathing located in the attic. Recommend all flashing and penetrations be reviewed by a qualified roofing contractor.

Staining seen on roof decking in attic

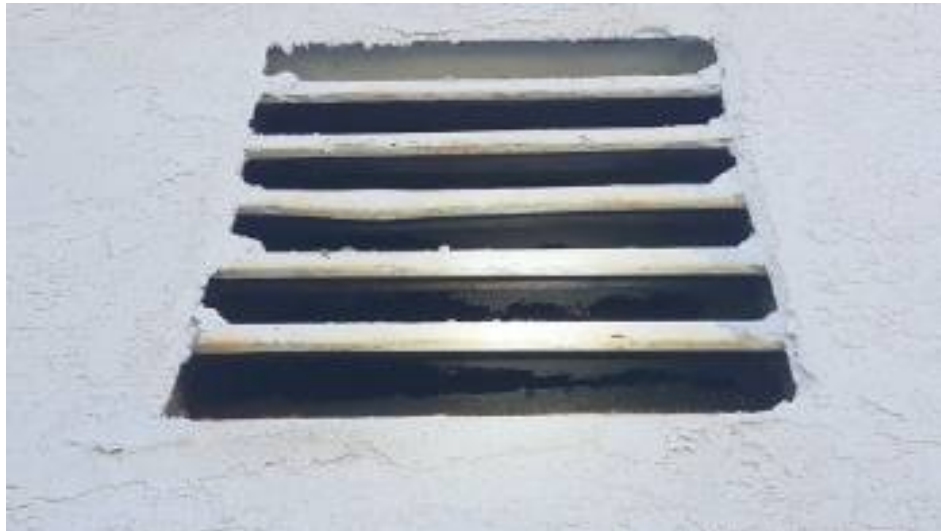
• Vent screen damaged at gable and louvre vent. Recommend a qualified contractor repair the vent to prevent any pests, birds or insects from entering the attic

Vent screen damaged

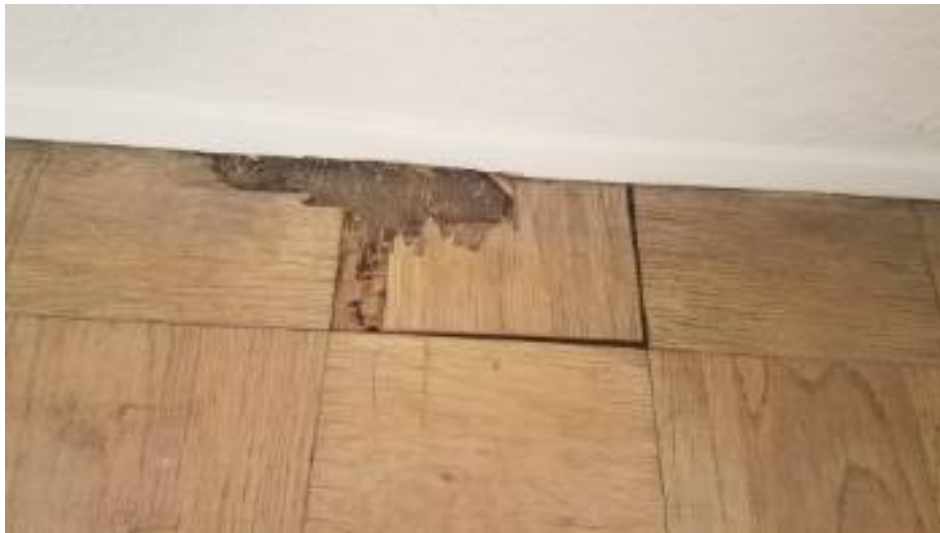
- Damaged wood flooring in rear great room. Repairs are needed.

Damaged flooring

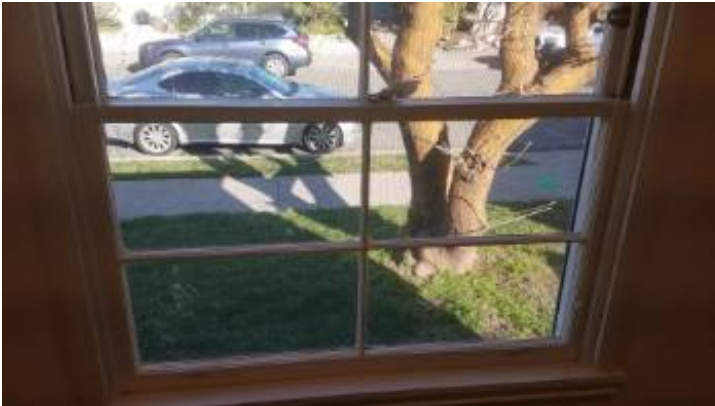
- In accordance with CREIA Standards, we do not test every window in the house, and particularly if it is furnished. We do test every unobstructed window in every bedroom to ensure that at least one provides and emergency exit.
- Highly recommend operating all windows during final walk through inspection.
- DEFERRED COST: Windows are original, older type. Consider upgrading to double pane, thermally insulated, newer efficient type.
- Some windows did not open when tested. Recommend all windows reviewed for proper operation during walkthrough inspection prior to closing
- Cloudiness/condensation observed in thermopane double glazed window in downstairs rear bedroom. This is an indication of a failed seal. A qualified contractor should review for replacement as needed.

window inoperable

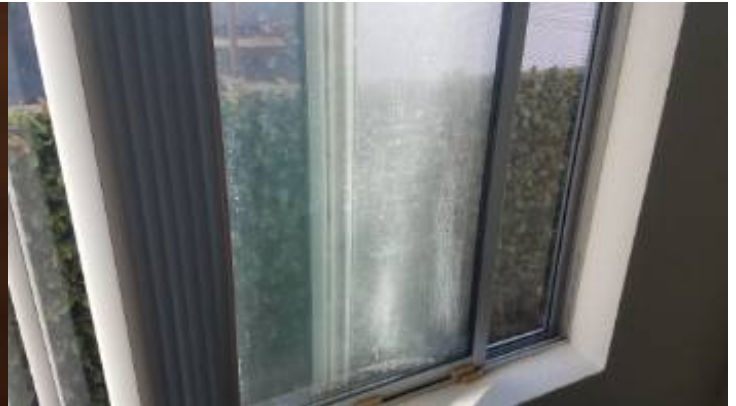
failed seal at master bedroom window

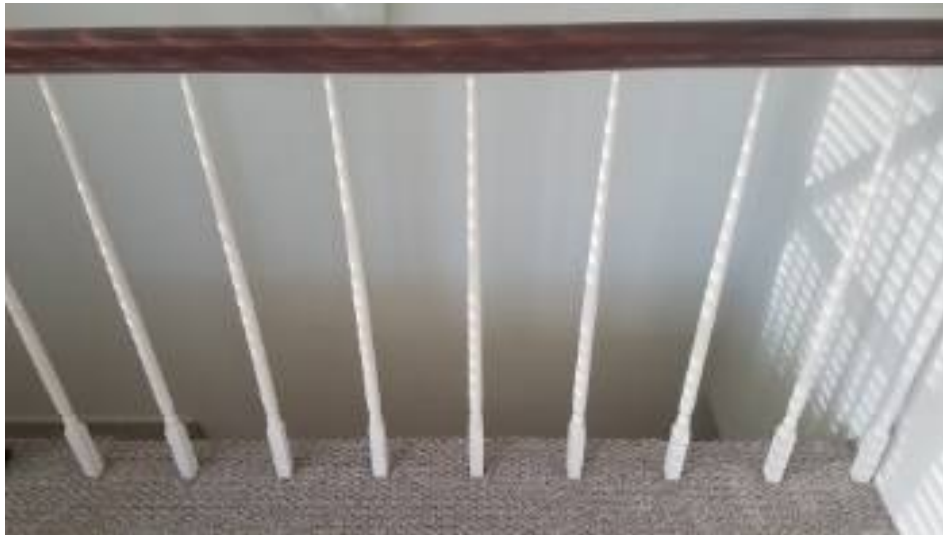
- **SAFETY CONCERN:** The opening between Balusters (vertical posts comprising barrier in railings) is 6 inches. A toddler can very easily fall through this spacing from the landing to floor below. Although 6" spacing was adequate when home was built -- modern building safety standards is now a maximum of 4" between balusters. Consider installing appropriate safety guard as determined.

Fall hazard

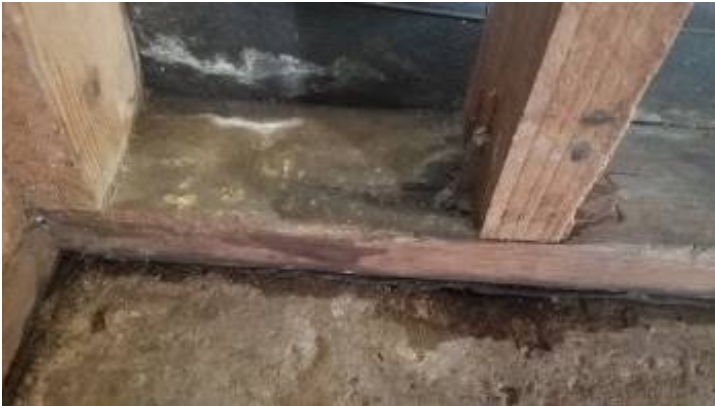
- Minimal lag bolts
- Rotting and damage was observed at the garage sill plates. This weakens the support for the framing. The corresponding exterior wall shows signs of moisture and poor drainage. Recommend further review by a qualified contractor.

Moisture entry

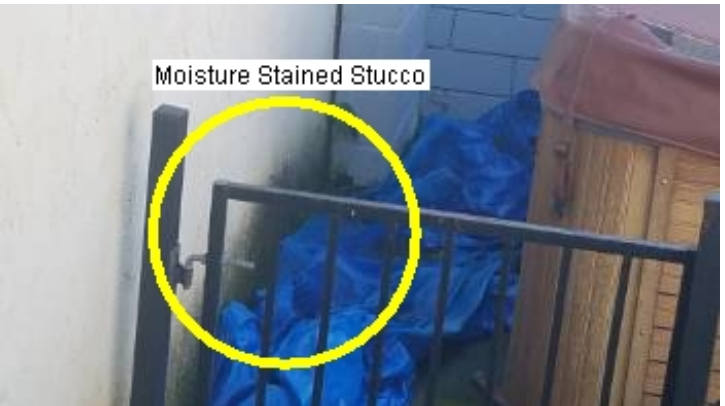
Moisture Stained Stucco  
exterior wall corresponding with moisture entry in garage

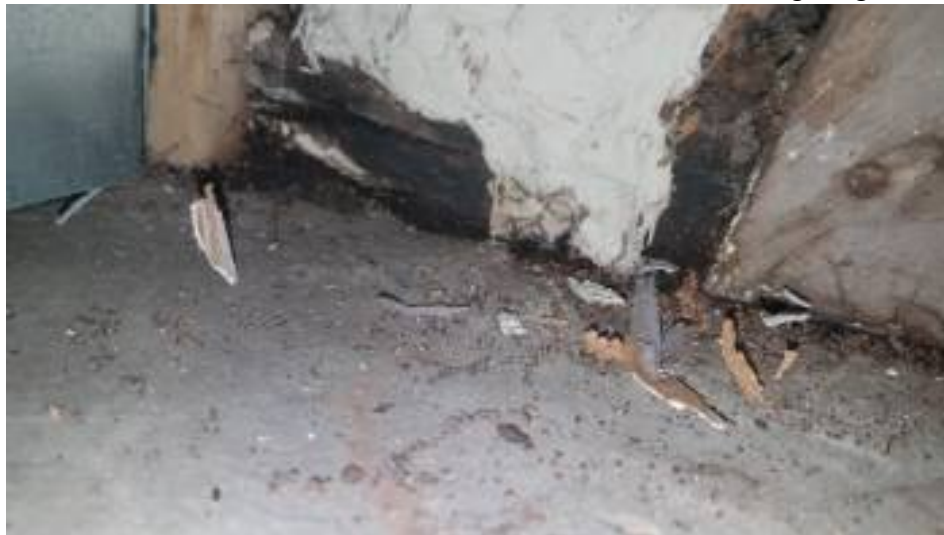
Moisture intrusion at garage sill plate next to door

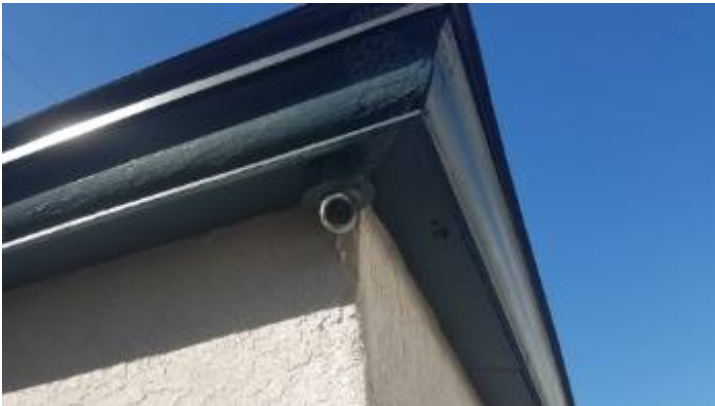
- SAFETY CONCERN: One receptacle has a "reverse polarity" fault. Location: Garage. This is an electrical shock hazard. A qualified individual or company should correct/repair as needed.
- SAFETY CONCERN: One/Several receptacle(s) have "open ground" fault. Location: Garage. This is an electrical shock hazard. A qualified individual or company should correct/repair as needed.
- Switches with unknown purpose found. Possible burned out bulbs or abandoned receptacles. Recommend inquiring with seller as to purpose of switches or hire a qualified electrician for more information.
- Missing bulb. Location:garage exterior

missing bulb

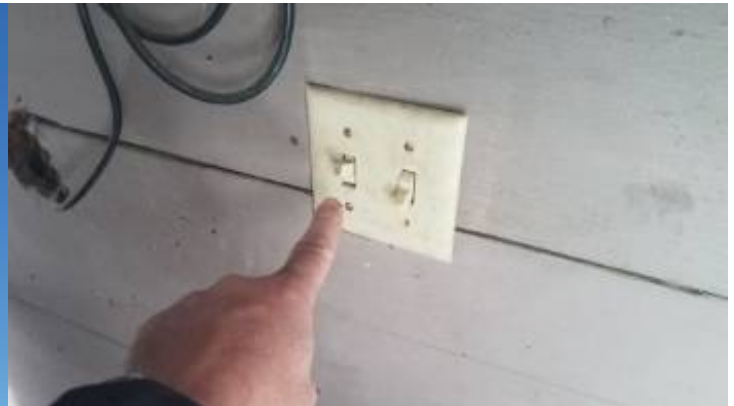
Switch With Unknown Purpose

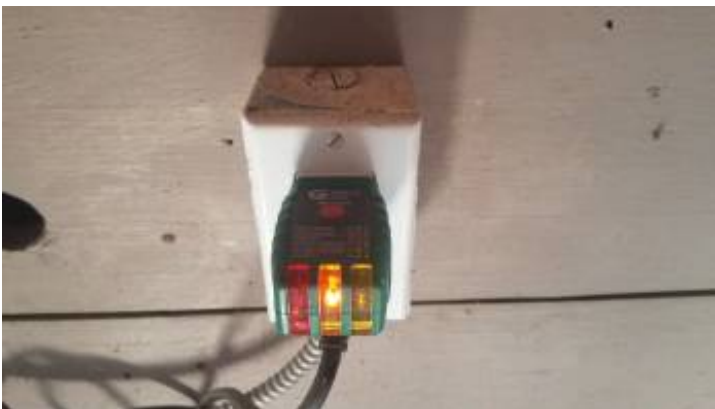
Receptacle Not Grounded In Garage

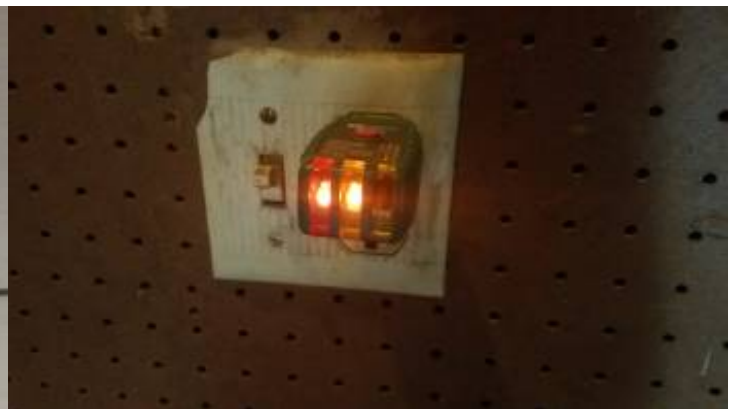
Receptacle with reverse polarity in garage

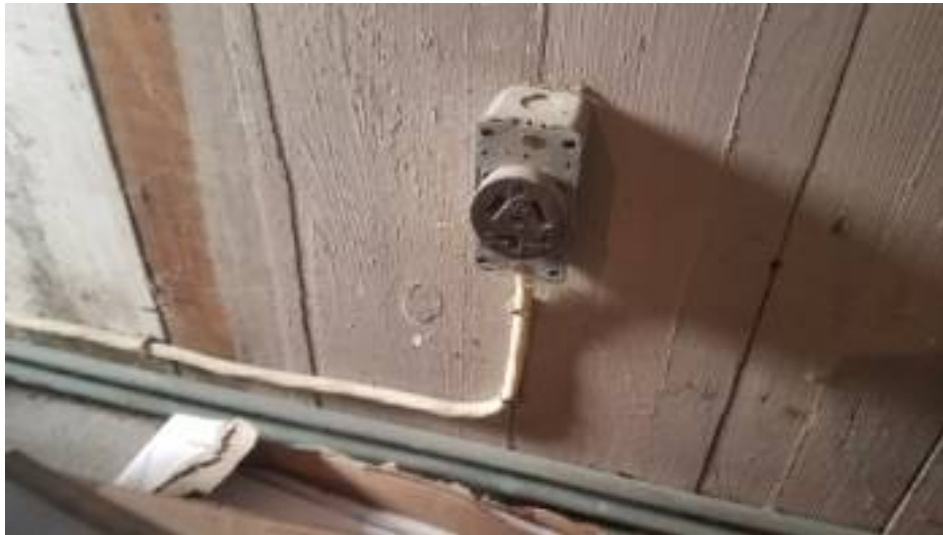
Receptacle without power

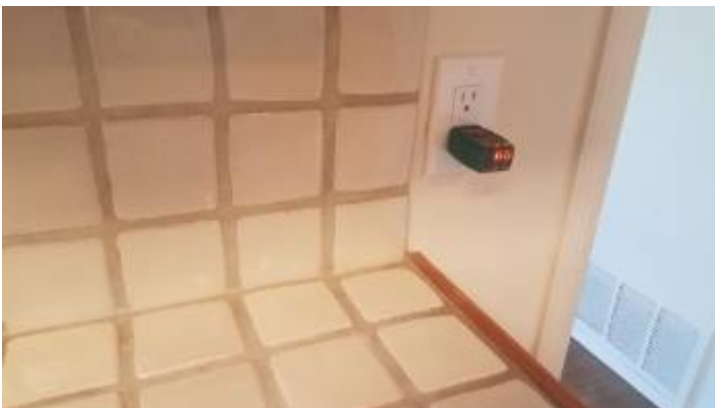
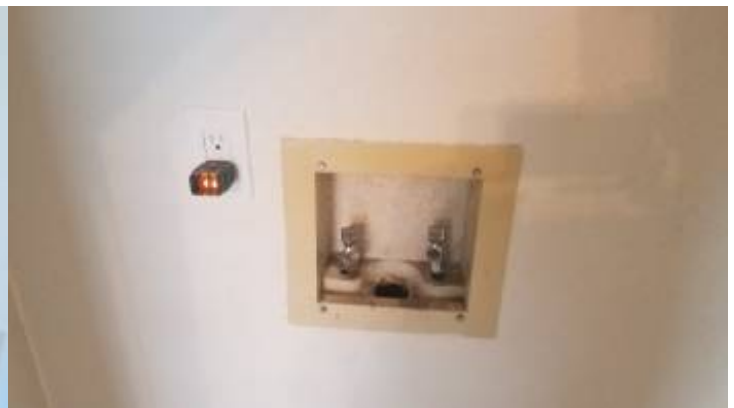
• This house was built prior to the requirement for the installation of GFCI receptacles in certain locations in the house. The locations where GFCI receptacles are required has increased, but it is not required to retrofit older homes unless a remodel takes place. For safety, it is advisable to upgrade all receptacles within 6 feet of a plumbing fixture, in garage, all kitchen counter top outlets, and at exterior, to GFCI protected outlets. A qualified electrician is recommended.

No GFCI Present

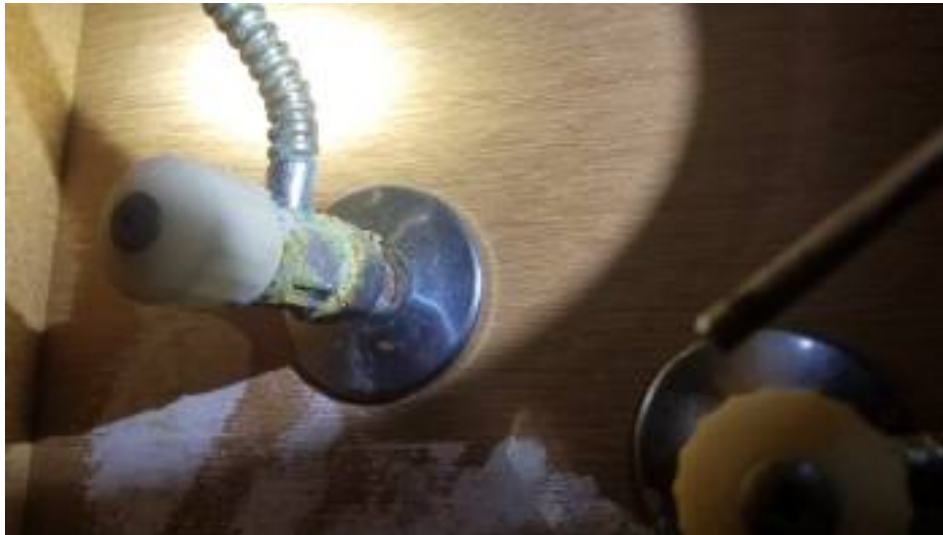
- Corrosion observed. Location:downstairs master bathroom sink. Have all pipes reviewed.

corrosion at master bathroom sink shut off valve

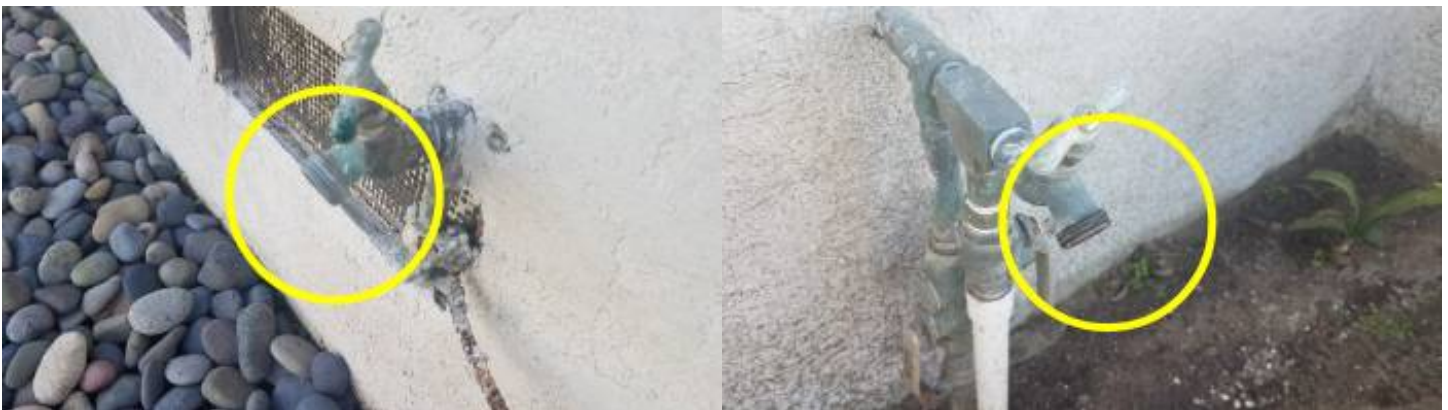
- IMPROVE: There are no anti siphon devices at the exterior faucets. This is a potential cross contamination. Recommend installing anti siphon devices.
- Shut off valve leading to the garage is currently leaking. Repairs are needed buy a qualified plumber.

Missing Anti-Siphon Valve

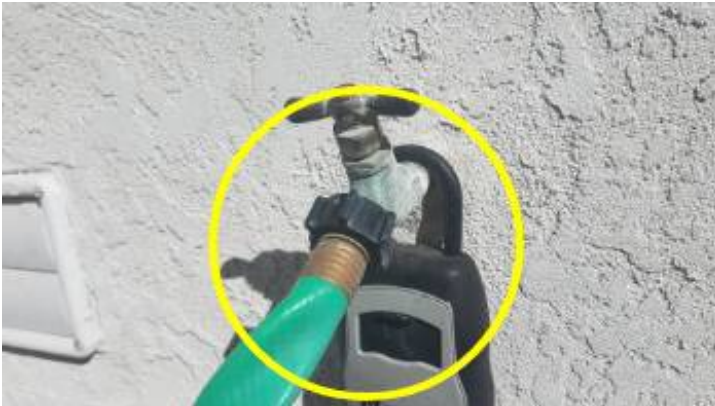
Missing Anti-Siphon Valve

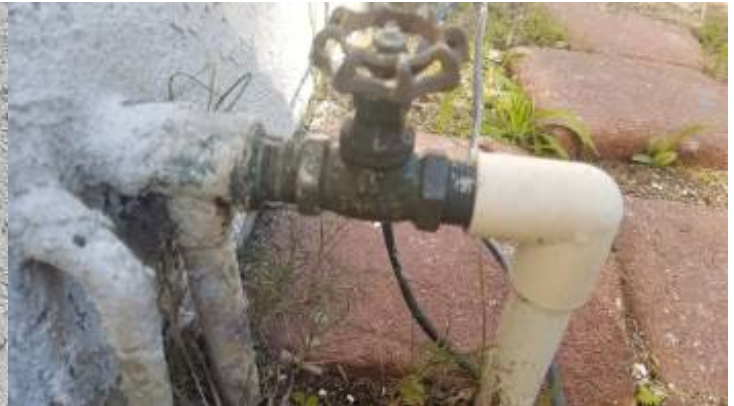
Leaking shut off valve

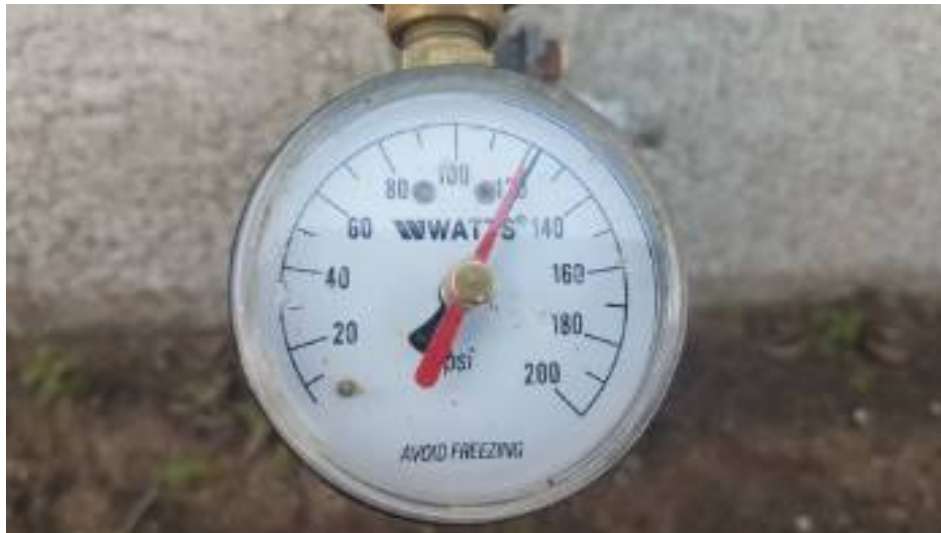
- The water pressure was tested and was found to be over 80PSI. The plumbing system may be prone to leaks in piping, fittings are other components. It is advised to adjust or install a new pressure regulator to reduce the pressure under 80PSI. Most jurisdictions require an **expansion tank** if a regulator is installed.

water pressure is at 120 PSI

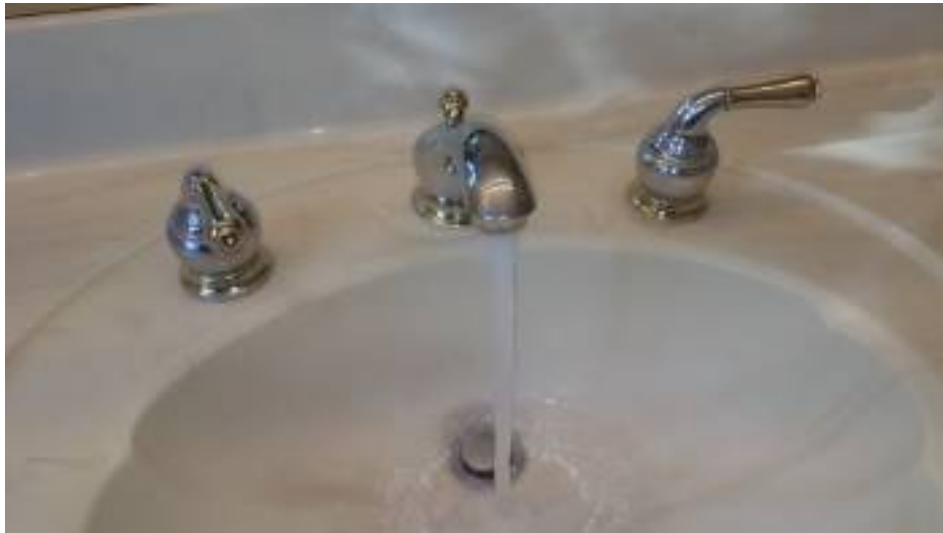
- Stopper is missing/inoperable at downstairs bathroom. Recommend review for repair or replacement as necessary.

Stopper inoperable at master bathroom sink

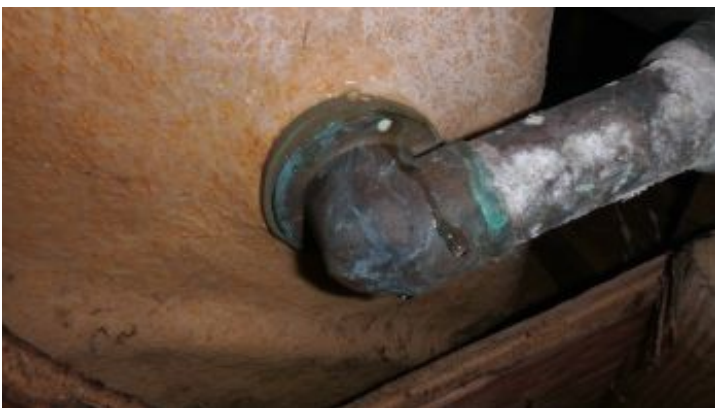
Leak was seen at master bathroom tub drain

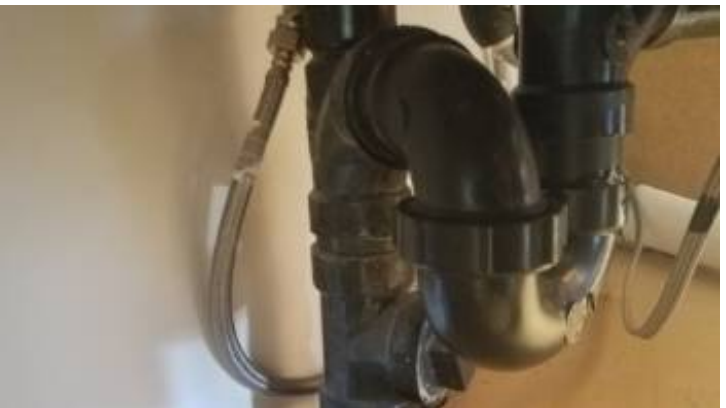
- Improper "S" trap installed.. This trap configuration may cause the water in the trap to siphon dry, allowing sewer gas and odor to enter the dwelling. Suggest repair by a qualified professional. In the alternative, run a little bit of water into the sink to reseal the trap if odor is detected.
- Slow, less than functional drainage observed at master bathroom tub and upstairs bathroom sink. Further review is needed by a qualified plumber.

S trap under kitchen sink

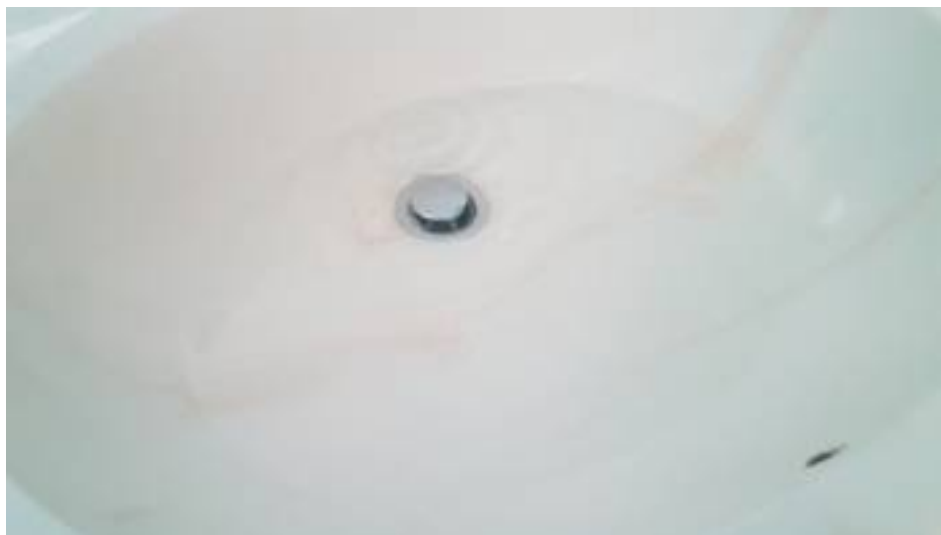
Slow Draining Sink At Upstairs Bathroom

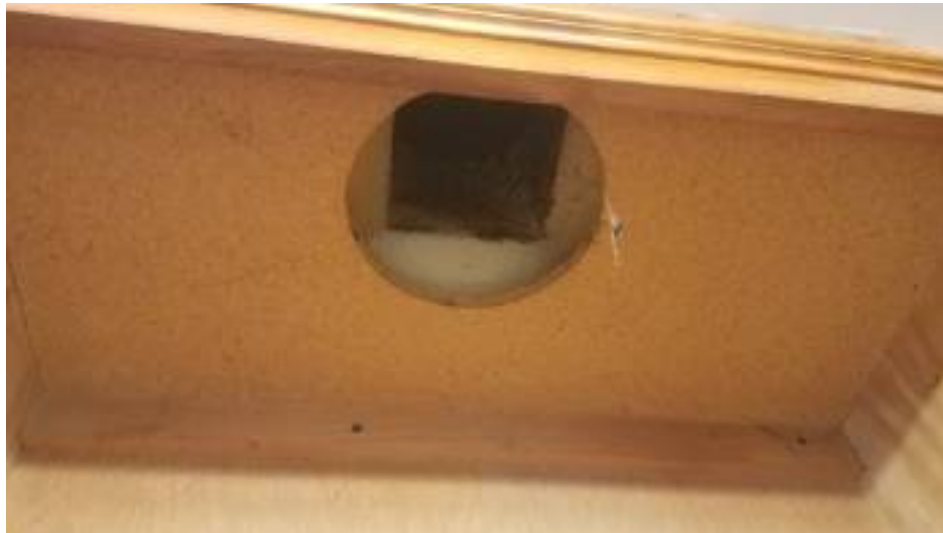
- The original vent opening exists but it is enclosed in the cabinet above the stove with no mechanical means to push the air out. Recommend adding an exhaust fan or range hood to allow for proper ventilation of the stove.

vent opening in cabinet above stove

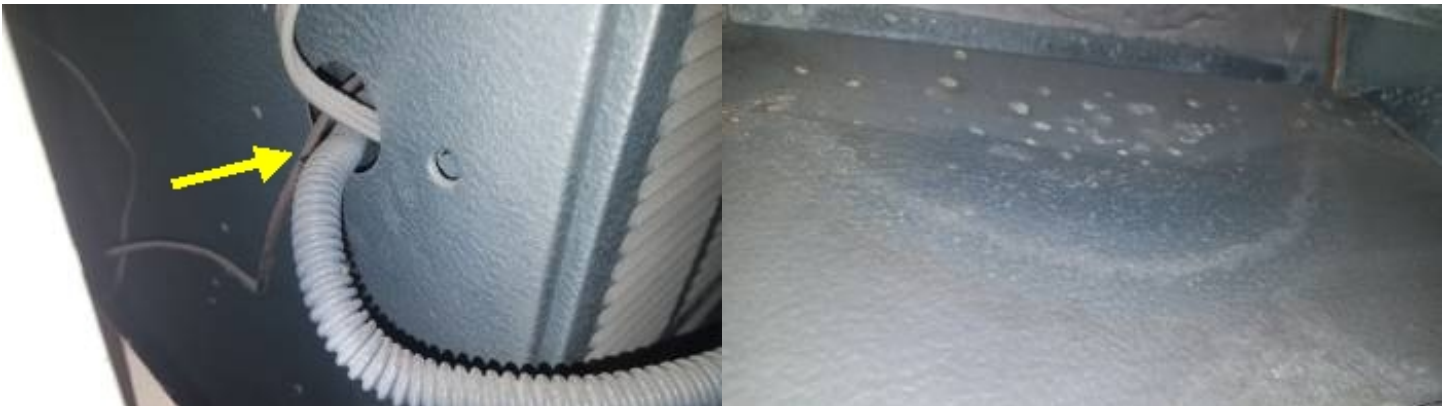
- IMPROVE: The unit is dirty with signs of rust inside the cabinet. There are no records of prior service. Recommend an HVAC contractor perform a system Clean-and-Check. HVAC systems require yearly maintenance.
- The flexible gas line runs through the cabinet of the appliance. This soft flex gas line is easily damaged if it contacts the appliance cabinet. We recommend that a qualified HVAC contractor install a rigid gas line at the appliance regulator and pass through the cabinet before connecting to the flexible gas line. A sediment trap is also recommended.

Fuel line susceptible to damage

water stains

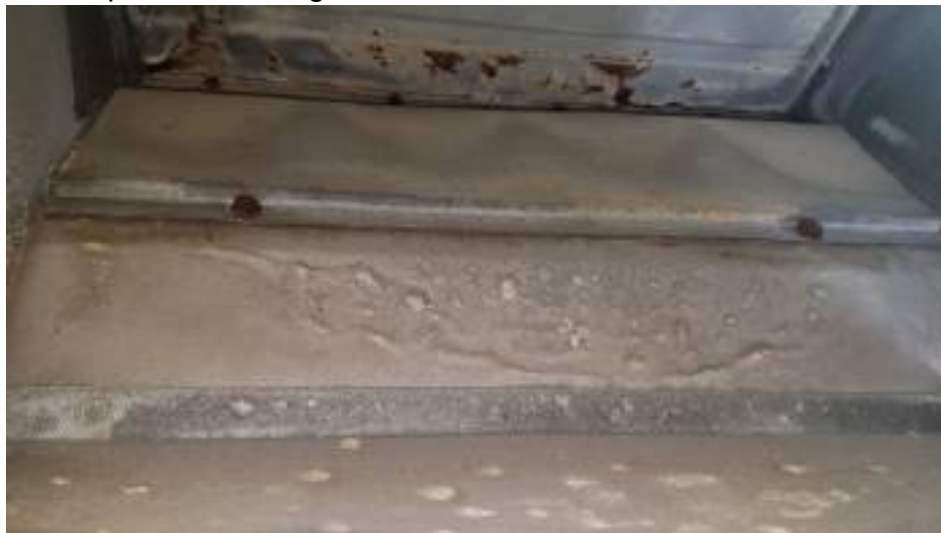
rust seen inside furnace cabinet
