# PROPERTY INSPECTION REPORT

**1234 Buena Vista St**  
**Inspection Prepared For: Happy Client**  
**Agent: Christian Castner - Harcourts Luxury Estates**

**Date of Inspection: 2/6/2019**  
**Year Built: 1944 Size: 2158**

## **Sunset Property Inspection**

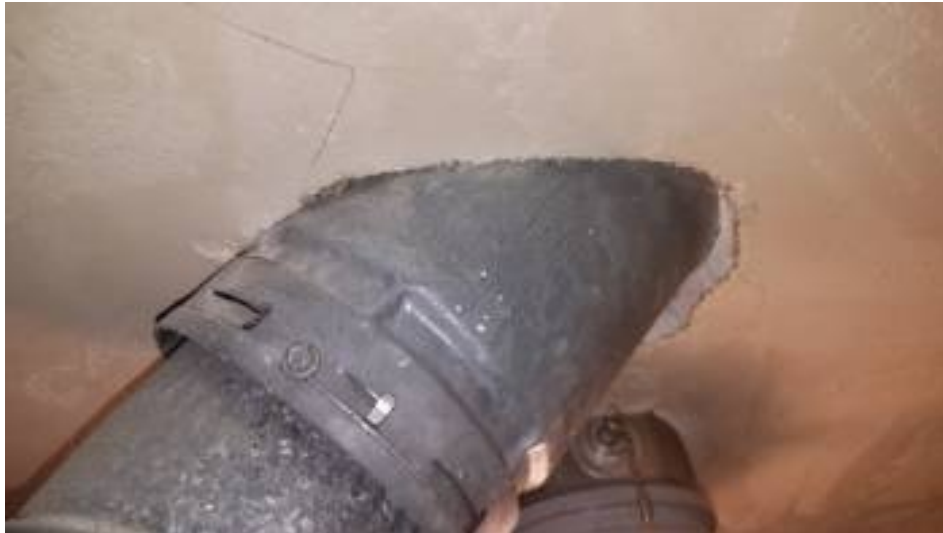
- Exhaust vent cap missing on roof. See roof section of this report.
- SAFETY CONCERN: Chimney flue/vent pipe has inadequate clearance to combustible materials. Repair as needed.

improper clearance to combustibles

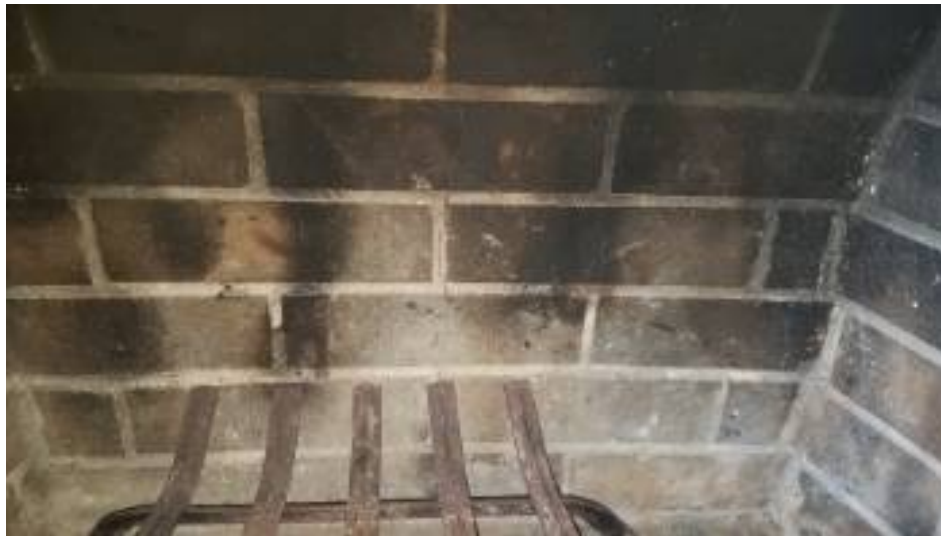
- Cracks seen in firebrick. A qualified chimney inspection advised before using. See Limitations section

Crack in firebrick
