INDY PRECISION
HOME INSPECTIONS

Home Inspection Report

1234 Drive Street Road, Anytown, IN 12345

20181127-01

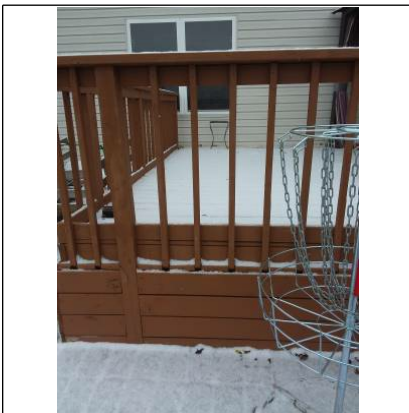
For added safety recommend balusters be spaced a maximum of 4" apart - safety concern for small children.

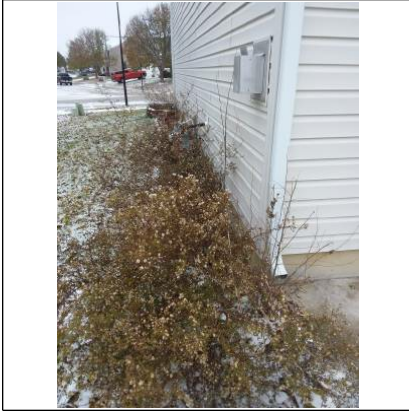
Comments Recommend trimming trees/vegetation so it doesn't come into contact with the home

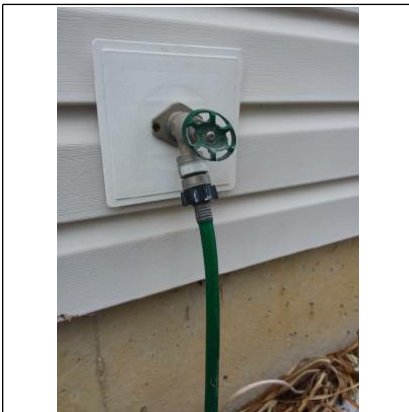
Recommend removing hoses before winter to prevent freezing.

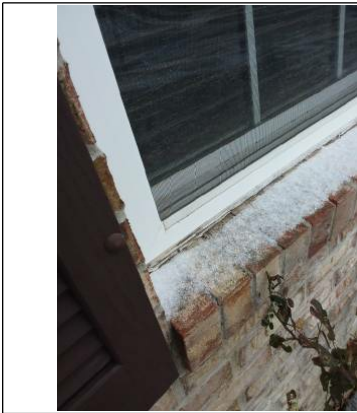
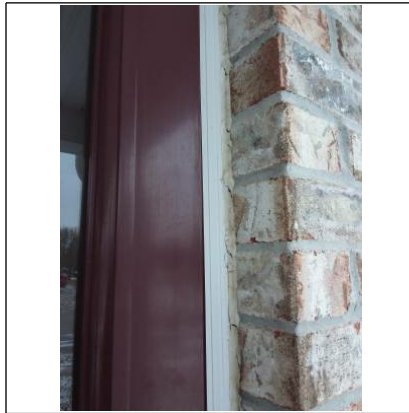
Comments Flashing at doors/windows missing, recommend proper installation by a qualified contractor

Comments Caulking dried and cracked in places, recommend removing and replacing. Monitor and repair as needed.

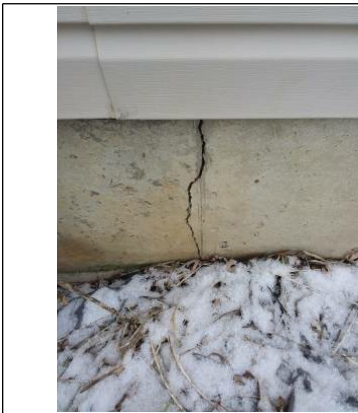
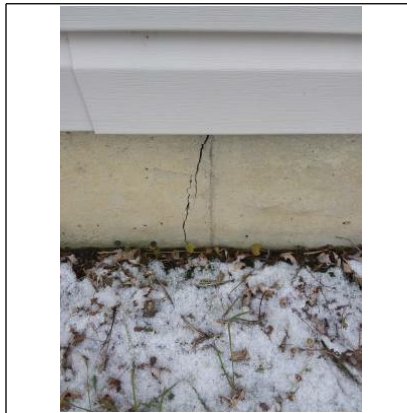
Comments Foundation (stem) wall contains typical cracks. Recommend sealing and monitoring.

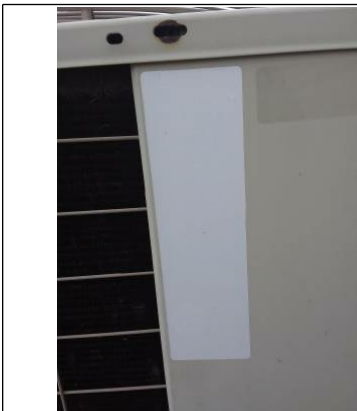
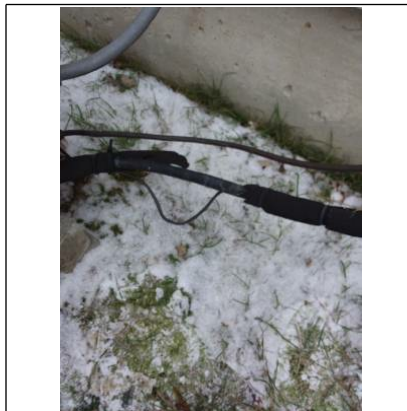
Heat pump nearing its life expectancy recommend budgeting for new unit.

Damaged/Missing insulation recommend replacing insulation.

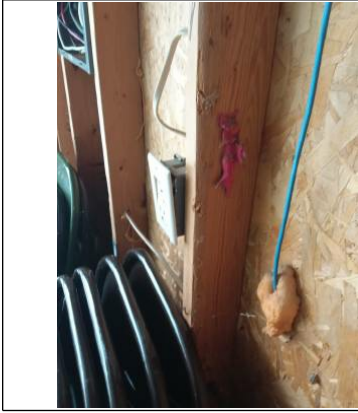
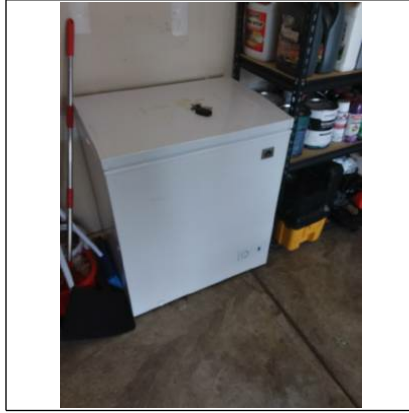
Comments Refrigerator/freezer on GFCI , recommend a non-GFCI outlet to prevent nuisance tripping.

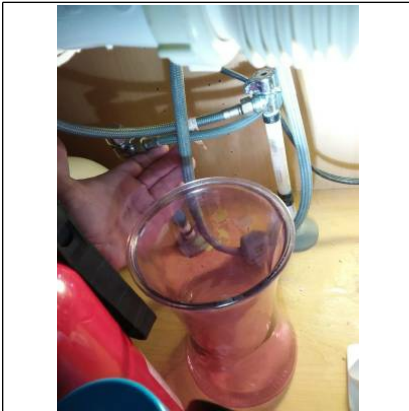
Comments Some water lines show signs of leaking recommend repair

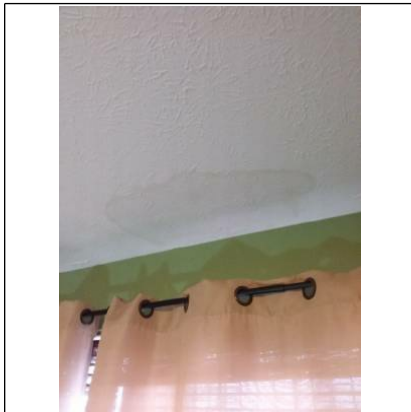
Comments Stains on ceiling. No moisture present at time of inspection. Continue to monitor.

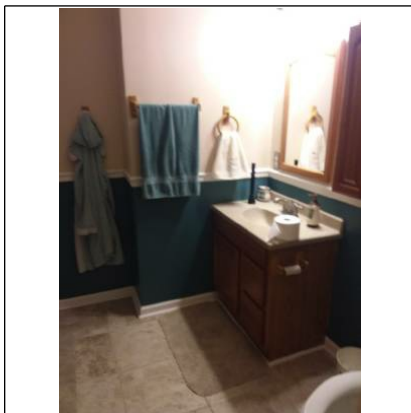
Toilet bowl is loose recommend repair

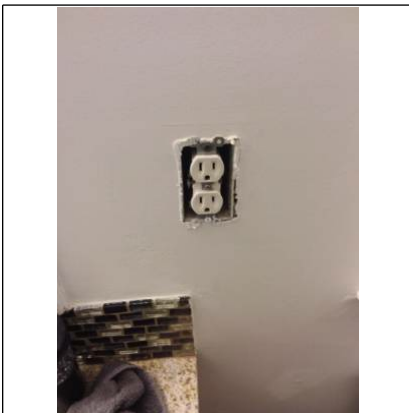
Comments Outlet cover plate missing. Potential safety hazard, recommend repair.

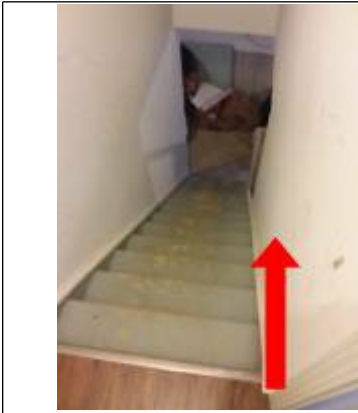
Missing handrail. Recommend installing one for safety.

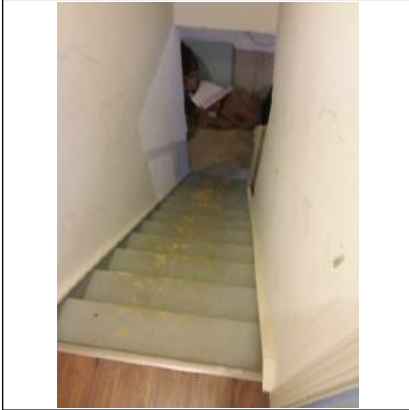
Comments Handrail missing, potential safety issue. Recommend Installing handrail

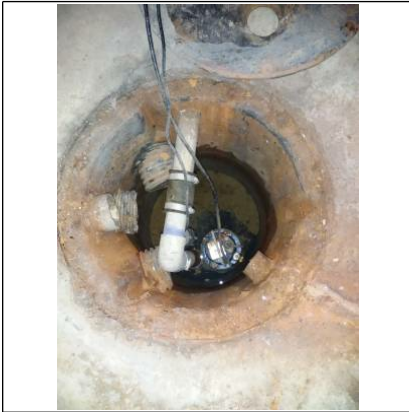
Recommend installing dedicated outlet for the sump pump. It is not a recommended practice to have a sump pump on a GFCI protected outlet.

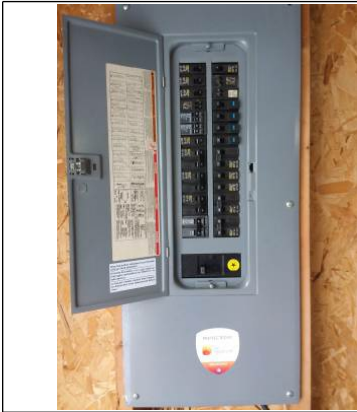
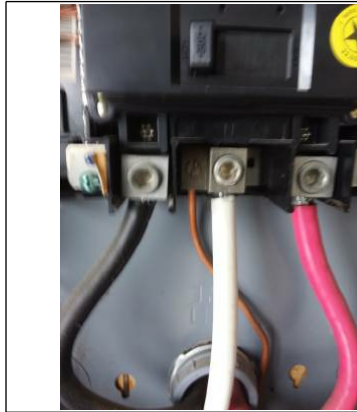
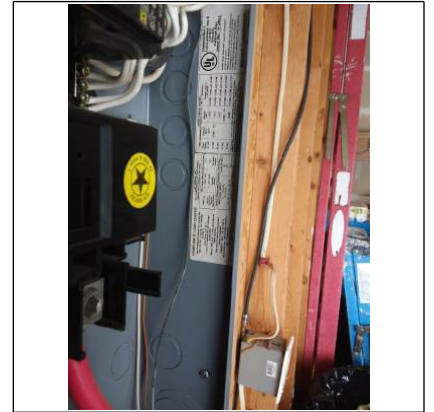
Comments Main wires are aluminum - recommend no-oxidation paste be applied to wires to prevent corrosion

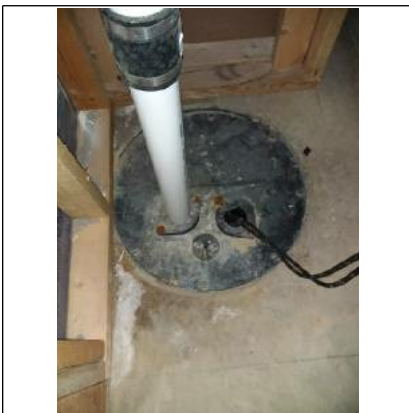
Comments Crock is not sealed properly. Recommend sealing lid properly.

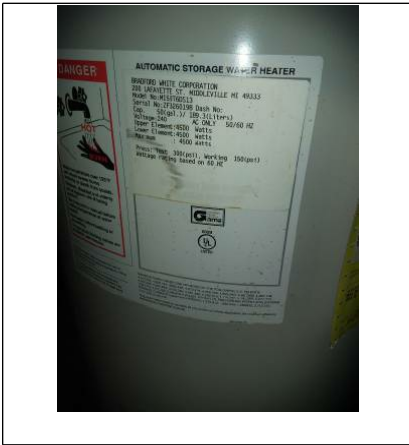
Comments Water heater nearing its life expectancy. Recommend budgeting for new unit.
