INDY PRECISION HOME INSPECTIONS

PROPERTY INSPECTION REPORT

**123 Anystreet Drive
Inspection Prepared For: John Homeowner
Agent: No Agent On File -**

**Date of Inspection: 1/1/2023
Year Built: 1998 Size: 1143 Square Feet
Weather: Sunny / 36 Degrees Fahrenheit**

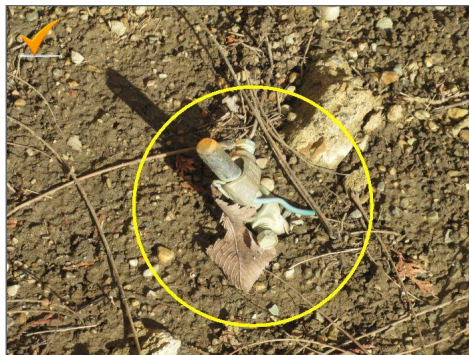
Ground rod should be installed at or below grade, use caution when operating lawn maintenance equipment

- It does not appear that the ground rod was installed to the proper depth. Ground rod should be at or below grade. This may affect the resistance and cause an improper impedance. Recommend a licensed electrician evaluation and repair as needed.

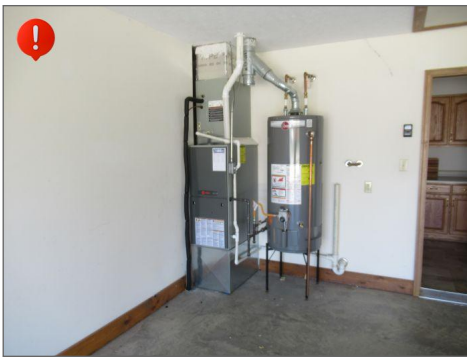
Recommend installing protective bollards to prevent accidental vehicle strike

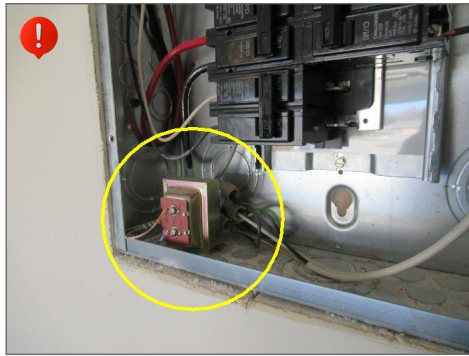
Doorbell transformer should not be inside of electrical panel, recommend proper installation by a licensed contractor

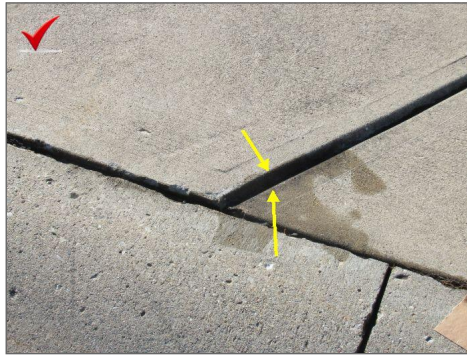
There are uneven slabs at the driveway which could be a tripping hazard, recommend using additional caution in these areas

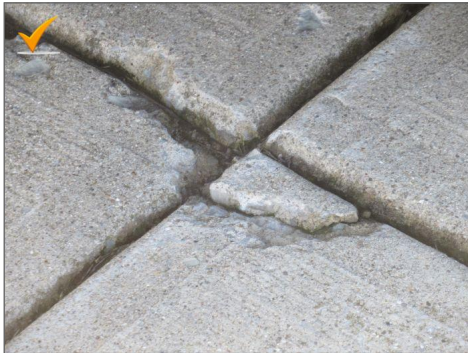
The driveway is cracked, recommend sealing the cracks to help prevent additional damage

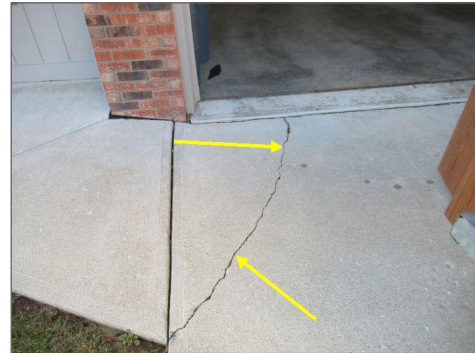
The driveway is cracked, recommend sealing the cracks to help prevent additional damage

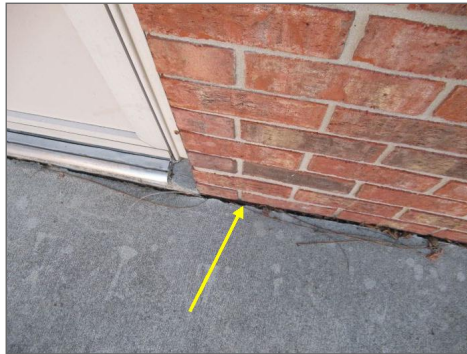
Recommend sealing the gap between the patio and the house to help prevent water penetration

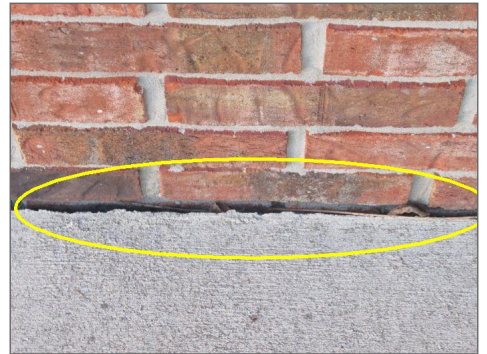
Recommend sealing the gap between the patio and the house to help prevent water penetration

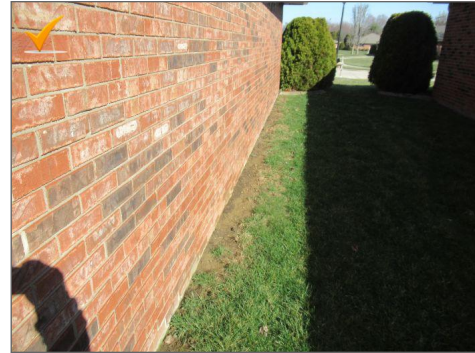
- There is a negative grading slope toward the foundation, in one or more locations (east side of home). Recommend maintaining a positive drainage slope away from the foundation. Consult a professional landscaper for proper drainage and grading as needed.
- There is vegetation in contact with the house. Recommend trimming back trees/vegetation, so it is doesn't come into contact with the home.

There is a negative grading slope toward the foundation, in one or more locations (east)

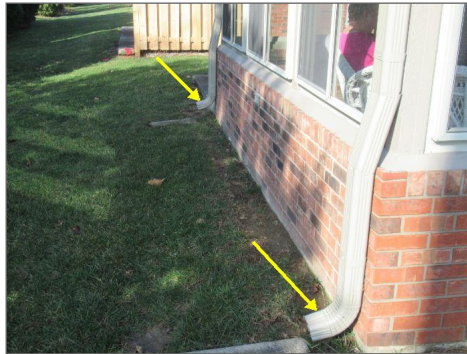
The gutter downspouts don't direct water far enough away from the house, recommend adding downspout extensions

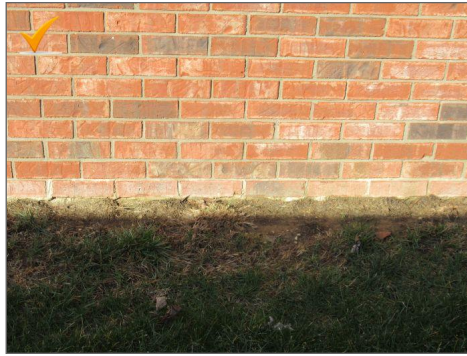
- The front brick veneer wall appeared to be missing weep holes. Moisture can penetrate the surface and siding junctions of the brick and mortar. Recommend a licensed contractor add weep holes to allow potential moisture to escape. We further recommend a contractor verify the presence of a proper vapor barrier and **air gap** between the brick veneer and exterior sheathing to allow for drying, as typically designed.

No weep holes were observed on brick veneer siding, recommend adding weep holes

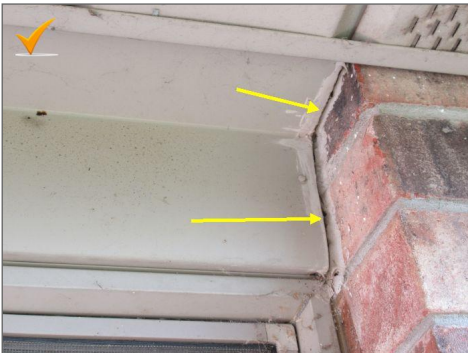
The caulking is dried and cracked, recommend a professional contractor to remove and replace the caulking

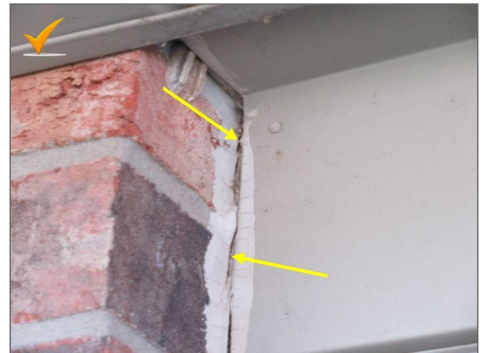
The caulking is dried and cracked, recommend a professional contractor to remove and replace the caulking

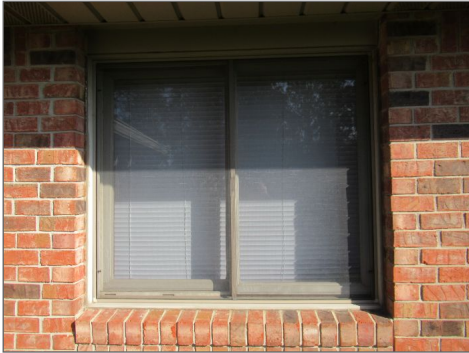
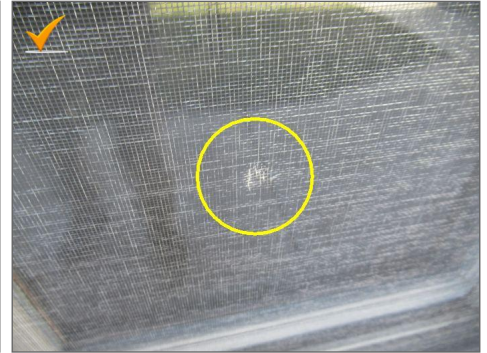
Some window screens are torn, damaged, or missing, recommend repair/replacement as needed

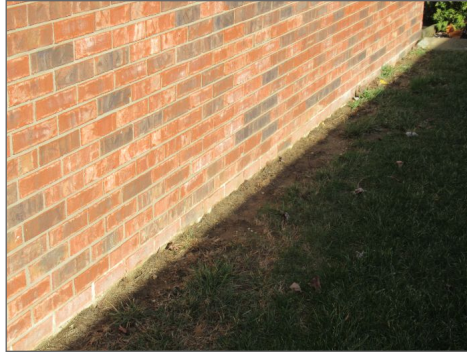
- One or more areas of the foundation wall(s) have limited or no visibility. No evaluation can be made. Recommend monitoring and consulting a licensed contractor as needed.

Foundation has limited/no visibility

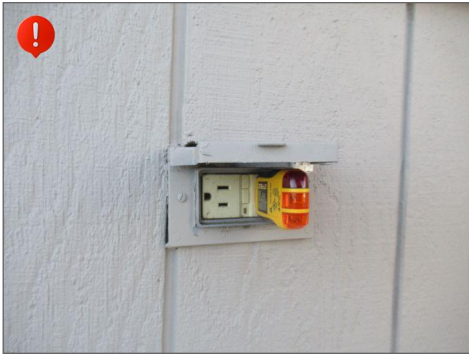
GFCI electrical receptacles were not operational, did not trip when tested, potential safety hazard

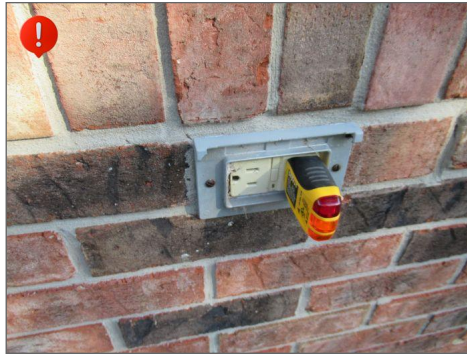
GFCI electrical receptacles were not operational, did not trip when tested, potential safety hazard

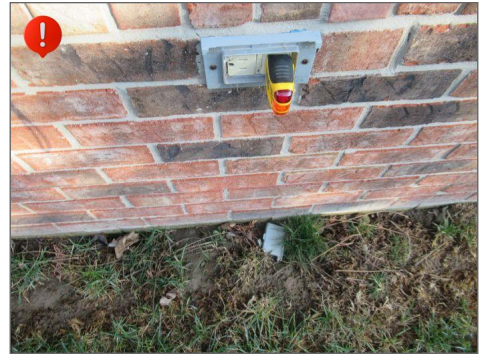
Weather cover is damaged/missing which is a safety concern, recommend repair/replacement

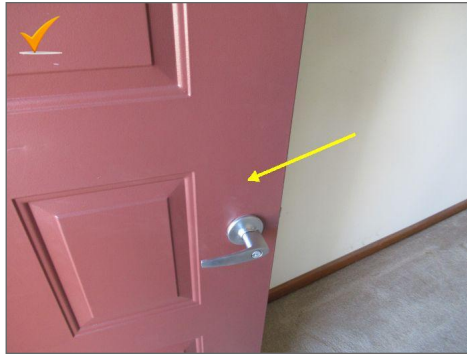
Main entrance door does not have a security lock (deadbolt) installed, recommend installing

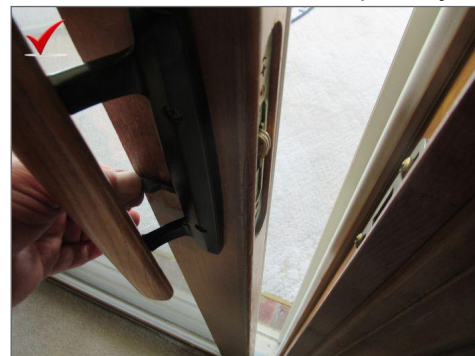
Patio door does not latch/lock as intended, recommend repair

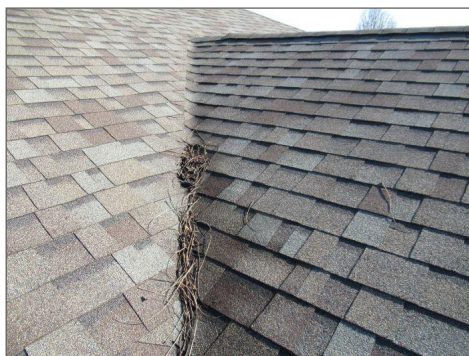
The roof **valley** view, recommend clearing debris to allow for better drainage

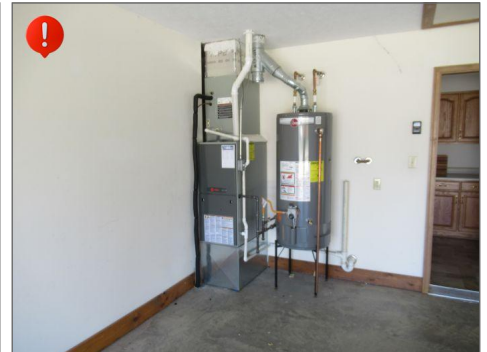
Recommend installing protective bollards to prevent accidental vehicle strike

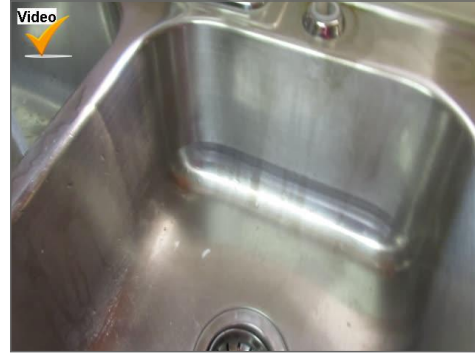
Low flow observed from kitchen faucet sprayer, recommend repair

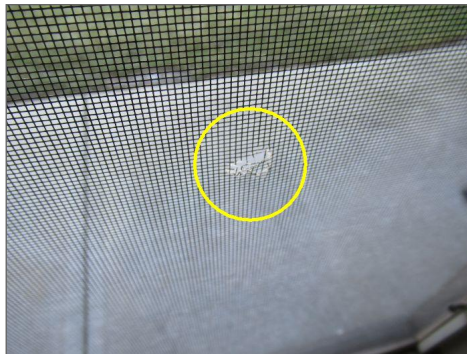
One or more window screens are damaged/torn/missing, recommend repair

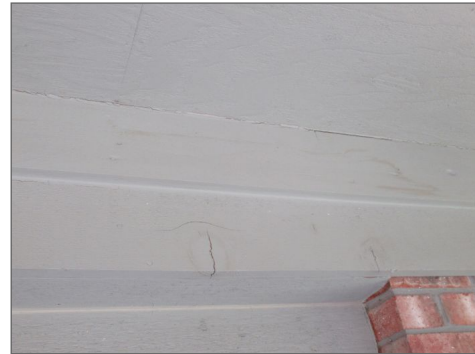
There are moisture stains on the walls, recommend maintaining proper ventilation and repair as needed

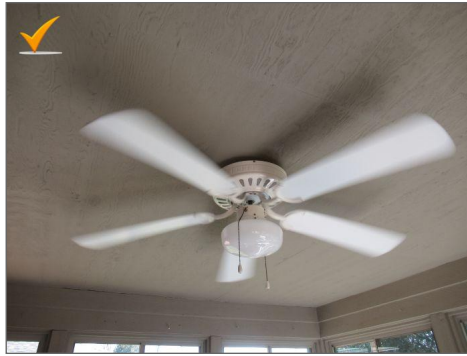
No representation can be made to the proper installation of ceiling fans, ceiling fan light does not operate

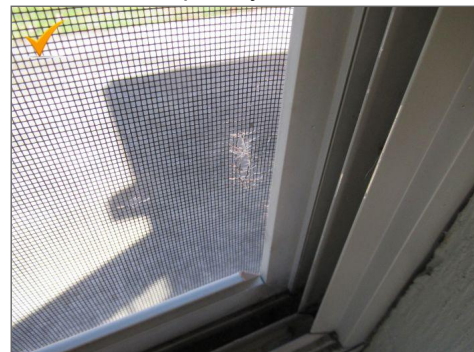
One or more window screens are damaged/torn/missing, recommend repair

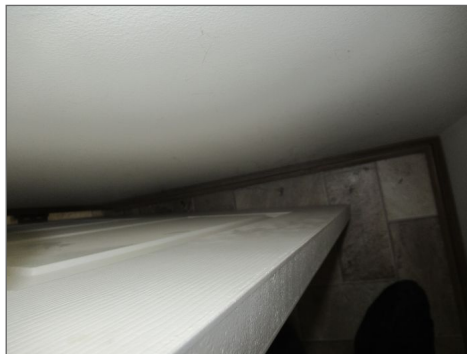
Recommend installing a doorstop, doorstops help prevent damage to the wall from the doorknob

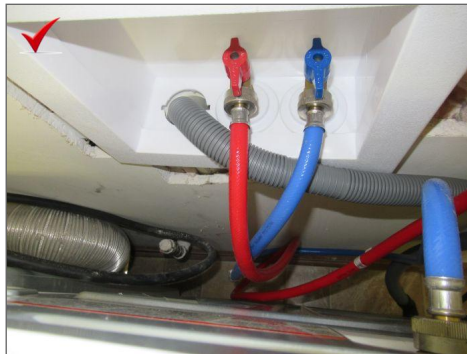
Recommend installing braided stainless steel washer hook-up lines for better protection from rupture

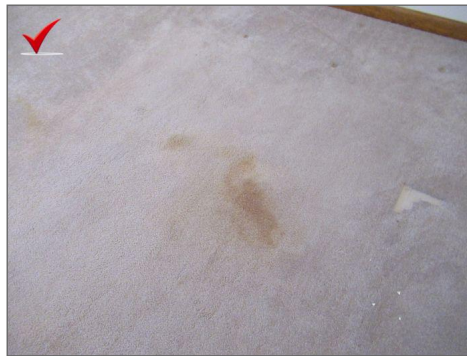
Floor covering is damaged/stained (cosmetic only), recommend replacing as needed

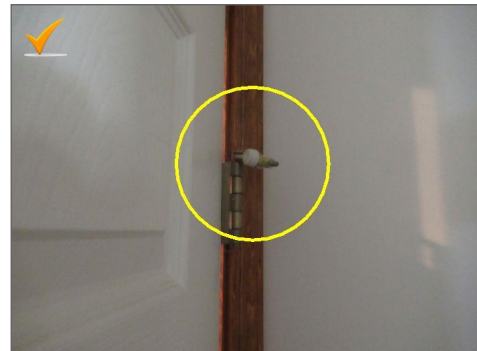
Recommend replacing existing doorstop, doorstops help prevent damage to the wall from the doorknob

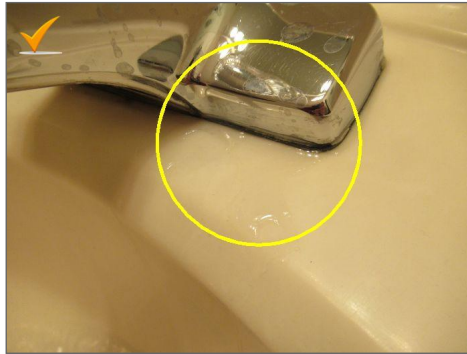
The faucet is leaking in the bathroom, recommend a licensed plumber repair or replace

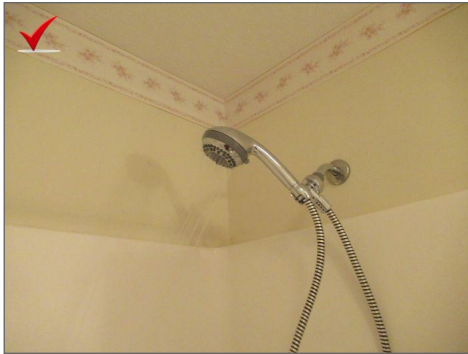
The shower diverter doesn't work correctly, recommend further evaluation and repair by a licensed plumber

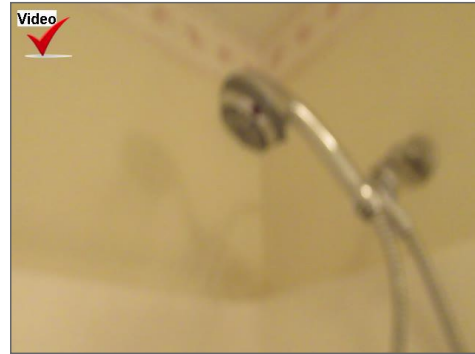
The shower diverter doesn't work correctly (runs from shower and tub simultaneously), recommend repair by licensed plumber

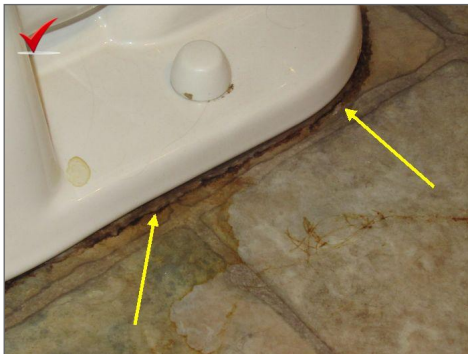
- There is evidence of leaking at the base of the toilet which indicates the presence of a failing wax ring. Recommend a qualified contractor evaluate and repair.

Evidence of a failing wax ring observed on bathroom toilet, recommend repair

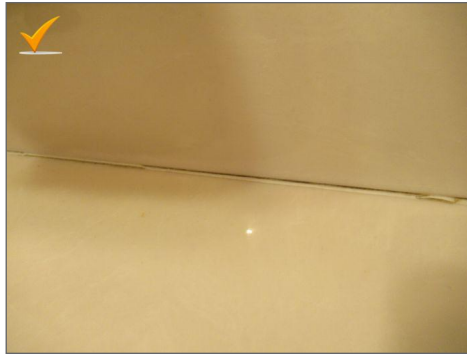
There are areas of missing grout/caulk in the bathroom, recommend re-grouting/caulking

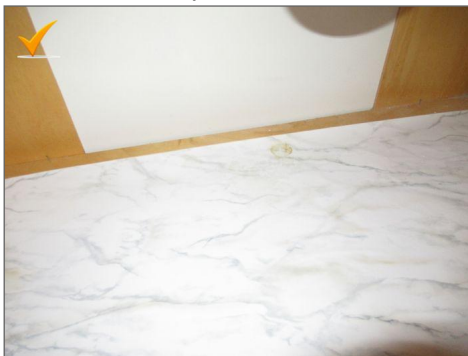
There is staining on the bathroom cabinets, there was no current moisture at the time of the inspection, recommend monitoring

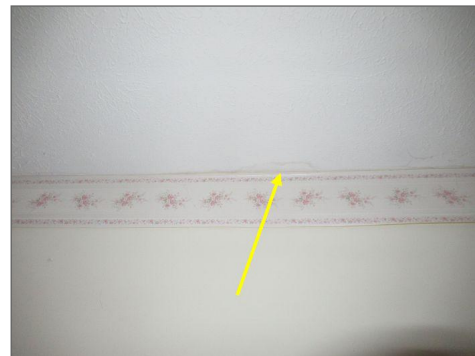
There is staining on the bathroom ceiling, there was no current moisture at the time of the inspection, recommend monitoring

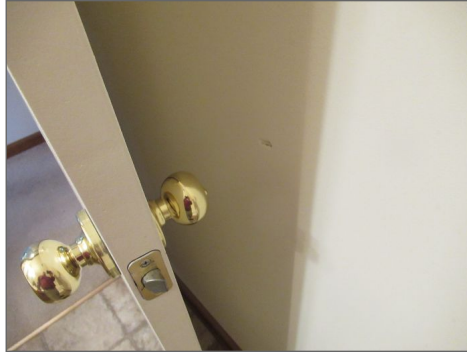
Recommend installing a doorstop, doorstops help prevent damage to the wall from the doorknob

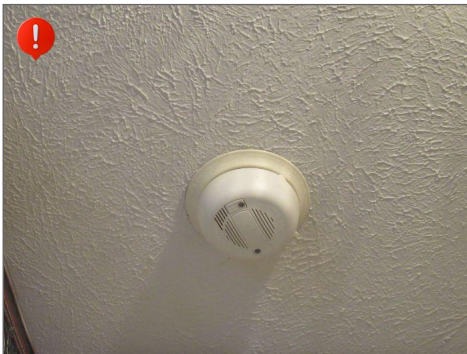
Smoke detector located in hallway
(recommend replacing due to age)

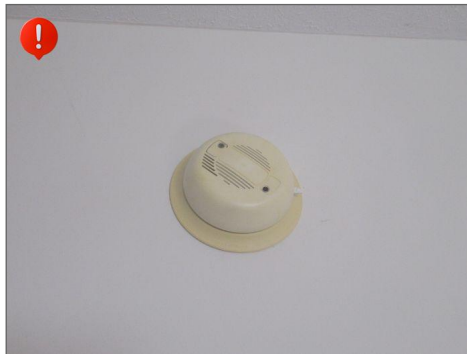
Smoke detector located in bedroom 2
(recommend replacing due to age)

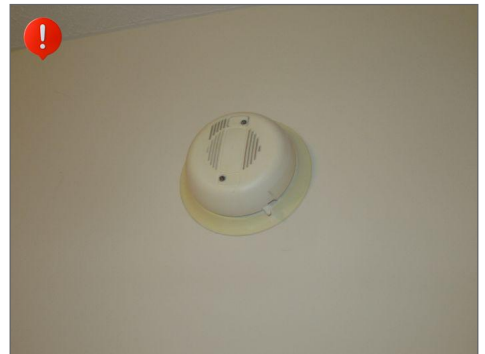
Smoke detector located in bedroom 1
(recommend replacing due to age)

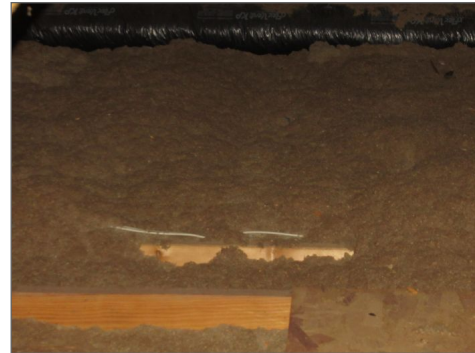
The attic insulation is not sufficient for current building standards, recommend a licensed professional add additional insulation

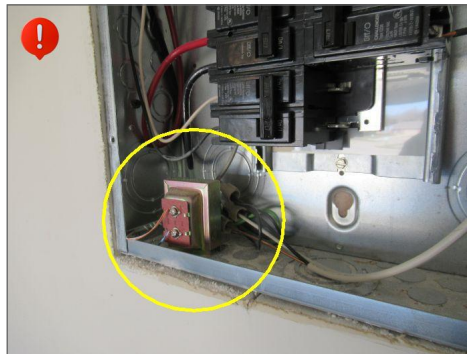
- The doorbell transformer (low voltage wiring) should not be installed inside the electrical panel. This is a safety concern. Recommend relocation of the doorbell transformer outside the electrical panel box by a licensed electrician.

Doorbell transformer should not be inside of electrical panel, recommend proper installation by a licensed contractor
