Professional Inspection Report

**Robert Malone
5015 Ossineke Ct
Spring, TX 77386**

PROPERTY INSPECTION REPORT

Reinspection Comments from Friday, September 7, 2018

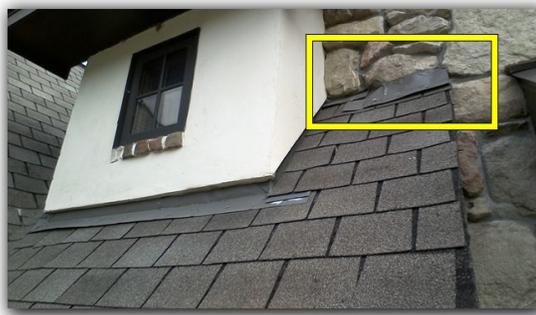
- The flashing on the front vertical wall outside the upstairs front bedroom was unsatisfactorily installed and appeared to be a location where moisture would be entering the wall that is causing damage and deterioration to the ceiling in the downstairs formal dining area. Recommend repair to properly flash and seal this area to prevent moisture penetration.

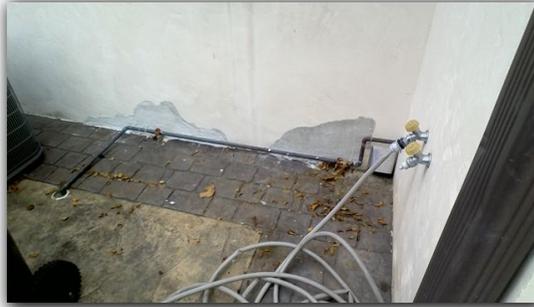
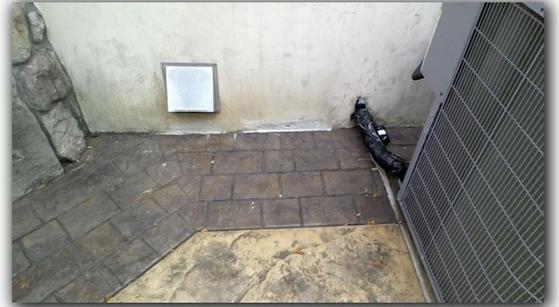
- The damaged material in the wine storage room appeared to be in satisfactory condition and the wine cooling / refrigeration equipment was functioning satisfactorily at the time of the reinspection.
- There was evidence of patching to a few locations of the locations mentioned in the April 3, 2018 report on the exterior stucco finish on the left side of the house. These areas were cosmetically corrected and, in this inspector's opinion, should be more satisfactorily finished.

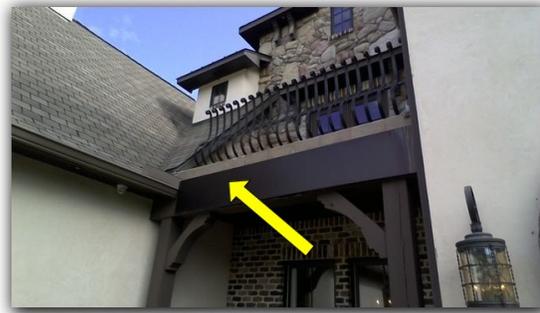
- The brick / tiles on the edge of the front upstairs balcony were repaired satisfactorily.

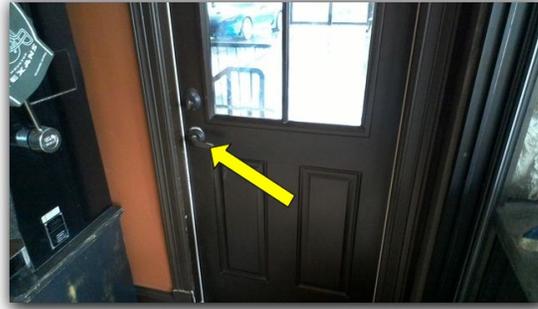
- The door knob hardware to the door entering the garage from the downstairs game room was broken and needs to be repaired.

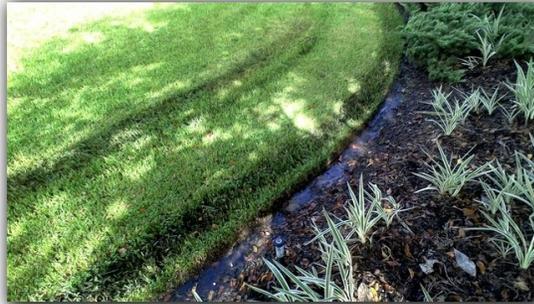
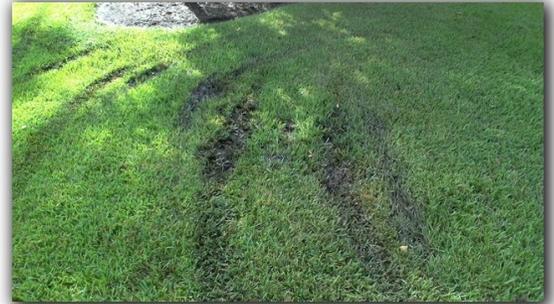
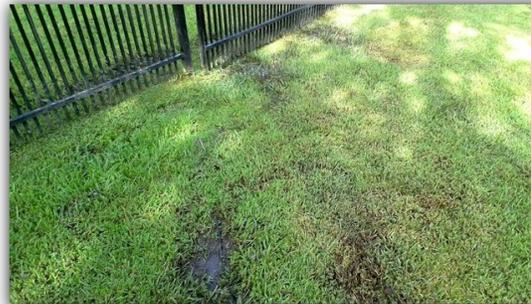
- There were multiple areas in the front and back yards that appeared to be overwatered that were excessively saturated. Recommend programming the sprinkler system zones satisfactorily to eliminate ground saturation and provide more effective watering.
