August 17, 2017

Re: Pinnacle Mountain North – Gated Entrance Site

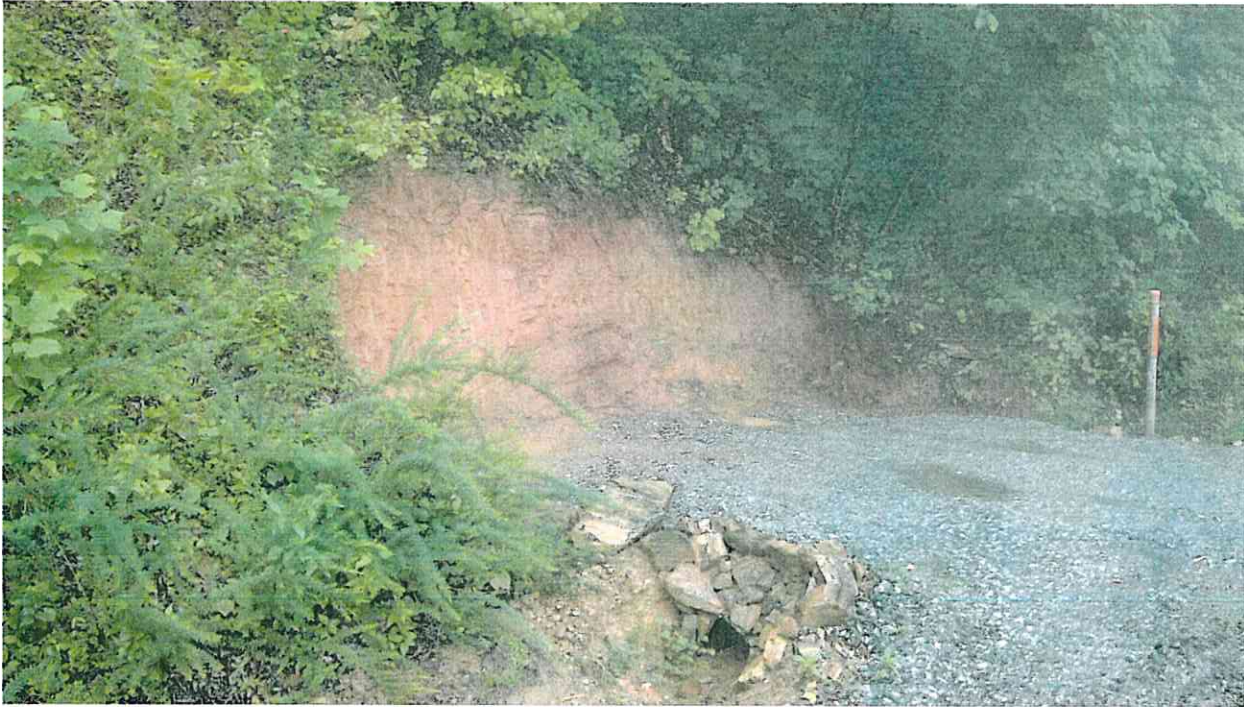
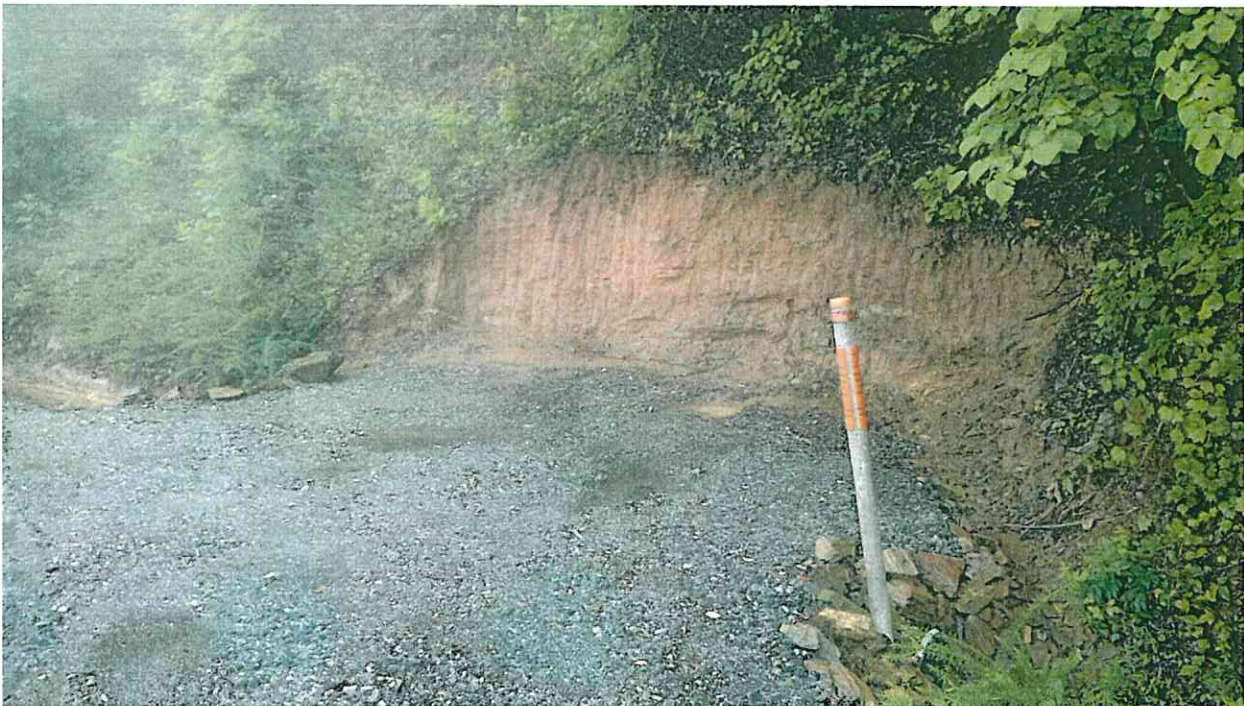
Item One: The current turnaround area is approximately 16 feet wide and 17 feet in depth with tight radius connecting to the existing roadway. At the back of the turnaround area is a vertical soil embankment approximately 8 feet in height. The area as currently constructed would not meet the minimum standards for a NCDOT "T" turnaround. Standard size vehicles are able to turnaround at this time, but a larger emergency vehicle would not be able to turnaround. A re-design of the turnaround to NCDOT "T" type is one option. It is likely that the design would require additional grading of the rear and side embankment areas and/or the design of a retaining wall structure.

Existing turn around area at Pinnacle Mtn. North new entrance gate location.

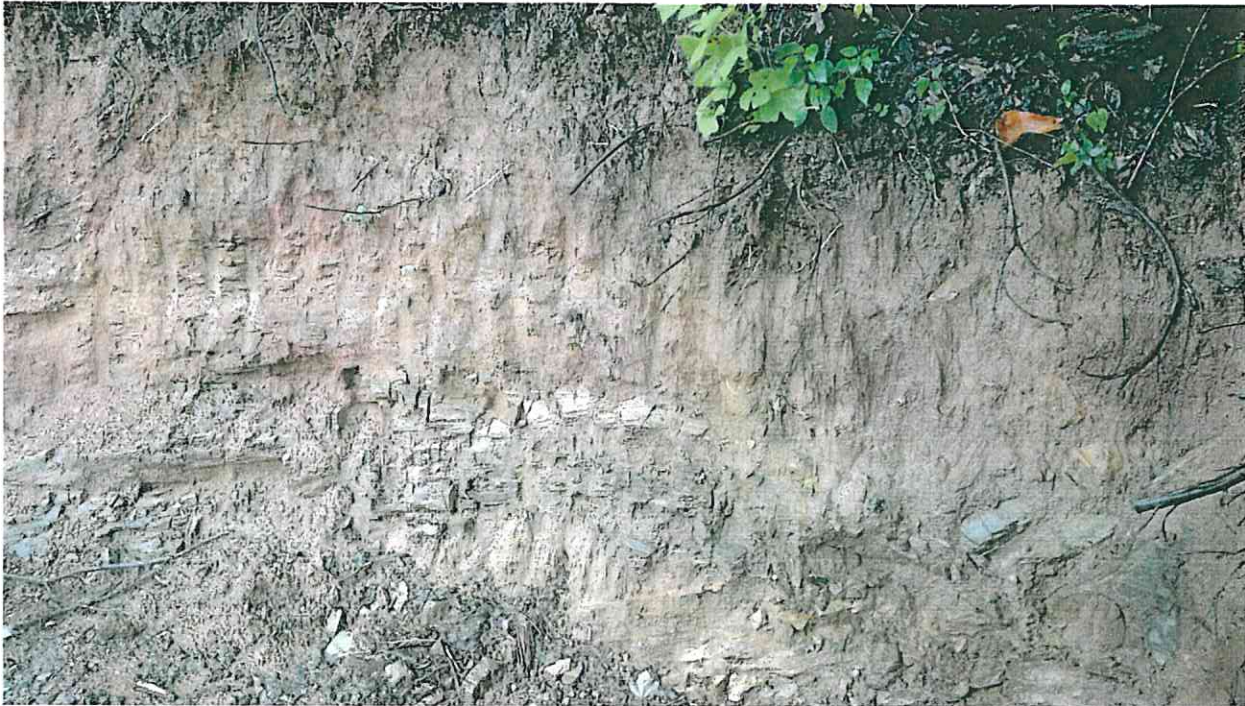
Item Two: There is evidence of former soil slope failure in the adjacent area located directly to the left while facing the turnaround. The area directly above the vertical embankment is wooded mountain side at approximately 2:1 slope. The drainage area above drains directly to the embankment face. The soil wall was probed to determine soil density and soil makeup. The lower embankment consists of a mixture of rock and soil/rock. From base elevation upward for approximately 4 feet the mixed soil/rock condition exists and appears dense with the probe entering 2-3" or less. The remaining vertical cut area – from three to four feet to top of cut was a mix of soil types and organic material. The probe penetrated 12" or more in these areas and the soils were noted as wet from recent rainfall. Many large trees are located at the top of the vertical embankment area placing a load on the unsupported vertical cut.

It is our opinion that the possibility of slope failure in this area is likely without re-grading of the area to reduce slope angle or the construction of a retaining structure.

Turn around rear cut embankment.

Stormwater drainage should be directed away from steep slopes especially in areas where roadways are narrow or shoulder width is limited. Maintaining dense vegetative groundcover is another important factor to protect steep graded slope areas.

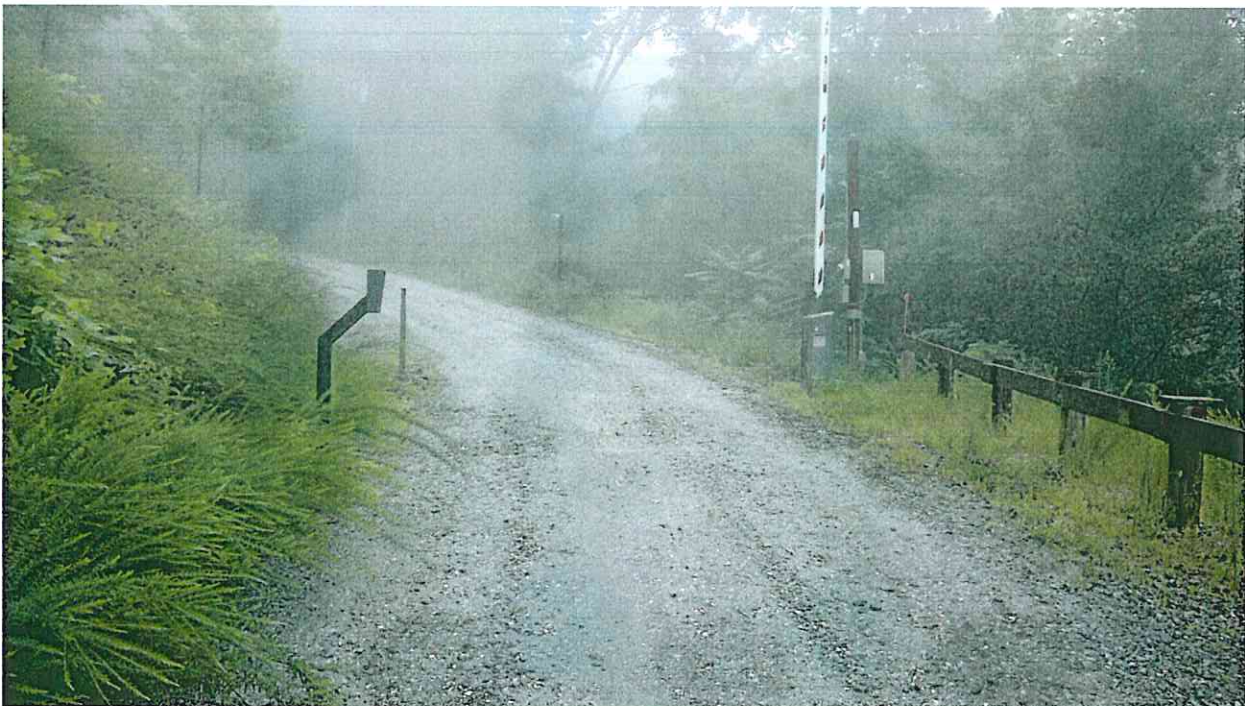
View of new entrance gate – Pinnacle Mountain North Association.

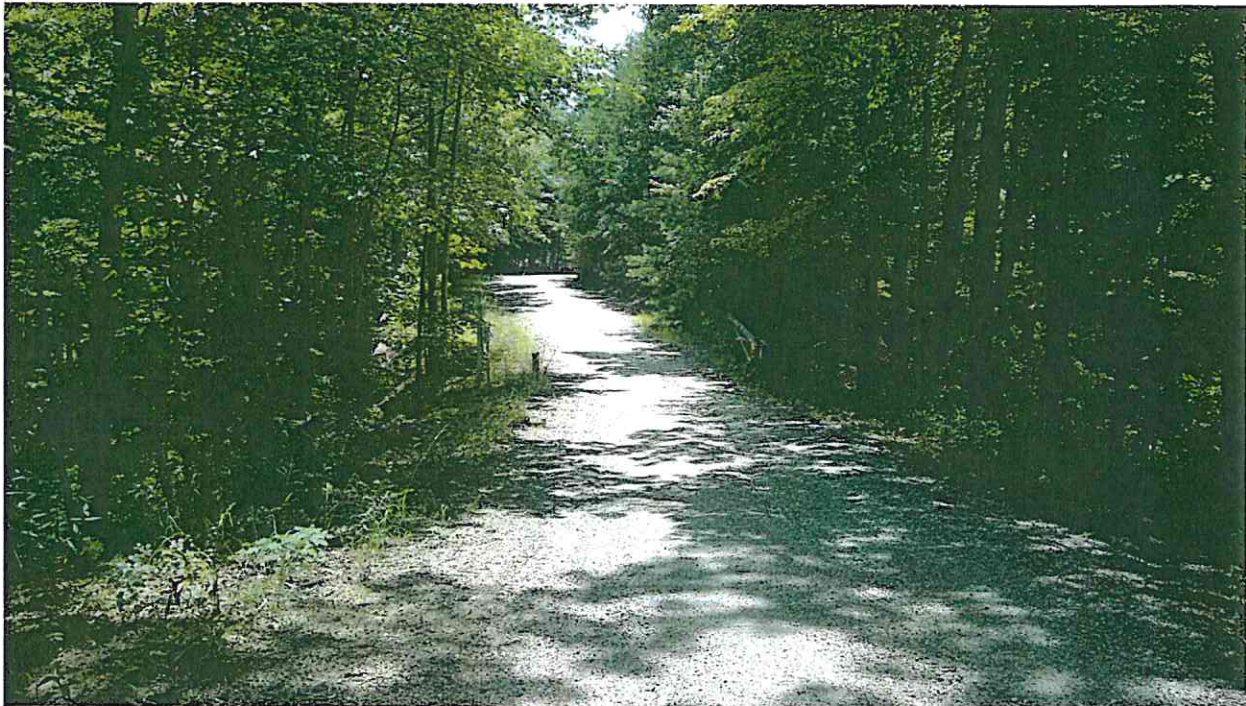
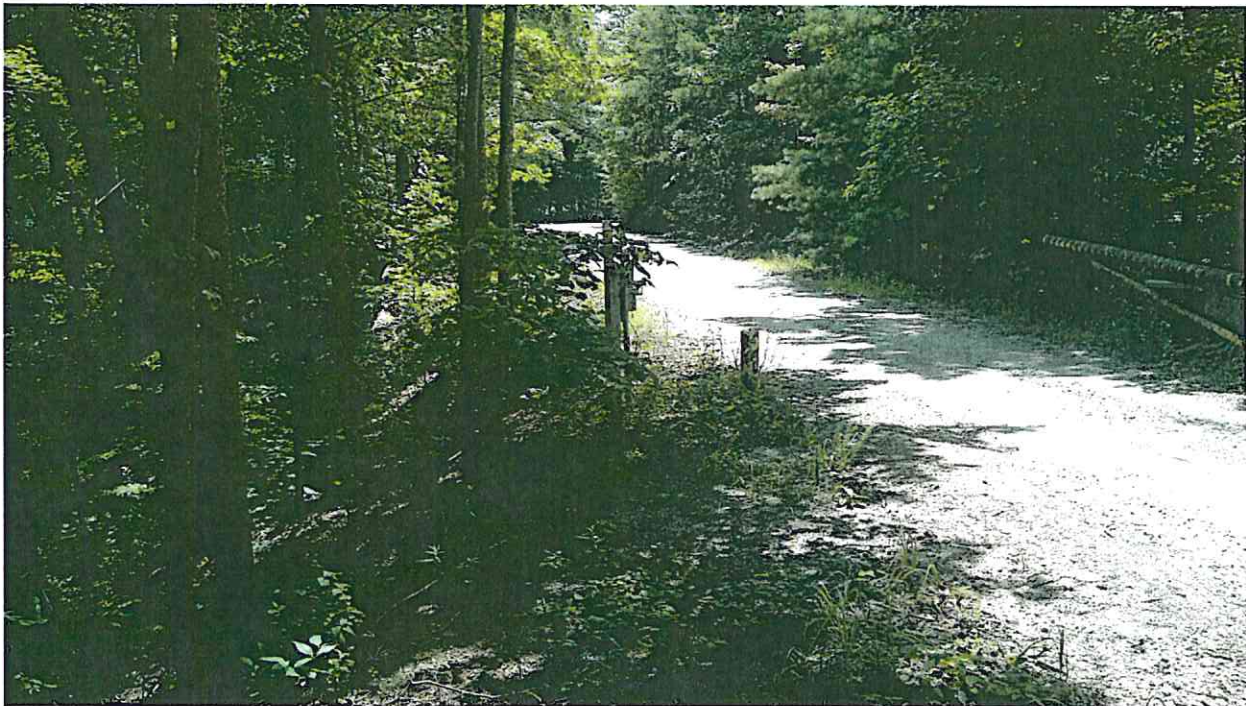
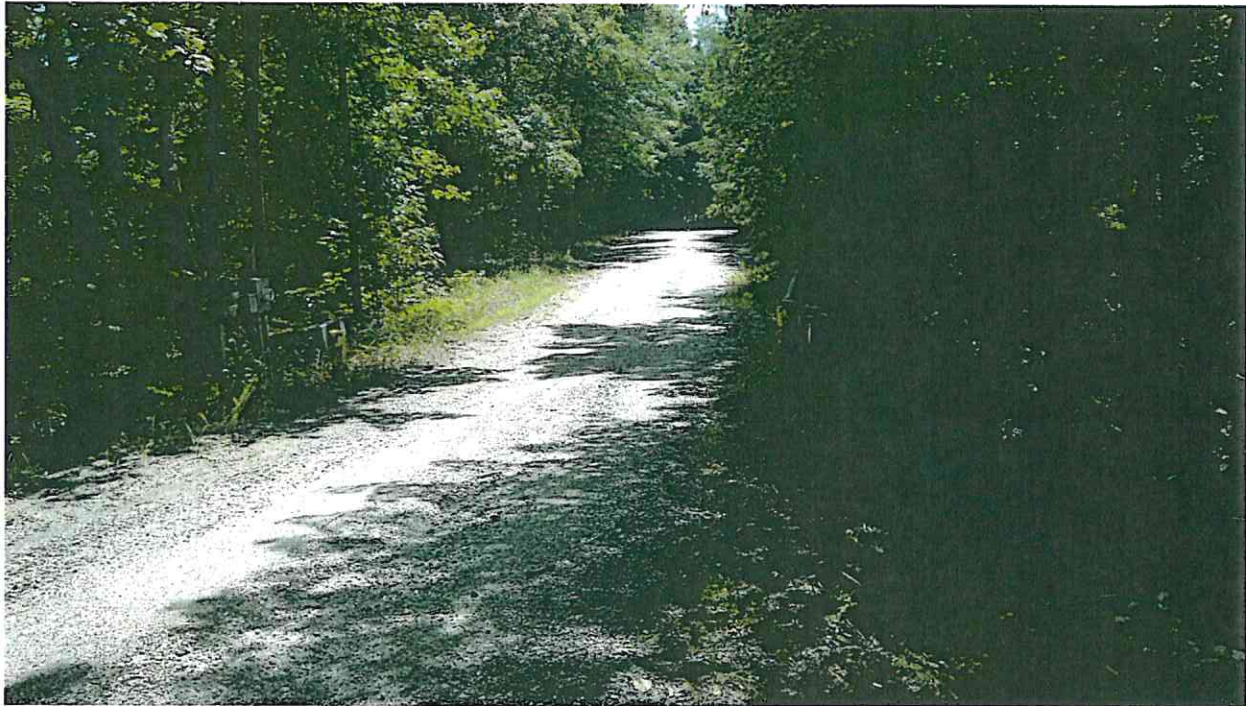
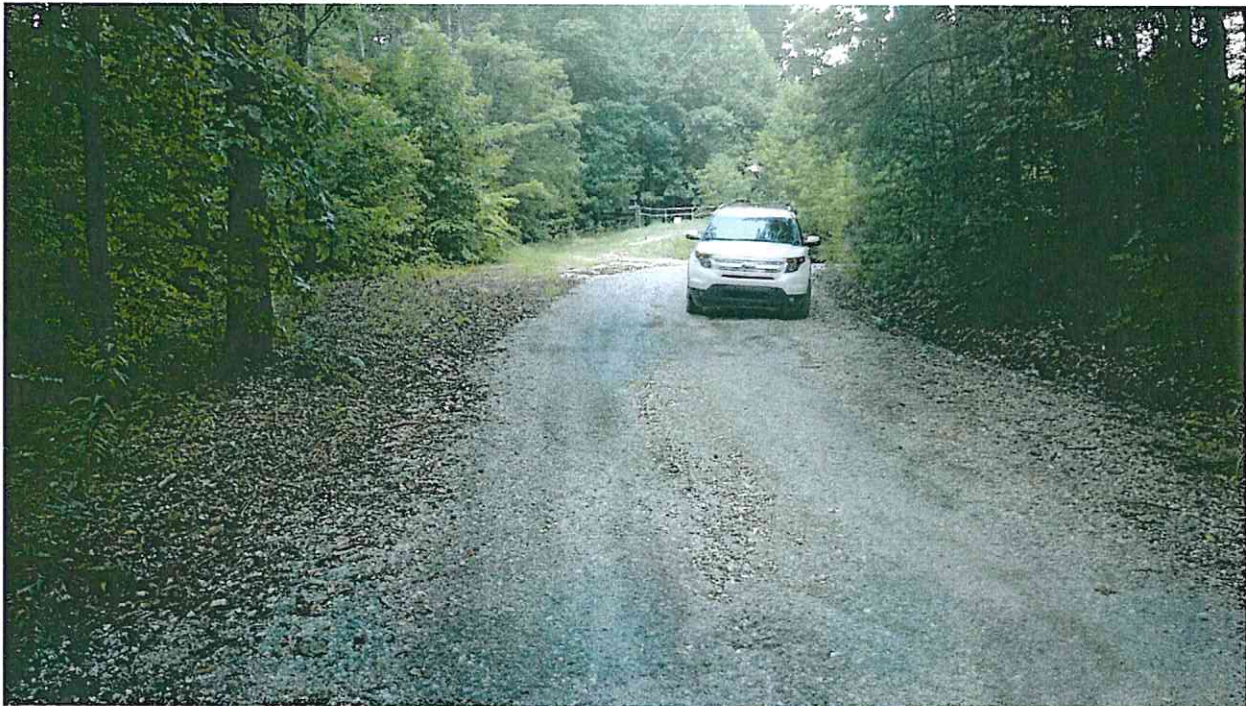
Existing entrance gate area (older entrance – located prior to Pinnacle Mtn. North Assoc.)

One additional consideration would be to explore the possibility of moving the new entrance gate to a location better suited for issues of use discussed above. The older gate located approximately half way into the property provides a better location given the area provides a better road width and gentle slope conditions on both sides of the road. If the property Owner's associations can work in cooperation to use this location site grading and safety issues may be lessened.
