BE-CI Field Report

Pelican Beach Resort (Exterior Restoration)
1002 US-98 E
Destin, FL 32541

FIELD REPORT NO: **PLCNBCHRST002**
CONSULTANTS PROJECT NO: **2022084**

SITE VISIT DATE: **10/6/2022** TIME: **11:30:00 AM** WEATHER: **83°F, Sunny**

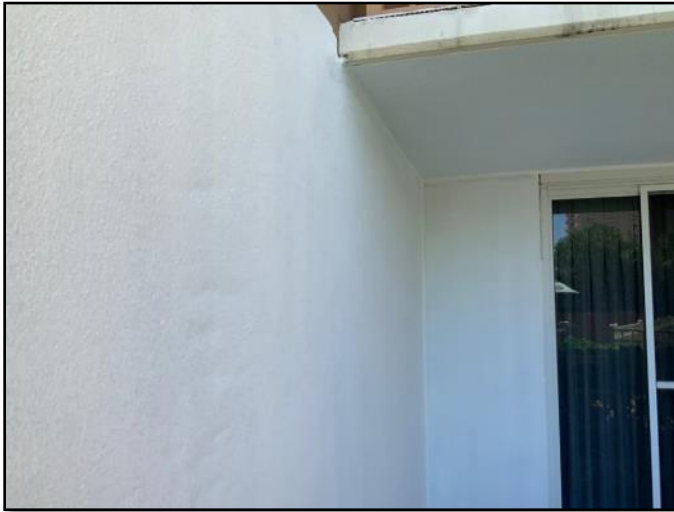
- 2.2 Upon arriving on site, BE-CI observed coating mockup was in progress at the ground floor on the East Elevation. BE-CI observed that one coat of the Sherwin-Williams Loxon Primer had been applied at the vertical surfaces (Reference Figure 1) and one coat of the Sherwin-Williams A100 had been applied at the overhead surface. BE-CI observed crewmen applying the first coat of the Sherwin-Williams Loxon Self-Cleaning Acrylic coating in the owner's selected color to the vertical surfaces (Reference Figure 2). BE-CI observed coating mockups to be a work in progress at the time of the site visit.

FIGURE 1 - Overall view of primer application at ground floor mockup.

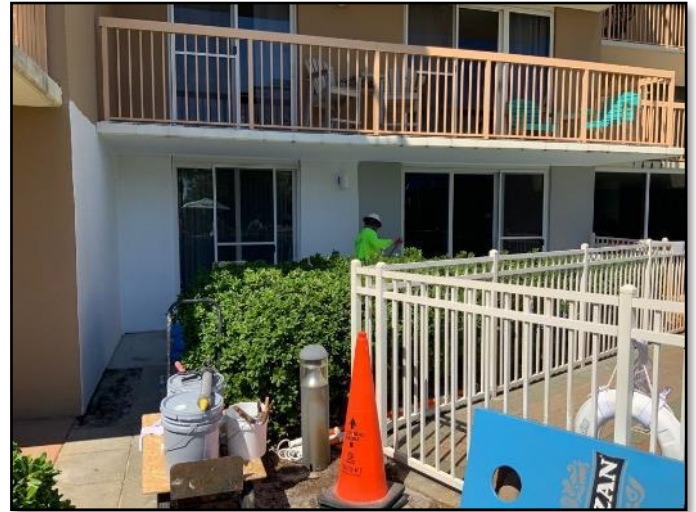
FIGURE 2 - Overall view of coating application in progress at ground floor mockup.

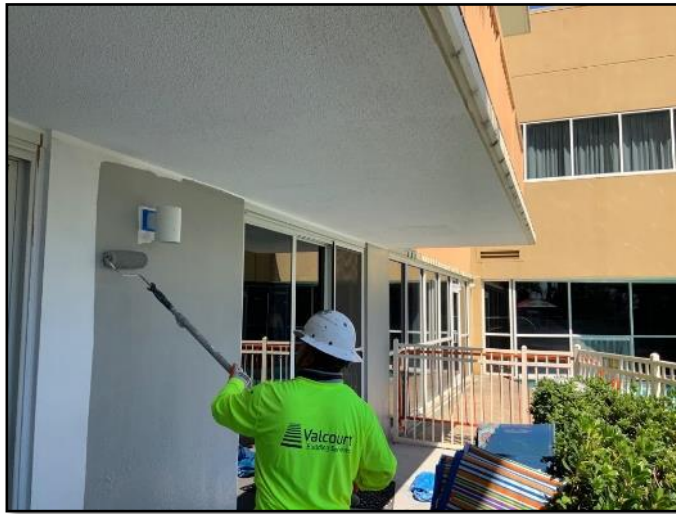
- 2.3 BE-CI also observed all deck coatings had been removed at the mock-up unit located on the ground floor (Reference Figure 3). BE-CI observed all coating and substrates had been removed down to the bare concrete. BE-CI observed the concrete surface profile to have between a Level 2 and a Level 3 concrete surface preparation texture as defined by the International Concrete Repair Institute. The deck coating manufacturer's representative was also present and stated the concrete finish at the mockup unit was acceptable for product application.

FIGURE 3 - Overall view of mockup location.

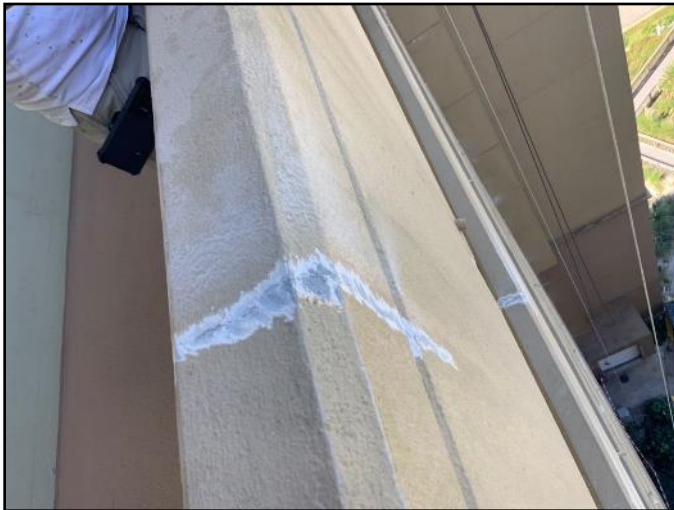
2.4 BE-CI also observed a swing stage had been erected for work on Drop 33 on the North Elevation. BE-CI observed concrete repair preparation had begun on the outside face of the knee walls along the common walkway. BE-CI observed that finish texture had been removed at cracks and small spalls, and that concrete had been removed around corroded rebar (Reference Figure 4). BE-CI observed rebar had been treated with MasterEmaco P124 corrosion inhibitor (Reference Figure 5). BE-CI observed preparation for concrete repairs at Drop 33 to be a work in progress at the time of the site visit.

FIGURE 4 - Close-up view of finish material removed around concrete crack prior to routing and sealing.

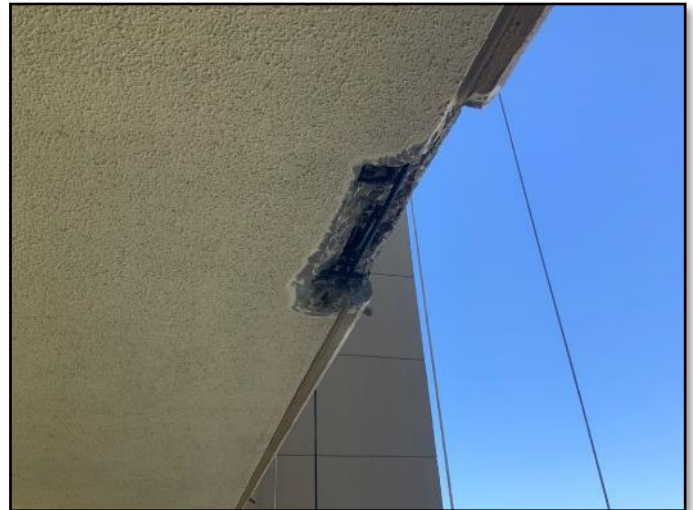
FIGURE 5 - Overall view of concrete removed around corroded rebar treated with corrosion inhibitor.

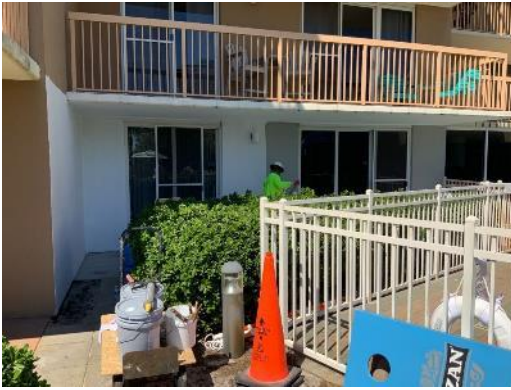
Photo 1

East - Ground - Overall view of ground floor mockup.

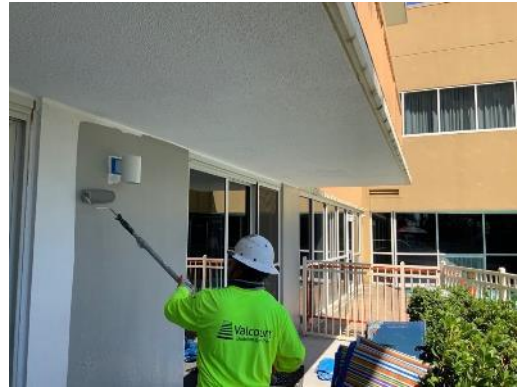
Photo 2

East - Ground - Overall view of crewman applying acrylic coating.

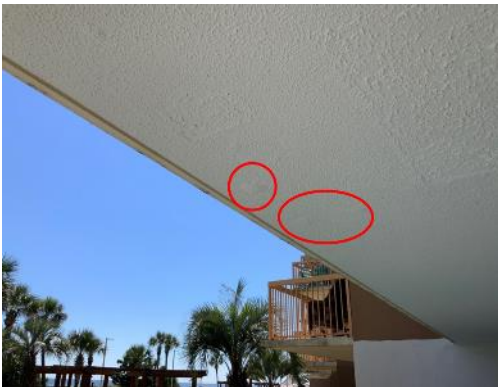
Photo 3

East - Ground - Overall view of blistering in mockup overhead coating.

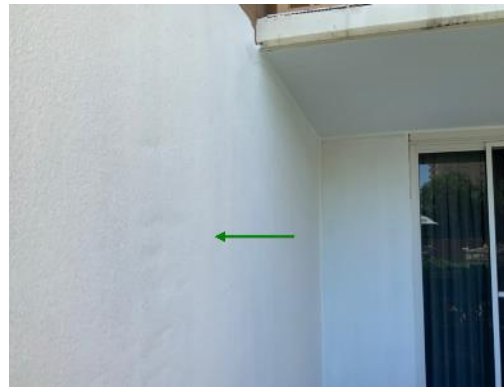
Photo 4

East - Ground - Overall view of 1 coat primer application at mockup.

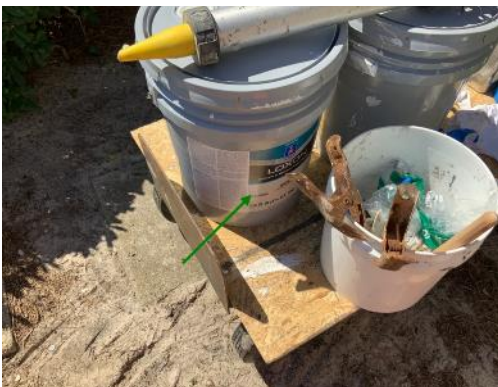
Photo 5

East - Ground - Close-up view of approved primer at mockup.

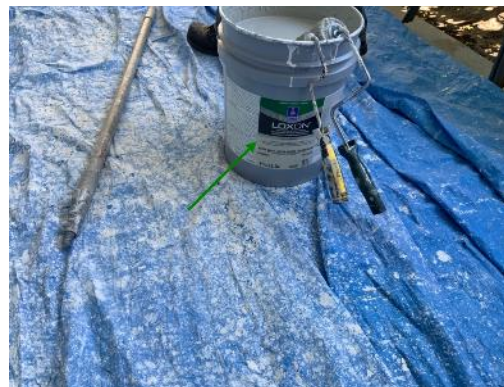
Photo 6

East - Ground - Close-up view of approved coating at mockup.

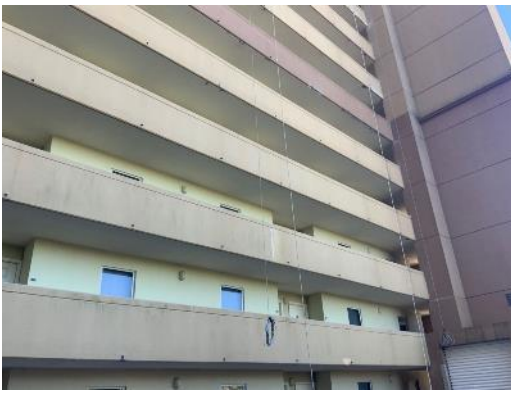
Photo 7

North - Overall view of work in progress at Drop 33.

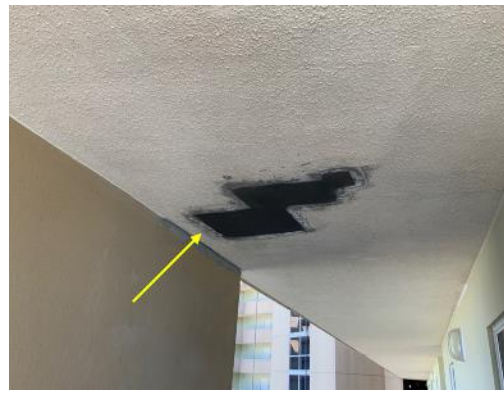
Photo 8

North - Floor 19 - Overall view of concrete mockup repair in progress at common walkway.

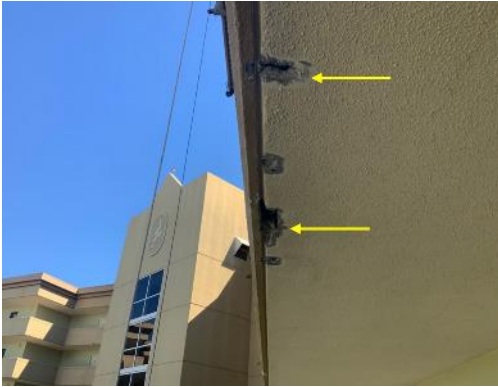
Photo 9

North - Floor 19 - Overall view of overhead concrete repairs in progress at common walkway slab edge.

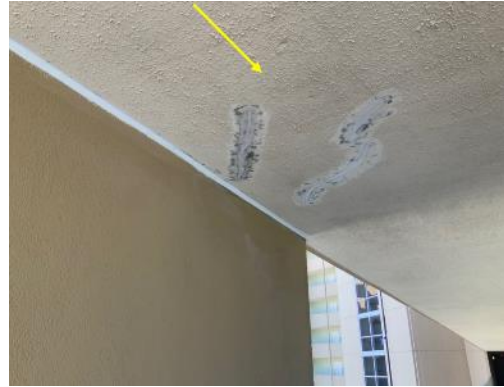
Photo 10

North - Floor 17 - Overall view of overhead crack routing and sealing in progress.

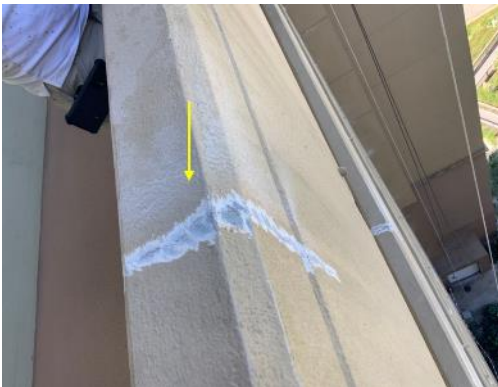
Photo 11

North - Floor 17 - Close-up view of finish removed around crack at knee wall to prepare for routing and sealing.

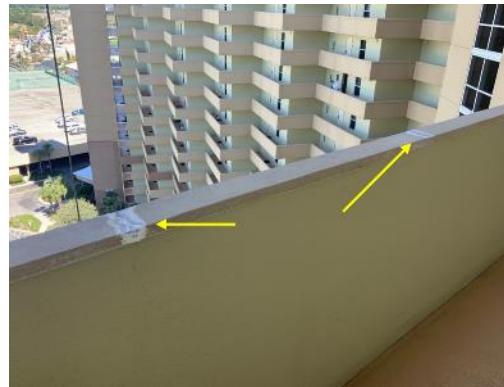
Photo 12

North - Floor 15 - Overall view of crack repair preparation in progress.

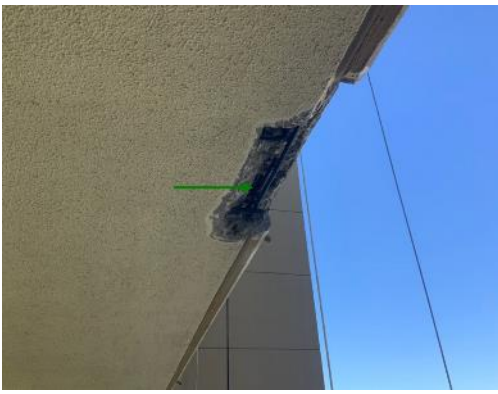
Photo 13

North - Floor 15 - Overall view of overhead concrete removed at spall and corrosion inhibitor applied to rebar.

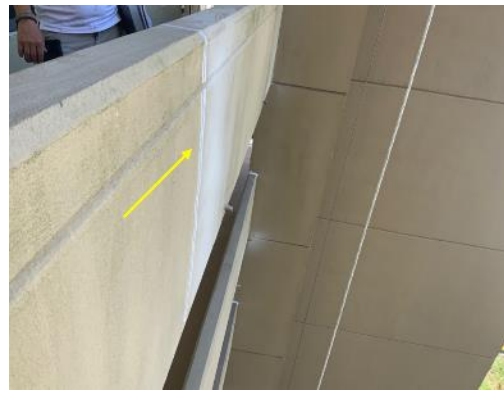
Photo 14

North - Floor 10 - Overall view of crack in face of knee wall prepared for crack routing and sealing.

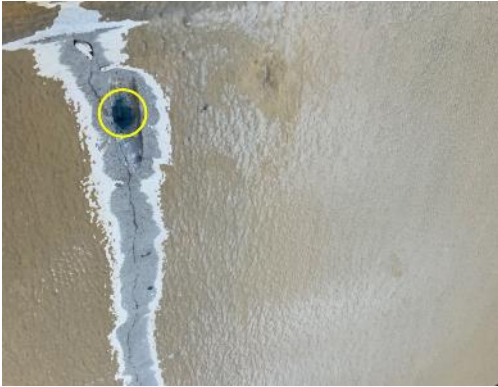
Photo 15

North - Floor 10 - Close-up view of crack and rod chair repair in progress at knee wall.

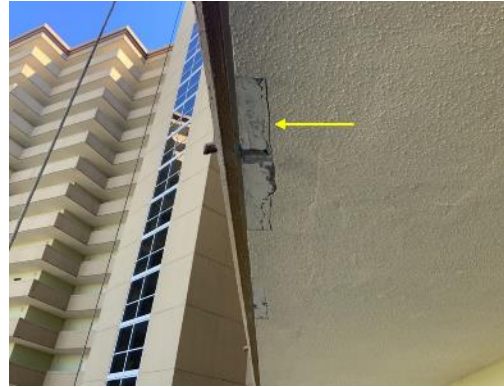
Photo 16

North - Floor 6 - Overall view of ceiling finish delamination at deck drain along common walkway.

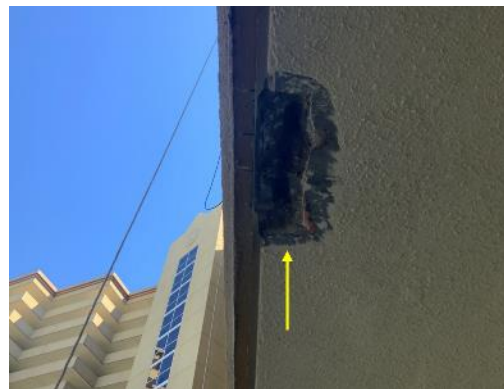
Photo 18

North - Floor 6 - Close-up view of concrete repair in progress at slab edge along common walkway.

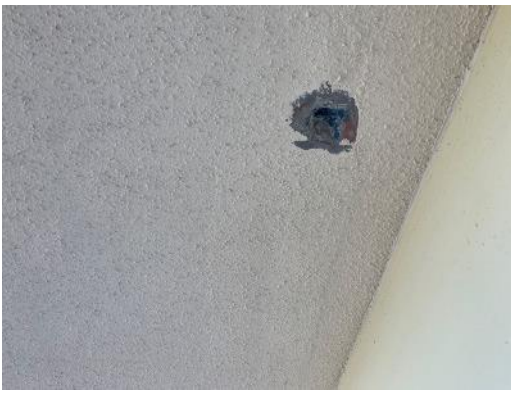
Photo 19

North - Floor 6 - Overall view of overhead rod chair repair in progress at common walkway.

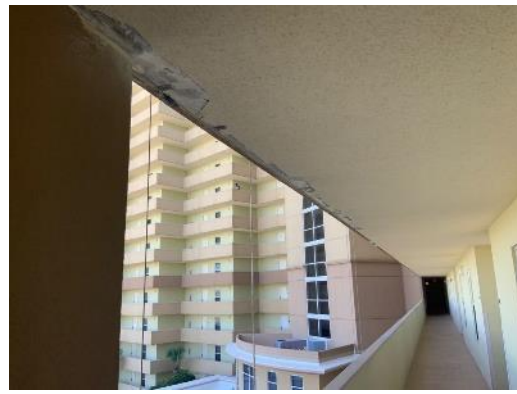
Photo 20

North - Floor 5 - Overall view of ceiling finish delamination along common walkway.

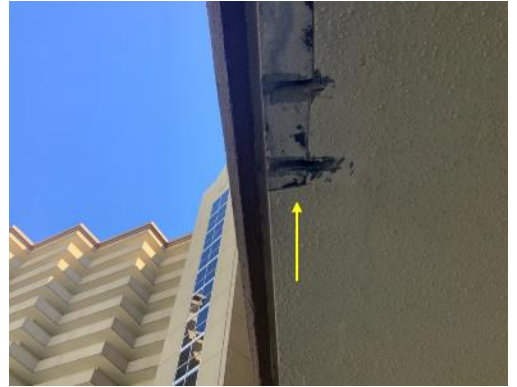
Photo 22

North - Floor 5 - Close-up view of ceiling delamination and rod chair repair at common walkway.

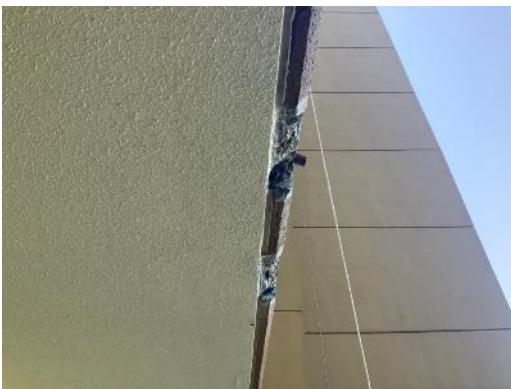
Photo 23

North - Floor 5 - Overall view of concrete repair along common walkway around deck drain.

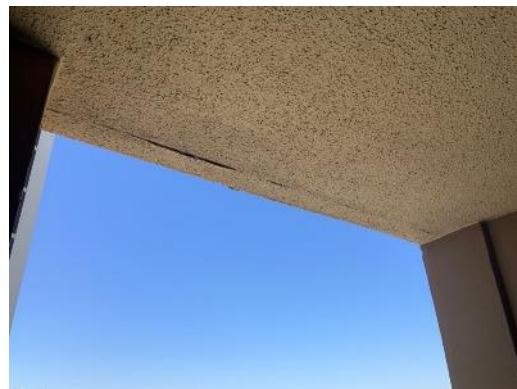
Photo 24

West - Floor 3 - Overall view of corroded overhead flashing along common walkway.

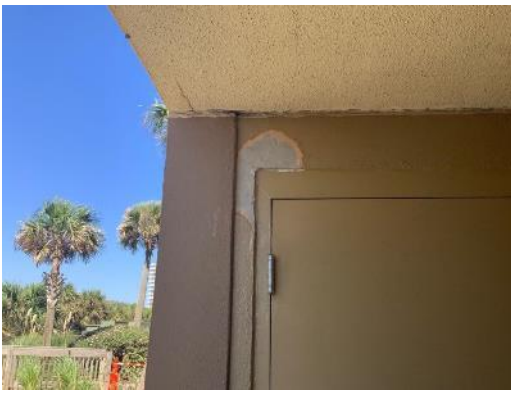
Photo 25

North - Floor 3 - Overall view of concrete crack repair in progress around stair tower door.

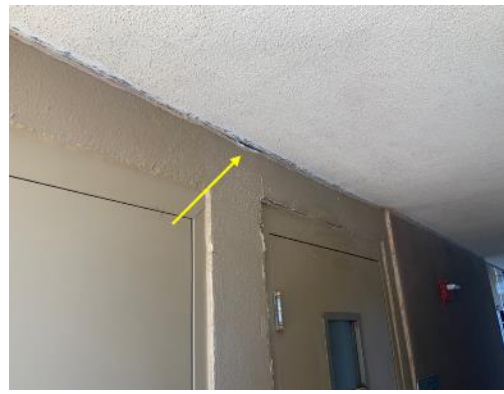
Photo 26

North - Ground - Overall view of failed sealant removed at top of wall.

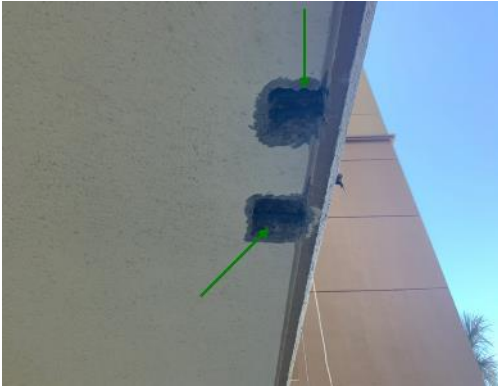
Photo 27

North - Ground - Overall view of corrosion inhibitor applied to rebar at overhead concrete repair location.

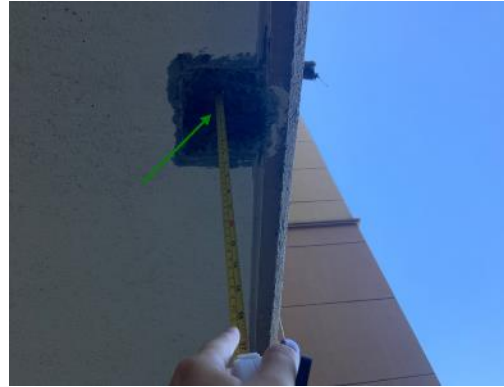
Photo 28

North - Overall view of 2" clearance around treated rebar.

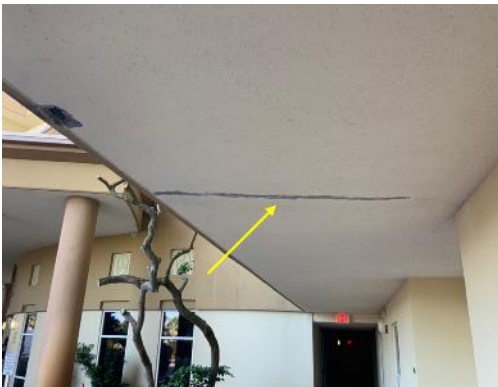
Photo 29

North - Overall view of finish removed around overhead crack prior to routing and sealing.
