## Multi-source water ingress found behind a single damp report

19-unit residential block · Property investment due diligence · 3-day turnaround

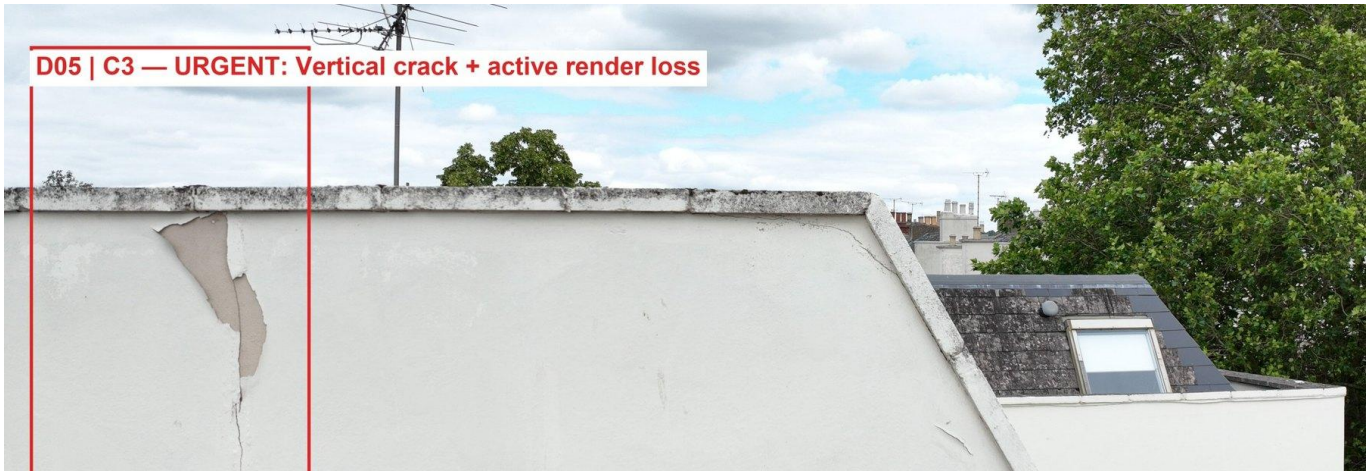
Full-height parapet crack with active render loss, one of four water routes traced (annotated report photo).

The survey found 11 defects across the building envelope, severity-rated: 3 urgent, 7 requiring repair or review, 1 to monitor. The damp wasn't coming from one place — the report traced it to four concurrent water-ingress sources acting together: a flat roof membrane detached from the parapet upstand (the primary suspected source), a full-width crack in the front parapet with active water-tracking, a full-height vertical crack in the side parapet with exposed substrate, and blocked parapet gutters aggravating an already-failing roof.

**The insight that mattered:** the render failure on both gable elevations and the deteriorating window sills looked like separate repairs, but the report treats them as consequences of water entering at roof level — fixing the render first would have failed again. The report set the correct sequence: roof membrane and parapet junctions first, elevations afterwards.
