## A chimney letting the weather in, recorded in six minutes

Example survey · Terraced house, north Manchester · Shown with the owner's permission

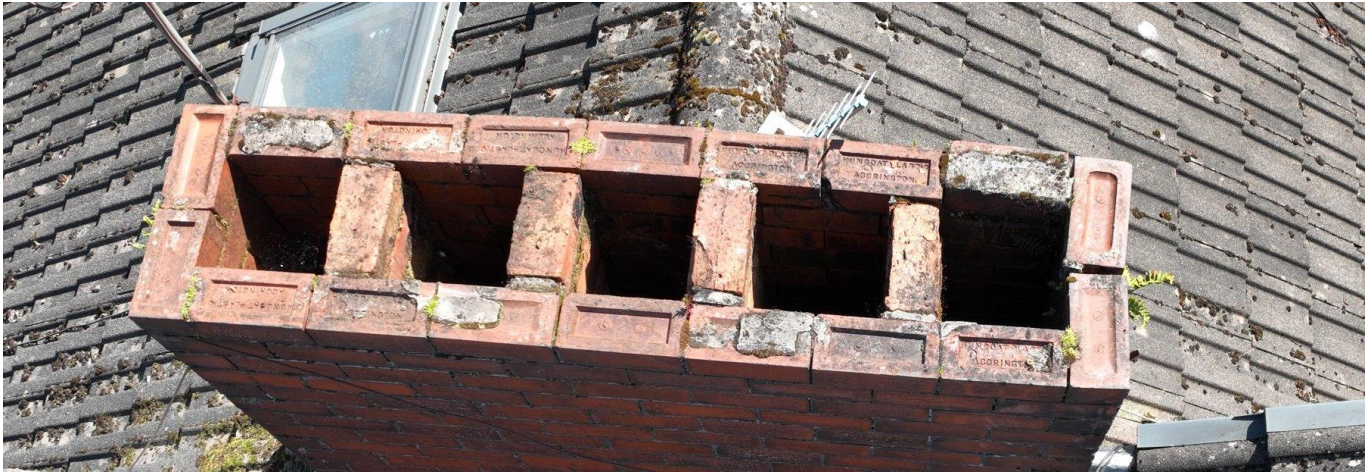
Five open flues with no caps, and plants rooted in the chimney joints. Example survey, shown with the owner's permission.

Eight findings, none urgent. The chimney stood out: plants rooted in its joints, five open flues with no caps, and a foil-tape patch where the chimney meets the roof, a short-term fix on one of the most common leak points there is. Along the gable the cement fillet had cracked, and a detached TV aerial lay loose on the rear flat roof.

**What it gave the owner:** a priority list for before winter, two questions to settle before calling a roofer (are any flues in use, and whose is the gable wall?), and an indicative repair budget of about £4,500 to plan around.
