## HMO conversion structural risk found before renovation began

Residential corner property, Warrington · Pre-renovation condition assessment · 2-day turnaround

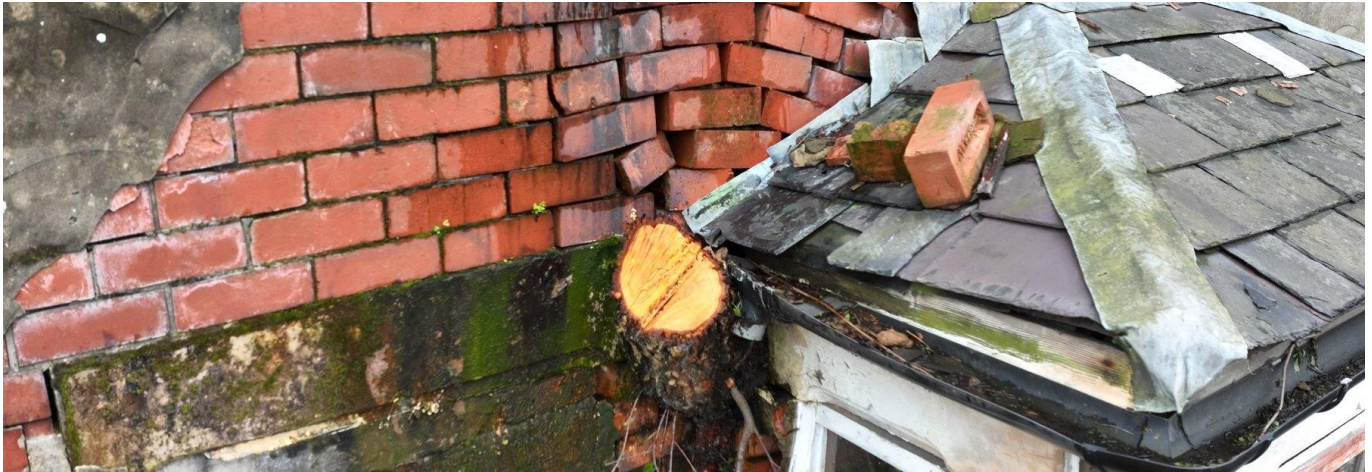
Upper side elevation: missing and displaced brickwork with vegetation growing in the wall (inspection photo).

**HIGH**

risk rating on the primary finding

The inspection found significant brickwork failure on the side elevation: missing and displaced bricks, structural cracking around the windows, and vegetation growing inside the wall — a sign of long-term moisture penetration invisible from ground level. Rated high risk, not cosmetic damage.

**Our recommendation:** a structural engineer's inspection before the conversion proceeded. The findings gave the client the evidence to make an informed call on the renovation budget and timeline before any work began — assessed safely, without scaffolding, and without anyone needing to get close to an unstable wall.
