# Aerial visual inspection report

19-unit residential block (anonymised)

Envelope & roof condition | June 2026

| Report reference | SRD-SAMPLE-001 |

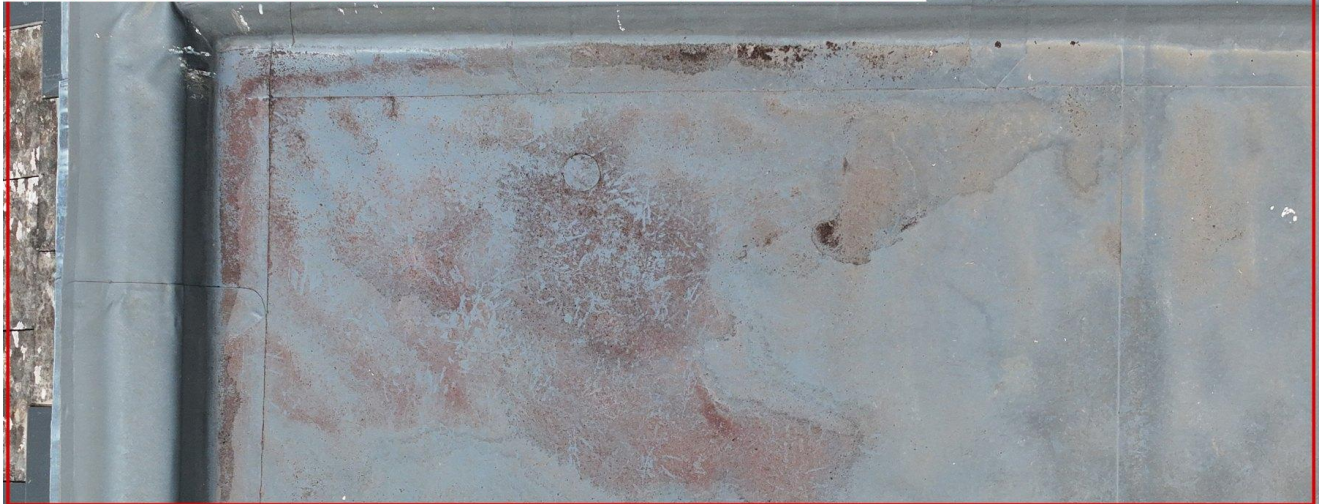
| Ref | Element | Location | Rating | Recommended action |
|---|---|---|---|---|
| D07 | Flat roof membrane | Main flat roof | <b>C3 - URGENT</b> | Flat roof specialist, urgent |

##### D07 | C3 - URGENT: Widespread deterioration + ponding deposits

**Observation:** An aged felt/bitumen membrane with the top coating eroded, mineral deposits from long-standing ponding, and moss working into the surface. The membrane has lifted away from the parapet upstand in several places, exposing the layer beneath. The central drain is part-blocked.

**Interpretation:** Separation at the upstand lets water run straight behind the membrane into the parapet and the structure.

**Risk / significance:** Active water ingress; the most likely cause of the top-floor damp.

**Recommendation:** Flat roof specialist, urgently; temporary repair at the upstands pending a replacement specification.

| Element / indicative work | Rating | Indicative range | Basis |
|---|---|---|---|
| Flat roof: recover/replace membrane, upstands, drain | <b>C3 - URGENT</b> | £17,000 to £33,000 | ~280 m <sup>2</sup> at £60 to £110/m <sup>2</sup> , plus strip-out |

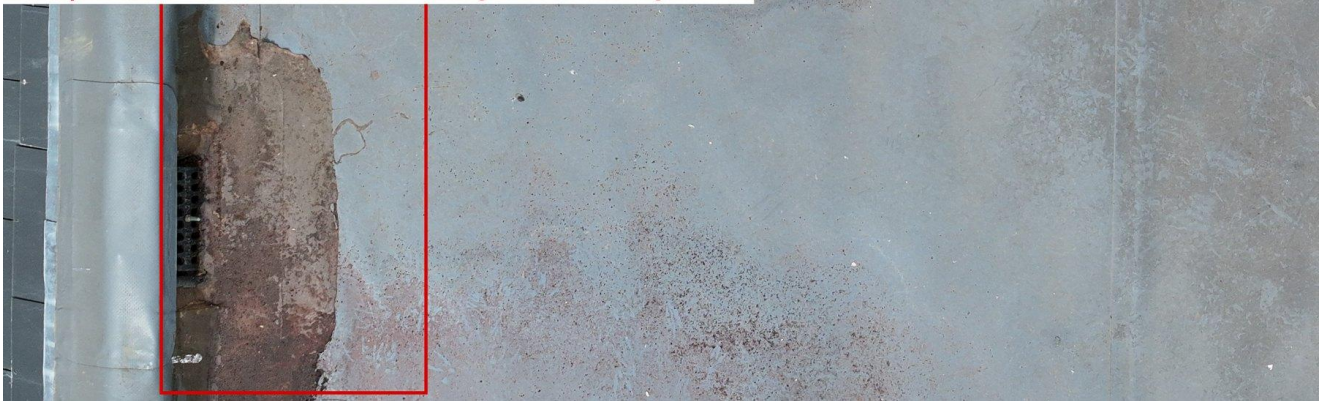
##### D07 | C3 - URGENT: Membrane separation at upstand

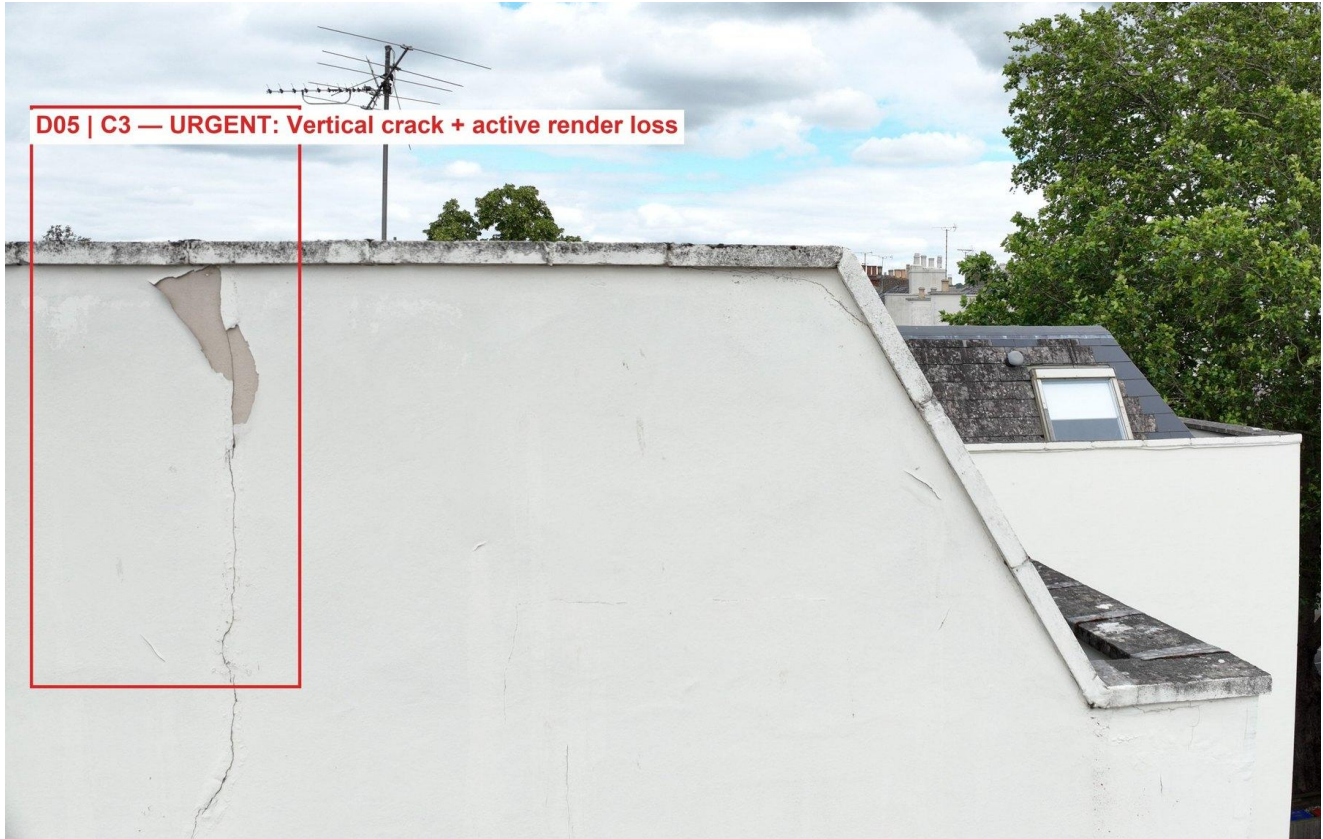
**D05 - Vertical crack and active render loss**

| Ref | Element | Location | Rating | Recommended action |
|---|---|---|---|---|
| D05 | Parapet wall crack | Side parapet | <b>C3 - URGENT</b> | Surveyor / structural engineer |

Location: side parapet wall

**C3 - URGENT**

**Observation:** A crack runs from the coping down the full height of the parapet, with render fallen away in two places and branching cracks around it.

**Interpretation:** Consistent with real movement at this point, not just a surface render fault.

**Risk / significance:** More render could fall; a direct water route at roof level.

**Recommendation:** Building surveyor or structural engineer, urgently; restrict access below if the area is used.

| Element / indicative work | Rating | Indicative range | Basis |
|---|---|---|---|
| Side parapet: repair/rebuild, repoint, coping | <b>C3 - URGENT</b> | £2,500 to £8,000 | Structural review first |

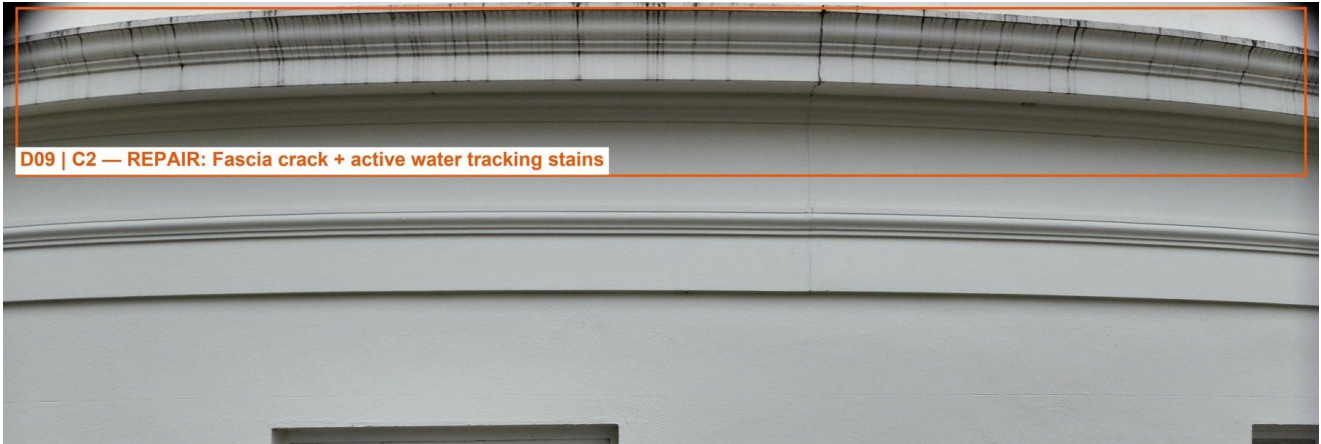
**D09 - Fascia crack with active water tracking**

| Ref | Element | Location | Rating | Recommended action |
|---|---|---|---|---|
| D09 | Fascia crack, water tracking | Front parapet | <b>C2 - REPAIR</b> | Surveyor / roofer |

Location: front parapet / flat roof fascia

**C2 - REPAIR**

**Observation:** A crack runs the full width of the parapet fascia, with dark water stains running down the face beneath it.

**Interpretation:** The stains confirm water is getting in at this joint.

**Risk / significance:** An active route into the top floor across the whole front.

**Recommendation:** Surveyor or roofer to specify a reseal or coping replacement; a temporary weather seal meanwhile.

| Element / indicative work | Rating | Indicative range | Basis |
|---|---|---|---|
| Front fascia: rake out and seal joint, coping | <b>C2 - REPAIR</b> | £2,000 to £7,000 | Full elevation length |
