Our Lady and St Peter's Church, Bridlington

North Elevation (Street Facing) - Pinnacles, Stone Cross Finial & Trifold Window Repairs

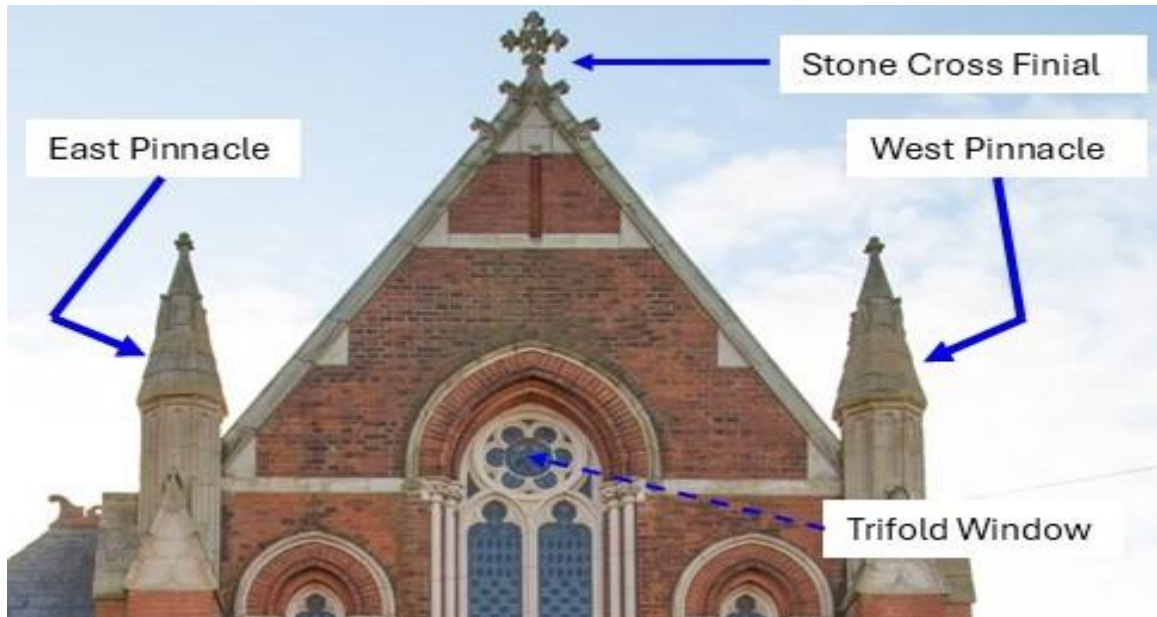
The above photo shows the upper part of the north elevation of the church, with items of concern arrowed. The Diocesan Quinquennial report, carried out in November 2022, identified the items arrowed as requiring further investigation due to age and visible weathering, creating concern for the stability of the pinnacles & other stonework. Following further inspections, using powerful lenses, the parish obtained quotations for access scaffold, close inspection and repairs, based on what was visible. A contract was subsequently awarded for the works.

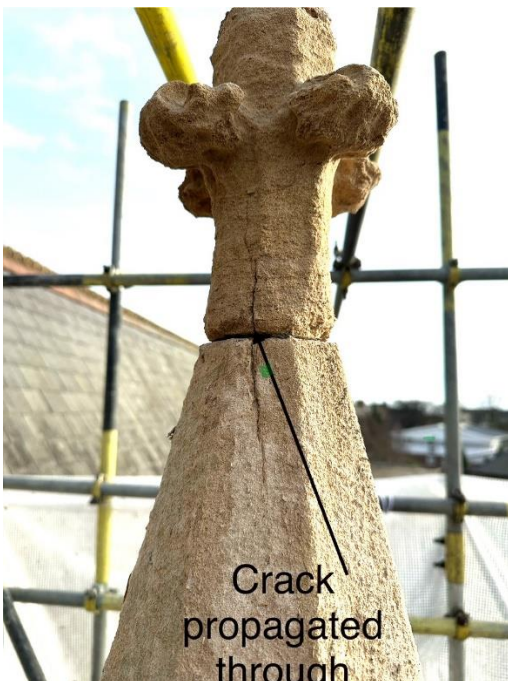
Photo1 – Top of west pinnacle the finial after cleaning, 3 cracks clearly visible.

After Thermatec cleaning, to remove algae growth, pollution deposits (sulphur), paint & mastic, it was clear that cracking had propagated into the stone below the finial in both pinnacles, requiring these stones to be dismantled.

The new Finials were each carved from new larger stones to increase length of piece enhance base area at mounting to 2nd stone. Increased area improves stability and reduces risk of cracking. Existing defects removed. 2nd stone length reduced to maintain pinnacle original height and shape. All pinnacle joints raked out and renewed with lime-based mortar. Finally, each pinnacle was given a layer of Sheltercoat, a conserving product enhancing the appearance and resistance to weathering of the stonework.

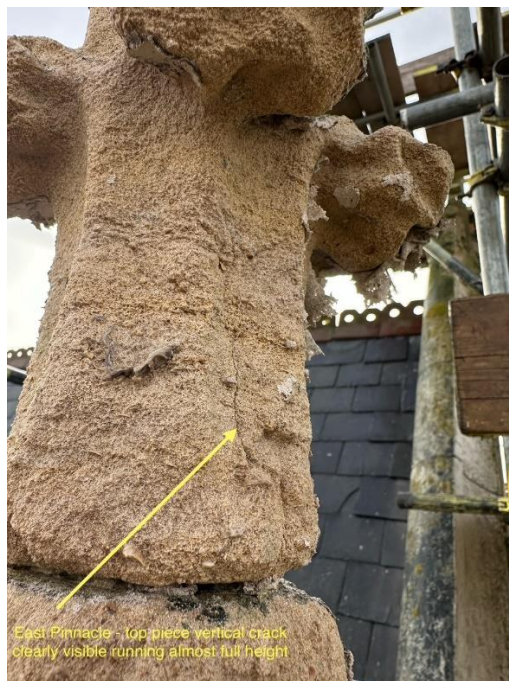
Photo 2 – East pinnacle finial showing similar cracking as west. NB Finial is top decorative part

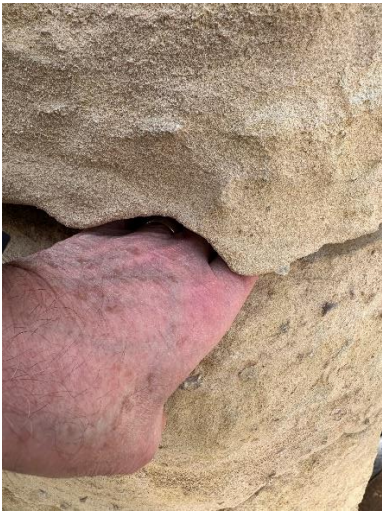
Photo 3 Extent of erosion at joints hand showing depth of weathering

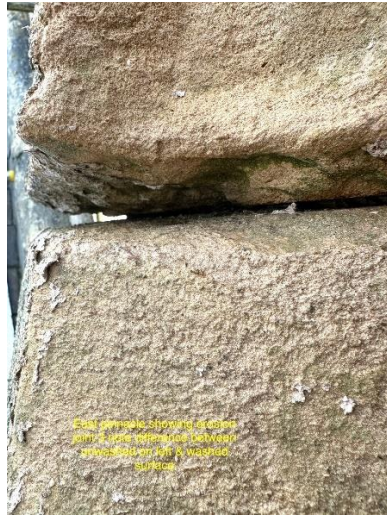
Photo 4 Weathering at joint

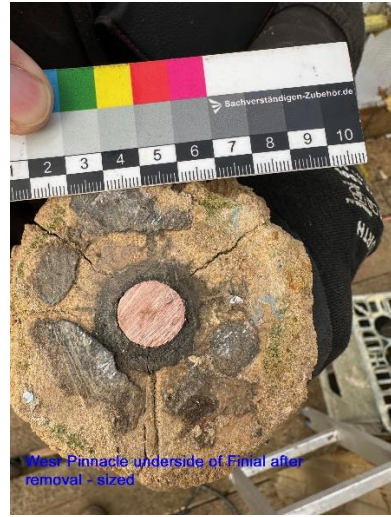
Photo 5 Underside of finial, extent of cracking to core clearly visible

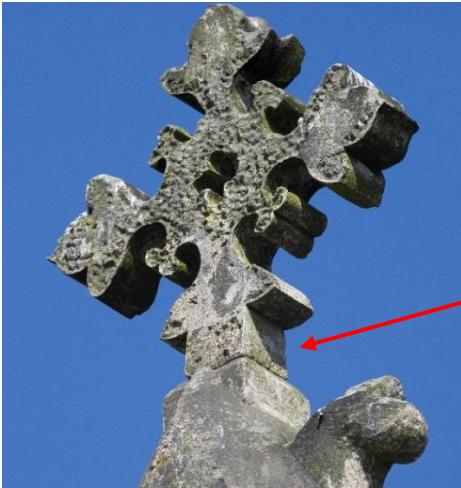
Photo 6 South face of Cross red arrow showing position of detail

As can be seen in photos 6 through 9 the Stone Cross was found to be seriously compromised. However, matching new stone material has been obtained and shaping (carving) begun. Due to the need to recreate the detail & complexity of the original, the work is expected to take about two weeks to complete and is an additional cost.

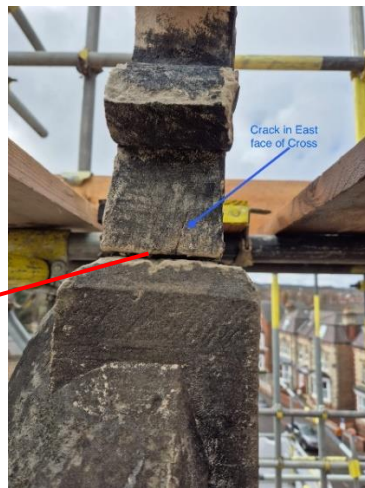
Photo 7 Detail of cracking in Cross base

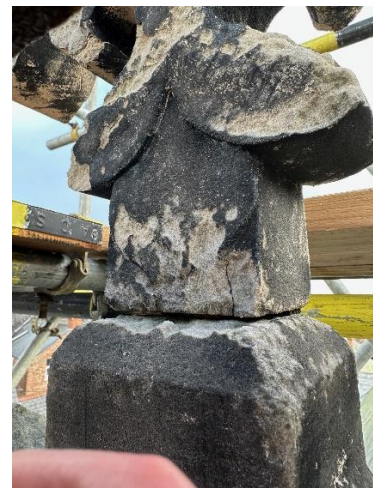
Photo 8 further detail of cracking

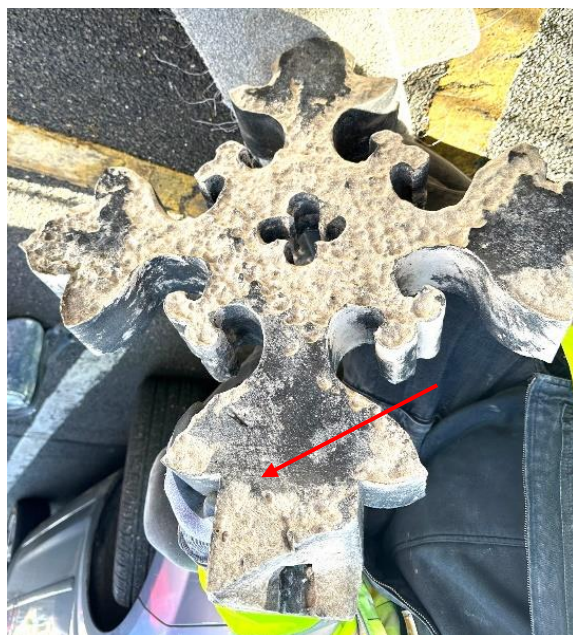
Photo 9 Cross after removal – note half of base (arrowed) fell away when cross lifted

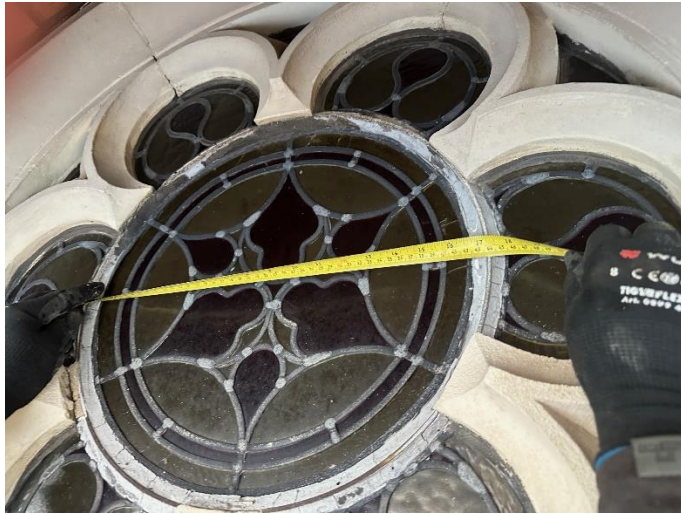
Photo 10 Circular Stained-Glass window found bowed inwards & at risk of failure

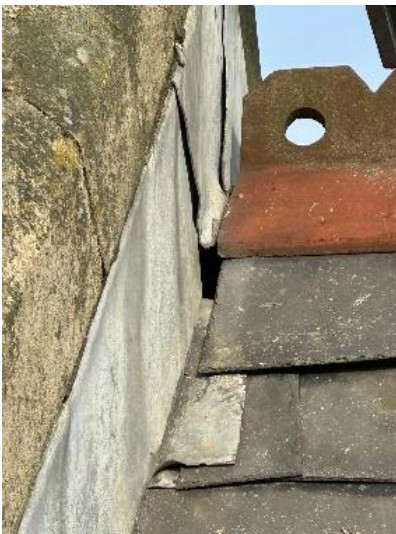
Photo 11 Apex of roof lead flashing incomplete

The opportunity was taken to rectify a number of roof defects while access was available from the scaffold built to repair the pinnacles.

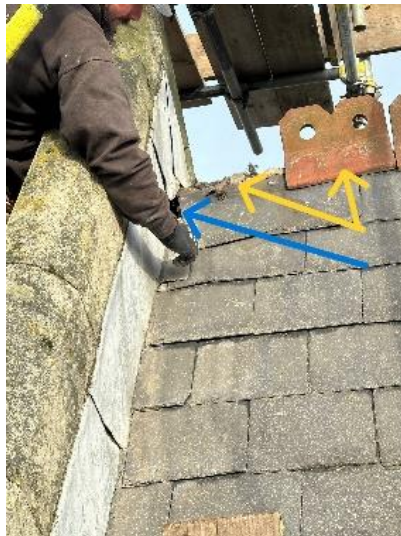
Photo 12 Missing lead flashing flashing.

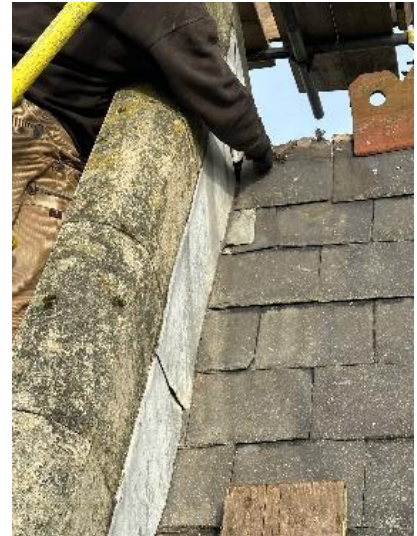
Photo 13 Apex Cresting not bedded in mortar

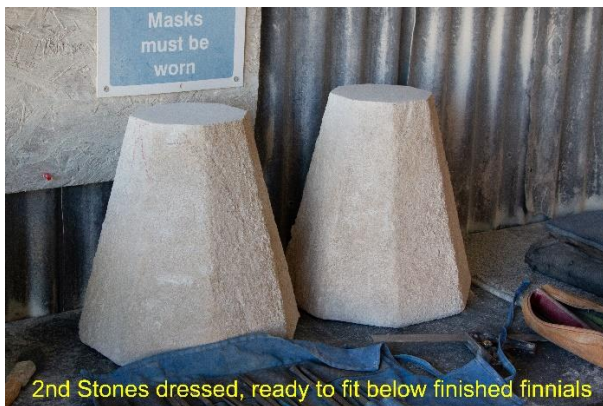
Photo 14 2nd Stones ready to be installed

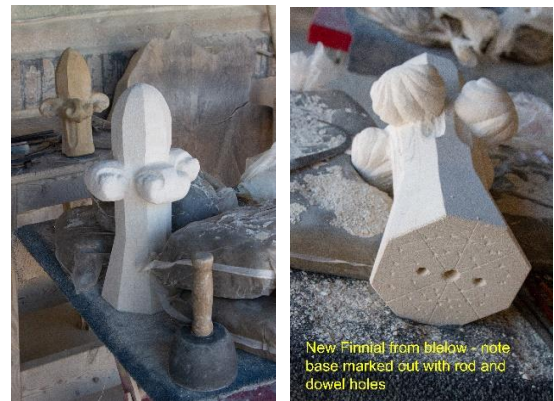
Photo 15 New Finial in workshop

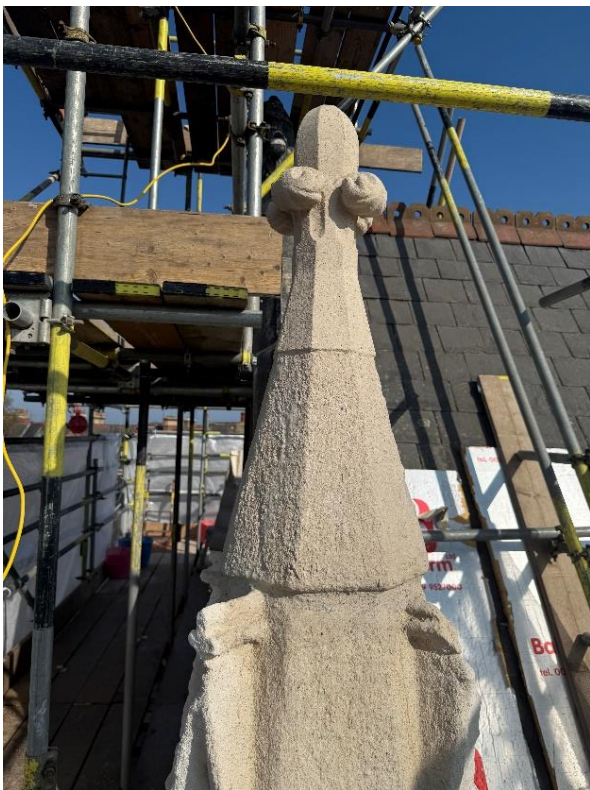
Photo16 Rebuilt Pinnacle showing new carved finial (Top section), note filled joints & Sheltercoat

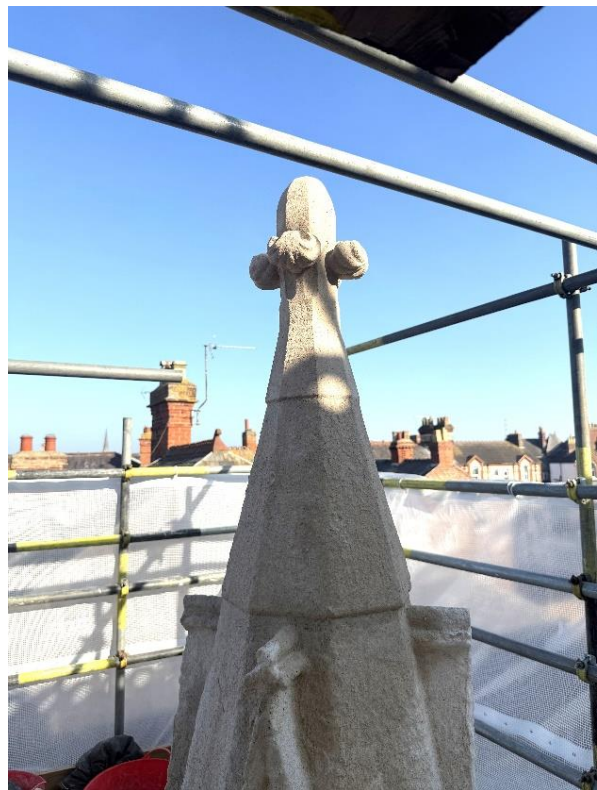
Photo 17 Rebuilt Pinnacle from other side
