# Your Inspection Report

6736 West Stonegate Drive  
Zionsville, IN 46077

RE: Report No. 59345  
6736 West Stonegate Drive  
Zionsville, IN  
46077

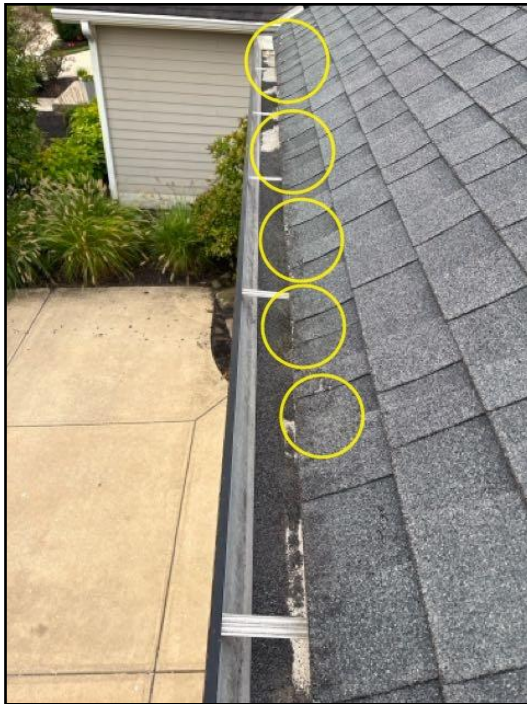
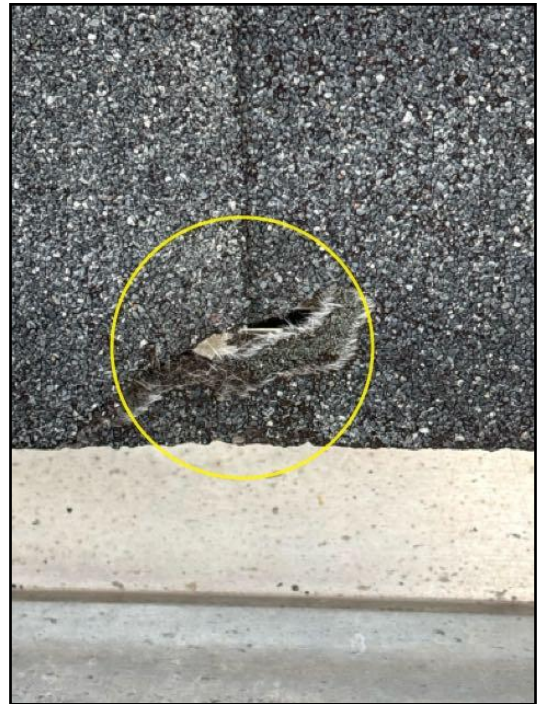
**1. Condition:** • Damaged shingles are present at the following locations.

**Location:** Front edge of garage roof

**Task:** Repair or replace as determined by qualified roofing contractor

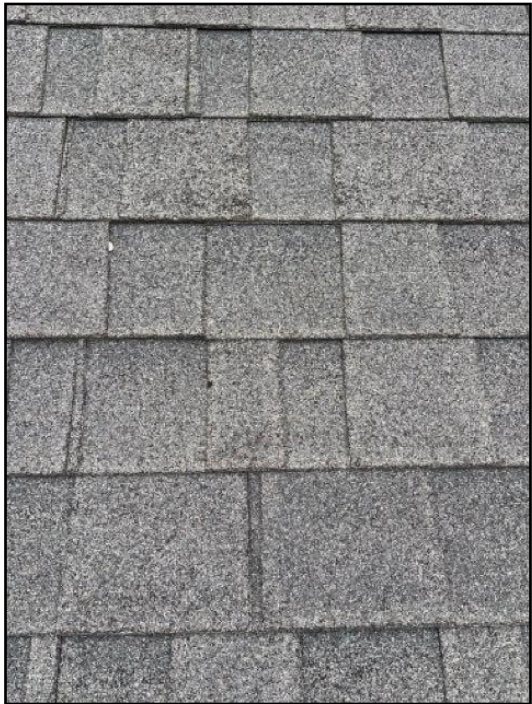
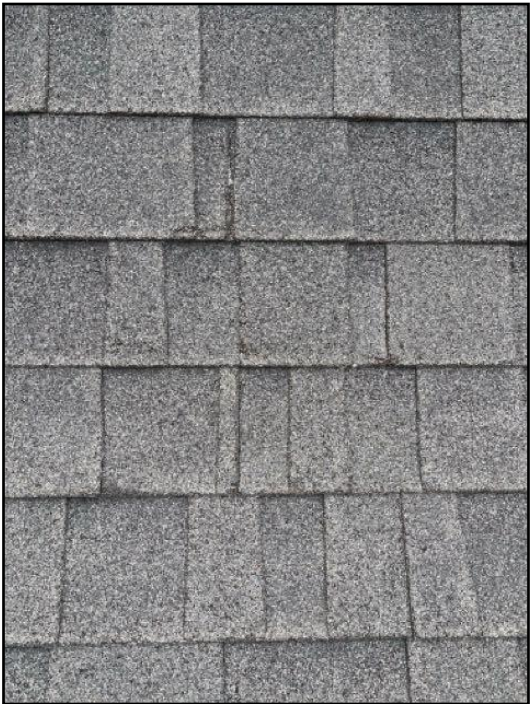
**2. Condition:** • Mild age-related granule loss was observed on portions of the asphalt shingles. This is typical of normal aging process and reduces the shingle's ability to protect the asphalt from UV exposure over time. No immediate action needed but inspector recommends periodic inspections and maintenance to extend the life of the roof.

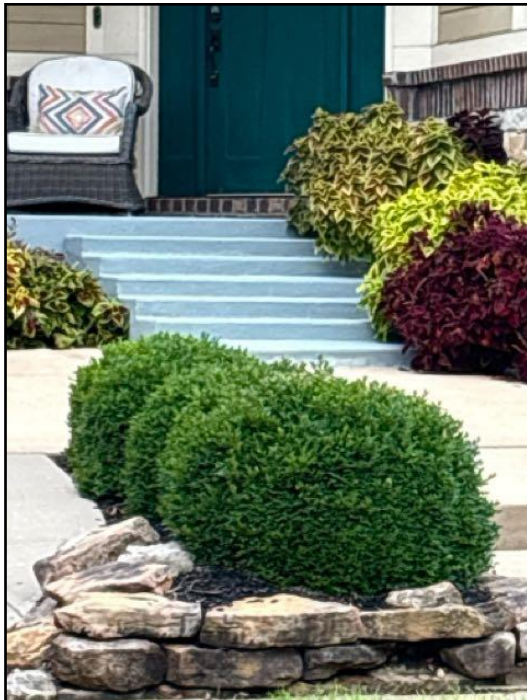
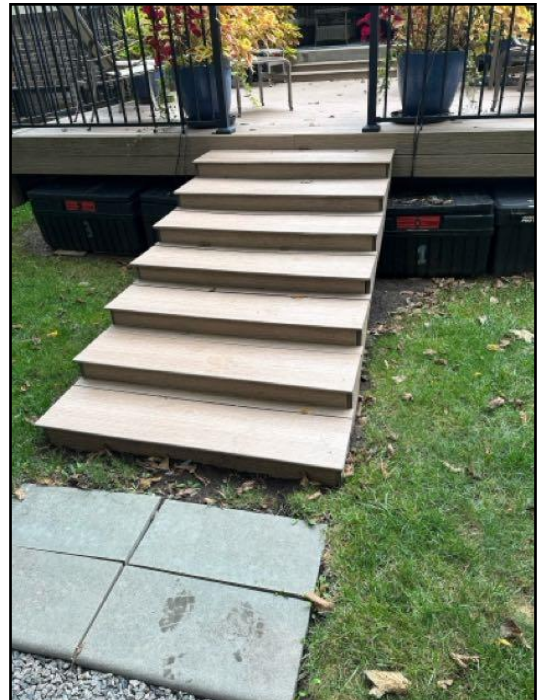
**4. Condition:** • -Handrail is missing from the following location. (4+risers)

**Location:** Front porch and patio

**Task:** Install

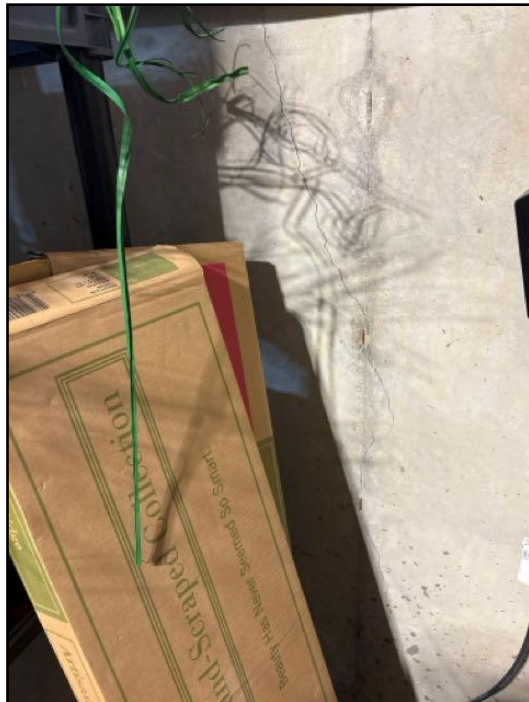
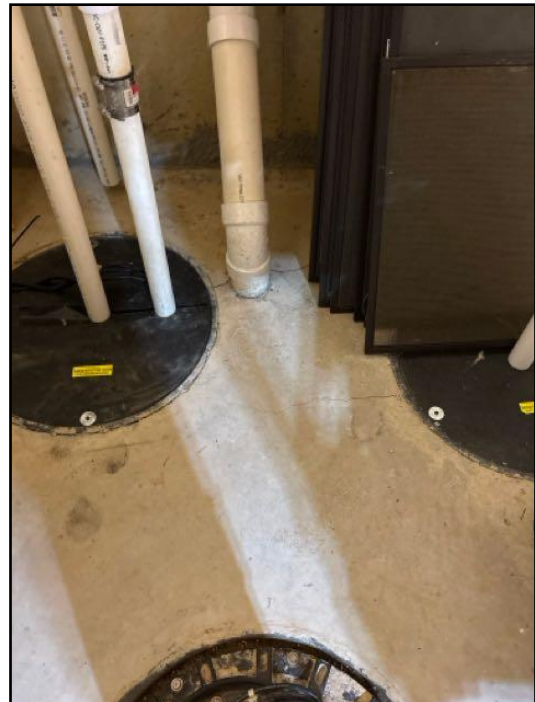
**6. Condition:** • Typical cracks were noted on the basement walls and floor.

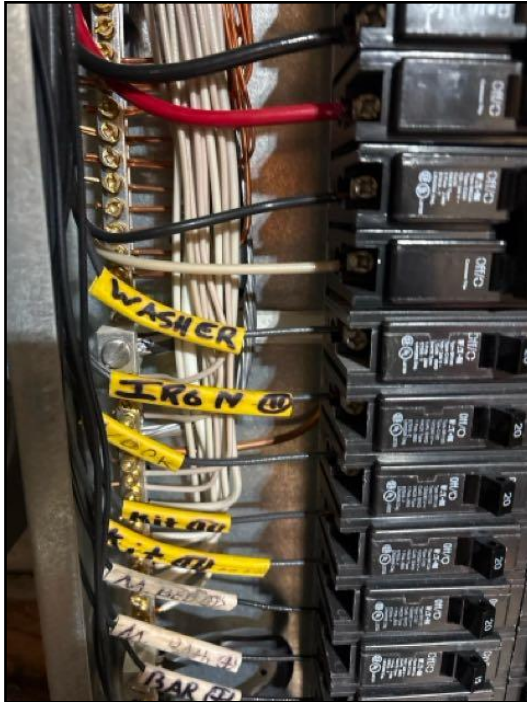
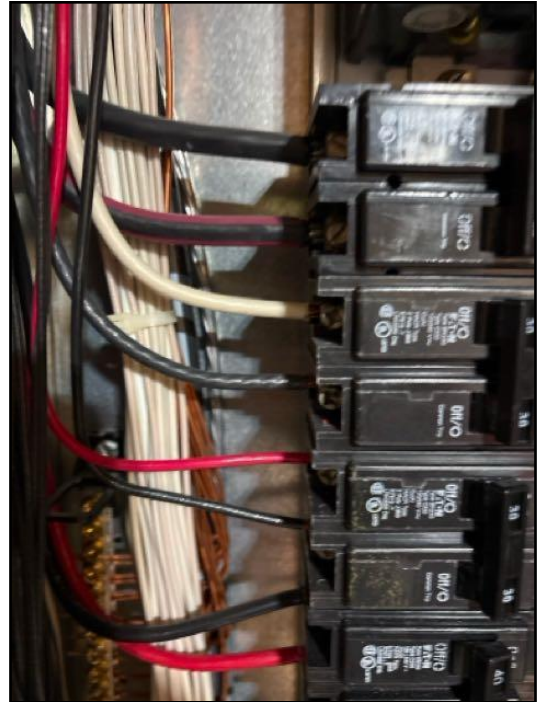
**7. Condition:** • White wires in panel are connected to breakers.

Task: Color code as "Hot"

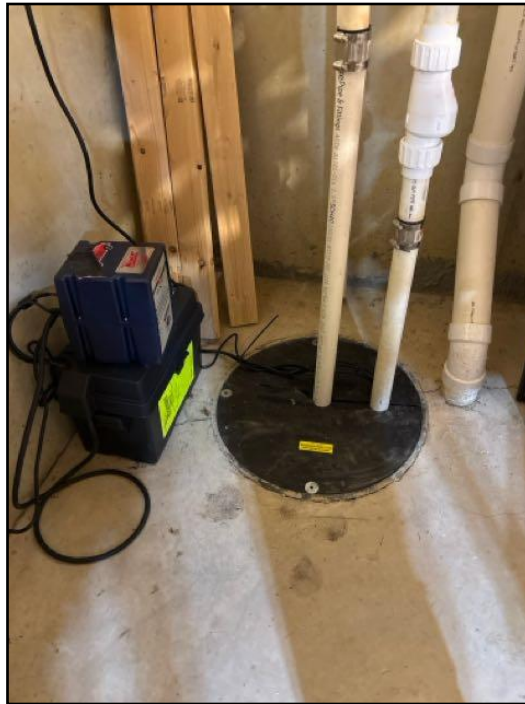
**13. Condition:** • -A sealed lid prevented access to the sump pump(s) and complete testing/evaluation was not possible.

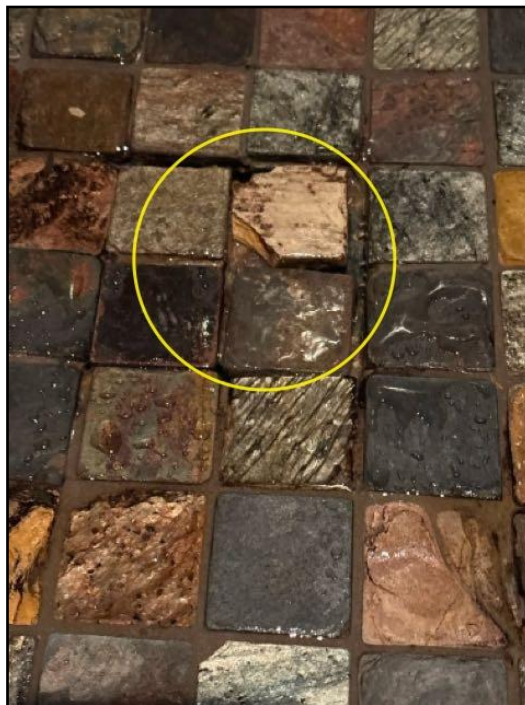
**14. Condition:** • Loose and broken tile was noted around the drain in the primary bathroom shower.

**Task:** Repair

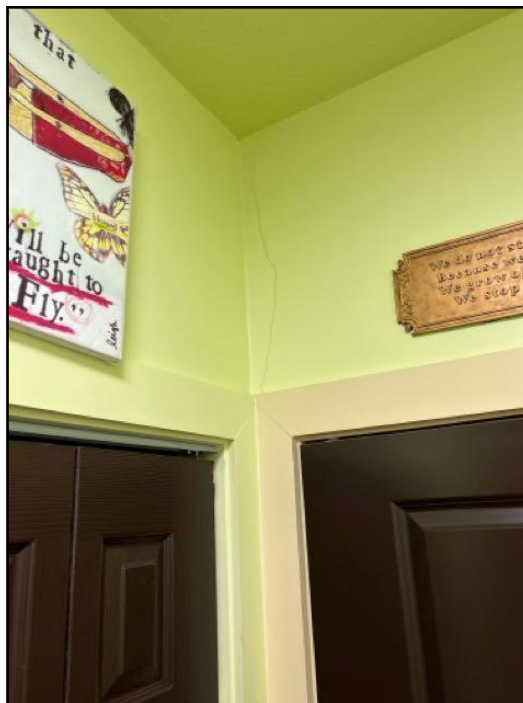
**15. Condition:** • Typical cracks are present in walls and ceilings.

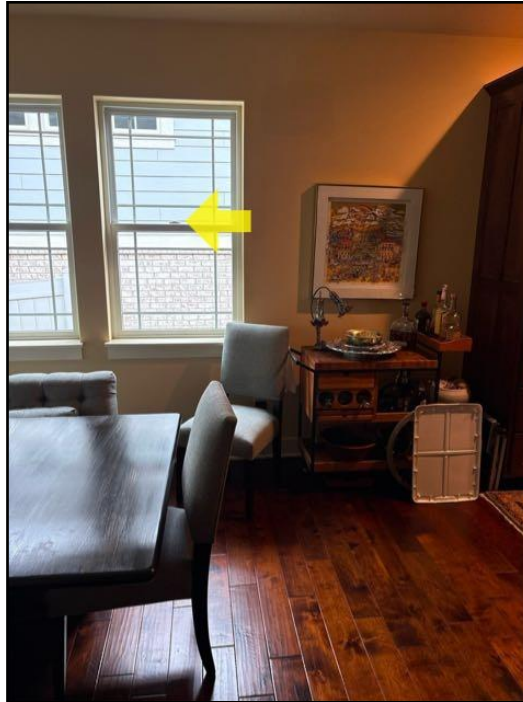
**18. Condition:** • Window did not lock or latch in the following locations.

**Location:** East dining area

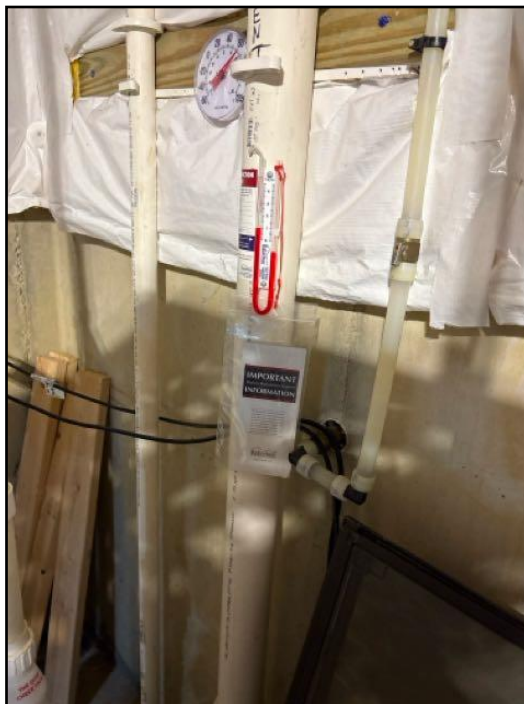
**21. Condition:** • A radon mitigation system is installed. No testing was performed.
