SODBURY

House Survey Report

123 High Street
Sampletown
Bristol
BS1 1AA

Inspection Date: XX/XX/2023

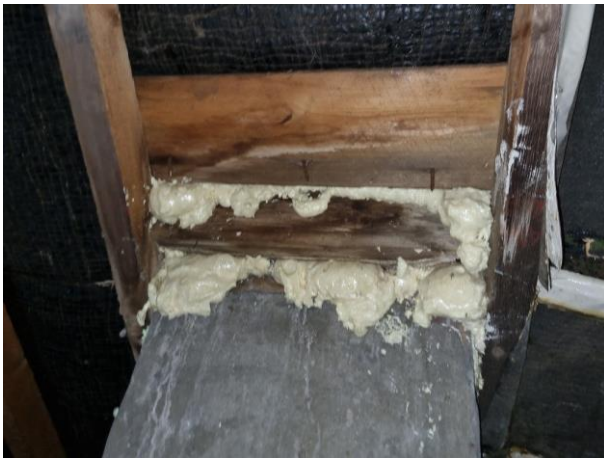
There have evidently been previous leaks into the roof space around the chimney, which have been 'repaired' using expanding foam. This is not a permanent repair and although the leaks are not currently ongoing, I would expect them to reappear in the medium-term.

See also [Section D2](#) for the effects of the leaks on the roof structure.

Urgency	Action
B	Replace the lead flashings and other waterproofing details around the base of the chimney stack with new Code 4 lead in accordance with Lead Sheet Association guidelines.

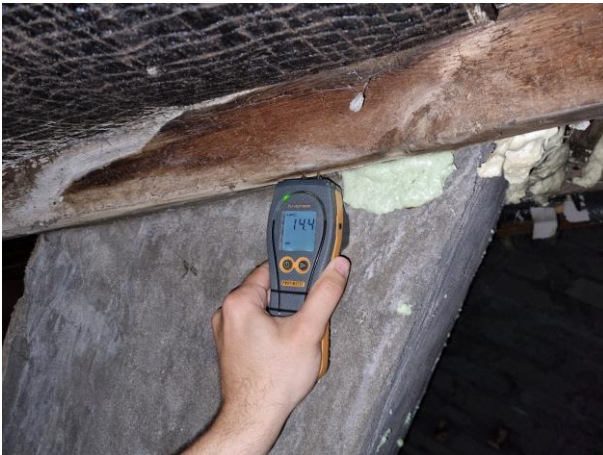
As described in [Section D1](#), there has evidently been a leak previously through the bottom of the chimney stack. This has made the timber roof structure around the chimney damp within the loft space and there is much staining to these timbers. However, the timbers are now reading as dry when tested with an electronic moisture meter, so I do not believe any repair / remedial work is required as long as the recommendations in Section D1 are followed.

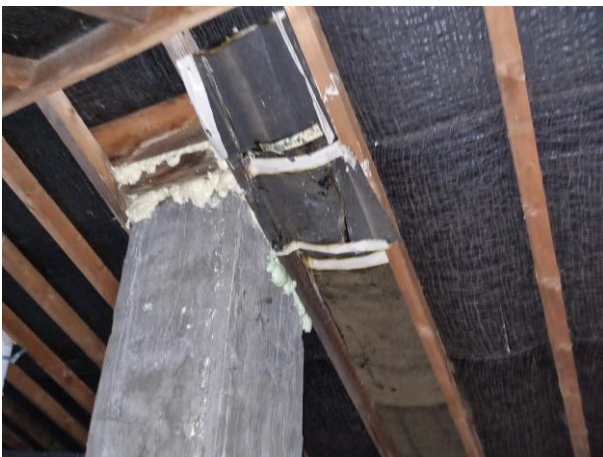
Around the chimney in the loft, there are some poorly retrofitted sarking felt sheets which will not adequately protect against water ingress.

Urgency	Action
B	I recommend temporarily removing the tiles from the part of the roof around the chimney stack where the existing sarking felt is damaged. The old / damaged sarking felt should be cut out and replaced with a section of new sarking felt (lapped with the existing in accordance with manufacturer's recommendations) and new sections of tiling batten. The set aside roof tiles may then be re-laid back in place. Note a small scaffold will be required to carry out this work safely.

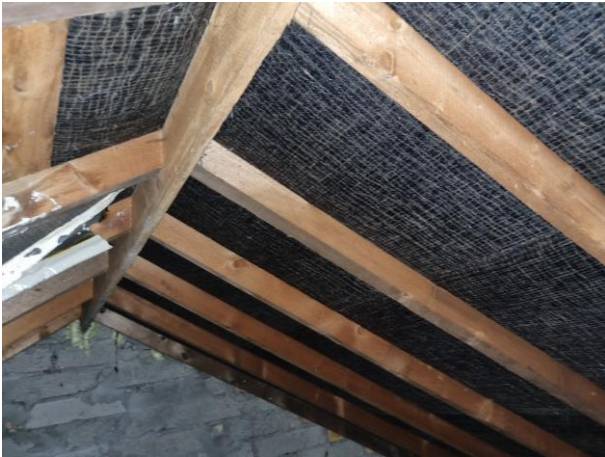
The sarking membrane is impervious to the passage of water vapour and can therefore trap airborne moisture in the roof space, which can lead to condensation and rot to roof timbers. There is limited evidence of this currently in the form of some staining to the rafters, although this is not excessive and not currently detrimental to their integrity.

Additional ventilation should be installed to the loft space to prevent moisture build-up. This may take the form of either eaves ventilation, or vent tiles installed into the roof slopes at high and low level, enabling sufficient cross ventilation.

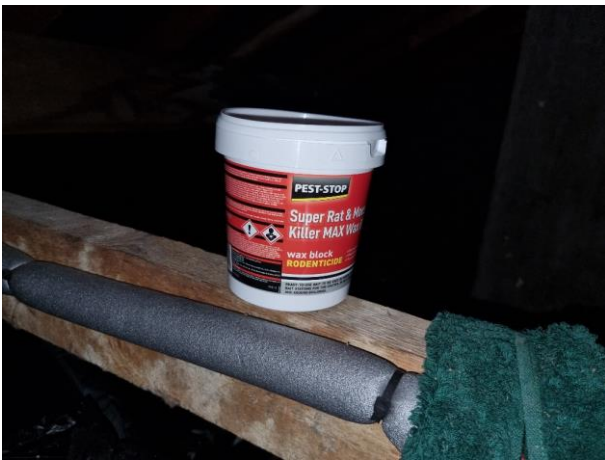
A tub of rodenticide was discovered within the loft. The vendor reported that they had a small rodent issue in the loft several years ago, which has not reoccurred. I saw no recent evidence of rodents within the loft space, so am satisfied that this issue is now likely resolved and no further action needs to be taken.

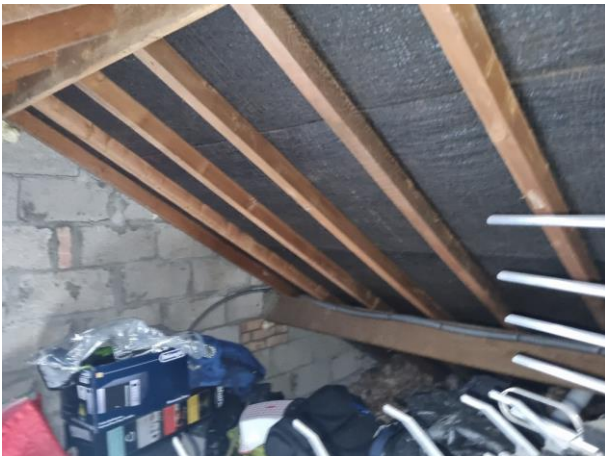
There is little lateral support provided to the roof structure. Instead, the roof structure relies on the tiling battens and ceilings to provide lateral support which is generally considered inadequate by modern standards. This said, I recognise that this property was constructed to older standards and the roof structure has not failed since it was constructed, so I do not anticipate this being a major issue. However, some of the cracking to first floor ceilings may be partly attributable to slight roof structure movement.

You should consider installing timber bracing diagonally across the rafters. This would provide additional lateral support / rigidity to the roof structure and may help to prevent cracking to the first floor ceilings in future.

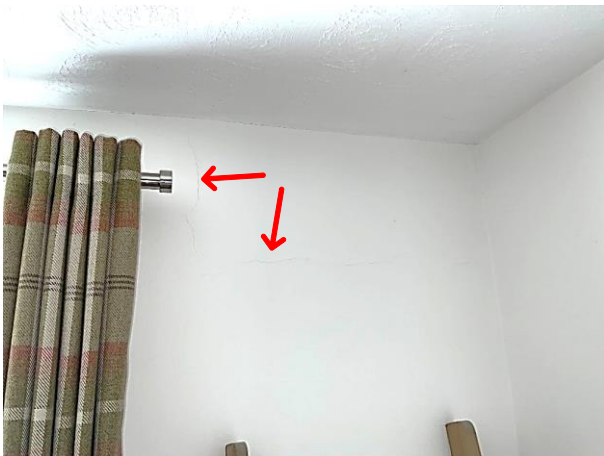
I noticed some slight cracks to the plaster in the lounge next to the window. There was no evidence of any external defect or structural issue. The most likely cause of these cracks is vibration from the floor above, or slight seasonal building movement, both of which are not serious and do not pose a structural concern.

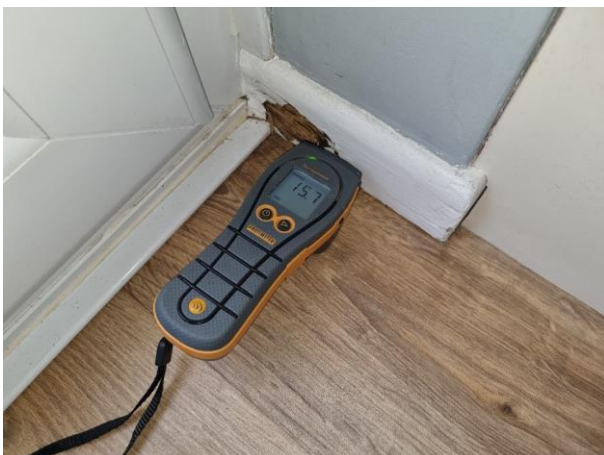
Either side of the kitchen door, there are sections of damaged / rotten skirting. However, when tested with an electronic moisture meter, the skirtings were found to be dry. This may be an old, now resolved issue, or damage caused by a pet etc. No remedial works necessary, except replacement or redecoration for aesthetic purposes if desired.

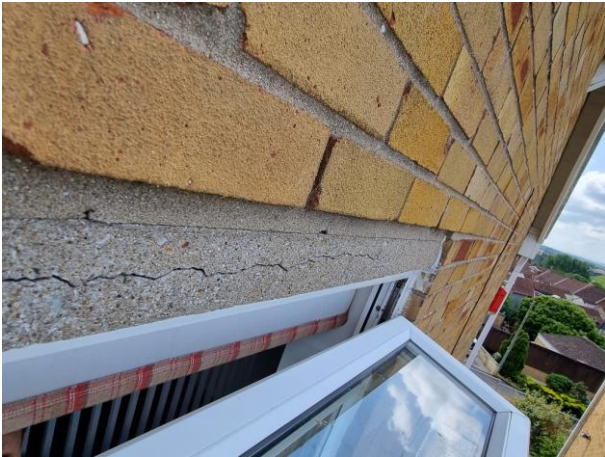
The concrete lintel over the first-floor landing window is severely cracked. This is likely to have resulted from corrosion of the metal reinforcement bars within the lintel. This will continue to deteriorate if not addressed, and is likely to eventually cause sections of concrete to fall off, and the lintel may even fail.

B	Prop the brickwork above the landing window, remove the concrete lintel and replace with a new insulated steel lintel, including a new cavity tray and weep vents above the opening. Some internal replastering and redecoration will also be required. A small scaffold will be needed to carry out this work safely.
C	The cracks to the rear elevation render should be raked out back to sound render and patch repaired to match. This will prevent water ingress through the cracks, which may eventually cause sections of render to come loose and fall off the wall.
D	Rake out and re-point the brickwork to the front corner of the building.

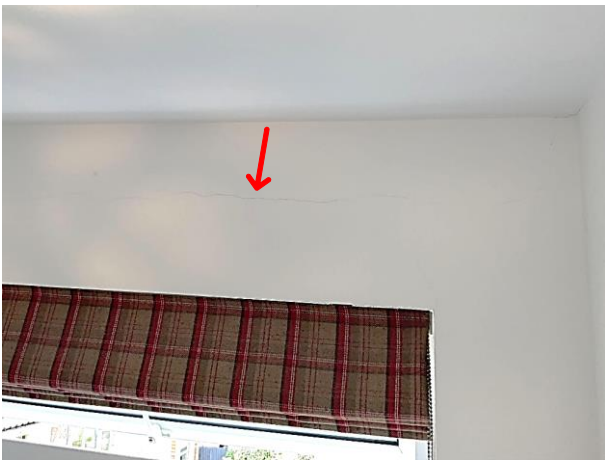
Internally, there are cracks to the plaster finish around the top of the landing window, indicating that the full depth of the lintel has been affected by the corroded reinforcement bars. With this in mind, I would estimate that the lintel may be at risk of failure within approx 1-2 years.

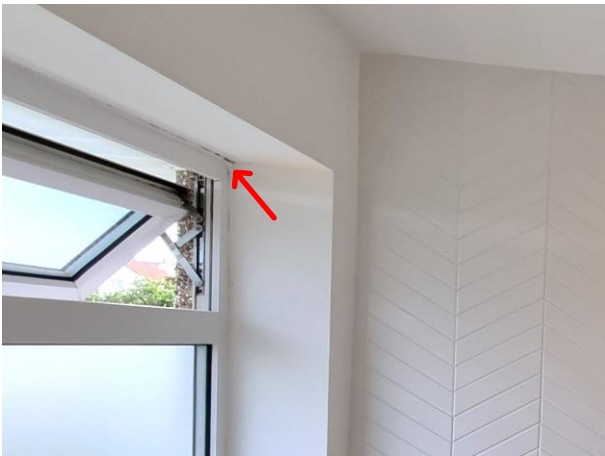
There is a small amount of black spot mould on the bathroom window reveal. Mould spores can cause health problems, especially for people with respiratory conditions such as asthma. The reason for this growth is expected to be cold bridging whereby the small part of the reveal (the walls forming the window opening) immediately adjacent the window frame gets colder than surrounding areas, attracting condensation which encourages mould growth. There is little which can be done to prevent this except ensuring that the extract fan in the bathroom is used appropriately and any mould growth is cleaned away regularly.

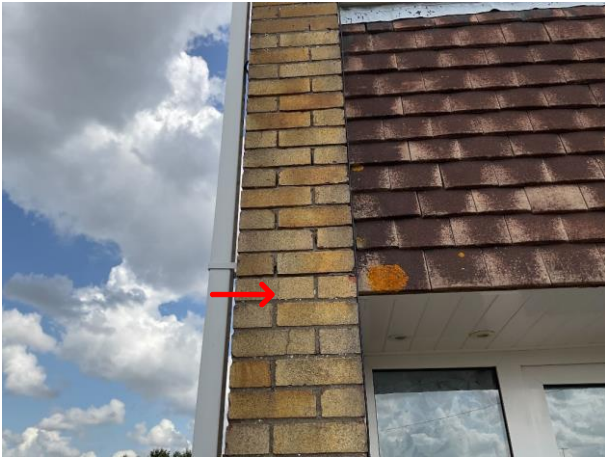
To the area indicated, the mortar between the brickwork was noted to be eroded and there were some slightly cracked bricks. This is expected to result from weathering and natural expansion/contraction due to the exposure of this corner of the building.

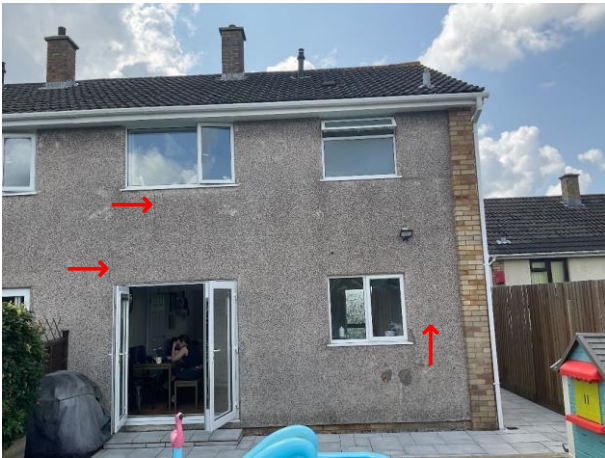
There are several slight to moderate cracks through the pebbledash render finish to the rear elevation to the areas indicated. There are no internal signs of cracking to these areas and no other evidence of structural movement, so I am not concerned about any structural issues.

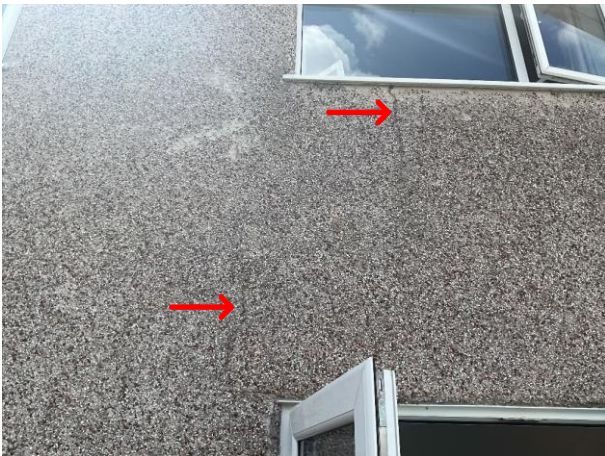
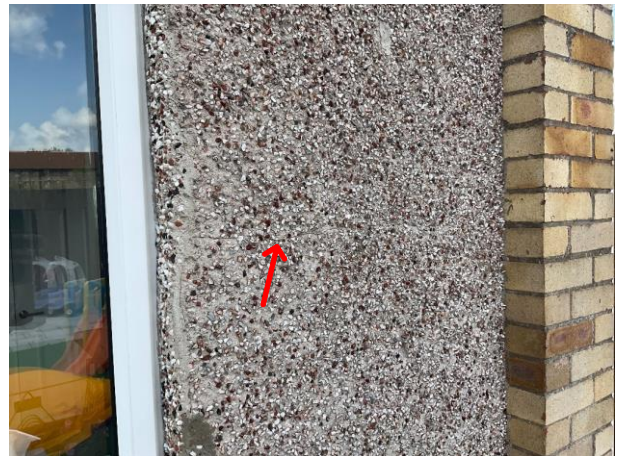
Additional views of cracks to rear elevation render.

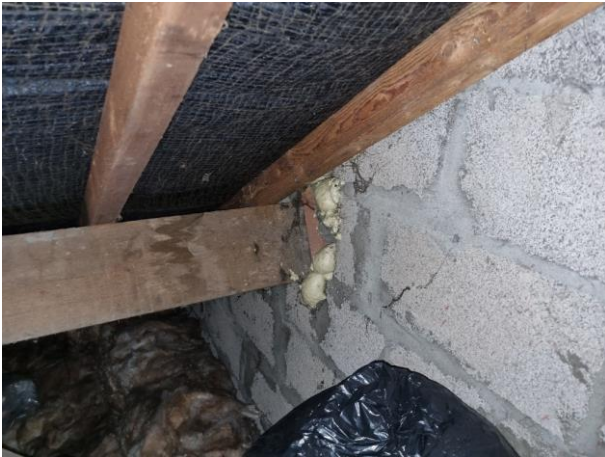
There are several small gaps in the side gable wall where the roof timbers meet the wall structure, which have been filled with expanding foam. I understand this was done when a rodent was found in the loft space (see [Section D2](#)) to prevent reinfestation. Although rudimentary, this solution appears to be fulfilling its purpose and I do not expect it to cause any future issues, so may be retained in place.

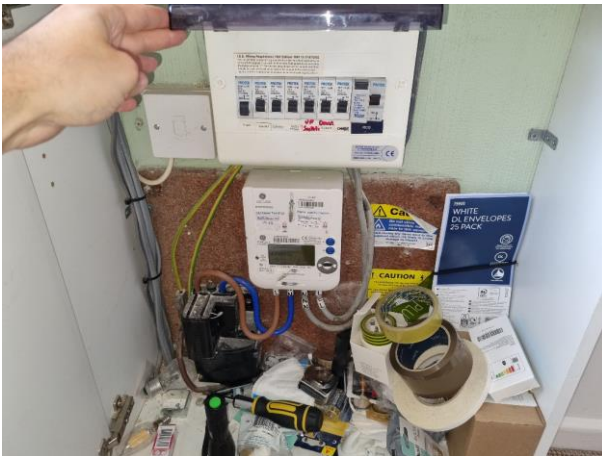
I have seen no Electrical Installation Condition Report for the property from within the last 10 years, so am unable to comment on the condition and safety of the electrical installations and wiring. However, I should note that I have seen nothing within the property to suggest that any of the electrical installations are currently in a dangerous condition.

You should arrange for a NICEIC (or other Government approved body) registered electrician to carry out a full Electrical Installation Condition Report (EICR) for the property before entering into contract to purchase the property. This will allow you to quantify likely expenditure liability before committing to the purchase.

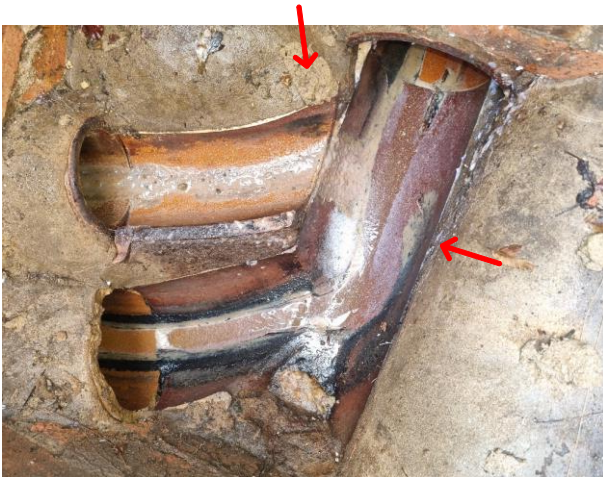
Areas of the cement benching around the pipes in the inspection chamber (manhole) in the rear garden is worn, but is not currently considered defective. The condition of this benching should be monitored and should be renewed if any becomes detached or develops cracks or holes as this can lead to water seeping into the ground.

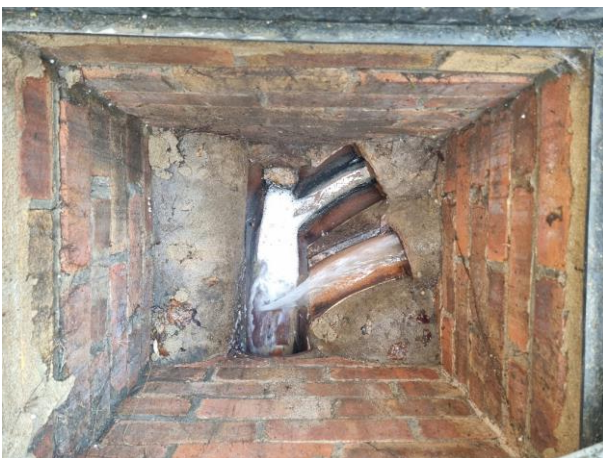
Clay pipework can develop cracks either in the pipes themselves or in the joints, which can result in foul water seeping into the ground beneath the pipes, which can lead to soil particles being 'washed out', creating voids in the ground. This can de-stabilise building foundations and surfacing (although there is no evidence of such de-stabilisation currently). Without carrying out an inspection of the pipework, you would be purchasing the risk of defects along with the property.

You may wish to instruct a CCTV survey of the below ground drainage pipework to confirm its condition and identify any potential hidden issues.

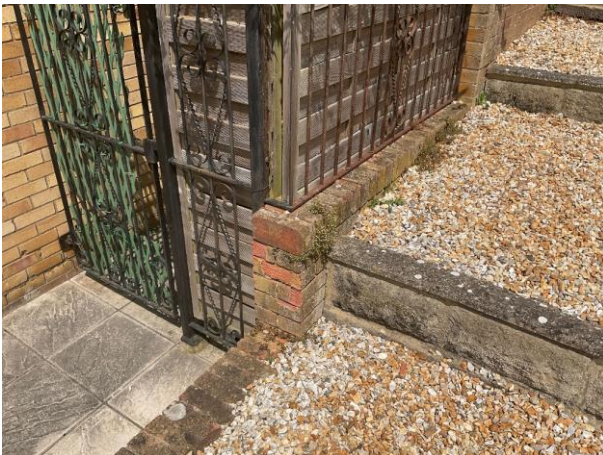
Some of the brickwork to the boundary walls of the front garden is aged and frost damaged, resulting in bricks beginning to crumble and spall. This is not expected to pose an issue in the short term, but may contribute towards instability in the longer term as deterioration continues.

C Loose bricks to the front garden boundary walls should be re-bedded into cement mortar to ensure they do not fall out of the wall. Frost damaged bricks may be cut out and replaced individually as and when they become significantly deteriorated.

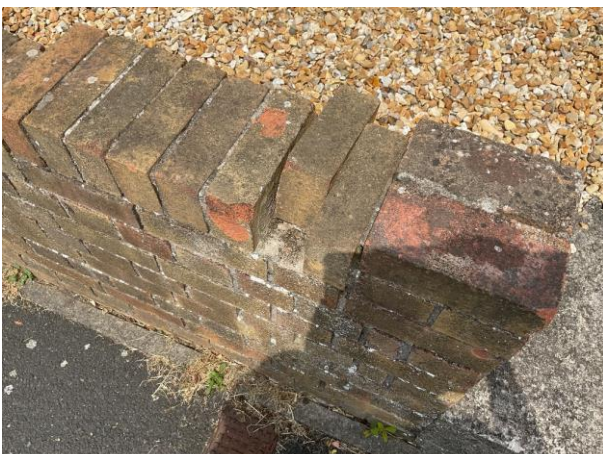
The front and right hand side boundary walls to the front garden have numerous loose bricks at the top of the wall.

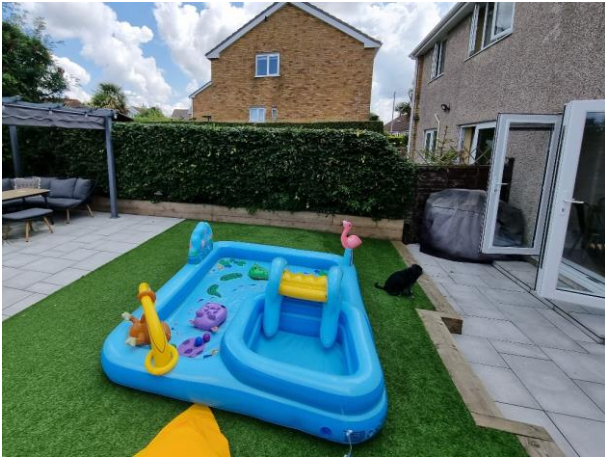
Plastic grass has been installed in the rear garden. You should be aware that this can become extremely hot when exposed to the sun and can cause burns. Extra care should be taken with pets and children.

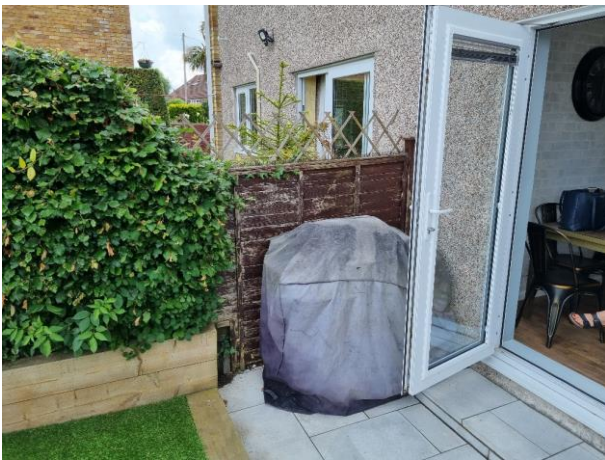
The rear garden side boundary has a section of old timber fence which is heavily aged, although appears stable currently.

D It is likely that the old section of fence to the rear garden side boundary will need to be replaced within 5 years. Your solicitor should confirm ownership and maintenance responsibilities for the property's shared boundaries.
