SODBURY

House Survey Report

123 Sample Road

Inspection Date: XX/XX/2023

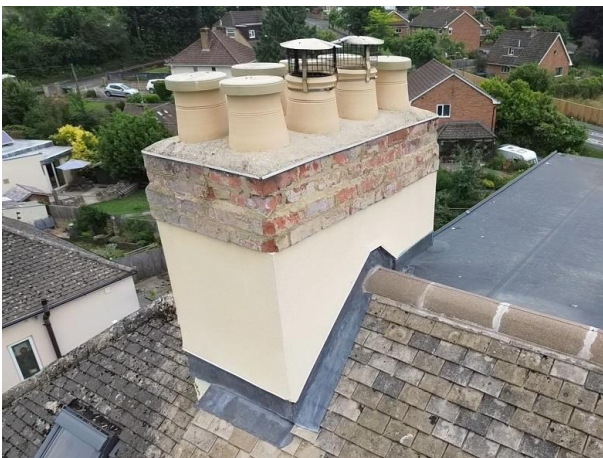
General view of chimney stack.

The render, flashings, chimney pots and flaunching all appear to have been recently renewed.

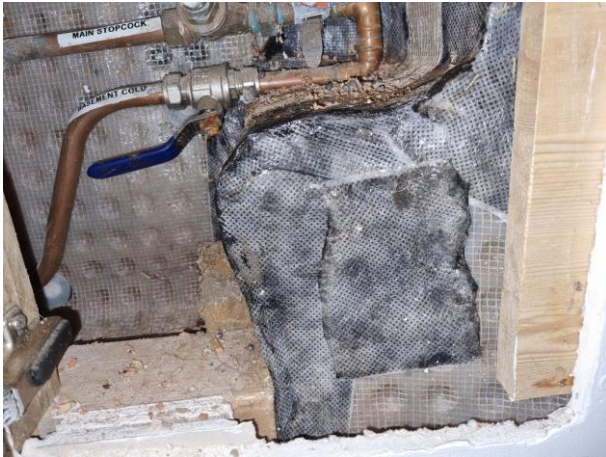
Photograph showing the limited view gained of 'Type C' waterproofing system to basement walls.

During my inspection, I did not see a pump which is required to drain away any moisture within the cavity created by this waterproofing membrane, as required by BS8102. This could enable water to build up behind the membrane, which can eventually leak through and cause internal dampness issues.

Urgency	Action
A	You should enquire with the vendor whether a pump is installed to drain the cavity behind the basement waterproofing system. If none is installed, you will need to seek specialist advice around what measures might need to be taken to prevent future failure of the waterproofing membrane. This advice should be obtained from a specialist structural waterproofing contractor, ideally one registered with the Property Care Association and holding a CSSW (certified surveyor in structural waterproofing) qualification to ensure you are receiving competent advice.
A	Loose cladding boards should be re-fixed to the structure as soon as possible to prevent them becoming detached in strong winds.
B	The heavily blistered external render under the kitchen window and beside the basement patio doors will need to be hacked off and replaced with new matching roughcast render in the short term to prevent further significant deterioration and water ingress. Other render repairs can be undertaken slightly longer-term as described below.

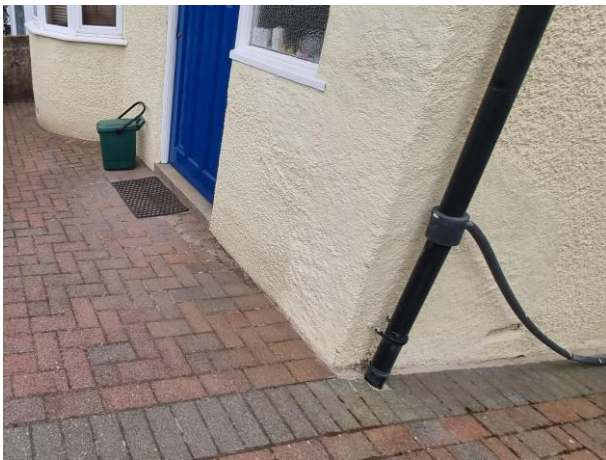
The external render finish is installed right down to ground level. Typically, render is finished above the level of the damp proof course (DPC) to prevent surface water from 'bridging' the DPC and causing internal dampness issues. This does not appear to be causing issues internally at the moment, so no remedial work is considered justified. However, you should be vigilant to low level dampness to the external walls in the ground floor front rooms and if this is seen to become an issue then it would be advisable to cut the render finish off at DPC level (approx. internal ground level) and finish the render in a drip detail to enable rainwater to be effectively shed from the wall. The bottom of the wall may then be finished with a thin coat render which is disconnected from the render above the DPC.

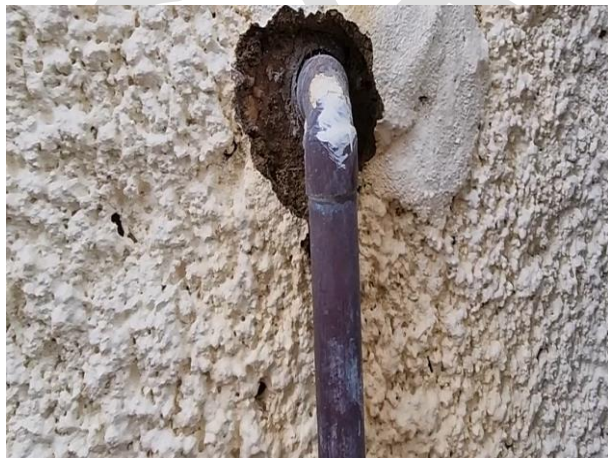
Some areas of render to the external walls were noted to be hollow/delaminating from the structure behind. This is generally caused by water ingress through small cracks or areas of damage (as per the photo which shows damaged render around the gas pipe to the side elevation). If left without repair, this can cause large areas of render to become detached and eventually fall off. The render can also trap moisture within the wall causing internal dampness.

C	The external render to the whole of the building should be tested for hollow patches by dragging a hammer across the surface and any hollow sounding patches should be marked out. This hollow render should be hacked off back to sound render. Please note that it is often the case that when hacking off render, more initially stable render will become detached and need to be removed to reach a sound substrate. With this in mind, I recommend budgeting for replacement of approximately 30-40% of all the render to the outside of the property with a new matching roughcast render.

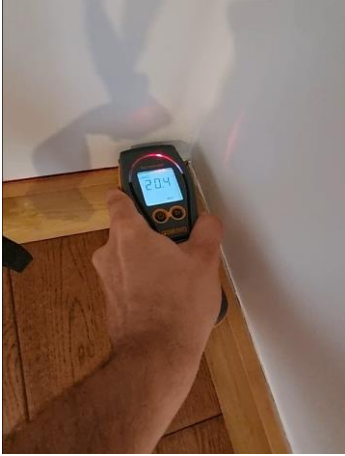
Within the dining area of the basement, I noted slightly raised moisture readings to the party wall plasterboard linings, although there were no damaged plaster or paint finishes to this area. This is expected to be related to the render damage outside (see below).

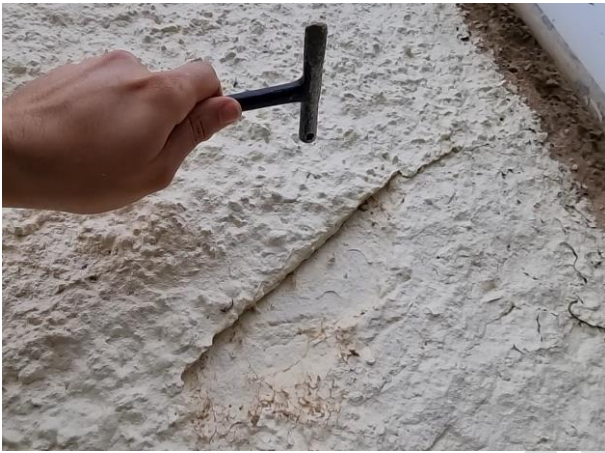
There is a large patch of hollow render to the rear elevation to the right of the patio doors. This is expected to have resulted from water ingress behind the render. I would expect this patch of render to deteriorate to the point of falling off within 2 years. This area also correlates with an area of raised moisture meter readings inside (see above).

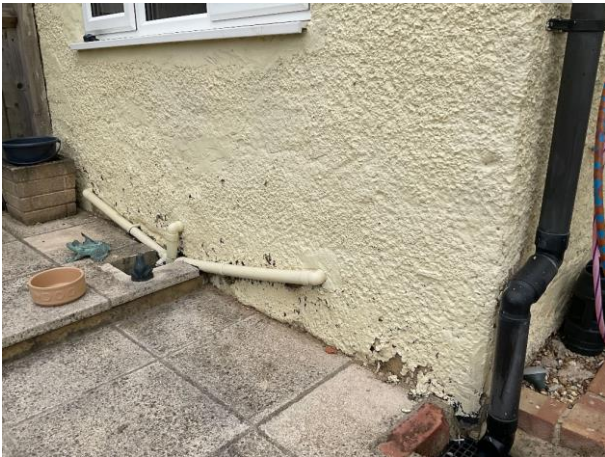
The render finish under the kitchen window is almost entirely delaminated from the structure behind and is crumbling at the bottom. This is expected to have resulted from water ingress behind the render through small cracks evident further up the wall. I would expect this patch of render to deteriorate to the point of falling off within 1 year.

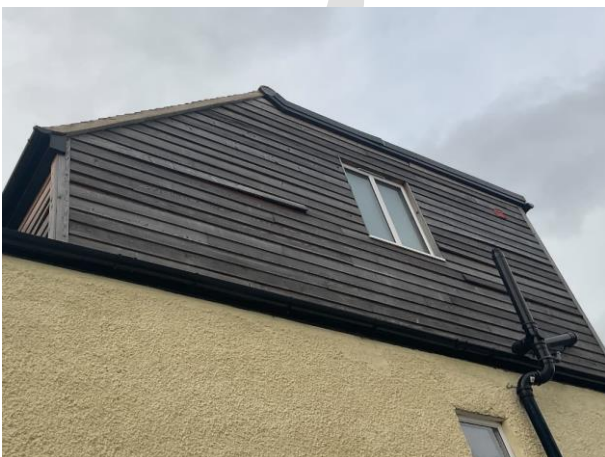
There are a number of loose cladding boards to the side and rear of the large dormer. These loose boards are vulnerable and may be detached by strong winds, creating a safety hazard.

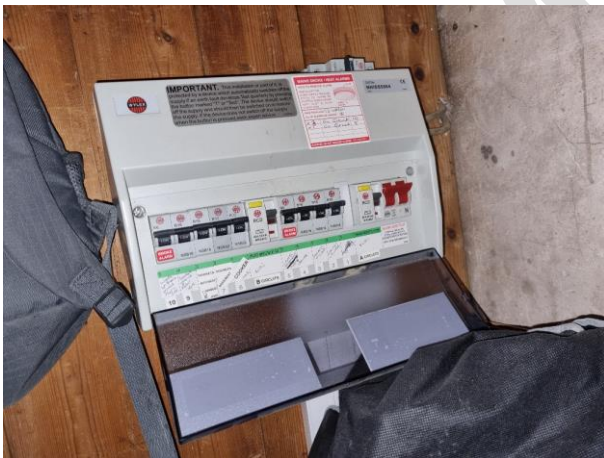
I have seen no Electrical Installation Condition Report for the property from within the last 10 years, so am unable to comment on the condition and safety of the electrical installations and wiring. However, I should note that I have seen nothing within the property to suggest that any of the electrical installations are currently in a dangerous condition.

Urgency	Action
A	You should arrange for a NICEIC (or other Government approved body) registered electrician to carry out a full Electrical Installation Condition Report (EICR) for the property before entering into contract to purchase the property. This will allow you to quantify likely expenditure liability before committing to the purchase.

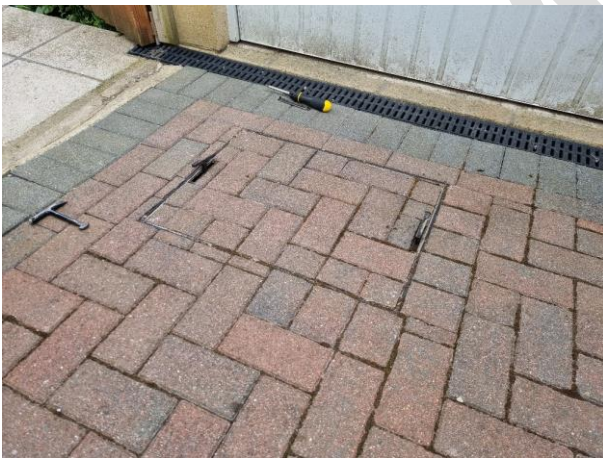
The inspection chamber serving the connection between the below ground foul drain under the driveway and the main sewer could not be lifted at the time of inspection as the cover appears to have siezed shut.

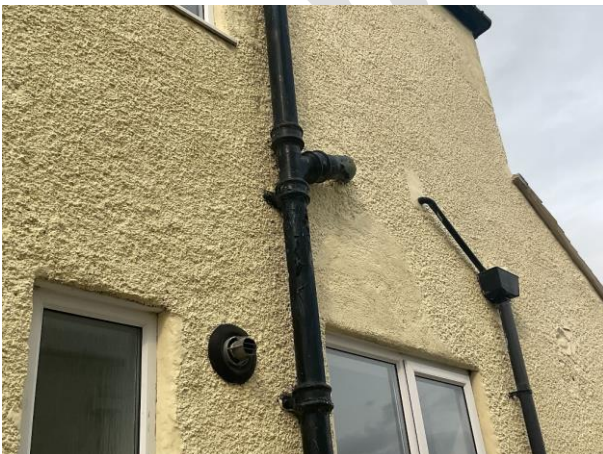
The SVP to the side elevation has some surface corrosion, which is not currently detrimental to its performance, but is likely to cause leaks if the pipe is not regularly maintained.

You should thoroughly clean, sand down and prime the entire cast iron SVP before applying a rust-resistant paint finish to the outside surface. This will help to prevent any corrosion from deteriorating.

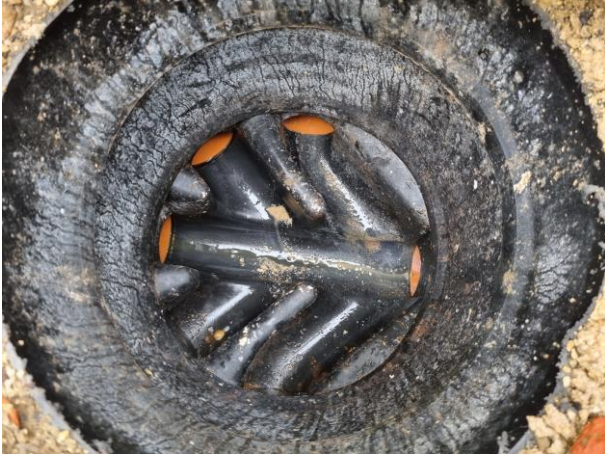
General photograph of below ground drainage pipework.

All free-flowing at the time of inspection.

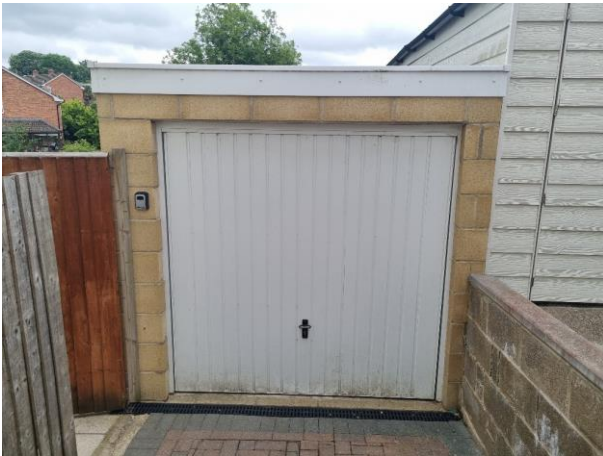
No defects were identified during my inspection.

General view of garage.

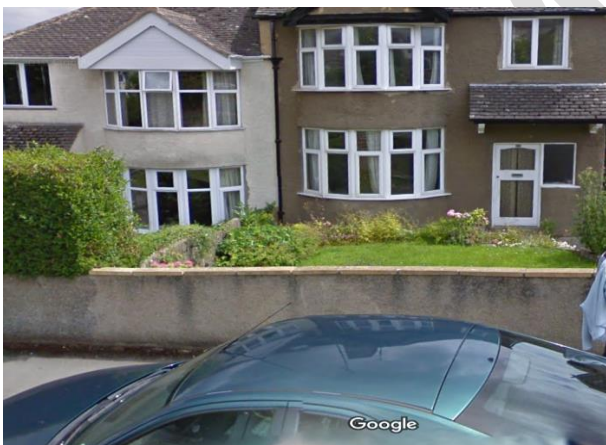
Google Streetview image from July 2009. © Google.

I can see from historical Google Streetview imagery that the front drive was actually a lawn area at least as recently as 2009. The creation of more than 5m² of additional surfacing to a front driveway requires planning permission, but I can see no record of any such permissions on the Local Authority website.

Urgency	Action
A	<p>You should confirm with the vendor when the front driveway was opened up / surfaced. If more than four years ago, no further action is required as no enforcement action can be taken by the Local Authority.</p> <p>If less than four years ago, you should instruct your solicitor to include a condition as part of the sale contract that the vendor must apply for retrospective planning permission for the alterations to the driveway. I advise that this should be done by the vendor so that they carry the risk of any alterations the Local Authority may insist upon along with their associated costs. You may choose to apply for this retrospective permission yourself after exchange of contracts, but in doing so, you should be aware that you will be assuming liability for any works required to achieve retrospective approval.</p>
A	<p>Given that the bamboo in the garden of this property is near a neighbouring house, I recommend you seek advice from your solicitor about limiting your liability should a claim be brought in future. I further recommend that the bamboo plant is removed (including the main root mass) to prevent any further root growth.</p>

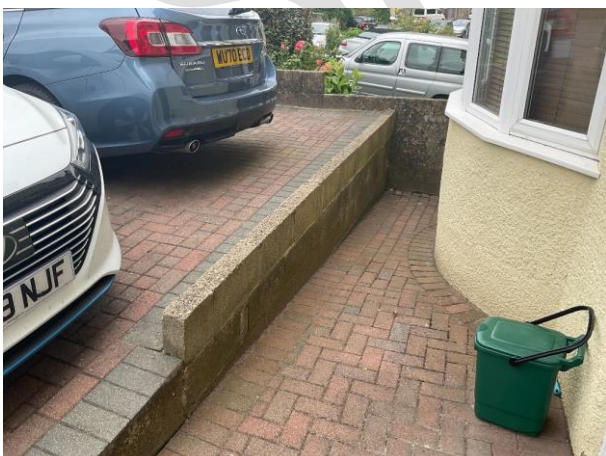
In the front garden, there is a change in level with a drop of approx. 1m. It would be possible for a car to drive over the edge, or for a person to fall and become injured.

B	<p>Provide edge protection to the change in level to the front garden, either in the form of a handrail or a low-level wall to a minimum height of 1.1m.</p>
B	<p>Take up and re-lay the block pavers around the inspection chamber at the bottom of the driveway. It may be necessary to lay these on a new compacted sand base to ensure no further settlement.</p>
B	<p>Take up and re-lay any loose paving slabs in the rear garden. New slabs should be laid onto a new bed of cement and joints should be fully pointed to keep the patio in good condition.</p>
C	<p>The loose coping stones to the right boundary wall should be re-laid in new mortar to ensure they are adequately secured to the top of the wall.</p>
D	<p>I recommend cutting out and replacing the damaged blocks to the front garden left boundary wall. At this time, any necessary repairs should be carried out to the rear garden fencing. As this is a shared boundary, you should consult the neighbouring owner and get their agreement to carry out these works. It may even be possible to share the costs of this work with the neighbouring owner if they are agreeable.</p>

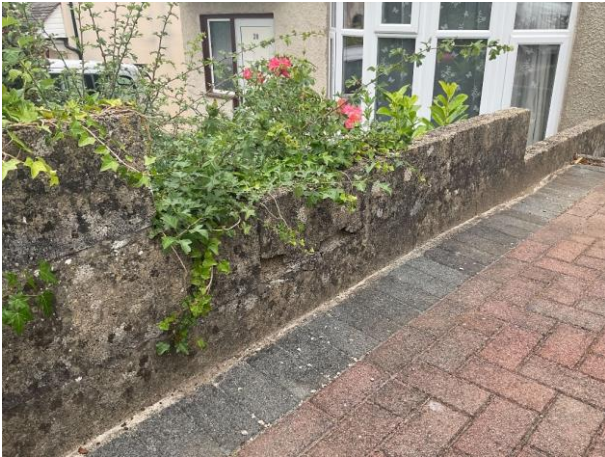
The left side boundary wall to the front garden has some damaged blocks which are likely to deteriorate and become unstable in the medium term.

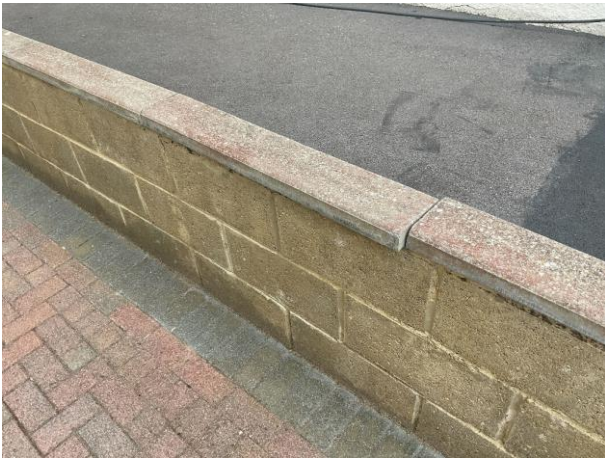
The coping stones are loose to approximately half the length of the right-side wall to the front garden. If knocked off, these may fall and cause a minor injury.

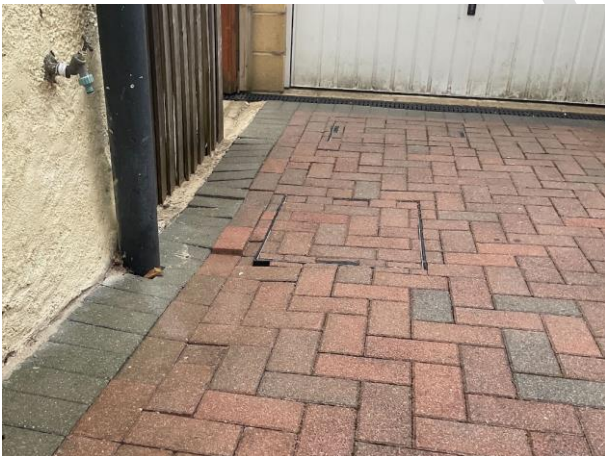
The brick pavers around the inspection chamber at the end of the driveway have sunken and are uneven, creating a trip hazard. I anticipate this has been due to settlement of the sand base onto which the pavers are laid, which is fairly common when pavings are newly laid. I am not concerned about this being a result of any issues with the drains.

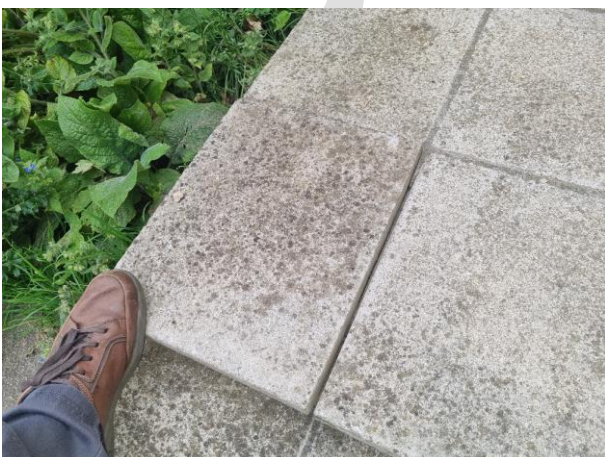
There are several isolated loose paving slabs to the rear patio area, one of which is on the edge of a small drop. If you were to step on the edge of this slab, it would be possible for it to tip and cause a fall / injury.

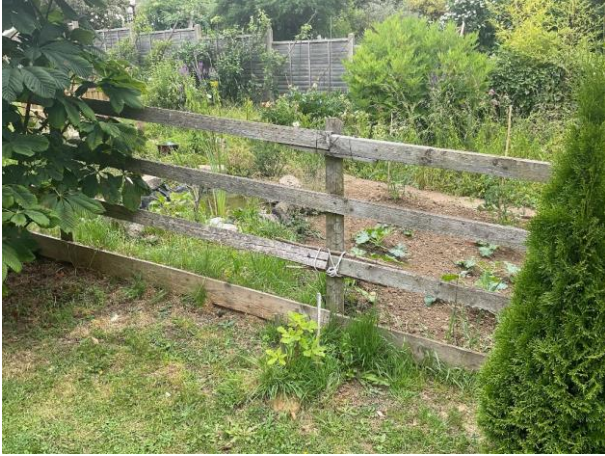
Some isolated areas of damage were noted to the rear garden boundary fencing.

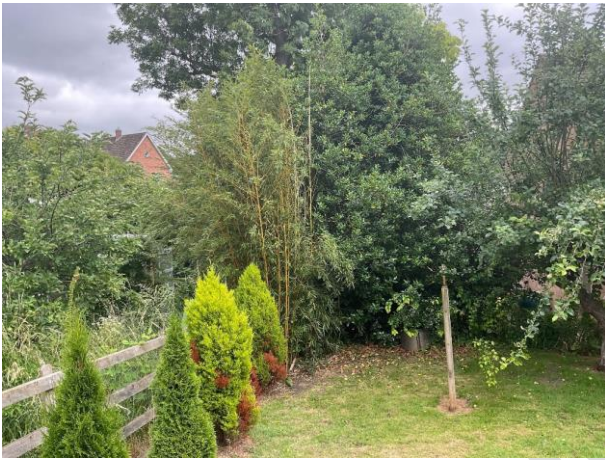
There is a large bamboo plant in the bottom corner of the rear garden, which is approximately 6m from neighbouring house. The roots of bamboo plants are generally shallow, but can be damaging to adjacent structures if there are already small cracks or gaps. Cases have been reported of major damage being done to properties by bamboo roots which have gone undetected for a number of years.

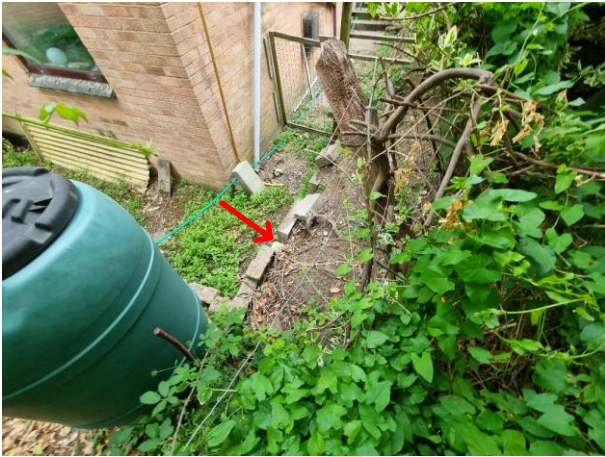
The end of the rear garden is retained from the lower level of the neighbouring property's garden by a block wall of questionable quality and condition. This wall is within the neighbour's garden, so is under their ownership. The failure of this wall could cause significant damage to the end of this property's garden. However, as you would not own the wall, there is little which can be done to mitigate this. You should be aware of this possible risk which will have to be accepted when purchasing the property.
