Subject: Installation Instructions, 94.5 GHz Holography Beacon	Date: 2023.11.20 DK2023.001revNC	From: Derek Kubo
To: Ming-Tang Chen	cc: Tim Norton, Satoki Matsushita, Nimesh Patel	Location: Hilo Office

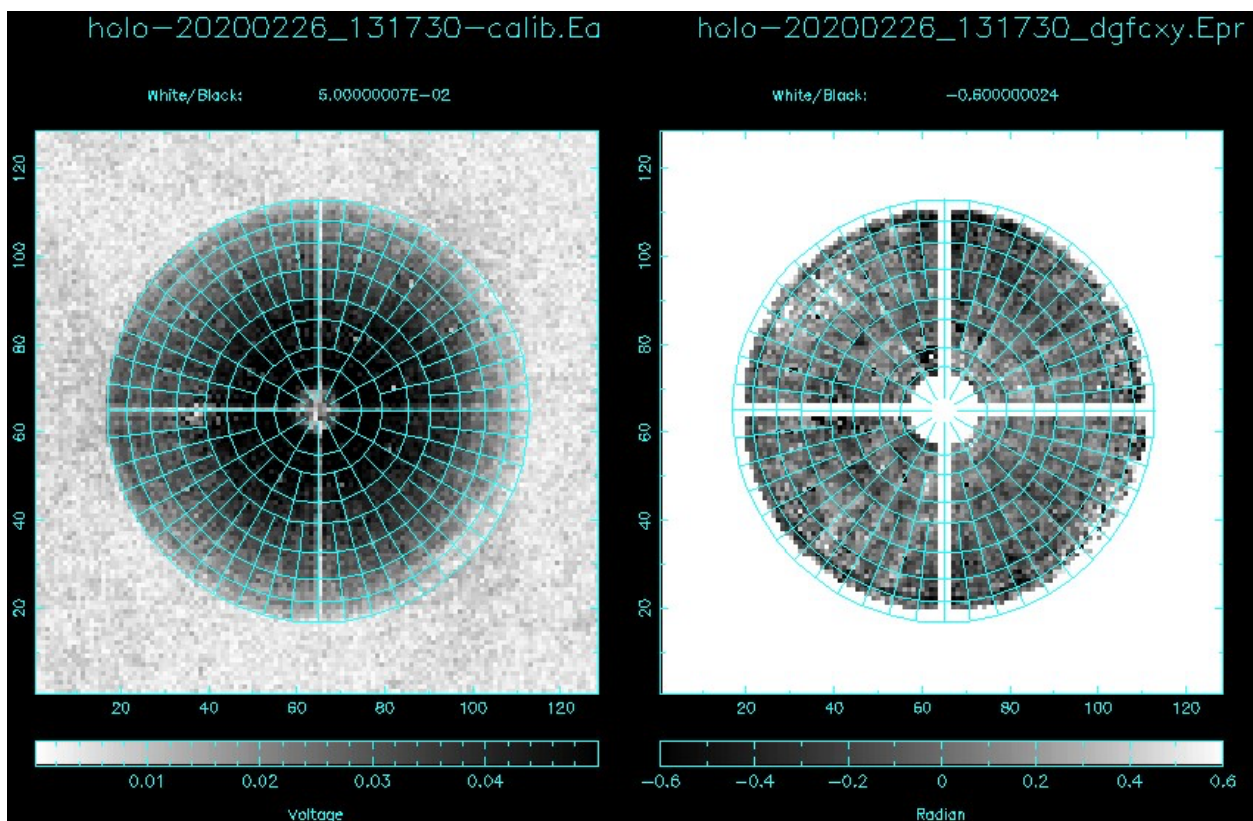
Figure-1. Coarse map of primary surface obtained by holography, refer to the log entry above for technical details.

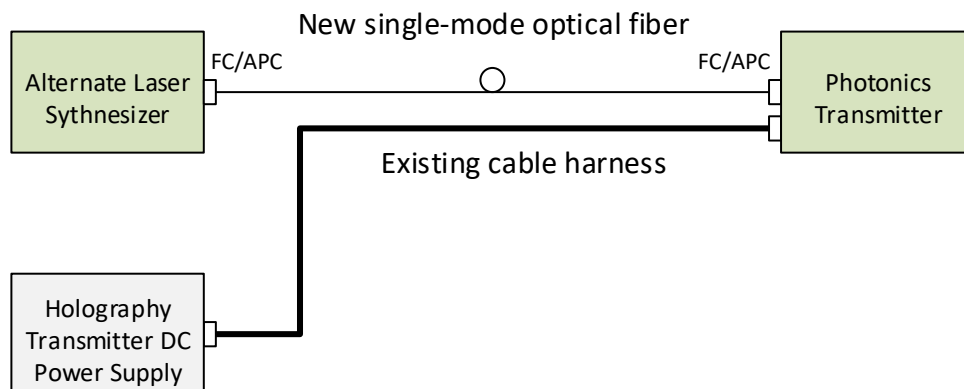
Figure-2. The installation of the “near field” beacon consists of items shaded in green and include the Alternate Laser Synthesizer chassis which will reside in the holography rack inside Bldg-1975, the Photonics Transmitter on the tower, and single-mode fiber between the Alternate Laser Synthesizer and Photonics Transmitter.

One potential solution to mitigate the existing intermittent transmitter beacon on the South Mountain tower is to replace it with the photonics version proposed for the “near field holography system” for use at Summit Station. It requires the installation of the Laser Synthesizer (LS) chassis into the holography rack located inside Bldg-1975, running a single-mode fiber from the LS through a conduit between Bldg-1975 and the tower, and the installation of the Photonics transmitter unit onto the tower. A simple diagram of the interconnection is shown in *Figure-2*.

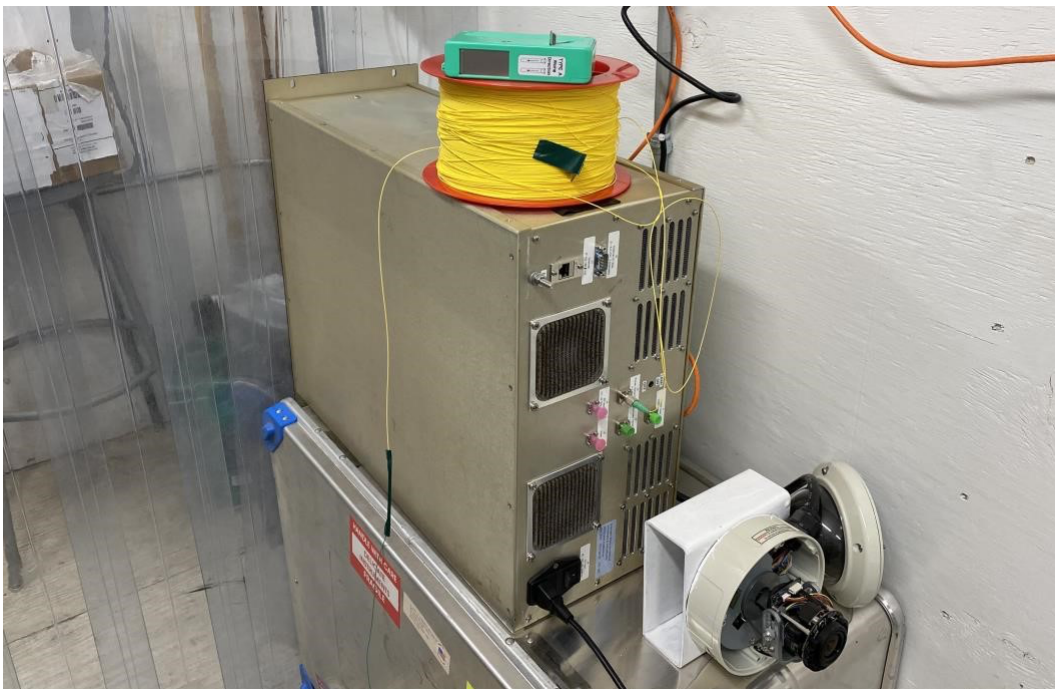
Figure-3. Rear view of the Laser Synthesizer located within the Maser House. The yellow spool on top consists of 200 meters of single-mode fiber with FC/APC connectors on each end. Though this fiber is not protected by a jacket it may be used temporarily to test the effectiveness of the beacon on the tower.

The Laser Synthesizer is a self-contained 3U rack mountable chassis that requires a 120 VAC power source. This Laser Synthesizer is presently located within the Maser House and a photo of it is provided in *Figure-3*. The optical output is via an FC/APC connector located on the rear panel. Note that this unit is too heavy to support itself from the front panel and requires the installation of a pair of supporting L-brackets into the rack. A pair of these L-brackets are located inside the Receiver Trailer along the right wall near the lab benches. I marked these L-brackets with a Sharpie pen indicating where they need to be cut to fit into the existing rack within Bldg-1975.

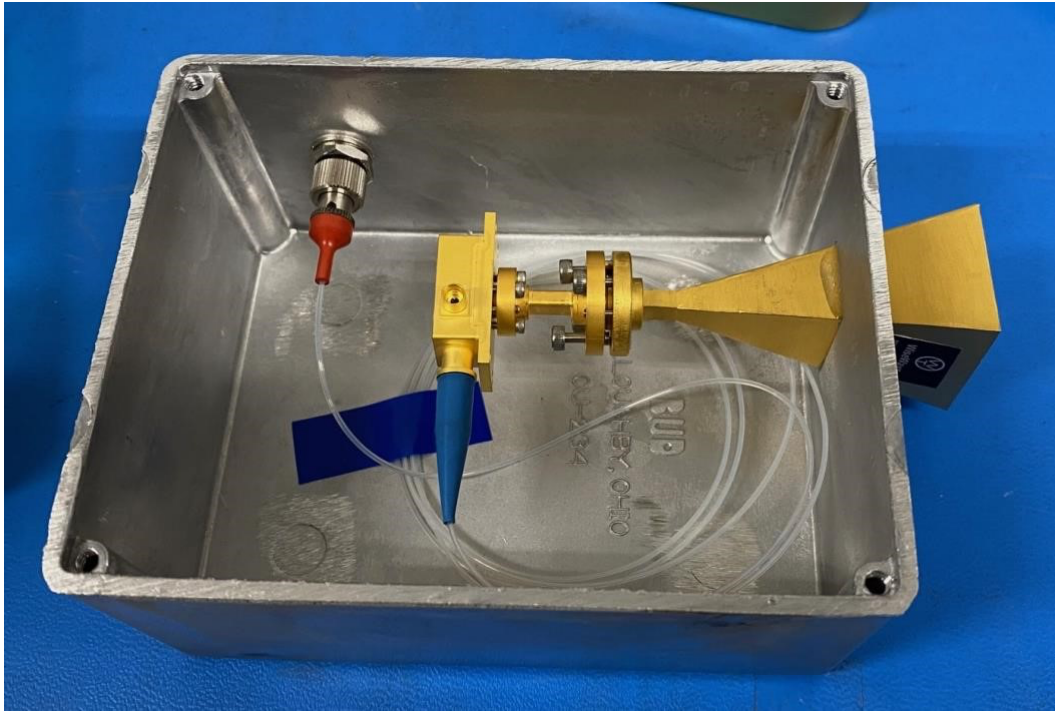
Figure-4. Transmitter consisting of photomixer and waveguide horn. The optical input is provided by the FC/APC connector at the top. The small MMCX connector on the photomixer is for DC bias. This unit will be repackaged for weather proofing and will accept the existing circular DC power connector.

The transmitter unit consists simply of a photomixer and waveguide horn and is shown in *Figure-4*. This transmitter unit is currently in Hilo for repackaging into a weather tight assembly. We are planning to use the existing power connector to provide the 28 VDC heater power and +12 VDC for the photomixer DC bias (regulated down to 3.3 VDC). Our current configuration utilizes two double-AA batteries and a series 500 Ohm potentiometer to adjust the DC current for the photomixer (optimal value -16 mA). This optimum current is a function of both optical power and DC voltage and requires adjustment of the potentiometer in-situ to account for fiber loss. Exactly how we are going to accomplish this, i.e., monitor current and adjust the potentiometer, is not yet determined. A photo of the tower with the current transmitter installed is shown in *Figure 5*. It is noted here that the transmitter E-field polarization shall be in the vertical direction.

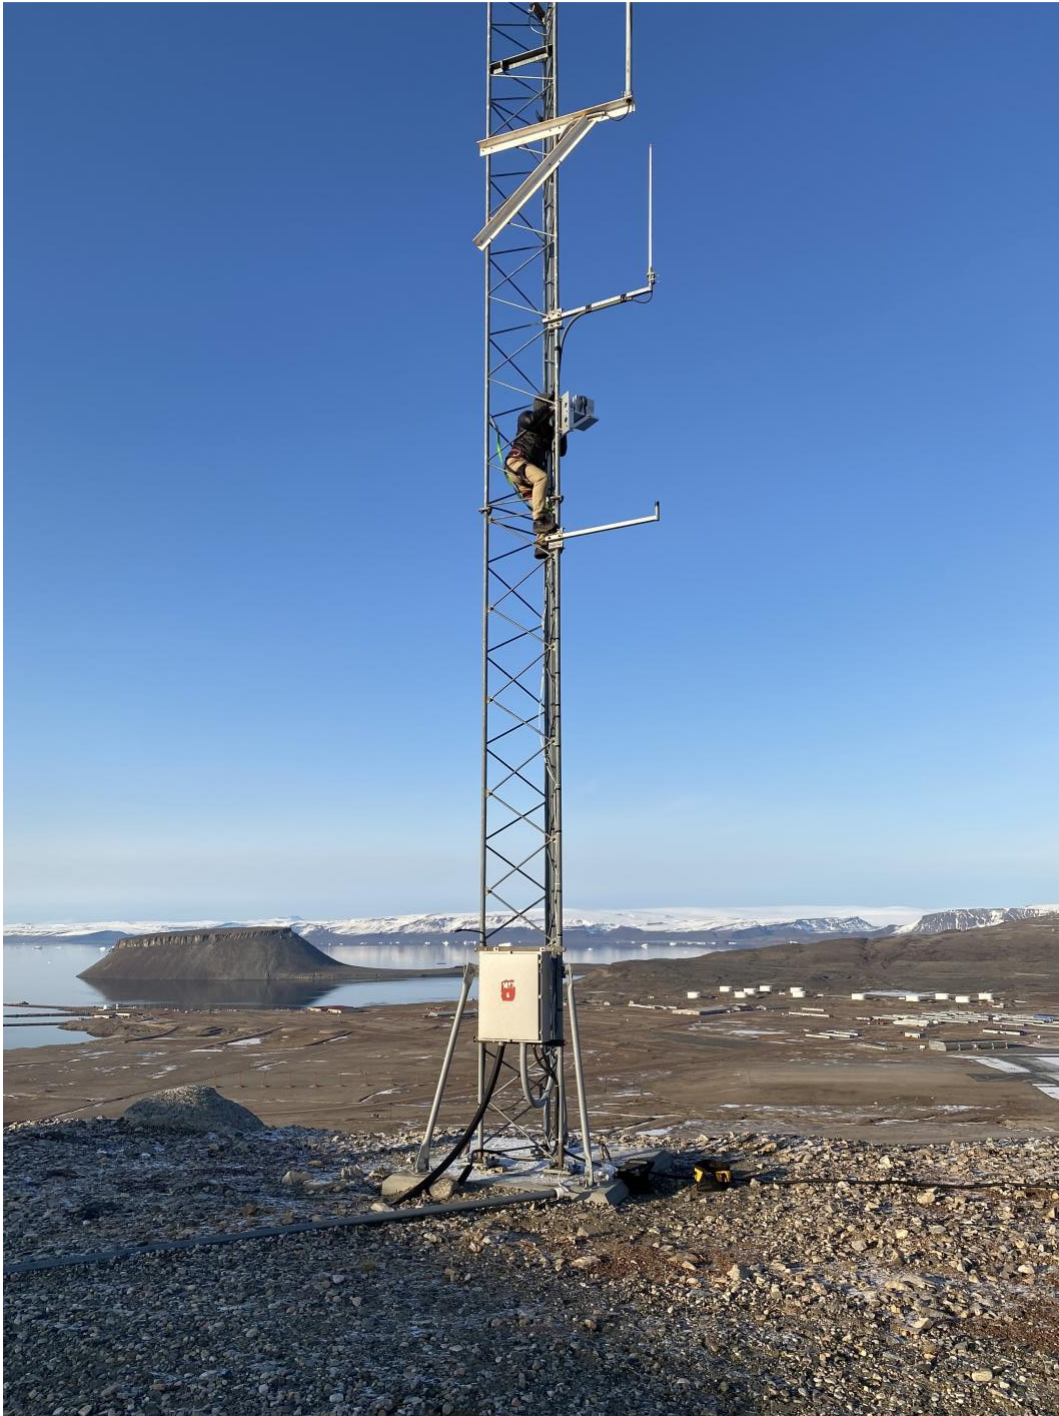
Figure 5. Current transmitter on tower located approximately 3.5 meters above the base. Note the above ground metal conduit carrying the DC power cable from Bldg-1975 located about 30 meters from the tower.

And finally, there is the fiber connection between the Laser Synthesizer and transmitter unit. The 200-meter spool of yellow unjacketed single-mode fiber can suffice for testing but may not survive a storm at the ridge of South Mountain. My suggestion is to pull the fiber from Bldg-1975 (spool side kept inside the building) through the existing conduit and up the tower. Tie off or tape the fiber every foot so there is minimum dangling up the tower.

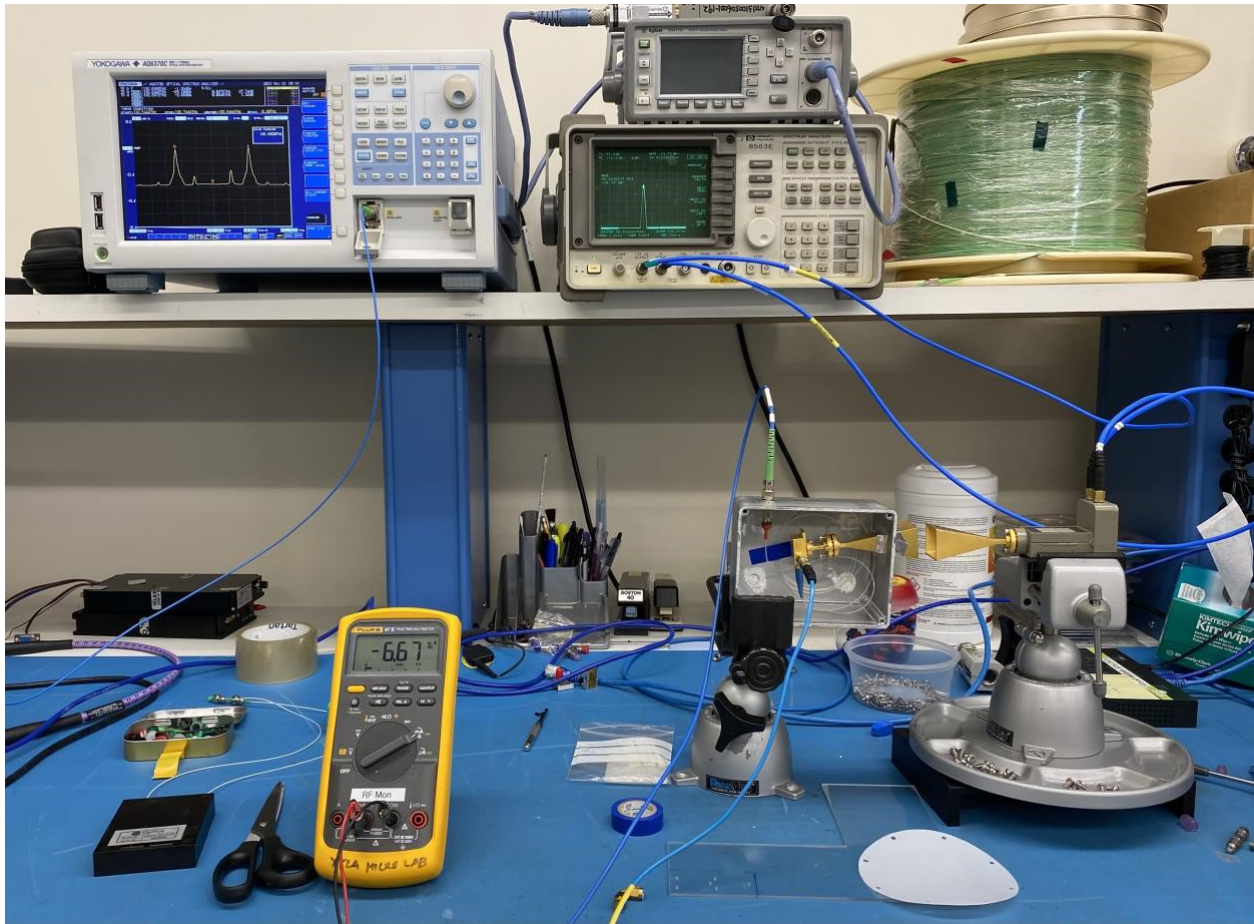
Figure-6. Test setup for repackaging of the transmitter unit. Here we are testing different windows to protect the waveguide horn from the external elements. The optical spectrum analyzer on the upper left shows a pair of optical tones centered at 192.643 THz and separated by 94.500 GHz. The RF spectrum analyzer on the right shows the desired 94.500 GHz tone generated by the photomixer. The Fluke DVM is used to monitor DC current through the photomixer.

Use of the Laser Synthesizer is overkill for this application as it was designed to produce an extremely low phase noise reference LO for the ALMA system. However, it is what we have for now and can be redesigned later to be simpler in function and lower cost. We know that this hardware is not intermittent in operation and the simplicity of the transmitter lends itself to the harsh environment of Greenland. One aspect that we currently don't know is whether this transmitter generates enough signal power to overcome what we believe to be 15 dB of shortage to lock the VVM. We have configured the test hardware in our Hilo lab answer these questions and will proceed on a success-oriented path. Refer to [Figure-6](#) for a photo of the test configuration.
