PROPERTY INSPECTION REPORT

Concerning: 1234 Happy Street, Fun City, TX 77777

By: Amandeep (Andy) Punia, Lic #22380 04/18/2017

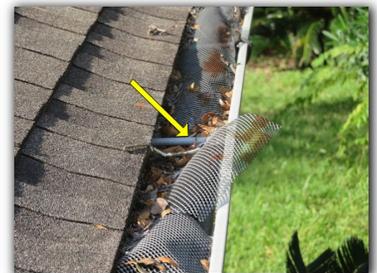
Leaf Guards were observed to be damaged and/or missing in multiple gutters.

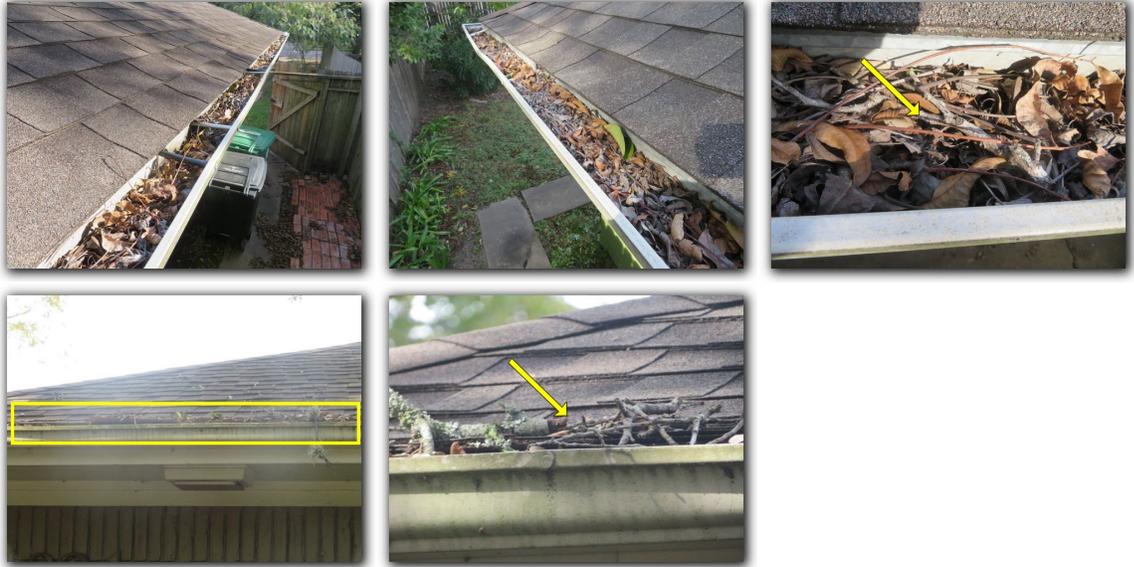
Debris was observed inside the gutters.. The debris should be cleared to allow for adequate drainage of rain water.

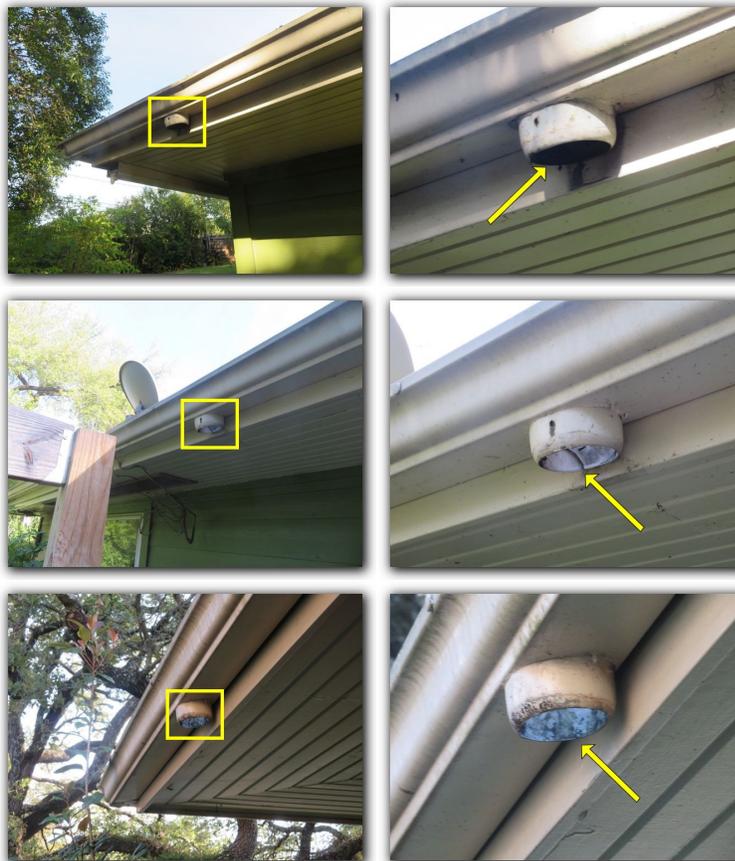
Multiple downspout's were observed to be missing. The downspout's can be installed to improve the drainage of rain water away from the property.

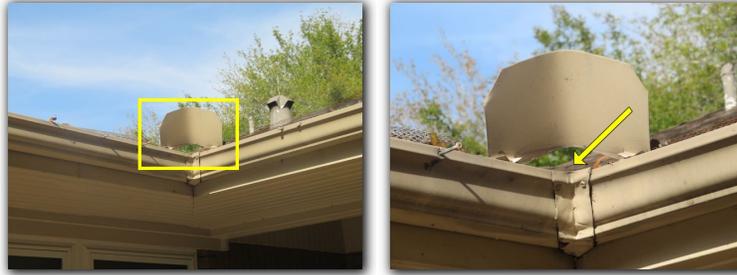
The splash guard was observed to be installed incorrectly. This can be improved to reduce the water run-off over the gutter.

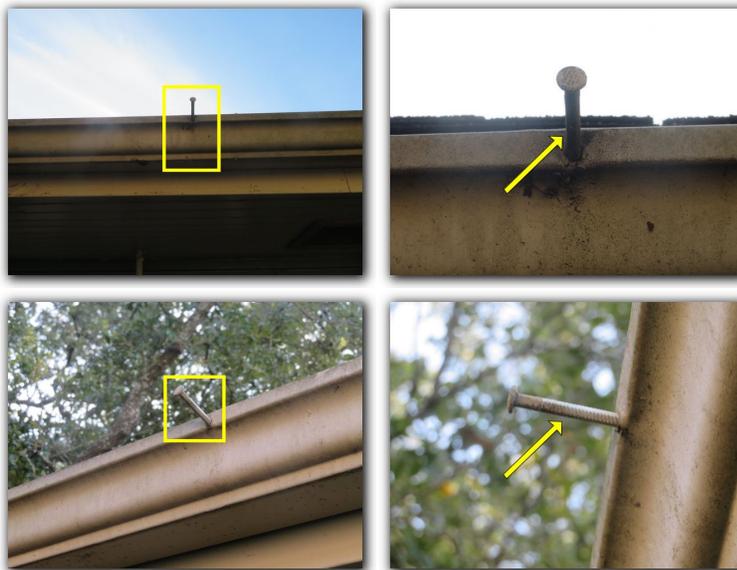
Nails were observed to be under driven on the gutter on the right side of the property. The nails should be fully driven to secure the gutter to the eave.

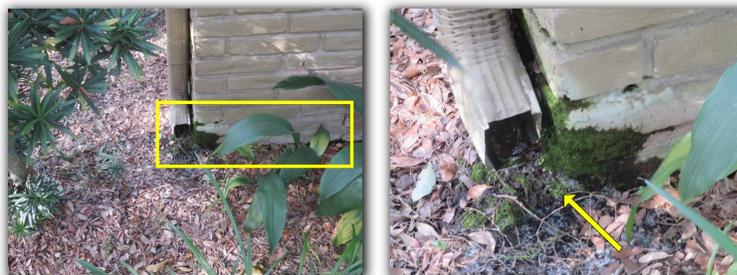
The downspout was observed to be discharging the rain water next to the foundation on the front of the property. Storm water should flow away from the structure at the points of discharge, at least 3 feet away from the foundation.

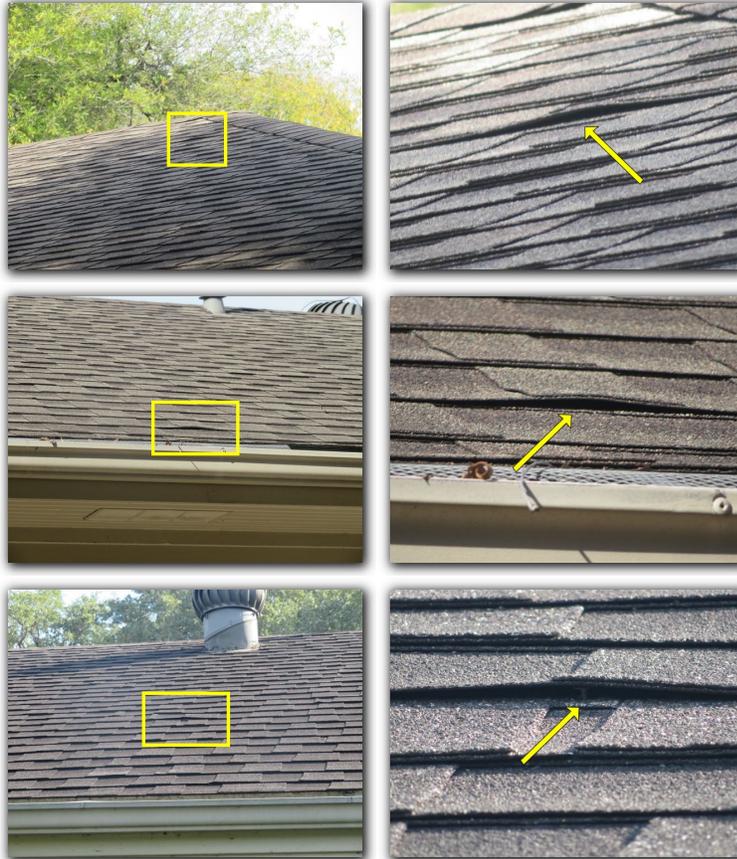
Multiple shingle uplifts were observed on the roof. All shingle uplifts and roof penetrations should be examined and sealed as necessary to reduce the risk of water intrusion.

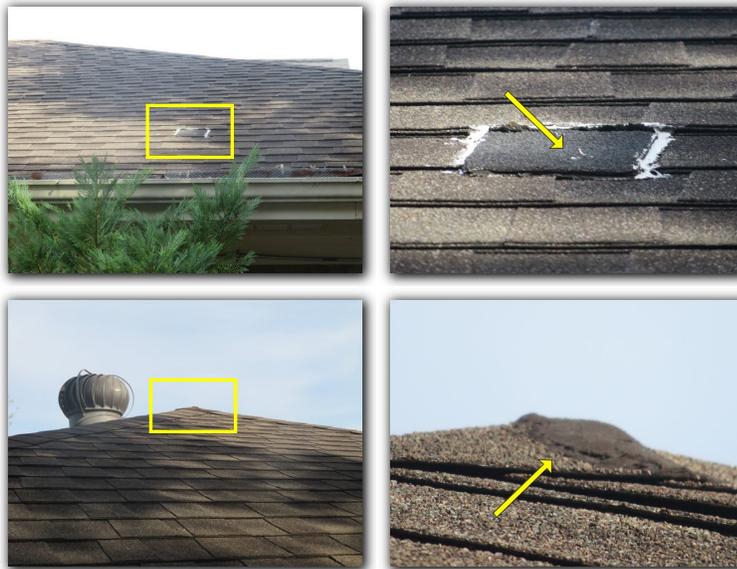
Evidence of prior shingle repairs was observed on the roof. All repaired areas should be monitored on a continual basis and sealed as needed to reduce the risk of water intrusion.

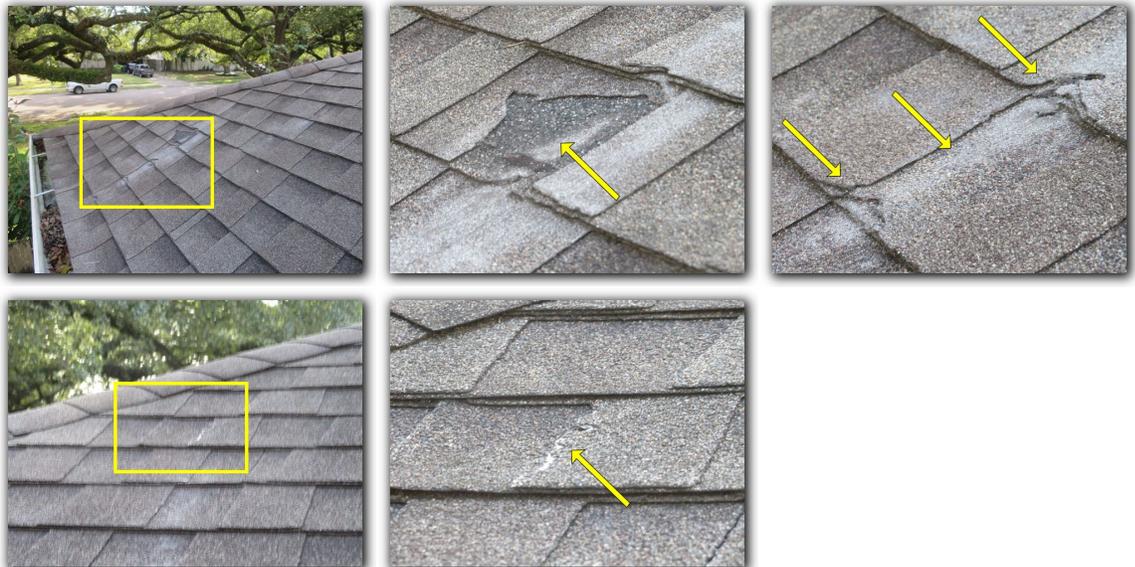
Damaged roof shingles were observed at multiple areas of the roof. Damaged and/or missing roofing material should be repaired to reduce the risk of water intrusion.

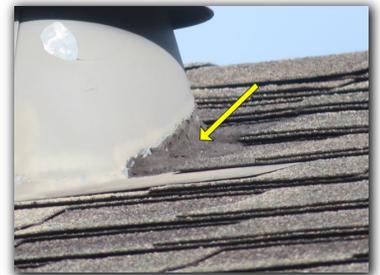
Evidence of prior repairs with sealant was observed on the roof vents. All repaired areas should be monitored on a continual basis and sealed as needed to reduce the risk of water intrusion.

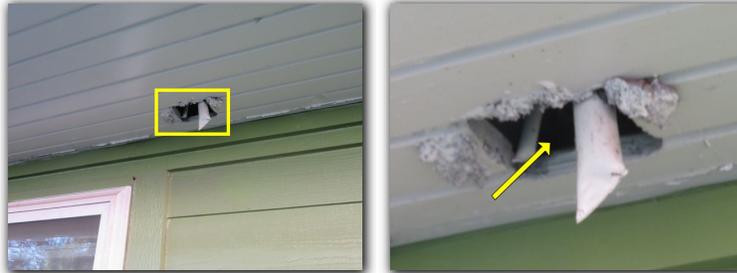
A gap was observed in the soffit board around the drain pipe. This should be sealed to reduce the risk of wood destroying insect entry.

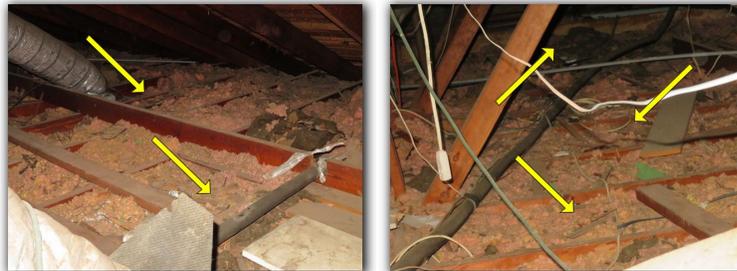
Insulation was observed to be 2" to 4" inches thick on the attic floor. Current building standards recommend 13" to 14" insulation thickness for most southern climates. This can be improved or additional floor insulation can be installed as needed.

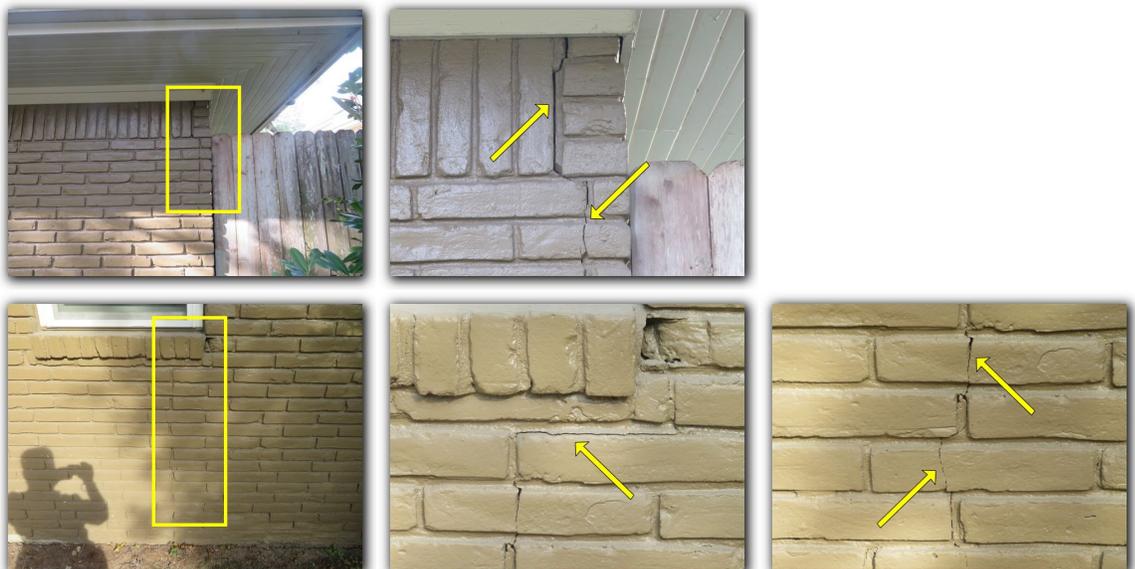
Typical cracks were observed on the exterior walls of the property. The extent of movement does not indicate a serious structural problem. This area should be monitored. The rate of movement cannot be predicted during a one-time inspection. In the event the cracks continue a structural specialist should be consulted to further evaluate this condition and the remedies available for correction.

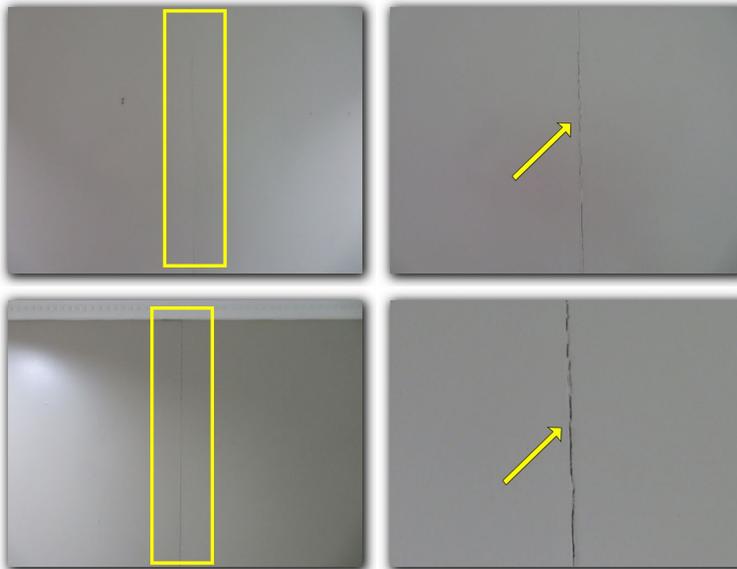
Typical cracks were observed on the walls of multiple rooms.

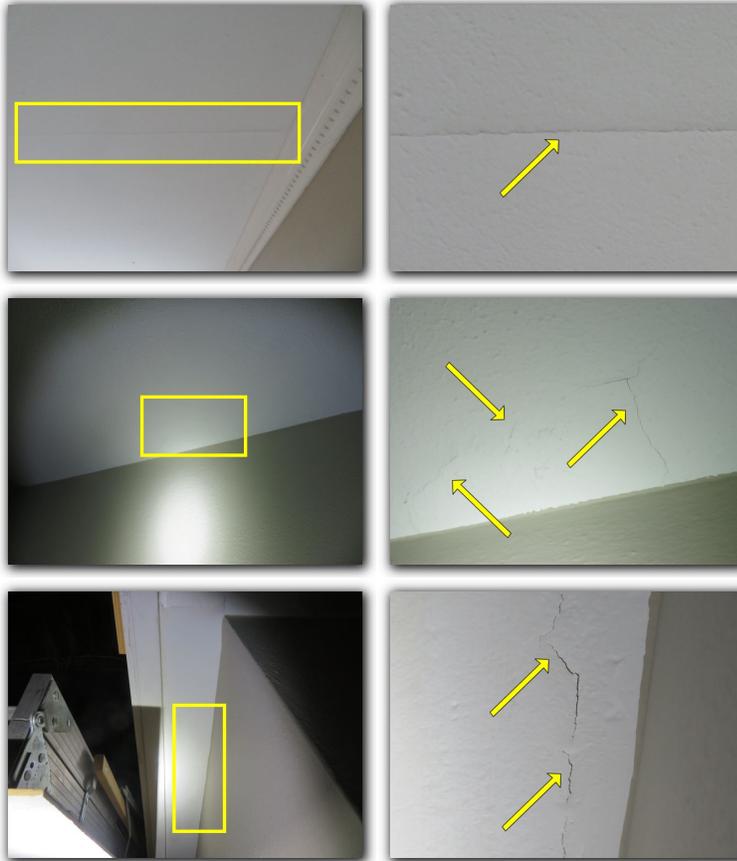
Typical cracks were observed on the ceiling of multiple rooms.

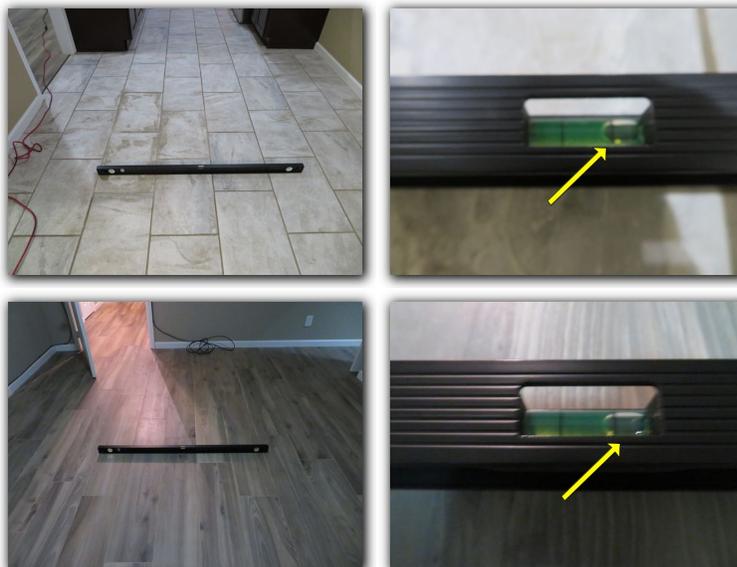
Uneven floor was observed in the Breakfast Area, and, Bedroom 1.

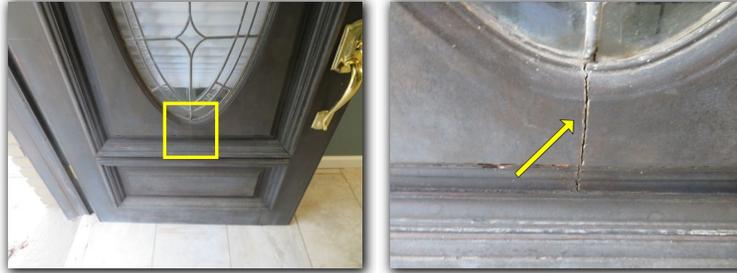
A crack was observed in the front door.

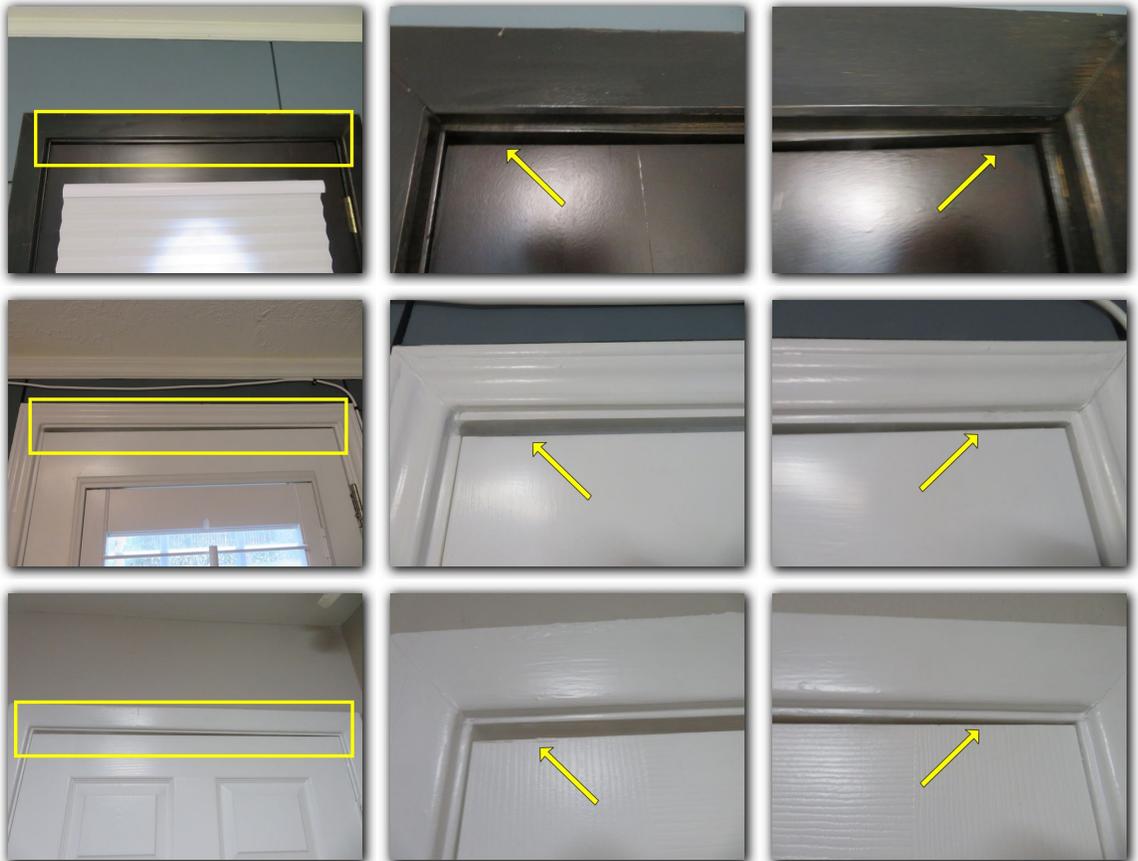
Multiple doors were observed to be out-of-square. This may be an indication of structural movement, sub-standard installation or door hardware issues.

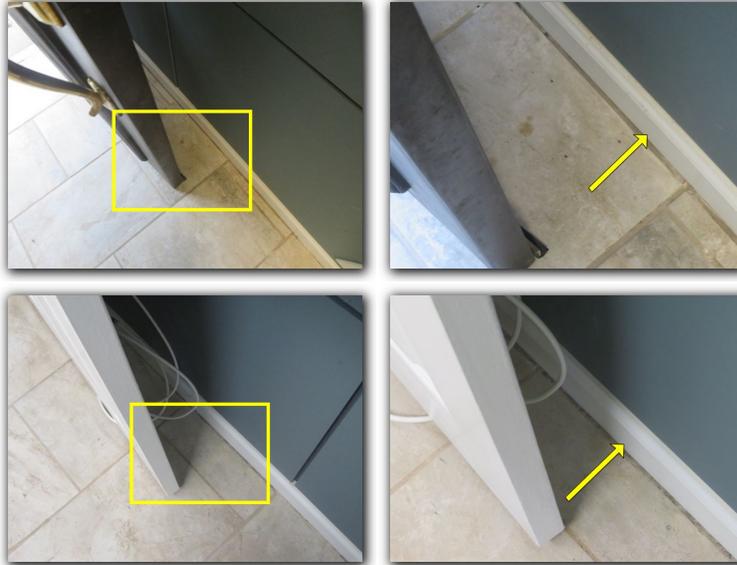
Door stoppers were observed to be missing in multiple rooms. The stoppers can be installed to reduce the risk of damage to the walls.

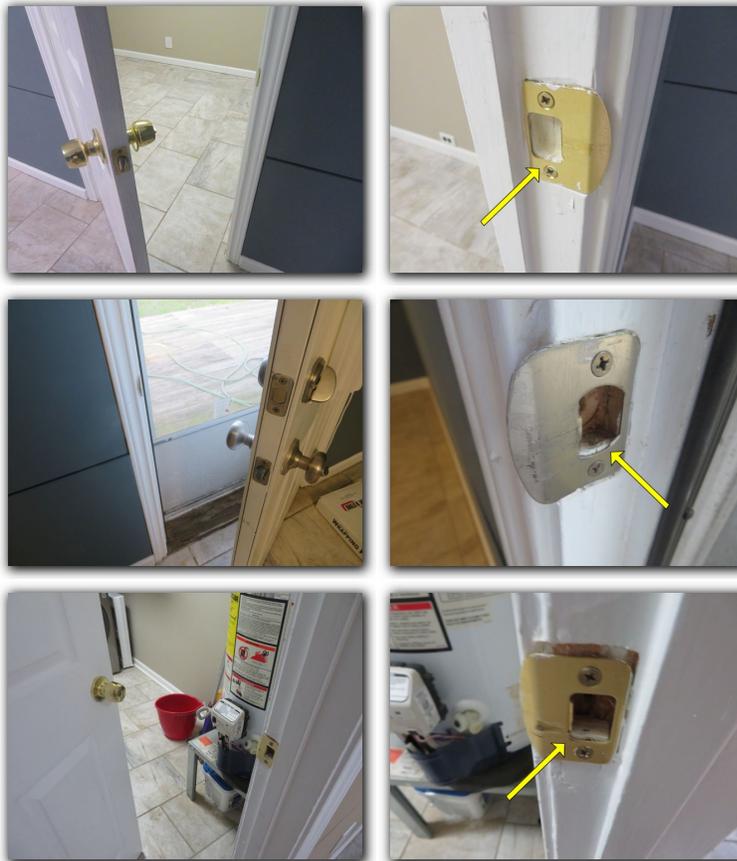
The door is not latching properly in multiple rooms. Door hardware can be repaired and/or replaced as needed for proper operation of the door.

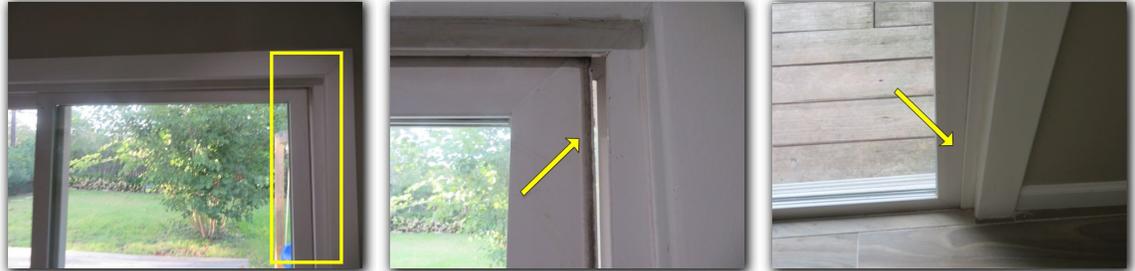
The back door was observed to be out of square. This may be an indication of structural movement or sub-standard installation. The door can be adjusted for proper operation of the door.

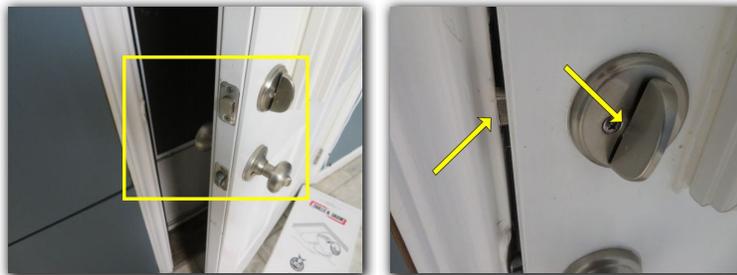
The latch bolt on the door lock is not latching in the strike plate in Backyard Door. Door hardware should be repaired and/or replaced as needed for proper operation of door and safety reasons.

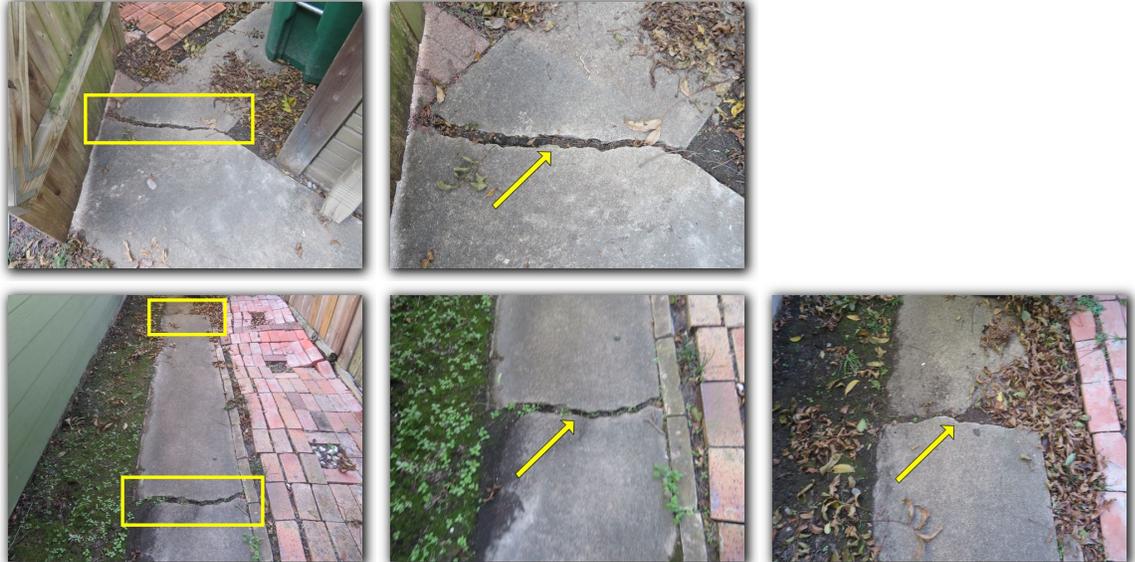
The walkway was observed to be cracked in multiple areas.

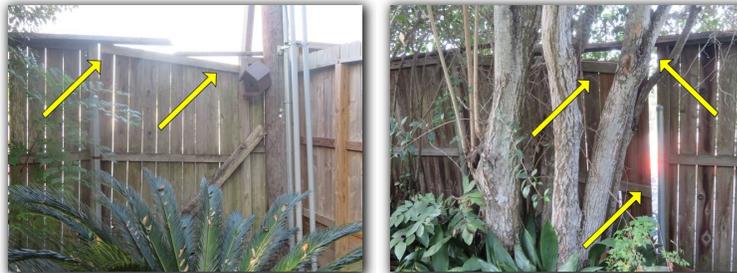
The fence was observed to be damaged at multiple areas.

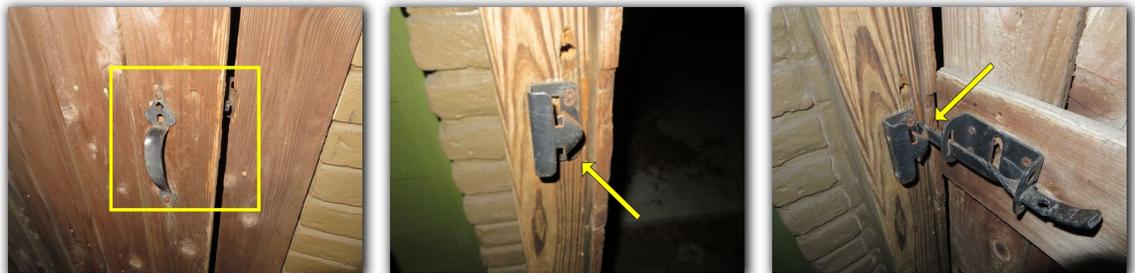
The gate on the fence was observed to have a broken latch. This can be repaired and/or replaced as needed.

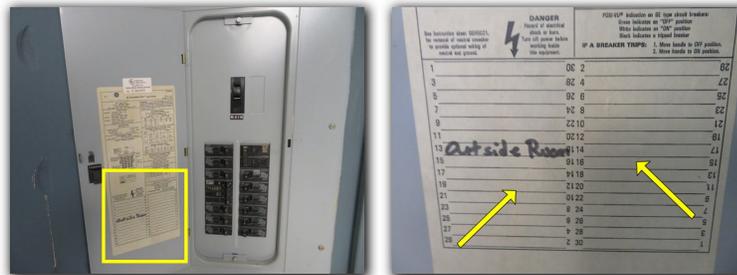
The main electrical service panel was observed to be not labeled. All circuit breakers should be identified with clearly marked labels so that in an emergency, individual circuits can be quickly shut off.

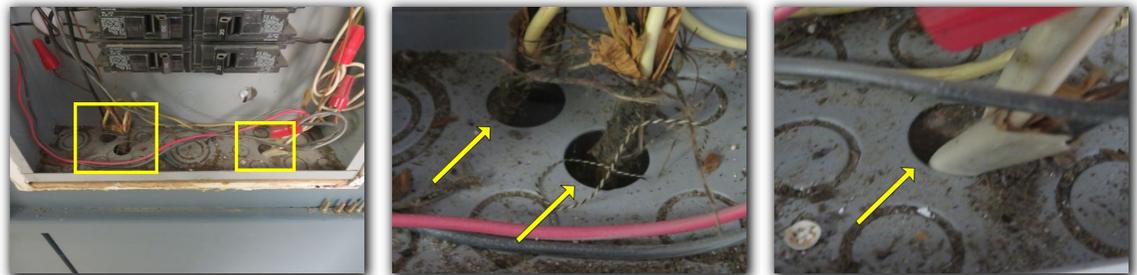
Bushing's and/or grommet's were observed to be missing in some panel knockouts. This should be corrected to reduce the risk of damage to the non-metallic conductor from the sheet metal sharp edge of the panel knockout.

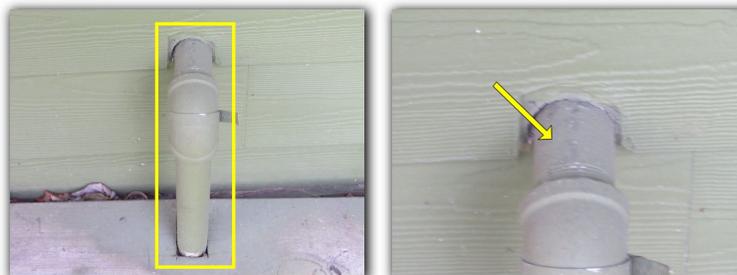
Gas pipes on the property were observed to be not bonded to the electrical system. Current electrical standards require that the gas pipes should be bonded to electrical system for safety reasons. This condition should be corrected by a qualified professional.

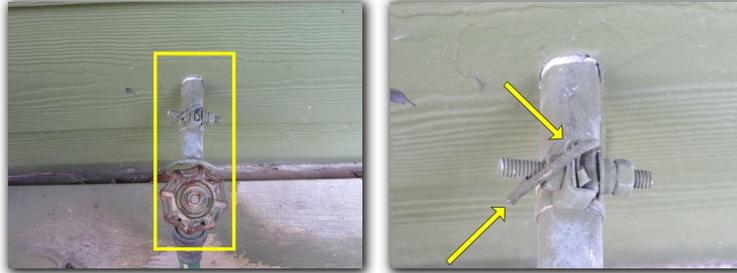
Water pipes on the property were observed to be not bonded to the electrical system. Current electrical standards require that the gas pipes should be bonded to electrical system for safety reasons. This condition should be corrected by a qualified professional.

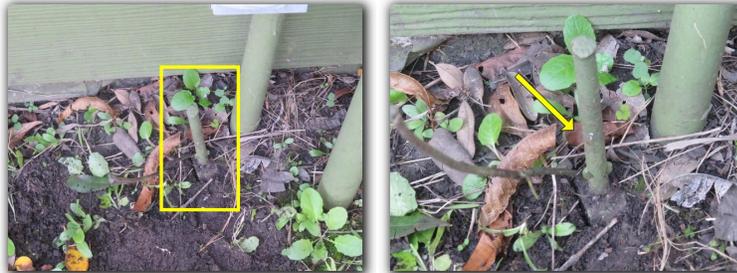
Only one grounding rod (grounding electrode) was observed on the property. Current building standards require installation of two grounding electrodes. The presence of a proper grounding electrode system should be verified or a proper grounding electrode system should be installed for safety. **This house predates the adoption of this standard; however, this should be corrected for safety reasons.**

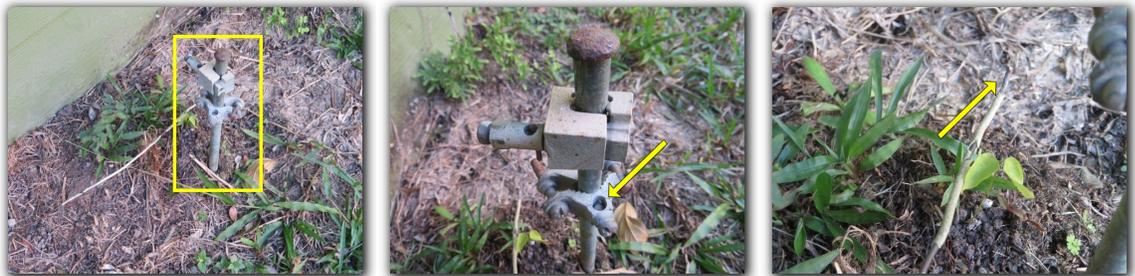
The grounding conductor was not connected to the grounding rod on the right side of the property. The purpose of this grounding rod should be evaluated by a qualified professional.

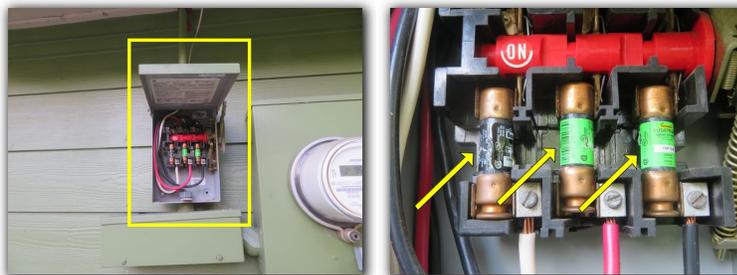
A disconnect containing fuses was observed next to the electric meter. The purpose and safety of this disconnect should be evaluated by a qualified professional.

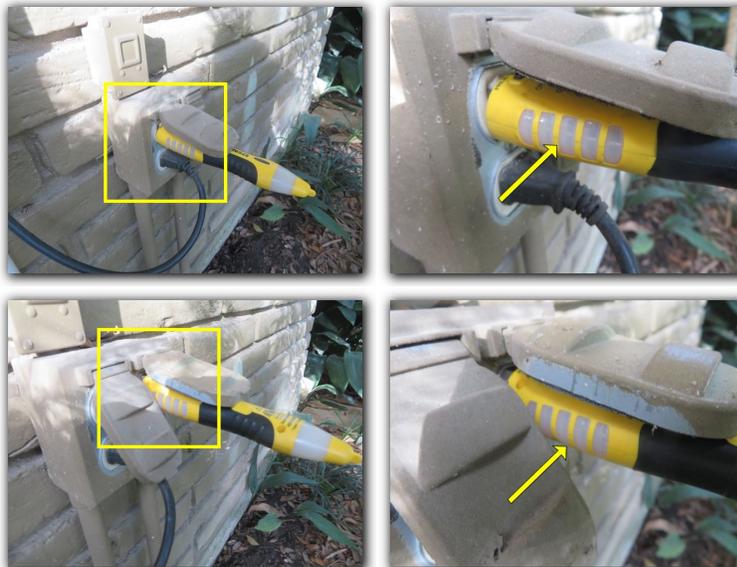
Multiple electrical receptacles/outlets were observed to be inoperative in the Exterior, and, Office. The circuit and/or outlet should be further evaluated, repaired and/or replaced as needed.

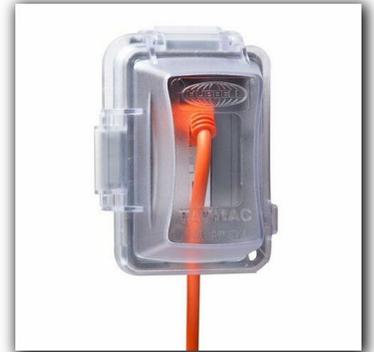
The outlets installed on the exterior were observed to be not compliant with the current electrical standards. Current electrical standards require for new construction and replacement outdoor outlet covers to be of the bubble cover type in all wet locations (being weatherproofed while outlet is in use). **This property predates the adoption of this standard; however, this should be corrected for safety reasons.**

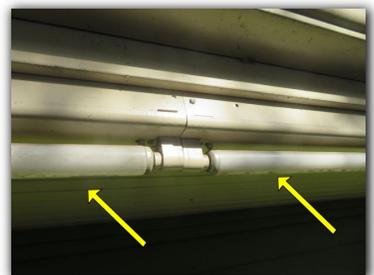
Multiple light fixtures installed on the soffit's in the exterior of the property were observed to be inoperative and/or missing the fluorescent lamps and light covers. This should be further evaluated by a qualified professional.

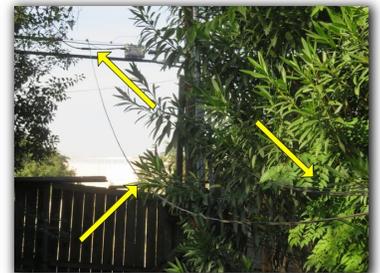
Multiple wires were observed in the back of the property having inadequate clearance from the ground. These wires should be further evaluated by a qualified professional to determine the purpose and safety.

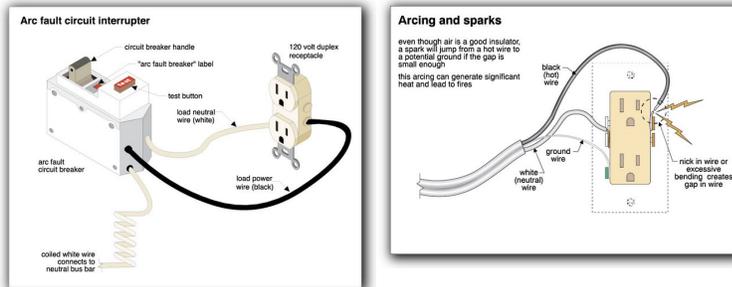
AFCI (Arc Fault Circuit Interrupter) protection was observed to be not installed to protect electrical circuits from arcing. Current building standards require AFCI protection for 15 and 20 amp circuits that serve outlets and devices in all areas of new residential construction, excluding bathrooms, garages, and outside areas. In addition to new construction, when receptacles are replaced in areas where AFCI protection is now required, the replacement receptacle must have AFCI protection. AFCI devices protect against fire by continuously monitoring the electrical current in a circuit and shutting off the circuit when unintended arcing occurs which can lead to high temperatures and sparking, possibly igniting combustibles. AFCIs can be installed as a circuit breaker in the main electrical panel or as a receptacle outlet. **This property predates the adoption of this standard; however, this should be corrected for safety reasons.**

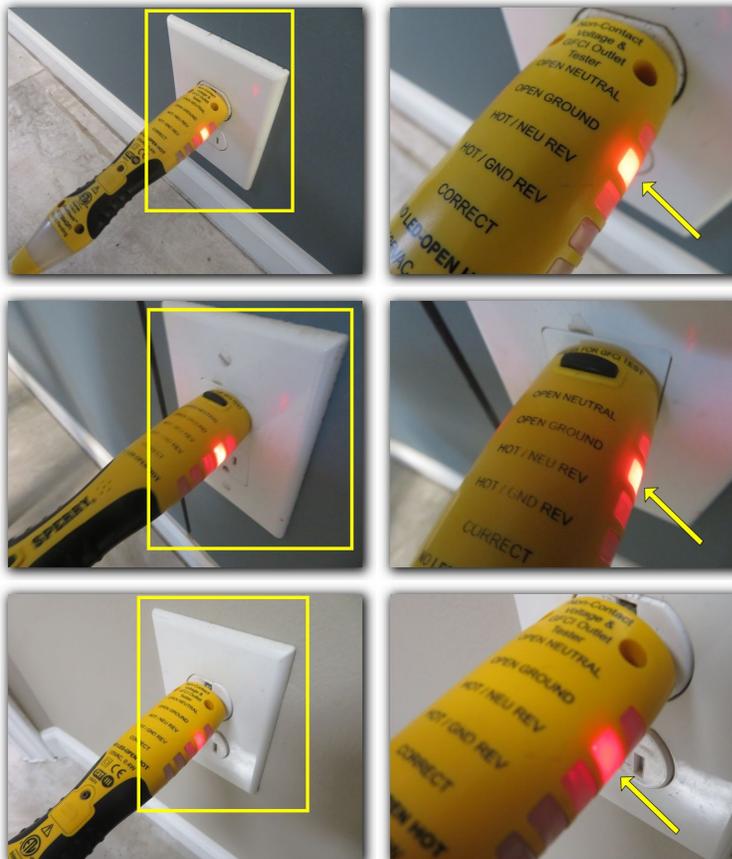
Receptacles were observed to have an open ground when tested in multiple rooms. All receptacles and circuits should be further evaluated, repaired and/or replaced by a qualified professional for safety reasons.

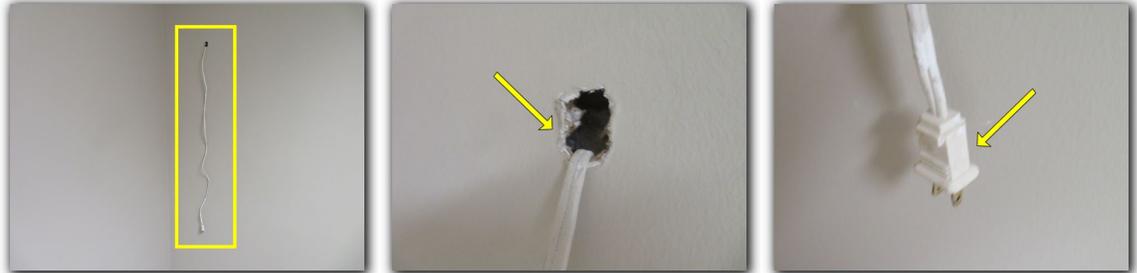
A cord was observed to be installed through the wall in the Office. This is not an approved method of installation.

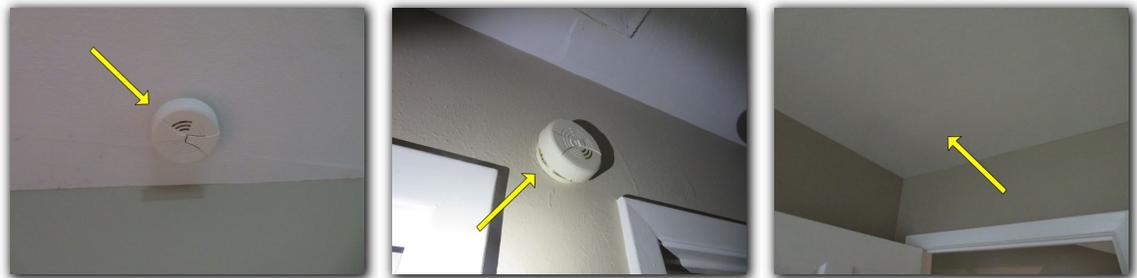
Smoke and Carbon Monoxide alarms were observed to be missing, disconnected and/or inoperative in multiple rooms.

These items should be installed, repaired and/or replaced for safety reasons.

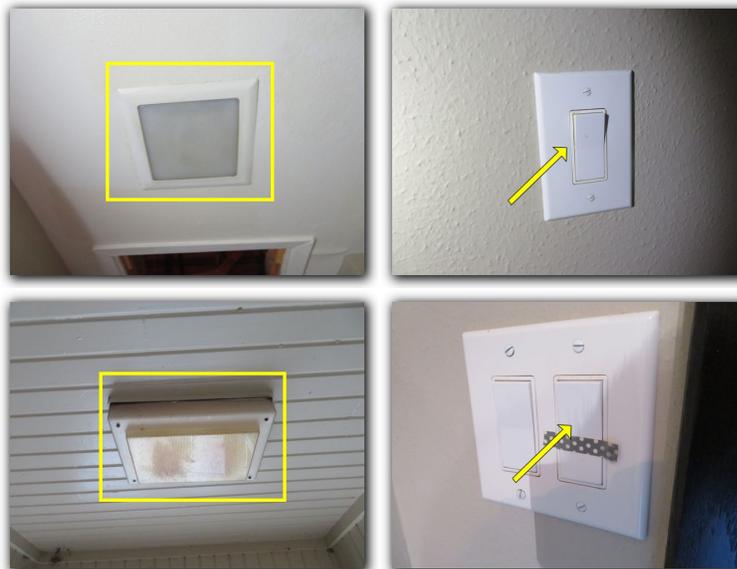
Light fixtures were observed to be inoperative in multiple rooms. This should be further evaluated, repaired and/or any burned out/missing light bulbs should be replaced as needed.

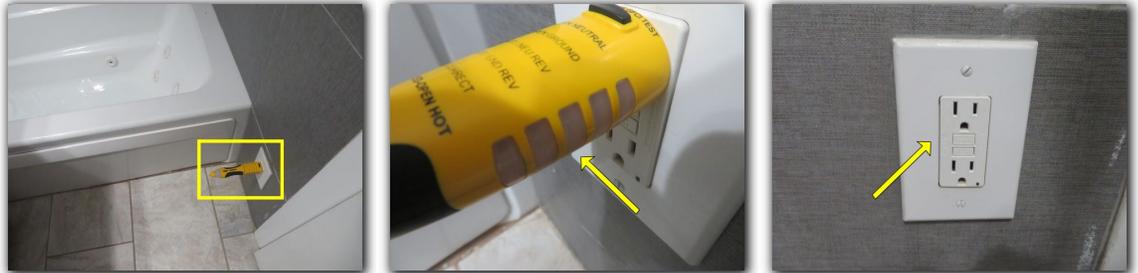
The GFCI (Ground Fault Circuit Interrupter) device serving the jetted whirlpool tub in the master bathroom was observed to be inoperative when tested. This should be corrected for safety reasons.

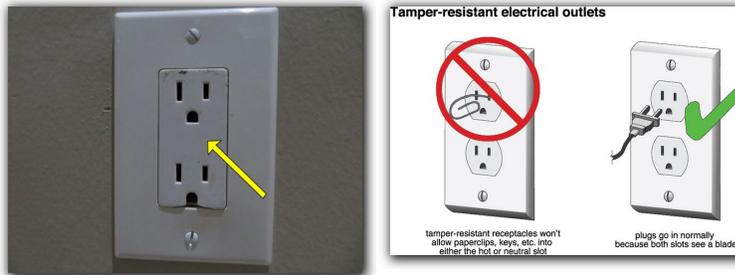
Tamper resistant receptacles were observed to be missing on the property. Current electrical standards require tamper resistant receptacles in new and renovated homes because it is the most effective way to prevent injuries associated with electrical receptacles, especially to children. **This property predates the adoption of this standard; however, this should be corrected for safety reasons.**

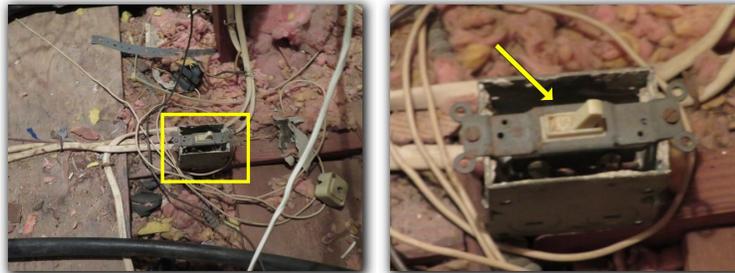
A cover plate was observed to be not installed in Attic. This should be corrected for safety reasons.

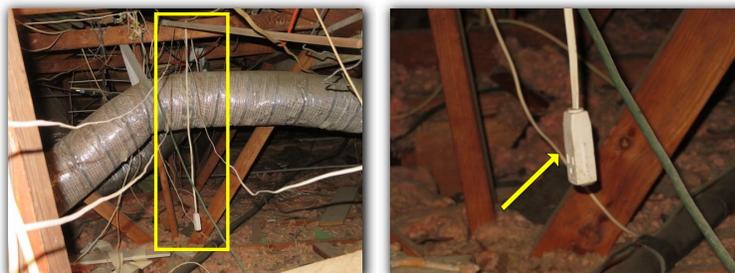
Extension cord wiring was observed in the Attic. Extension cords should not be used as permanent wiring.

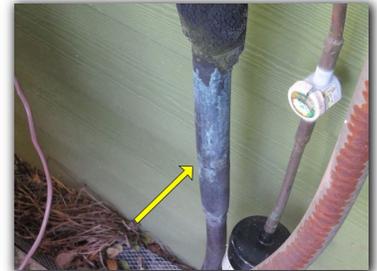
Insulation on the air-conditioning refrigerant (large, insulated) line was observed to be damaged at the compressor/condenser unit. It should be repaired and/or replaced by a qualified HVAC professional.

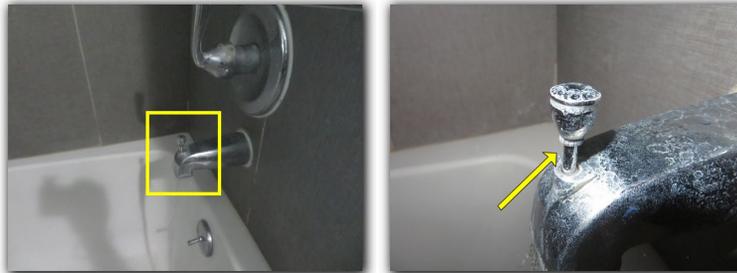
Diverter was observed to be inoperative in the Master Bathroom, and, Guest Bathroom. This can be repaired and/or replaced for comfort reasons.

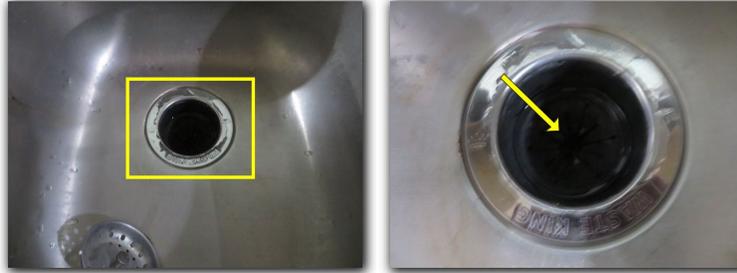
Debris was observed in the food waste disposer when tested. The debris should be removed before operating the food waste disposer to reduce the risk of damage.
