# Axis Real Estate Inspections

## PROPERTY INSPECTION REPORT

**Concerning:** 1234 Happy Trail, Fun City, TX 77777  
(Address or Other Identification of Inspected Property)

**By:** Amandeep (Andy) Punia, Lic #22380 06/27/2017  
(Name and License Number of Inspector) (Date)

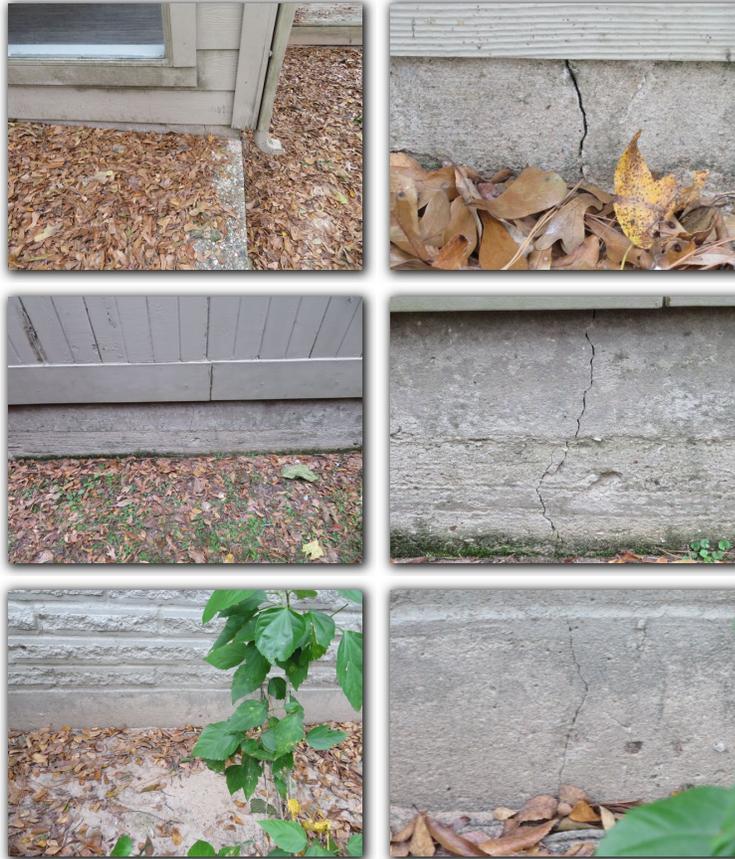
Shear cracks were observed on the foundation beam. This implies that structural movement of the building has occurred. The rate of movement cannot be predicted during one-time inspection and the cracks should be monitored. In the even the cracks continue, a foundation specialist should be consulted to further evaluate this condition and the remedies available for correction.

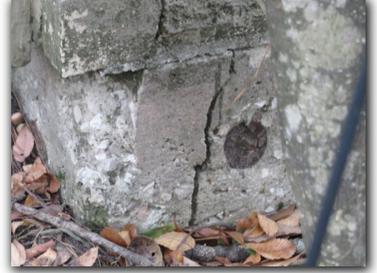
A corner pop was observed on the corner of the foundation. The rate of movement cannot be predicted during a one-time inspection. In the event the cracks and/or pops continue a structural specialist should be consulted to further evaluate this condition and the remedies available for correction.

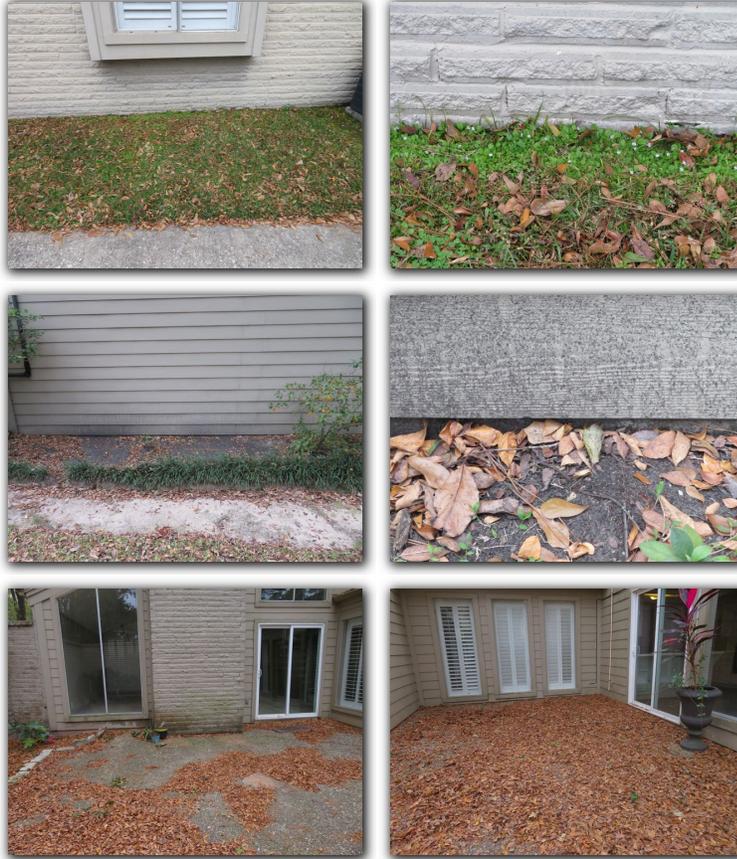
Foundation was not visible at multiple areas due to high soil, grass, and, patio. Building standards recommend minimum foundation exposure above the finished soil grade of at least 6 inches under wood siding and 4 inches under brick veneer.

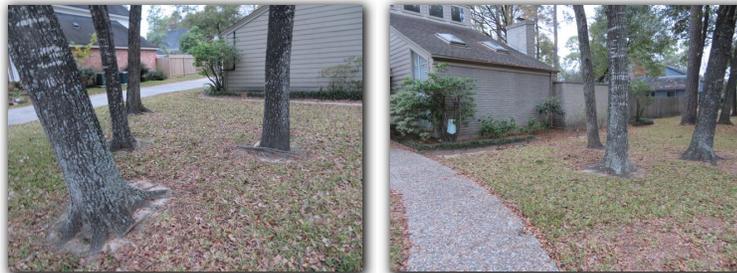
Roots from trees were observed near the foundation and may cause foundation damage as the tree grows and the root system expands. Monitor all areas of the foundation in close proximity to the trees for signs of damage. If signs of damage appear (such as cracks), the tree and/or the roots may need to be removed. The potential for damage from tree roots varies with tree species.

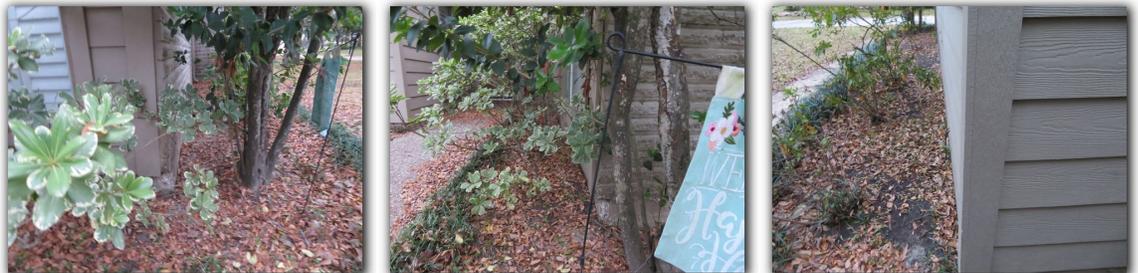
Areas of neutral and/or negative drainage that will route runoff from rain toward the foundation were observed on the property. The grading can be improved to promote the flow of storm water away from the house. The ground should slope away from the house a minimum of 6 inches within the first 10 feet or to a swale if 10 feet is not available.

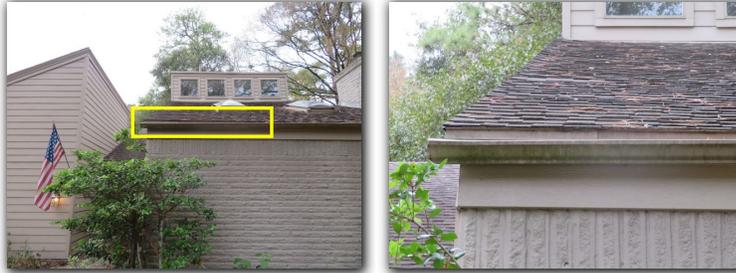
A gutter in the front of the property was observed to be not level and/or loose and draining water away from the downspout.

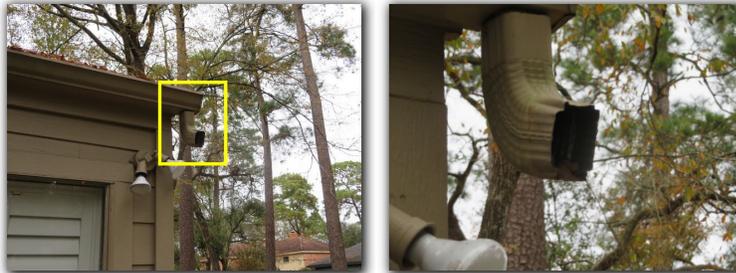
A downspout was observed to be missing on the right side of the property.

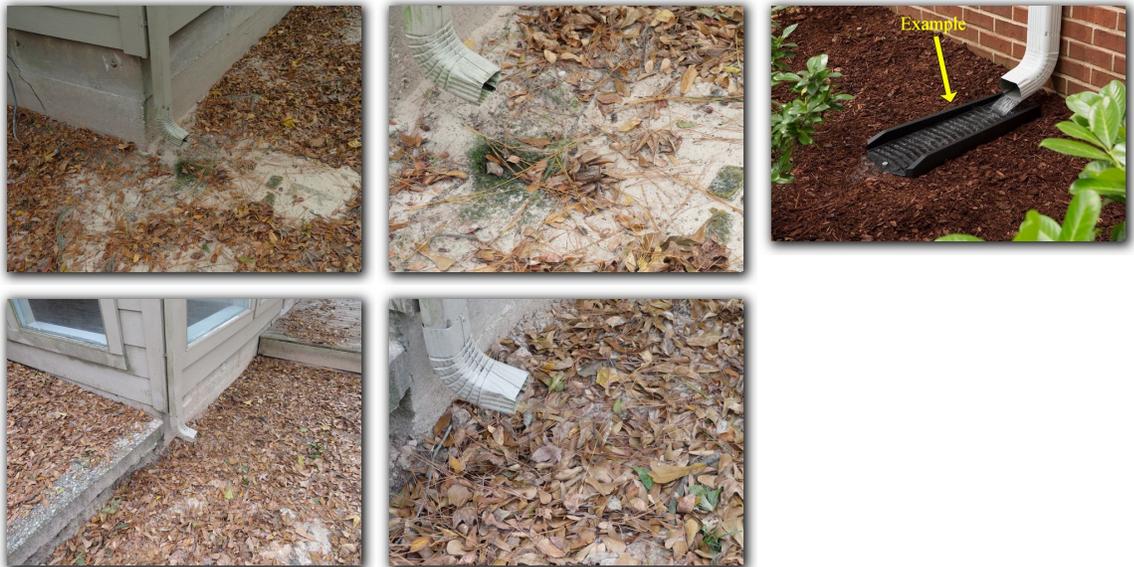
Splash blocks were observed to be missing under multiple downspouts. Splash blocks can be added to prevent soil erosion and for proper drainage of rain water. Rain water should flow away from the structure at the points of discharge, at least 3 feet away from the foundation.

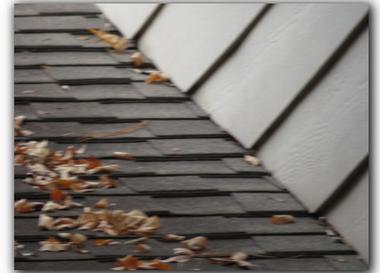
Inadequate clearance was observed between the wood siding and roof of the house. Current building standards recommend a minimum of 2 inches of clearance in the area where siding is in close proximity to the roof. This is a potential area for wood rot due to exposure to rain water.

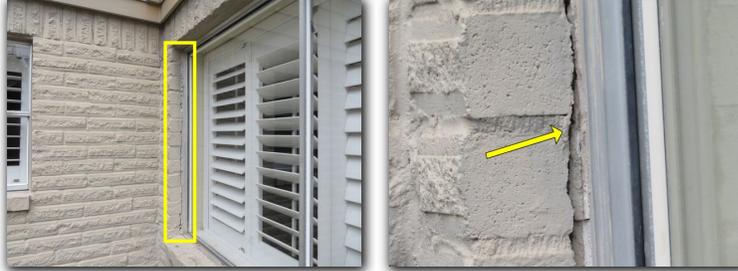
Separation was observed between the window and siding. All separations and/or gaps around the windows should be sealed to reduce the risk of water intrusion.

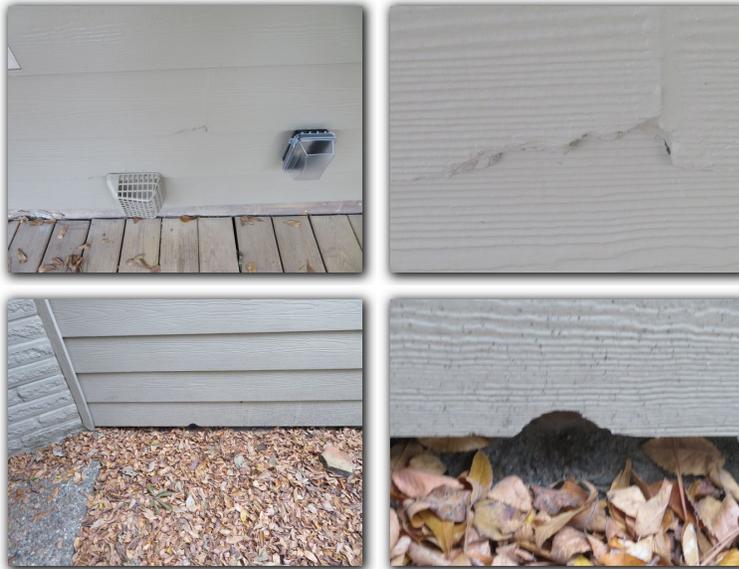
Damage was observed on the siding.

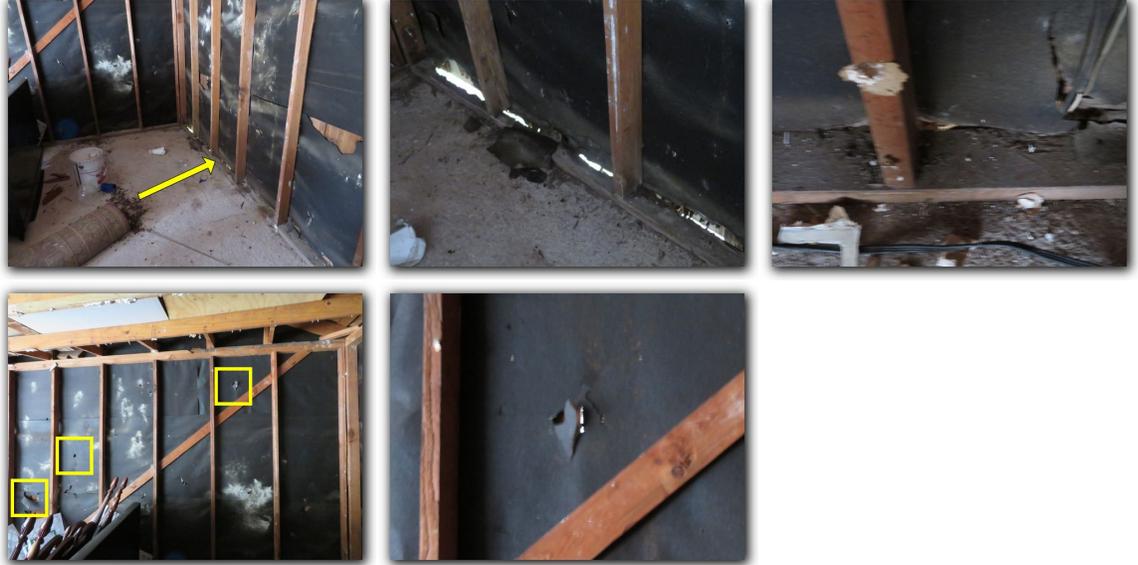
Multiple gaps and/or holes were observed in the siding in the Garage. All gaps and/or holes should be sealed to reduce the risk of water intrusion and wood destroying insect entry.

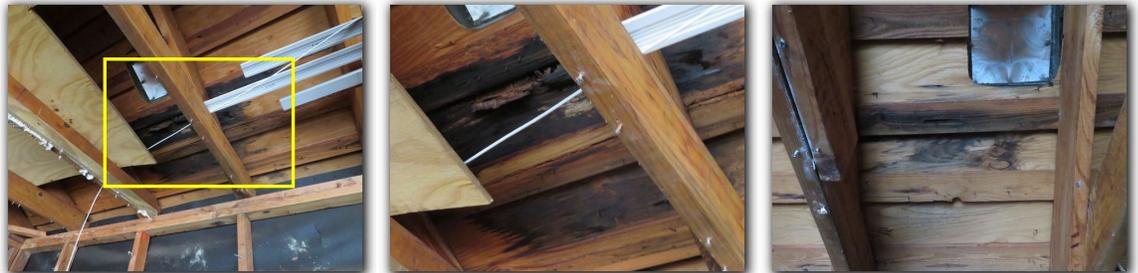
Evidence of prior damage was observed on the ceiling of the Garage.

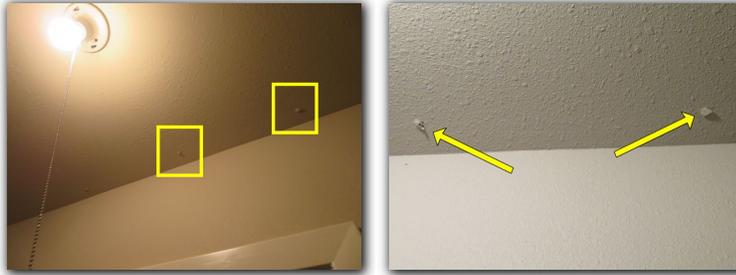
Nail pops were observed on the ceiling of the Bathroom 2 Closet.

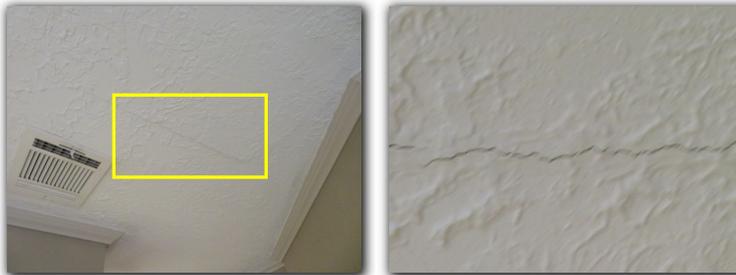
Typical ceiling crack was observed in the Breakfast Area.

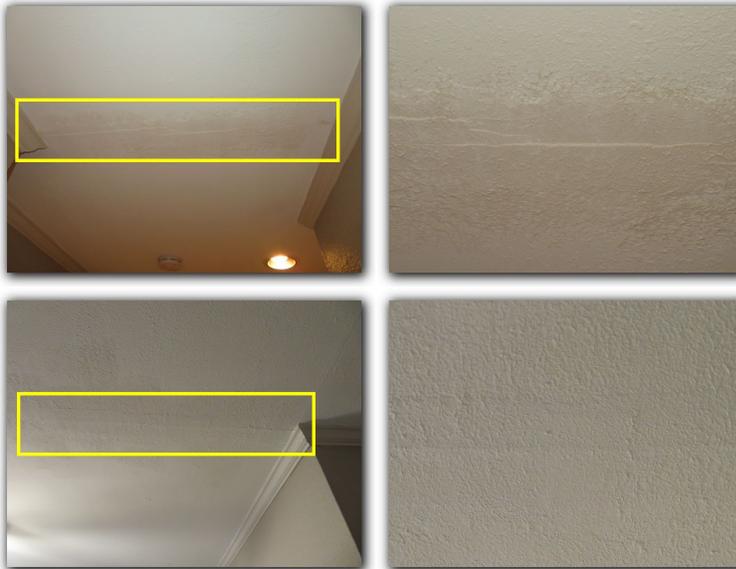
Evidence of prior repairs was observed on the ceiling of the Hallway, and, Bedroom 3.

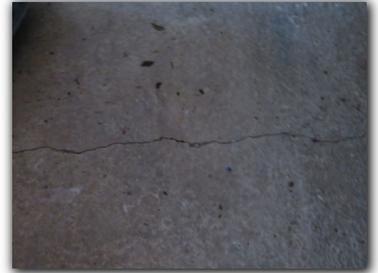
Typical cracks were observed in the Garage floor. This condition is very common and is not a structural concern.

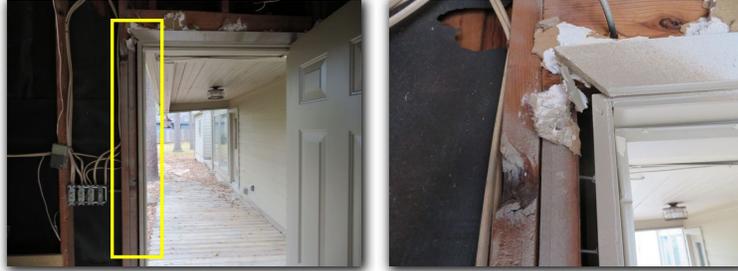
The door frame was observed to be damaged in the Garage. This can be repaired to prevent further damage to the frame.

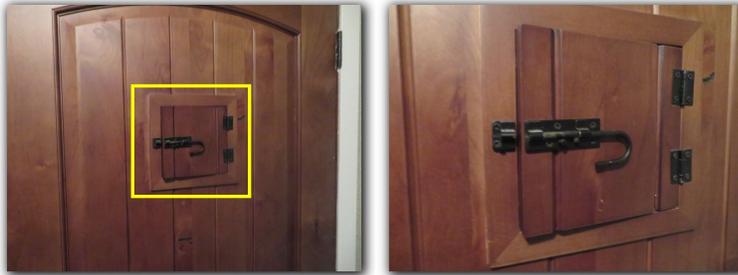
The window in the front door was observed to be inoperative.

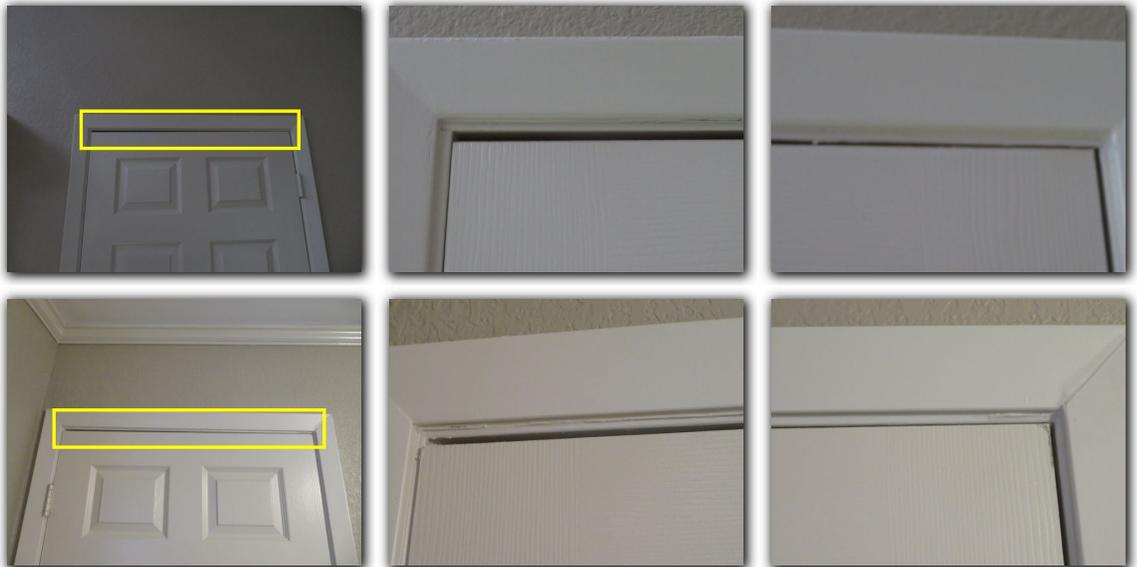
Multiple doors were observed to be out-of-square. This may be an indication of structural movement, sub-standard installation or door hardware issues.

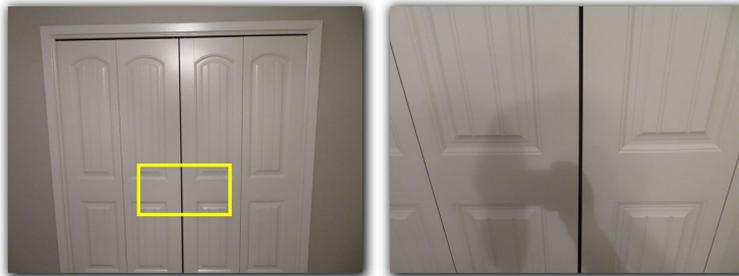
Door knob was observed to be missing on the Bedroom 1 Closet door.

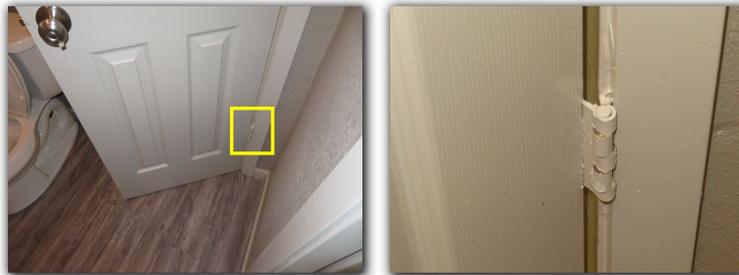
The hinge was observed to be loose on the door in the Jack & Jill Bathroom. This can be improved for proper operation of the door.

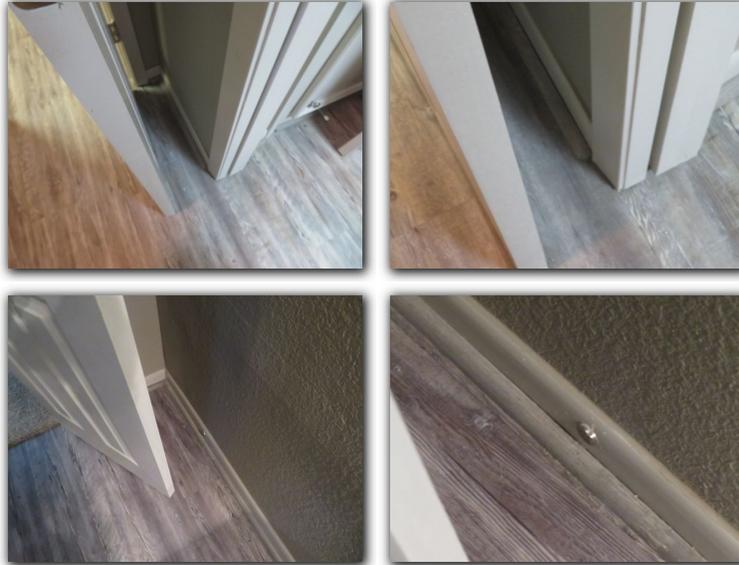
Door stopper was observed to be not installed in the Jack & Jill Bathroom, and, Master Bathroom. All missing stoppers can be installed to reduce the risk of damage to the wall.

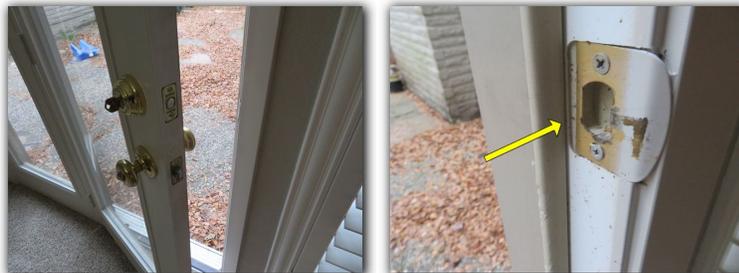
The door is not latching properly in the Master Bathroom. Door hardware can be repaired and/or replaced as needed for proper operation of the door.

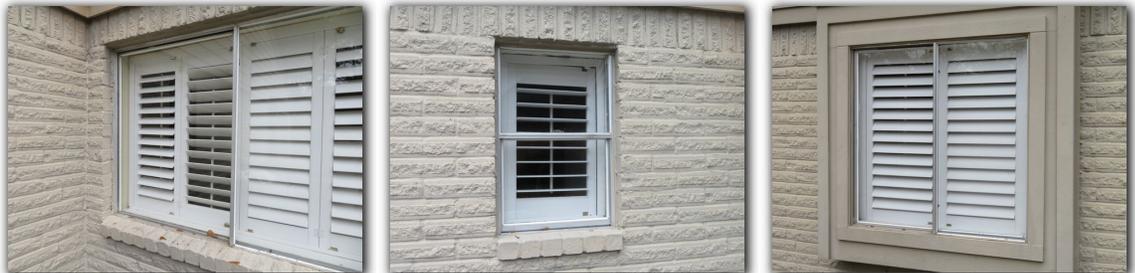
Screens were observed to be missing on multiple windows.

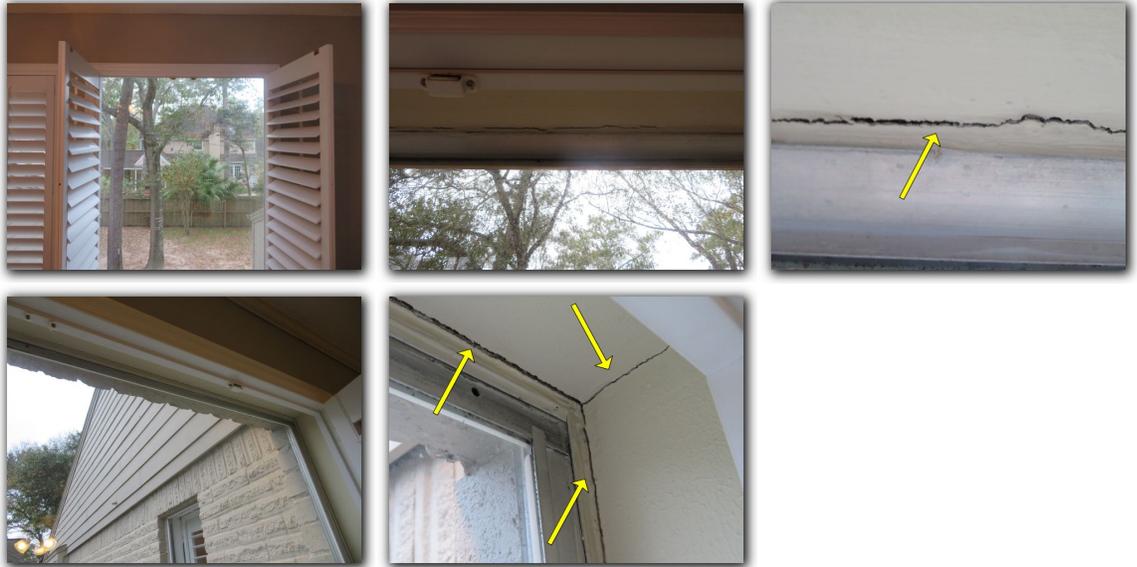
Separation and/or cracks were observed around windows in multiple rooms.

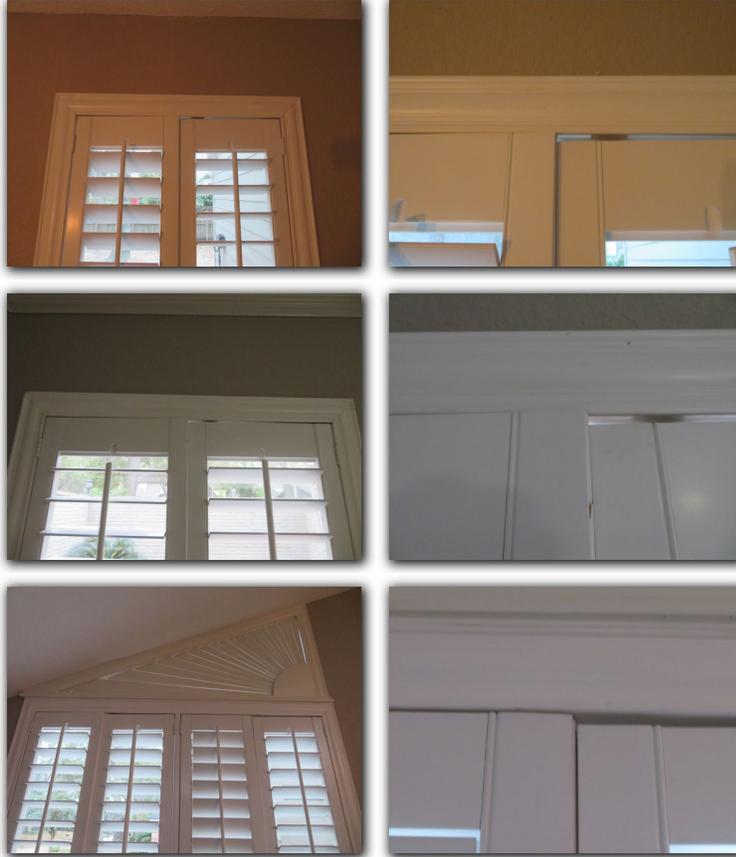
Multiple windows were observed to be out-of-square. This may be an indication of structural movement, sub-standard installation or door hardware issues.

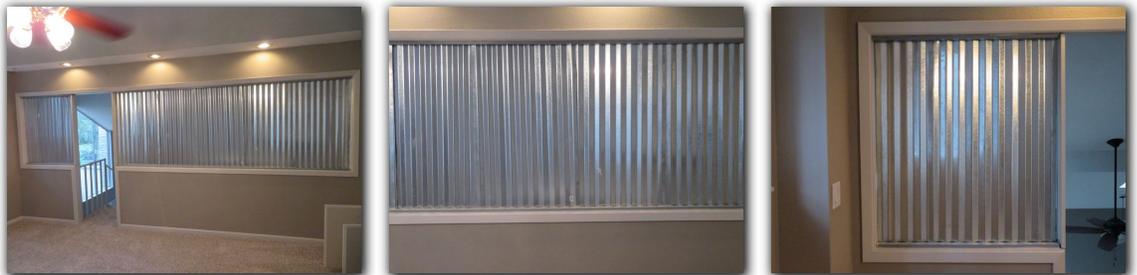
Windows in Second Floor Bedroom were observed to be permanently closed with siding.

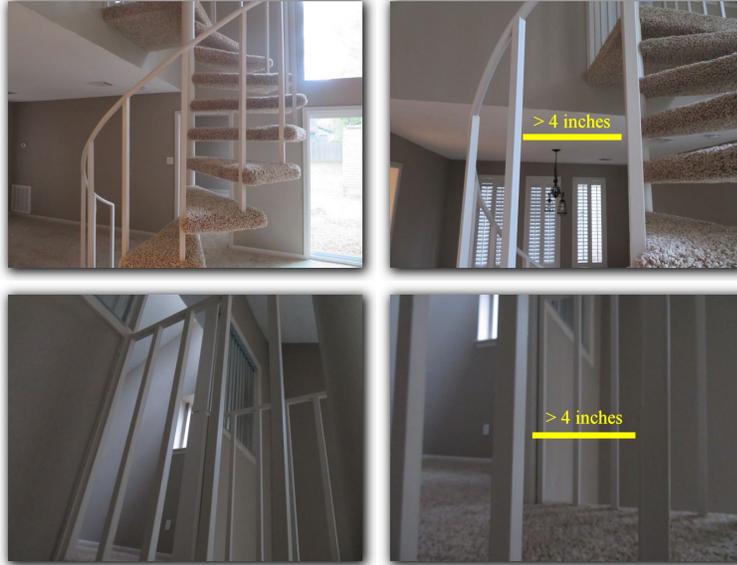
The stairway stair rail and guardrail vertical guards and/or ornamental closures were observed to be installed too far apart. Current building standards require that the stair rails and guardrail's on open sides of stairways, raised floor areas of balconies, decks and porches should have vertical guards and/or ornamental closures which do not allow passage of an object 4 inches in diameter.

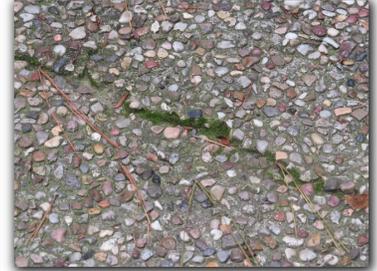
Cracks were observed in the patio floor.

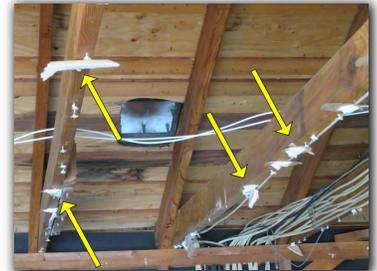
Incomplete ceiling and wall repairs were observed in the Garage.

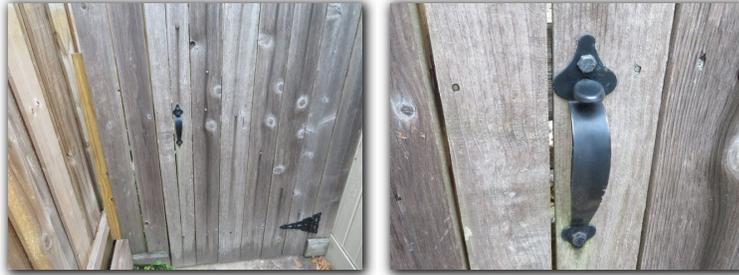
The latch on the fence gate was observed to be inoperative.

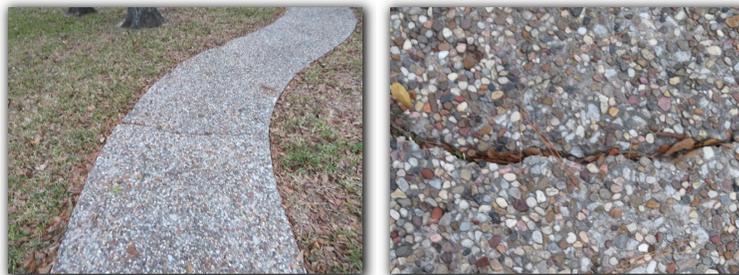
Crack was observed in the walkway.

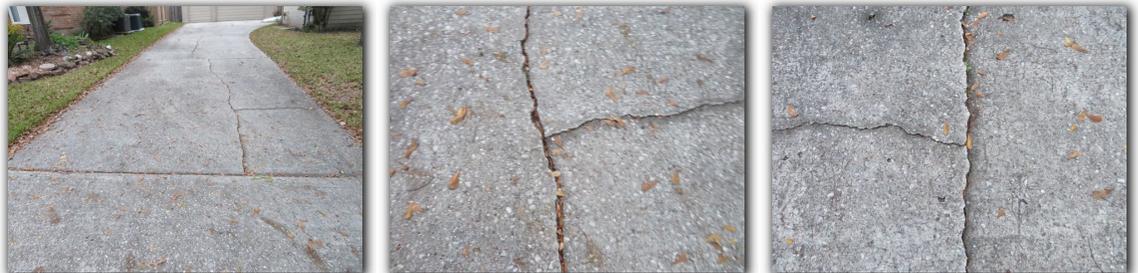
Cracks were observed in the driveway.

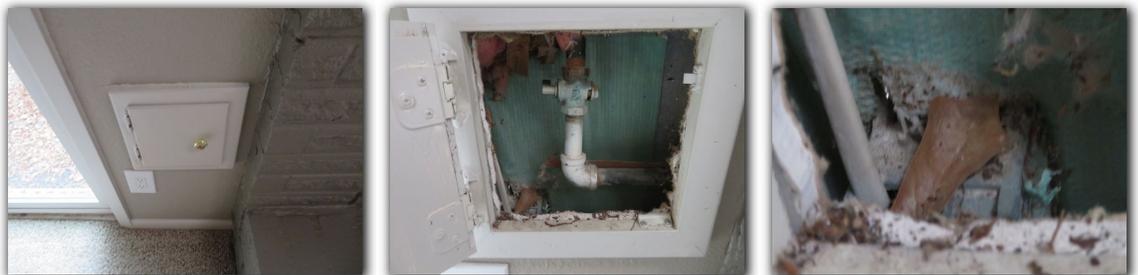
Debris from exterior was observed in the gas shutoff valve box.

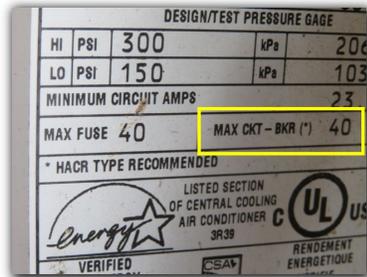
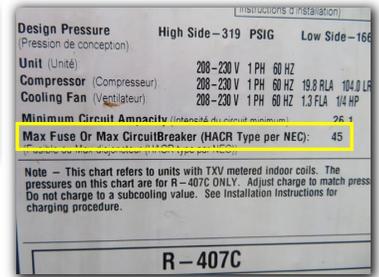
The electrical panel breakers for the air conditioning compressor condenser units were observed to be oversized. Manufacturer recommends that the electrical panel breaker size should match the size on the equipment manufacturer data plate.

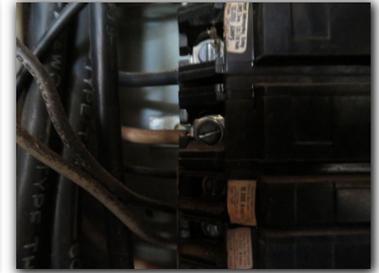
Multiple white (neutral) wires were observed to be used as a hot wires in the electrical panel. These wires should be marked with black or red colored tape for proper identification and safety reasons.

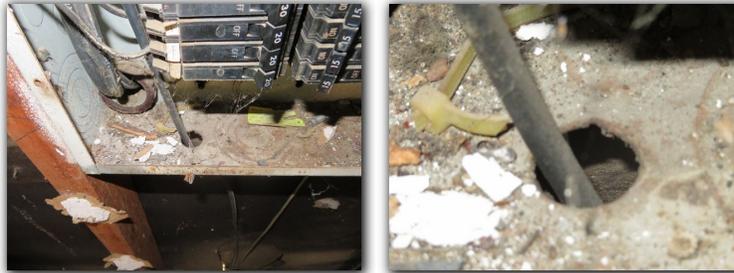
A bushing and/or grommet was observed to be missing in a panel knockout. This should be corrected to reduce the risk of damage to the non-metallic conductor from the sheet metal sharp edge of the panel knockout.

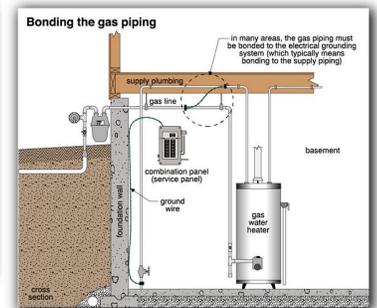
Gas and water pipes on the property were observed to be not bonded to the electrical system. Current building standards require that the gas and water pipes should be bonded to electrical system. This condition should be corrected by a qualified professional for safety reasons.

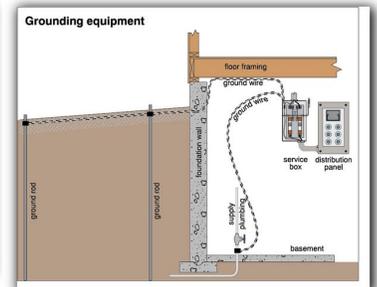
Only one grounding rod (grounding electrode ) was observed on the property. Current building standards require installation of two grounding electrodes. The presence of a proper grounding electrode system should be verified or a proper grounding electrode system should be installed for safety. **This house predates the adoption of this standard; however, this should be corrected for safety reasons.**

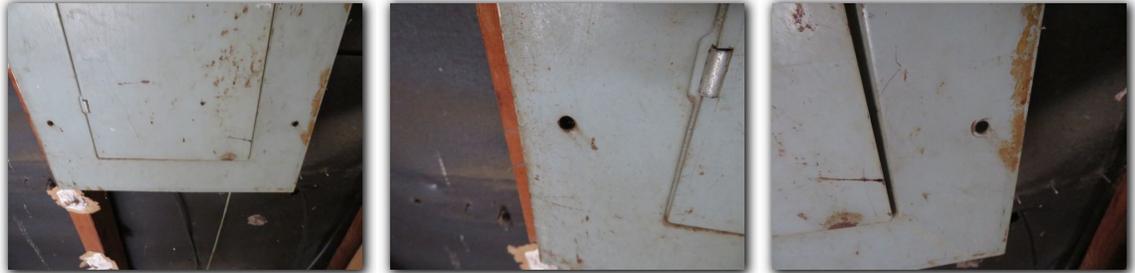
The electrical panel dead front was missing multiple mounting screws.

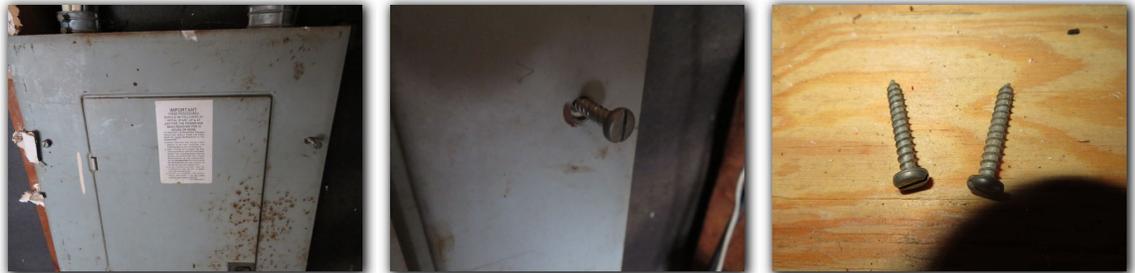
The electrical panel screws were observed to be replaced with sharp pointed sheet metal screws. These screws are unsafe and can pierce and/or damage the panel wiring. These should be replaced for safety reasons.

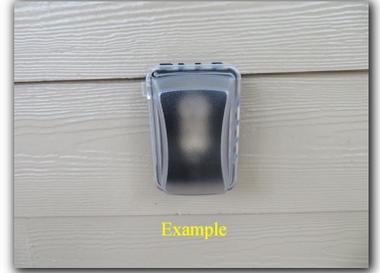
The outlets installed on the exterior were observed to be not compliant with the current electrical standards. Current electrical standards require for new construction and replacement outdoor outlet covers to be of the bubble cover type in all wet locations (being weatherproofed while outlet is in use). **This house predates the adoption of this standard; however, this should be corrected for safety reasons.**

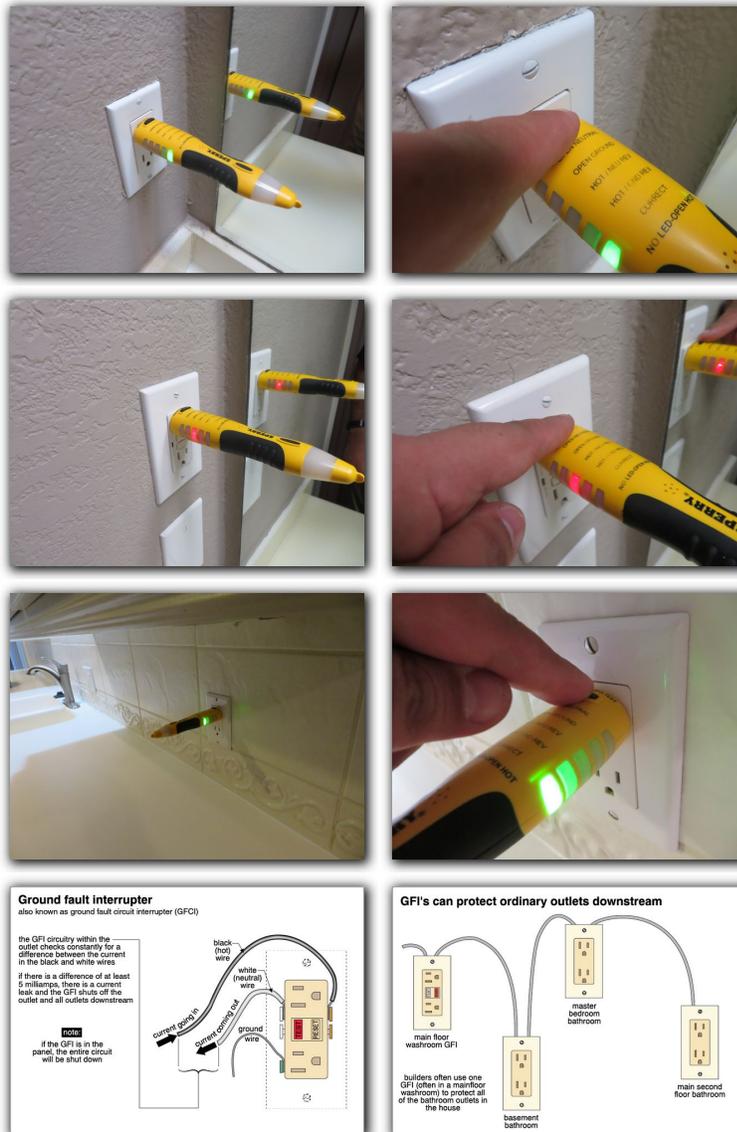
GFCI (Ground Fault Circuit Interrupter) protection was observed to be not installed to protect electrical circuits from ground faults. Current building standards require GFCI protection for 15 and 20 amp receptacles in kitchens, bathrooms, outdoor areas, unfinished basements and crawl spaces, garages, boathouses, laundry areas, and within 6' of sinks, bathtubs and shower stalls. GFCI protection is also required for certain appliances that have a history of being a shock hazard such as dishwashers and food waste disposers etc. GFCI devices can greatly reduce the risk of shock by immediately shutting off an electrical circuit when that circuit represents a shock hazard (i.e., a person comes in contact with a faulty appliance together with a grounded surface). GFCI devices can be installed as a circuit breaker in a panel or as a receptacle outlet. **This property predates the adoption of this standard; however, this should be corrected for safety reasons.**

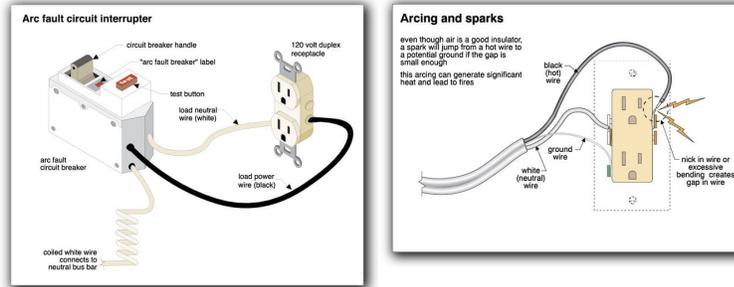
AFCI (Arc Fault Circuit Interrupter) protection was observed to be not installed to protect electrical circuits from arcing. Current building standards require AFCI protection for 15 and 20 amp circuits that serve outlets and devices in all areas of new residential construction, excluding bathrooms, garages, and outside areas. In addition to new construction, when receptacles are replaced in areas where AFCI protection is now required, the replacement receptacle must have AFCI protection. AFCI devices protect against fire by continuously monitoring the electrical current in a circuit and shutting off the circuit when unintended arcing occurs which can lead to high temperatures and sparking, possibly igniting combustibles. AFCIs can be installed as a circuit breaker in the main electrical panel or as a receptacle outlet. **This property predates the adoption of this standard; however, this should be corrected for safety reasons.**

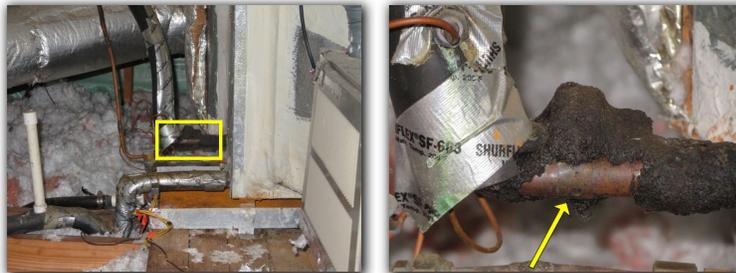
Damaged and/or missing insulation on the refrigerant line was observed at the evaporator coil unit in the attic. The cold copper tubing in contact with warm humid air causes moisture in the air to condense and then drip off of the refrigerant line. This should be repaired and/or replaced to reduce the risk of moisture intrusion.

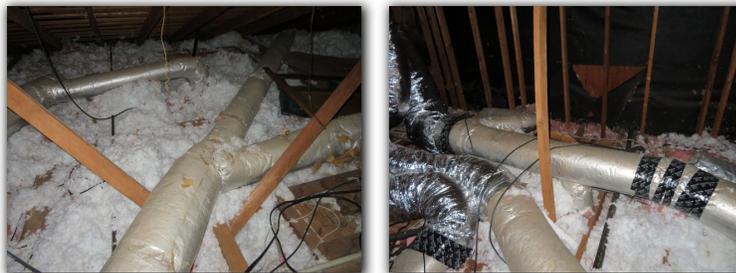
Several ducts were observed to be lying on insulation on the attic floor. Current building standards recommend that the ducts should be properly strapped above attic insulation at 4 foot intervals and hung from the rafters.

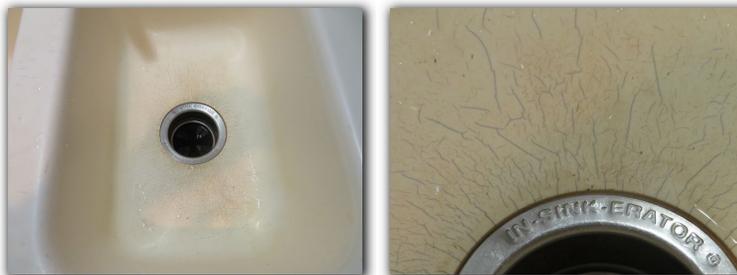
Cracks were observed on the sink in Kitchen, and, Master Bathroom. No leaks were observed under the sink.

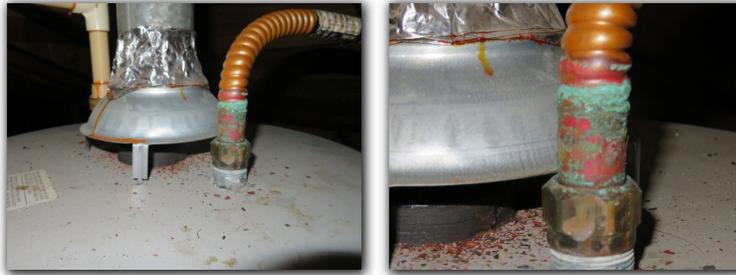
Corrosion was observed on the piping connected to the water heater.

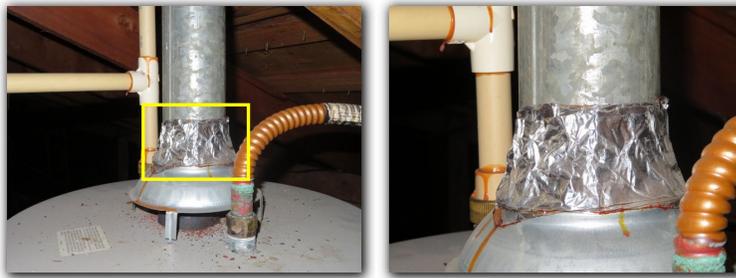
Foil was observed to be wrapped around the water heater vent flue. This is not an approved and recommended method of installation and repair.
