## PROPERTY INSPECTION REPORT

**Prepared For:** Jack William  
(Name of Client)

**Concerning:** 1234 Happy Avenue, Fun City, TX 77777  
(Address or Other Identification of Inspected Property)

**By:** Amandeep (Andy) Punia, Lic #22380 04/27/2017  
(Name and License Number of Inspector) (Date)

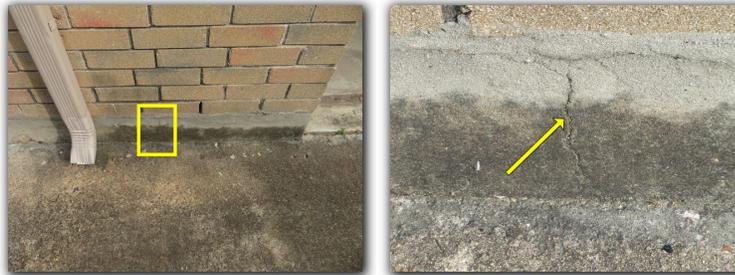
A shear crack was observed on the back of the foundation and is not a structural concern. This implies that structural movement of the building has occurred. The rate of movement cannot be predicted during one-time inspection and the crack should be monitored. In the even the crack continues a foundation specialist should be consulted to further evaluate this condition and the remedies available for correction.

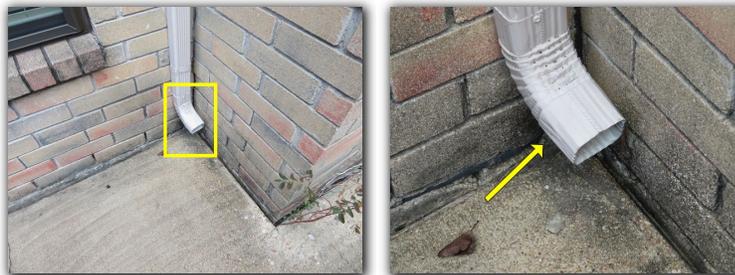
The downspout was observed to be discharging the rain water next to the foundation on the front of the property. Storm water should flow away from the structure at the points of discharge, at least 3 feet away from the foundation.

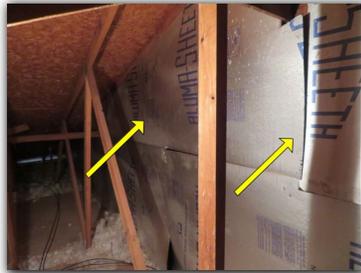
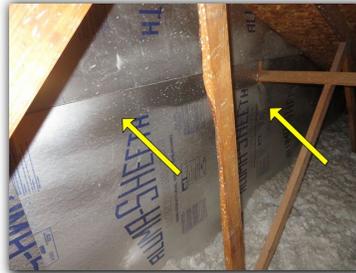
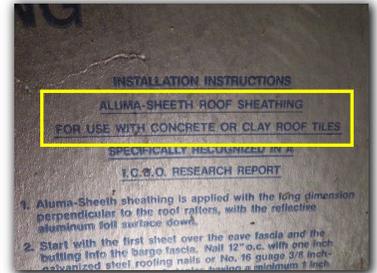
Fire-resistant-rated wall was observed to be missing on the right side in the attic. Current building standards require that the fire-resistance-rated wall assembly separating townhouses shall be continuous from the foundation to the underside of the roof sheathing, roof deck, or roof slab. The fire-resistance rating shall extend the full length of the wall or assembly, including wall extensions through and separating attached enclosed accessory structures. The separation shall extend through enclosed soffit's, overhangs, and similar projections. This should be corrected for fire safety reasons.

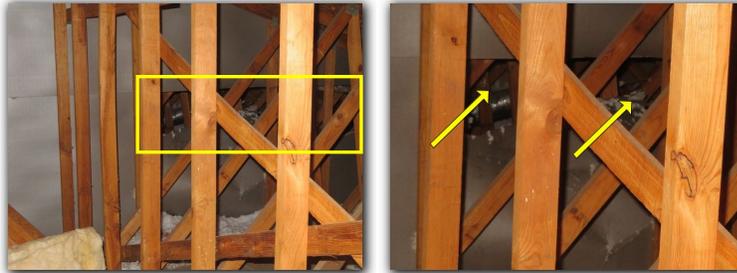
An opening was observed in the wall on the left side in the attic. Current building standards require that the fire-resistance-rated wall assembly separating townhouses shall be continuous from the foundation to the underside of the roof sheathing, roof deck, or roof slab. The fire-resistance rating shall extend the full length of the wall or assembly, including wall extensions through and separating attached enclosed accessory structures. The separation shall extend through enclosed soffit's, overhangs, and similar projections. This should be corrected for fire safety reasons.

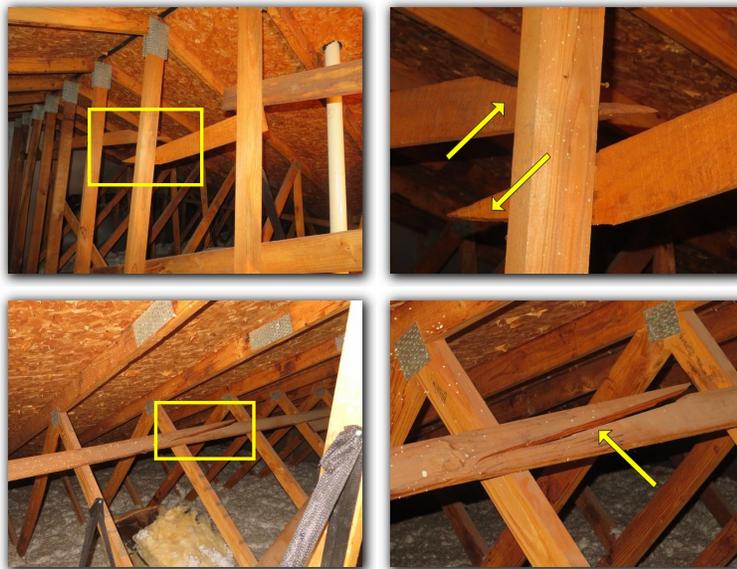
A frame brace was observed to be cracked in the attic. This should be reinforced to provide adequate strength and support to the roof framework.

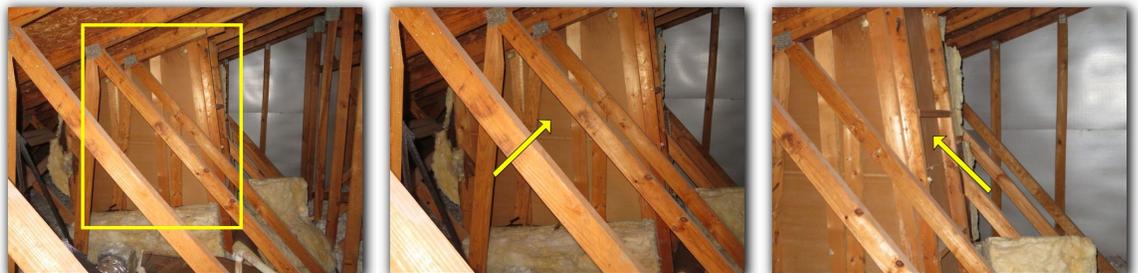
The insulation was observed to be partially missing around the skylight shaft. This should be improved or additional insulation should be installed as needed.

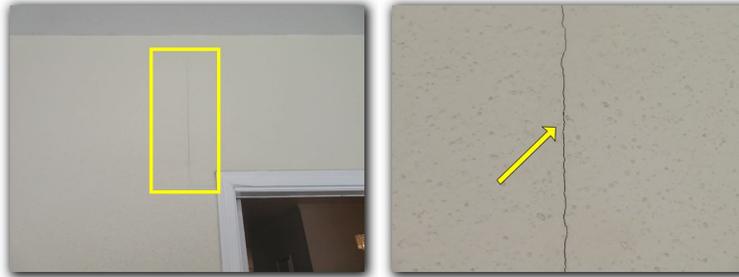
Typical crack was observed on the wall of the Garage. This condition is very common and is not a structural concern.

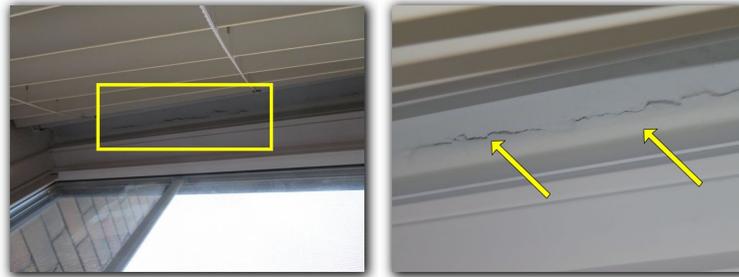
Paint damage was observed on the wall of window in the Den.

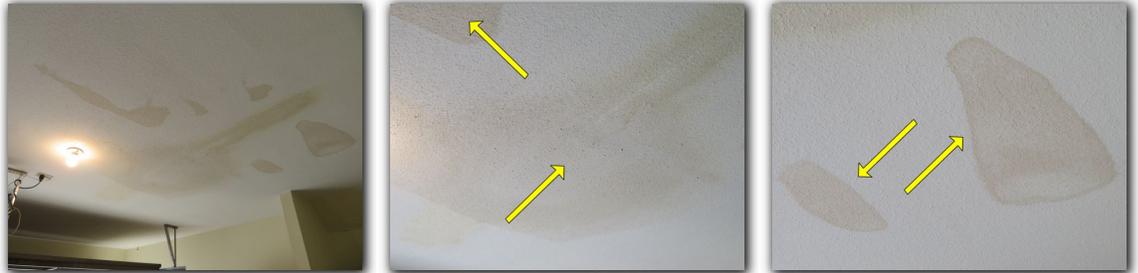
Multiple moisture stains were observed on the ceiling of the Garage. This should be further evaluated to determine the cause and condition.

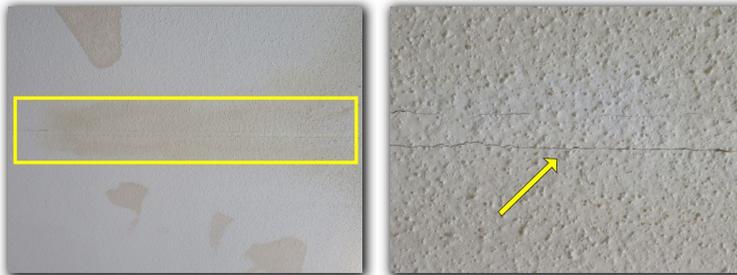
Typical ceiling cracks were observed in the Garage. This condition is very common and is not a structural concern.

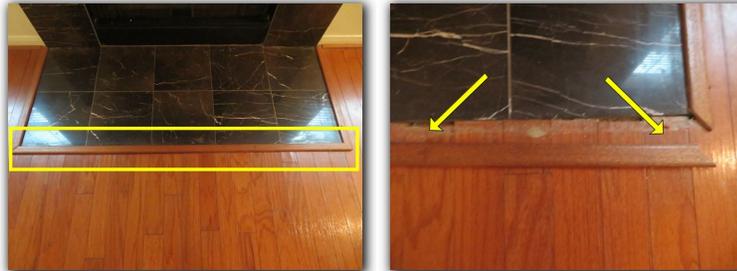
The molding in front of the fireplace hearth was observed to be loose and should be secured.

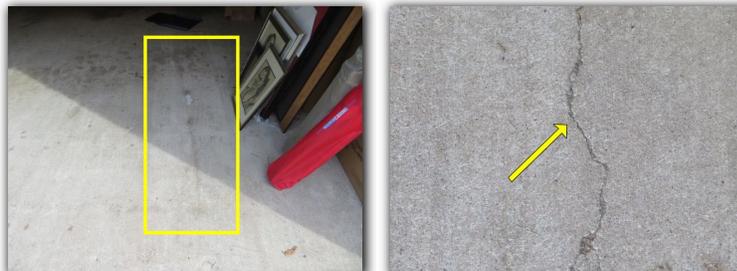
Typical cracks were observed in the Garage floor. This condition is very common and is not a structural concern.

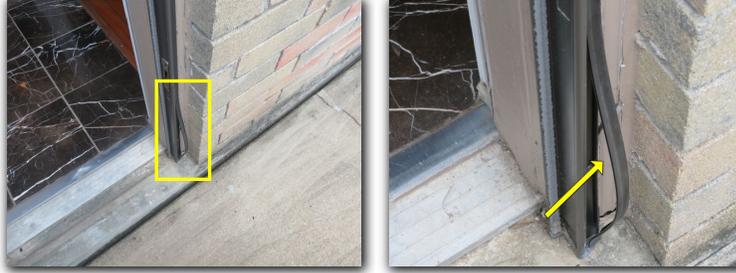
The weather strip/seal was observed to be loose in the Front Door and should be repaired.

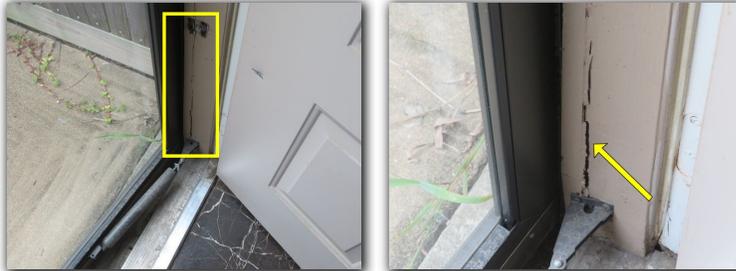
The door frame was observed to be cracked in the door frame of Front Door. This should be repaired to prevent further damage to the frame.

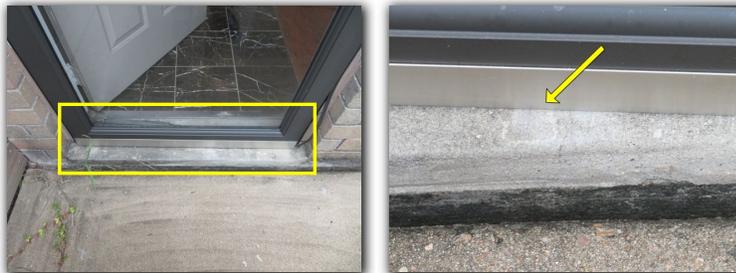
The front door was observed to be misaligned and hits/rubs the floor when opened/closed. This should be improved for proper operation of the door.

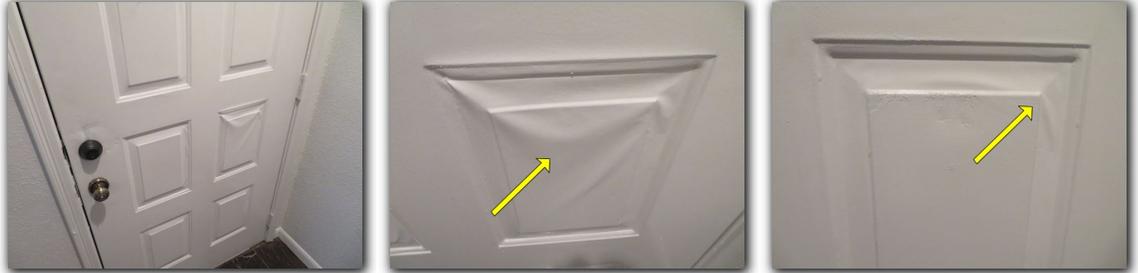
The paint was observed to be damaged on the inside of the front door. This should be further evaluated to determine the cause and remedies available for correction.

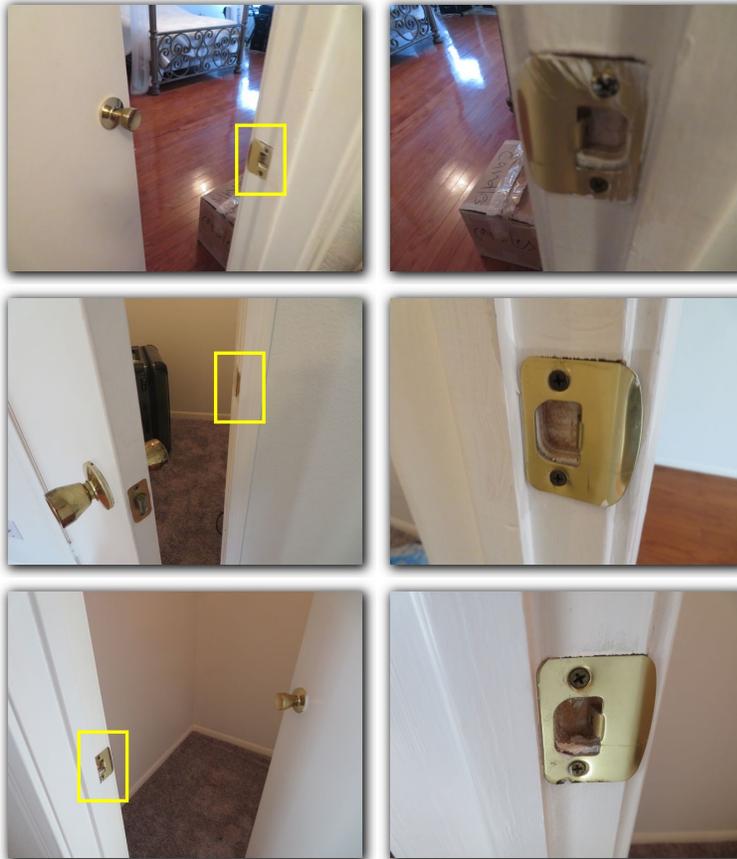
The door is not latching properly in the Master Bedroom, and, Guest Bedroom. Door hardware should be repaired and/or replaced as needed for proper operation of the door.

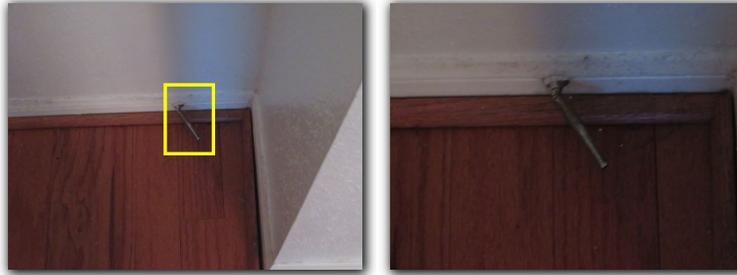
Door stopper was observed to be damaged in the Master Bedroom.

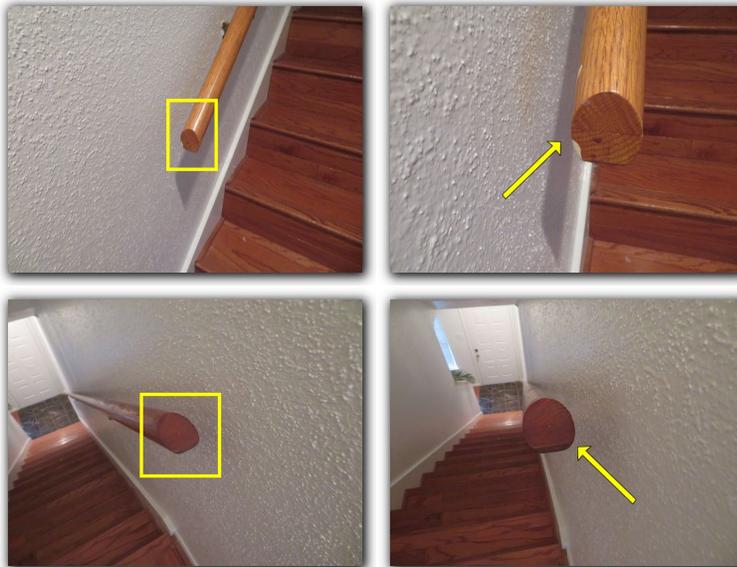
Building standards require the handrail should return to the wall and be attached to the wall. This should be corrected for safety reasons.

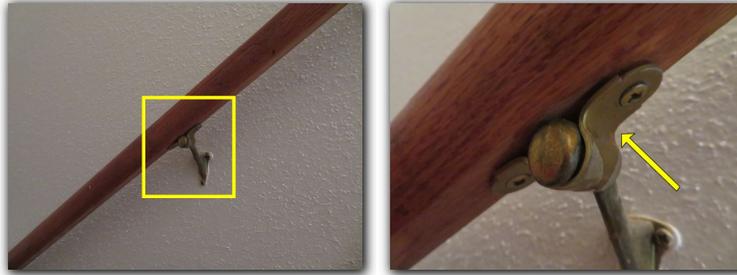
The handrail was observed to be loose and should be secured.

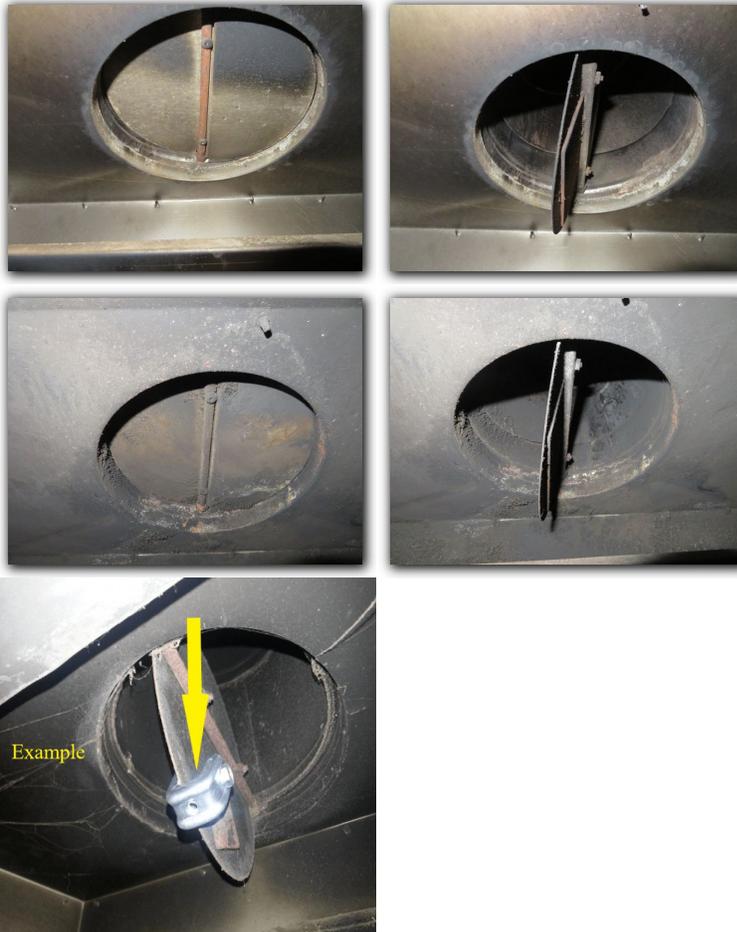
The damper in the chimney was missing the damper stop or clamp. Current fuel gas standards require a damper stop/clamp be installed on the damper when artificial gas logs or a log lighter are present in an open fireplace.

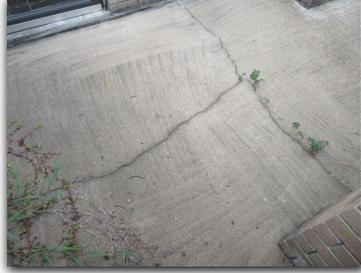
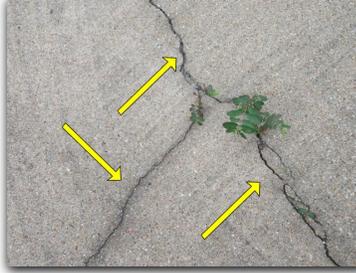
Typical cracks were observed in the concrete slab in the front of the property.

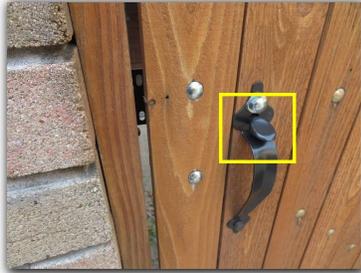
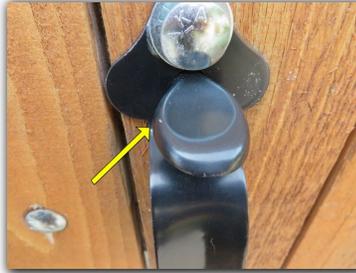
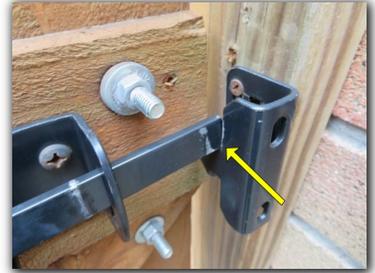
The latch on the gate was observed to be in need of some adjustment at the time of the inspection.

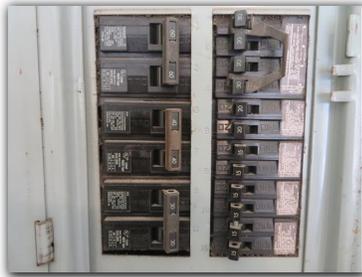
The main electrical panel was observed to have no single service disconnect. Shutting off power to all the homes circuits required shutting off more than 6 switches or circuit breakers. Current electrical standards require the ability to shut off power to all circuits by shutting off no more than 6 switches or circuit breakers.

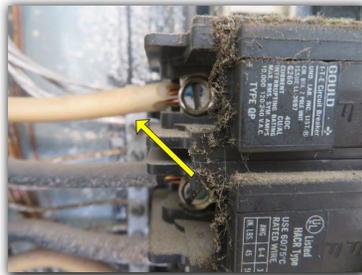
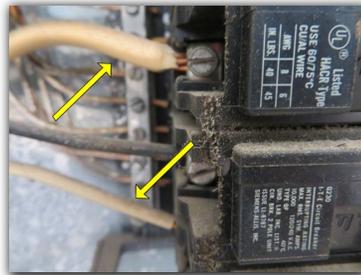
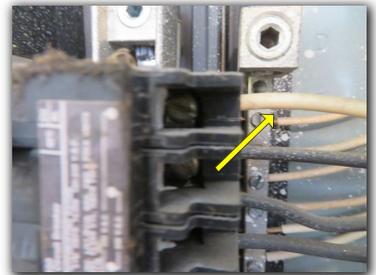
Multiple white (neutral) wires were observed to be used as a hot wires in the electrical panel. These wires should be marked with black or red colored tape for proper identification and safety reasons.

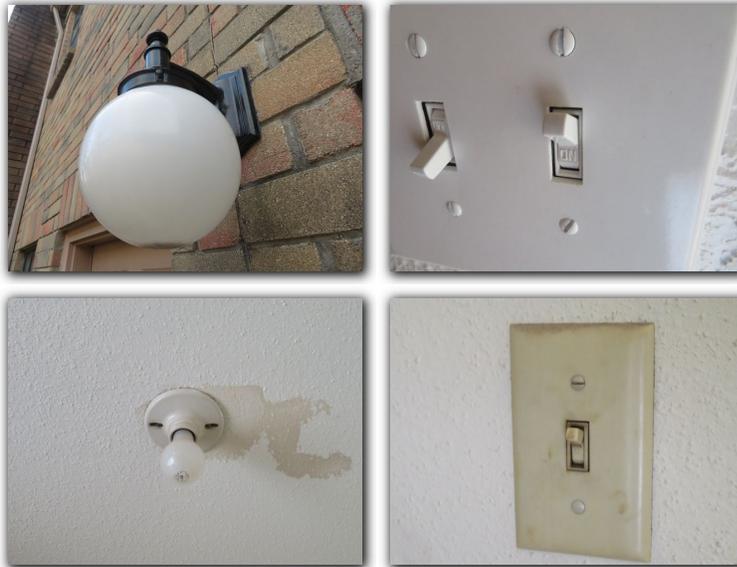
Multiple light fixtures were observed to be inoperative in the Exterior, and, Garage. This should be further investigated, repaired and/or any burned out light bulbs should be replaced as needed.

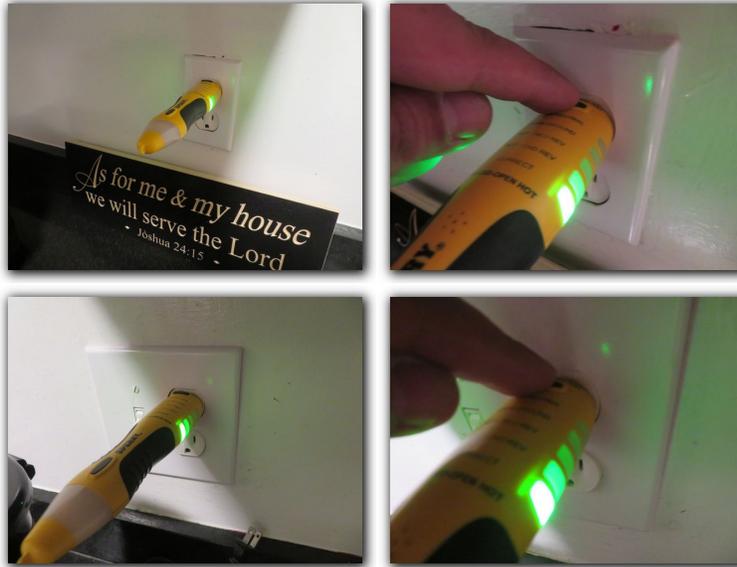
GFCI (Ground Fault Circuit Interrupter) protection was observed to be missing in the Kitchen. Current building standards require GFCI protection for 15 and 20 amp receptacles on kitchen countertops, in bathrooms, outdoor areas, unfinished basements and crawl spaces, garages, boathouses, laundry areas, and within 6' of sinks, bathtubs and shower stalls. GFCI protection is also required for certain appliances that have a history of being a shock hazard such as dishwashers and food waste disposers etc. GFCI devices can greatly reduce the risk of shock by immediately shutting off an electrical circuit when that circuit represents a shock hazard (i.e., a person comes in contact with a faulty appliance together with a grounded surface). GFCI devices can be installed as a circuit breaker in a panel or as a receptacle outlet. **This house predates the adoption of this standard; however, this should be corrected for safety reasons.**

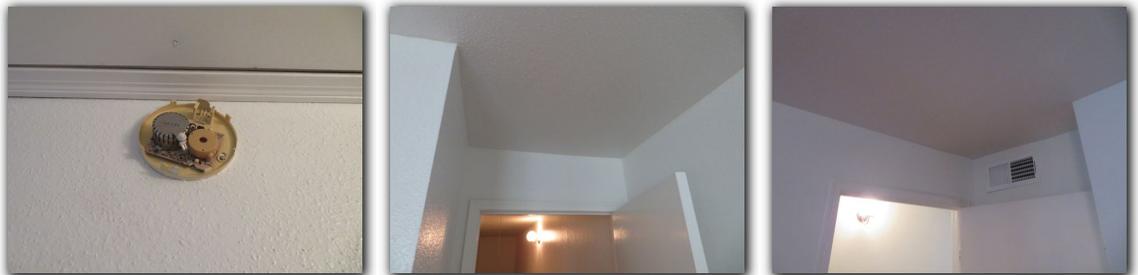
Smoke and Carbon Monoxide detectors were observed to be missing, damaged and/or disconnected where required.

These items should be installed for safety reasons.

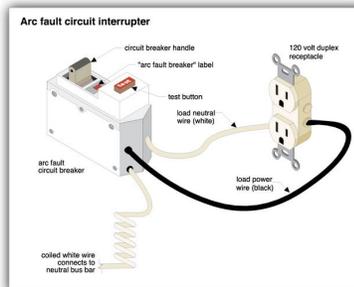
AFCI (Arc Fault Circuit Interrupter) protection was observed to be not installed to protect electrical circuits from arcing. Current building standards require AFCI protection for 15 and 20 amp circuits that serve outlets and devices in all areas of new residential construction, excluding bathrooms, garages, and outside areas. In addition to new construction, when receptacles are replaced in areas where AFCI protection is now required, the replacement receptacle must have AFCI protection. AFCI devices protect against fire by continuously monitoring the electrical current in a circuit and shutting off the circuit when unintended arcing occurs which can lead to high temperatures and sparking, possibly igniting combustibles. AFCIs can be installed as a circuit breaker in the main electrical panel or as a receptacle outlet. **This property predates the adoption of this standard; however, this should be corrected for safety reasons.**

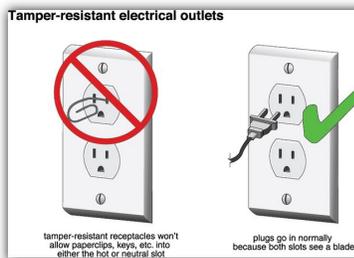
Tamper resistant receptacles were observed to be missing on the property. Current electrical standards require tamper resistant receptacles in new and renovated homes because it is the most effective way to prevent injuries associated with electrical receptacles, especially to children. **This property predates the adoption of this standard; however, this should be corrected for safety reasons.**

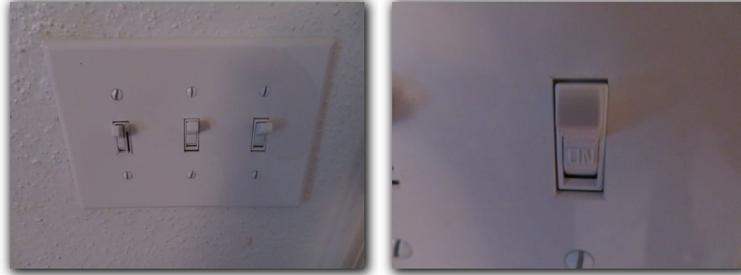
A mystery switch was observed in the Master Bedroom. The switch function should be verified with the owner before closing.

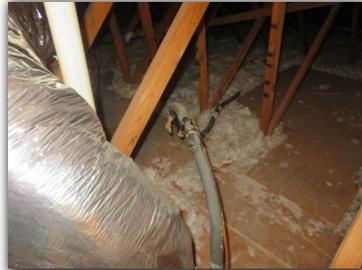
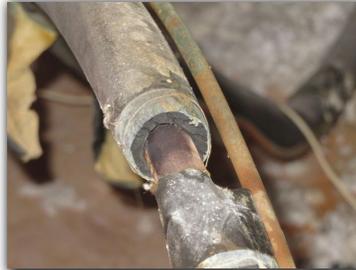
Damaged and/or missing insulation on the refrigerant line was observed at the evaporator coil unit in the attic. The cold copper tubing in contact with warm humid air causes moisture in the air to condense and then drip off of the refrigerant line. This should be repaired and/or replaced to reduce the risk of moisture intrusion.

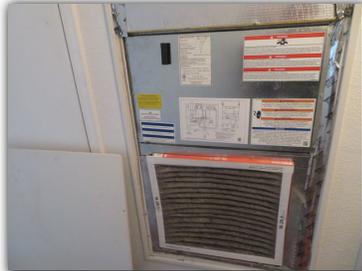
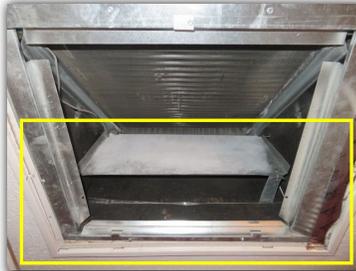
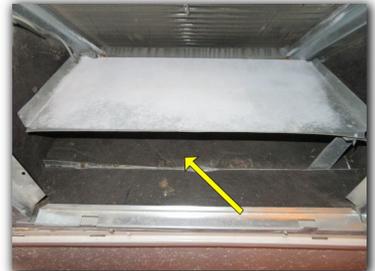
The inspector was unable to verify the visible presence of the condensate pan and drain. Current building standards require a condensate disposal assembly including pans, drains and/or a safety or float switch.

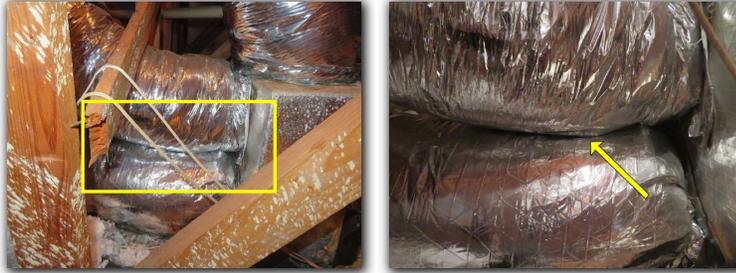
Supply air ductwork has ducts in contact with each other in the attic. Ideally there should be at least a 1-inch separation or a moisture barrier between the ducts to prevent damage from condensation and rot.

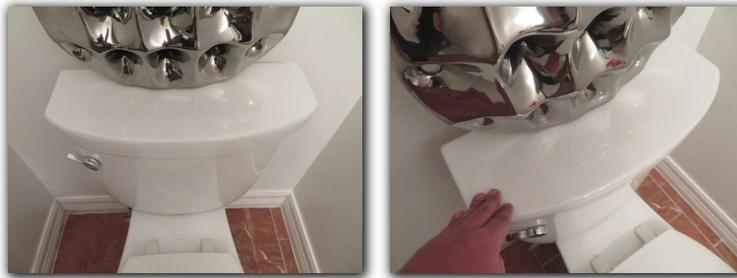
The toilet tank was observed to be loose in the Powder Room.

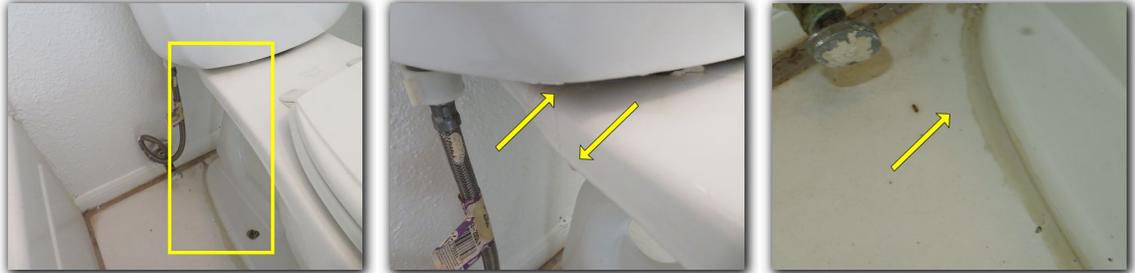
The toilet tank was observed to be leaking when used.

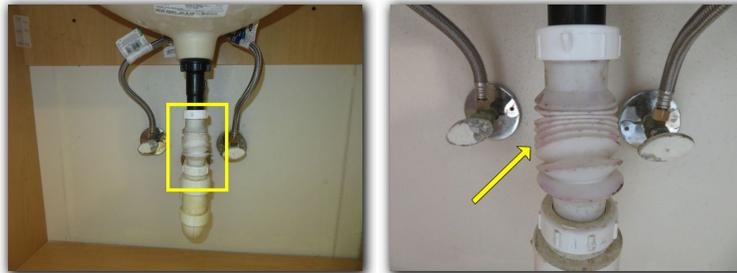
Flexible drain pipe was observed under the Guest Bathroom sink. It is not approved for installation by current plumbing standards, which require that any waste pipe fitting have a smooth interior surface that allows free flow of drain water and prevents waste buildup clogs.

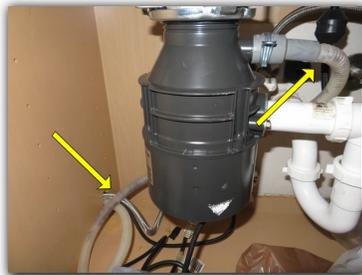
The dishwasher lacks an air gap device or a high loop. Air gaps are now standard equipment to assure a separation between supply and waste water. It is advised that one be installed or the waste pipe properly configured to prevent back flow of waste water into the dishwasher.

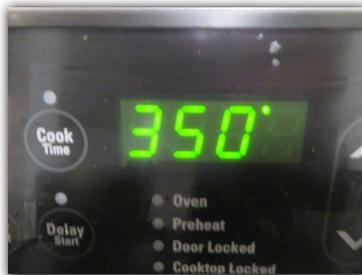
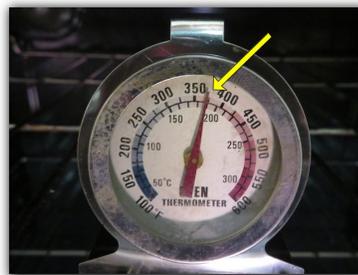
The thermostat for the oven was found to be inaccurate and should be recalibrated, repaired and/or replaced. The temperature was found to be 25 degrees greater than 350 degrees when tested.

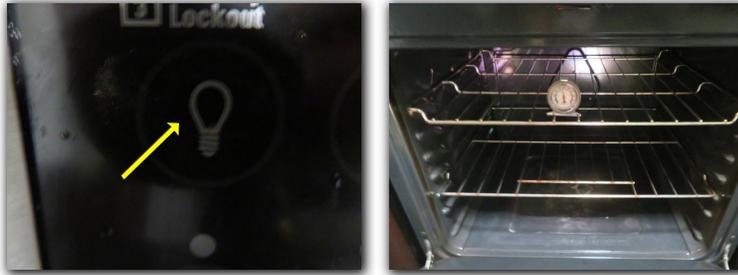
The oven light was observed to be inoperative.

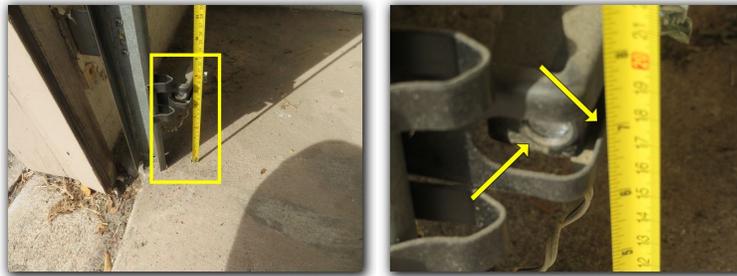
The photoelectric sensors for the garage door opener were observed to be installed at an improper height from the garage floor. The top of the photoelectric sensor eye should be installed no higher than 6 inches above the garage floor. This should be repaired for safety reasons.

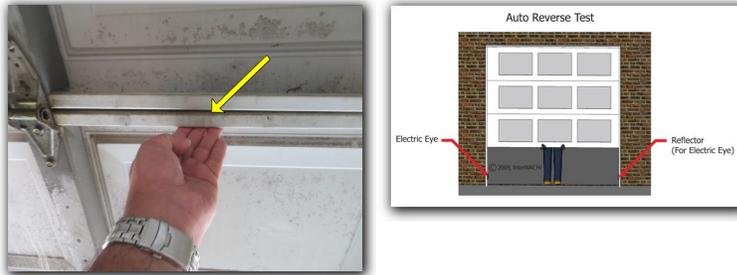
The garage door did not automatically reverse under resistance to closing. This should be corrected for safety reasons, particularly for children.
