# Axis Real Estate Inspections

## PROPERTY INSPECTION REPORT

Prepared For: Jane Smith

Concerning: 1234 Happy Court, Fun City, TX 77777

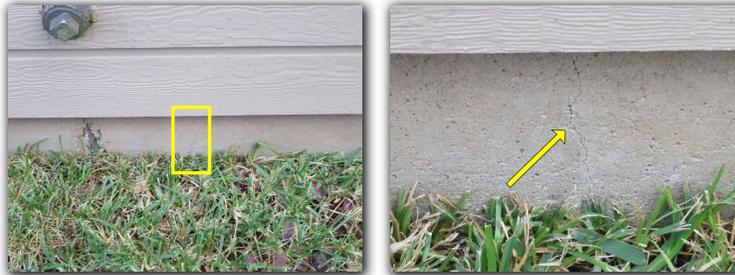
A shear crack was observed on the left side of the foundation and is not a structural concern. This implies that structural movement of the building has occurred. The rate of movement cannot be predicted during one-time inspection and the crack should be monitored. In the even the crack continues a foundation specialist should be consulted to further evaluate this condition and the remedies available for correction.

A shear crack was observed on the left side of the foundation and is not a structural concern. This implies that structural movement of the building has occurred. The rate of movement cannot be predicted during one-time inspection and the crack should be monitored. In the event the crack continues a foundation specialist should be consulted to further evaluate this condition and the remedies available for correction.

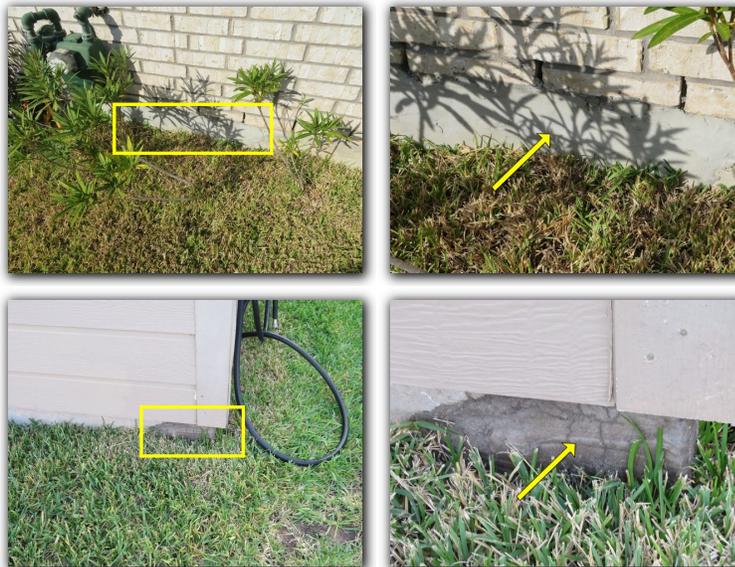
Evidence of parging was observed on the foundation perimeter beam on the right side, and, left back corner of the property. Parging is essentially a decorative mortar coat that is applied to the above grade foundation to act as a finish coat to hide surface imperfections, cracks, spalling, etc. Parging can be applied to new or existing foundation.

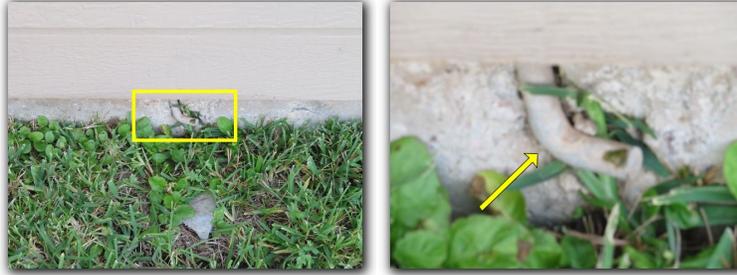
Rebar was exposed on the foundation on the back of the property. It should be sealed to prevent further corrosion.

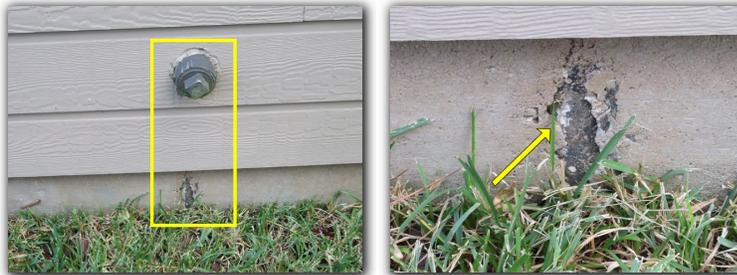
A drain pipe was observed to be exposed on the left side of the property and is not a structural concern.

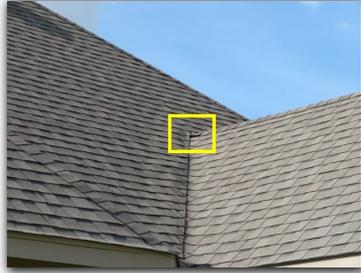
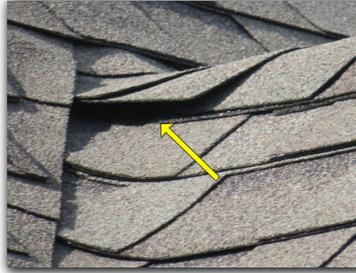
Shingle uplift was observed on the roof on the back of the property. All shingle uplifts and roof penetrations should be examined and sealed as necessary.

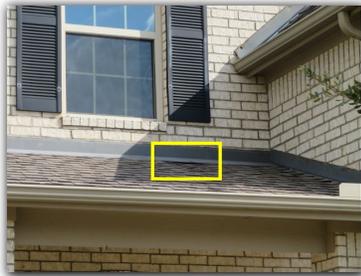
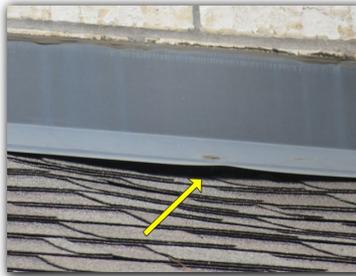
The wall flashing was observed to be loose with exposed nails on the front of the property. It should be secured and sealed to reduce the risk of water intrusion. All exposed flashing and roof penetrations should be examined and sealed as necessary.

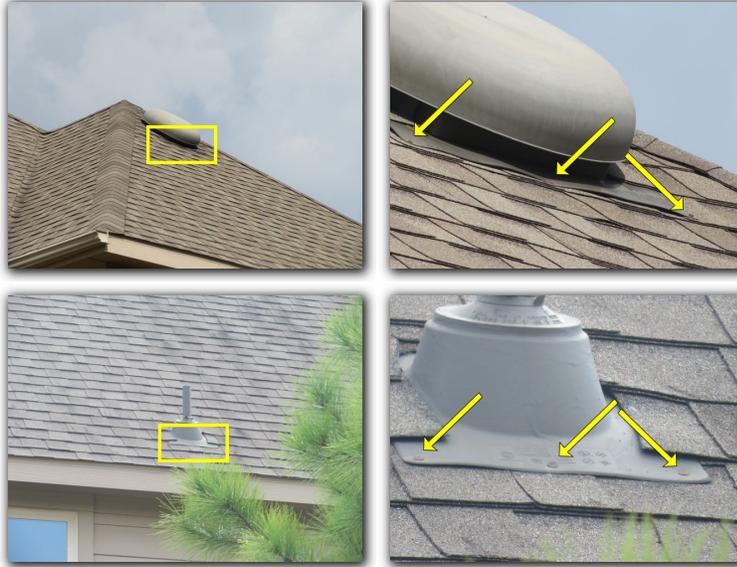
Nail heads on the roof vent flashing were observed to be exposed and should be sealed to reduce risk of water intrusion. All roof penetrations should be examined and sealed as necessary.

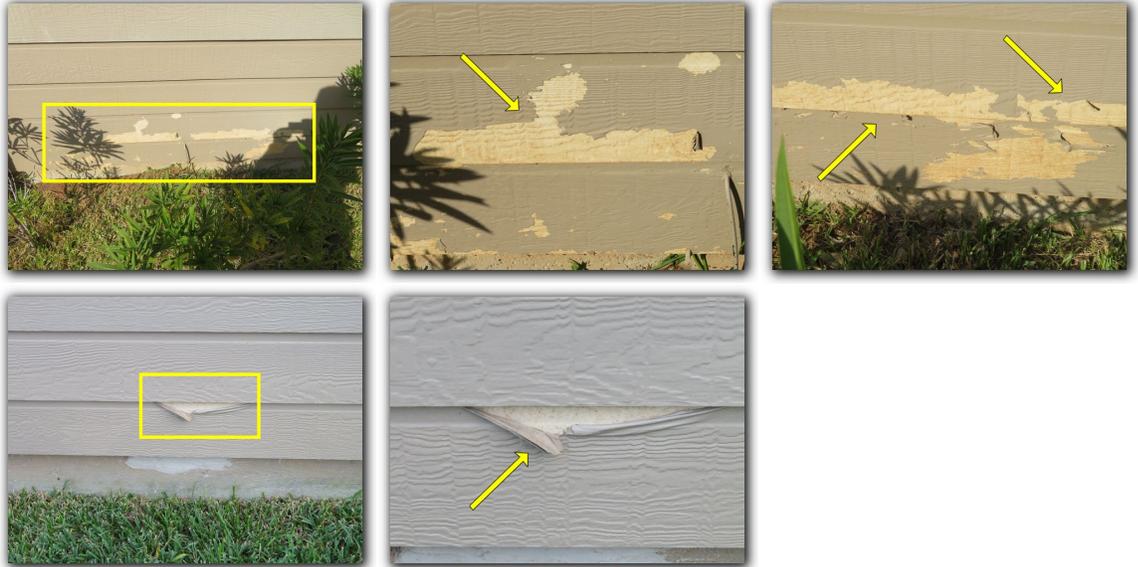
Paint damage was observed on the exterior siding on the right, and, left, side of the property and can be improved for cosmetic reasons.

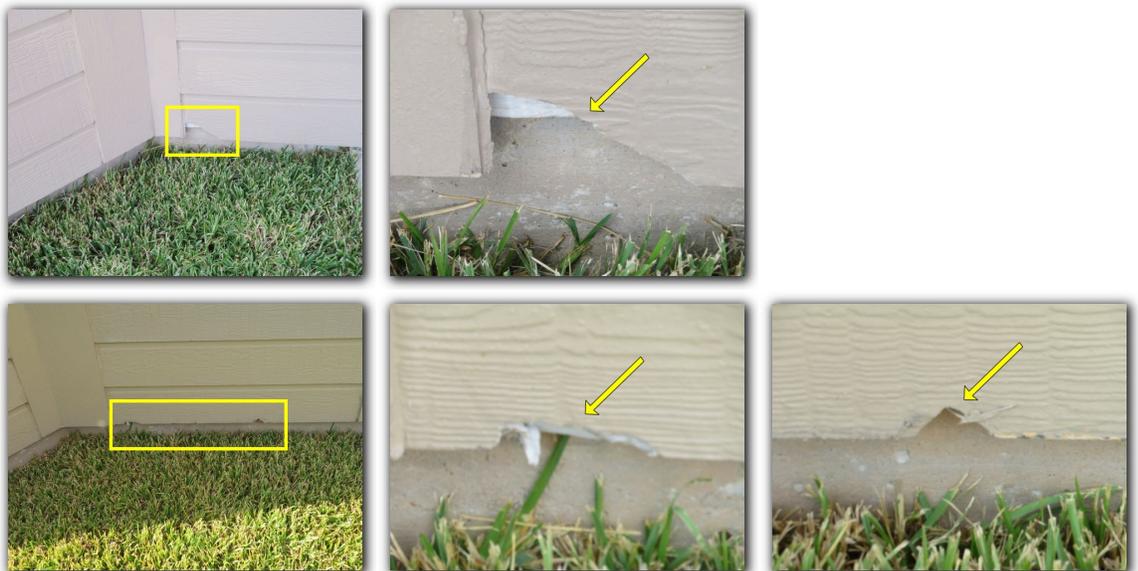
Damage was observed on the exterior siding on the back of the property and can be repaired for cosmetic reasons.

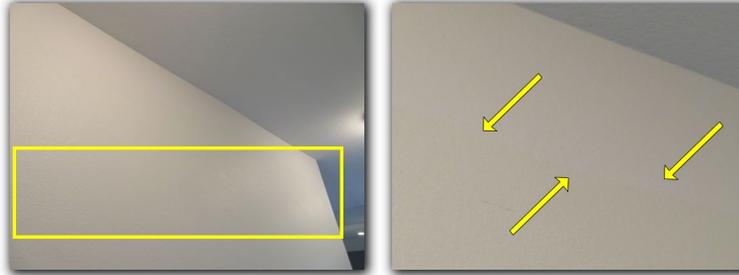
Paint mismatch was observed on the wall of Hallway.

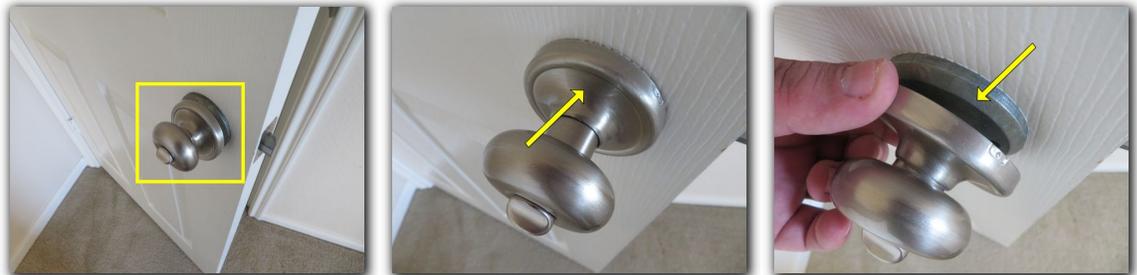
The decorative rosette was observed to be loose on the door knob of Second Floor Bedroom. The can be secured for cosmetic reasons.

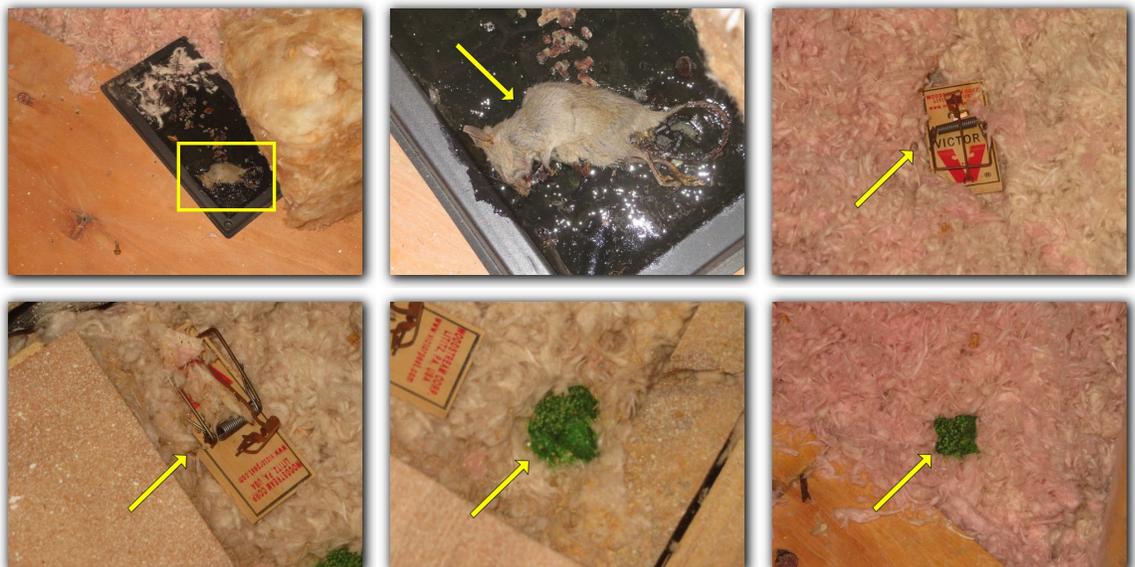
Multiple rodent traps, bait and/or fogger spray cans were observed in both attics. One rodent trap was observed with a trapped dead rodent in the attic. This is indicative of prior rodent activity on the property. Advisory: Pest inspection is not included with home inspection. This finding is for information purpose only.

Multiple rodent traps, bait and/or fogger spray cans were observed in both attics. One rodent trap was observed with a trapped dead rodent in the attic. This is indicative of prior rodent activity on the property.

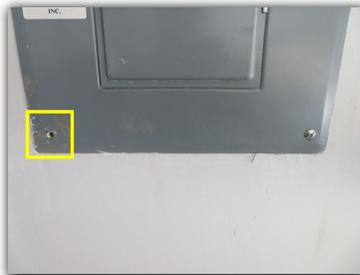
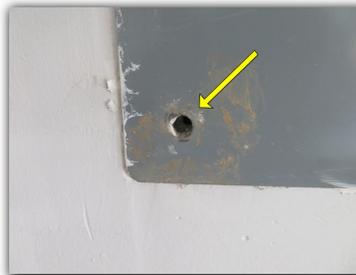
The electrical panel cover and/or dead front was missing a mounting screw.

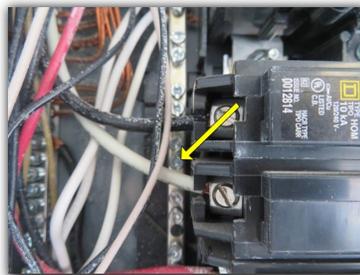
A white (neutral) wire was observed to be used as a hot wire in the electrical panel. This wire should be marked with black or red colored tape for proper identification and safety reasons.

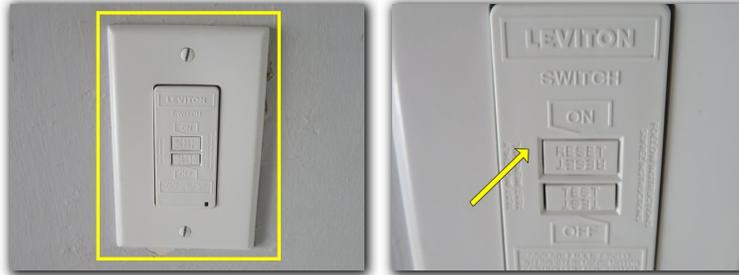
A mystery Ground Fault and/or Arc Fault Interrupter was observed in the Garage. The inspector was unable to determine the function of this component. The inspector recommends that the function be verified with the seller before closing.

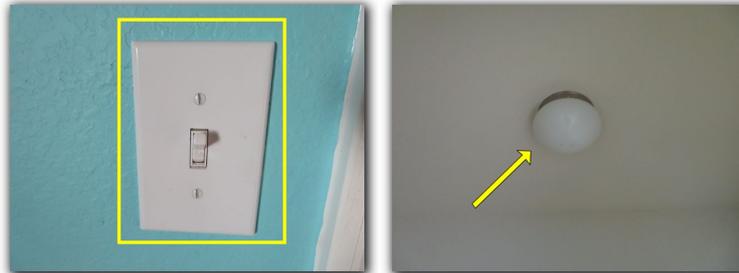
A light fixture was observed to be inoperative in the Second Floor Bedroom 1 Closet. This should be further investigated, repaired and/or replaced.

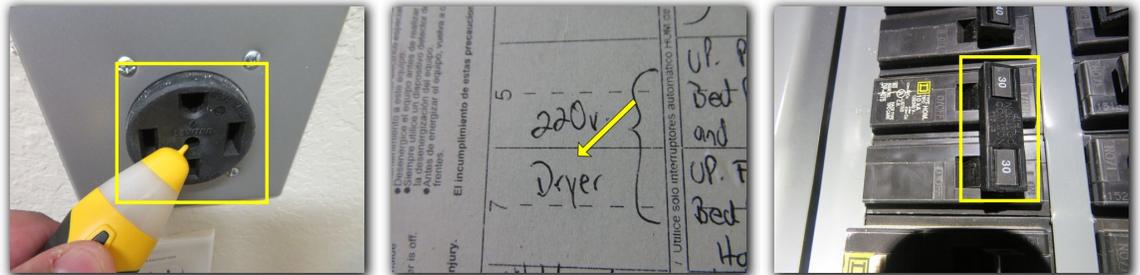
The electrical outlet installed in the laundry room for the dryer was observed to be inoperative. The breaker in the electrical panel was observed to be on and not tripped. This should be further evaluated, repaired and/or replaced as needed.

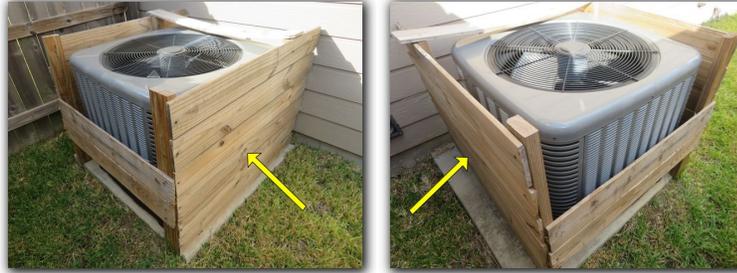
The enclosure surrounding the air-conditioner compressor housing may impede air flow and limit the ability of the unit to adequately dissipate heat. Inadequate air flow can result in a reduced compressor lifespan and higher operating costs.

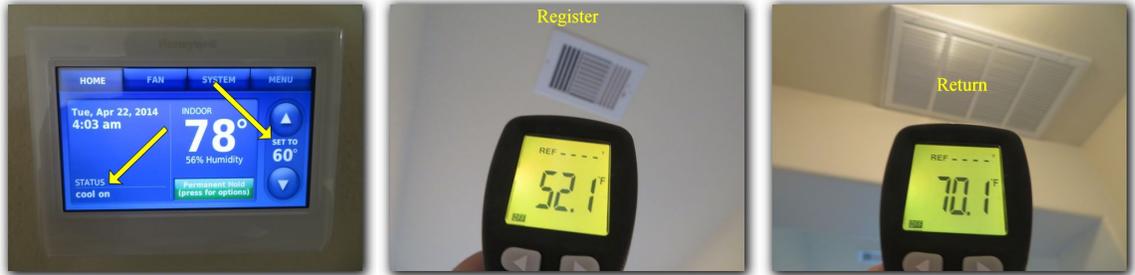
The air temperature differential measured at supply registers and return was observed to be within the acceptable range of between 14 and 22 degrees F when tested.

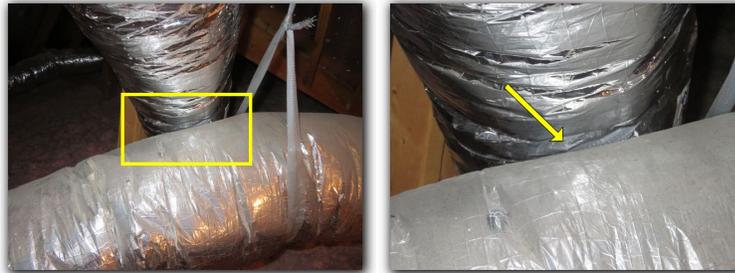
Supply air ductwork has ducts in contact with each other in the attic. Ideally there should be at least a 1-inch separation or a moisture barrier between the ducts to prevent damage from condensation and rot.

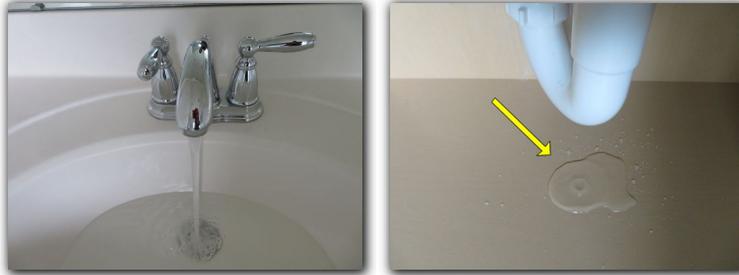
The drain pipe was observed to be leaking under the master bathroom sink. This should be corrected to reduce the risk of water damage.

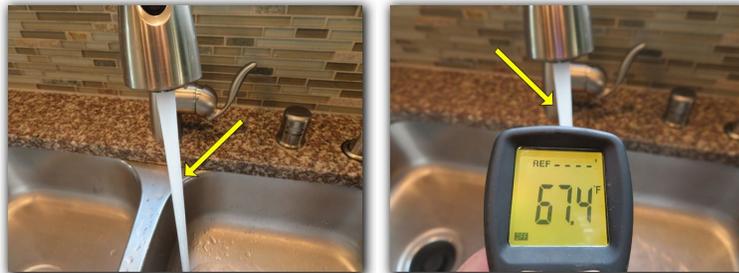
The water heater was observed to be inoperative. This condition should be further evaluated to determine the cause and remedies available for correction.

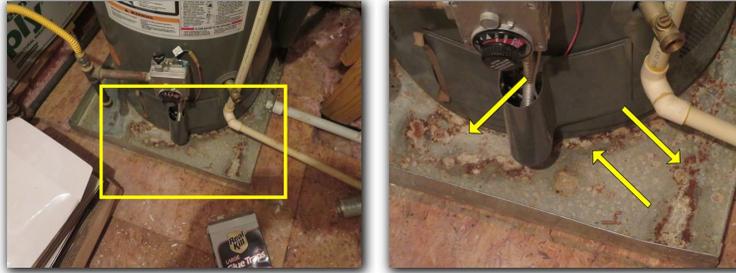
Rust was observed in the drain pan under the water heater.

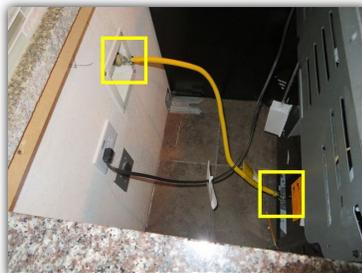
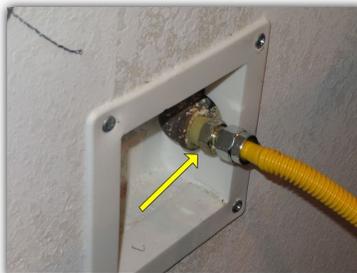
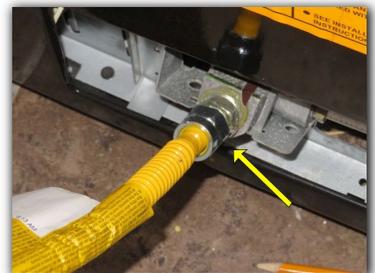
The gas range was observed to have no gas shut-off valve installed at the supply pipe. Current building standards require a gas shutoff valve should be installed within six feet of the appliance and in the same room.

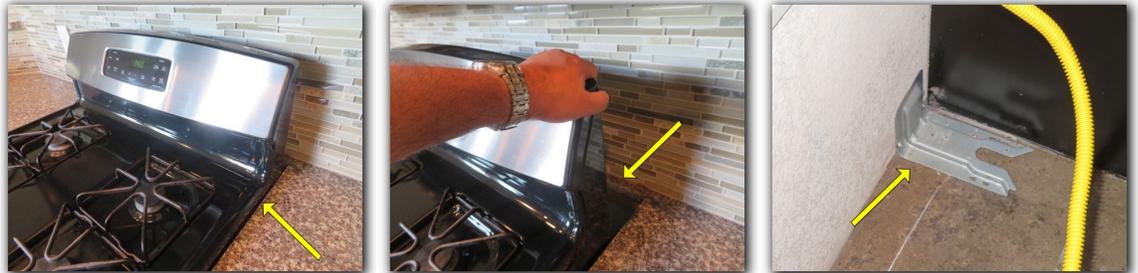
The cooking range was observed to be not secured to the wall or cabinet. An anti-tip bracket is installed but not engaging the rear leg of the range. This anti-tip device and/or the range rear leg should be adjusted to avoid the range from tipping over and causing injury.

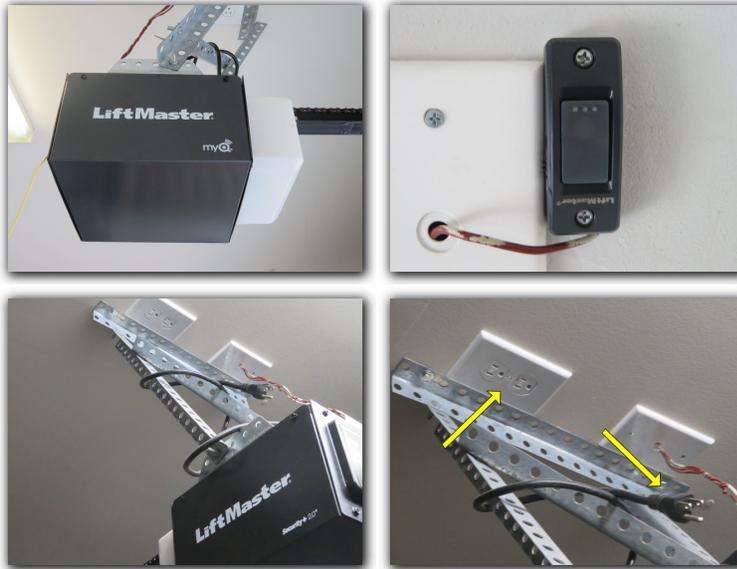
The garage door operator was observed to be inoperative when tested. This should be further evaluated to determine the cause and remedies available for correction.

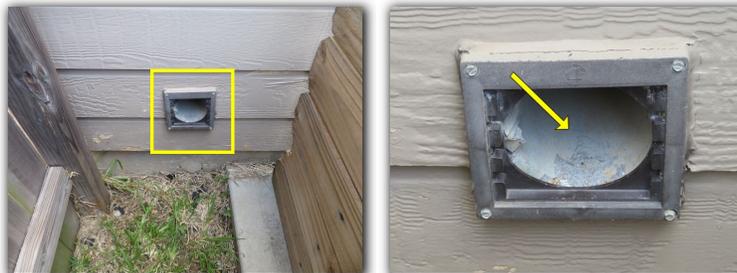
The dryer exhaust vent cover was observed to be damaged. Current building standards require that the dryer exhaust vent should end outside in a backdraft damper.
