## PROPERTY INSPECTION REPORT

Prepared For: John Smith

Concerning: 1234 Happy Lane, Fun City, TX 77777

By: Amandeep (Andy) Punia, Lic #22380 03/10/2017

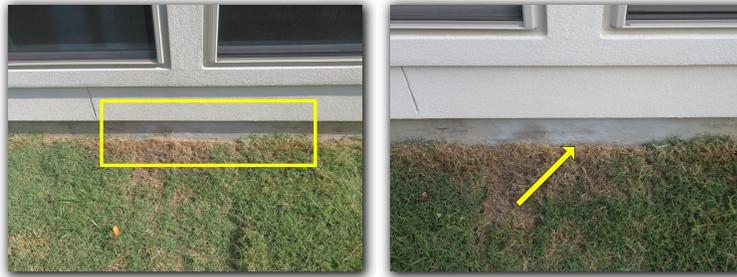
Evidence of parging was observed on the foundation perimeter beam on the left side of the property. Parging is essentially a decorative mortar coat that is applied to the above grade foundation to act as a finish coat to hide surface imperfections, cracks, spalling, etc. Parging can be applied to new or existing foundation.

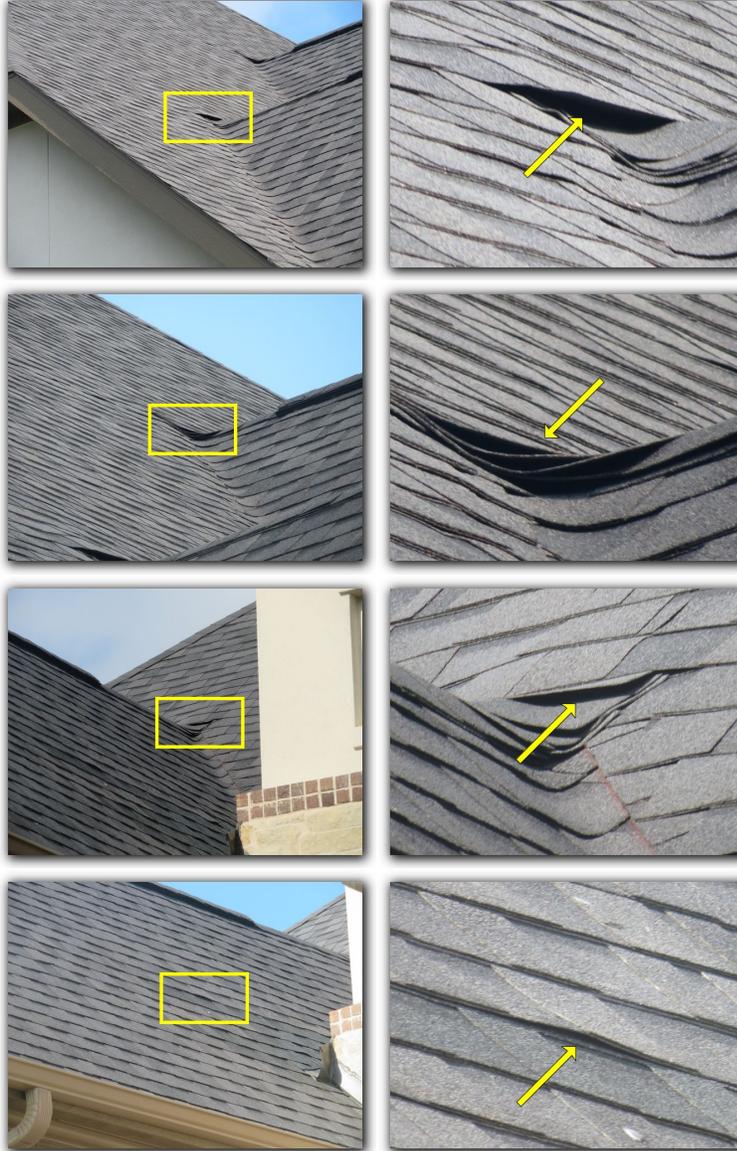
Shingle uplift was observed on the roof at multiple areas. All shingle uplifts and roof penetrations should be examined and sealed as necessary to reduce the risk of water intrusion.

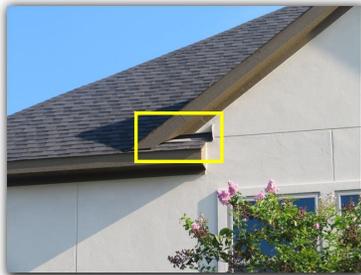
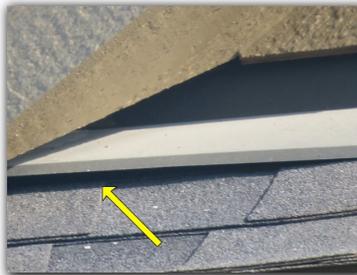
The wall flashing was observed to be loose on the left side of the property. It should be secured and sealed to reduce the risk of water intrusion. All exposed flashing and roof penetrations should be examined and sealed as necessary.

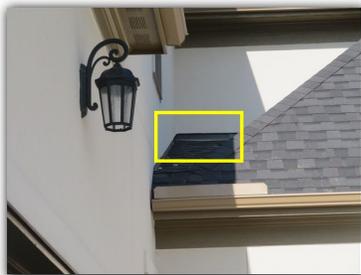
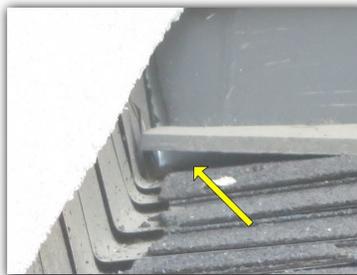
The wall flashing was observed to be loose on the front of the property. It should be secured and sealed to reduce the risk of water intrusion. All exposed flashing and roof penetrations should be examined and sealed as necessary.

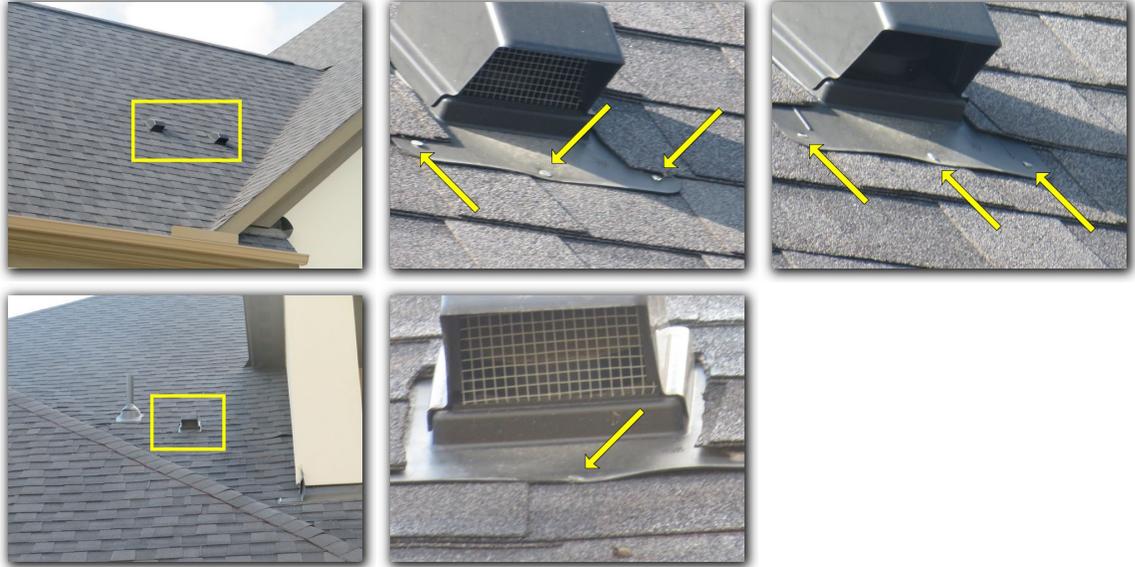
Nail heads on the roof vent flashing were observed to be exposed on multiple vents and should be sealed to reduce risk of water intrusion. All roof penetrations should be examined and sealed as necessary.

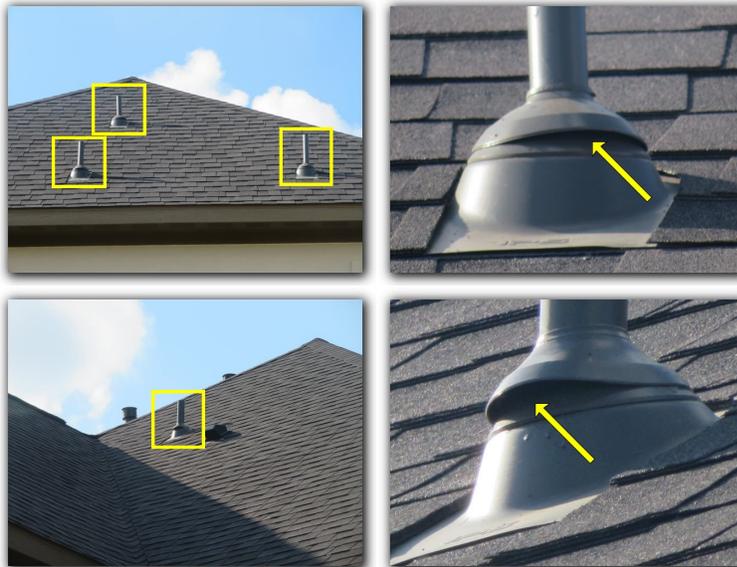
The storm collar was observed to be not seated on the base of the vent at multiple areas. This should be corrected to reduce the risk of water intrusion.

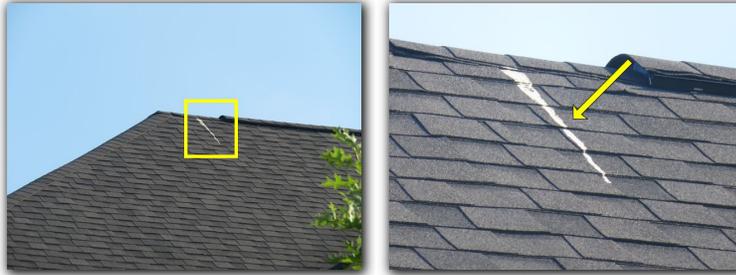
A stain was observed on the roof on the left side and should be removed for cosmetic reasons.

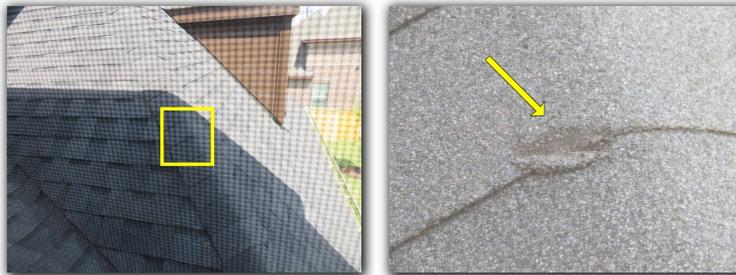
Damage was observed on the roof shingles on the front of the property. All damaged shingles should be repaired and/or replaced to reduce the risk of water intrusion.

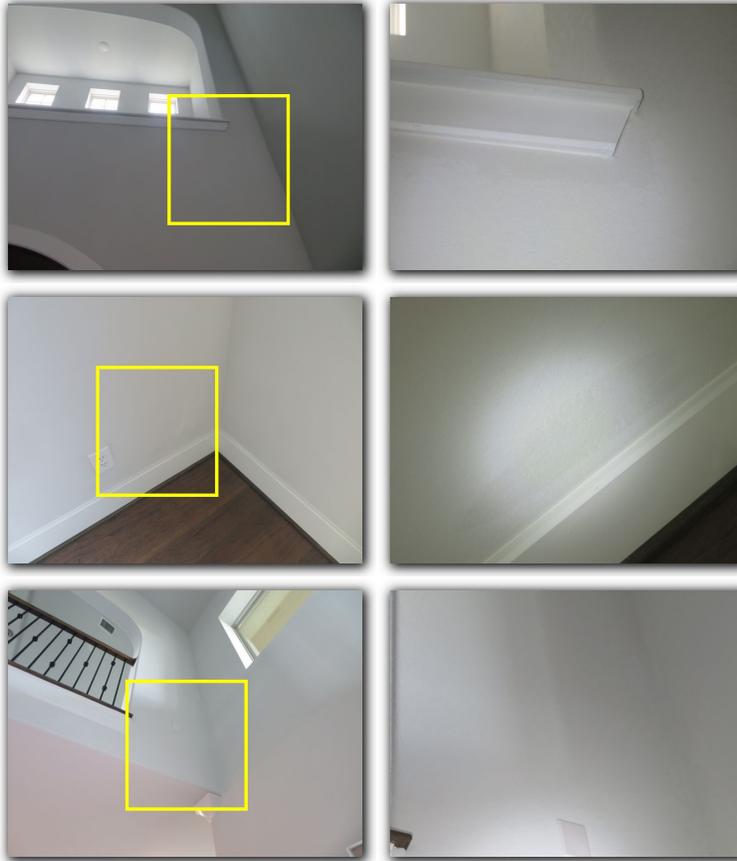
Paint mismatch was observed on the wall finish of multiple rooms. This should be improved for cosmetic reasons.

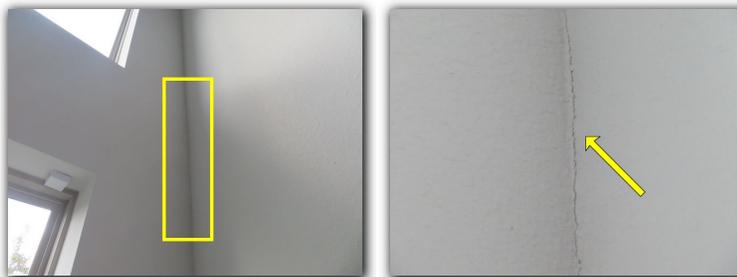
Paint flaw was observed on the interior wall finish in the Dining Room. This should be improved for cosmetic reasons.

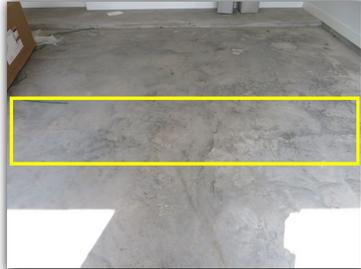
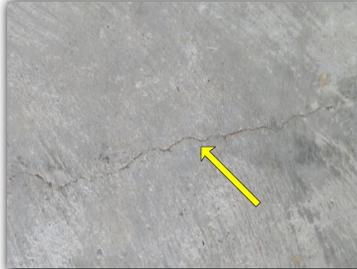
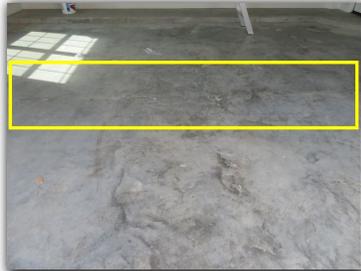
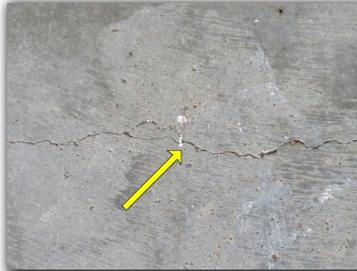
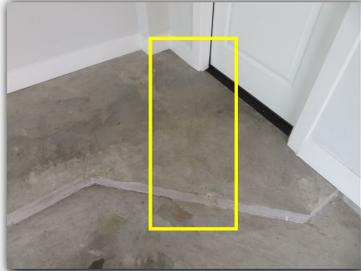
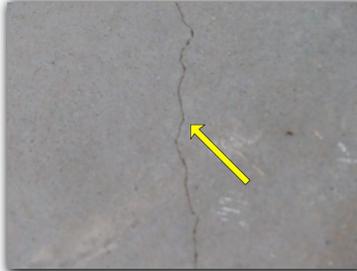
Typical cracks were observed in the Garage floor. This condition is very common and is not a structural concern.

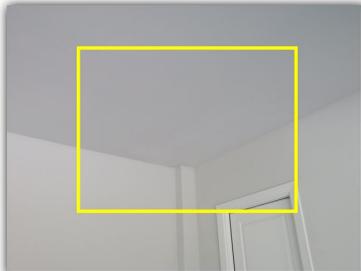
Paint mismatch was observed on the ceiling of Garage.

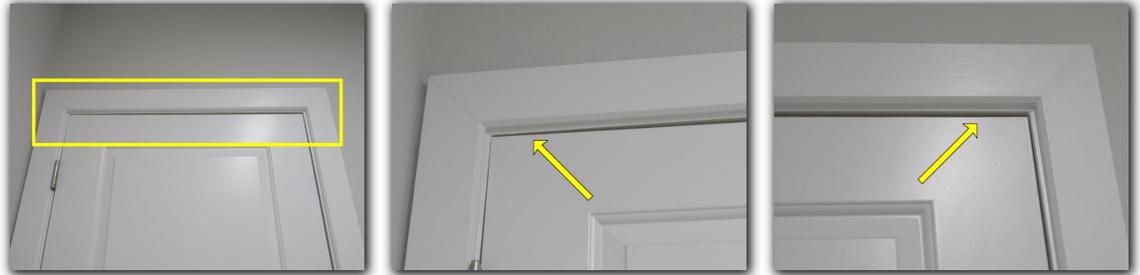
The door was observed to be out of square in the door frame of Laundry Room. This may be an indication of sub-standard installation.

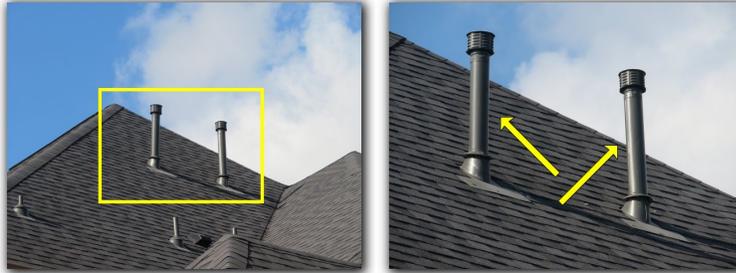
Gas vents installed on the roof were observed to be of inadequate height. Current mechanical standards require that combustion vents should terminate at least 2 feet above any part of the roof or wall within 10 feet.

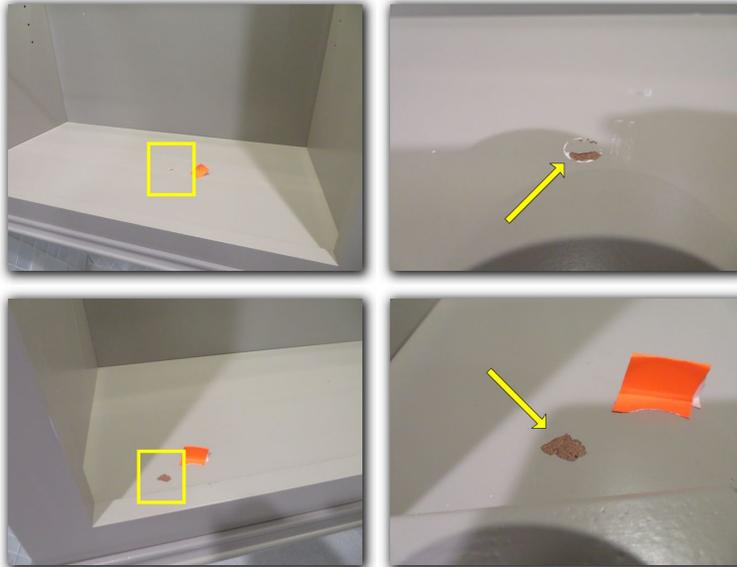
Minor paint damage was observed inside the cabinet in the Wet Bar. This should be improved for cosmetic reasons.

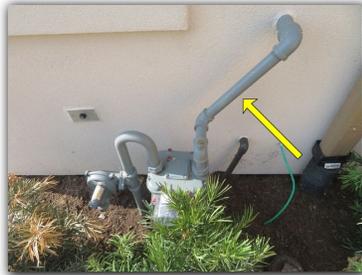
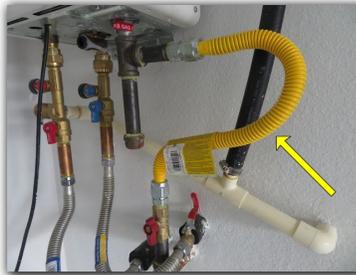
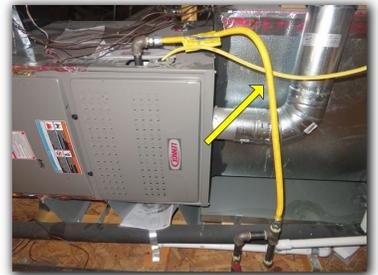
Gas pipes on the property were observed to be not bonded to the electrical system. Current electrical standards require that the gas pipes should be bonded to electrical system for safety reasons. This condition should be corrected by a qualified electrical professional.

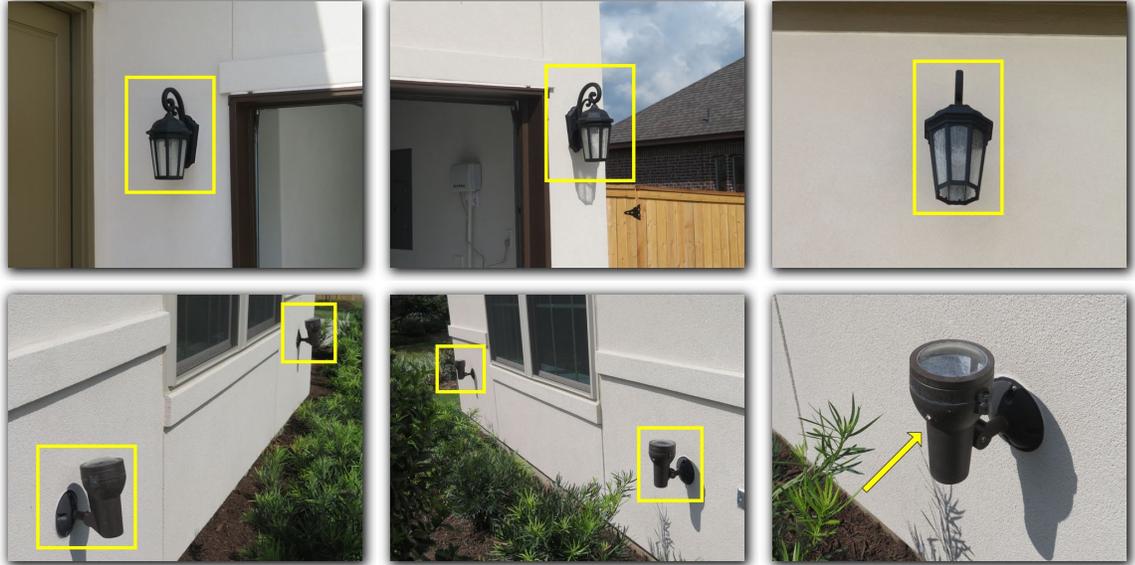
Multiple light fixtures were observed to be inoperative in the Exterior. This should be further evaluated, repaired and/or any burned out light bulbs should be replaced as needed.

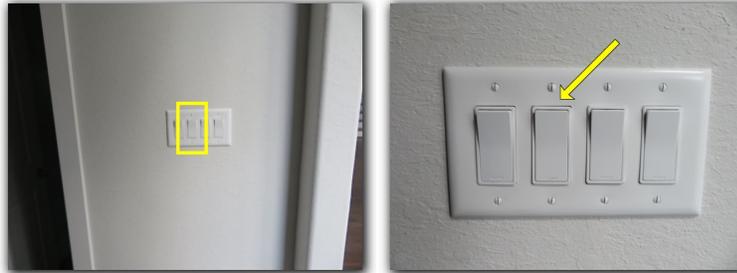
A mystery switch was observed in the Kitchen. The switch function should be verified with the builder before closing.

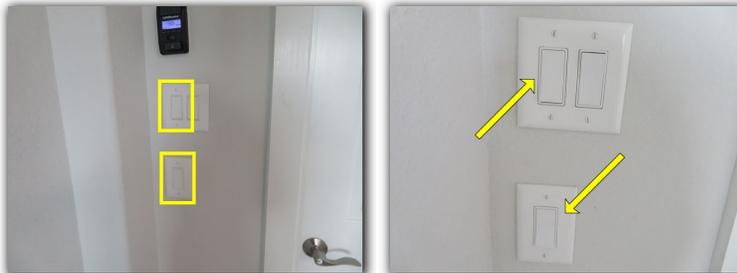
Multiple mystery switches were observed in the Garage. The switch function should be verified with the builder before closing.

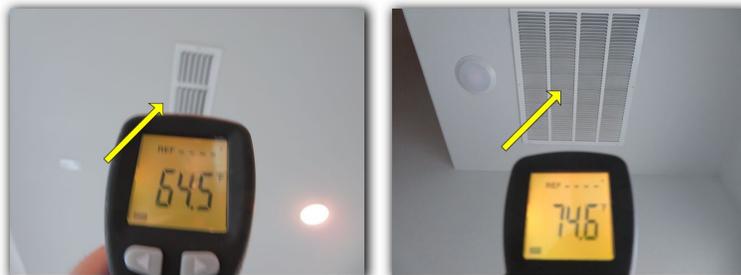
The temperature drop measured across the return air vents and supply air registers of the air conditioning system is lower than considered typical (14 degrees to 22 degrees Fahrenheit) on the first floor. This usually indicates that servicing is needed. A qualified heating and cooling technician should be consulted to further evaluate this condition and the remedies available for correction.

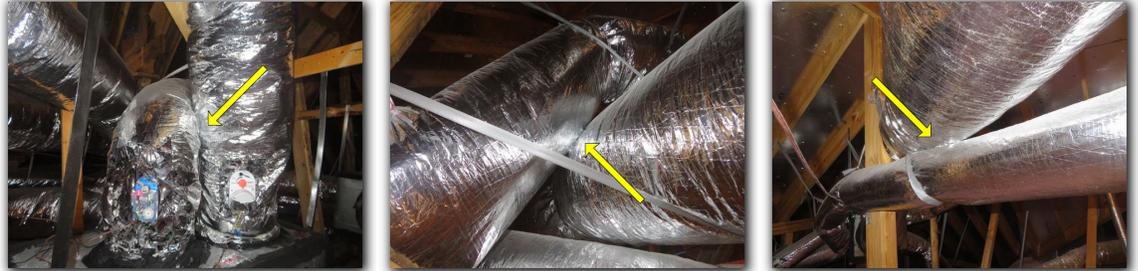
Supply air ductwork has several ducts touching each other in the attic. Ideally there should be at least a 1-inch separation or a moisture barrier between the ducts to prevent damage from condensation and rot.

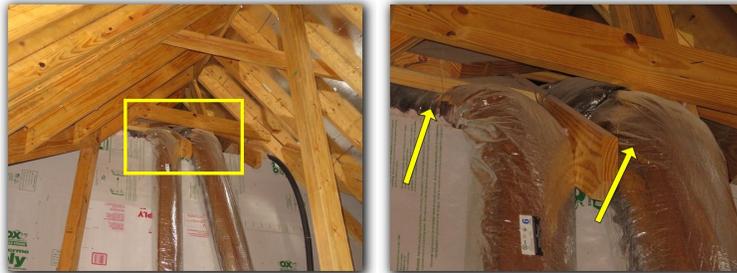
Supply air ducts were observed to be crimped between the framework and sheathing in the attic above the garage causing airflow obstruction. This should be corrected to improve the air flow.

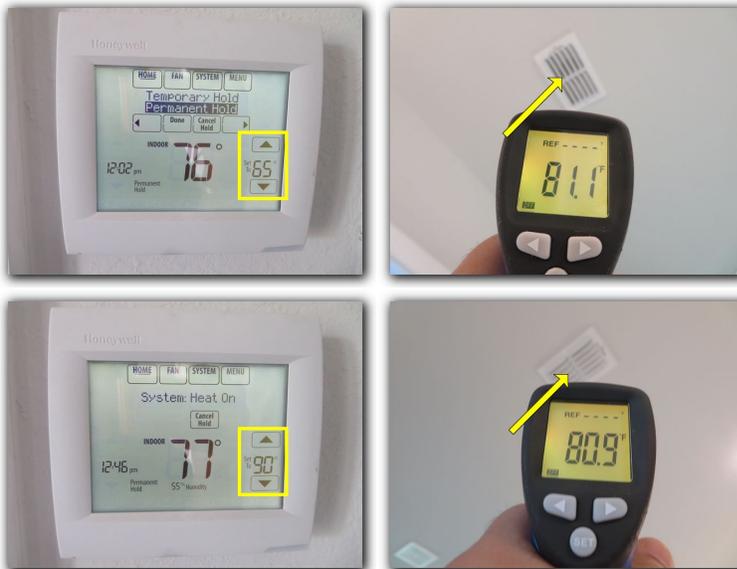
No heating or cooling was observed in the Master Bedroom, Master Bathroom and surrounding area when tested. The HVAC system and/or the duct system should be further evaluated and corrected by a qualified HVAC professional for comfort reasons.

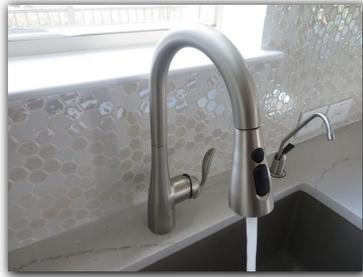
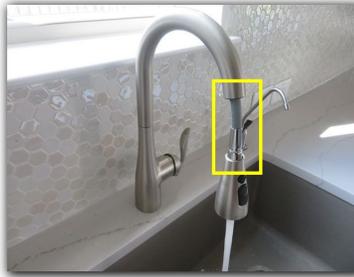
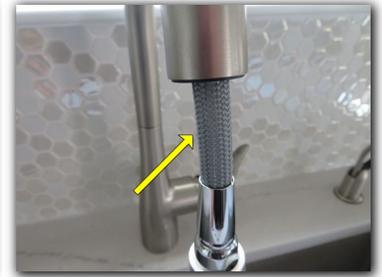
The pull-out faucet in the kitchen sink did not completely retract when tested. This condition should be improved for comfort reasons.

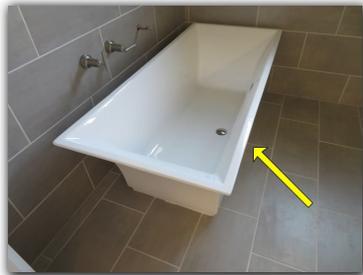
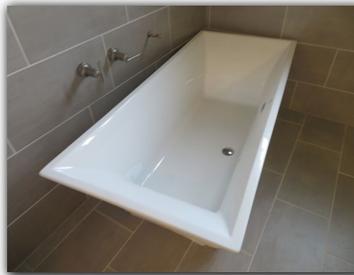
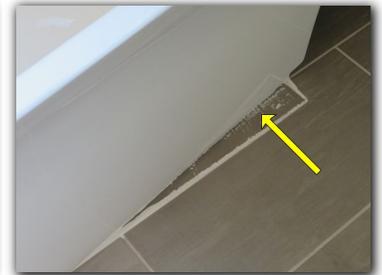
The bath tub in the Master Bathroom was observed to be loose and not secured to the bathroom floor. This condition should be corrected for comfort reasons.

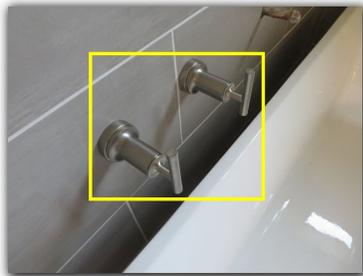
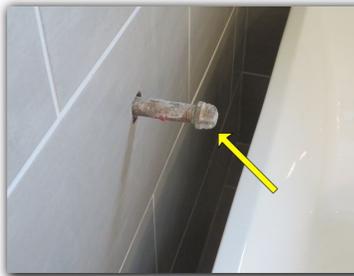
The water supply to the bath tub in the Master Bathroom was observed to be not installed and/or operational when tested. This condition should be corrected by a qualified plumber.

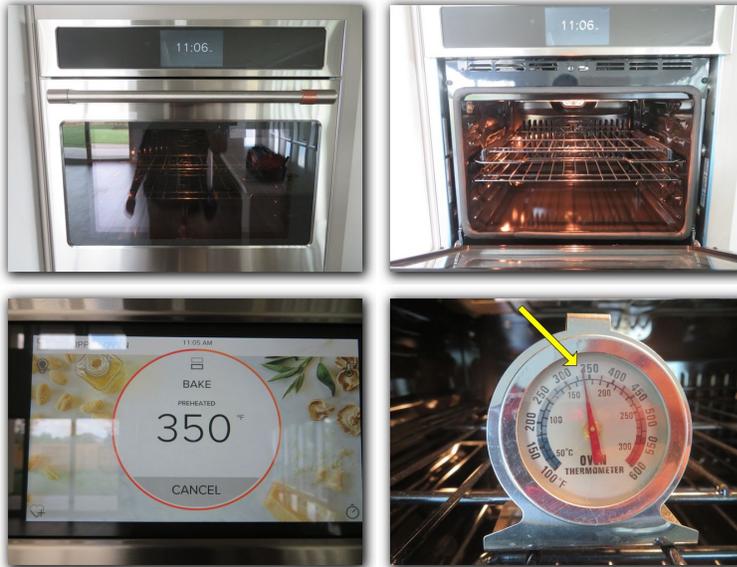
The thermostat for the upper oven was observed to be inaccurate when tested and should be recalibrated, repaired and/or replaced.
