Taconic Shores Property Owners Associations, Inc.

Robinson Dam Update 6/1/2020

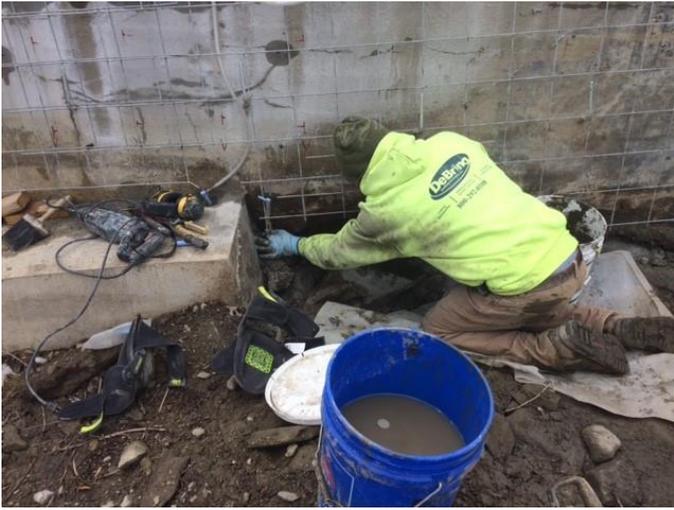
Deteriorated concrete under North Wall

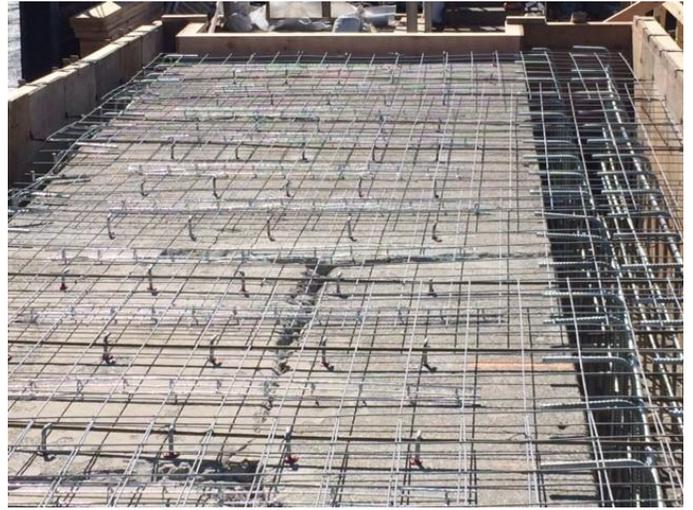
Steel Mesh installation on North Wall

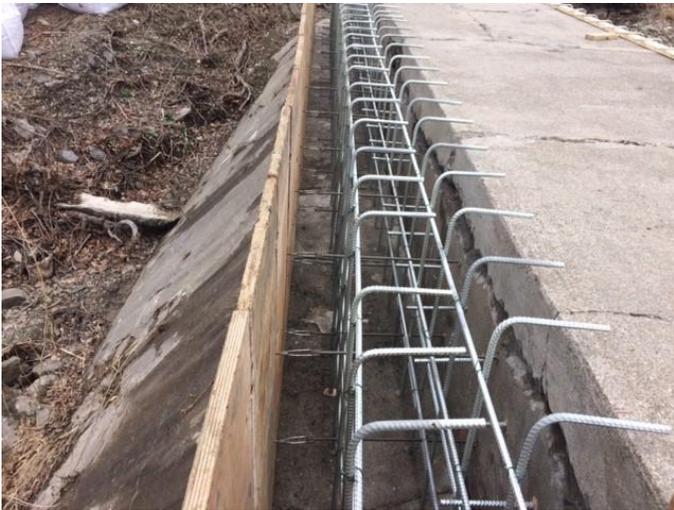
Steel rebar installation on North Wall

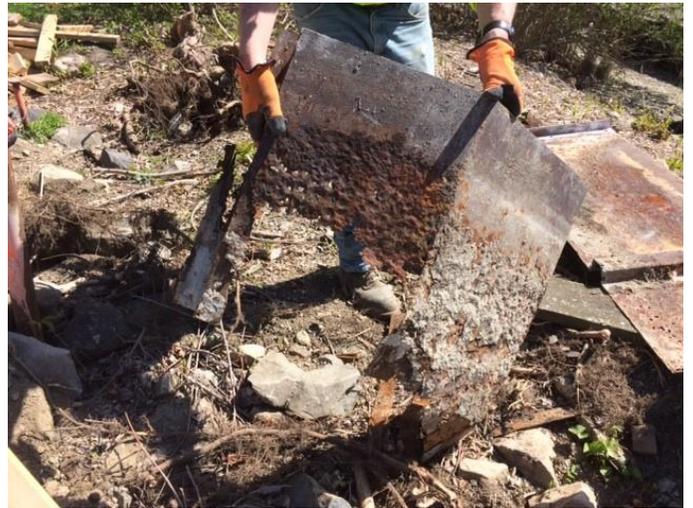
Once the Lake water was drawn down, additional cracks and holes from deteriorated concrete were discovered around the Sluice Gate Area. This additional work added roughly 10 days to the project. Additionally, a pier on the center spillway revealed deteriorated steel and concrete. These repairs added roughly 2 days to the project.

Corroded steel removed from center pier

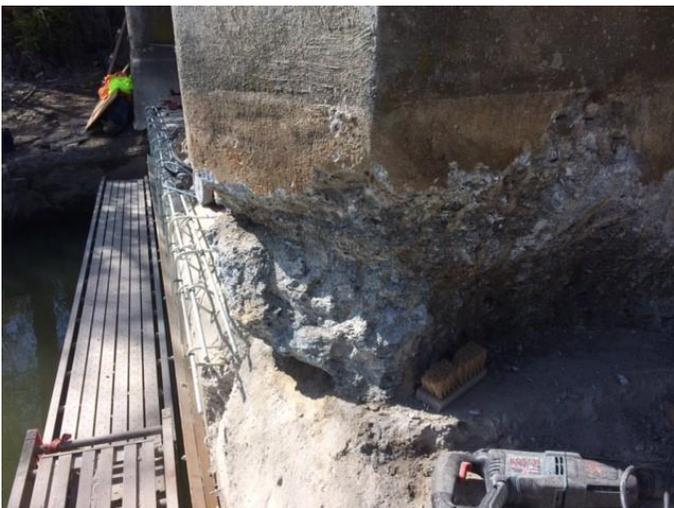
Deteriorated concrete under corroded steel on center pier

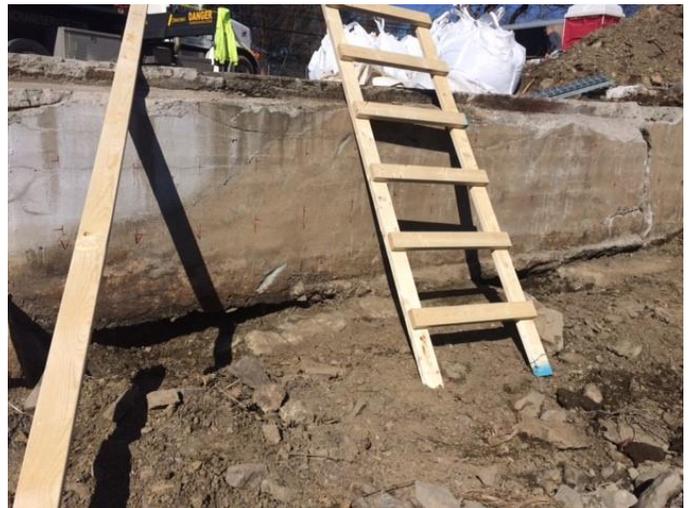
Deteriorated concrete under North Wall
