Report on Consultation Work for Green River Panels., Songkhla September 2008

Raymond J. Roberts

Abstract. This report details work done to improve operations of the Green River Panels Particleboard Plant carried out over two weeks in September 2008. The major efforts were to improve the recovery of "A" grade board and primarily involved the optimisation of the blenders including the commissioning of the new chiller. The blenders had no manufacturing setups and were running in a manner that resulted in poorly blended flake which in the core resulted in lower MOR and resulted in the production of an unacceptable level of dust and glue spots in the surface. The report also details work to be carried out prior to the next visit and also sets priorities for future visits and plant improvements in both the short and longer terms.

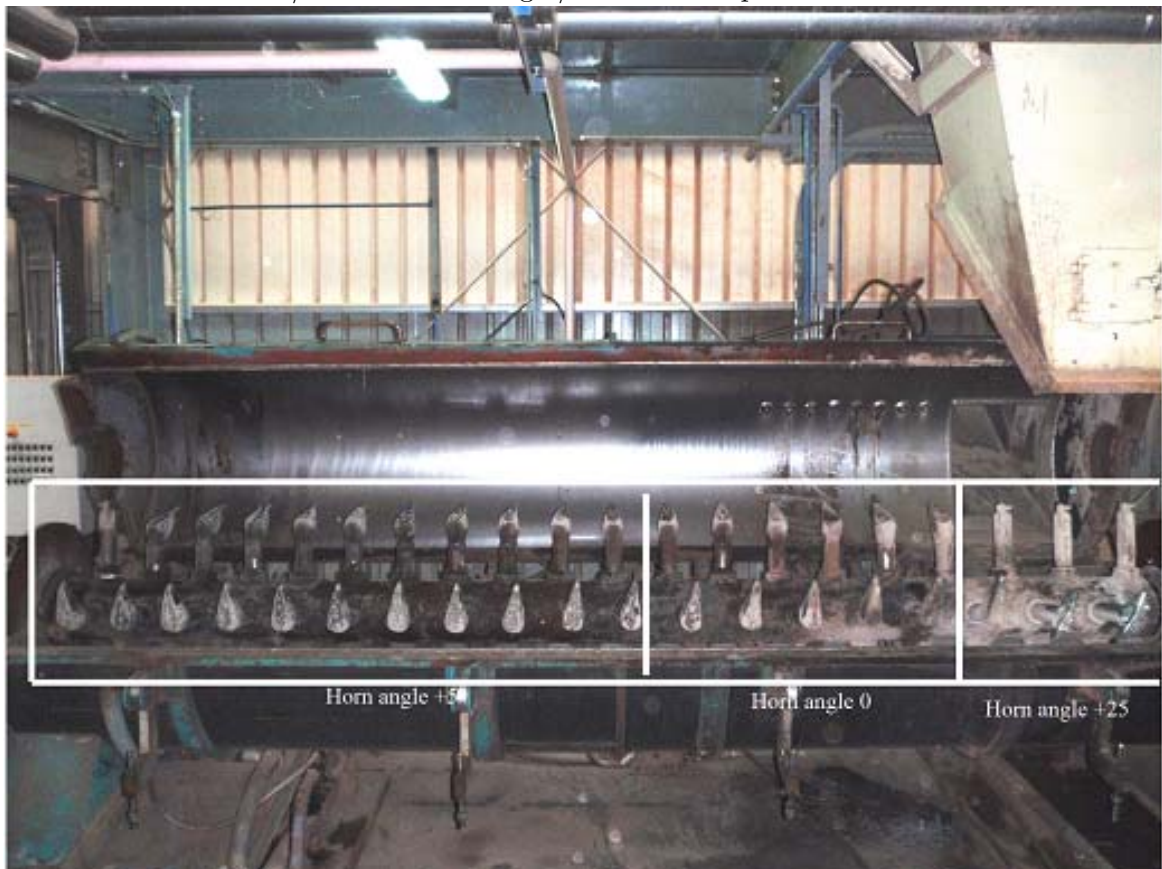
Figure 1. Horn angle positions for both blenders

- Insufficient chilling capacity resulting in resin curing at the tips of the horns resulting in increased motor current and very poor blending.
- No setups for the blenders were provided for by the manufacturers. This resulted in;
- Incorrect setups with horn angles resulting in very poor blending efficiency leading to low MOR's and a high frequency of dust and glue spots.
- Outfeed flaps were stuck in position providing no control for flake retention.
- Injection nozzles were incorrectly set up and some were not even operational

What was achieved in terms of optimal horn and paddle positioning resulted in a reduction of dust and glue spots in the surface blender and improved bending strength as a result of optimisation of the core blender refer to Figure 1. It is important to commission the automatic control for the outfeed flaps which is especially important when the amount of flake that is blended is very low, however most of the effort of blending takes place in the injection and mixing zones as per Figure 1. If the motor current is too high or too low then the only horns to be adjusted are those in the mixing zone i.e. if current is too low then the angle of only one row of horns is to be zero and if the motor current is too high then the angle of only one row of horns is to be changed to plus five degrees.
