# Gympie Chipout; a report on the identification of the root cause and the solution using laboratory and plant trials

**Abstract.** This report fully details all work on the problem of chipout at the Gympie factory of Carter Holt Harvey Panels carried out by the author including a full literature review on the blending of particleboard. All of the techniques used were developed while the author was a undergoing doctoral and post doctoral studies at the Australian National University. It includes the identification of the mode of failure of chipout, a full statistical analysis of all trials carried out by CHH in 2002, and full details of all laboratory work carried out at both ANU and the Hexion Technical Centre, Deer Park Vic. It also includes full details of plant scale trials carried out at the Gympie factory. The report is divided in to the following sections;

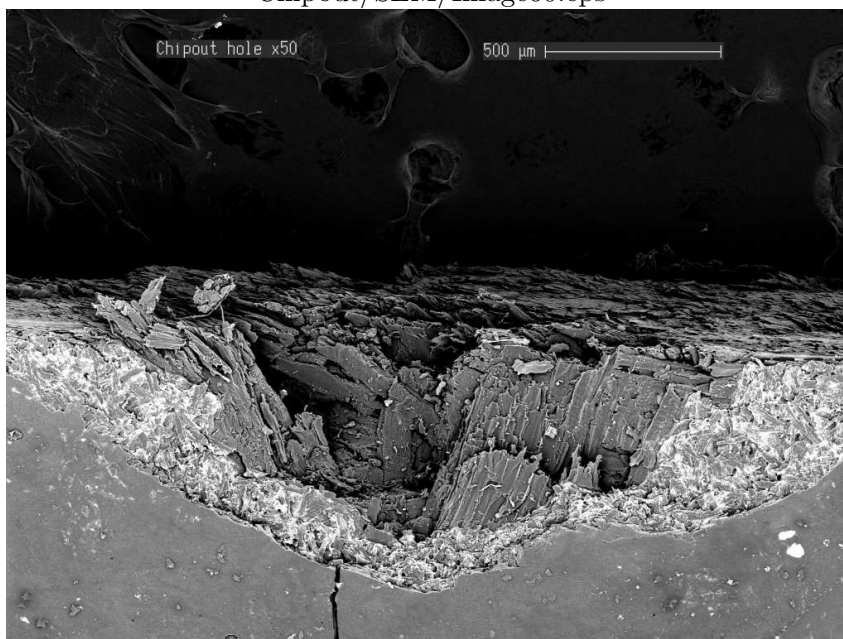
Of the 92 samples examined using SEM, only one sample showed any evidence of resination either on the chipout piece or chipout hole (Figure 4). Note in the image that where there is resin present, the detail on the surface of the flake appears somewhat blurred and where there is no resin on the flake the surface detail can be seen with high clarity. Figure 3 shows both the hole and particle caused by chipout. This image shows that the only resin evident is the saturating resin within the LPM paper. There is no resin on any of the flake either in the remaining hole or the chipout particle itself. What SEM analysis does not make clear however is whether the particles of flake are actually breaking as opposed to being chipped out whole, which would obviously result in little resin being apparent or whether there is very poor resin distribution. Figures 1 & 2 show details of the hole left by chipout and the particle that caused it.

Figure 1. Scanning electron microscopy image x50 of the void caused by chipout.

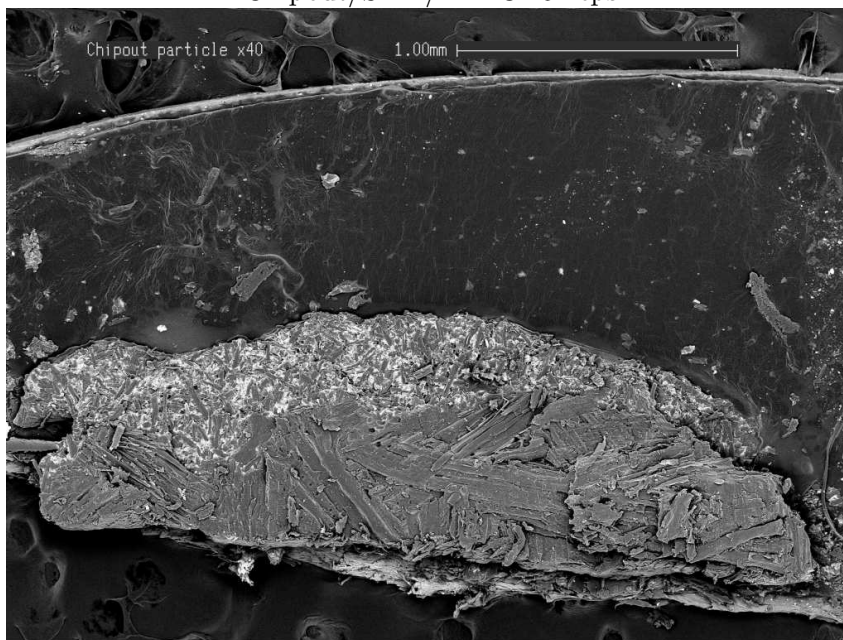
Figure 2. Scanning electron microscopy image x40 showing the particle that came out of the chipout hole in Figure 1.

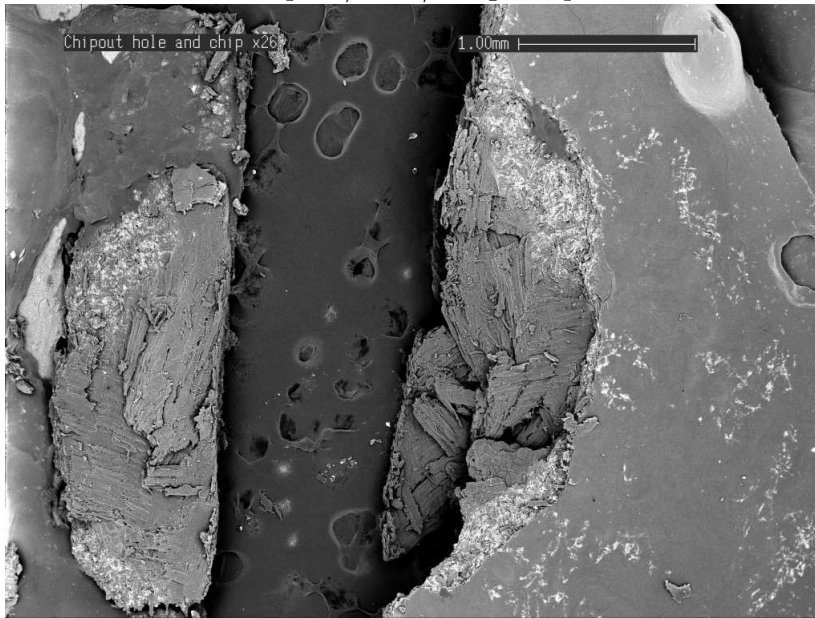
Figure 3. Scanning electron microscopy image x26 of the void (RHS) and particle (LHS) caused by chipout.

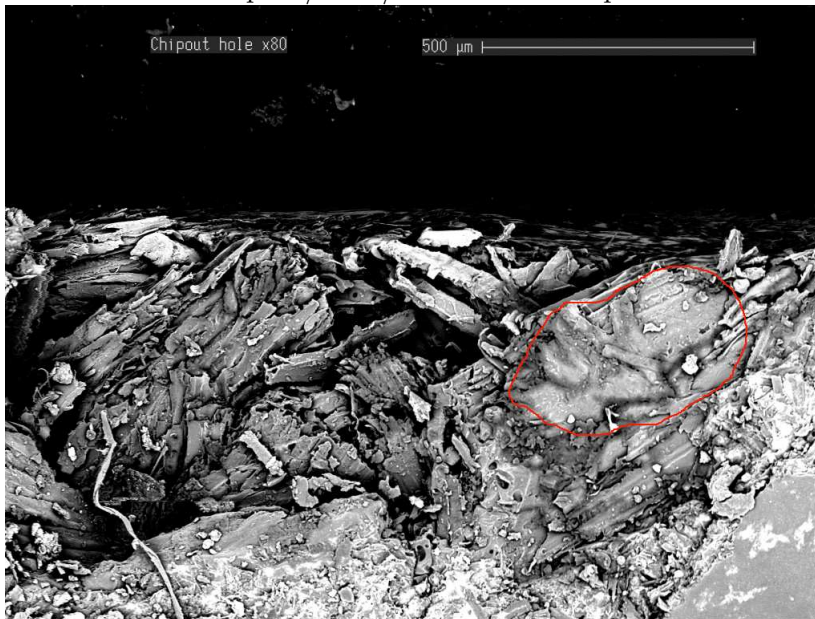
Figure 4. Scanning electron microscopy image x80 showing some resination of particles in the chipout hole.

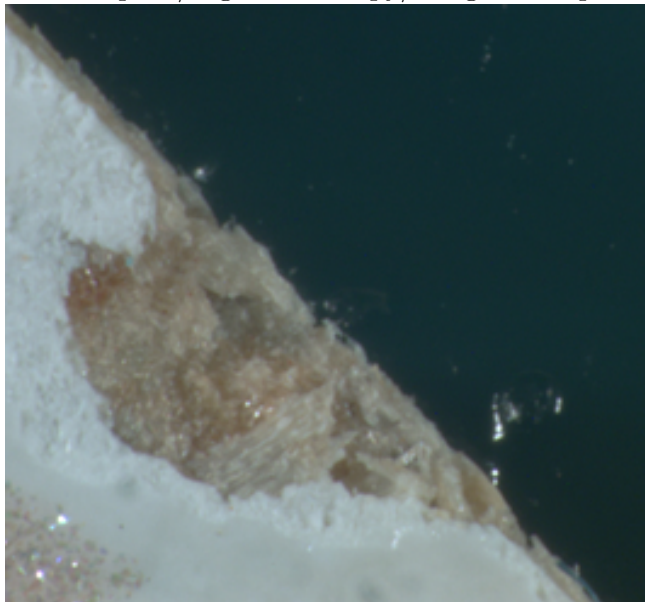
*Figure 6. Light microscopy image x16 showing the void caused by the removal of the particle in Figure 5.*

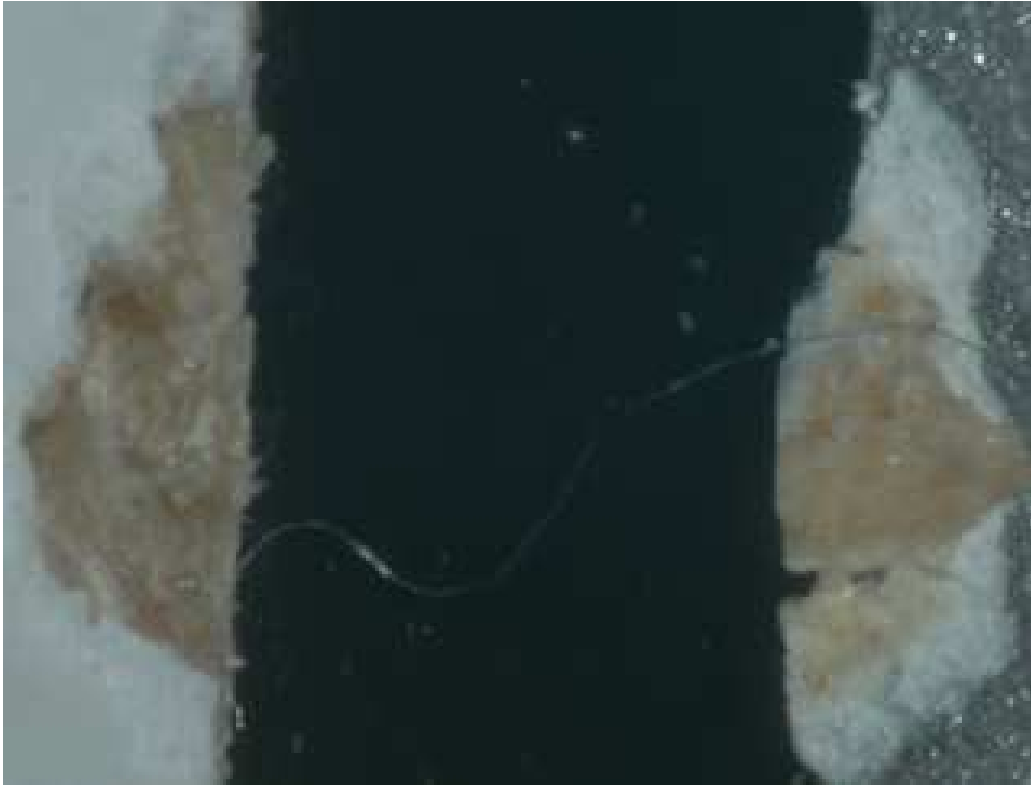
*Figure 7. Light microscopy image x16 showing both the void and particle caused by chipout. Note that the evidence of sapstain in the hole is not evident in the removed particle, i.e. the particles which were removed were whole and not fractured.*

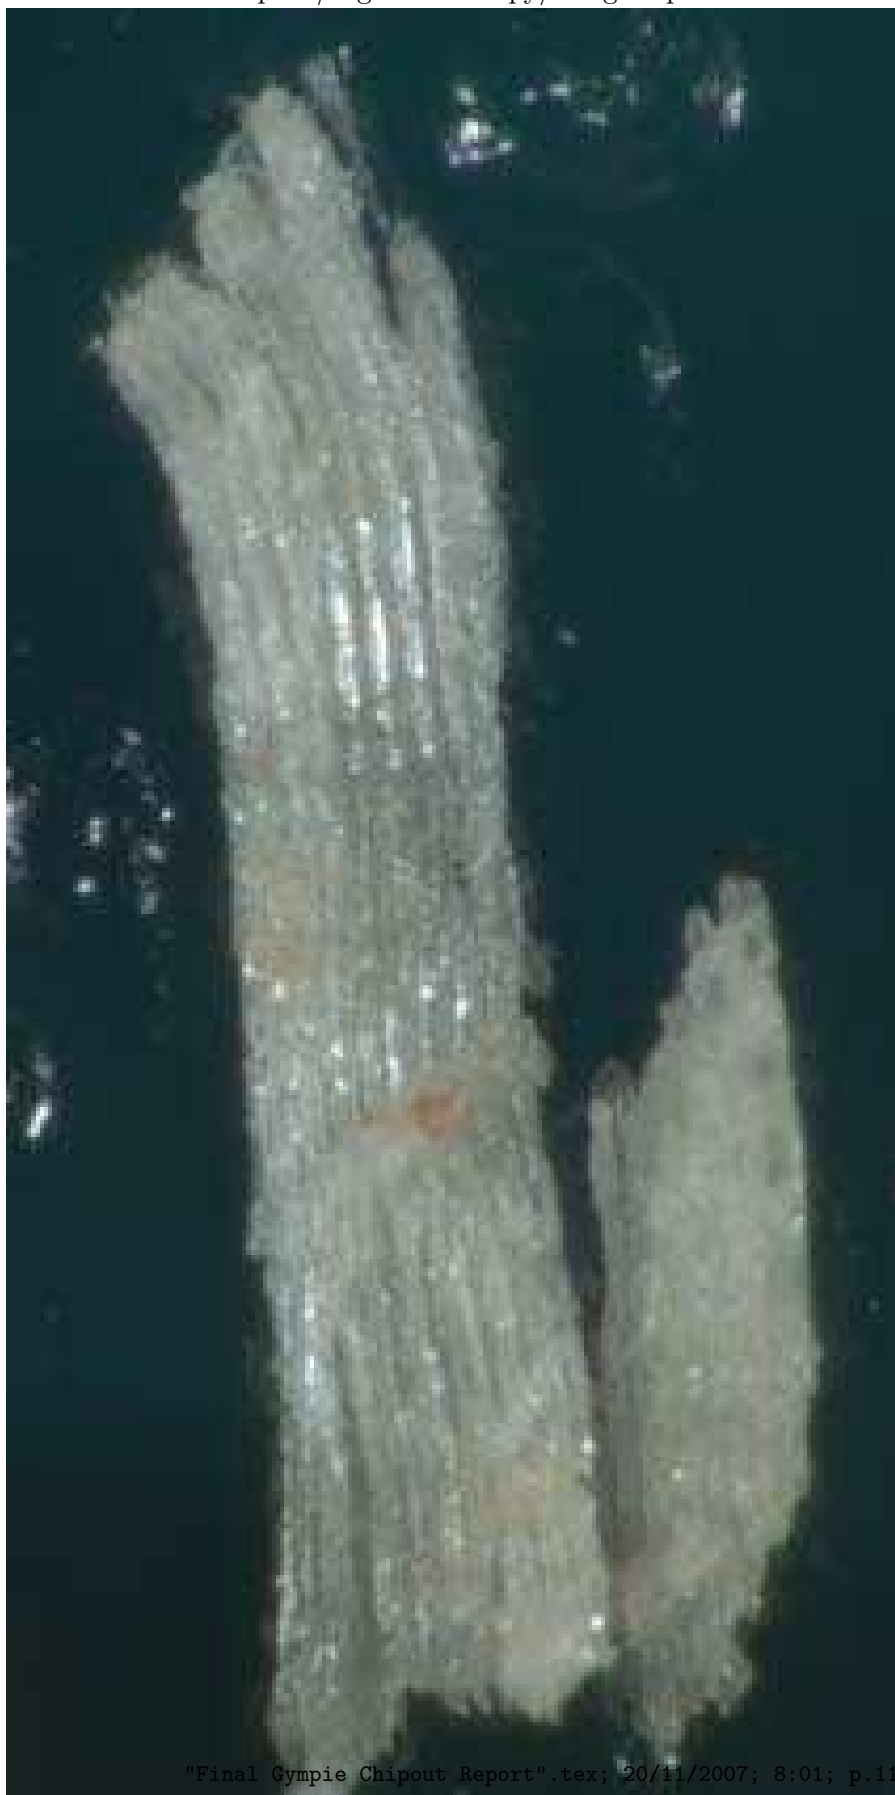
The other aspect that was examined was the particle geometry of Gympie surface flake. It can be seen from Figures 8 & 9 that the aspect ratio of the flake is excellent and only very few "cubic" flakes were observed. The flake geometry shown in the images is very good and would only enhance the ability of the flake to be maintained in the surface matrix and thus was not considered as part of the problem.

Figure 8. Light microscopy image x32 showing particle geometry of Gympie surface flake.

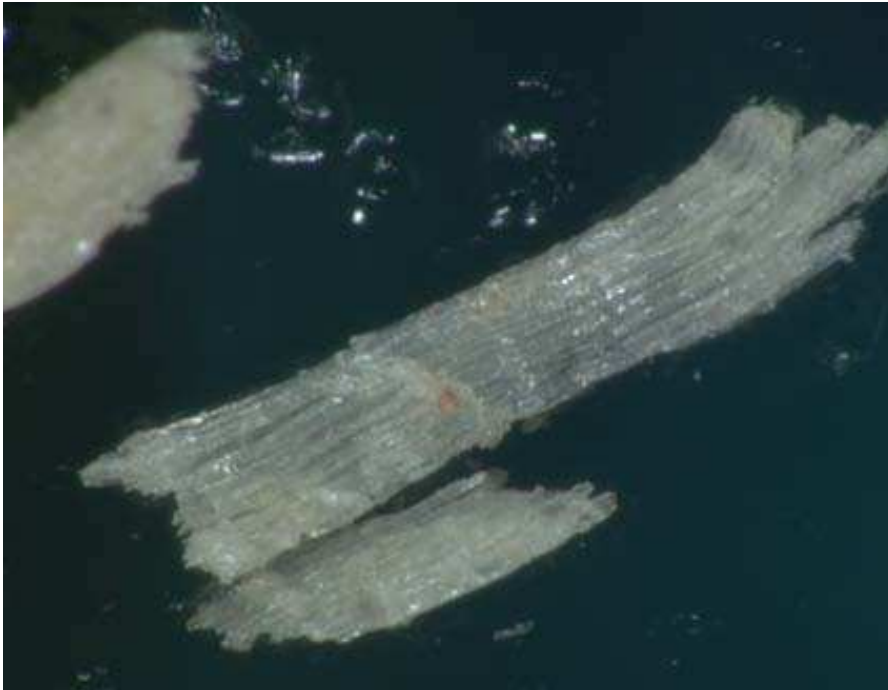
*Figure 9. Light microscopy image x32 showing both particle geometry of Gympie surface flake. Note the high surface area to volume (aspect) ratio.*

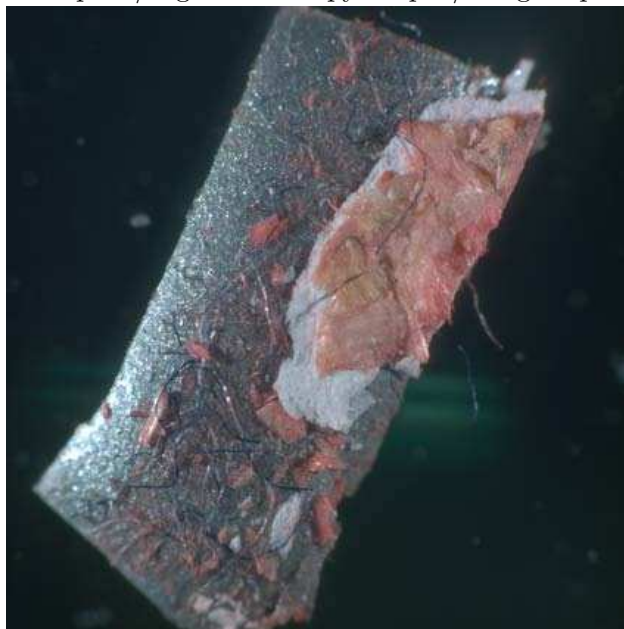
As demonstrated above SEM and light microscopy examination showed that firstly there was insufficient resin on both the chip-out particles as well the remaining void. It was also shown that the particles were not fracturing and that particle geometry was not a factor. A technique was developed to determine the distribution of resin on individual flake. The presence of red dye on the flake indicates a lack of resin. Figures 10 & 11 & 12 & 13 show a heavy presence of red dye on all of the particles that had chipped out. This shows that there was very little if any resin on these particles fully explaining why they chipped out, i.e. if particles are not strongly bound to each other in the surface then machining will easily dislodge them, hence chip-out.

*Figure 10. Light microscopy image x10 showing both particle removed as a result of chip-out, note presence of red dye indicating little resin.*

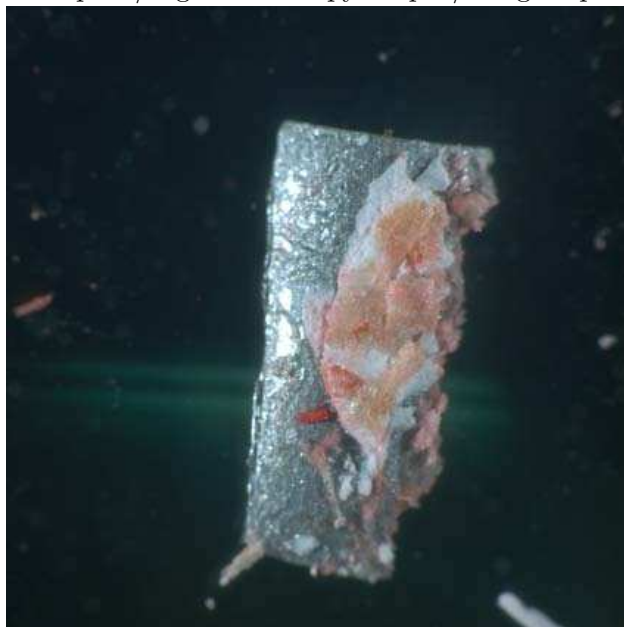
*Figure 11. Light microscopy image x10 showing both particle removed as a result of chip-out, note presence of red dye indicating little resin.*

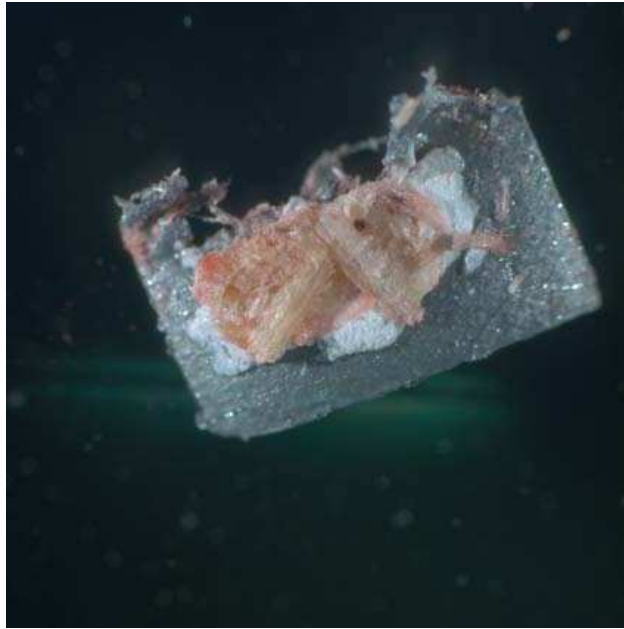
*Figure 12. Light microscopy image x10 showing both particle removed as a result of chip-out, note presence of red dye indicating little resin.*

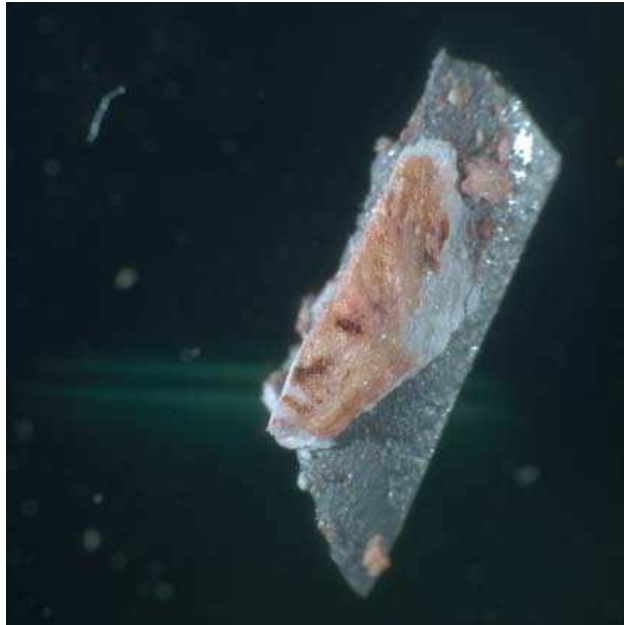
*Figure 13. Light microscopy image x10 showing both particle removed as a result of chip-out, note presence of red dye indicating little resin.*

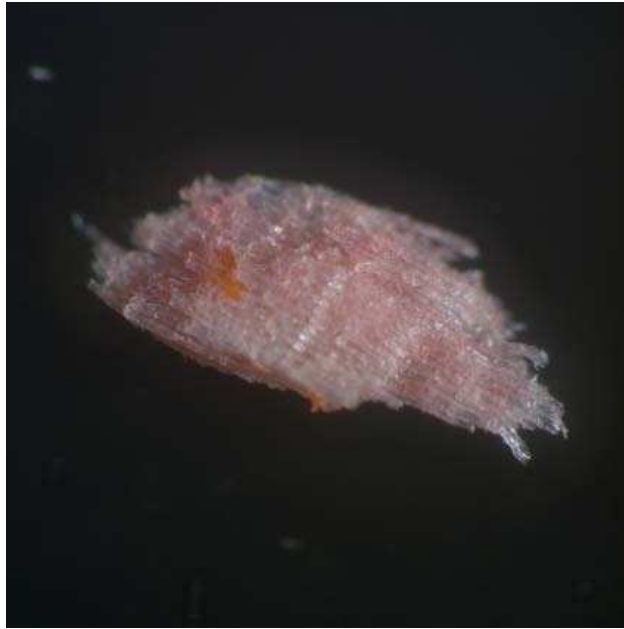
A detailed examination of resin distribution was conducted on blended surface flake ex the G1 spreaders and the situation was exactly the same as with the chip-out particles themselves. There was very little flake that exhibited effective resin distribution. The following images (Figures 14 & 15 & 16) are taken from surface flake from the G1 spreaders, i.e. after blending. Most showed little or no resination. Figure 17 shows some degree of resination, however this degree of resination was rarely seen. Less than 5% of the flake was effectively resinated and >70% of the flake had no resin whatsoever.

*Figure 14. Light microscopy image x20 of blended surface flake ex the G1 spreaders showing little resination as seen by presence of red dye indicating little resin.*

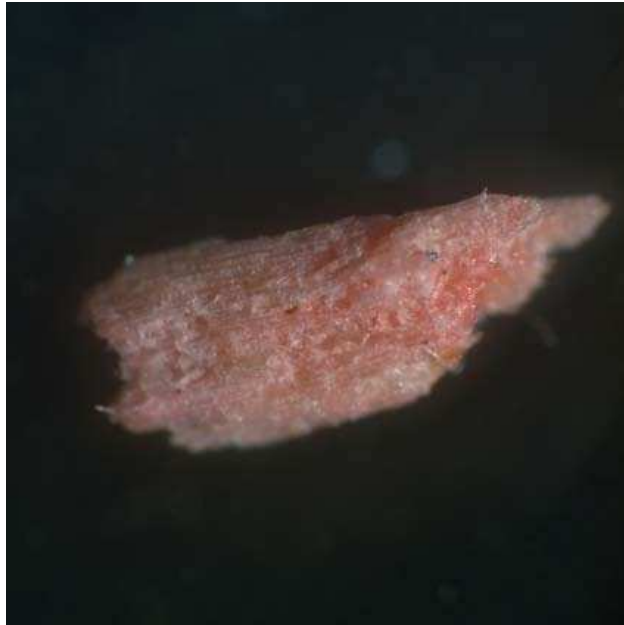
*Figure 15. Light microscopy image x20 of blended surface flake ex the G1 spreaders showing little resination as seen by presence of red dye indicating little resin.*

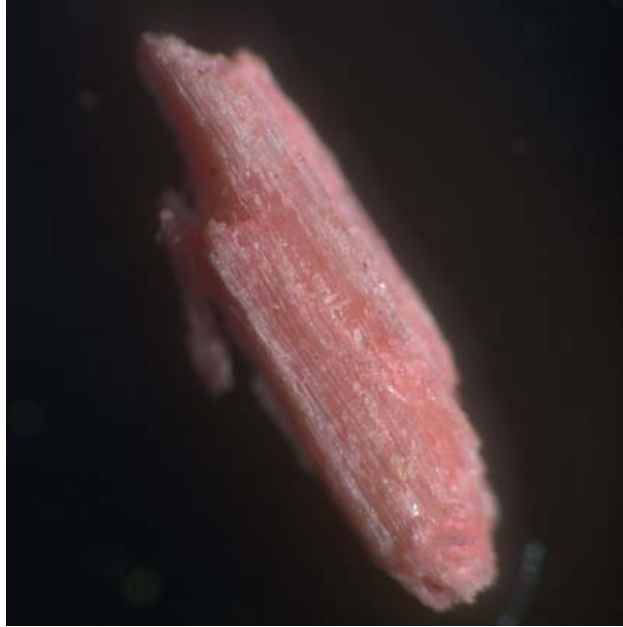
*Figure 16. Light microscopy image x20 of blended surface flake ex the G1 spreaders showing little resination as seen by presence of red dye indicating little resin.*

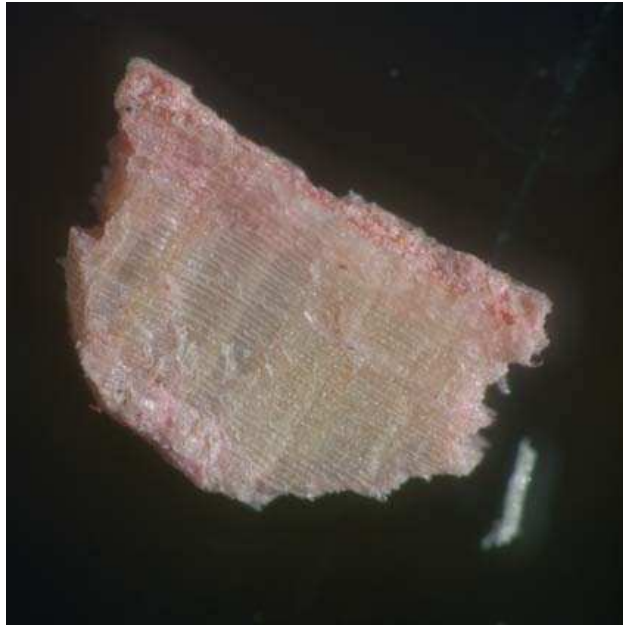
*Figure 17. Light microscopy image x20 of blended surface flake ex the G1 spreaders some resination as seen by a lower concentration of red dye on the flake.*

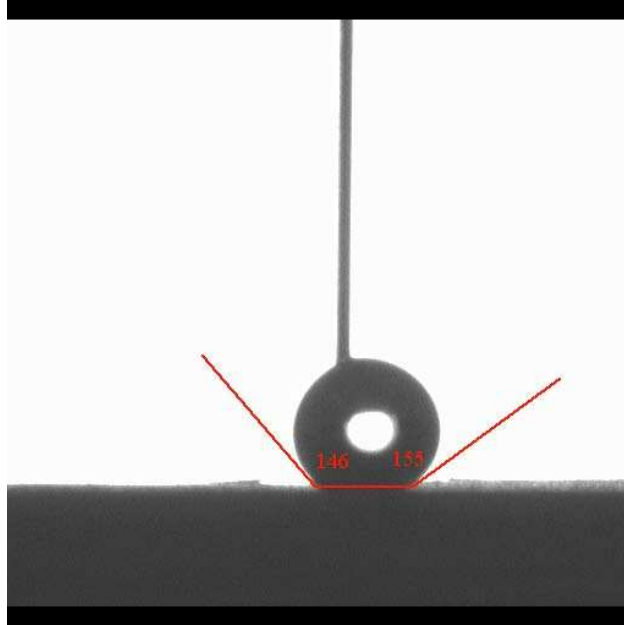
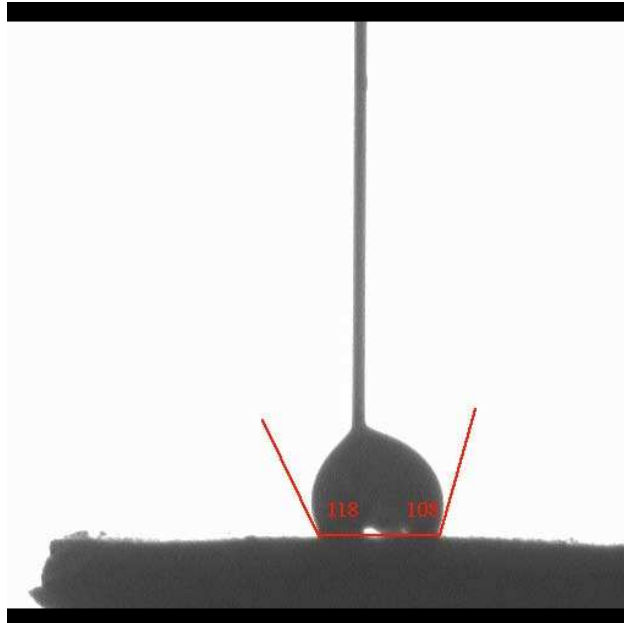
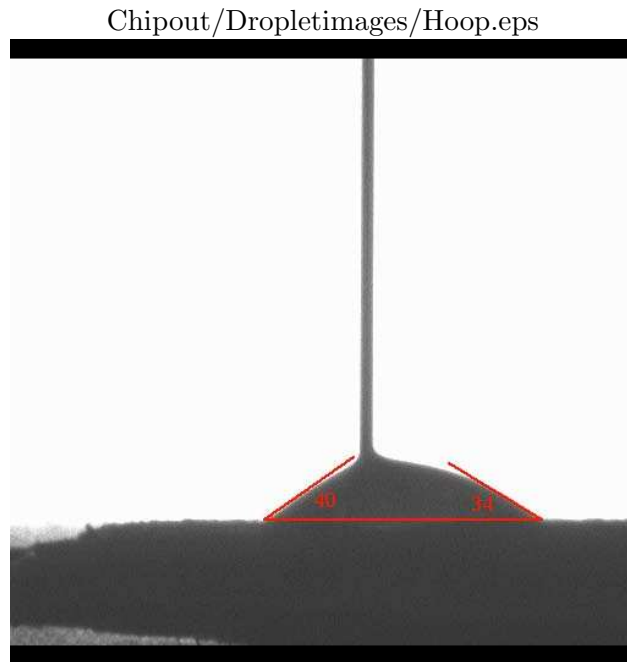
It is easy to see from Figures 18 to 20 that Slash pine is a non-wetting species whereas Hoop wets very well, explaining the reason why Hoop surface board machined well. The reason is that there is a very high resin content in Slash pine which under high temperature drying convert to fatty acids on the surface of the flake which are very hydrophobic. This would explain the finding by Ross Cunningham that with reduced drier temperatures resulted in better machinability properties because there is a lower level of conversion of wood resins in the Slash pine to fatty acids. Therefore the chipout problem is therefore caused by poor resination of surface flake, which is predominantly Slash pine. This is due to low surface energy of slash pine and high surface tension of resin mix (high interfacial energy)

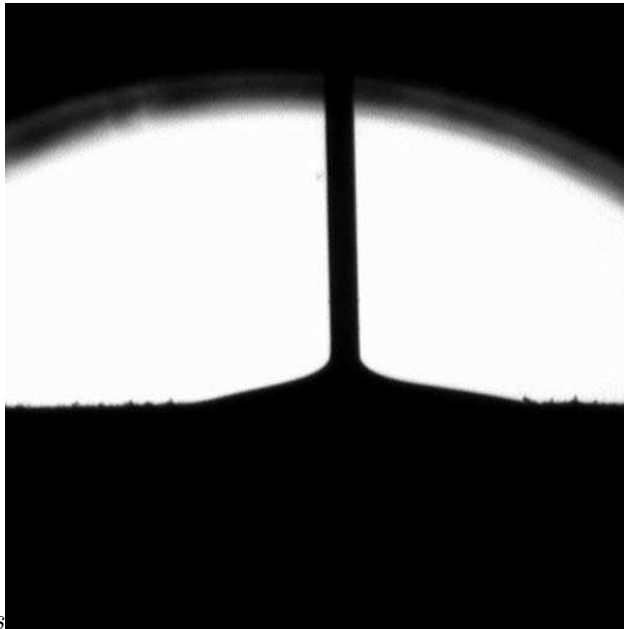
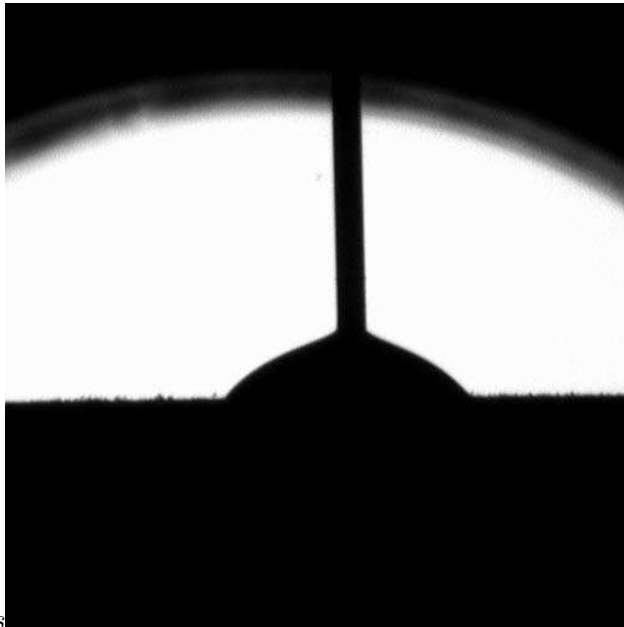
In the end a number of combinations of concentrations of Teric N9 an alkyl nonylphenol ethoxylate non-ionic surfactant sourced from Hunstman Chemicals were added to water to pre-wet the flake and in so doing increase the surface energy of the wood and to the resin to reduce the surface tension of the resin. In the end a combination of 0.1% N9 added to the water with 0.5% N9 added to the resin proved to be the best combination as determined by measuring contact angle. Figures 21 & 22 show the effect i.e. reducing the contact angle from above  $140^\circ$  to less than  $20^\circ$ .
