Blending efficiency Part A:

Solving the problem of chipout in laminated particleboard

Dr Raymond J. Roberts

RJRoberts Consulting Pty Ltd

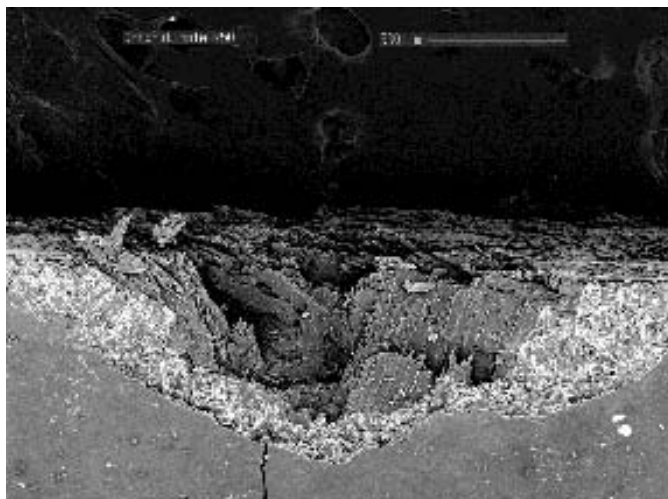
Figures 1, 2 & 3 show details of the void left by chipout and the removed particle that caused it. The only resin evident is the saturating UF resin within the LPM paper. Of the 98 samples examined using SEM (both particle and void), only one sample showed any evidence of resination either on the chipout piece or chipout void (Figure 4). Note in the image that where there is resin present, the detail on the surface of the flake appears somewhat blurred and where there is no resin on the flake the surface detail can be seen with high clarity. The resin was only present on a small proportion of the total void. Apart from on this one sample, there was no resin on any of the flake either in the remaining hole or the chipout particle itself. What SEM analysis did not make clear however is whether the particles of flake actually broke apart as opposed to being chipped out whole. Both of these scenarios would result in little or no resin being apparent.

Figure 1 (x50) the void caused by chipout

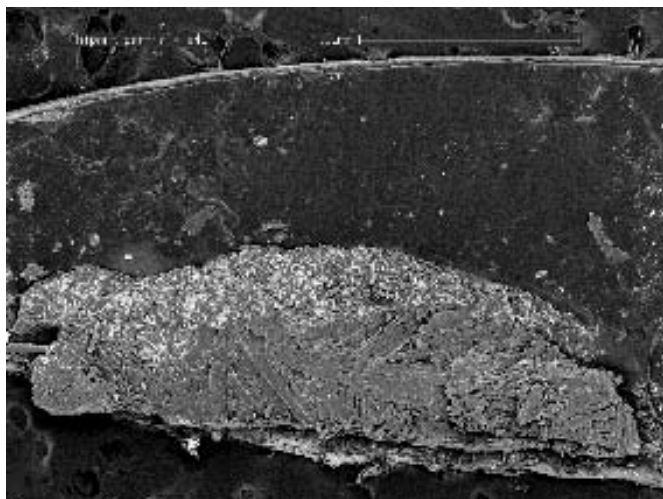
Figure 2 (x40) particle that was removed

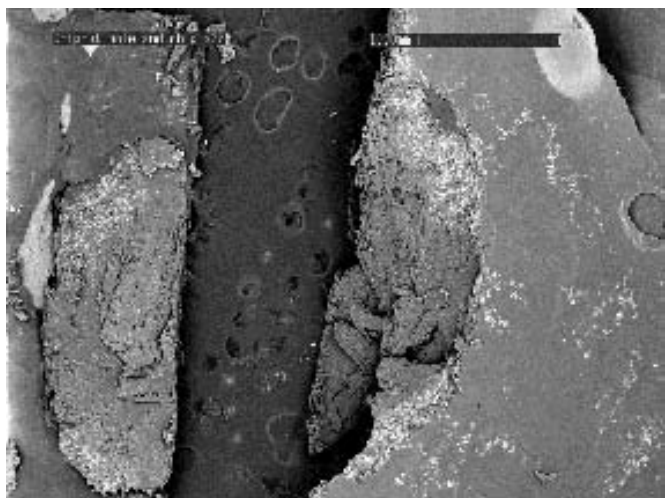
Figure 3 (x26) void and associated particle

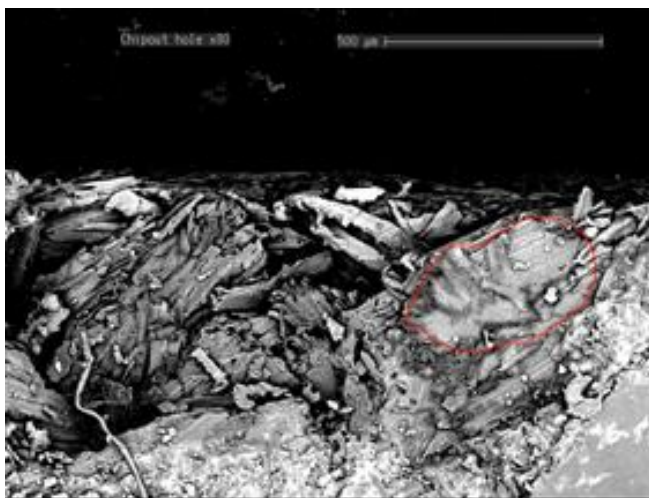
Figure 4 (x80) showing some resination in the chipout void (bounded by a red line)

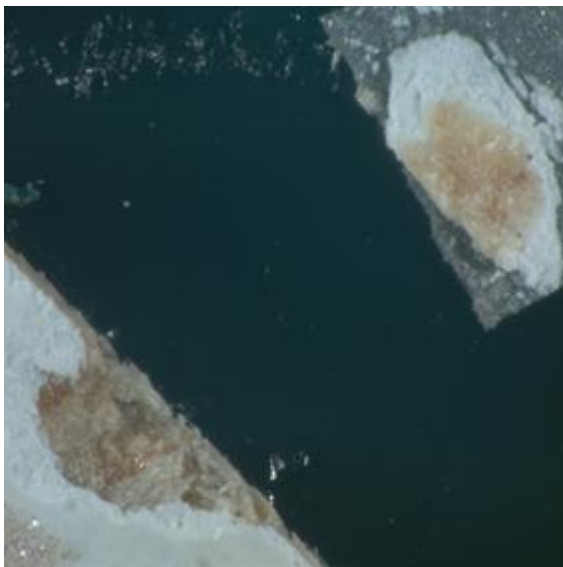
Light microscopy images (*Figures 5 & 6*) show a chipout particle and associated void. Note that the area of paper is larger than the actual amount of wood particles removed. This was the case in every instance showing that even if a small particle was dislodged, a resultant much larger section of laminated paper was removed leaving a substantial void. In most cases the paper actually partially delaminated i.e. the melamine coated layer splits from the UF impregnated core. This is more clearly shown by SEM (*Figures 1-3*) where the impregnating UF resin is highlighted with backscattered SEM imaging. Light microscopy also showed that a chipout particle had evidence of sapstain fungus (*Figure 7*), and there being no corresponding sapstain fungus on the associated chipout void. This suggested that the particles were chipping out whole i.e. they were not actually splitting up.

Figure 5 chipout particle and associated void

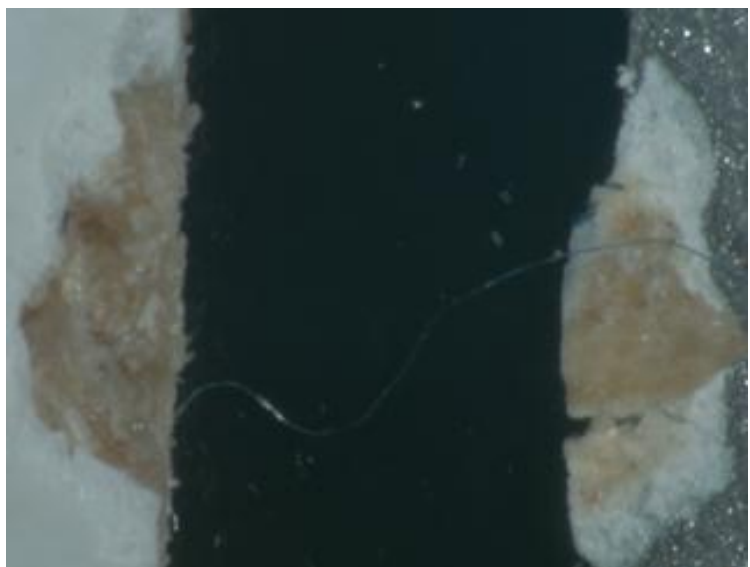
Figure 6 chipout particle and void

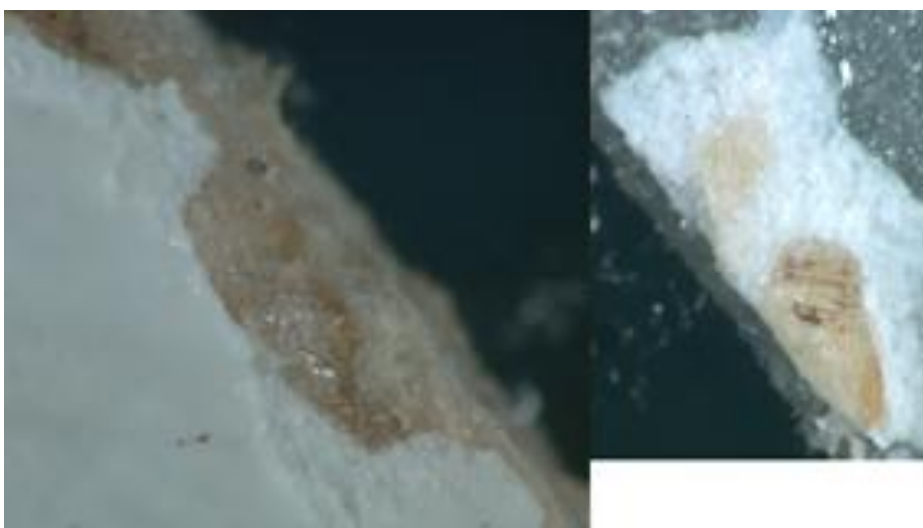
Figure 7 showing a chipout particle with sapstain fungus and associated void without

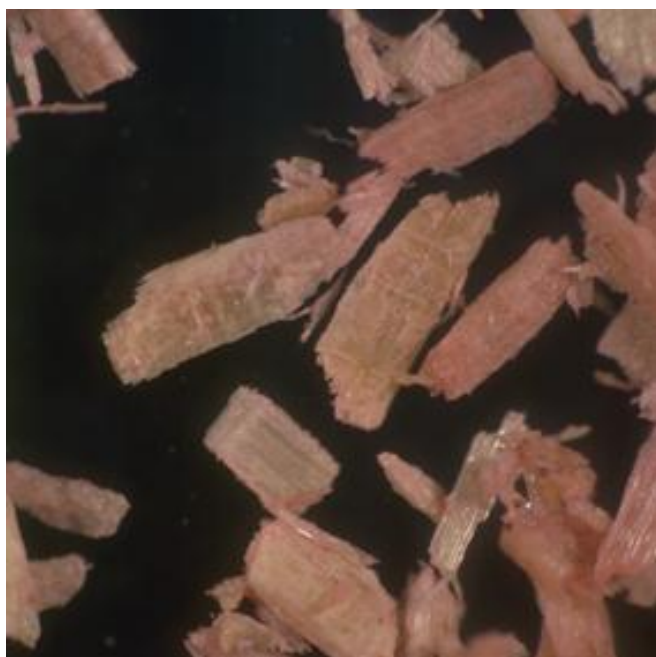
The other aspect that was examined was the particle geometry of plant's surface flake. It can be seen from *Figures 8 & 9* that the aspect ratio of the flake was excellent and only very few "cubic" flakes were observed. Thus flake geometry as shown in the images was very good and would only enhance the ability of the flake to be maintained in the surface matrix and thus was not considered as part of the problem.

Figure 8 (x10) showing good particle geometry of the plant's surface flake

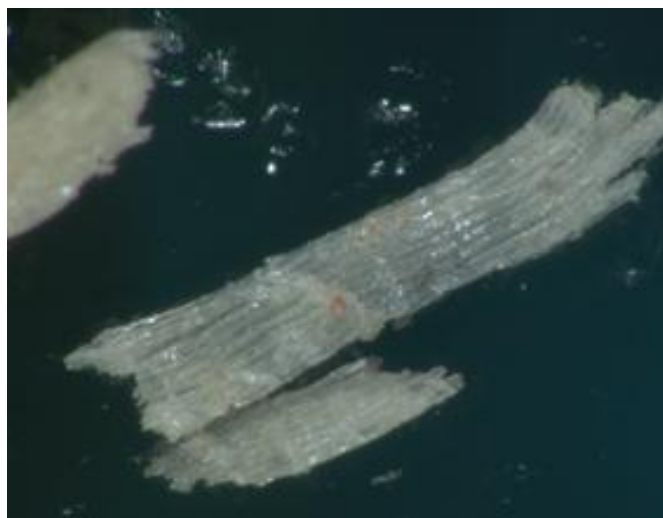
Figure 9 (x32) showing the high surface to volume (aspect) ratio

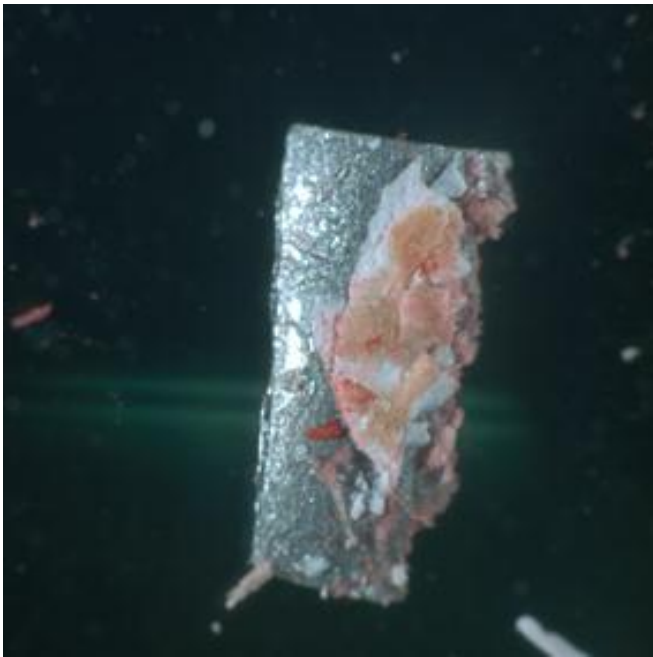
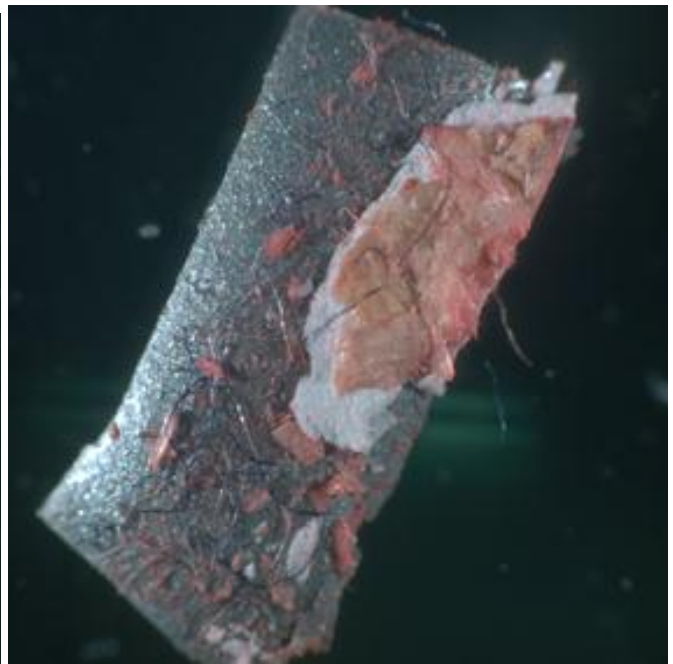
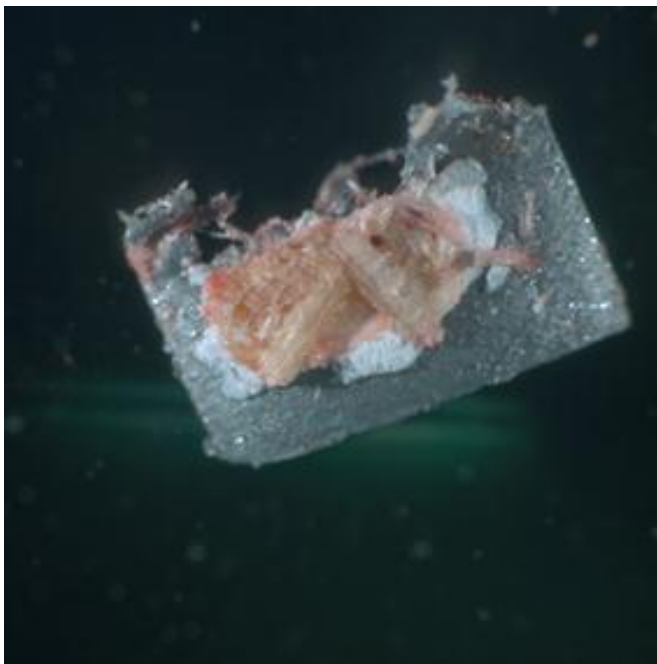
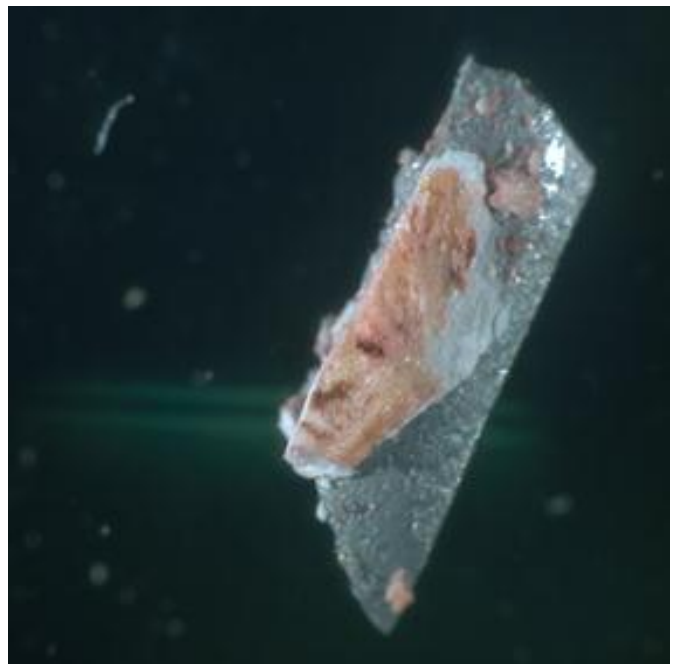
Figure 10 (x10) particle removed by chipout

Figure 11 (x10) particle removed by chipout

Figure 12 (x10) particle removed by chipout

Figure 13 (x10) particle removed by chipout

Note the presence of the Safronin O dye showing no resin distributed on the flake.

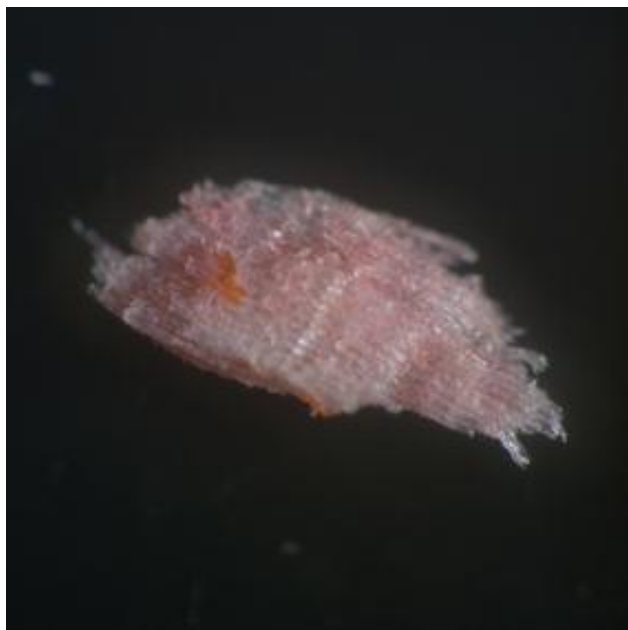
Figure 14 (x20) poorly blended surface flake as can be seen by the amount of Safronin O dye present

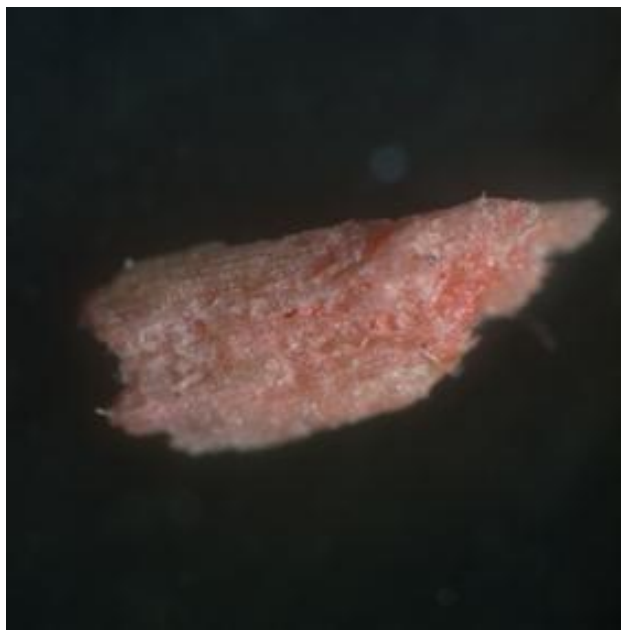
Figure 15 (x20) very poorly blended surface flake

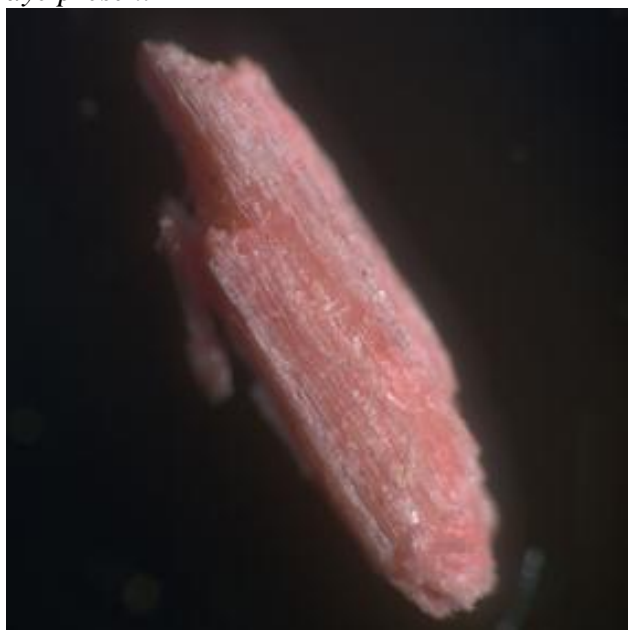
Figure 16 (x20) poorly blended surface flake

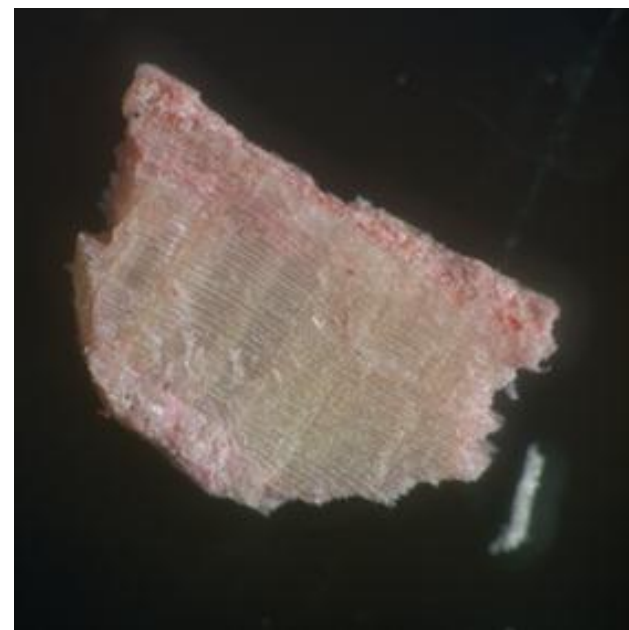
Figure 17 (x20) well blended surface flake note much less Safronin O dye on flake

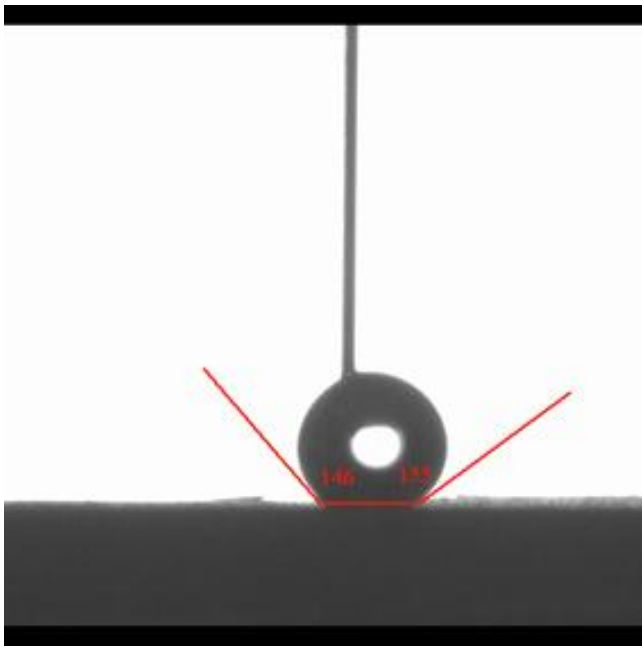
Figure 18 Goniometry image of resin drop on block of slash pine contact angle 150°

It is easy to see from *Figures 18 - 20* that Slash pine is a non-wetting species whereas Hoop wets very well, explaining the reason why board made with Hoop pine machined well. This was due to the very high resin content in Slash pine (5-48%), which under high temperature drying converted to fatty acids on the surface of the flake which became very hydrophobic. This would explain the finding by Cunningham 2003 that reduced drier temperatures resulted in better machinability properties because there was a lower level of conversion of wood resins in the Slash pine to fatty acids through pyrolysis

(Khan 2000). Therefore the chipout problem was caused by poor resination of surface flake, due to low surface free energy of slash pine after high temperature drying and high surface tension of resin mix (high interfacial energy). Viscosity of the resin mix obviously has an effect however it would be the same for all species. Simply adding water to resins is not a good solution as this may reduce viscosity but does nothing to change the surface tension. It also slows cure time down due to the increased level of steam that has to be removed from the curing panel during pressing.

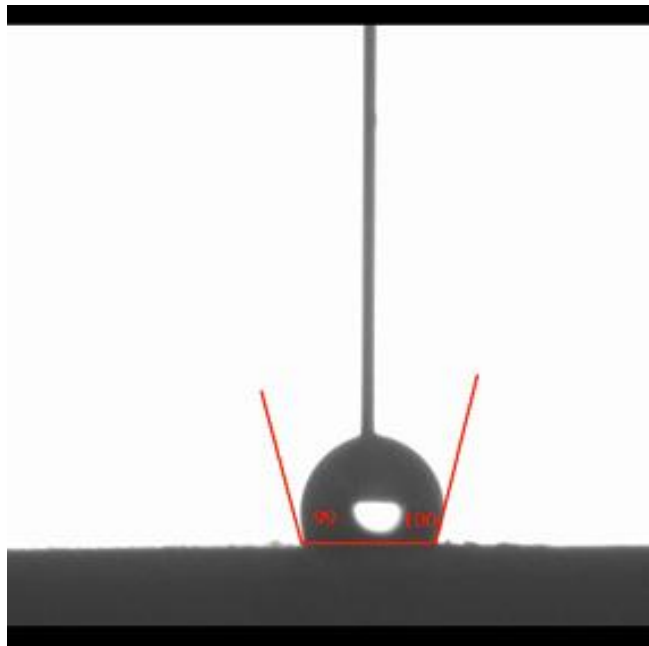
Figure 19 Goniometry image of resin drop on block of radiata pine contact angle 100°

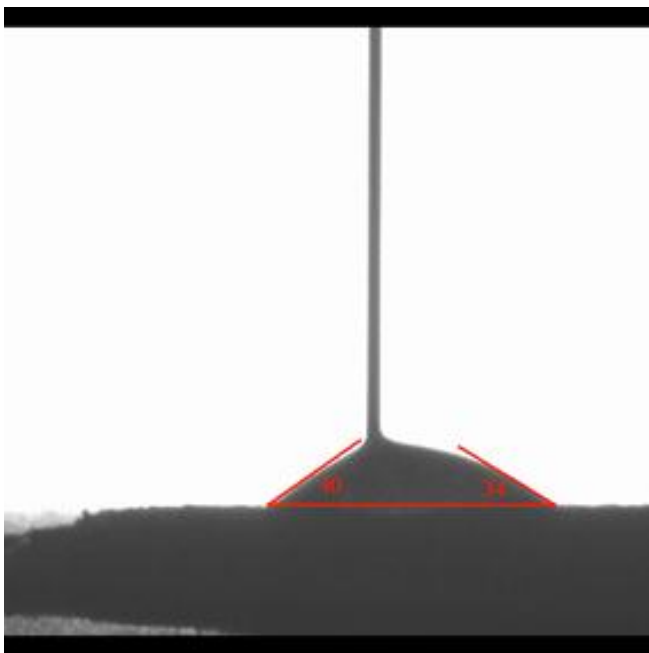
Figure 20 Goniometry image of resin drop on block of hoop pine contact angle 36°

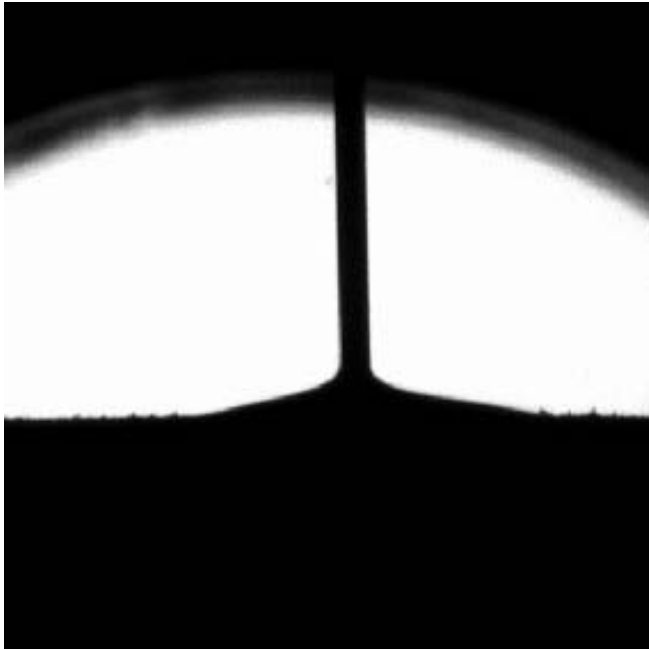
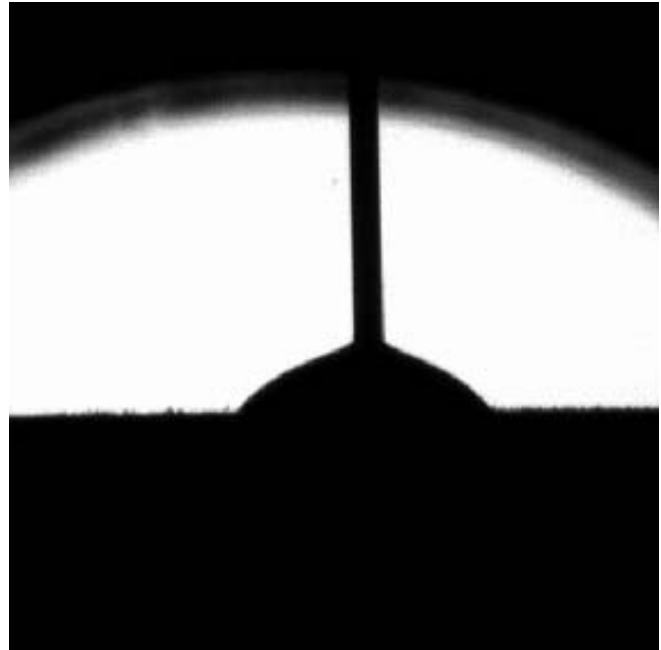
Figure 21 showing the contact angle of resin on Slash Pine with 0.2%

Figure 22 same as Figure 21, compare with Figure 18

A purposely developed multi-phase wetting system Rezex A™, was introduced to the surface resin mix only at an equivalent rate of 0.4% on dry wood weight. This was developed at the Australian National University and is now being manufactured by Oxford Technologies Australia in Melbourne. *Figures 21 & 22* show the effect i.e. reducing the contact angle of resin from above 140° to less than 20°.
