Blending efficiency Part A:

Solving the problem of chipout in laminated particleboard

Dr Raymond J. Roberts

RJRoberts Consulting Pty Ltd

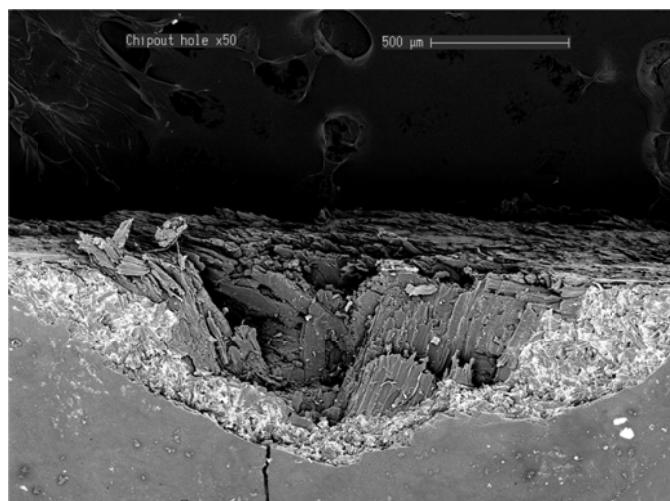
Figures 1, 2 & 3 show details of the void left by chipout and the removed particle that caused it. The only resin evident is the saturating UF resin within the LPM paper. Of the 98 samples examined using SEM (both particle and void), only one sample showed any evidence of resination either on the chipout piece or chipout void (*Figure 4*). Note in the image that where there is resin present, the detail on the surface of the flake appears somewhat blurred and where there is no resin on the flake the surface detail can be seen with high clarity. The resin was only present on a small proportion of the total void. Apart from on this one sample, there was no resin on any of the flake either in the remaining hole or the chipout particle itself. What SEM analysis did not make clear however is whether the particles of flake actually broke apart as opposed to being chipped out whole. Both of these scenarios would result in little or no resin being apparent.

Figure 1 (x50) the void caused by chipout

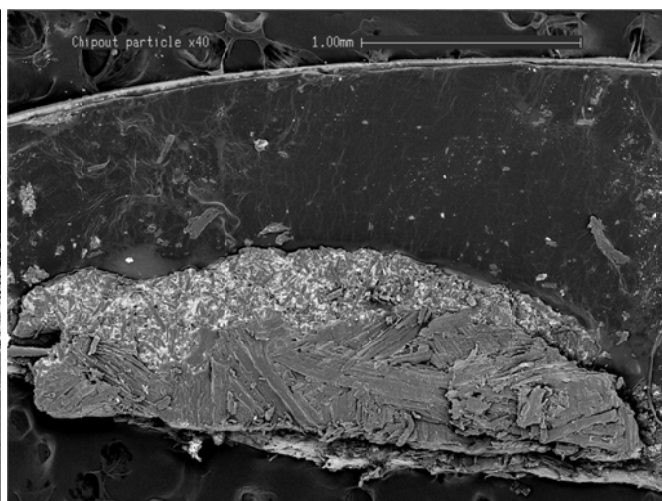
Figure 2 (x40) particle that was removed

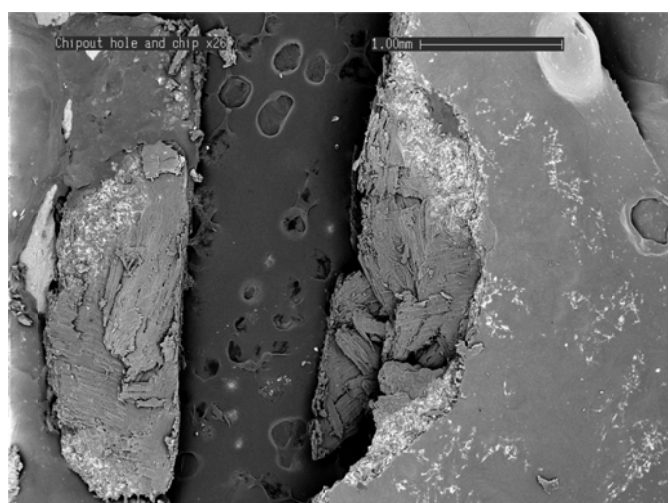
Figure 3 (x26) void and associated particle

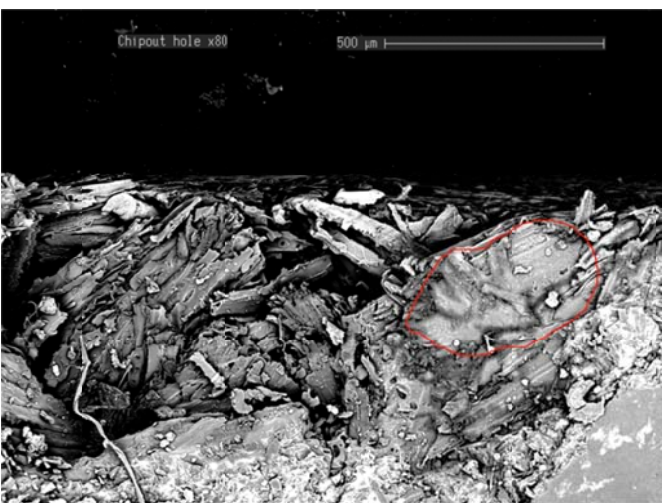
Figure 4 (x80) showing some resination in the chipout void (bounded by a red line)

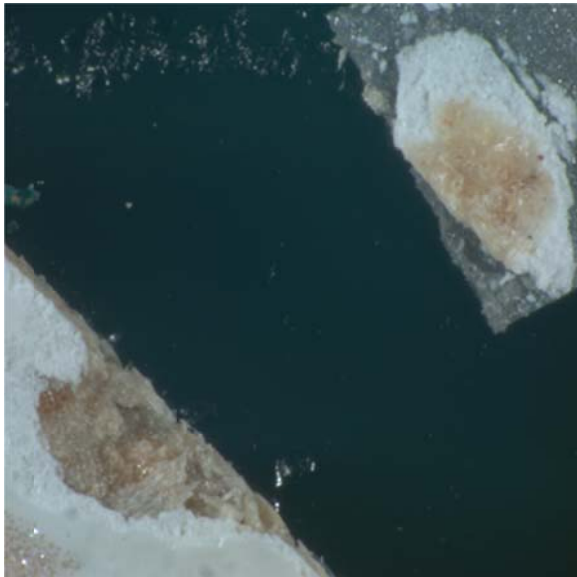
Light microscopy images (*Figures 5 & 6*) show a chipout particle and associated void. Note that the area of paper is larger than the actual amount of wood particles removed. This was the case in every instance showing that even if a small particle was dislodged, a resultant much larger section of laminated paper was removed leaving a substantial void. In most cases the paper actually partially delaminated i.e. the melamine coated layer splits from the UF impregnated core. This is more clearly shown by SEM (*Figures 1-3*) where the impregnating UF resin is highlighted with backscattered SEM imaging. Light microscopy also showed that a chipout particle had evidence of sapstain fungus (*Figure 7*), and there being no corresponding sapstain fungus on the associated chipout void. This suggested that the particles were chipping out whole i.e. they were not actually splitting up.

Figure 5 chipout particle and associated void

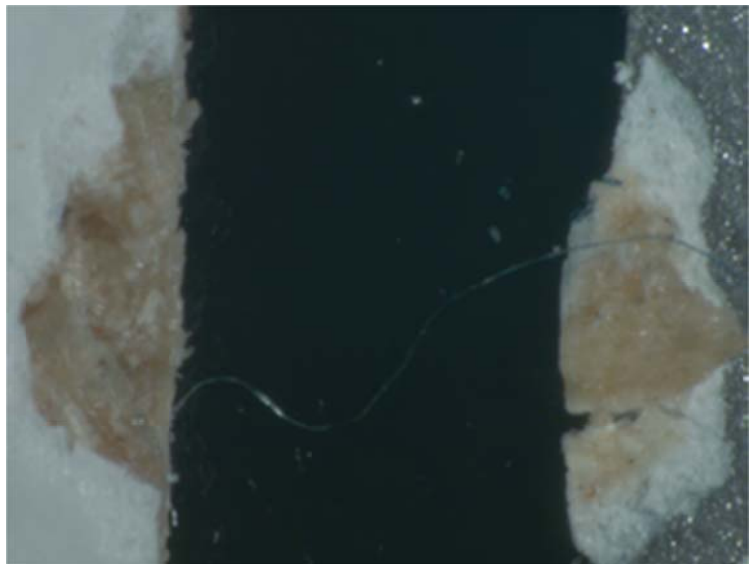
Figure 6 chipout particle and void

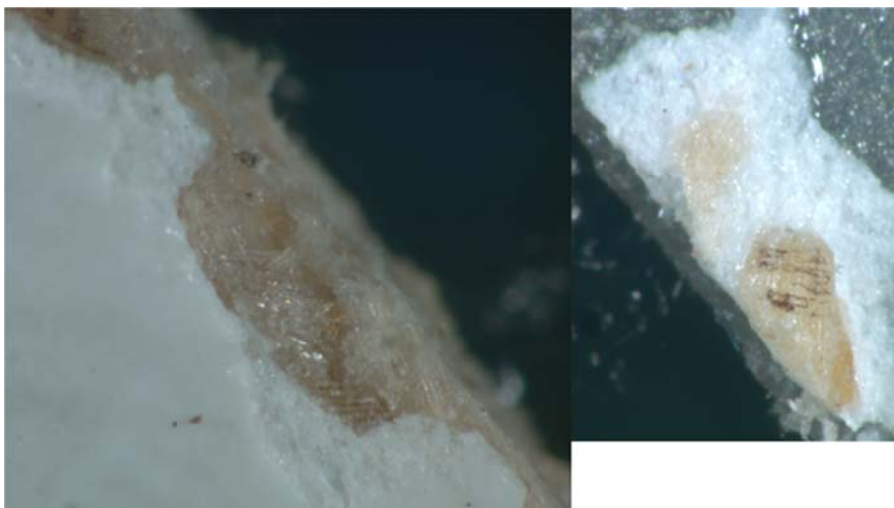
Figure 7 showing a chipout particle with sapstain fungus and associated void without

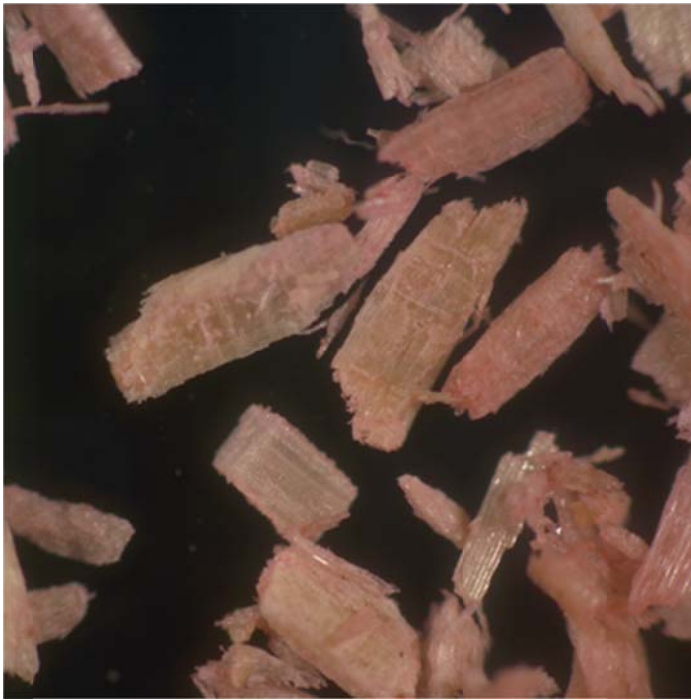
The other aspect that was examined was the particle geometry of plant's surface flake. It can be seen from *Figures 8 & 9* that the aspect ratio of the flake was excellent and only very few "cubic" flakes were observed. Thus flake geometry as shown in the images was very good and would only enhance the ability of the flake to be maintained in the surface matrix and thus was not considered as part of the problem.

Figure 8 (x10) showing good particle geometry of the plant's surface flake

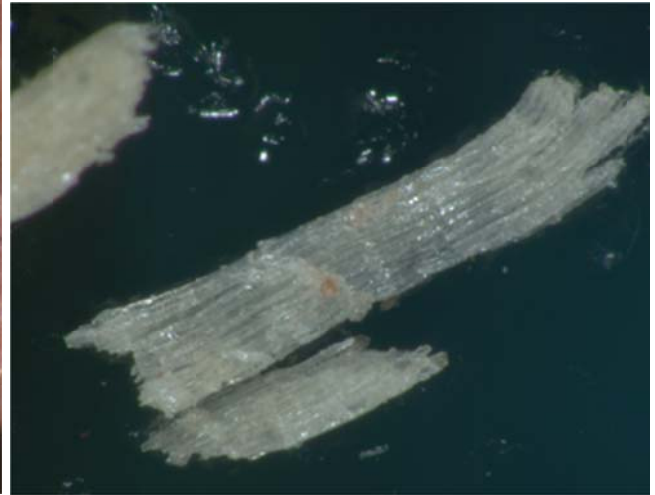
Figure 9 (x32) showing the high surface to volume (aspect) ratio

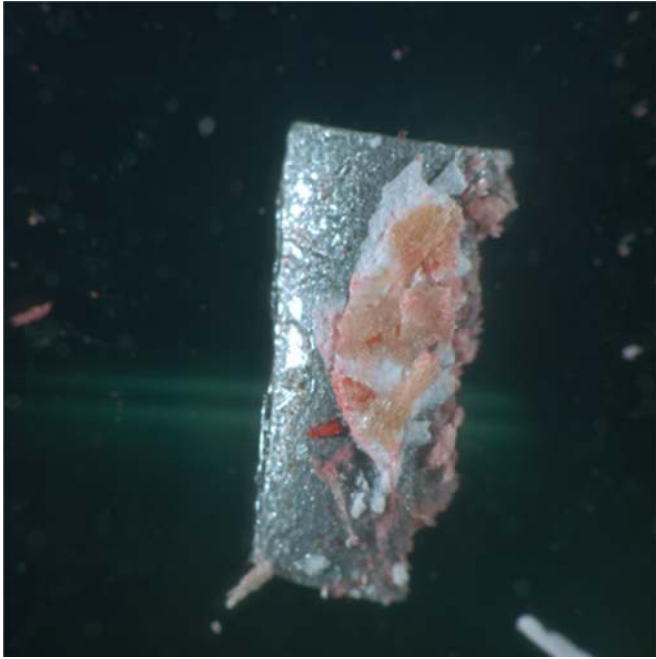
Figure 10 (x10) particle removed by chipout

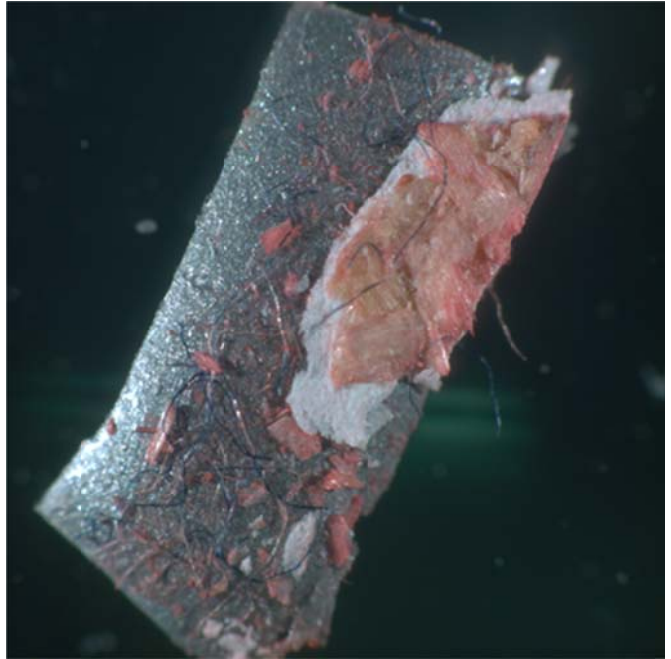
Figure 11 (x10) particle removed by chipout

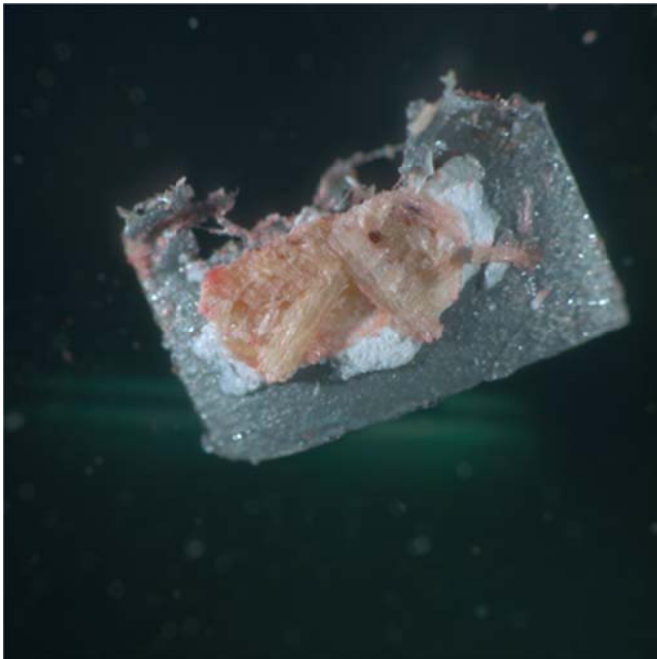
Figure 12 (x10) particle removed by chipout
Note the presence of the Safronin O dye showing no resin distributed on the flake.

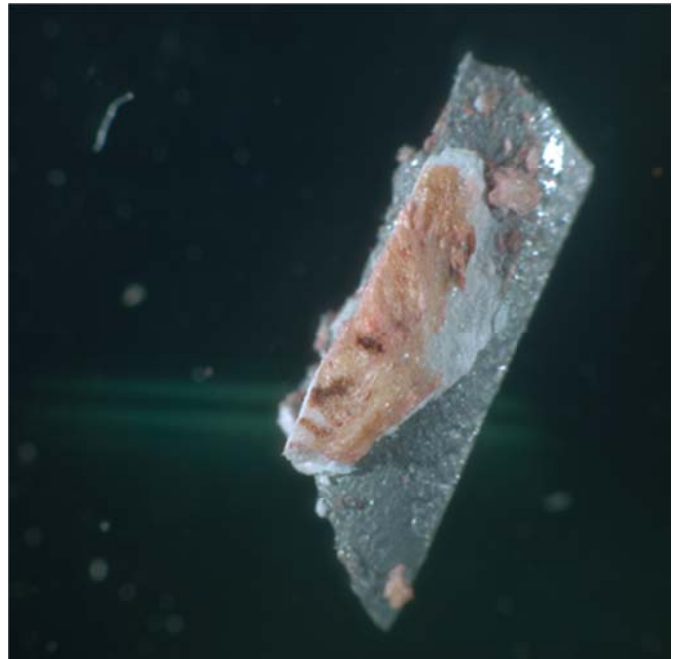
Figure 32 (x10) particle removed by chipout

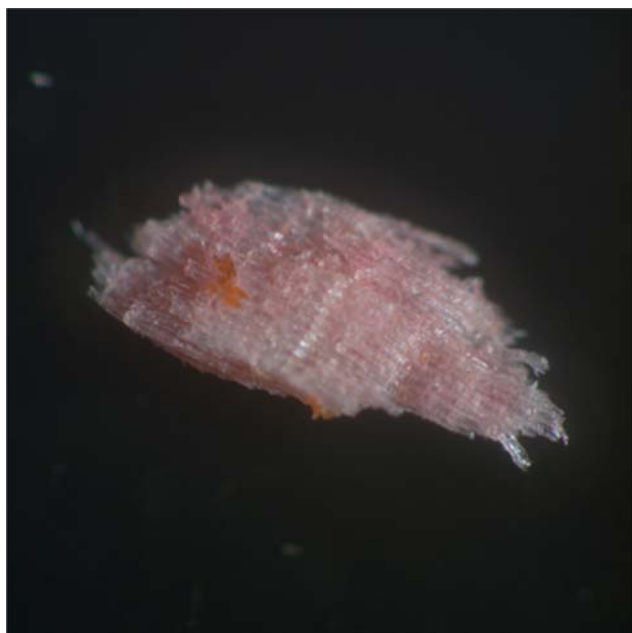
Figure 14 (x20) poorly blended surface flake as can be seen by the amount of Safronin O dye present

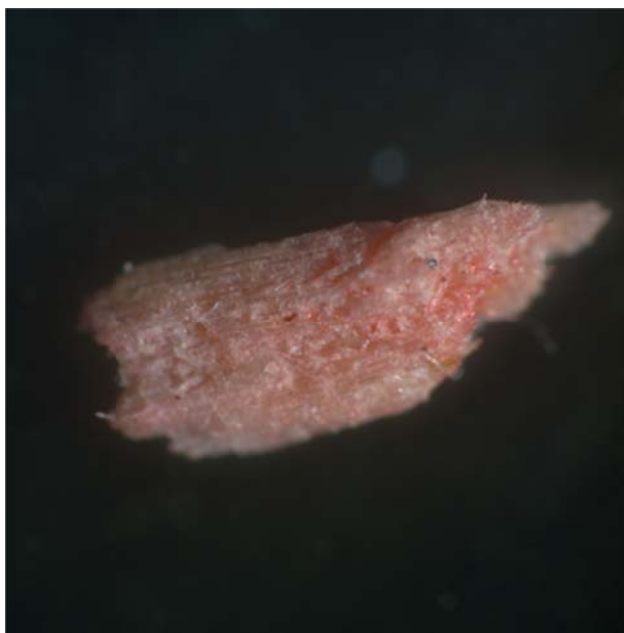
Figure 15 (x20) very poorly blended surface flake

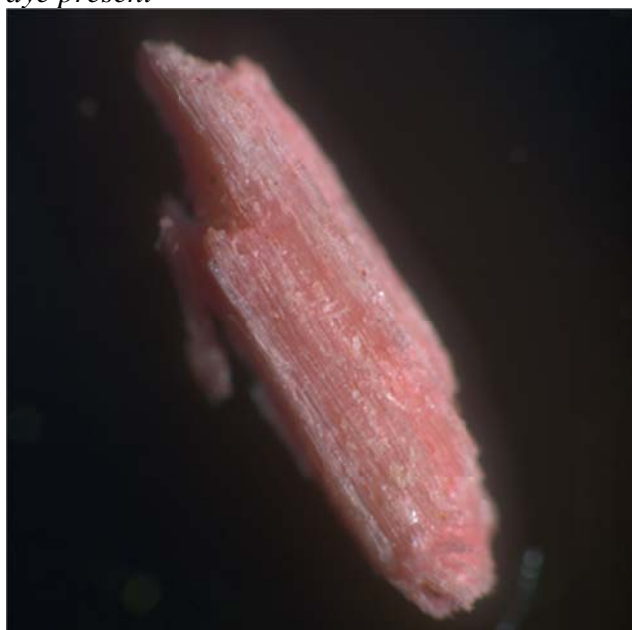
Figure 16 (x20) poorly blended surface flake

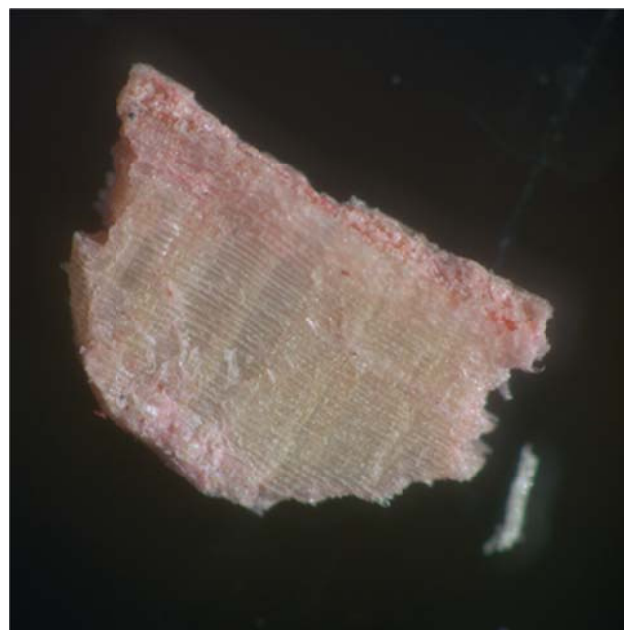
Figure 17 (x20) well blended surface flake note much less Safronin O dye on flake

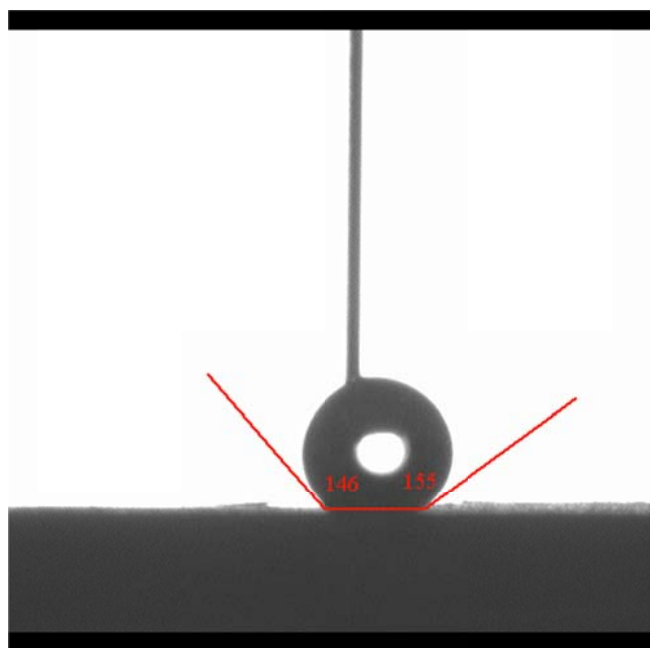
Figure 18 Goniometry image of resin drop on block of slash pine contact angle 150°

It is easy to see from *Figures 18 - 20* that Slash pine is a non-wetting species whereas Hoop wets very well, explaining the reason why board made with Hoop pine machined well. This was due to the very high resin content in Slash pine (5-48%), which under high temperature drying converted to fatty acids

on the surface of the flake which became very hydrophobic. This would explain the finding by Cunningham 2003 that reduced drier temperatures resulted in better machinability properties because there was a lower level of conversion of wood resins in the Slash pine to fatty acids through pyrolysis (Khan 2000). Therefore the chipout problem was caused by poor resination of surface flake, due to low surface free energy of slash pine after high temperature drying and high surface tension of resin mix (high interfacial energy). Viscosity of the resin mix obviously has an effect however it would be the same for all species. Simply adding water to resins is not a good solution as this may reduce viscosity but does nothing to change the surface tension. It also slows cure time down due to the increased level of steam that has to be removed from the curing panel during pressing.

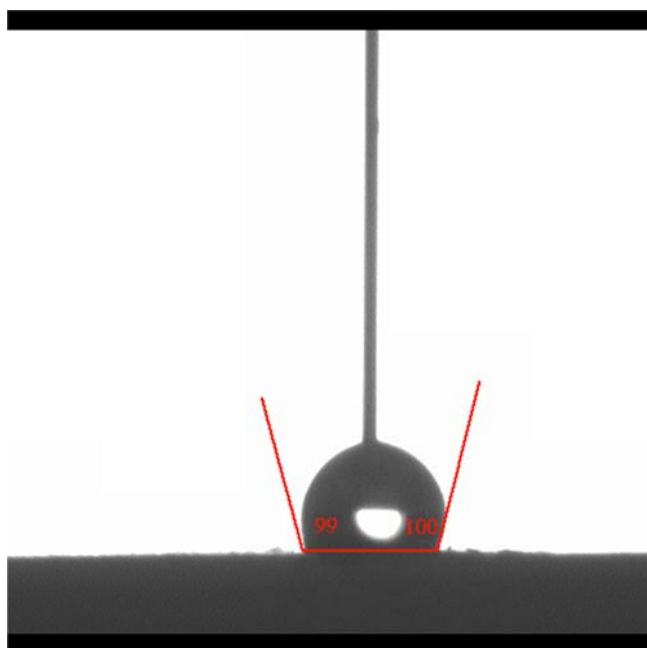
Figure 19 Goniometry image of resin drop on block of radiata pine contact angle 100°

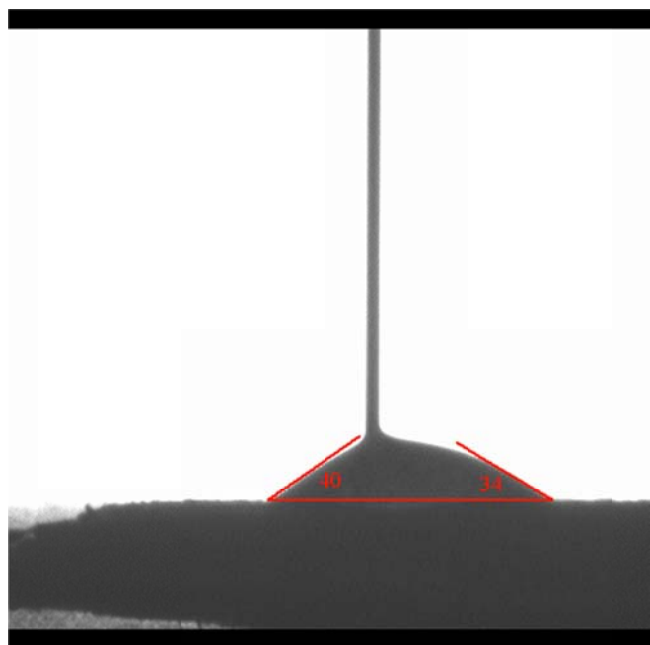
Figure 20 Goniometry image of resin drop on block of hoop pine contact angle 36°

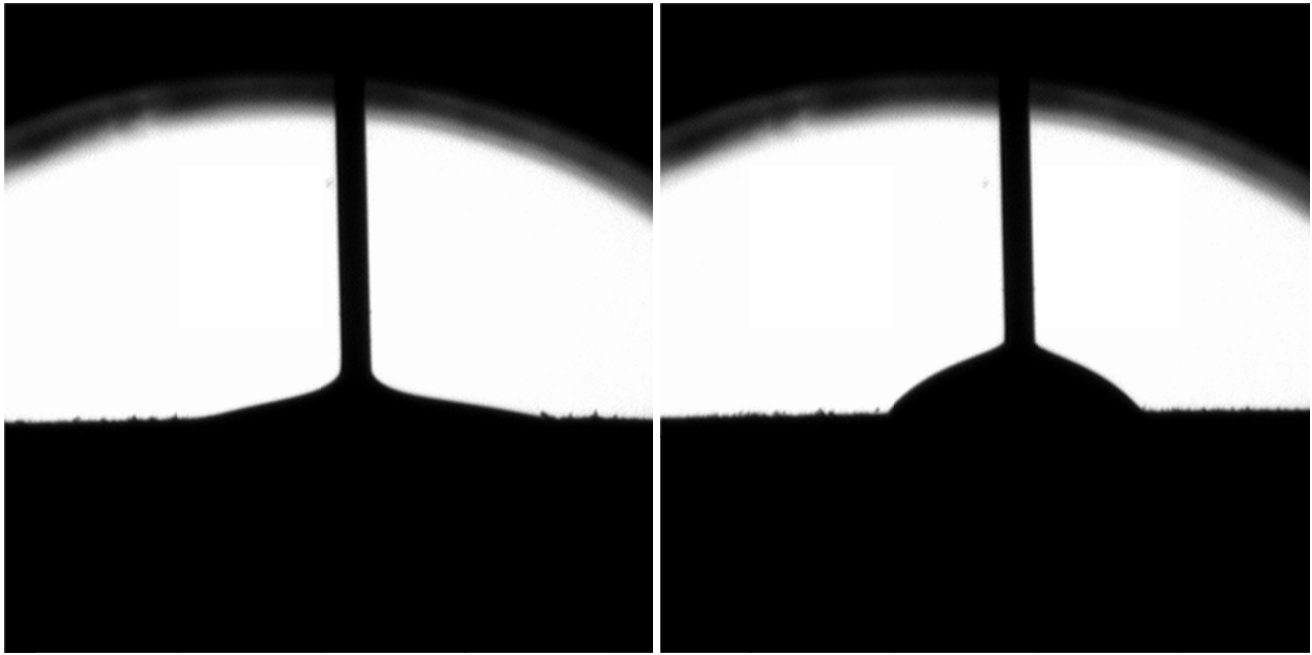
Figure 21 showing the contact angle of resin on Slash Pine with 0.2%

Figure 22 same as Figure 21, compare with Figure 18

A purposely developed multi-phase wetting system Rezex A™, was introduced to the surface resin mix only at an equivalent rate of 0.4% on dry wood weight. This was developed at the Australian National University and is now being manufactured by Oxford Technologies Australia in Melbourne. *Figures 21 & 22* show the effect i.e. reducing the contact angle of resin from above 140° to less than 20°.
